U.S. DEPARTMENT OF  
**ENERGY**

## 2018 Annual Site Inspection and Monitoring Report for Uranium Mill Tailings Radiation Control Act Title II Disposal Sites

December 2018

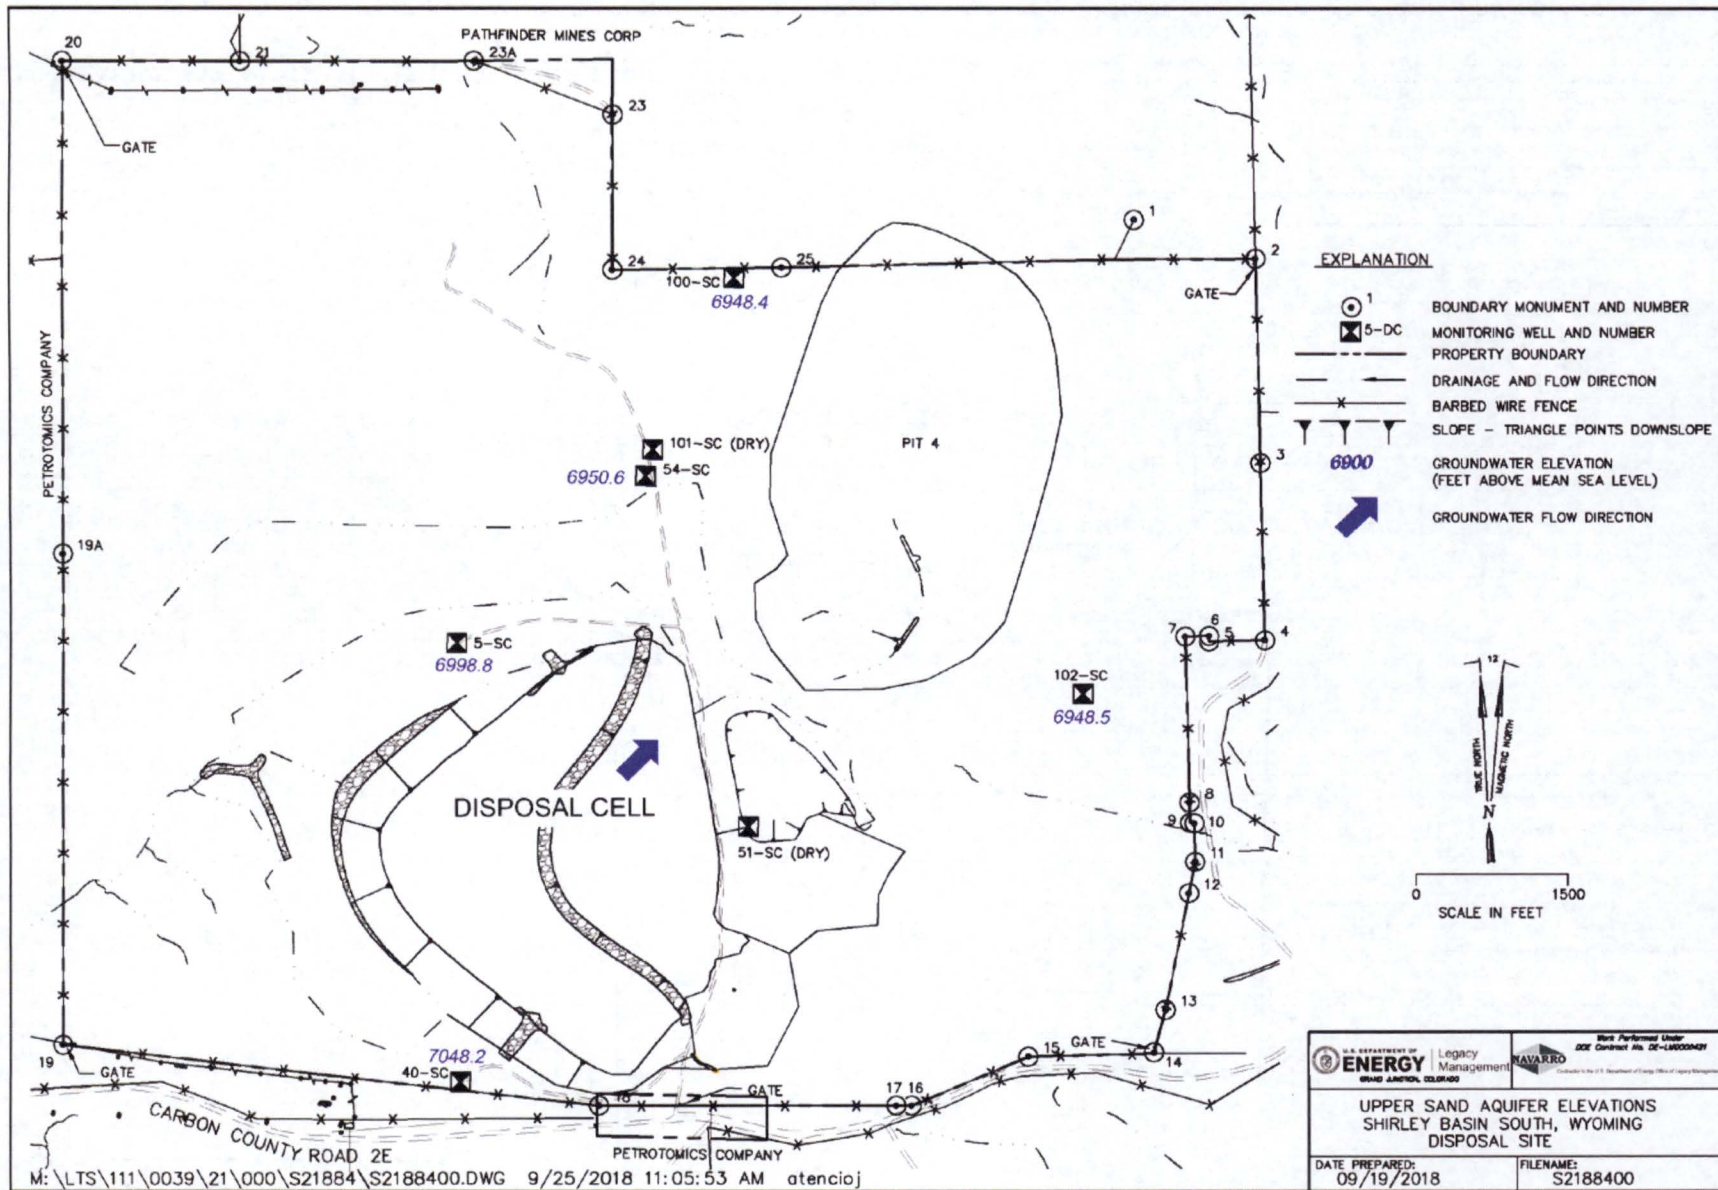
Figure 6-9. July 2018 Groundwater Elevations in the Upper Sand Aquifer at the Shirley Basin South, Wyoming, Disposal Site

Water-level elevations for the upper sand aquifer are shown in Figure 6-9. Water levels are increasing in wells 100-SC and 102-SC, but they are remaining constant in the other upper sand aquifer wells. The apparent flow direction is to the northeast, along the formation dip and toward Pit 4 (DOE 2011). The dry wells (51-SC and 101-SC) indicate that the upper sand aquifer has not recovered near Pit 4. Because the aquifer is no longer confined at the Pit 4 location and because the flooded open-pit mine on the Ur-Energy property downgradient of the site might be a groundwater sink, aquifer water levels on the site might never recover to their premining elevations (DOE 2011).

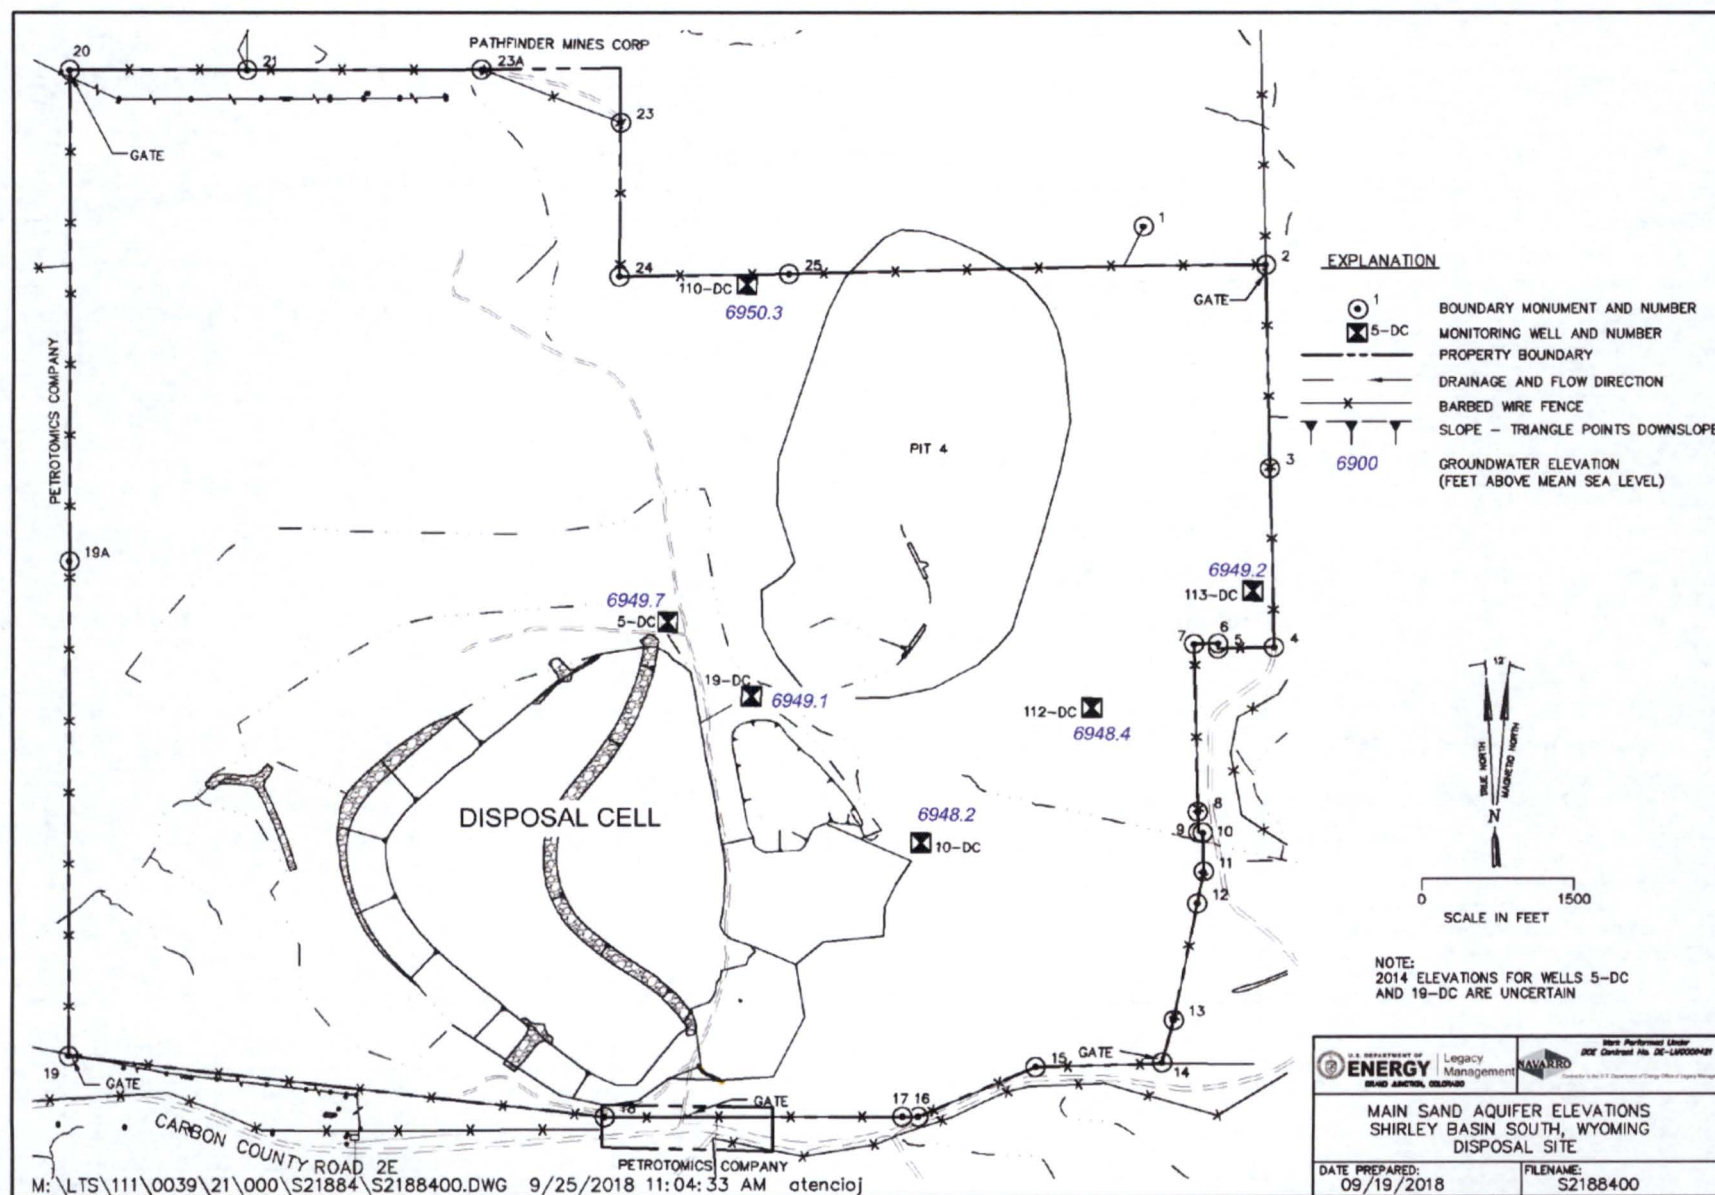
Figure 6-10. July 2018 Groundwater Elevations in the Main Sand Aquifer at the Shirley Basin South, Wyoming, Disposal Site

Main sand aquifer water elevations, shown in Figure 6-10, have been gradually rising at all wells since 2000, with an average rate of increase of approximately 0.9 foot per year since LM began monitoring water levels in 2005 (Figure 6-11). The rising levels indicate a gradual recovery of the aquifer. However, the altered conditions at Pit 4 might prevent a return to premining elevations of the water table. Also, the water surface elevation of the downgradient pit lake on the adjacent Ur-Energy property might control the surface elevation of the aquifers on the site. The groundwater elevations, several of which are from wells near Pit 4, do not indicate a definitive flow direction in the main sand aquifer. Local groundwater flow likely is affected by continued recovery of the aquifer and the hydraulic properties of the backfill material in Pit 4. Therefore, a flow direction arrow is not shown in Figure 6-10.
