DOCKET 50-255 - LICENSE DPR-20 - PALISADES
PLANT - FEED-WATER LINE WATER HAMMER

February 24, 1977

EVALUATION OF
AUXILIARY FEEDWATER AND MAIN FEEDWATER
WATER HAMMER POTENTIAL AT
PALISADES PLANT

Prepared for
CONSUMERS POWER COMPANY
by
NUCLEAR SERVICES CORPORATION
Campbell, California

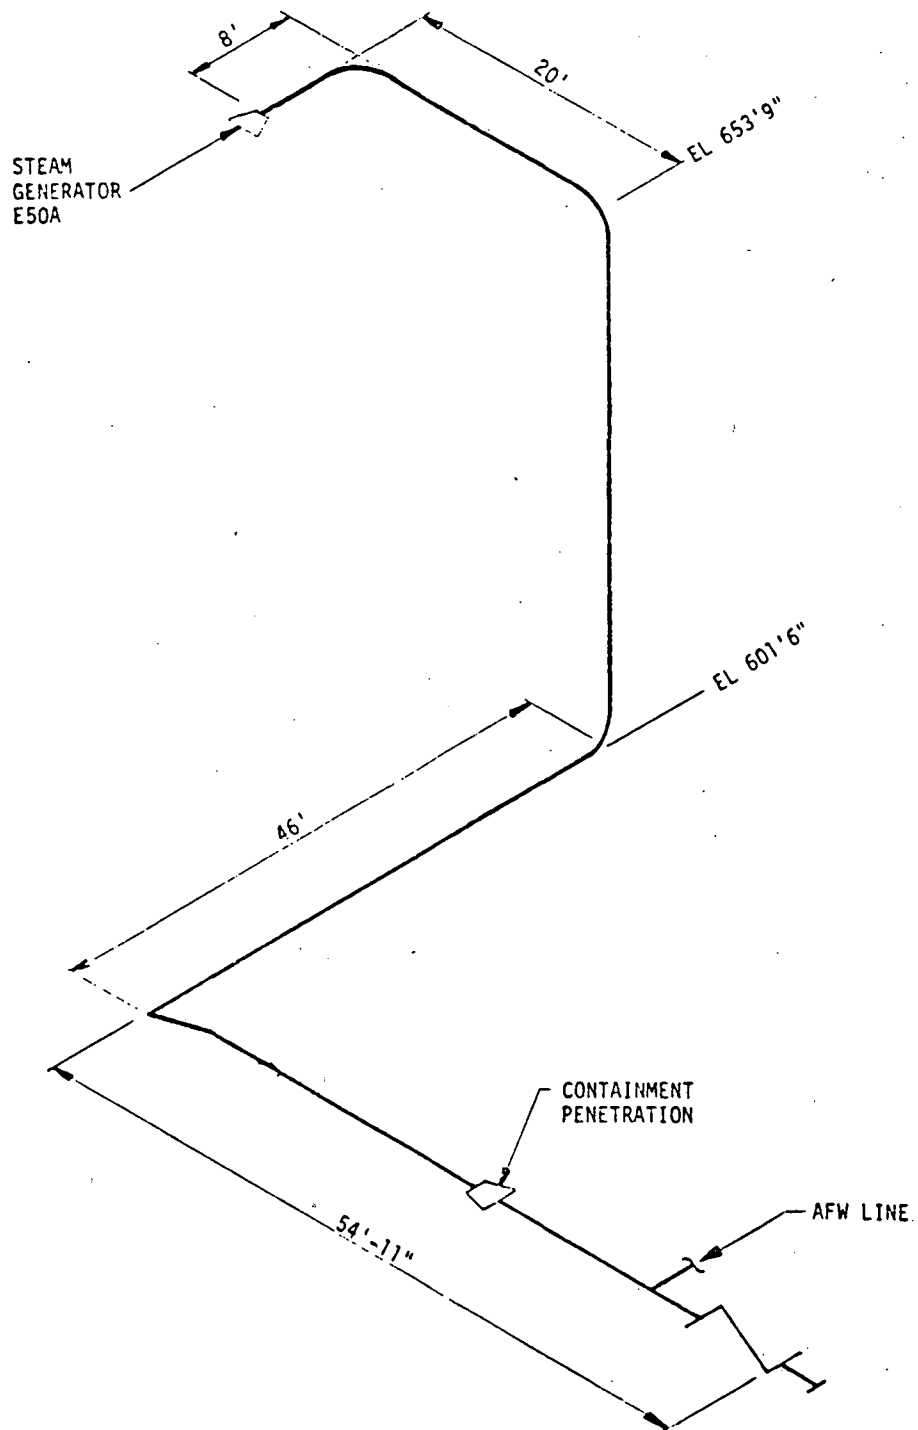
Figure 2-1. Palisades Plant
Feedwater Piping Inside Containment
Loop A (Loop B Opposite Hand)

The FW piping system originates at the two boiler feed pumps located at Elevation 590' of the turbine building. Two 18 inch lines run from the boiler feed pumps to a common header. The header divides into two branches each feeding a high pressure heater and continuing on through the containment. Each line enters the containment at Elevation 601'6" and after a horizontal run rises to Elevation 653'9". The piping after another horizontal run enters the steam generators at this elevation as shown in Figure 2-1. Each line contains a feedwater control valve and shut off valve between the pump and the high pressure heater. There is a check valve in each line just outside the containment penetration.

Inside each steam generator two 12" piping branches carry flow from the feedwater line to the feedwater sparger which is located two feet below the feedwater nozzle as shown in Figure 2-2.

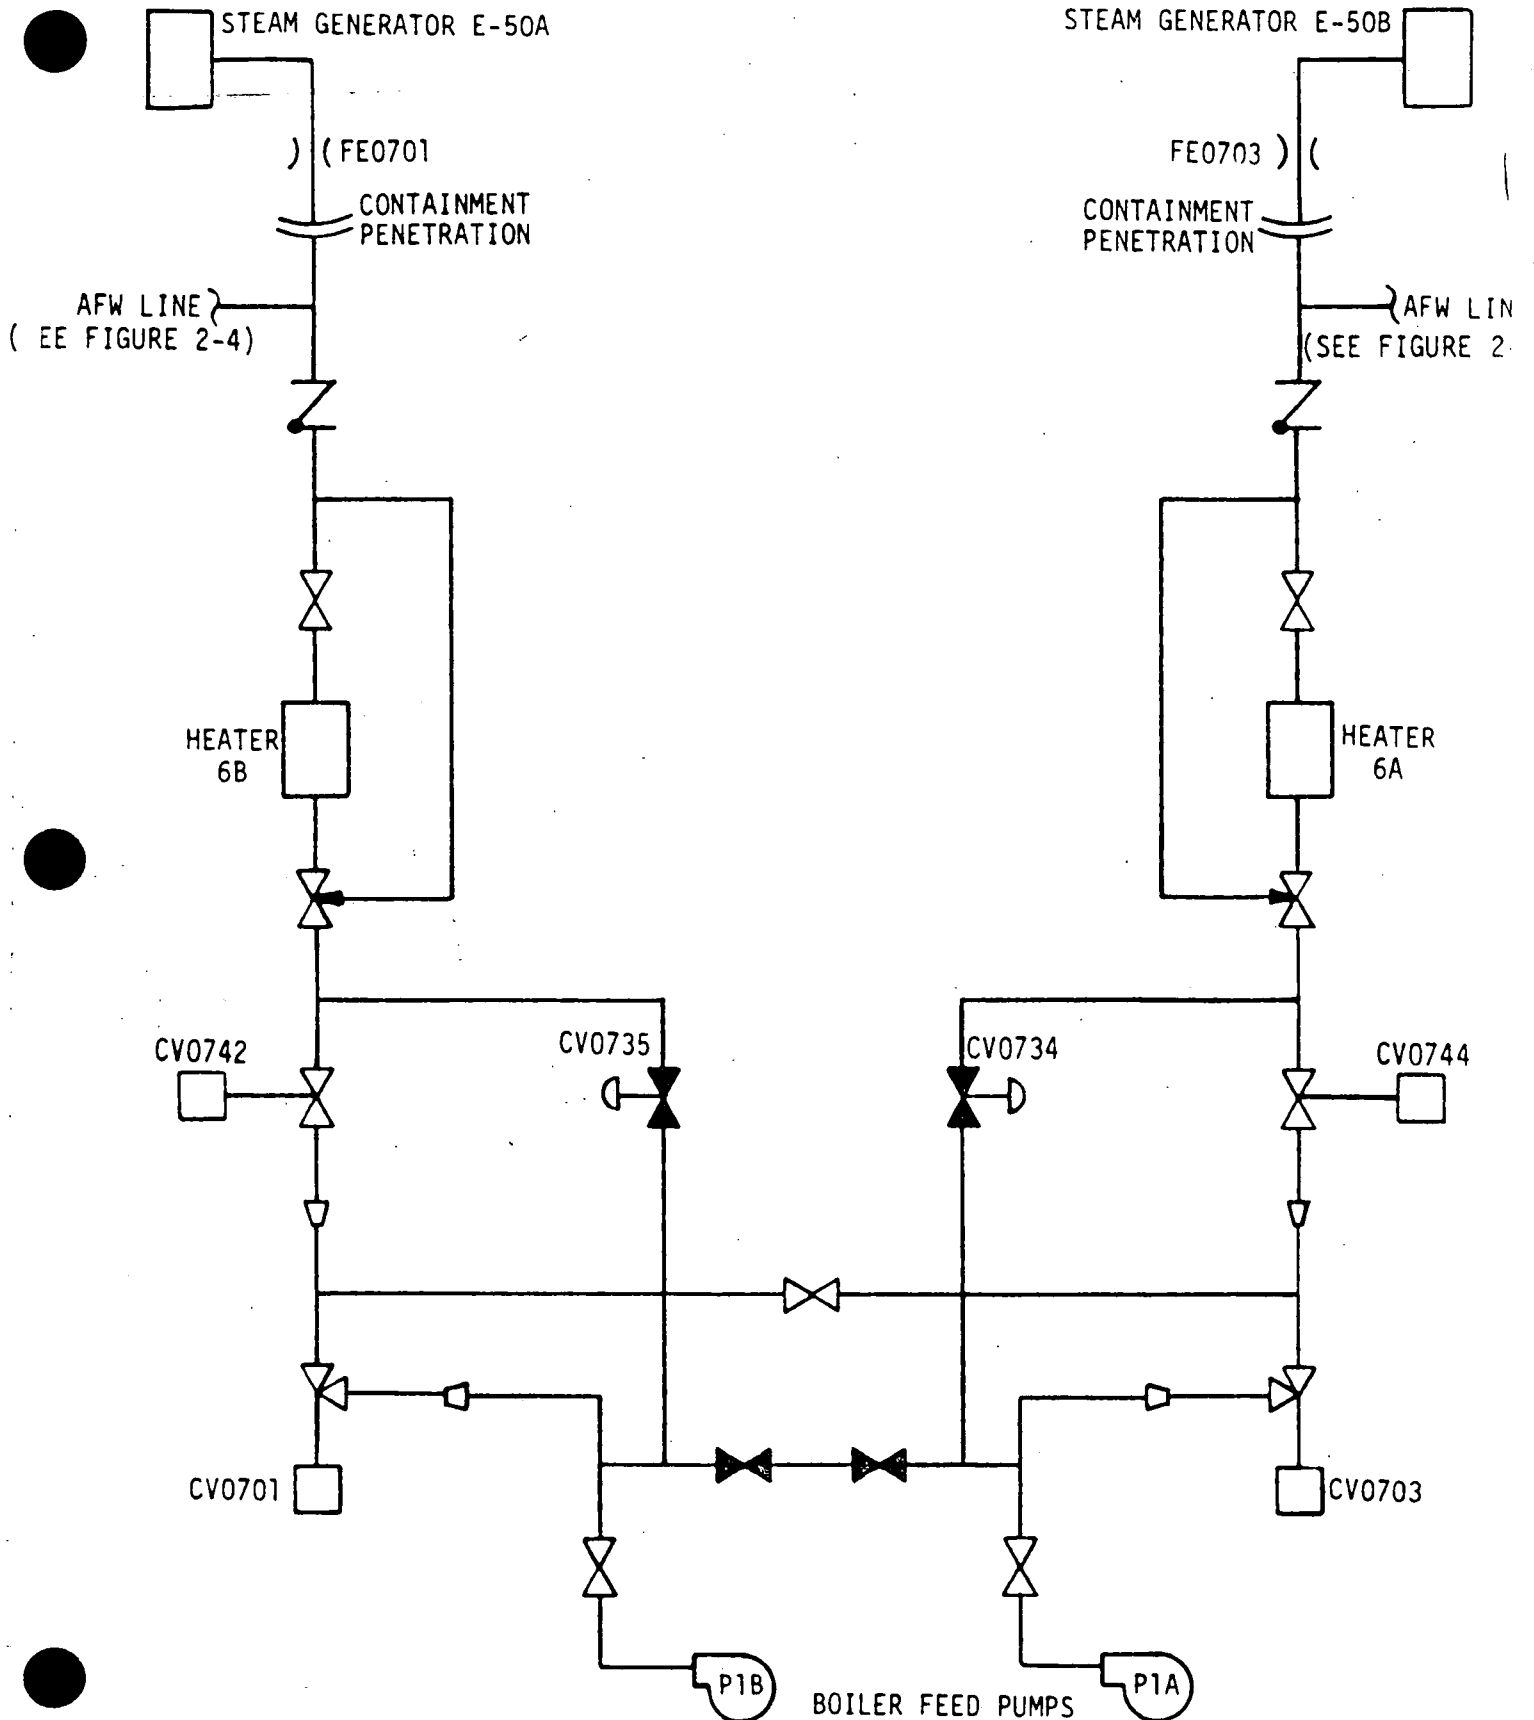
Figure 2-3. Palisades Plant
Simplified Feedwater
Flow Path

Simplified flow diagrams of the FW and AFW systems are shown in Figure 2-3 and 2-4 respectively.

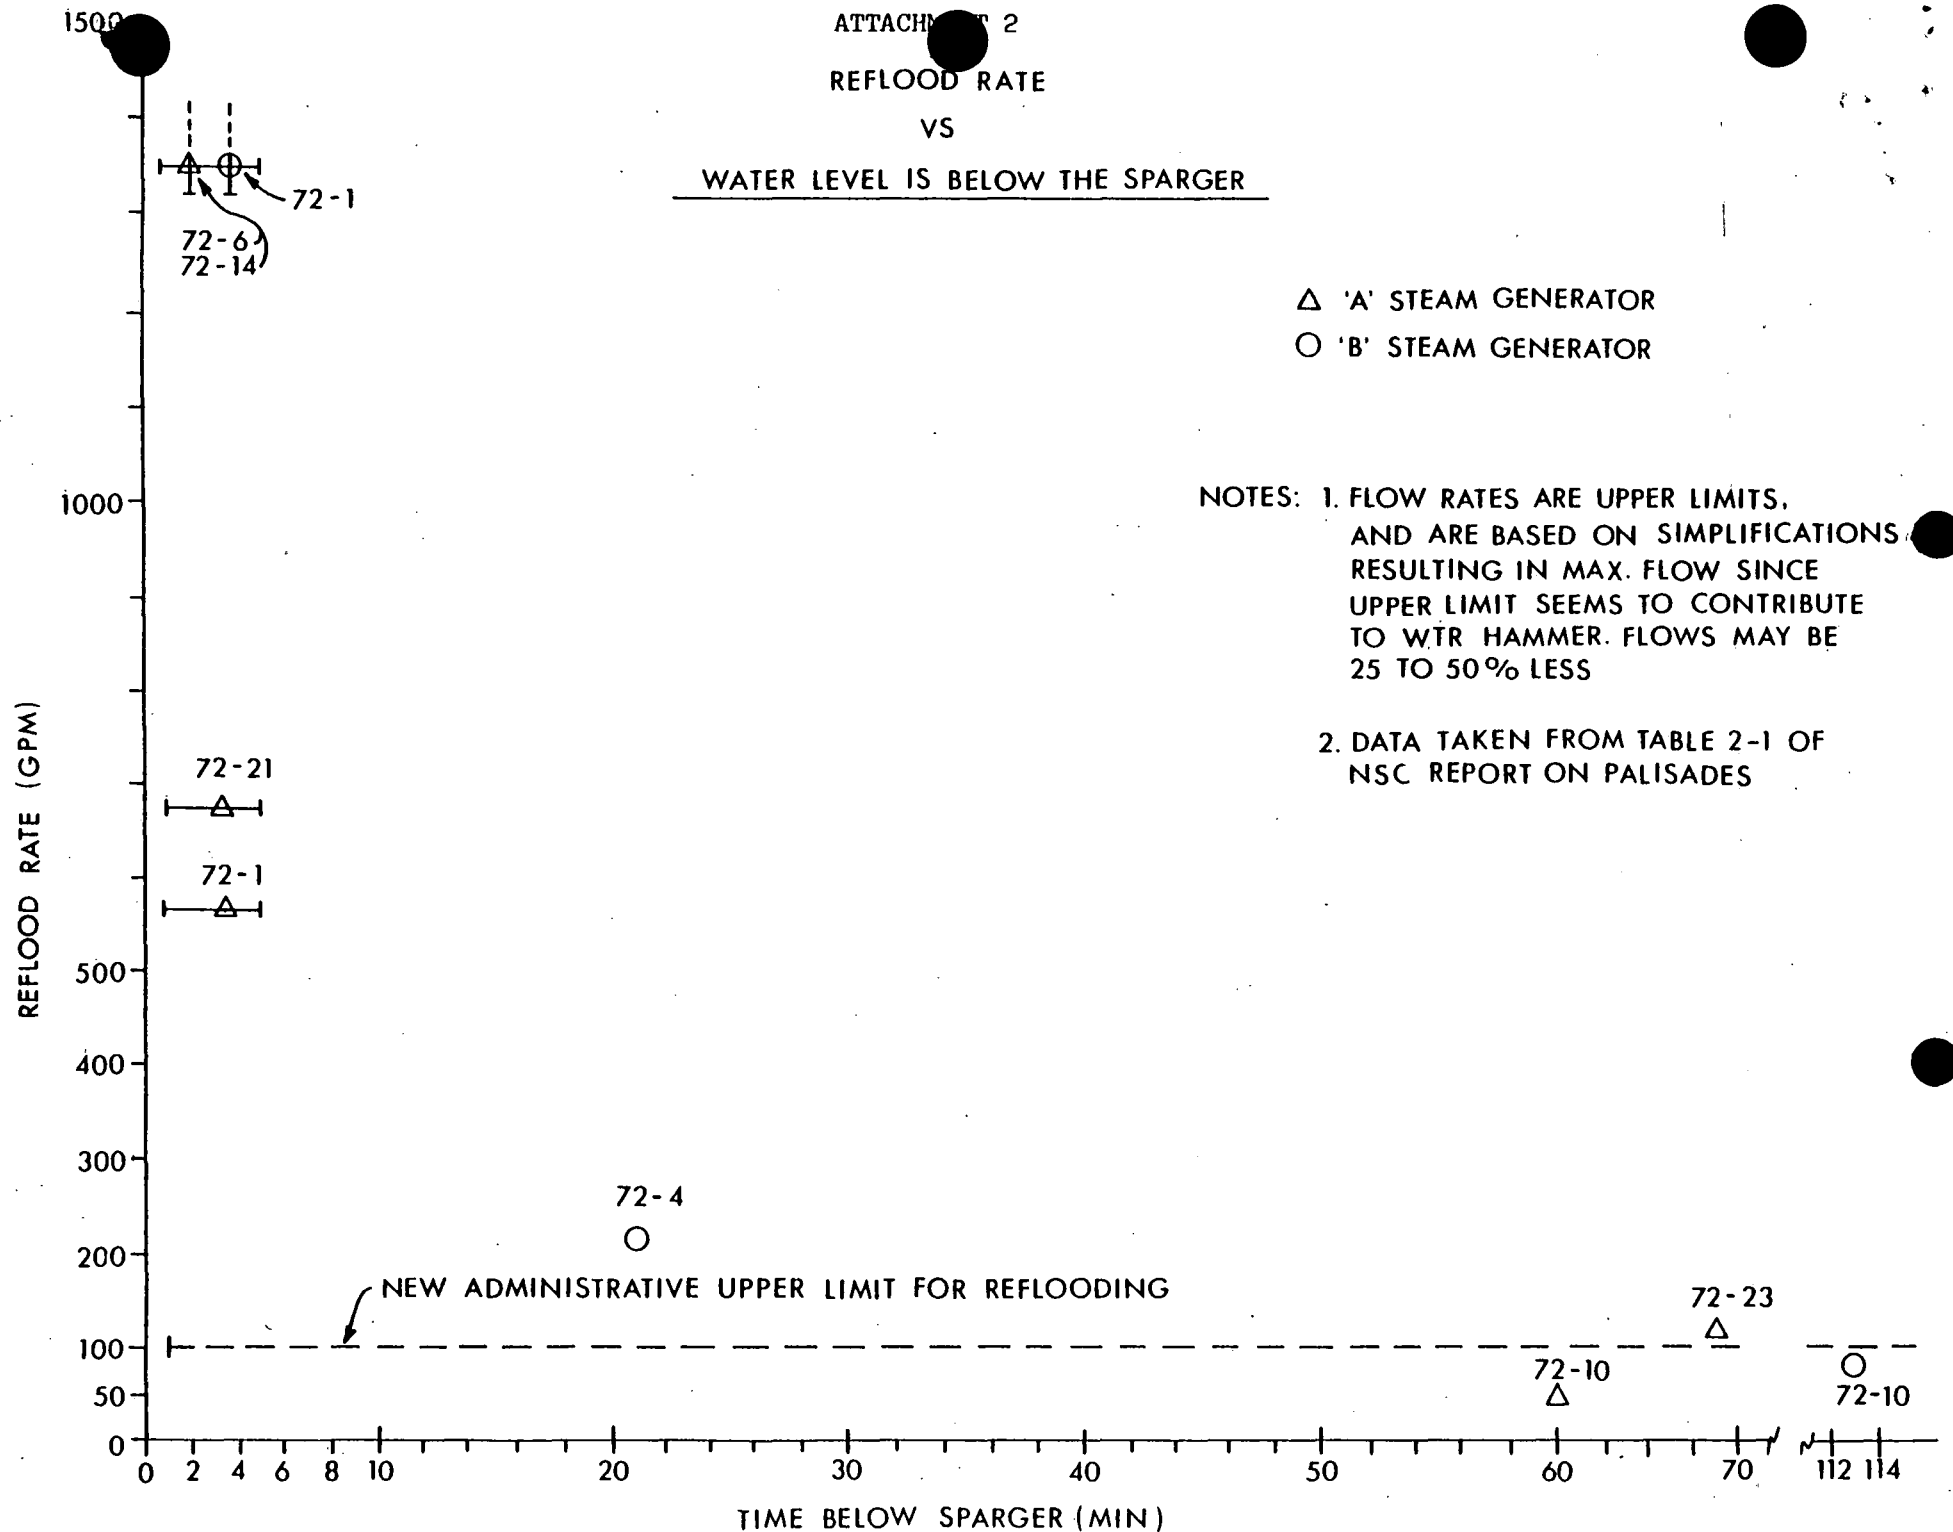
ATTACHMENT 2
REFLOOD RATE
VS

As a result of our consultant's report, Palisades Plant Administrative Procedures were modified to limit steam generator reflooding rate to 100 gpm. (See Attachment 2 for a comparison of various reflood rates and plant trips.)
