UNITED STATES
NUCLEAR REGULATORY COMMISSION

SUBJECT: NRC INSPECTION REPORT 030-37816/2019-001 AND NOTICE OF VIOLATION

Intertek Asset Integrity Management, Inc. NRC Reactive Inspection Report 030-37816/2019-001 (Health and Safety)

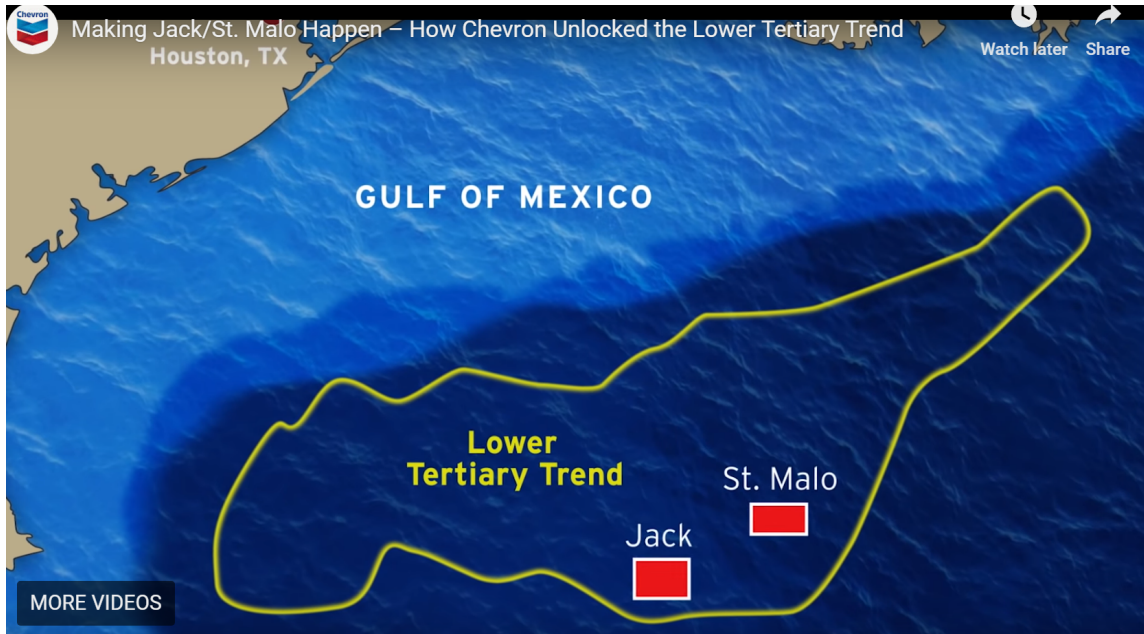
During a series of radiographic exposures offshore in the Gulf of Mexico in Walker Ridge, approximately 280 miles south of New Orleans (see Figure 1), the licensee experienced a radiography source disconnect on January 26, 2019, at approximately 4:30 p.m. (all times are in Central Time). The radiography was occurring in one of the "legs" (Chiller Room, Northwest Hull) to an offshore production platform in the Jack/St. Malo offshore oil field (see Figure 2).

Figure 1 - Location of the offshore fields that the single platform services (Chevron website).
