TENNESSEE VALLEY AUTHORITY

September 6, 1979

PHIPPS BEND NUCLEAR PLANT REVERSE FAULT IN SOIL PIT

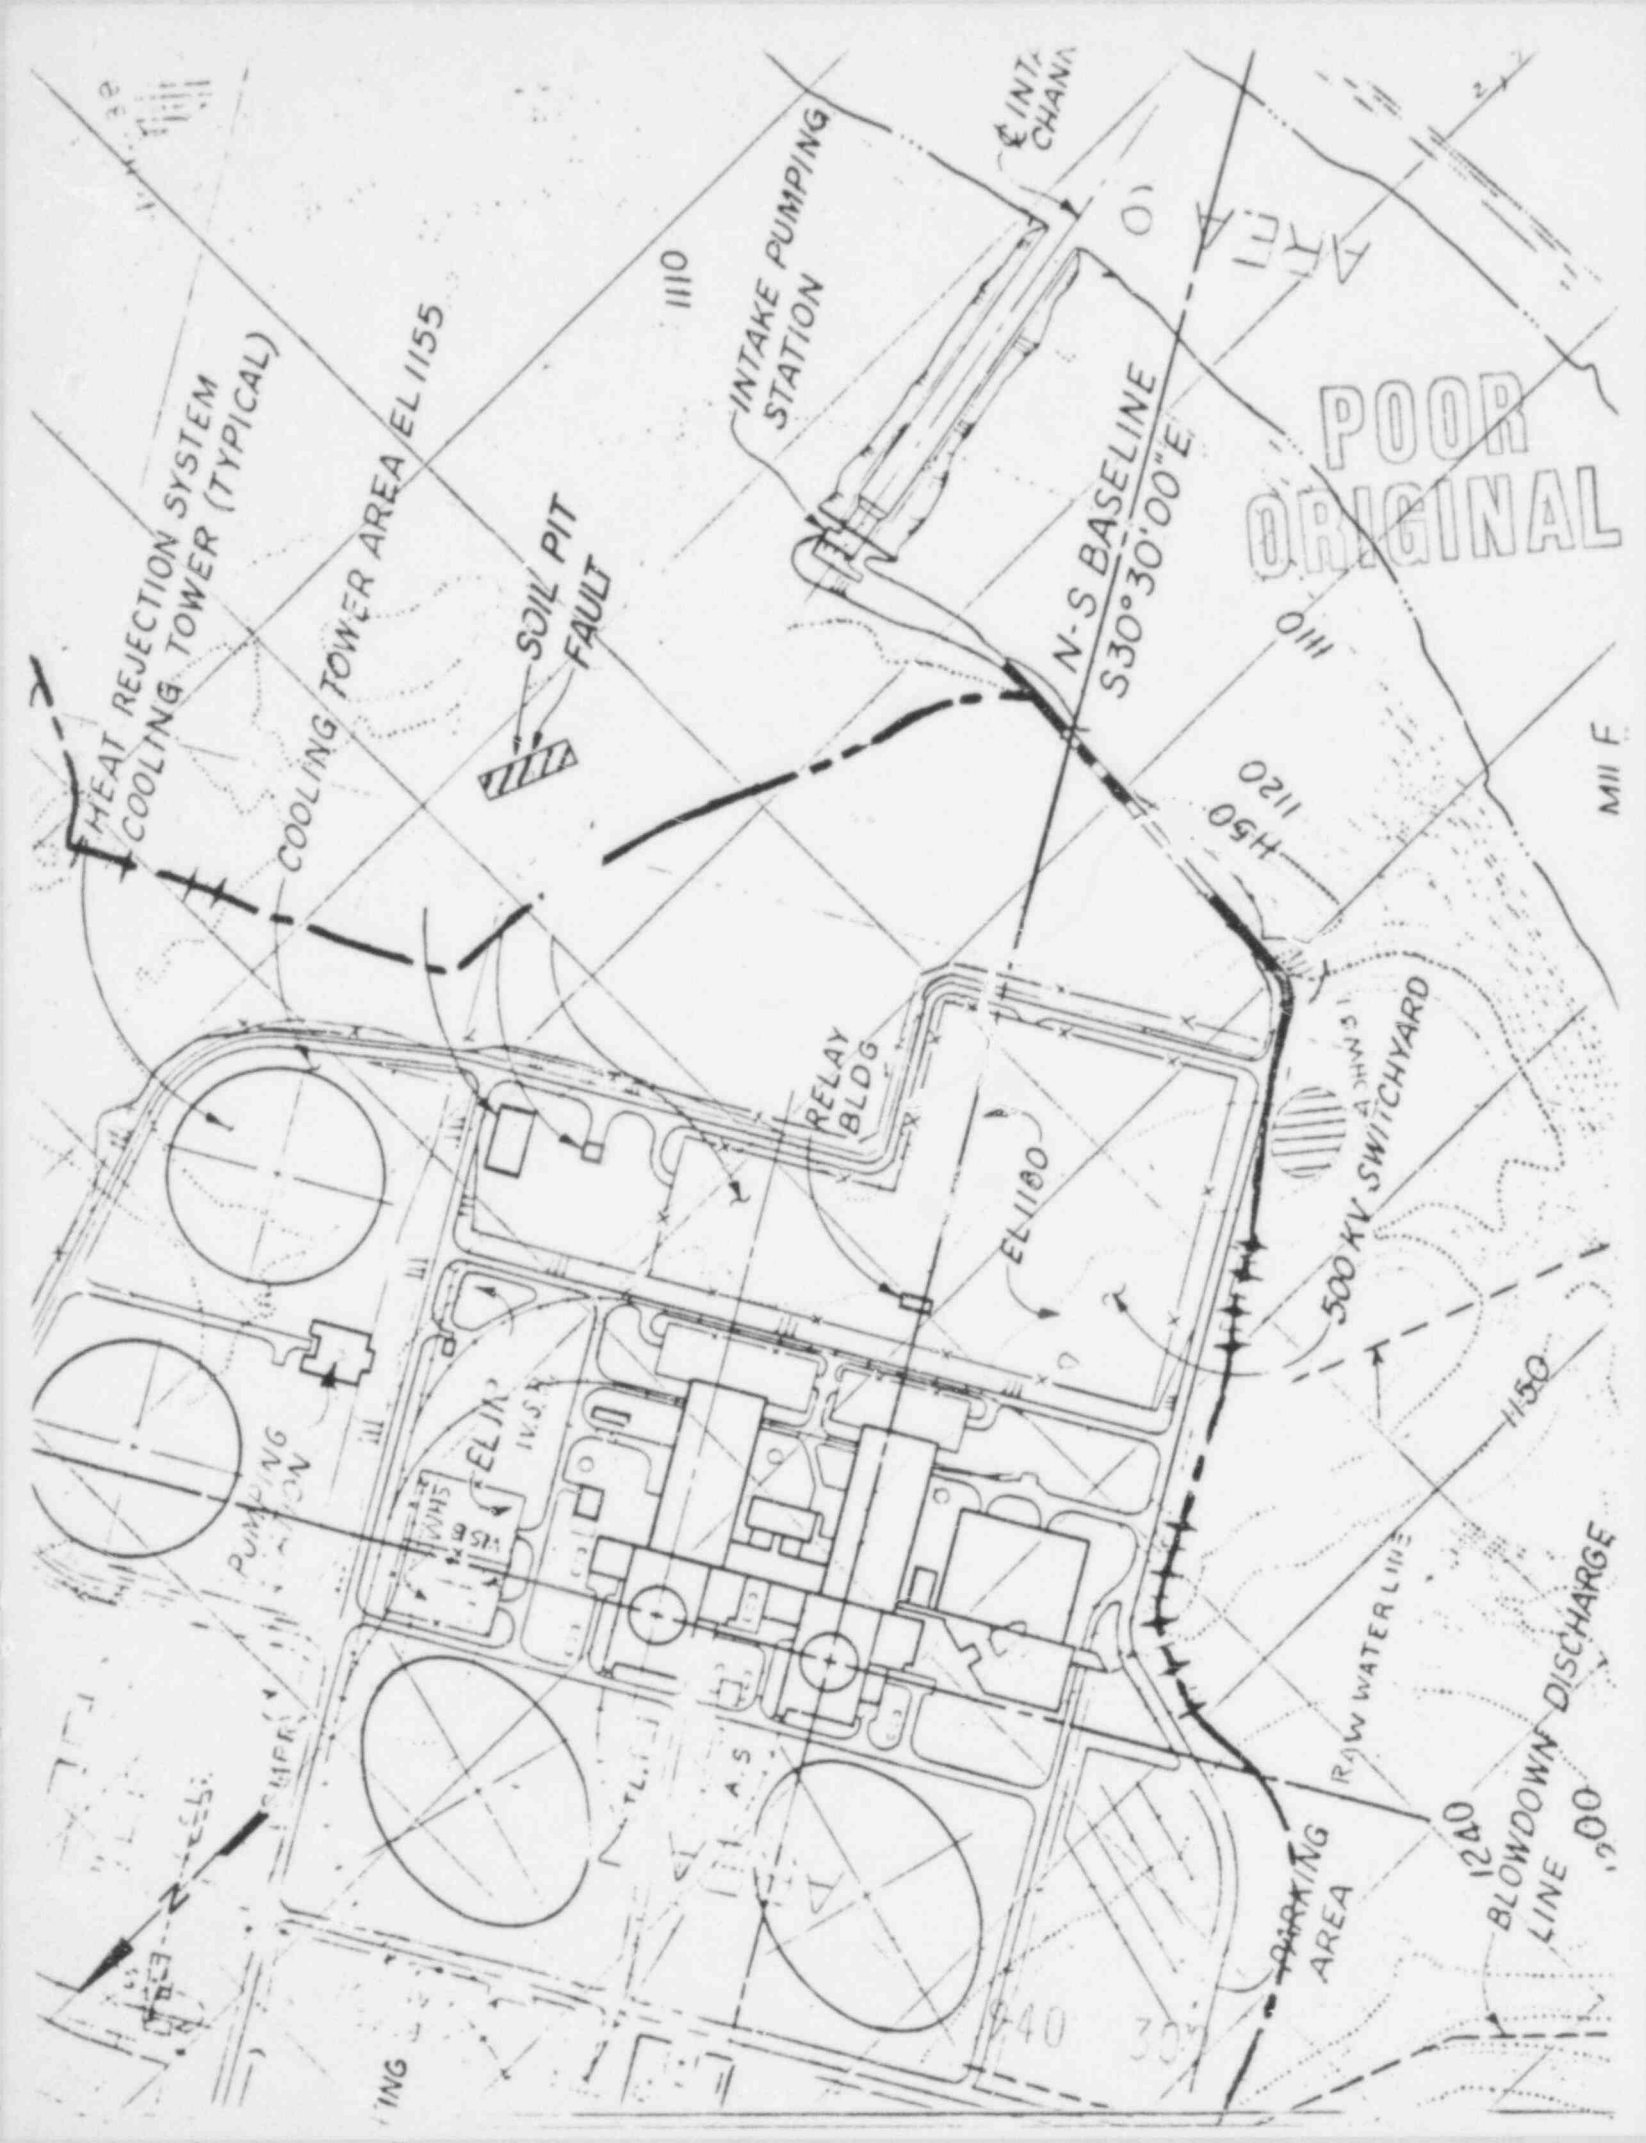
SOIL PIT EAST WALL

This is a reverse fault, defined by a tight fracture, which strikes N.50°E. and dips 55°SE. (See attached photographs and sketch.) On the north side of the fault, bedding strikes N.50°E. and dips 62°SE.; on the south side, adjacent to the fault, bedding is contorted, but farther to the south it strikes N.45°E. and dips 45°SE.

Above the fault, at the contact between top of rock and Quaternary terrace deposits, the gravel layer shows no offsets or disturbances. No evidence has been found which would indicate that this fault did not occur in the early tectonic development of the Paleozoic (250 ⁺ million years before present) folding and faulting in this area. The fault site, having been stable for 250 million years, is not considered to be capable of producing ground offsets or generating earthquakes. Therefore, we do not classify it as a capable fault, within the meaning of Appendix A to 10 CFR Part 100.
