June 17, 1977

THREE MILE ISLAND NUCLEAR STATION
UNIT 1

REACTOR CONTAINMENT BUILDING
RING GIRDER SURVEILLANCE TEST
THREE YEARS AFTER S. I. T.

METROPOLITAN EDISON COMPANY
Subsidiary of General Public Utilities, Corp.

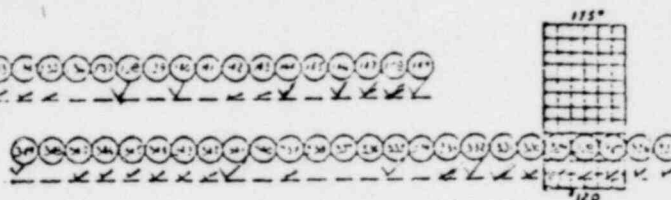
CONCRETE CRACKS ADJACENT TO DOME TENDON BEARING AREAS
AND CONCRETE-TO-METAL GAPS
Southwest (S.W.) Quadrant

1. All cracks are less than 0.005 in. wide.
2. Unless otherwise noted the cracks extend from the metal bearing plate across the adjoining two to four inches of concrete.
3. Bearing area blocked from inspection by vent stack.
4. Voids Discovered. (All Voids are shown on Figures 6-12).
5. D 247SW & D248SW have very narrow gaps (unmeasurable) between the bottom of the bearing plate and the adjoining concrete.
6. Note 4 & 5 refer to 1976 data. No additional cavities or voids were discovered during 1977.

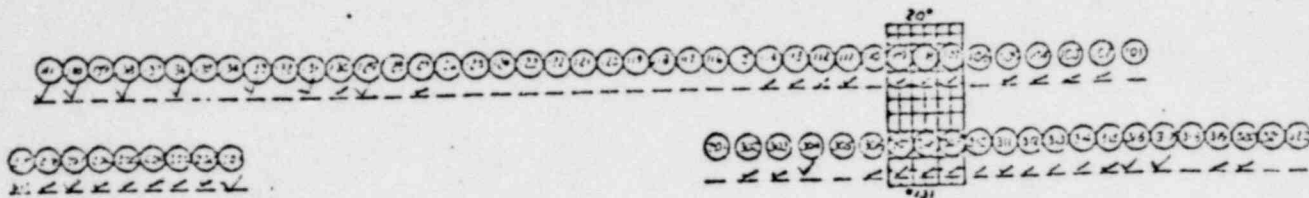
CONCRETE CRACKS ADJACENT TO DOME TENDON BEARING AREAS
AND CONCRETE-TO-METAL GAPS
Northeast (N.E.) Quadrant

1. All cracks are less than 0.005 in. wide.
2. Unless otherwise noted the cracks extend from the metal bearing plate across the adjoining two to four inches of concrete.
3. Five cracks less than 0.005 inc. radiate down from the bottom of the bearing plate, spaced approximately five inches on centers and terminating about one inch from the edge of the bearing plate.
4. Four cracks -- similar to those described in Note 3.
5. Void Discovered. (All Voids are shown on Figures 6-12).
6. Note 4 & 5 refer to 1976 data. No additional cavities or voids were discovered during 1977.

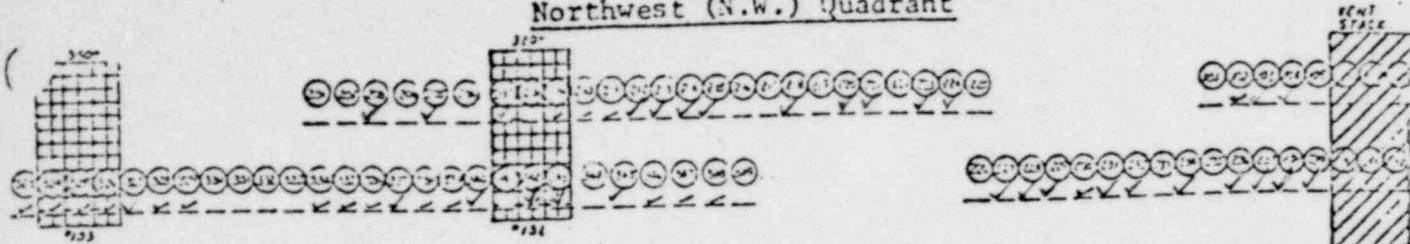
CONCRETE CRACKS ADJACENT TO DOME TENDON BEARING AREAS
AND CONCRETE-TO-METAL GAPS
Northwest (N.W.) Quadrant

1. All cracks are less than 0.005 in. wide
2. Unless otherwise noted the cracks extend from the metal bearing plate across the adjoining two to four inches of concrete.
3. Bearing area blocked from inspection by vent stack.
4. Void Discovered. (All Voids are shown on Figures 6-12).
5. Note 4 refers to 1976 data. No additional cavities or voids were discovered during 1977.
