ADDENDUM 4

REPORT ON CONTAINMENT BUILDING RING GIRDER  
CONSTRUCTION AND REPAIR

THREE MILE ISLAND NUCLEAR STATION

METROPOLITAN EDISON COMPANY

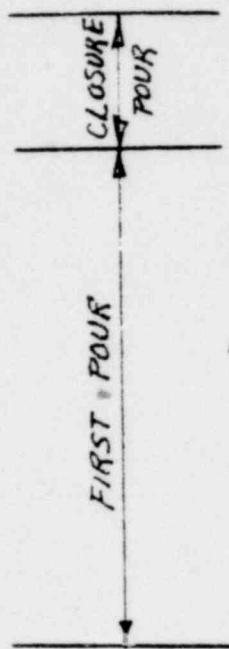
FIGURE 3 Part Section through ring beam showing typical repair pours for upper dome tendon areas

The horizontal ring girder construction joints at elevations 443 ft-0 in. and 446 ft-9 in. have been investigated for transfer of shear under load combinations including normal operation, initial prestress, accident, pressure test, seismic, wind, and aircraft impact. As originally constructed, the joints at these elevations extended horizontally across the entire ring girder section. Visual examination and core-borings as documented in Addendum 2 indicated that part of the joint extending in from the outside face of the ring beam was questionable for load transfer. The questionable areas of the joint have been completely excavated as shown in Figures 1, 2, and 3.

Note: Shading indicates area excavated for repair
