**Wisconsin Electric** POWER COMPANY

DOCKET NOS. 50-266 AND 50-301  
RESPONSE TO IE BULLETIN 79-13  
POINT BEACH NUCLEAR PLANT, UNITS 1 AND 2

Response to  
IE Bulletin 79-13  
July 10, 1979

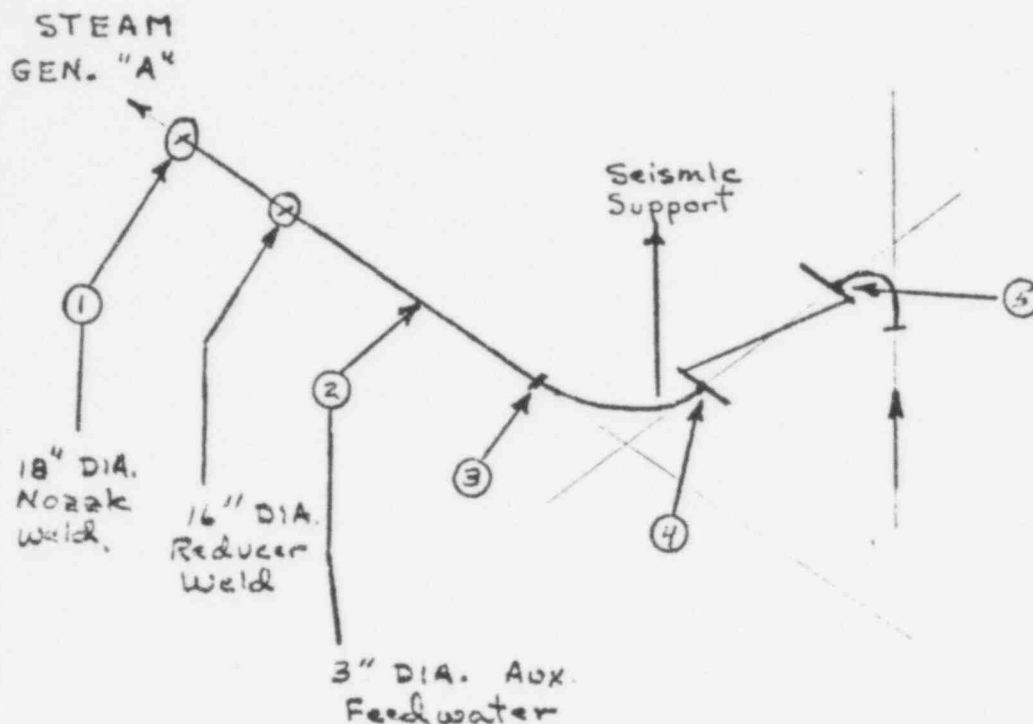
FIGURE 1

Figures 1 thru 4 tabulate the design stress levels from the steam generator nozzle weld (data point 1) thru the check valve located closest to the steam generator. The original piping analysis did not consider the reducer; the stress results for data point 1 are for a 16 inch diameter pipe. Thus, the actual stresses are less than those tabulated. However, based upon the original piping analysis, there are no known weld locations in the feedwater piping where either the thermal stress or the summation of the seismic stresses exceed 90% of the code allowable stresses. Thus, no other welds have been examined.

Data Point	Item	Thermal Stress, psi	Summation of OBE Stresses, psi	Summation of SSE Stresses, psi
1*	St. Gen. Nozzle to reducer weld	3,621	12,534	18,460
2	Aux. FW Conn.	-	12,280	17,952
3	Pipe to elbow	3,728	15,434	24,260
4	Elbow to check valve	5,706	11,232	15,856
5	Check valve to elbow	-	14,011	21,414
-	Allowable stress, psi	22,500	18,000	27,000
* - see text.		593 286

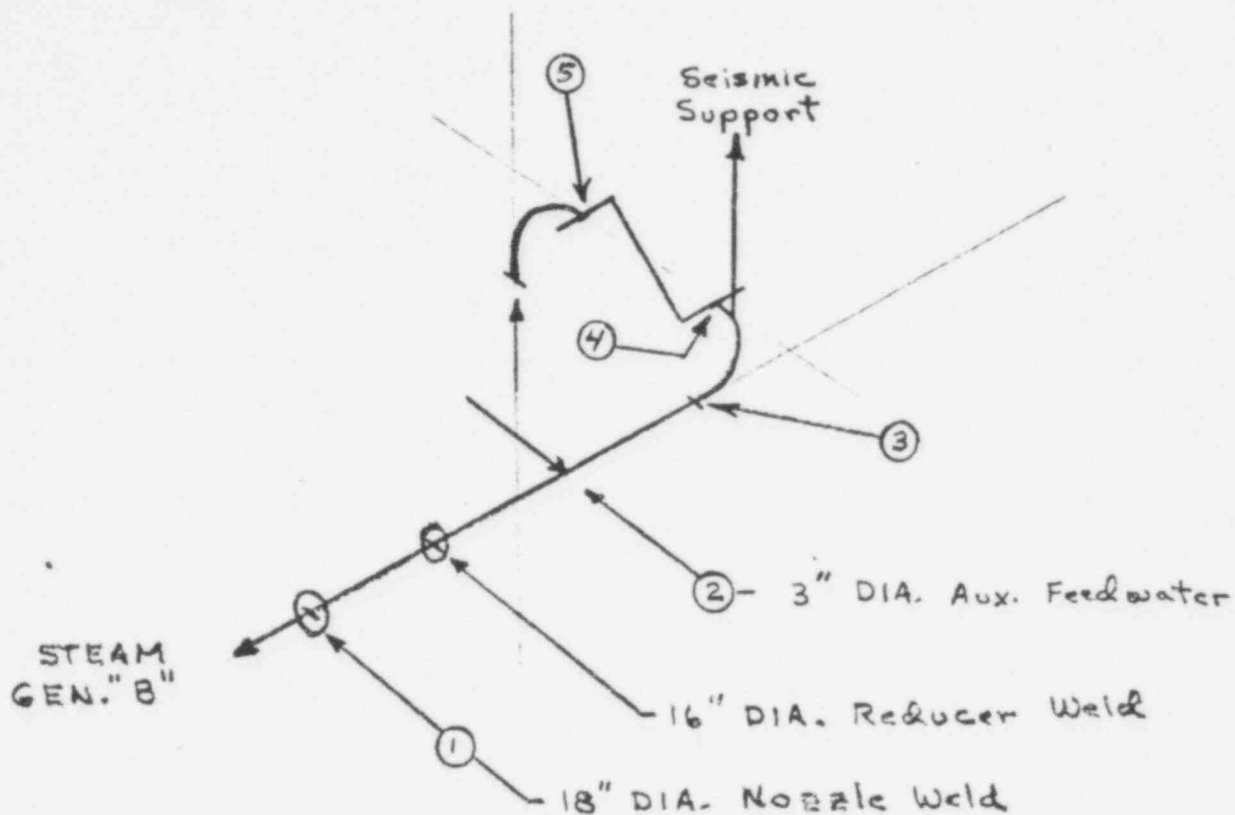
Data Point	Item	Thermal Stress, psi	Summation of OBE Stresses, psi	Summation of SSE Stresses, psi
1*	St. Gen. Nozzle to reducer weld	1,730	7,955	9,302
2	Aux. FW Conn.	—	11,072	15,536
3	Pipe to elbow	12,860	7,832	9,056
4	Elbow to check valve	—	8,130	9,652
5	Check valve to elbow	576	7,736	8,864
			593	<del>285</del> 287
—	Allowable Stress, psi	22,500	18,000	27,000

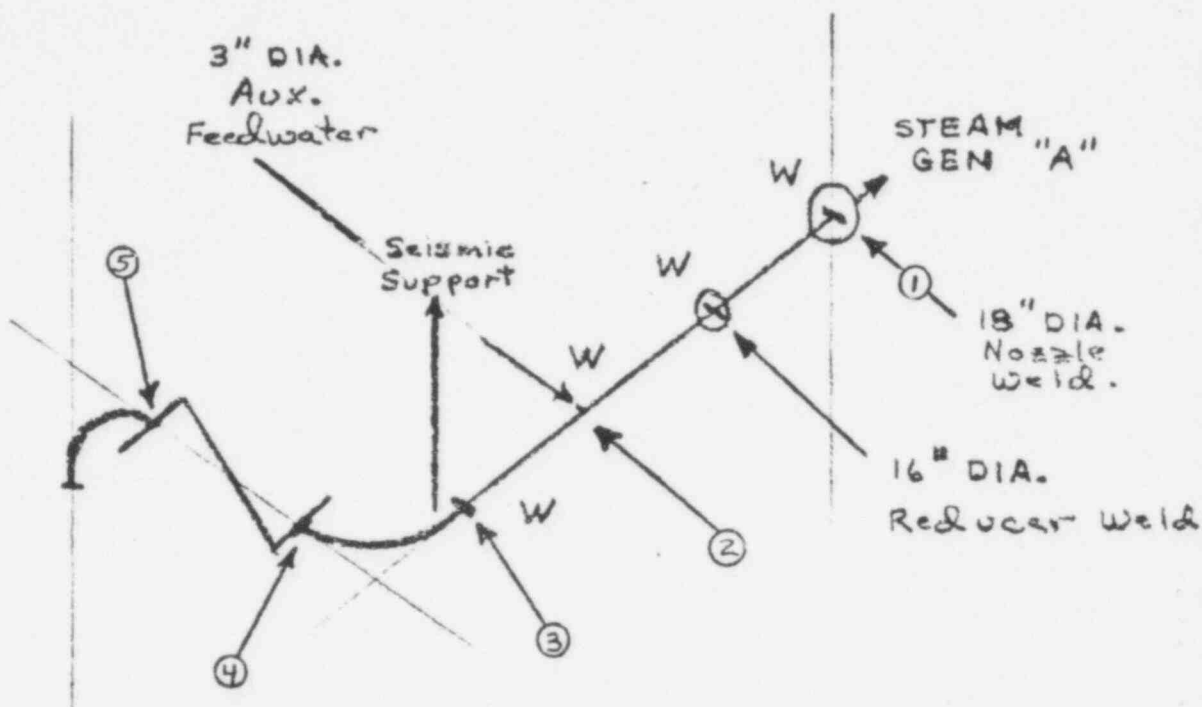
FIGURE 3

The Unit 2 welds identified on Figures 3 and 4 have been inspected and repaired.

W - Inspected  
Weld

Data Point	Item	Thermal Stress, psi	Summation of OBE stresses, psi	Summation of SSE stresses, psi
1*	St. Gen. Nozzle To Reducer Weld	7,925	9,689	12,770
2	Aux. FW Conn.	—	8,607	10,606
3	Pipe to elbow	12,860	11,144	15,680
4	Elbow to check Valve	—	8,020	9,432
5	check valve to elbow	516	10,256	13,904

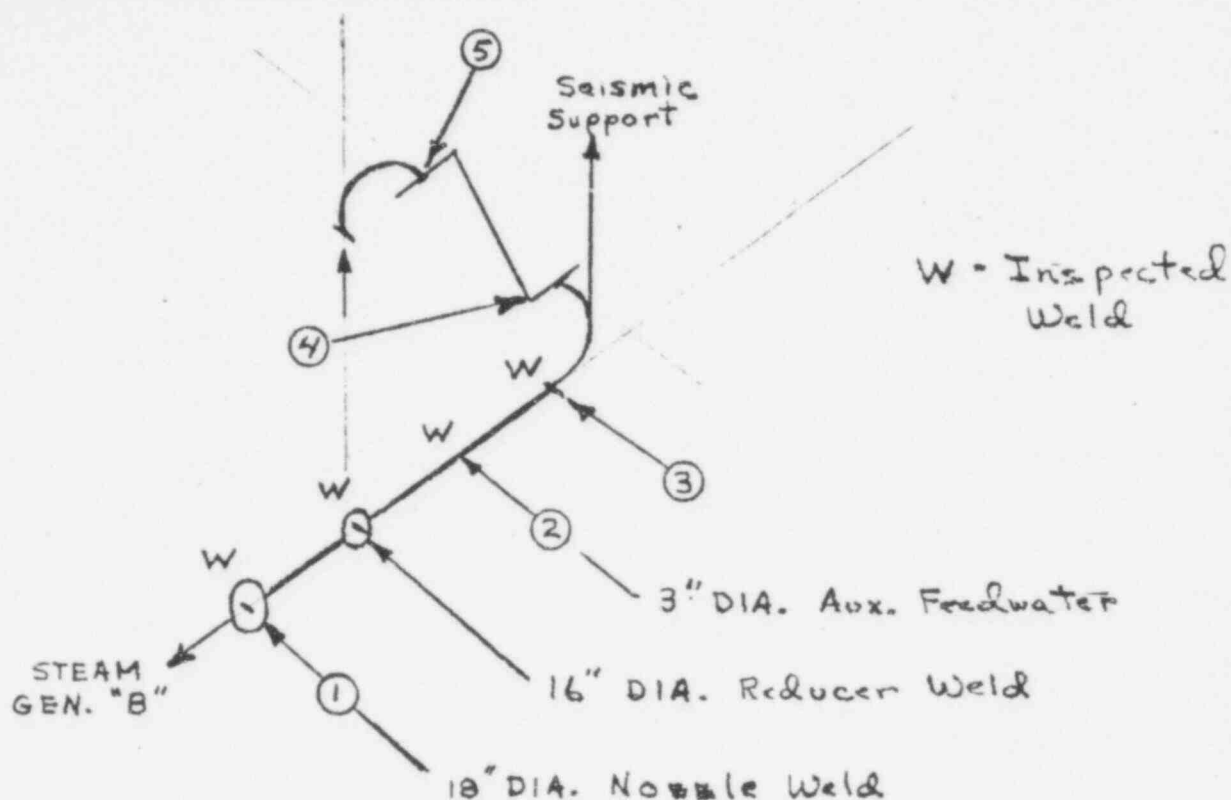
FIGURE 4

Data Point	Item	Thermal Stress, psi	Summation of OBE Stresses, psi	Summation of SSE Stresses, psi
1*	St. Gen. Nozzle To Reducer Weld	4,613	8,065	9,522
2	Aux. FW Conn.	5,127	7,736	8,864
3	Pipe to elbow	11,331	7,985	9,362
4	Elbow to check valve	971	8,639	10,670
5	check valve to elbow	7,433	8,231	9,854
-	Allowable stress, psi	22,500	18,000	27,000
* -	See text.

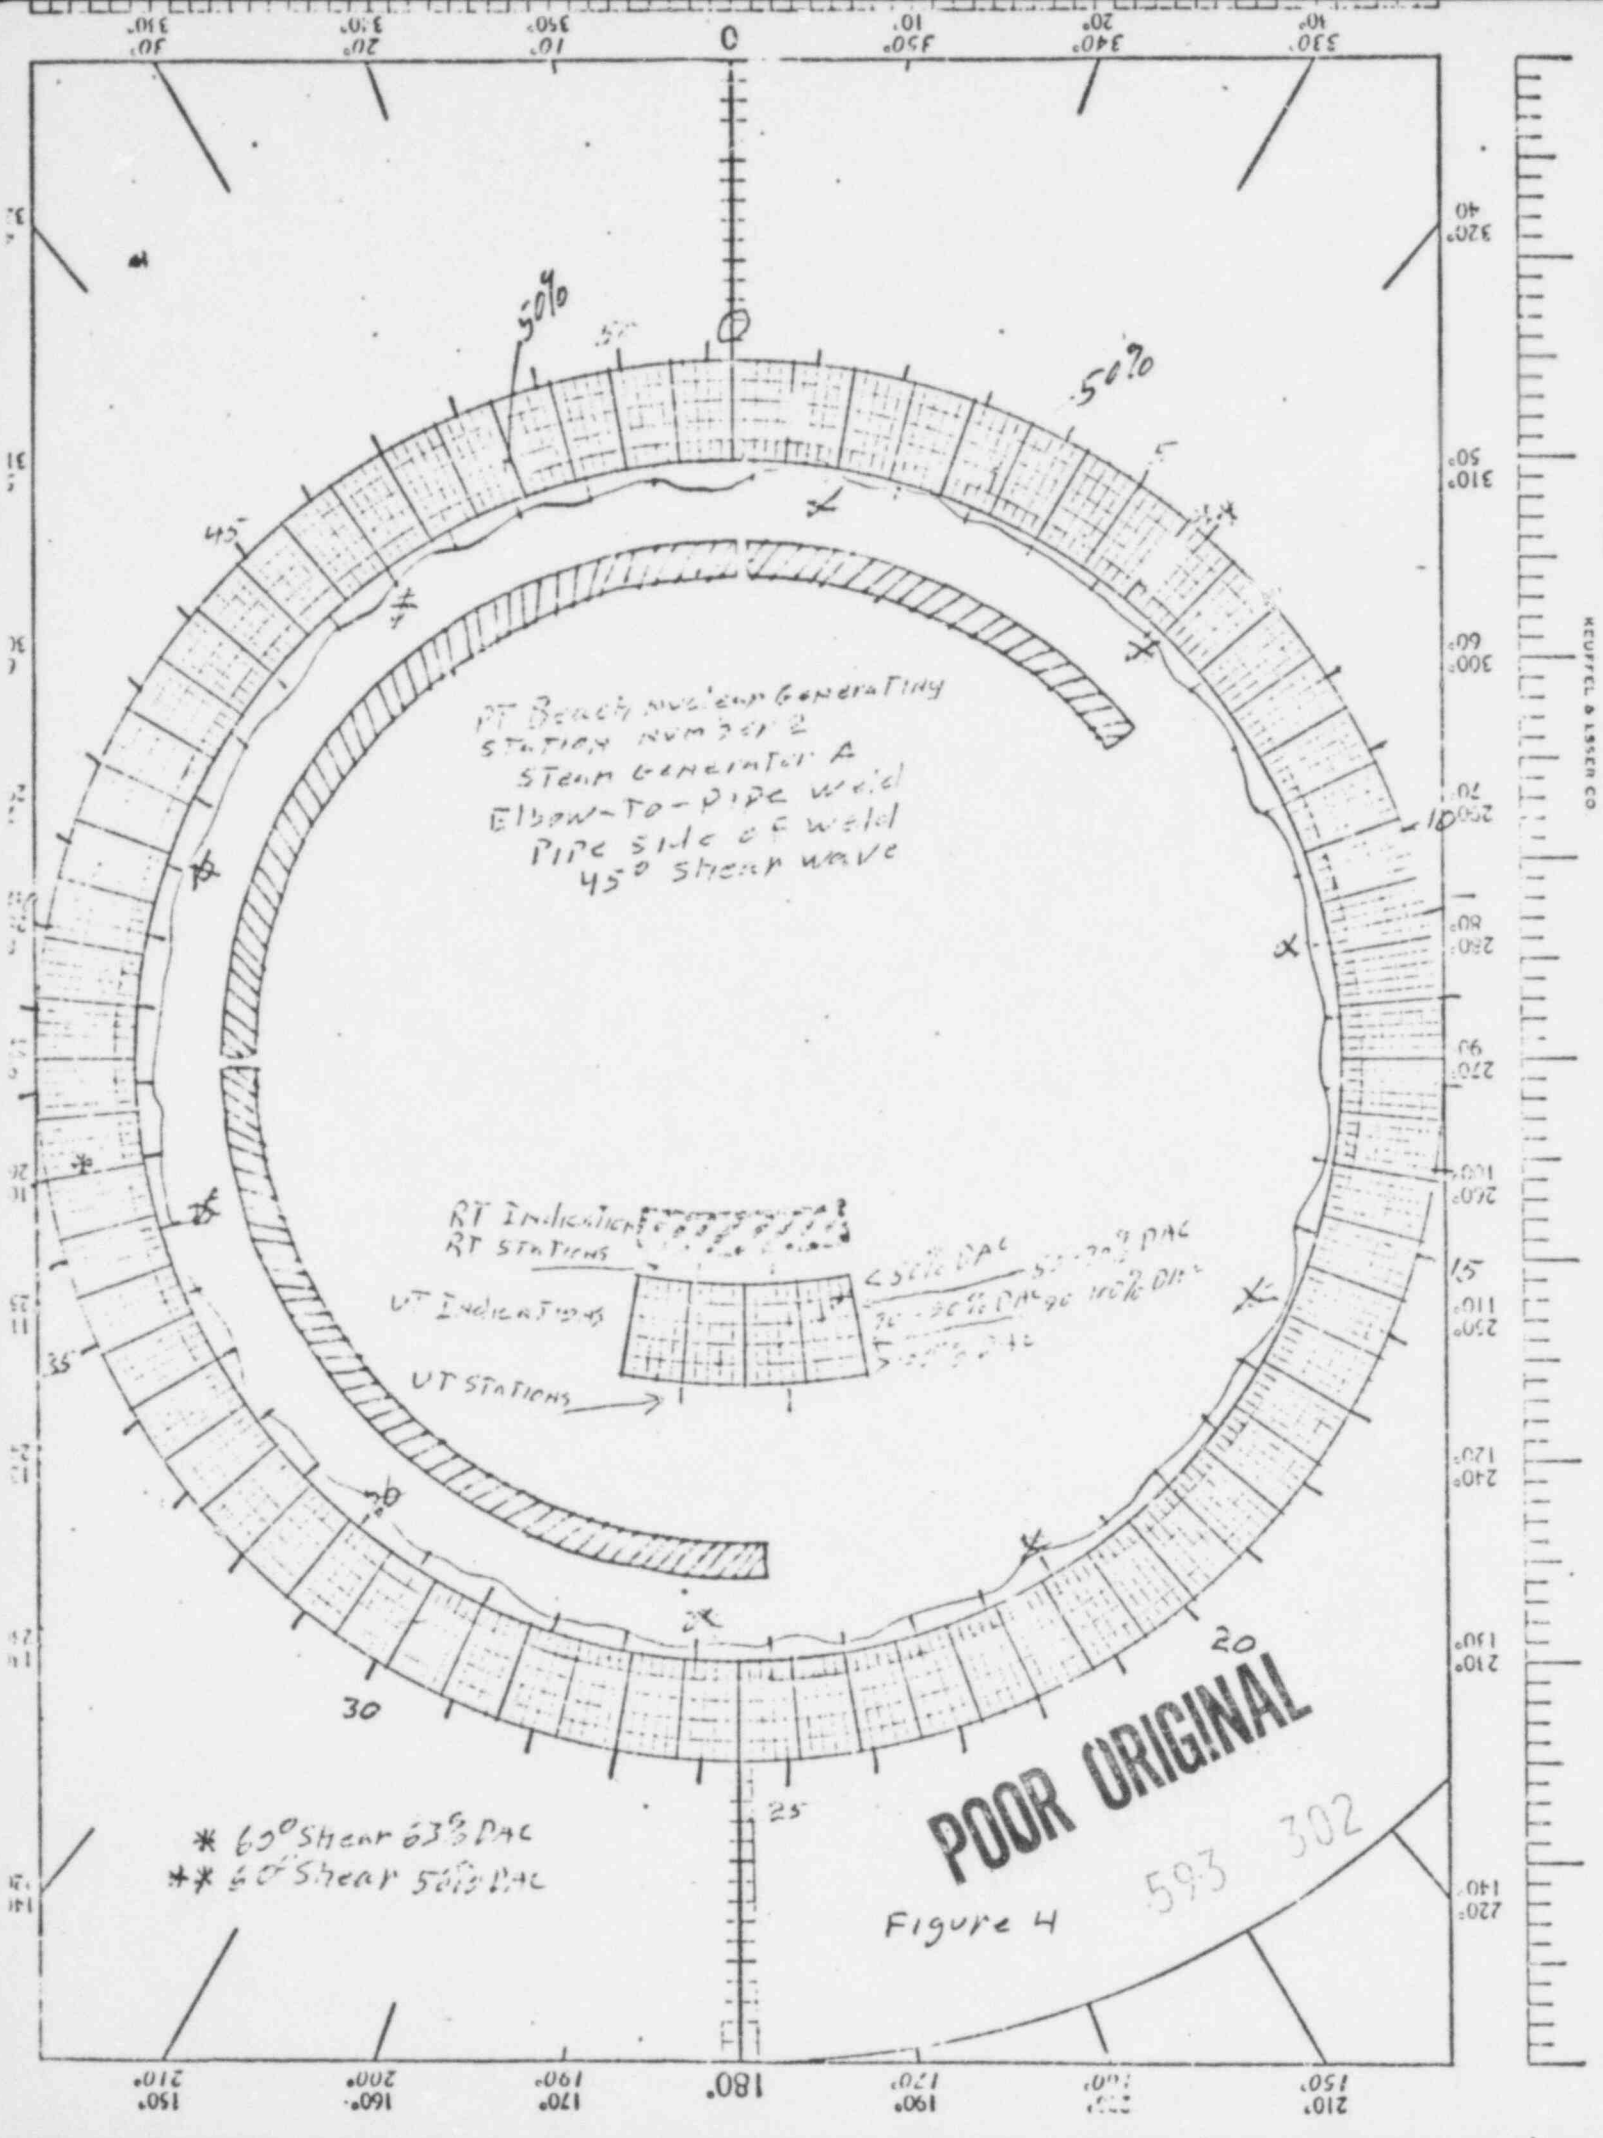
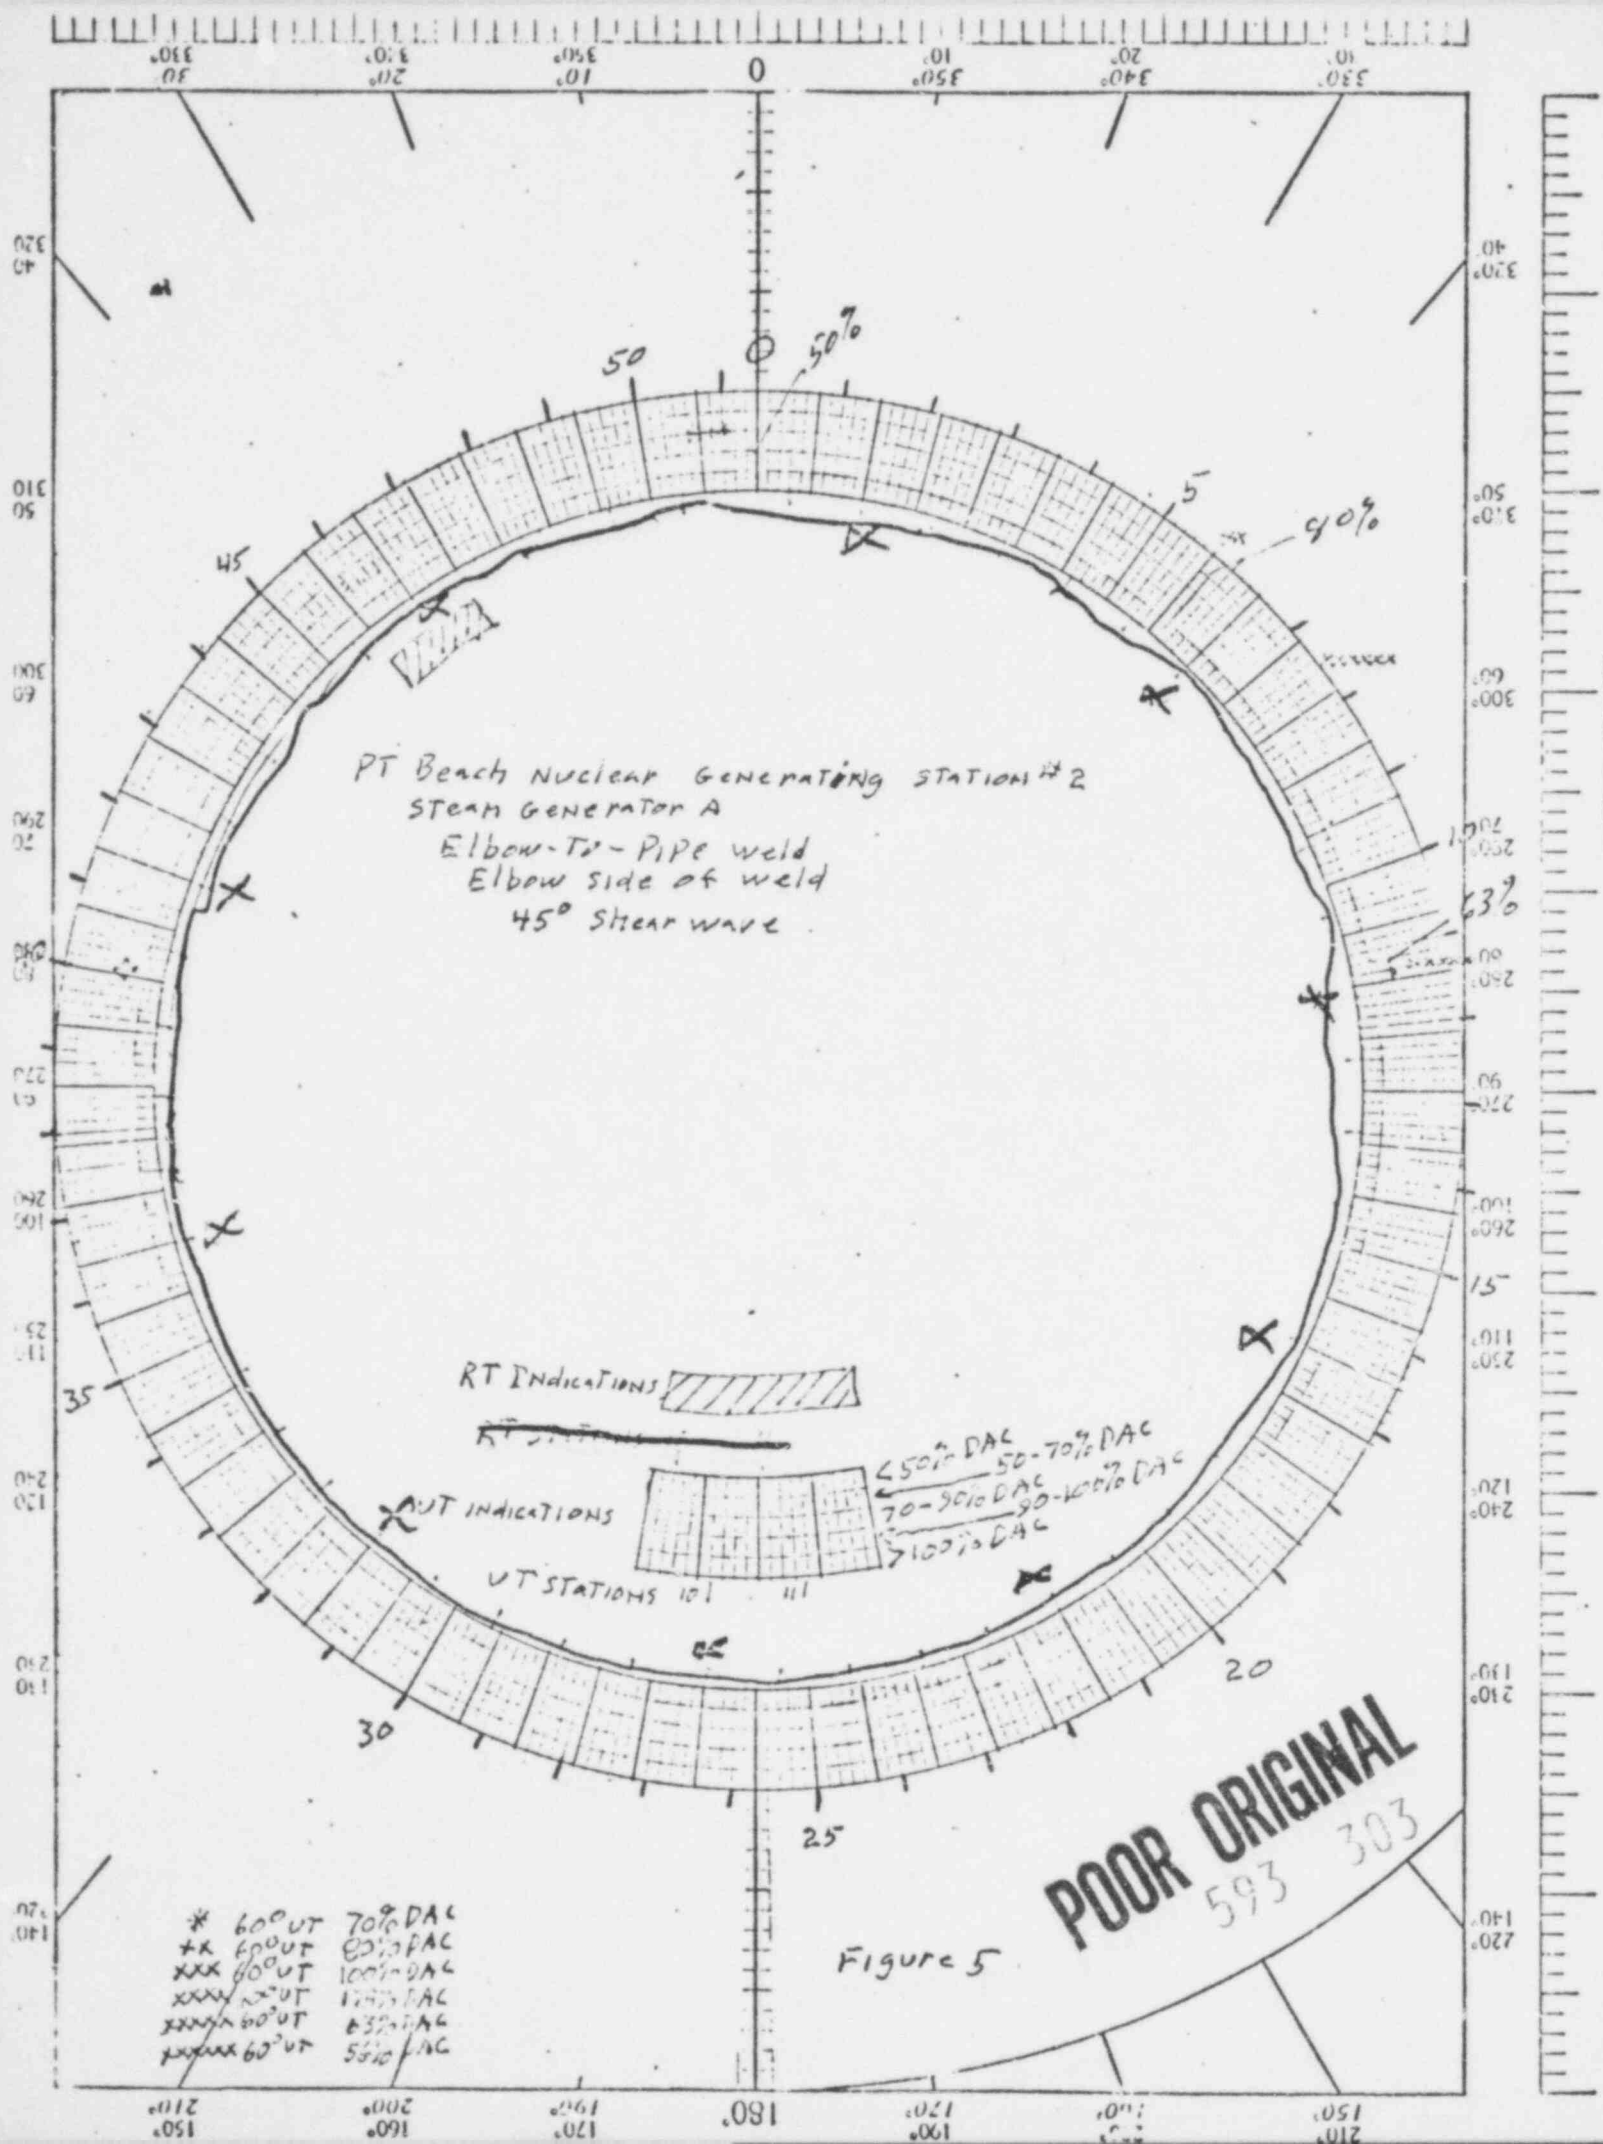
On 3 July 1979 ultrasonic examinations were performed on the elbow-to-pipe weld for both steam generators A and B. During the 45° shear wave examination it was again noted that there was a singular signal trackable for 360° of the pipe circumference. However, in most cases this signal did not exceed 50 percent of the calibration amplitude. The one point at which the signal exceeded 50 percent of the calibration amplitude is clearly indicated in Figure 3. This plot is from the data taken from the pipe side of the weld.

Figure 3 is a polar ordinate plot showing the respective positions for the ultrasonic and radiographic examinations.
