INTERIM REPORT
ON THE
STPEGS RCB NO. 1 LIFT 8 CONTAINMENT VOIDS

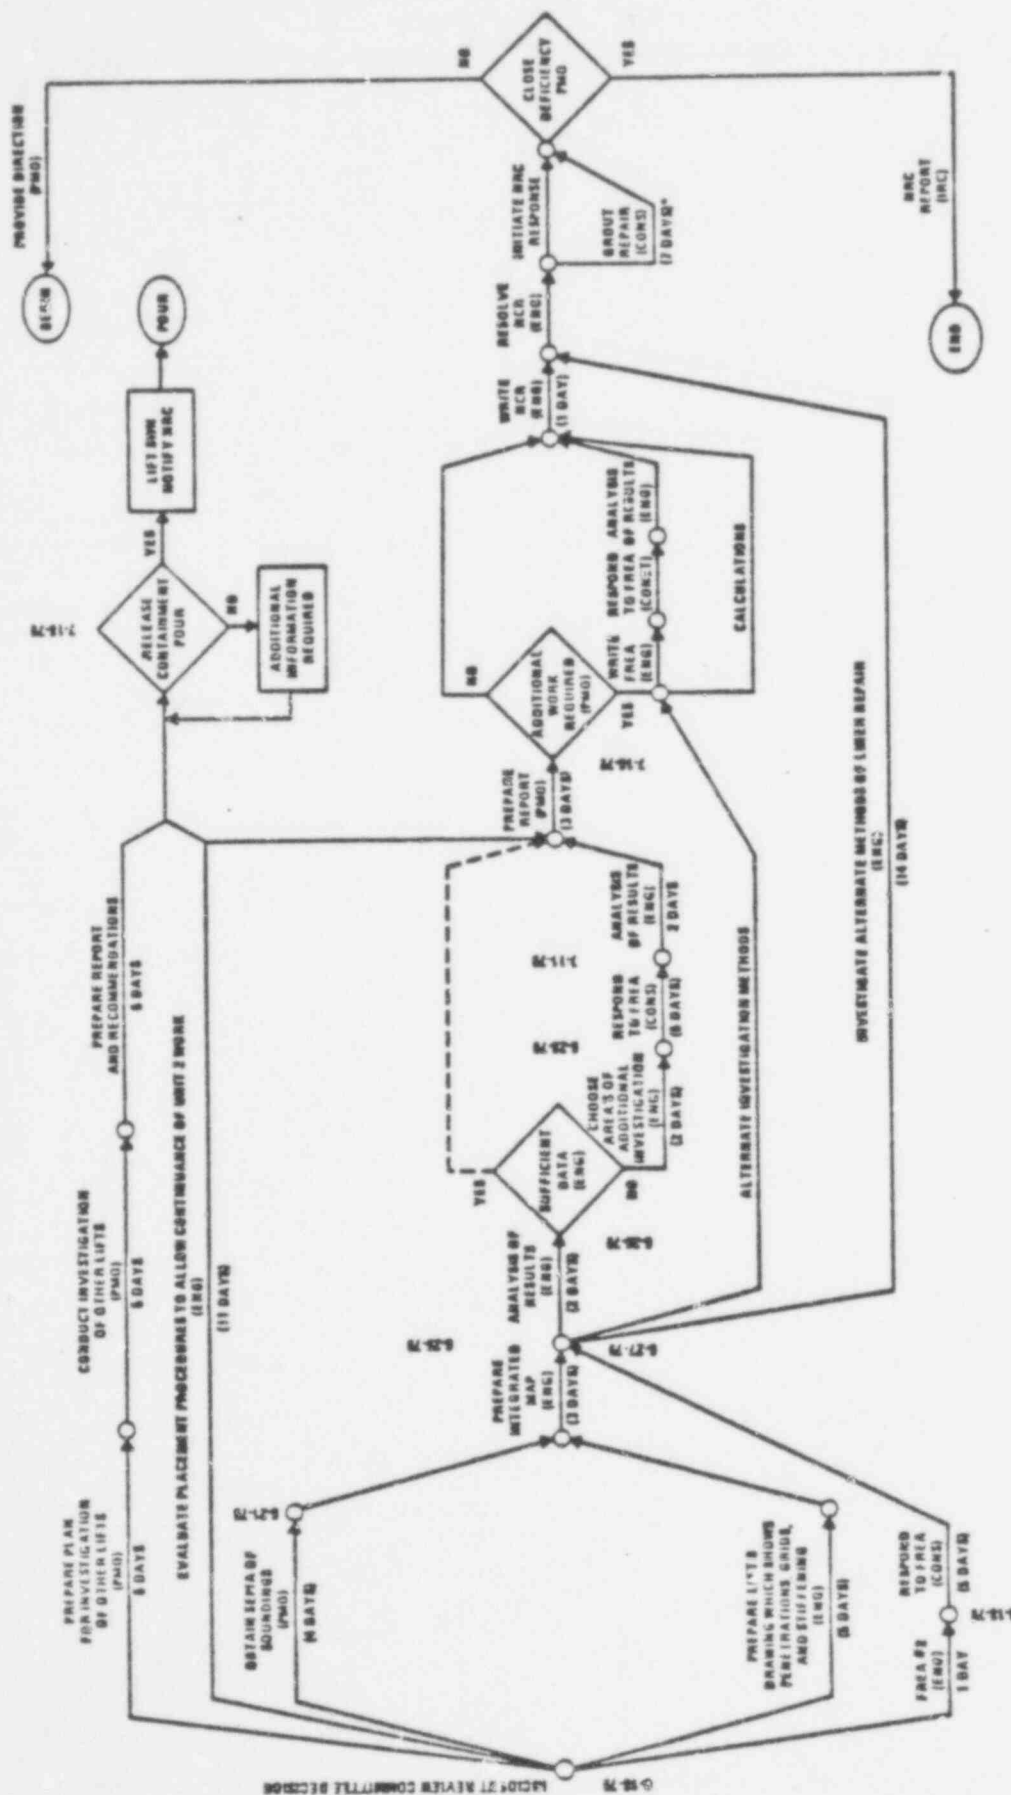
Figure 1

LOGIC FOR THE COMPLETION OF THE ACTIVITIES REQUIRED TO DETERMINE THE EXTENT OF THE LIFT 8 VOID PROBLEM AND TO PROVIDE MANAGEMENT WITH THE INFORMATION NECESSARY TO MAKE CRITICAL DECISIONS FOR FUTURE ACTIONS
* DEPENDENT UPON THE EXTENT OF VOIDS
