Subject: 10CFR21 Reporting of Defects and Non-Compliance -
Engine Systems, Inc. Report No. 10CFR21-0126, Rev. 0

EMD Fuel Injector – Cracked Spray Tip, P/N 5229250

Report No. 10CFR21-0126

10CFR21 REPORTING OF DEFECTS AND NON-COMPLIANCE

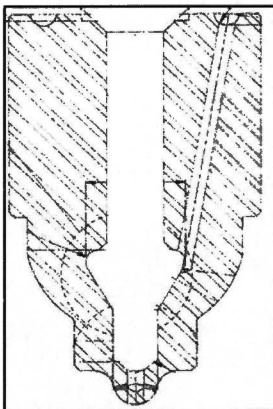
The section was made to bisect the spray tip through one of the fuel feed holes, as shown below. See Photo #2 for end view of sections.

The sectioned spray tip identified the fuel feed holes were not properly oriented. The axis of the feed holes are supposed to be on the centerline of the body, and tilted 10° off vertical. The as-found holes are not on the body centerline as shown in Photo #3.

The incorrect drilling resulted in one of the holes not properly penetrating the reservoir. A small indication is visible in the left hand section where the reservoir and hole have joined. It is in this area where the crack initiated and propagated through the full section of the spray tip. See Photos #3 through #5.
