**MRP 2019-023**

Subject: Transmittal of MRP-227-A-Related Interim Inspection Guidance Regarding PWR  
Core Barrel

Subject: Transmittal of NEI-03-08 "Good Practice" Interim Guidance Regarding MRP-227-A and MRP-227, Revision 1 PWR Core Barrel and Core Support Barrel Inspection Requirements

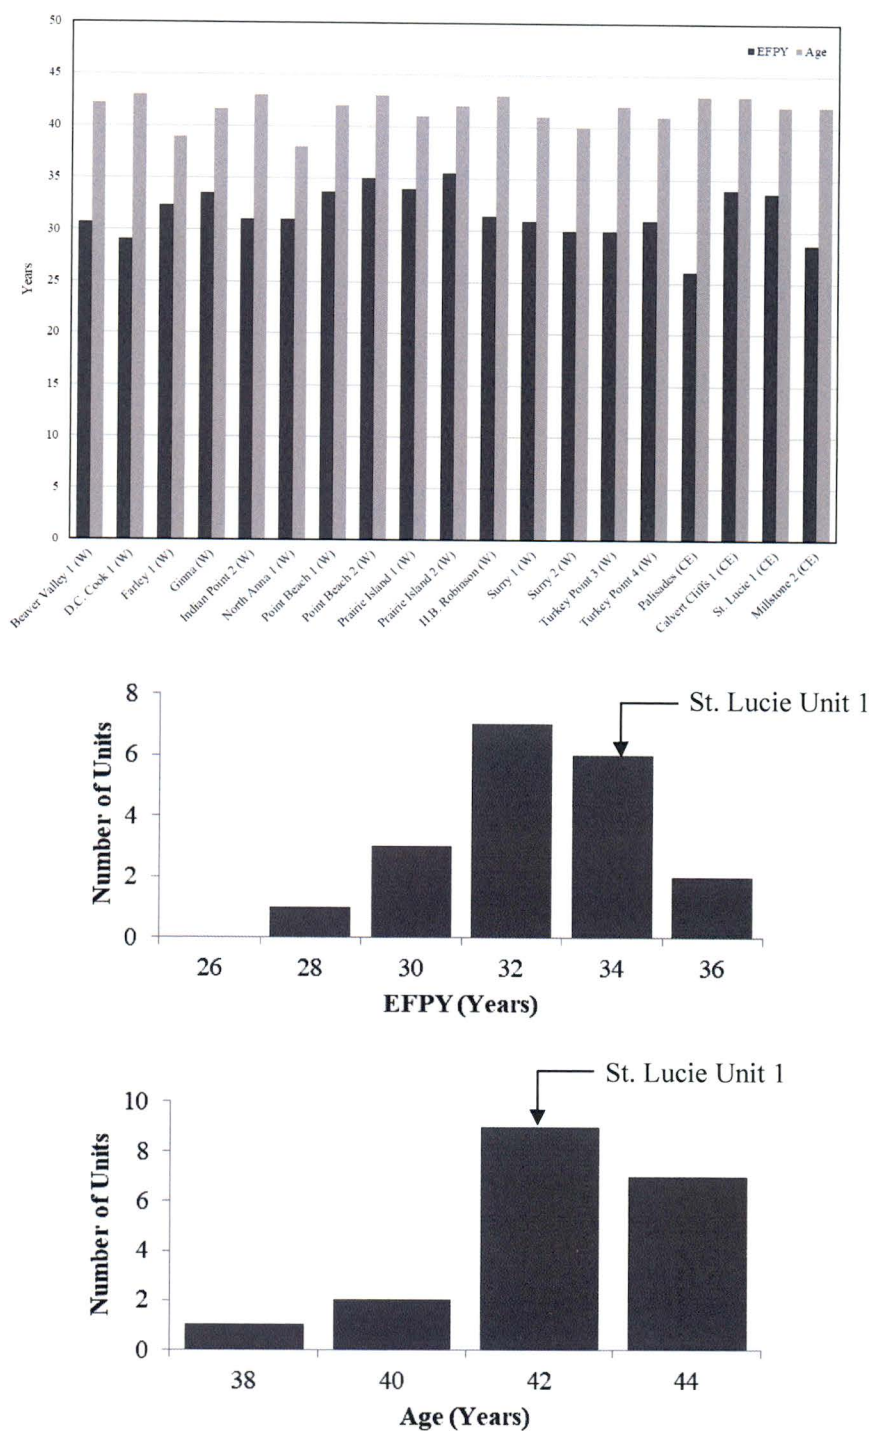
Figure 7: Operating Time at Baseline Barrel Weld Inspections

Figure 7 summarizes the effective full power year (EFPY) and unit age data from [25], [26], [27], and [28] corresponding to the date of the baseline barrel weld inspections. From these data, operating time alone may not be a reliable indicator for barrel flange and girth weld cracking potential, because units similar in age and EFPY to the unit with confirmed cracking showed no indication of cracking in the girth welds inspected. Only three plants have completed EVT-1 inspections of the axial welds, to date. As noted above, only one of these plants identified core barrel weld indications. With only one data point for confirmed detection of cracking for either the girth welds or axial welds and a limited number of axial weld inspections, meaningful assessments cannot be made at this point. Considering the measured crack lengths and the expected growth rates, it is possible that the initiating mechanism for the observed condition at St. Lucie Unit 1 could be related to the early-life thermal shield failure that occurred at that plant and caused earlier CSB cracking. However, without further confirmatory inspections or analysis, the conservative approach is to assume that the flaws observed at St. Lucie Unit 1 could be applicable to all of the units of similar design and age.
