THREE MILE ISLAND NUCLEAR STATION  
UNIT 1

REACTOR CONTAINMENT BUILDING  
RING GIRDER  
SURVEILLANCE TEST  
SIX MONTHS AFTER S.I.T.

November 8, 1974

GAI REPORT NO. 1855

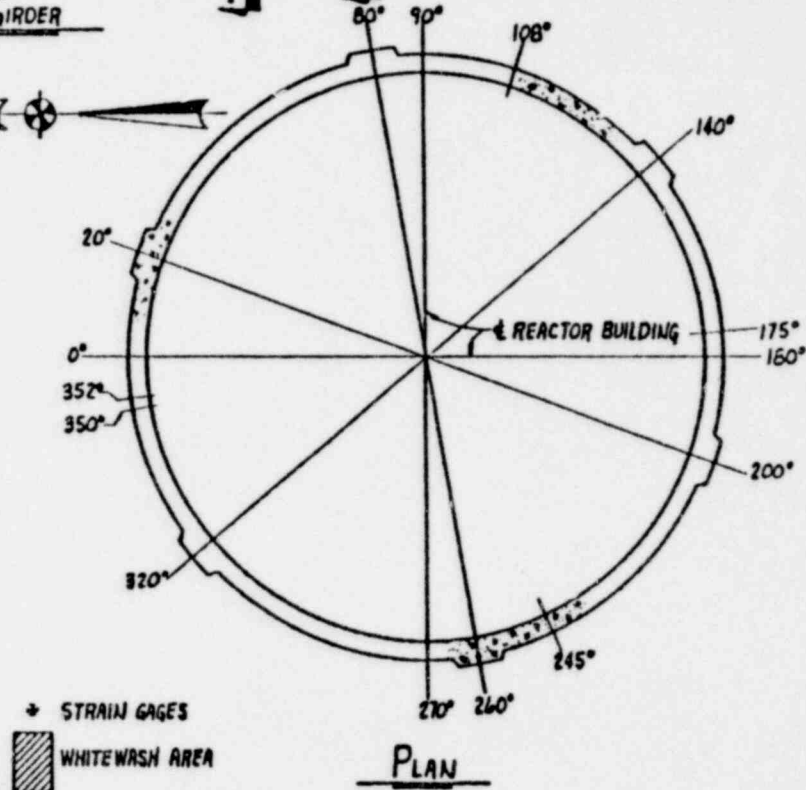
All of the visible cracks around the accessible dome tendon bearing plates were visually inspected, and a description of their location, direction, and size was entered on a data sheet (see Table 2 and Figure 2).

+ STRAIN GAGES

WHITE WASH AREA

NOTE: AREAS WITH CRACKS NOTED THUS ✓  
SEE TABLE 2 FOR DESCRIPTION.
