THREE MILE ISLAND NUCLEAR STATION
UNIT 1

REACTOR CONTAINMENT BUILDING
RING GIRDER SURVEILLANCE TEST
TWO YEARS AFTER S.I.T.

September 17, 1976

METROPOLITAN EDISON COMPANY
Subsidiary of General Public Utilities, Corp.

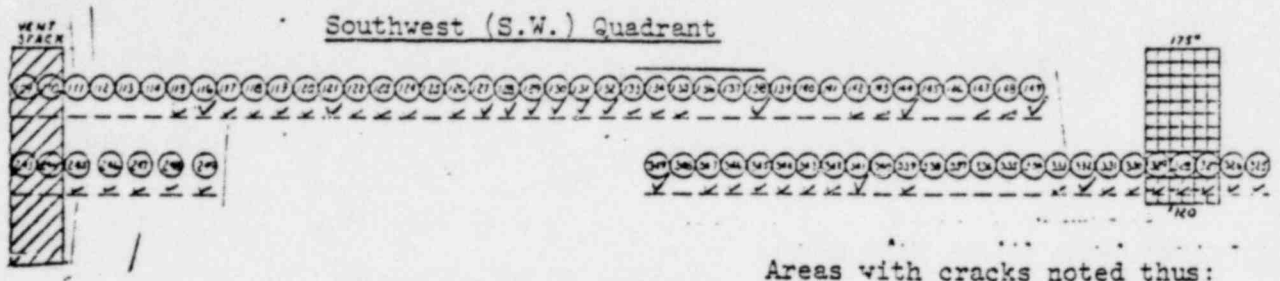
TABLE 3
CONCRETE CRACKS ADJACENT TO DOME TENDON BEARING AREAS

<u>Tendon No.</u>	<u>Crack Location</u>	<u>Remarks</u>	<u>Tendon No.</u>	<u>Crack Location</u>	<u>Remarks</u>	<u>Tendon No.</u>	<u>Crack Location</u>	<u>Remarks</u>
109		(Note 3)	133	HUR		325	CLL,VLC,VLR,VUR	
110		(Note 3)	134	VUC		326	CLL,VLL,VLC,VLR,VUR	
111	-		135	VUC,VLL,VUL		327	VUR,VLL,HLR,VUC	
112	-		136	-		328	VLL,VLC,VUR,VUC	
113	-		137	-		329	VUR,VLL	
114	-		138	CUR		330	VLL,VLC,CLR,VUR	
115	VLL (Note 4)		139	-		331	CLL,VLC,VLR	
116	CUL		140	-		332	CLR,VLC,VLR	
117	VLR,VLL		141	-	(Note 4)	333	VLL,VLC,VLR,CUR	
118	VUR,VLR,HUL		142	VLL	(Note 4)	334	-	
119	VLR,VUR,CLR		143	CUR,VUC		335	-	
120	VUR		144	HUR		336	-	
121	VUR		145	-		337	-	
122	VLR,VUR		146	-		338	-	
123	VUR,VLR,VUC		147	HUR		339	CUL	
124	VUL,VLR,VUC, VLL,HLL,CUR		148	HUR		340	-	
125	-		149	CUR,VUR		341	HUL,CUR	
126	VUL,VLL		243		(Note 3)	342	CUL,VUC	
127	VUL		244		(Note 3)	343	HUL,VLR	
128	VUL		245	HLR,HCR		344	HUL,VUC,VLR	
129	CUL		246	HLR,HUR,VUC		345	HUL,VUR,VLR

1. All cracks are less than 0.005 in. wide.
2. Unless otherwise noted the cracks extend from the metal bearing plate across the adjoining two to four inches of concrete.
3. Bearing area blocked from inspection by vent stack.
4. Voids Discovered. (All Voids are shown on Figures 6-12).
5. D 247SW & D248SW have very narrow gaps (unmeasurable) between the bottom of the bearing plate and the adjoining concrete.

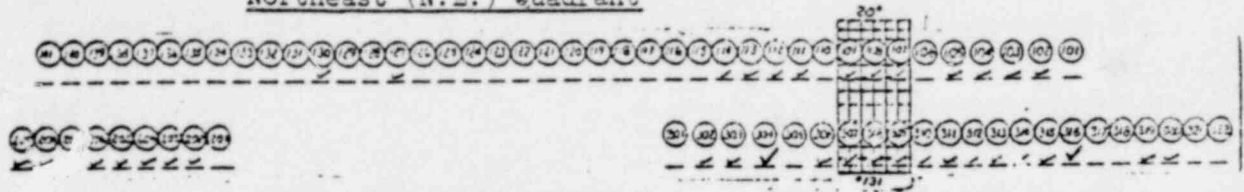
TABLE 5
CONCRETE CRACKS ADJACENT TO DOME TENDON BEARING AREAS

<u>Tendon No.</u>	<u>Crack Location</u>	<u>Remarks</u>	<u>Tendon No.</u>	<u>Crack Location</u>	<u>Remarks</u>	<u>Tendon No.</u>	<u>Crack Location</u>	<u>Remarks</u>
101	-		125	-		208	HUR,VLC	
102	CUR,VLR		126	-		209	VLC,VLR,VLL,CUR	
103	VLL,CUL		127	CUR		301	-	
104	VUL		128	-		302	HUL,VUL	
105	CUR		129	-		303	HUL	
106	-		130	VUL,HUR,HUL		304	CUL	
107	CUR,VLL,VLR,VUL		131	-		305	-	
108	VUC		132	-		306	HUL,VUR,VLL	
109	HUR		133	-		307	HUL,HUR	
110	-		134	-	(Note 5)	308	HUL,CLR	
111	VLL,VUL		135	-		309	HUL,VLL,VUR	
112	VLL		136	-		310	HUL,VLL,VLR,HLR	
113	VUR,VLL		137	-		311	VUL,VLR	(Note 3)
114	VUL		138	HUL		312	VUL	(Note 4)
115	-		139	-	(Note 5)	313	HUL,VLL	
116	-		140	-		314	HUL	
117	-	(Note 5)	141	-		315	VUL,HUR	
118	-		142	-		316	HLL	
119	-		202	CUR,VLR,CUL		317	-	
120	-		203	CUR,VLR,CUL,VUC		318	-	
121	-		204	HUR		319	VUR	
122	-		205	CUR,VLR		320	VUR	
123	-		206	HUR,CLL,HUL		321	-	
124	-		207	CUR,CUL,VLL		322	-

1. All cracks are less than 0.005 in. wide.
2. Unless otherwise noted the cracks extend from the metal bearing plate across the adjoining two to four inches of concrete.
3. Five cracks less than 0.005 inc. radiate down from the bottom of the bearing plate, spaced approximately five inches on centers and terminating about one inch from the edge of the bearing plate.
4. Four cracks -- similar to those described in Note 3.
5. Void Discovered. (All Voids are shown on Figures 6-12)..

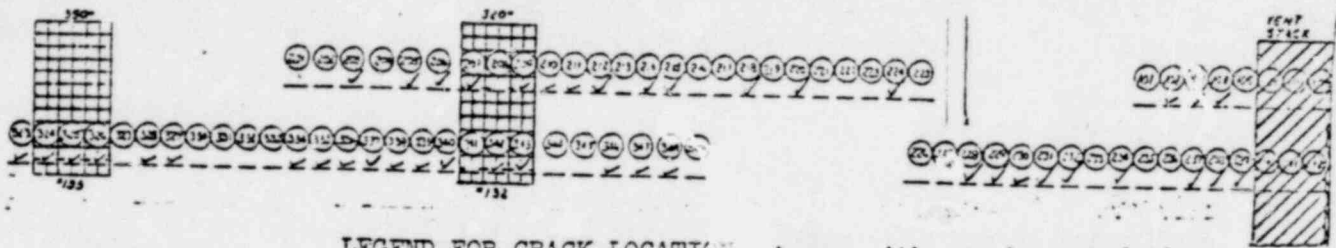
TABLE 6
CONCRETE CRACKS ADJACENT TO DOME TENDON BEARING AREAS

<u>Tendon No.</u>	<u>Crack Location</u>	<u>Remarks</u>	<u>Tendon No.</u>	<u>Crack Location</u>	<u>Remarks</u>	<u>Tendon No.</u>	<u>Crack Location</u>	<u>Remarks</u>
101	-		219	-		325	VUL,VUR,VLL	
102	CUR,HUL		220	CLL		326	VUC,VLL	
103	VUR		221	-		327	-	
104	VUR,HUL		222	-		328	VUL,HUL	
105	-		223	-		329	VUL,HUL	
106		(Note 3)	224	VUR		330	-	
107		(Note 3)	225	-		331	-	
108		(Note 3)	226	-		332	-	
201	-		227	-		333	-	
202	-		228	VUC		334	HUR	
203	HUL		229	VUC		335	CUR,VLR	
204	-		230	CUR		336	CUR	
205	CUL		231	CUR		337	VUL	
206	CUR		232	CUR,VUC		338	HUR,VLC	
207	HUL,VUR		233	-		339	HUR,VLC	
208	-		234	HUR		340	CUR	
209	CLL,VUC		235	-		341	-	
210	UL		236	-		342	HUR,VUC	
211	UL		237	CUR		343	HUR,CLR	
212	VUR,CUL		238	CUR		344	-	
213	-		239	HUR		345	HUR	
214	VUR,CUL		240		(Note 3)	346	HUR	
215	VUR		241		(Note 3)	347	HUR,HUL,VUR	
216	-		242		(Note 3)	348	CUR,HLL	
217	-		323	VUR,VUL,VLL		349	-	
218	HUL		324	HUL,VLL

1. All cracks are less than 0.005 in. wide
2. Unless otherwise noted the cracks extend from the metal bearing plate across the adjoining two to four inches of concrete.
3. Bearing area blocked from inspection by vent stack.
4. Void Discovered. (All Voids are shown on Figures 6-12).

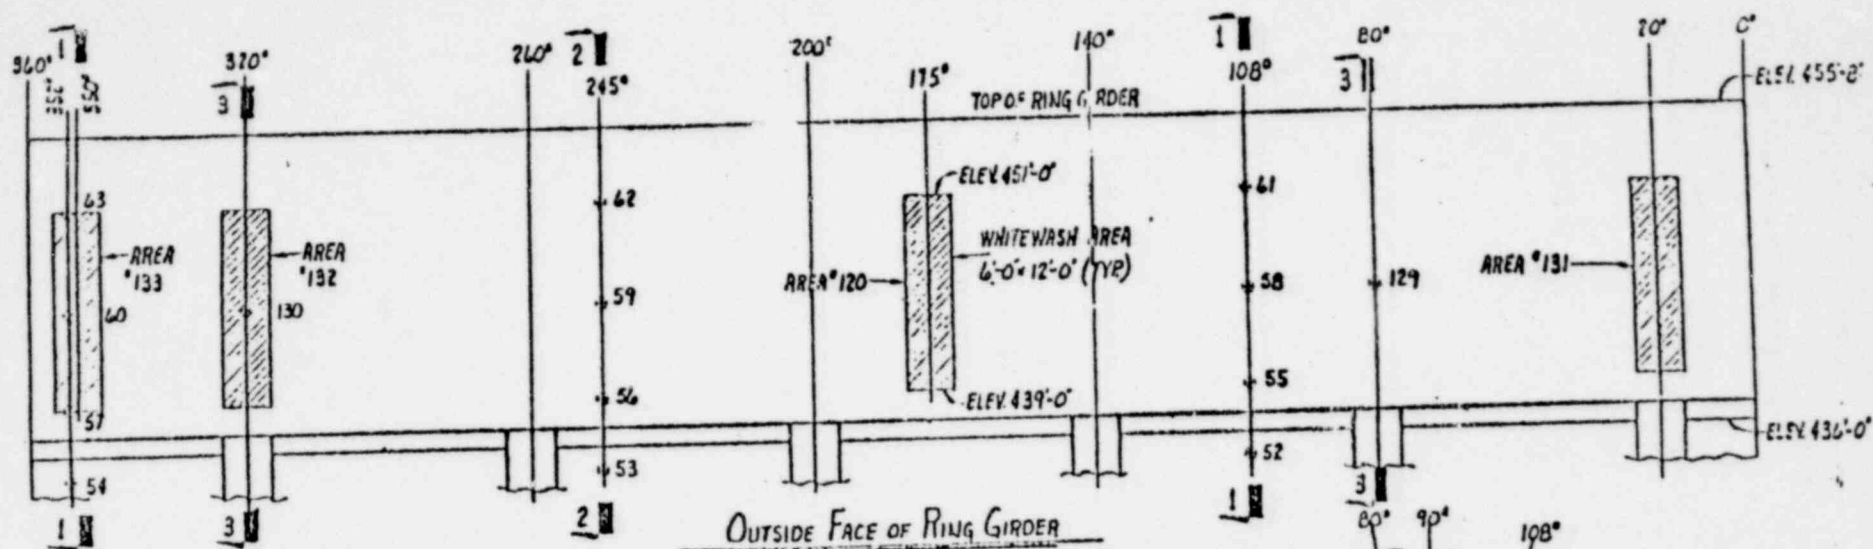
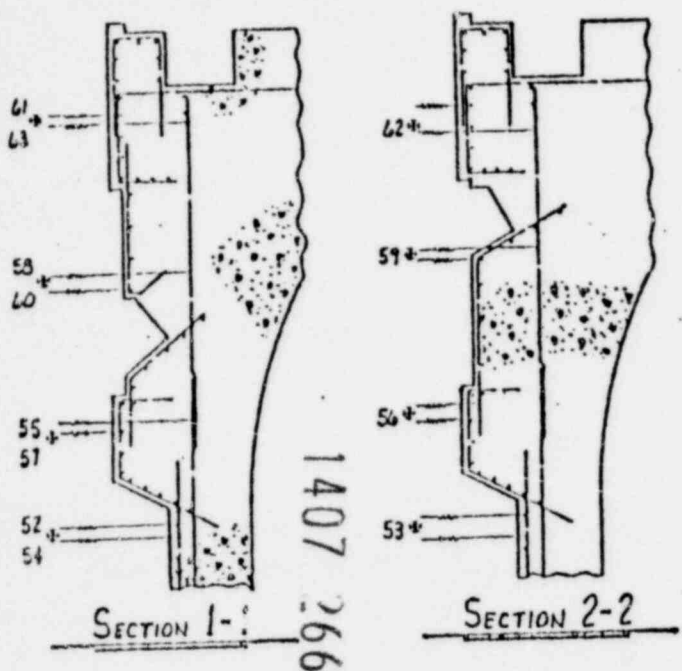
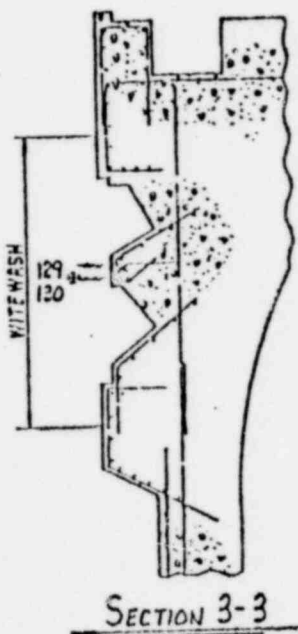
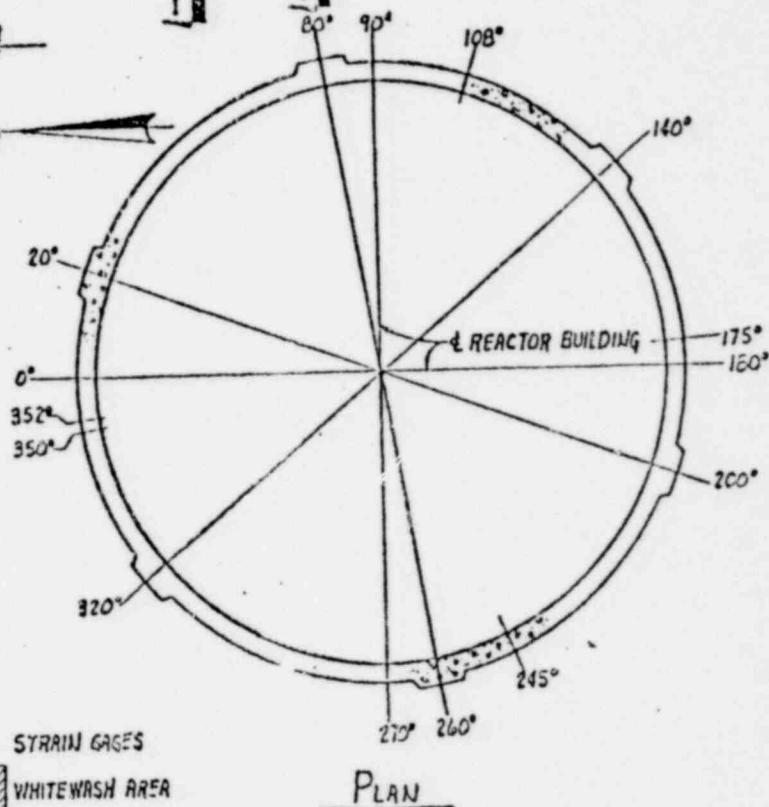
OUTSIDE FACE OF RING GIRDER

NEW CRACKS SHOWN IN RED

ALL CRACKS ARE LESS THAN
0.005 IN. WIDE UNLESS NOTED.
