REPORTABLE OCCURRENCE 79-24

FORT ST. VRAIN NUCLEAR GENERATING STATION
PUBLIC SERVICE COMPANY OF COLORADO
P. O. BOX 361
PLATTEVILLE, COLORADO 80651

REPORT NO. 50-267/79-24/03-L-0

CORE AVERAGE OUTLET TEMPERATURE AND TOTAL PRIMARY COOLANT OXIDANTS

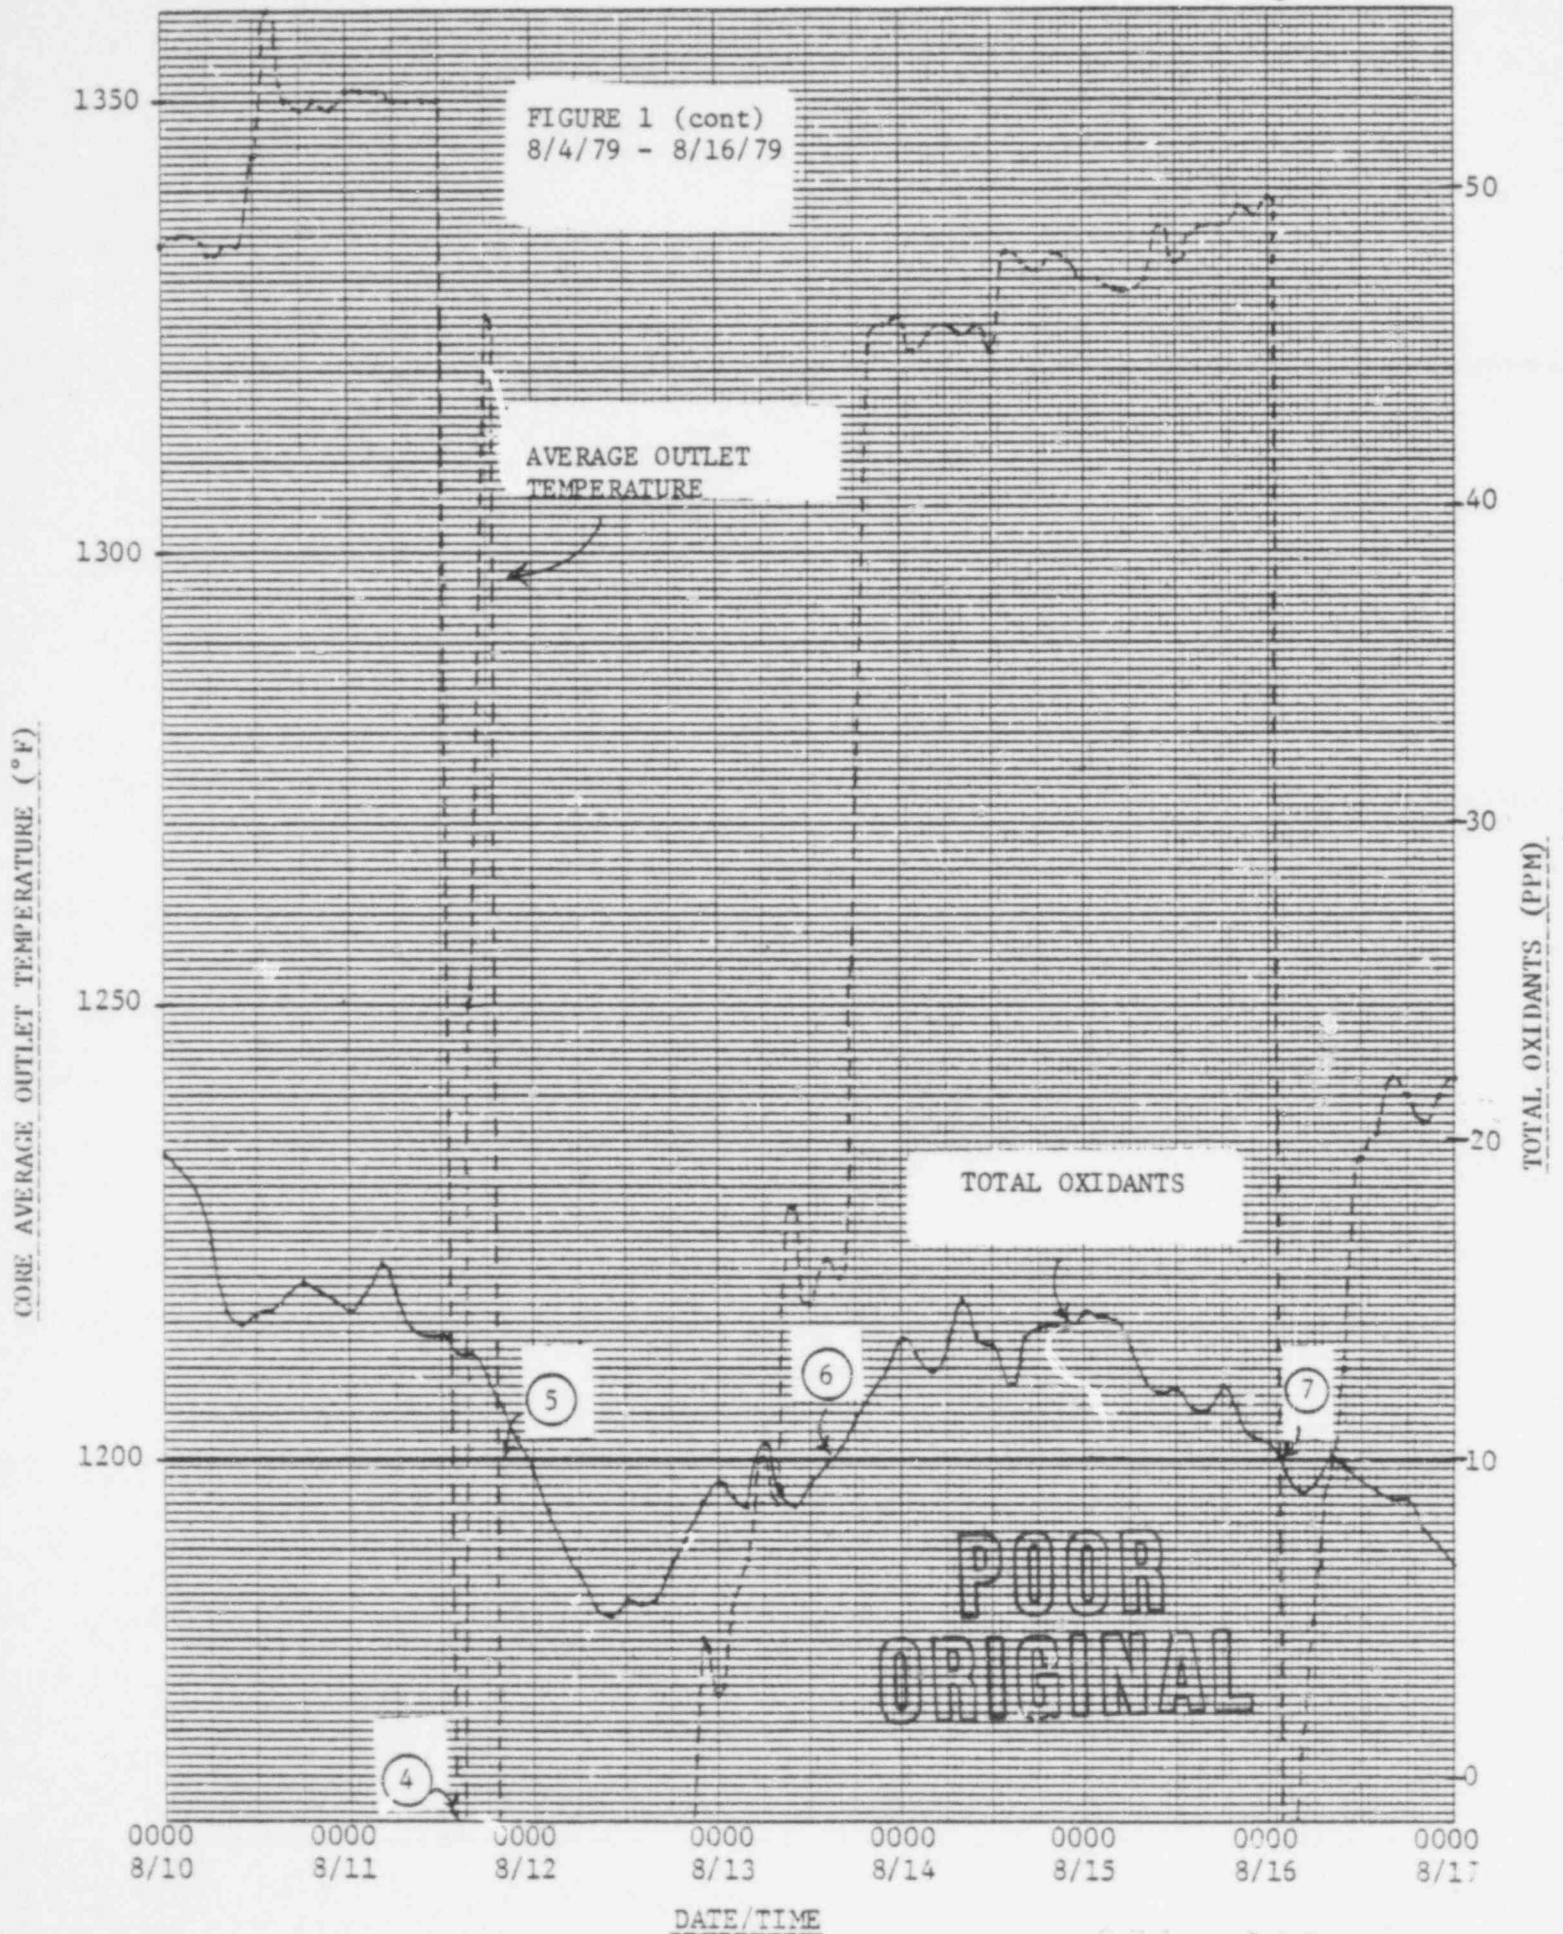
At 0230 hours on August 7, 1979, it was observed that primary coolant carbon dioxide levels were also increasing. At this point, it was determined that the "A" helium purification dryer had apparently broken through. Maximum oxidant concentration of 51.5 ppm was reached at approximately 0600 hours with average core outlet temperature of 1,300°F (reference Figure 1, point (3)).

At 0040 hours on August 16, 1979, a circulator trip occurred. Reactor power and temperature were decreased to allow recovery of the circulator (reference Figure 1, point (7)). Following this occurrence, no further degraded mode operation of LCO 4.2.10 occurred.
