DOCKET NOS. 50-266 AND 50-301
FURTHER RESPONSE TO IE BULLETIN 79-13
POINT BEACH NUCLEAR PLANT, UNITS 1 AND 2

METALLURGICAL EVALUATION OF FEEDWATER PIPE CRACKING

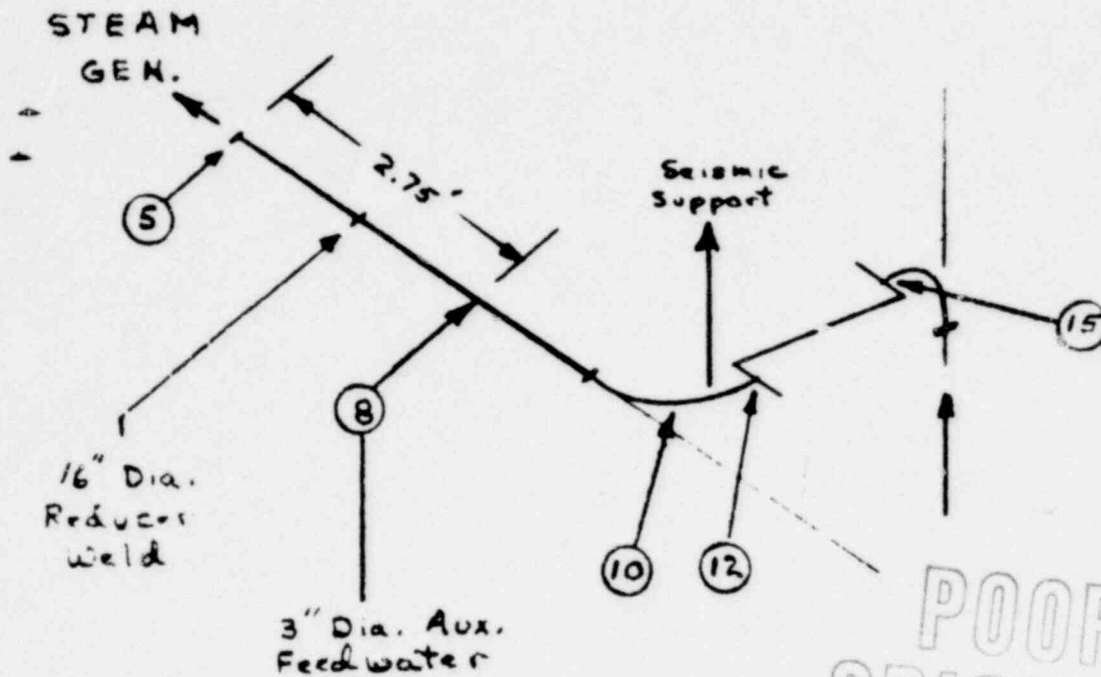
POOR
ORIGINALSTRESS SUMMARY

Data Point	Thermal Stress, psi	Gravity Stress, psi	Longitudinal Pressure stress, psi	Total Seismic Stress, psi		REMARKS
				<u>OBE</u>	<u>SSE</u>	
5	3621	3000	3608	12532	18456	Nozzle
8	3728*	3000	3608	9546*	12484*	Aux. F-W Connec.
10	5706	3000	3608	13331	20054	Elbow
12	455	3000	3608	8546	10484	End Bend
15	6043	3000	3608	8289	9970	Begin Bend

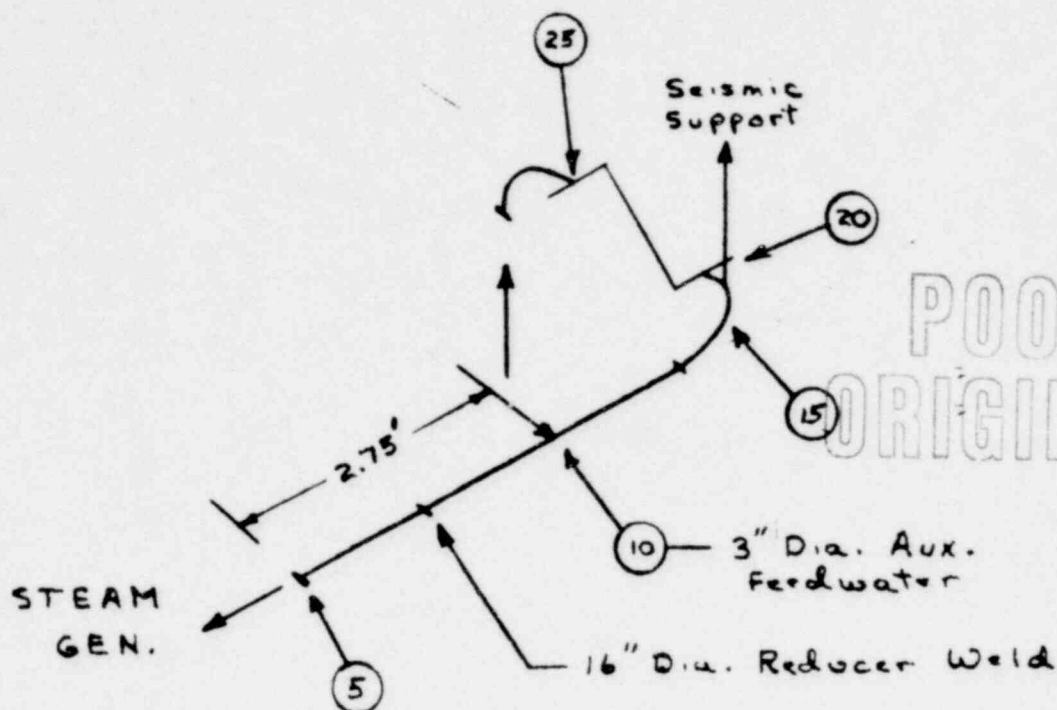
FIGURE 2

STRESS SUMMARY

Data Point	Thermal Stress, psi	Gravity Stress, psi	Longitudinal Pressure stress, psi	Total Seismic Stress, psi		REMARKS
				<u>OBE</u>	<u>SSE</u>	
5	4736	104	3608	5059	6406	Nozzle
10	4163*	65*	3608	8138*	12603*	Aux. F.W. Connec.
15	6804	90	3608	5719	7740	Elbow
20	5934	183	3608	4159	4527	End Bend
25	5993	104	3608	4031	4350	Begin Bend

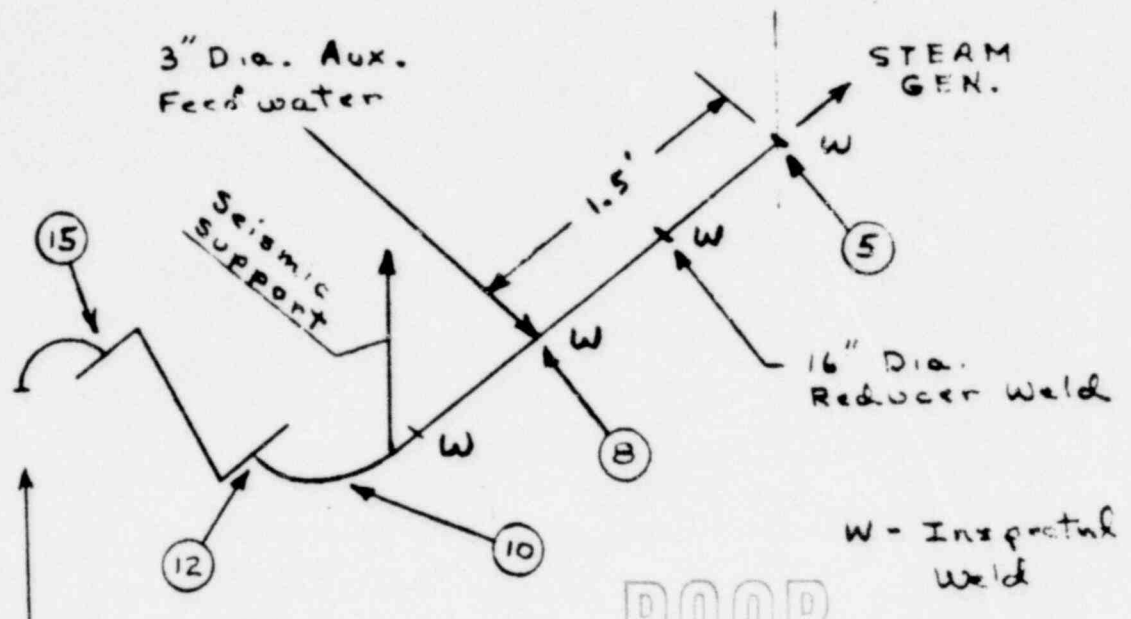
FIGURE 3

POOR
ORIGINALSTRESS SUMMARY

Data Point	Thermal Stress, psi	Gravity Stress, psi	Longitudinal Pressure stress, psi	Total Seismic Stress, psi		REMARKS
				<u>OBE</u>	<u>SSE</u>	
5	1730	3000	3608	9692	12776	Nozzle
3	3114*	3000	3608	7559*	8510*	Aux. F.W. Connec.
10	3114	3000	3608	11143	15678	Elbow
12	2129	3000	3608	7566	8524	End Bend
15	126	3000	3608	7379	8150	Begin Bend

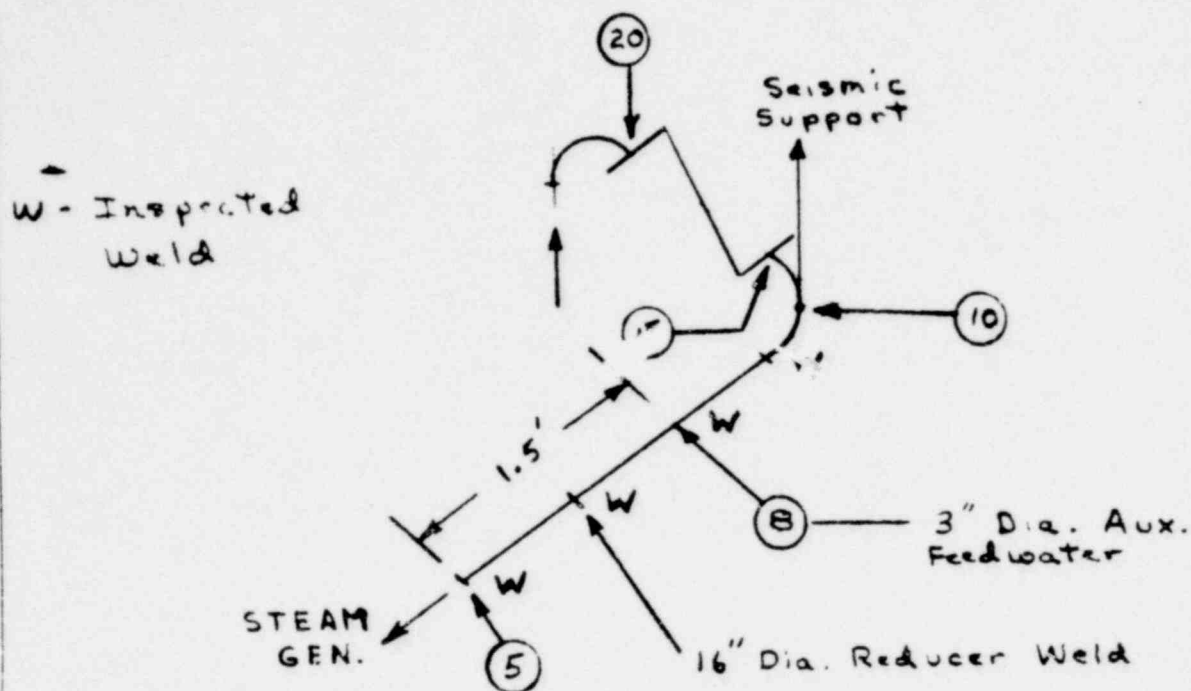
FIGURE 4

POOR
ORIGINALSTRESS SUMMARY

Data Point	Thermal Stress, psi	Gravity Stress, psi	Longitudinal pressure stress, psi	Total Seismic Stress, psi		REMARKS
				<u>OBE</u>	<u>SSE</u>	
5	4613	3000	3608	8066	9524	Nozzle
8	5127*	3000	3608	7893*	9358*	Aux. F.W. Connec.
10	11331	3000	3608	8636	10664	Elbow
15	971	3000	3608	6976	7344	End Bend
20	7433	3000	3608	7059	7510	Begin Bend

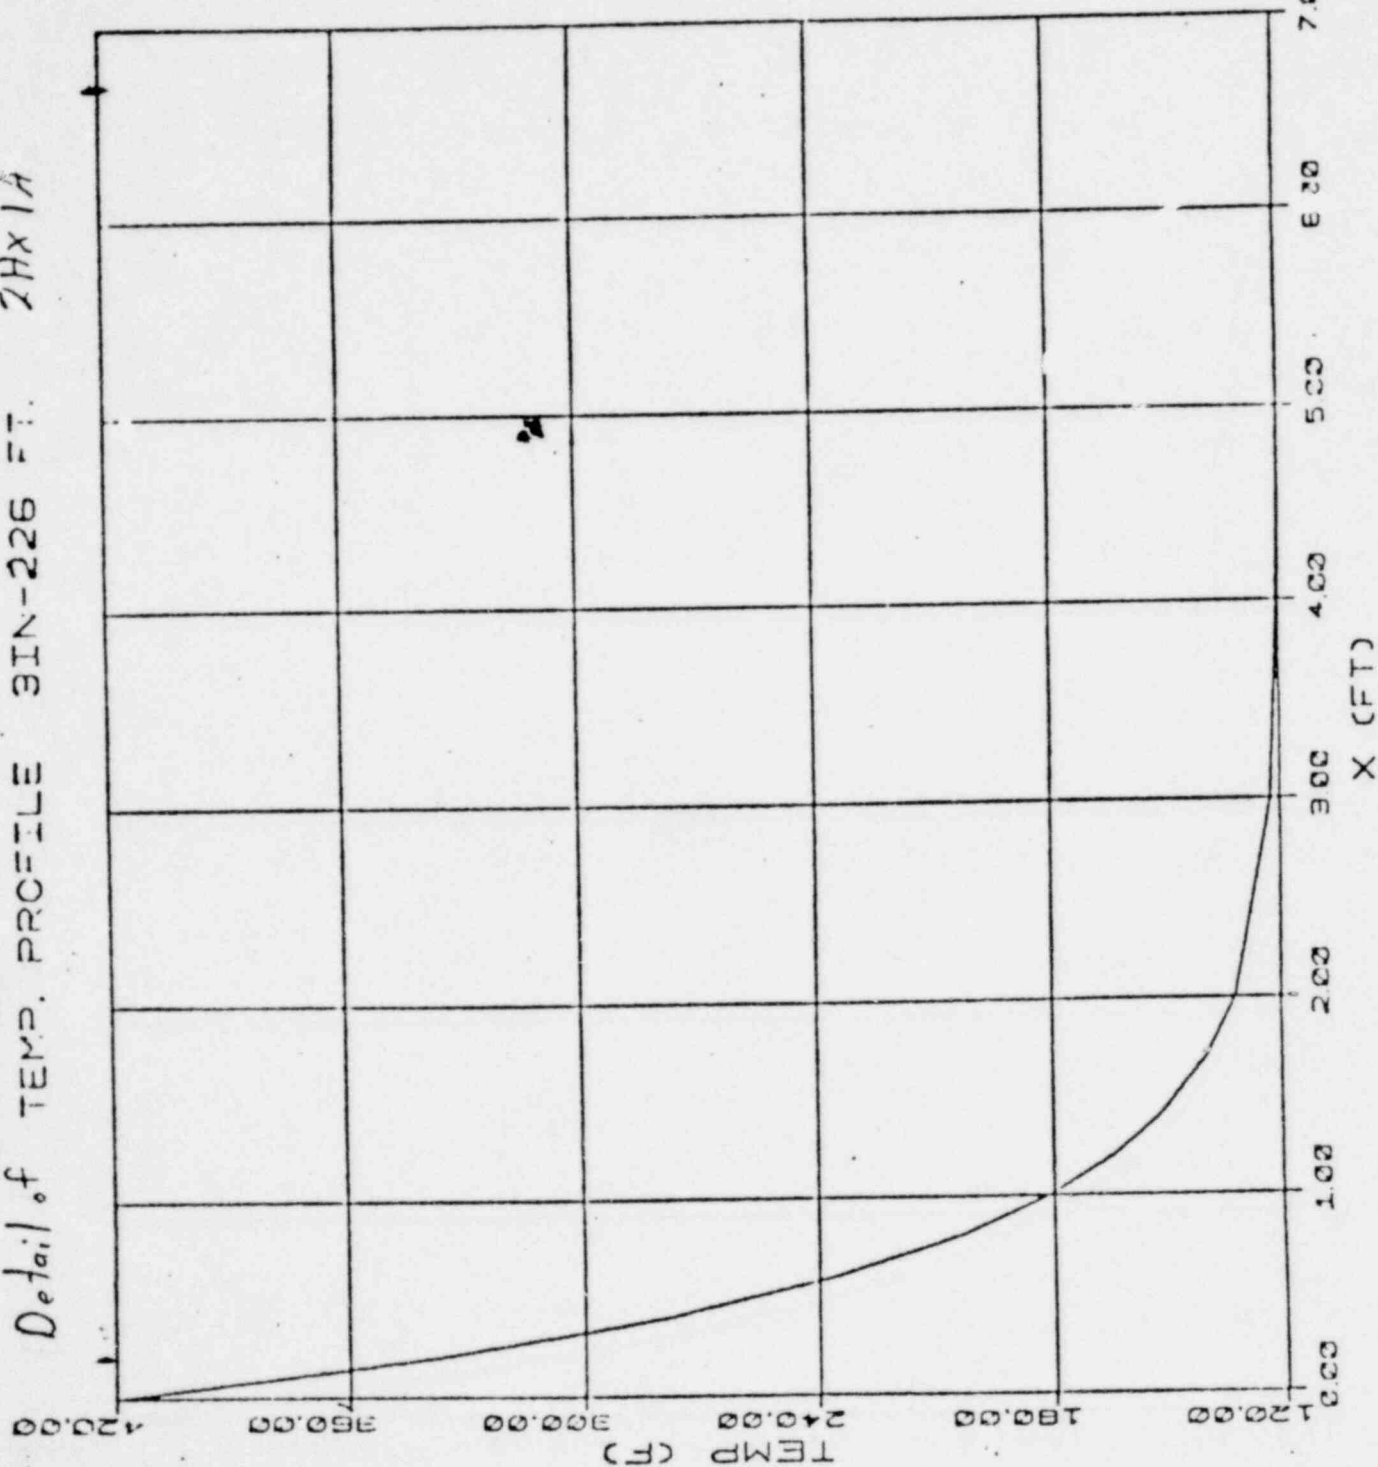
Figure 5.

The maximum length to where the 3 inch pipe wall temperature reaches 150° F. under the above conditions is three (3) feet. This temperature is essentially ambient conditions in the containment near the piping. Attached are the temperature distribution curves for two auxiliary feedwater lines.

Detail of TEMP. PROFILE 3IN-226 FT. 2HX1A

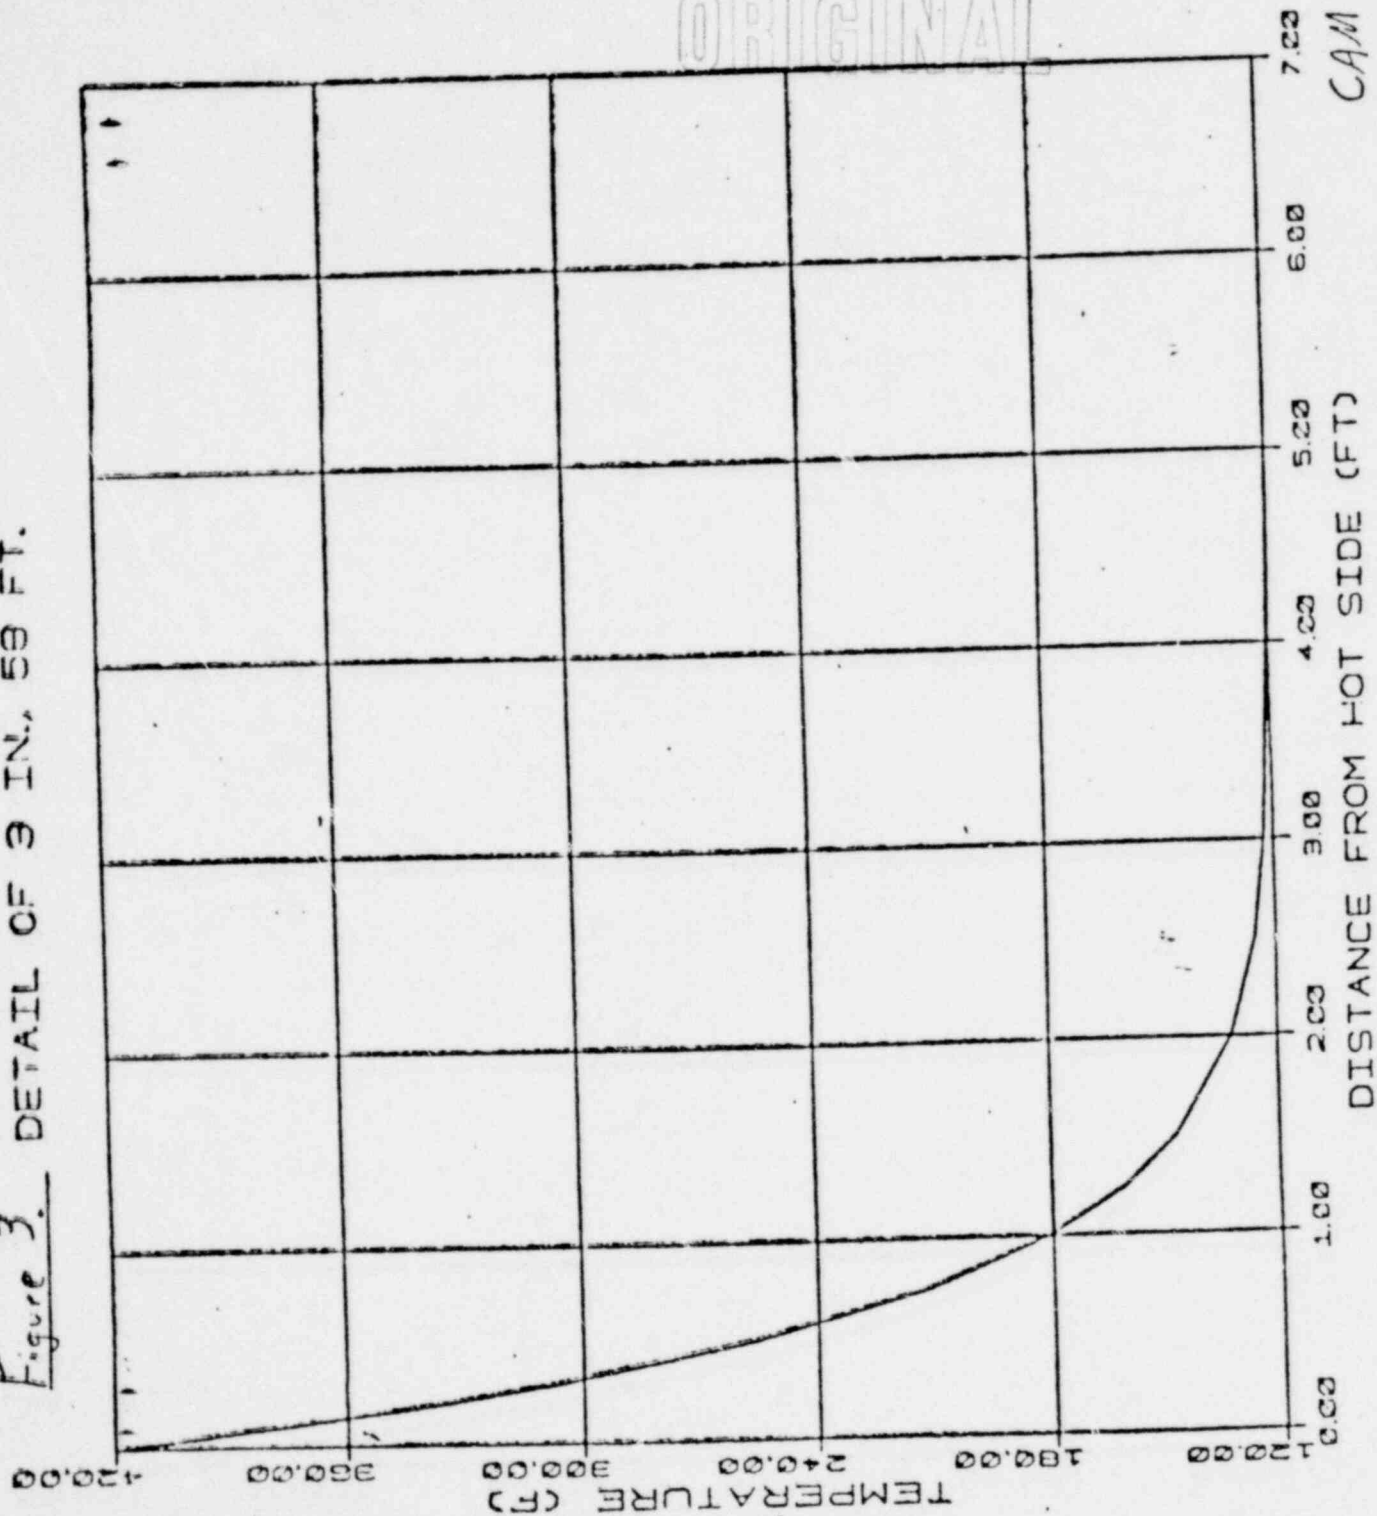
Figure 3. DETAIL OF 3 IN., 58 FT.

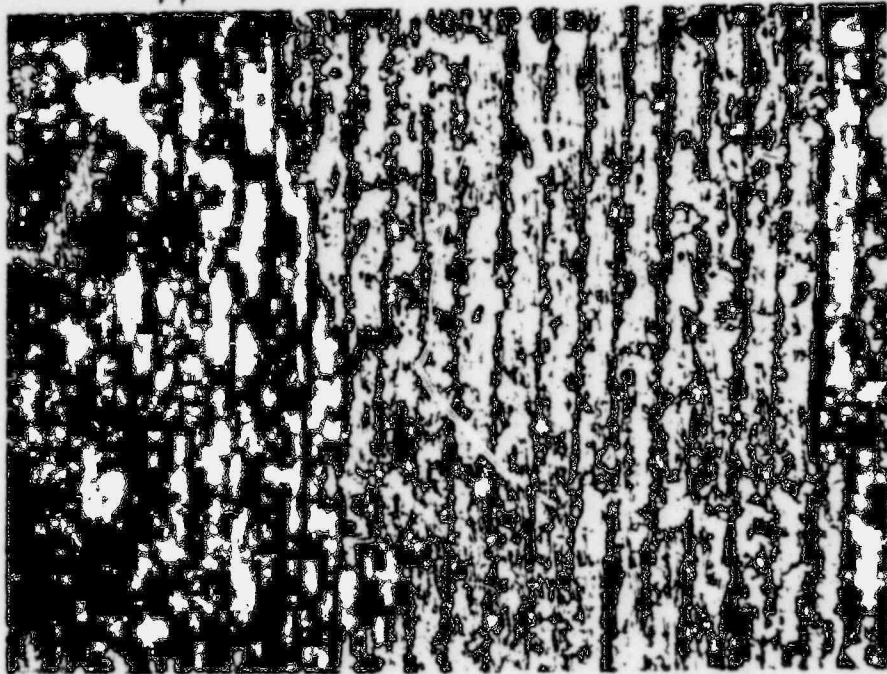
(a)

The oxide was electrolytically removed from selected segments to examine the underlying surface. On the 18-in. end copious cracking was observed at and near the counter-bore transition, that is, at the intersection of the flat counter-bore and bevelled counter-bore regions, Figure 2. Most cracks were situated at the root of machining grooves, at the root-pass fusion line or at the base of deep pits. No cracks in an axial orientation could be found in the base metal, although several small axial cracks were present on the weld bead, Figure 3(b). As will be seen below, no cracks were observed at the HAZ in metallographic sections. Macroscopic examination showed that grinding of the weld bead had virtually removed the machining marks in this area, Figure 3. Some small cracks were present in the HAZ, Figure 3(b), at pits or small grooves. Thus, the general absence of cracks in the HAZ is attributed to the elimination of stress-raisers, rather than to metallurgical structure or residual stress effects.

FIGURE 2. INTERNAL SURFACE OF 18" END OF REDUCER AFTER ELECTROLYTIC CLEANING. Note that cracking occurs at the root of machine marks near the counter-bore transition, (a), #15. Small axial cracks were occasionally present on the weld bead, (b), #43, in addition to fusion-line cracking.

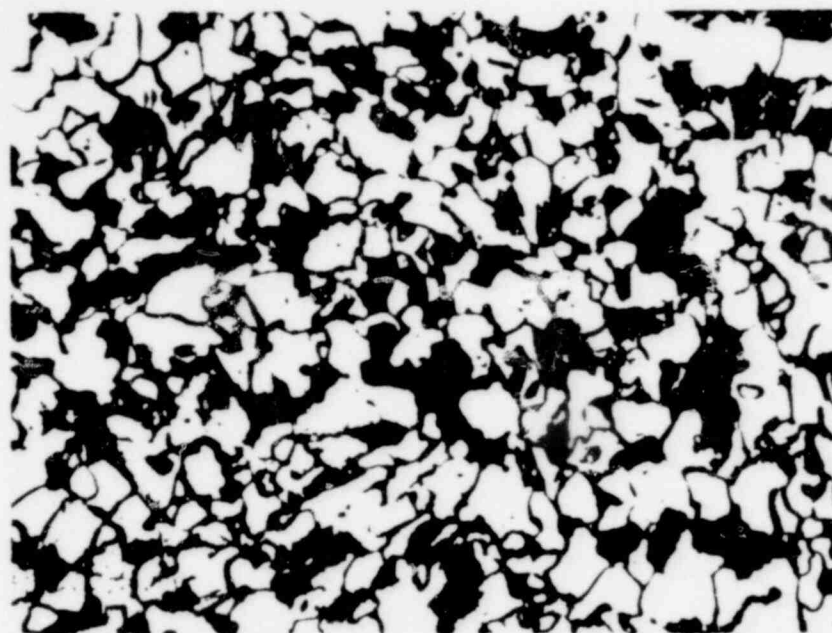
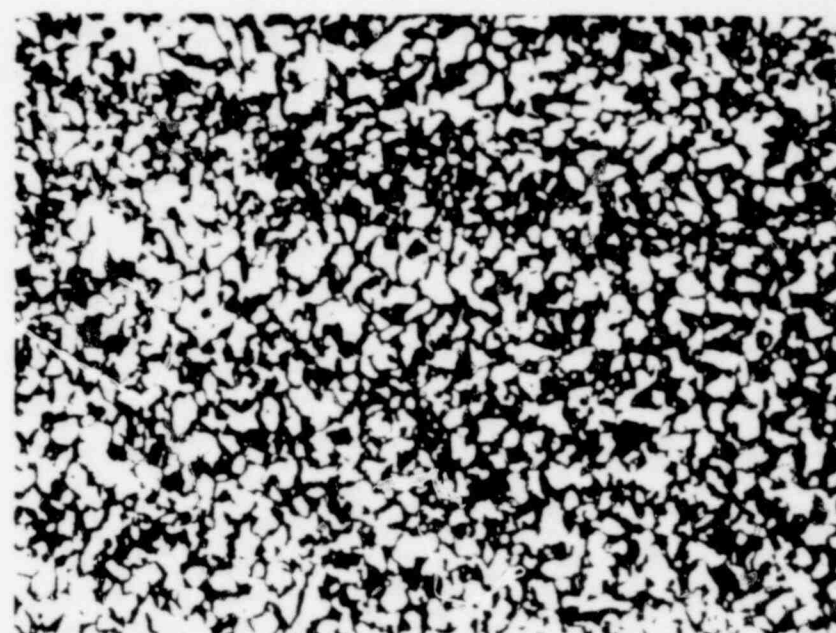
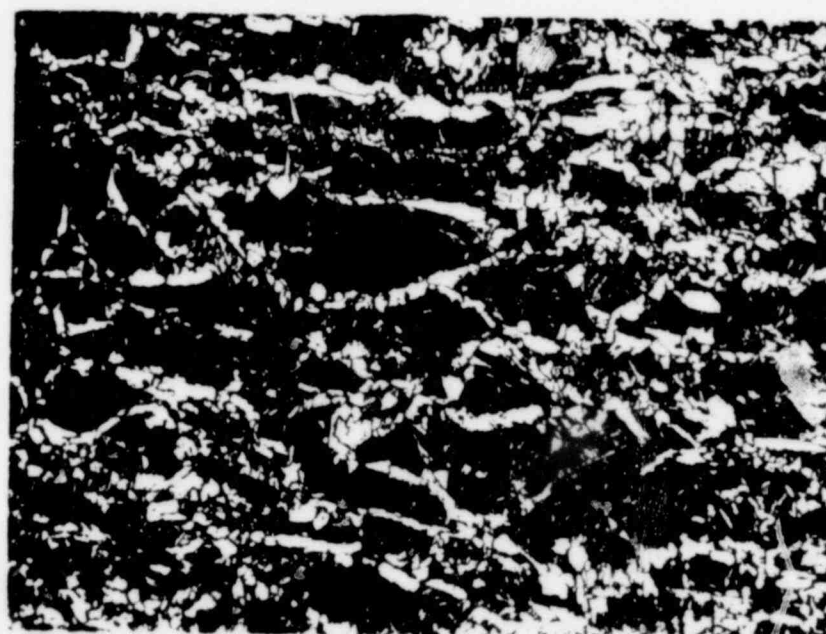
The structure of the reducer and welds was normal for mild steel piping, Figure 5. No metallurgical abnormalities such as islands of martensite, heavy banding or gross inclusions were observed. Sections at stations #11, #14, and #41 (80°, 100° and 295°) of the 16-in. end revealed a lack of fusion defect between the first and second passes, Figure 6.

FIGURE 5. TYPICAL MICROSTRUCTURES OF REDUCER AND WELD. Base metal, (a), and heat-affected zone, (b), of reducer; Widmanstätten ferrite in weld bead, (c).

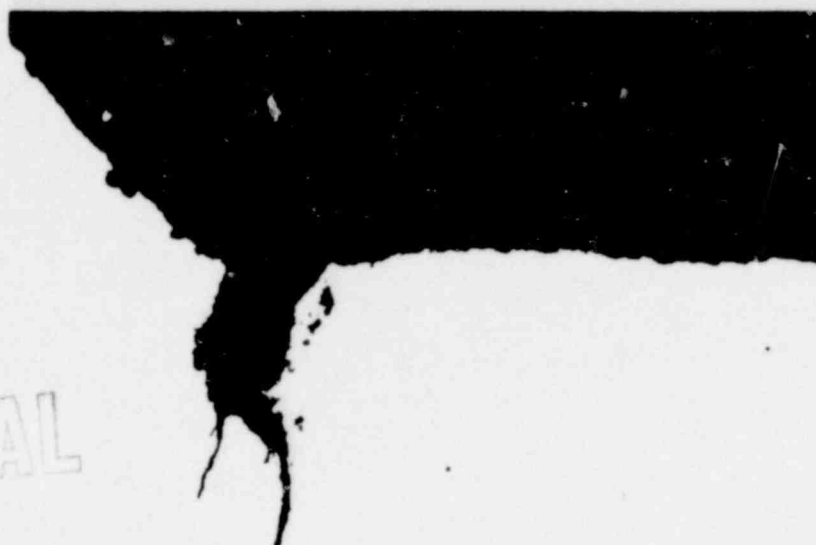
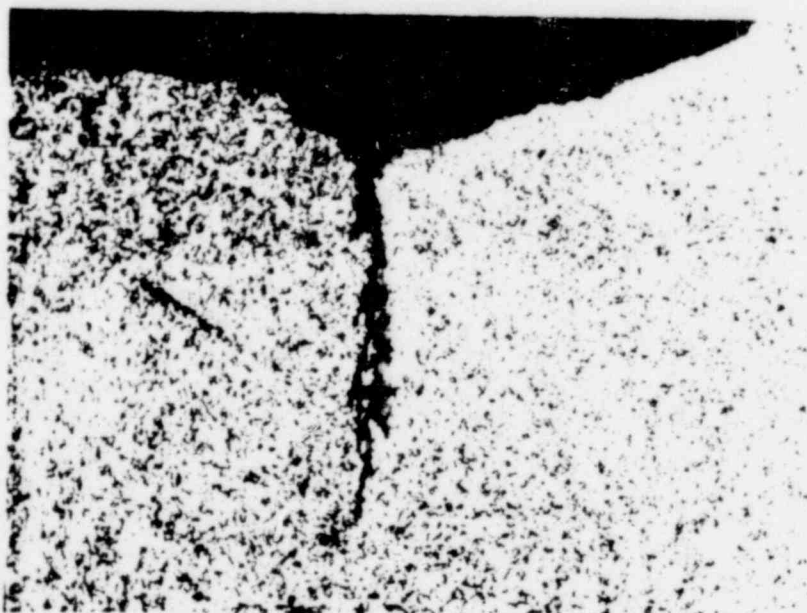
FIGURE 9. TRANSVERSE SECTION OF REDUCER I.D. AT STATION #17. Typical structure and surface finish, (a), and most severe attack observed, (b).
