BEDROCK DEFORMATION IN THE COOLING WATER TUNNELS

**Perry Nuclear Power Plant
Units 1 & 2**

GAI REPORT NO. 2063
Prepared for Cleveland Electric Illuminating Co.

BEDROCK DEFORMATION IN THE
COOLING WATER TUNNELS
PERRY NUCLEAR POWER PLANT
NORTH PERRY, OHIO

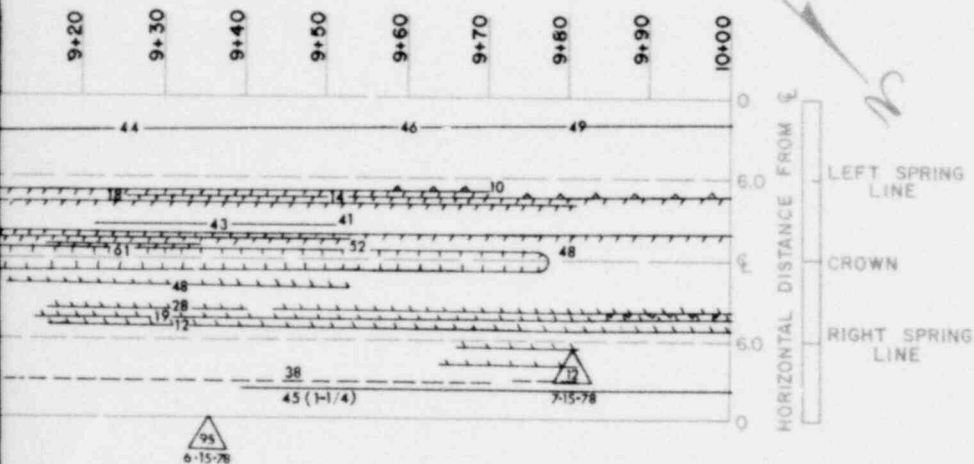
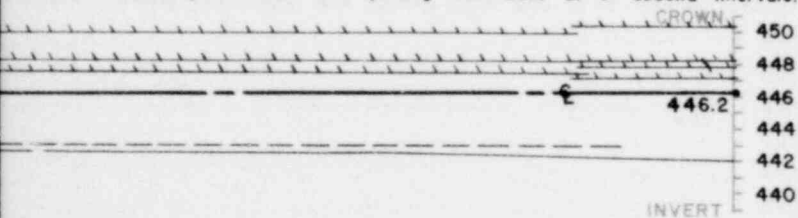
FIGURE 2
SHEET 4 OF 24

At station 9+64 encountered brine groundwater and clay, 4/14/78. A 2" diameter probe yielded a full bore of inflow. By 4:45 A.M. inflow decreased volume. At 7:45 A.M. groundwater was spurting from bore at 3 second intervals.

4-13/78	na 4-5
1"-8"	2'-10"
Bedding fractures only	
near crown staining	1 * See Note Above
	Slight moisture along 20% of bedding fractures and rock bolts
	16.5' water
	116.8' subsurface (shale)

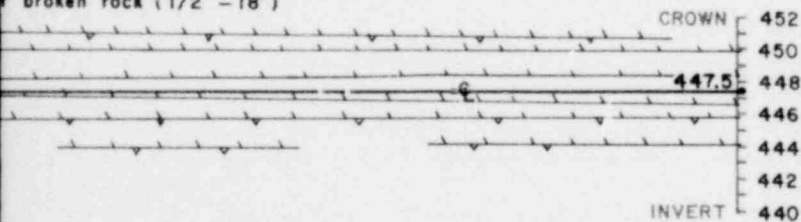
FIGURE 2
SHEET 5 OF 24

displacement - 22"
vertical displacement - 12"
N 47° E
prox. 17°
broken rock (1/2" - 18")

4.27 78	4.20 78
no 4-5	5 rock bolts at 2' centers in ribs at 3.5' centers, spanned by wire mesh
3'-3.5' centers spanned by wire mesh	Full shielding
14"	8"-15"
ictures only, spaced as above	
ght moisture along approx. 20% of bedding fractures and rock bolts	
	8.5' water
	109.3' subsurface (shale) +

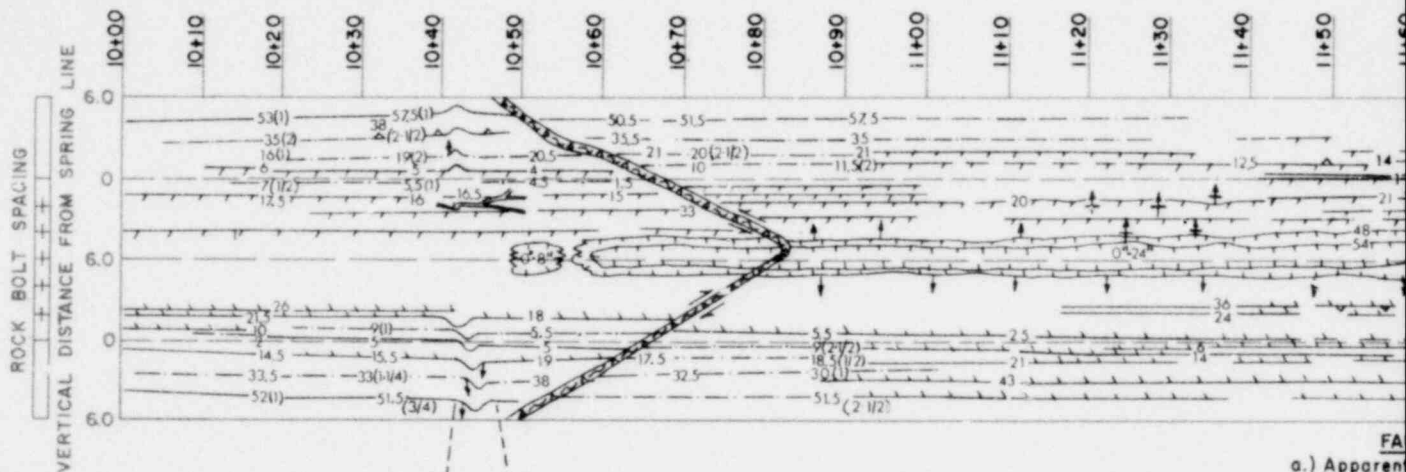
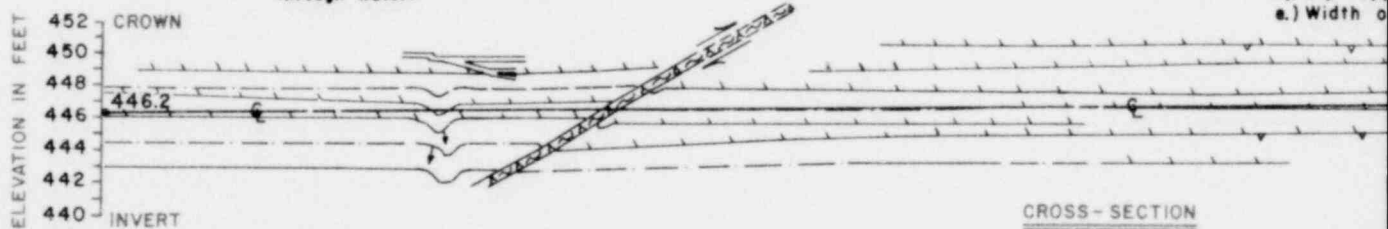
FIGURE 2
SHEET 6 OF 24

4-19 78	no 5-6		4-20 78	4-21 78	4-24 78	4-25 78	4-26 78
no 5-6		0-24' of overbreak between rock bolt no 2-4							
5 rock bolts at 2' centers in steel ribs at 3'-3.5' centers spanned by wire mesh		5 rock bolts at 2' centers in steel ribs at							
2"-10"	1'-7"	2'-9"		Full shielding - Rock bolts in liner plates completely shield upper 3/8 of tunnel				approx. 6"	
10"	Bedding fractures & 1/2" to 18" thick, highly fractured fault zone w/gauge		Bedding fra						
No inflows	Slight seep, from fold	No inflows		Slight inflow from rock bolts				Sl	
7.5' water		Water dripping from shielding		2 inflows at approx. 1 gal./min.					
111.7' subsurface (shale)

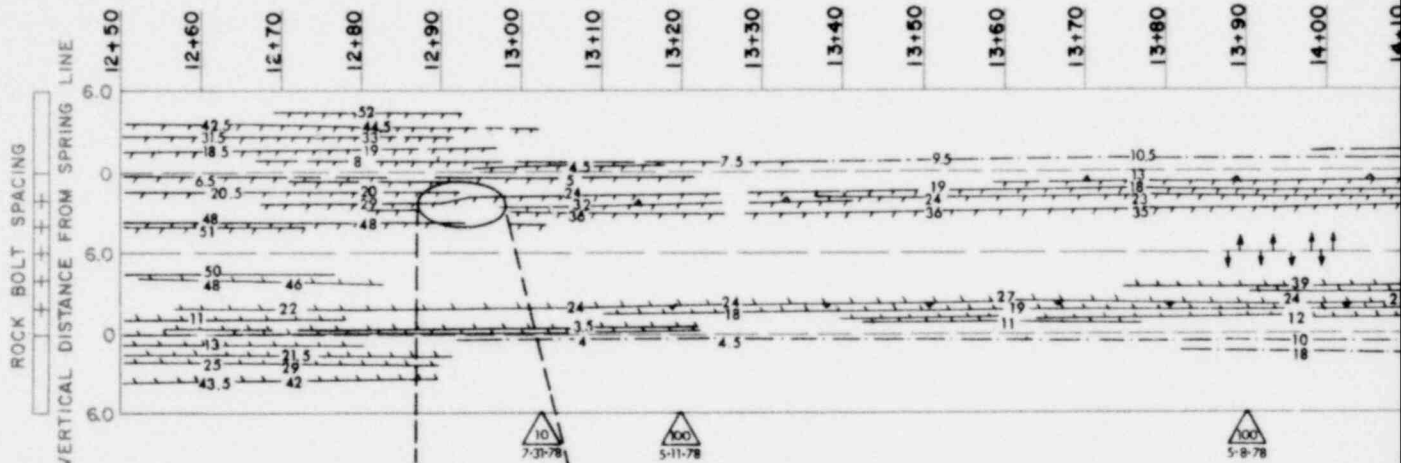
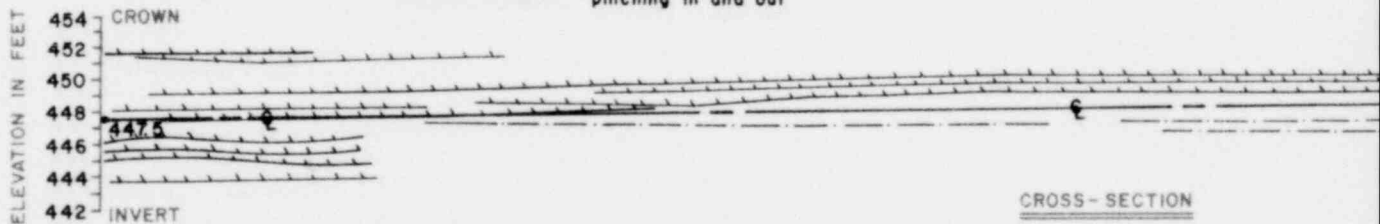
FIGURE 2
SHEET 7 OF 24

5-1 78	5-2 78	5-3 78	5-4 78	5-5 78	5-6 78
Rib bent 2"-6" between rock bolts no. 3-4		Rib bent 2"-6" between rock bolts no. 2-3		no. 4-5	
Approx. 8"-15"		Approx. 5"-15"		Rib bent 2"-6" between rock bolts no. 2-3	
No inflows		Approximately 20% of bedding fractures and rock bolts show minimal		Bedding fractures only, spaced as b	
+ 11.5 water					
+ 11.5 subsurface (shale)

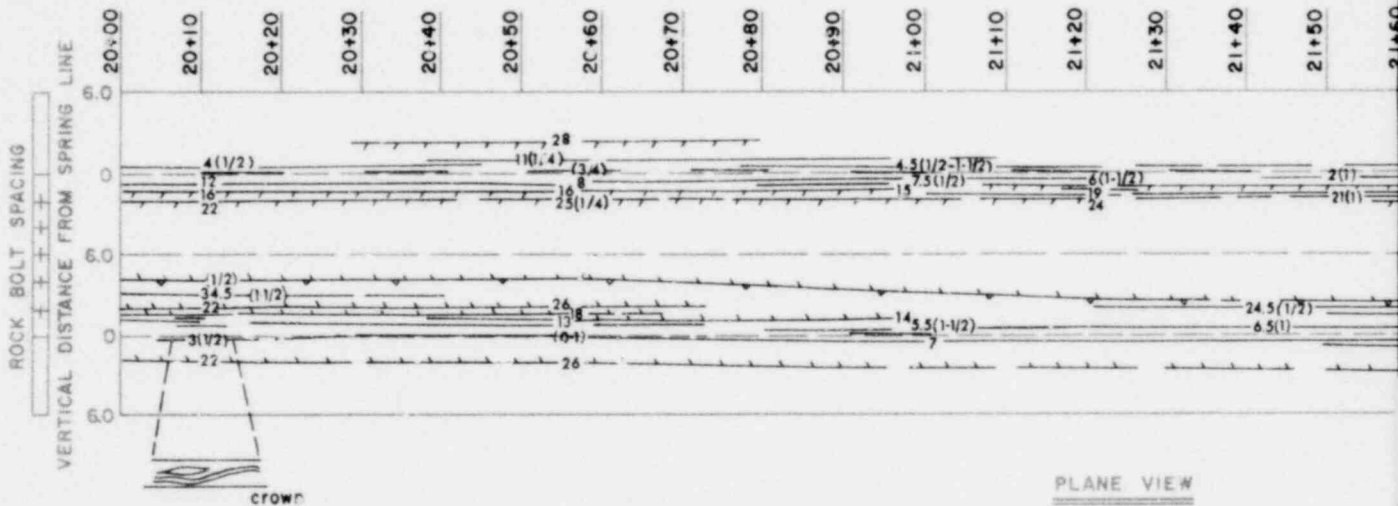
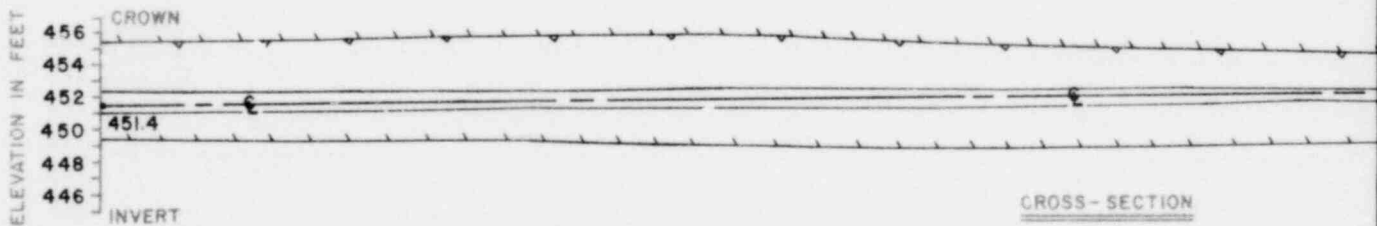
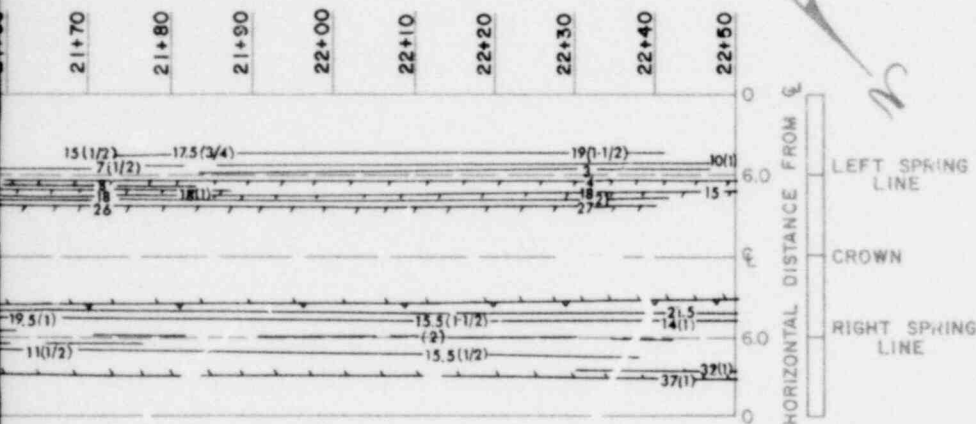
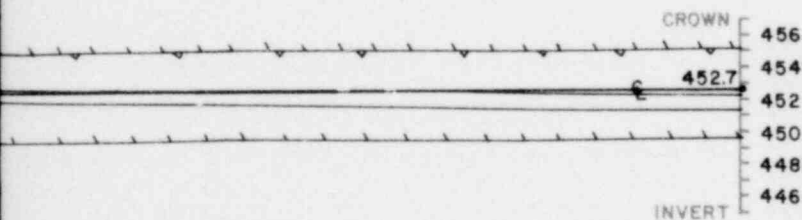
FIGURE 2
SHEET 9 OF 24

6-3/78
bolts at 2' centers in steel ribs at 3.5'-4.0' centers spanned by wire mesh
4"-9"
th
17.5' water
100.3' subsurface (shale) +

5+30	5+31	6+1	6+2
7/8	7/8	7/8	7/8
no. 4			
5 rock bolts at 2' centers in steel ribs at 4' centers spanned by wire mesh			
5 rock			
6"-9"			
Bedding fractures only			
Slight moisture from open parting along east wall for entire length			
+17.5 water			
+101.6 subsurface (shale)

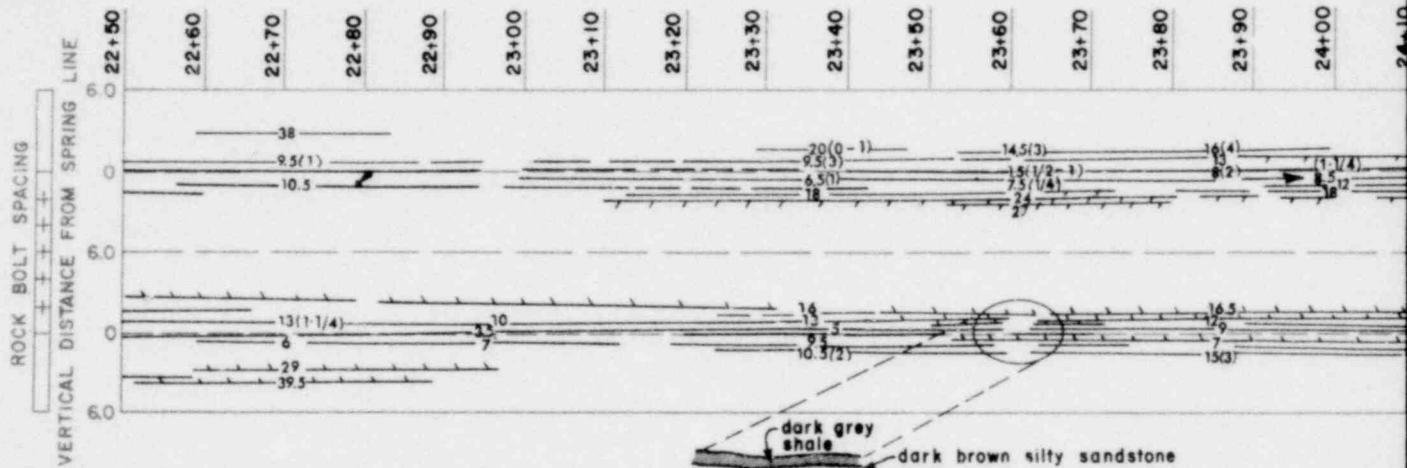
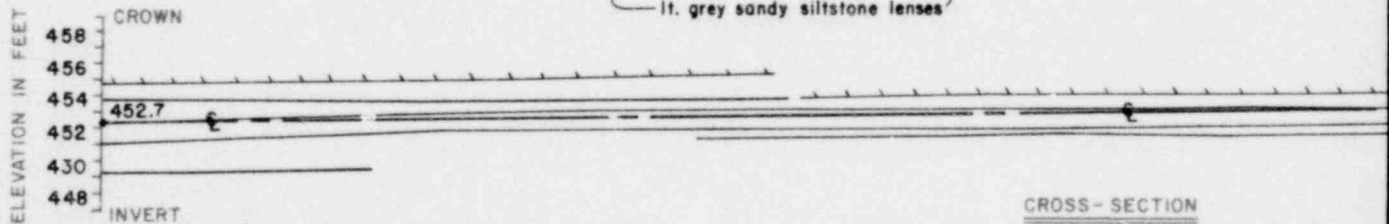
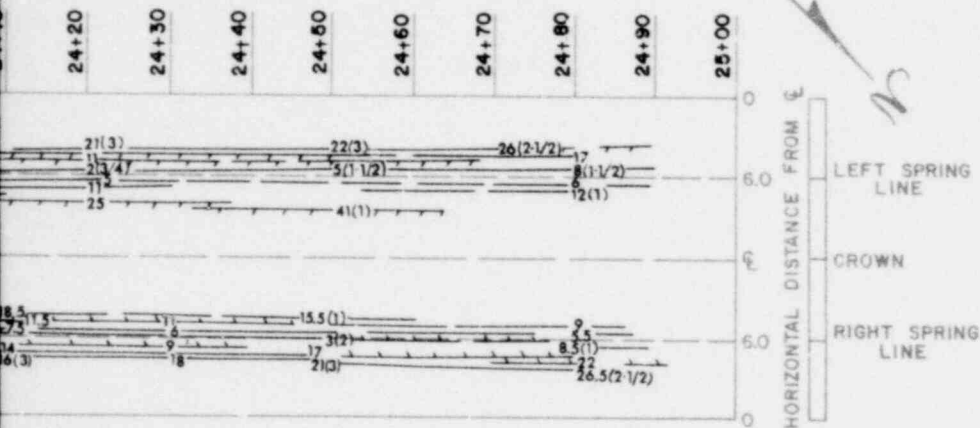
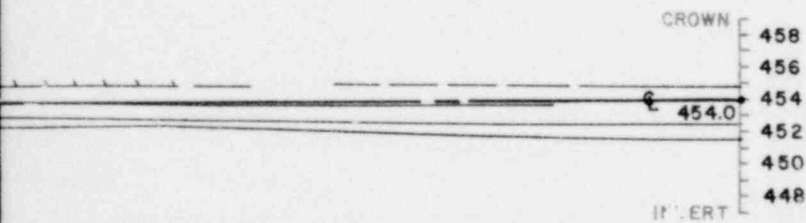
FIGURE 2
SHEET 10 OF 24

6.9	78
overbreak between rock bolts nos. 2 & 4, 1"-6" deep (max 3")	
by wire mesh	
3" - 9"	
No seepage	
18.5' water	
98.0' subsurface (shale) +

no. 4	0-6/78	0-7/78	0-8/78	no. 4
Slight overbreak between rock bolt nos. 2 & 4, 0"-6" deep (most >4")				
5 rock bolts at 2' centers in steel ribs at 3.5' to 4.0' centers, spanning				
3"-7"				
Bedding fractures only, spaced at or above				
Moist bedding fracture, above springline along east wall				
17.5' water				
100.3' subsurface (shale)

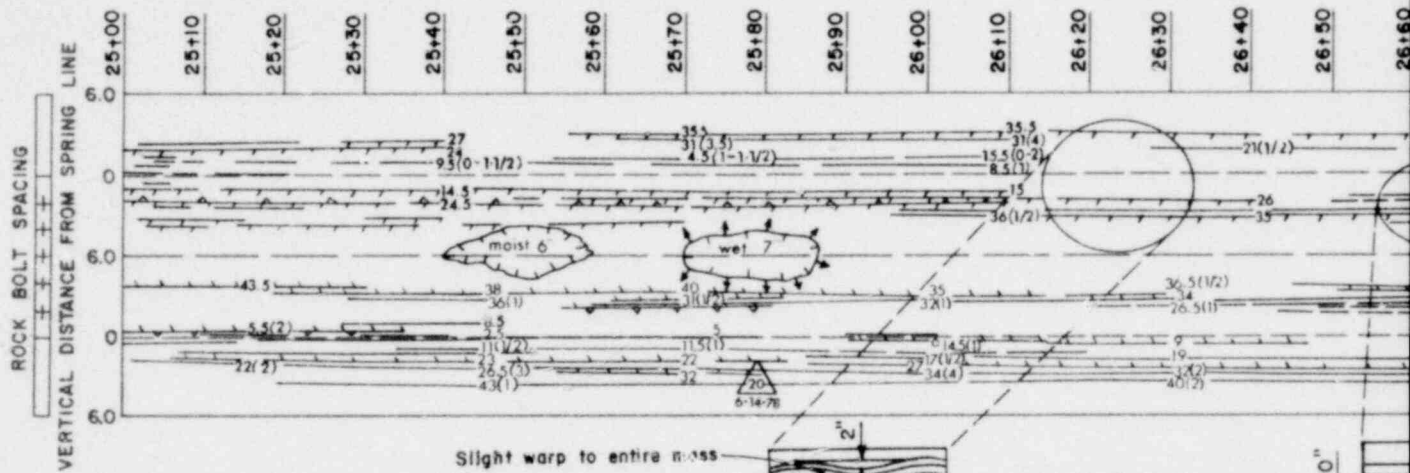
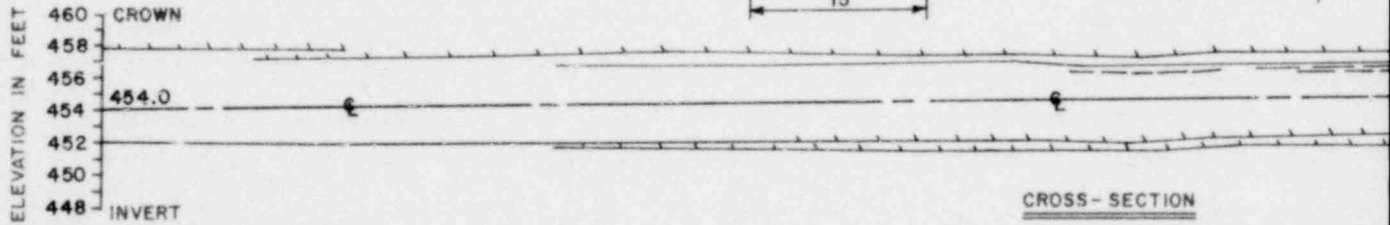
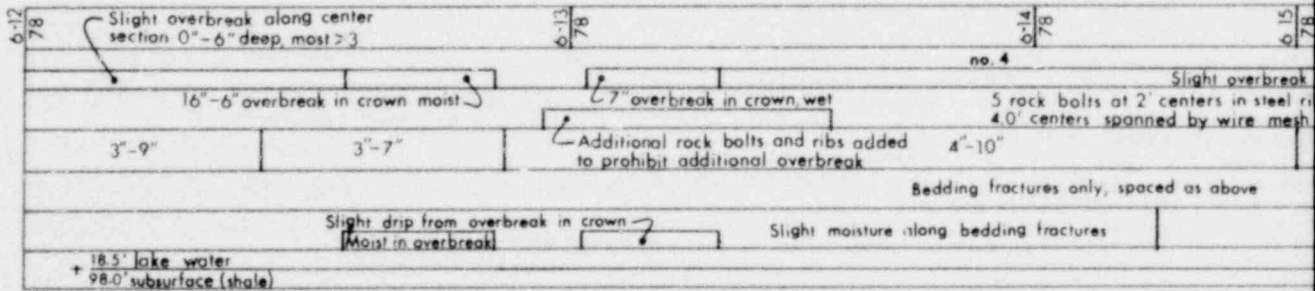
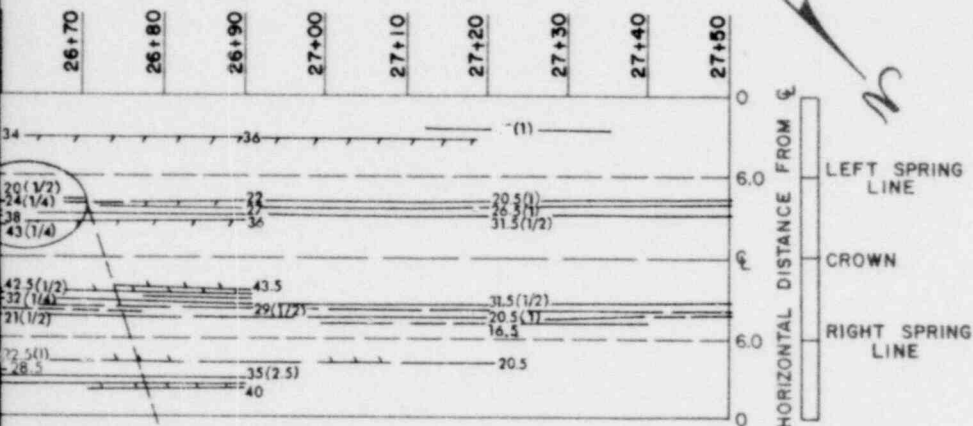
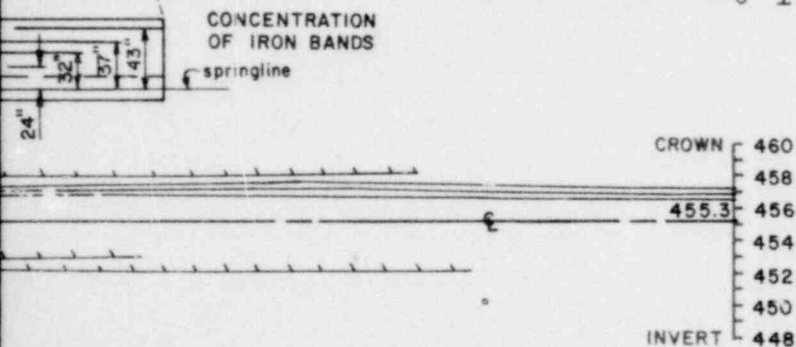
FIGURE 2
SHEET 11 OF 24

along entire section, 0' - 6'	5 rock bolts at 2' centers in steel ribs at 3.5'-4.0' centers spanned by wire mesh
at	4' - 9'
No seepage	
	20.5' water + 24.7' subsurface (shale)

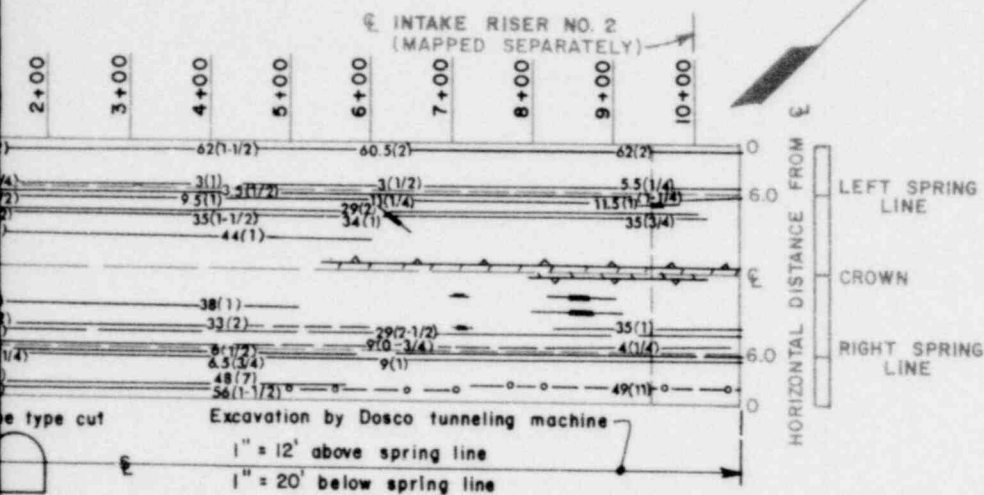
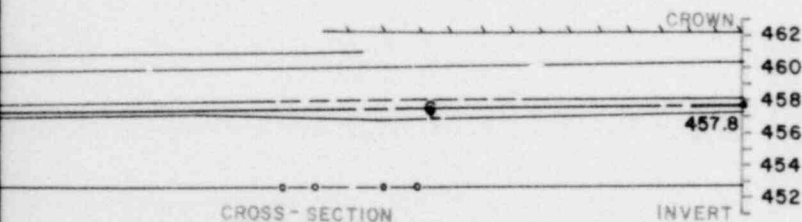
FIGURE 2
SHEET 13 OF 24

10-12	10-13	10-15	10-17	10-18	10-19	10-20	10-24	10-25	10-26
78	78	78	78	78	78	78	78	78	78
no. 4									
rock bolts at 2' centers in steel ribs at 4'-4.5' centers, spanned by wire mesh									
3"-8" Vertical joints, trending parallel to tunnel bearing, spaced at 2'-4'									
Bedding fractures only, spaced as above									
No seepage									
Slight moisture from bedding parting in crown									
20.5' water									
91.2' subsurface (shale)

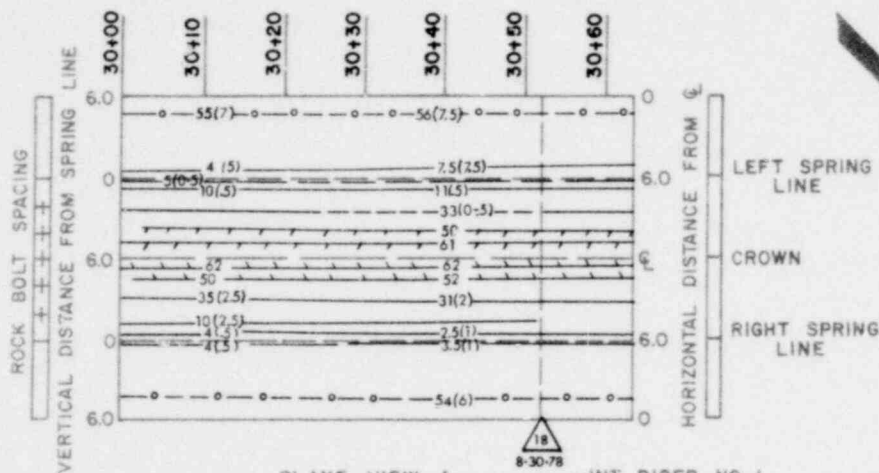
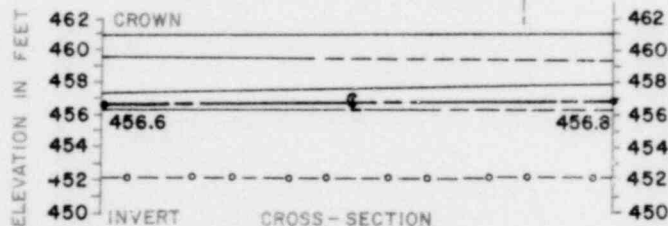
no. 4	
Slight overbreak along entire section	
5 rock bolts at 2' centers in steel ribs at 4' centers spanned by wire mesh	
4"-9"	
Bedding fractures only, spaced as above	
Slight moisture along all bedding fractures	
+ 22.5' lake water	22.5'
+ 91.5' subsurface (shale)	91.2'

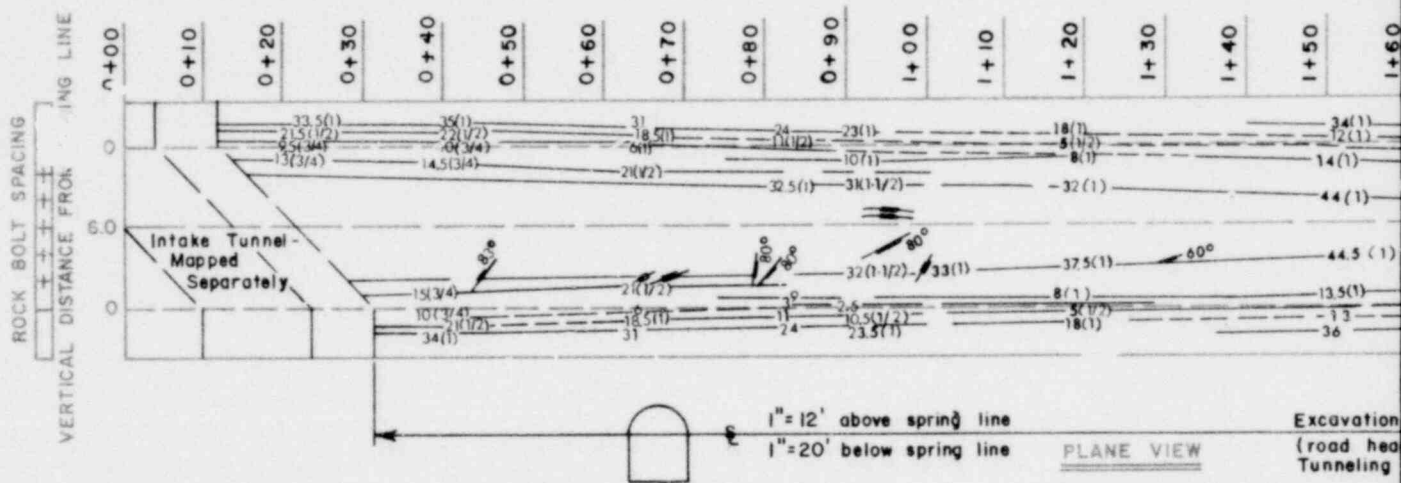
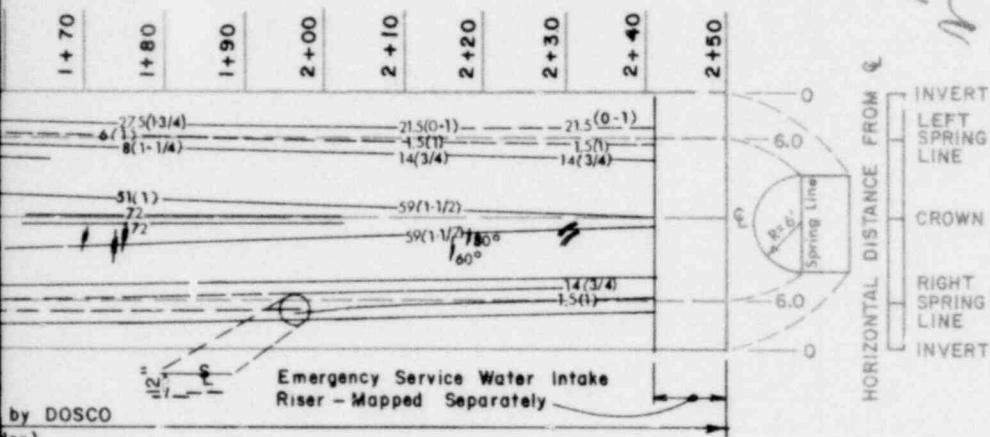
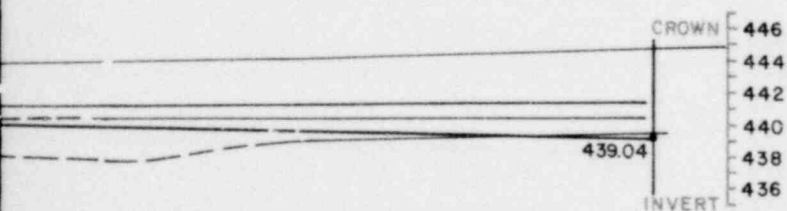
FIGURE 2
SHEET 14 OF 24

11-22	77	11-24	77
2" - 7"			
2" - 6"			
approx. 33.5' lacustrine, 27.5' glacial till			
121' of shale

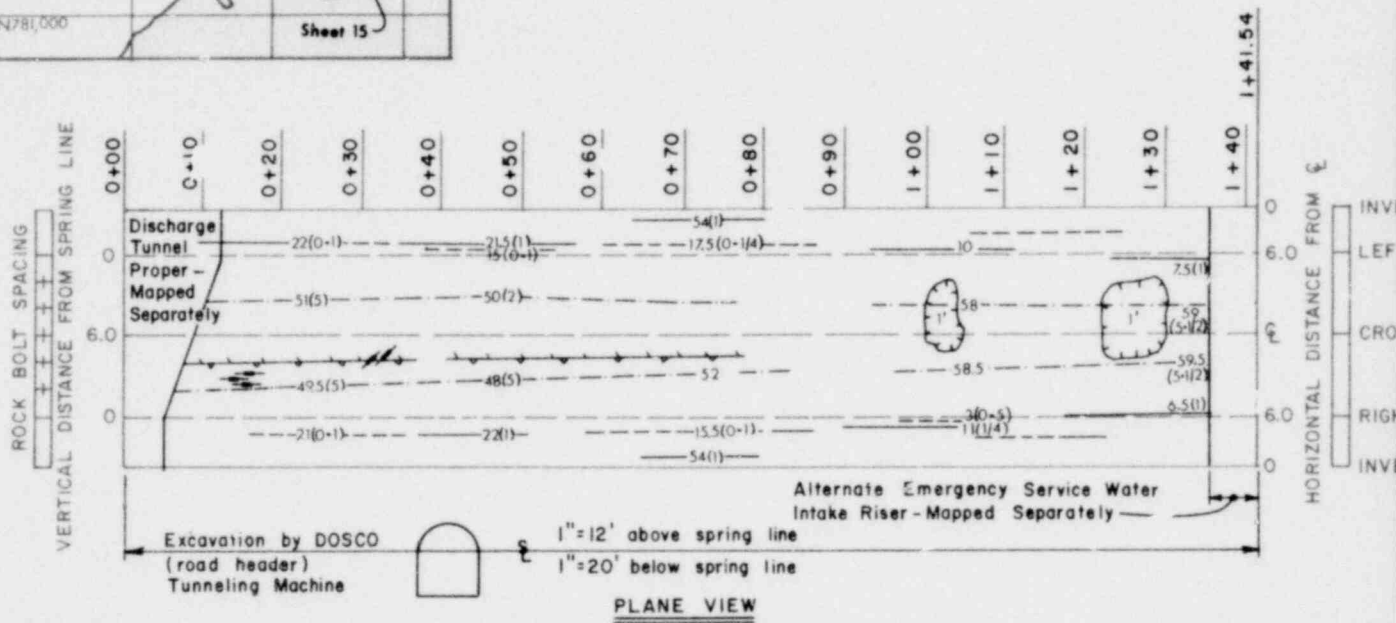
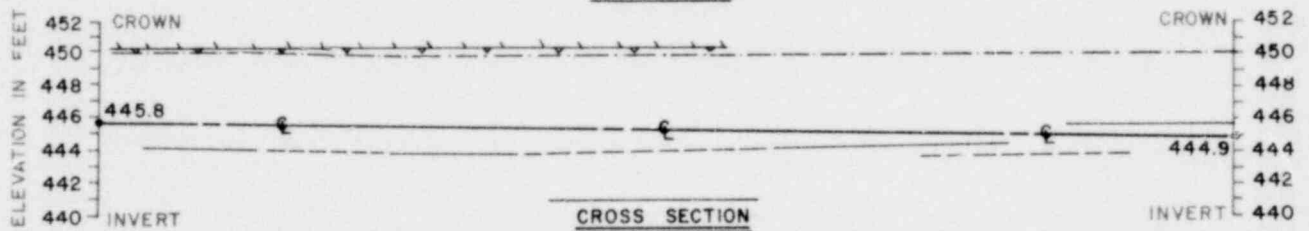
FIGURE 2
SHEET 15 OF 24

1-4 78	1-6 78	1-11 78	1-13 78
no. 4			
5 rock bolts at 2' centers, in steel ribs at 3.0'-3.5' centers, spanned by wire mesh			
1/2"-5"	6"-2"	1"-8"	Approx. 1"-5" partings vague
7"-14"	Bedding fractures only, spaced as above		
Slight seepage from bedding parting along west wall			No inflows
Approx. 33.5' lacustrine, 27.5' glacial till		Approx. 33.5' lacustrine, 27.5' glacial till	
111.7' shale		113.1' shale

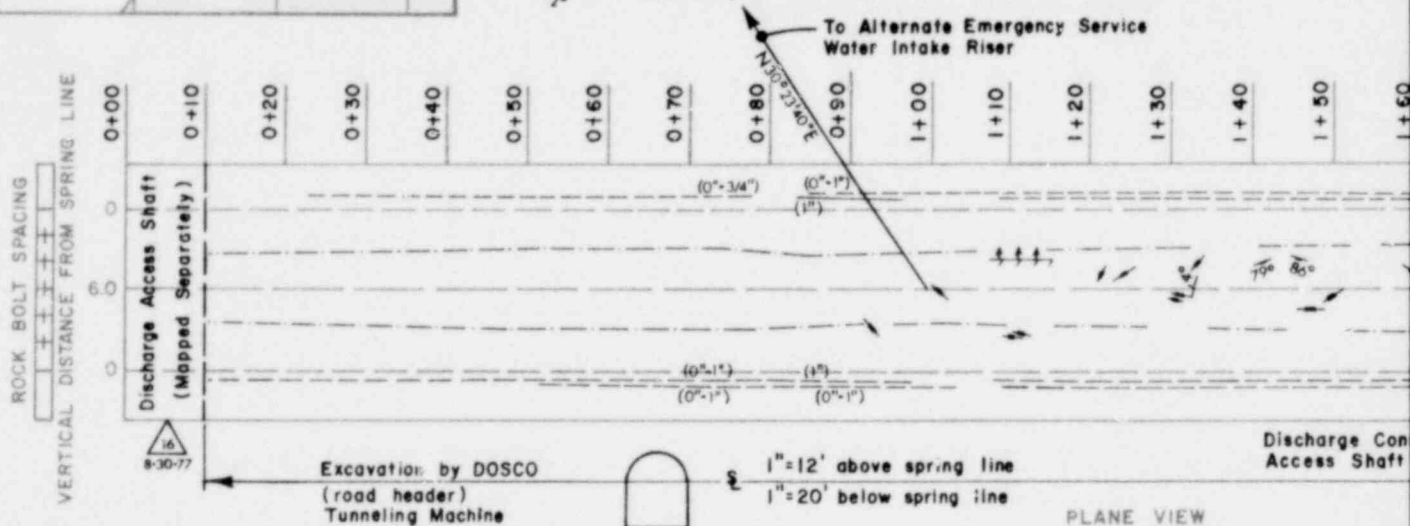
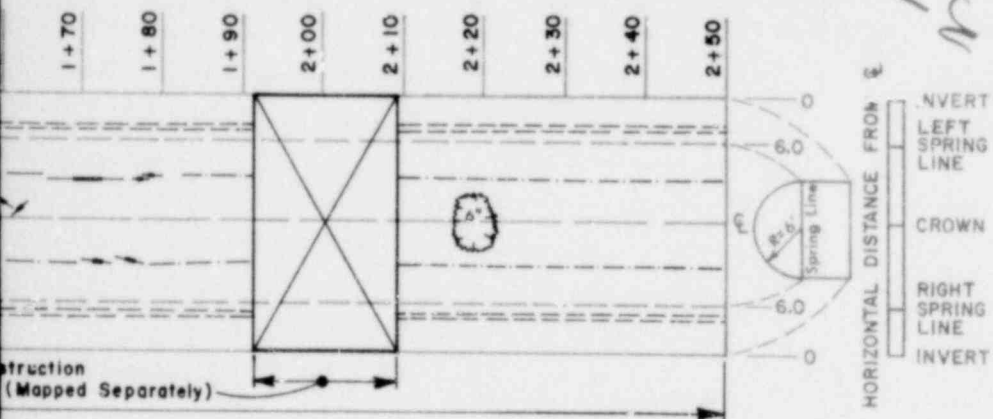
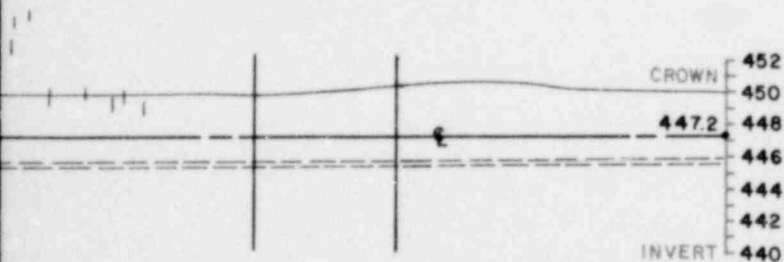
FIGURE 2
SHEET 16 OF 24

12-10 77	12-12 77	10-28 77	10-20 77	10-28 77	12-10 77	1-29 76
no. 4-5						
1/2" - 6"						
1' - 4' Noticed substantial amount of moisture in downshaft, May be from melting ice						
Approx. 33.5' lacustrine + 27.5' glacial till & 109.8' shale

2'-5"	1/2'-6"	1/2'-4"	2'-6"	1'-6"	1'-7"
1'-5'			5'-10'		
No seepage			Seepage out of parting 6 above springline on west wall

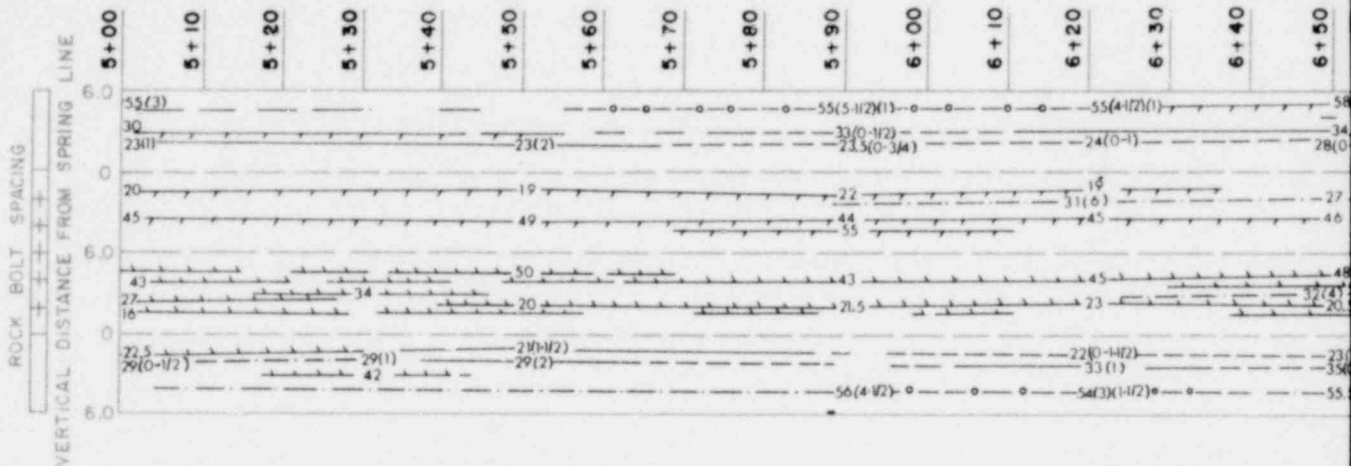
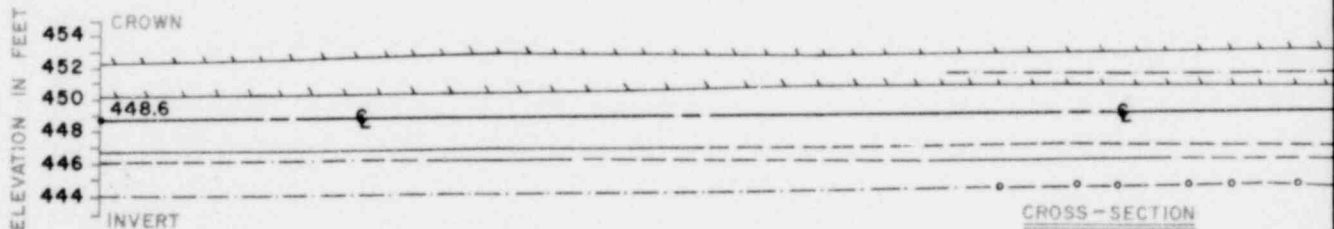
FIGURE 2
SHEET 19 OF 24

8+22	78	8+23	78	8+24	78
no. 4					
5 rock bolts at 2' centers in steel ribs at 3'-4' centers, spaced as above					
4"-12"					
Bedding fractures only, spaced as above					
No inflows					
+ 2' lake water					
116.1' subsurface (shale)

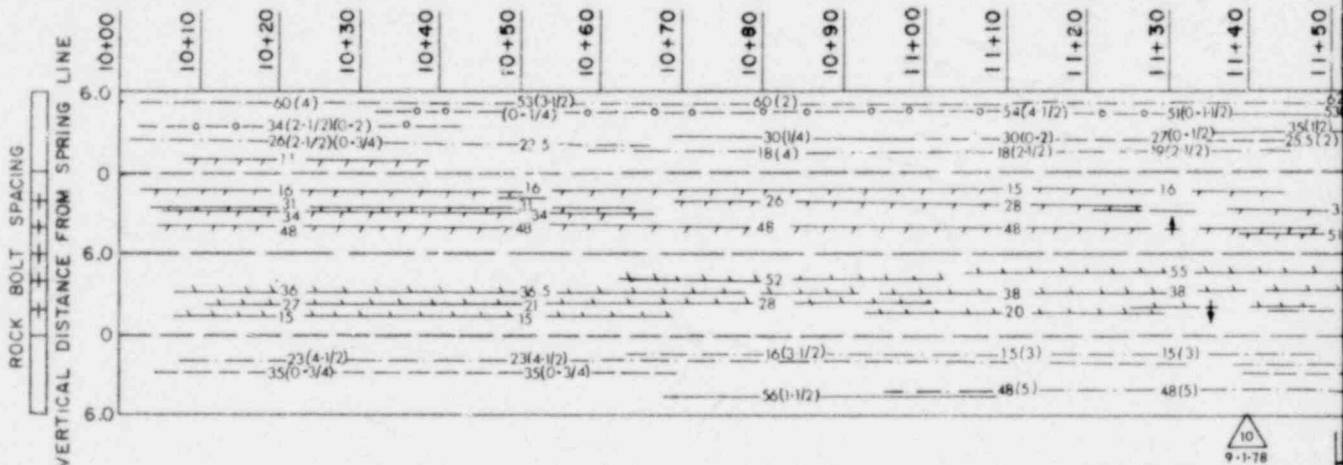
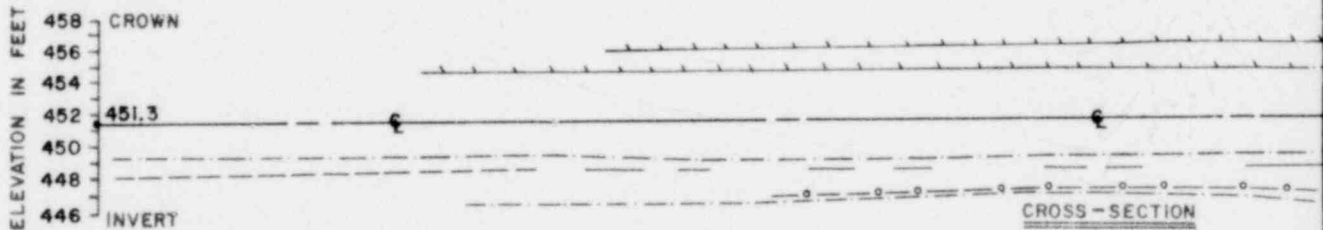
no. 4	0"-4" of overbreak spalling from crown
5 rock bolts at 2' centers in steel ribs at 4.0'-4.5' centers, spanned		
3"-10"		
Bedding fractures only, spaced as above		
No inflows	Seepage from rock bolts	
+ 7.5' water + 111.7' subsurface (shale)

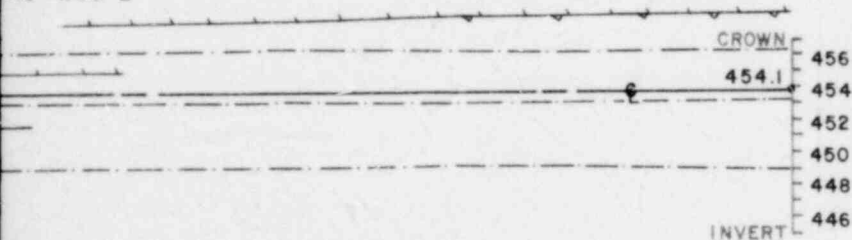
FAULT GEOMETRY
 parent displacement-12" to 25" d.) Dip approx. 16.5°
 dual vertical displacement-8-1/2" to 11-1/2" e.) Width of broken rock (1/2" to 24")
 like - N66°E

0.00	7.00	0.00	7.00
no. 4			
5	rock bolts at 2 centers in steel ribs at 3.5'-4' centers, spanned by wire mesh		
3'-9"			
Bedding fractures only, spaced as above			
14.5'	water		
101.9'	subsurface (shale)

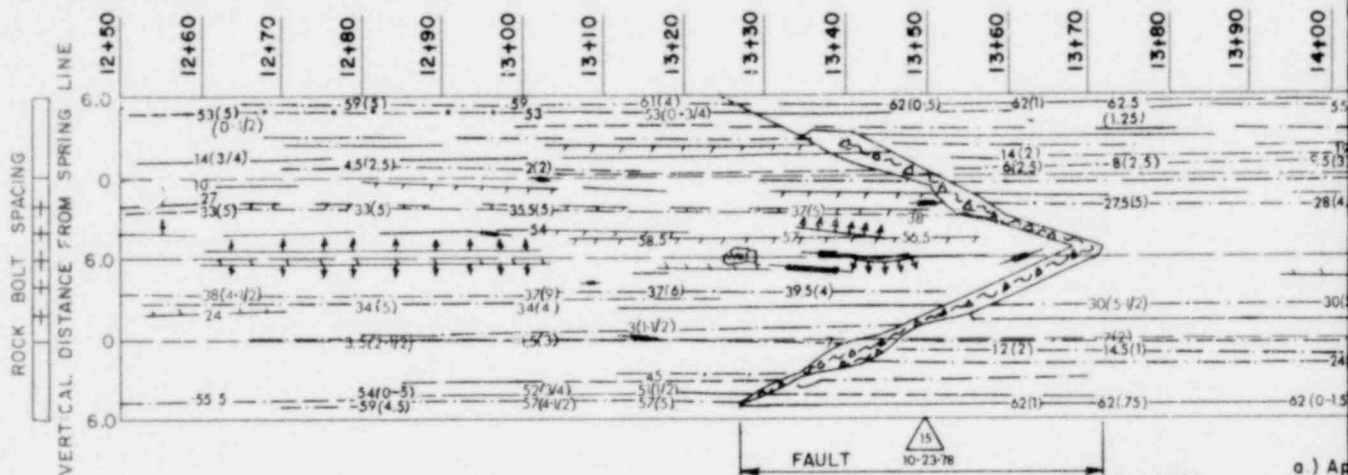
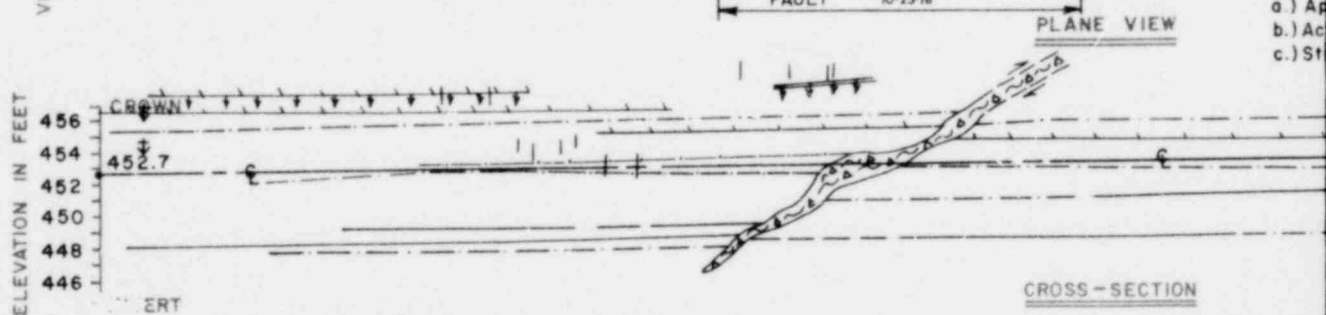
FIGURE 2
 SHEET 21 OF 24

no. 4	no. 4-6
5 rock bolts at 2' centers in steel ribs at 3.5'-4' centers, spanned by wire mesh	Full shielding employed
3'-9"	Ribs at 2' centers
Bedding fractures spaced as above, joints widely spaced	Joint pairs shown at .5'-1.5' apart, otherwise bedding fractures at 3'-9"
Moist bedding fractures where indicated	Several minor inflows in fractured areas of fault hang wall
+ 8.5 water	Several dripping flows along shaft
+ 109.3 subsurface (shale)	two max. inflows of 0.1 gal./min.

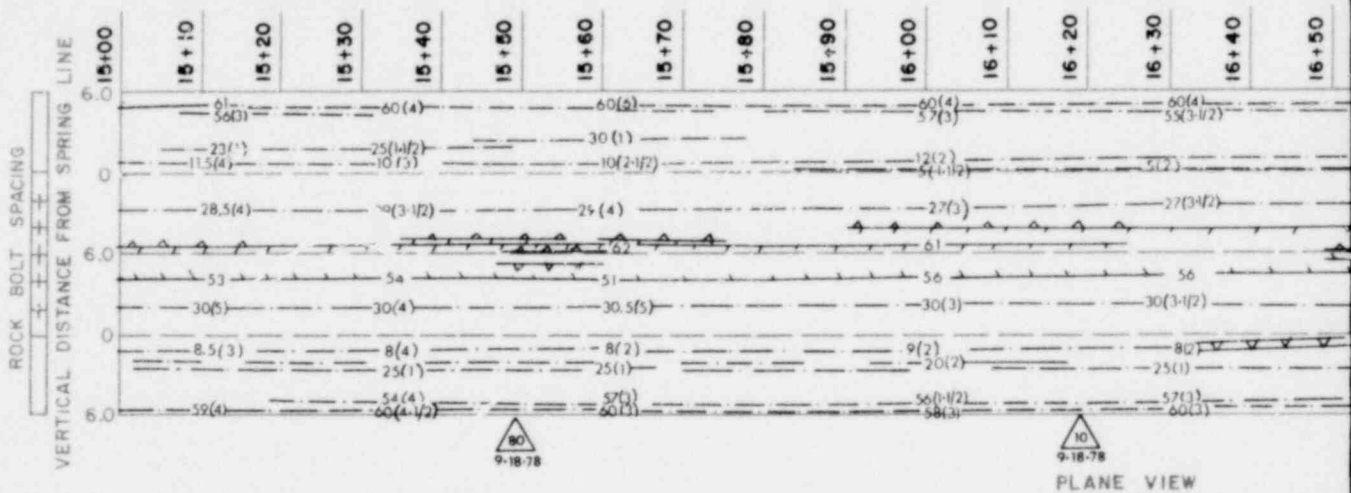
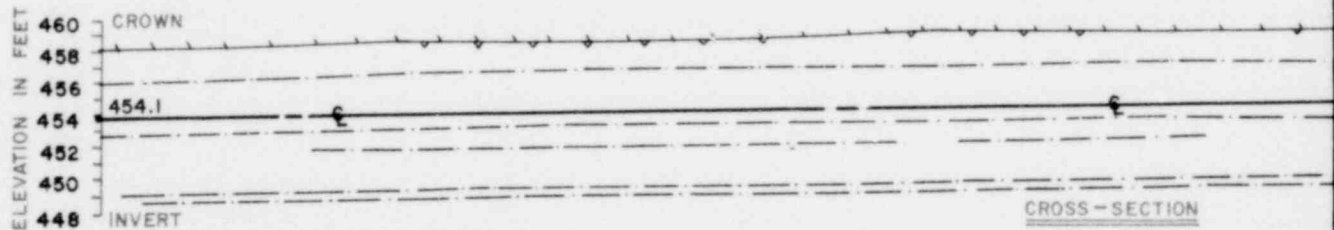
9-12/78		9-13/78		9-14/78	
Slight overbreak along entire excavation (0"-6")					
5 rock bolts at 2' centers in steel ribs at 40'-45' centers spanned					
3"-9"		4"-9"			
Bedding fractures only, spaced as above					
Moisture from bedding parting		Moisture from bedding parting		Moisture from bedding parting	
+ 14.5' water					
+ 101.9' subsurface (shale)

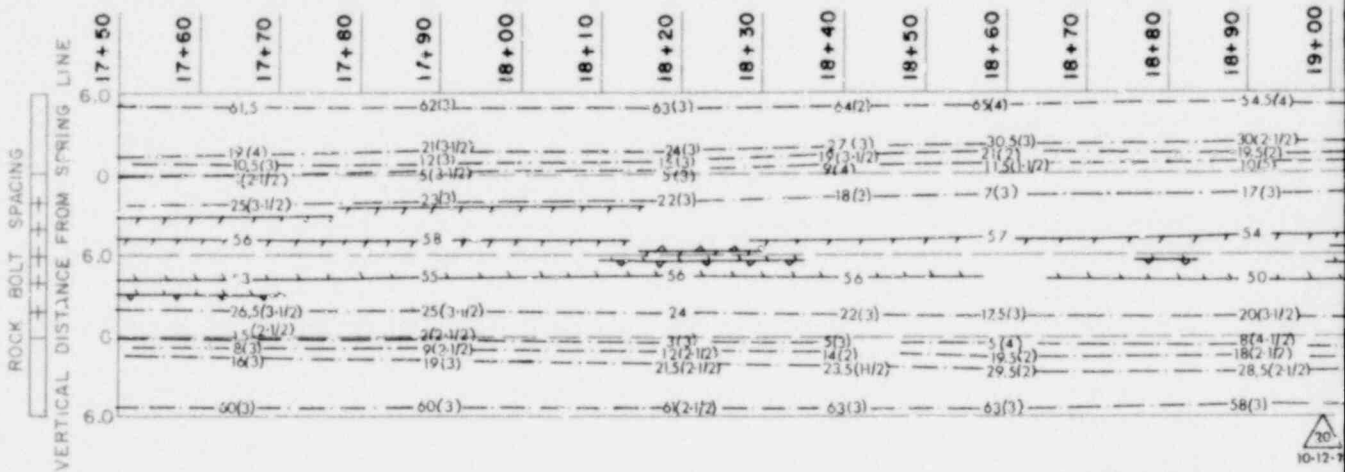
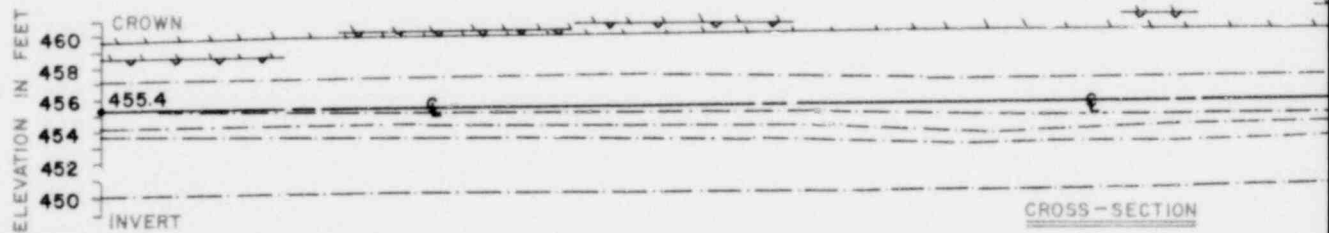
FIGURE 2
SHEET 23 OF 24

9-20	78	9-21	78
no. 4			
5 rock bolts at 2' centers in steel ribs at 4.0'-4.5' centers, spanning			
3" x 10"			
Moisture from bedding partings			
Moisture from bedding partings			
15.5' water			
99.6' subsurface (shale)

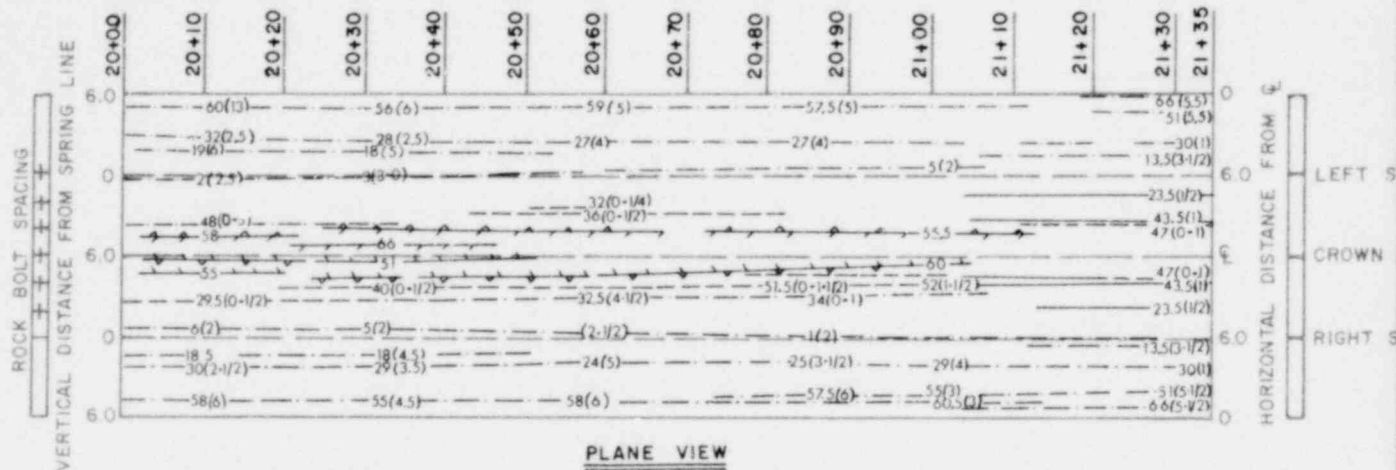
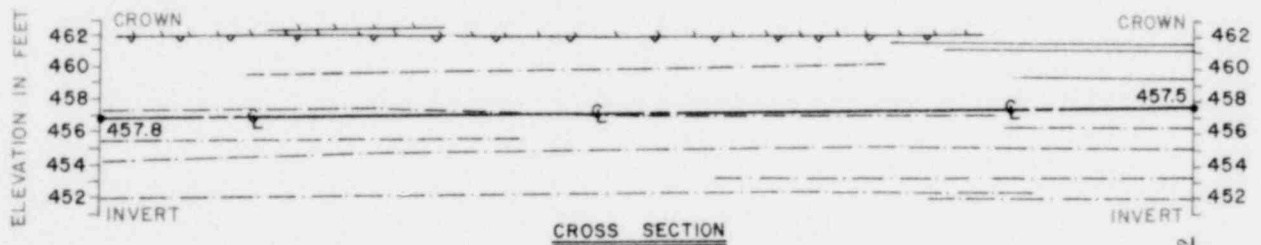
FIGURE 2
SHEET 24 OF 24

9.27	78	9.27	78	9.27	78
no. 4 Slight overbrenk along entire excavation (0"-3")					
5 rock bolts at 2 centers, in steel ribs at 4'-4.5' centers, spanned by wire mesh					
4'-11"					
Bedding partings only, spaced as above					
Slight moisture along bedding partings, where indicated					
+ 18.5' water			+ 19.5' water		
+ 95.2' subsurface (shale)			+ 93.5' subsurface (shale)

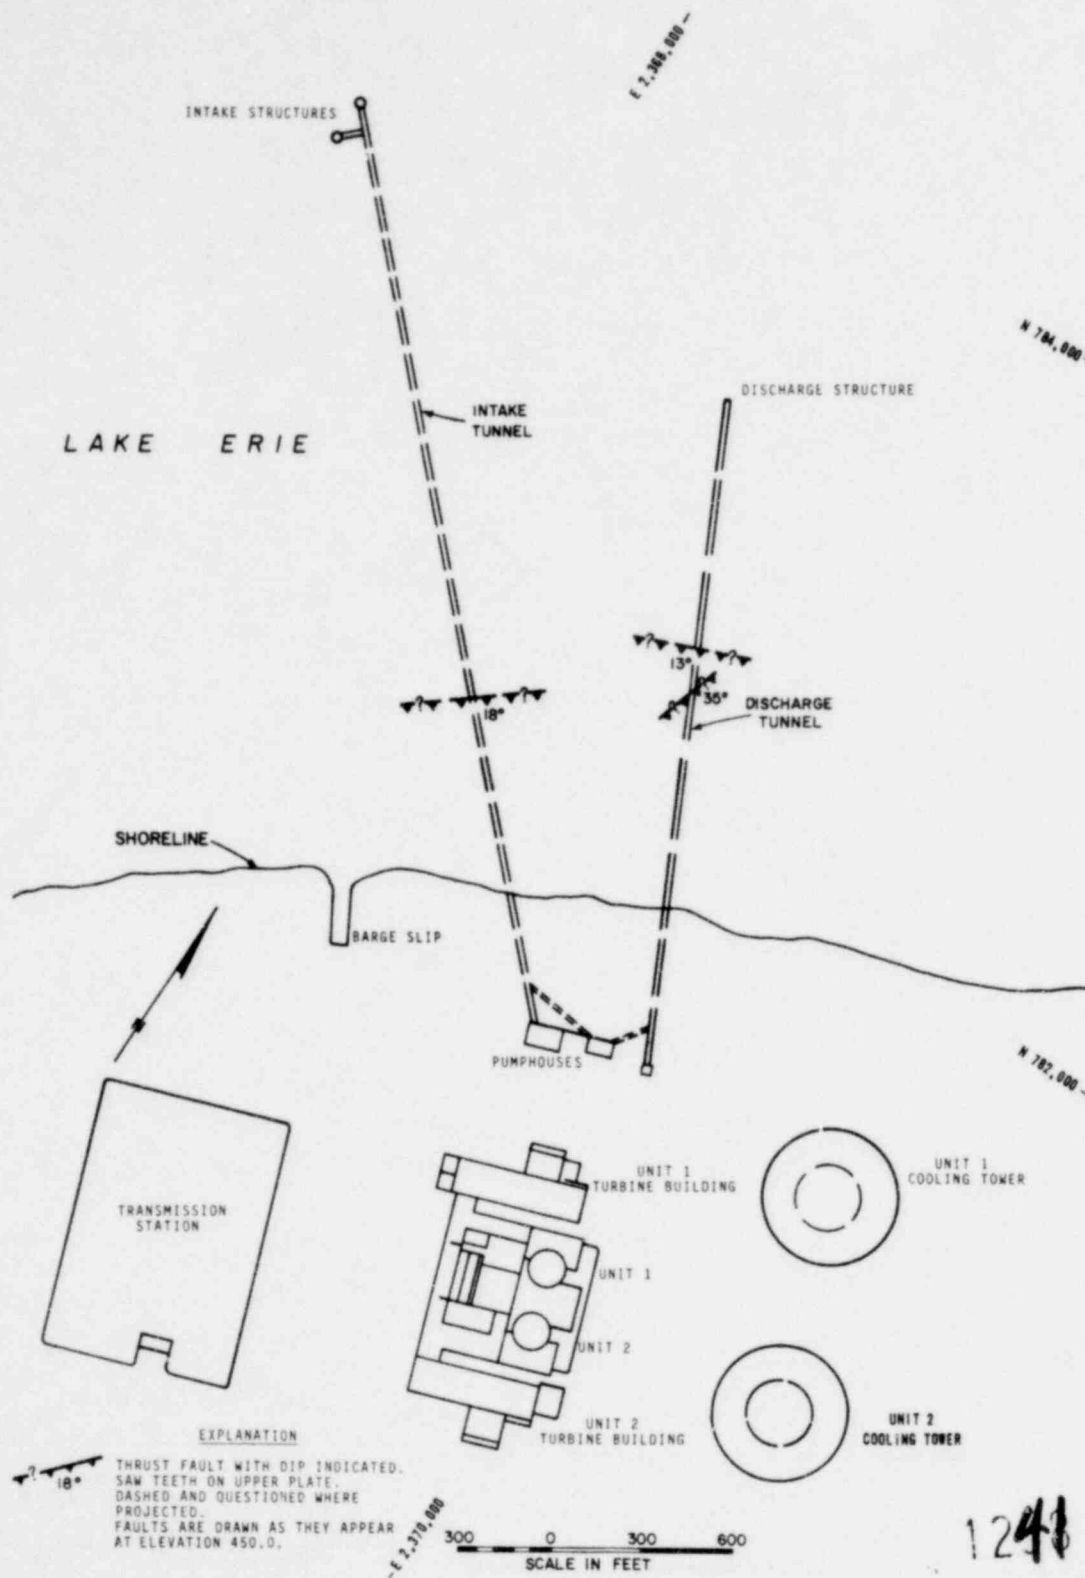
FIGURE 25

GEOLOGIC STRUCTURE MAP,
INTAKE & DISCHARGE TUNNEL FAULTS
