BEDROCK DEFORMATION IN THE COOLING WATER TUNNELS

**Perry Nuclear Power Plant
Units 1 & 2**

GAI REPORT NO. 2063
Prepared for Cleveland Electric Illuminating Co.

BEDROCK DEFORMATION IN THE
COOLING WATER TUNNELS
PERRY NUCLEAR POWER PLANT
NORTH PERRY, OHIO

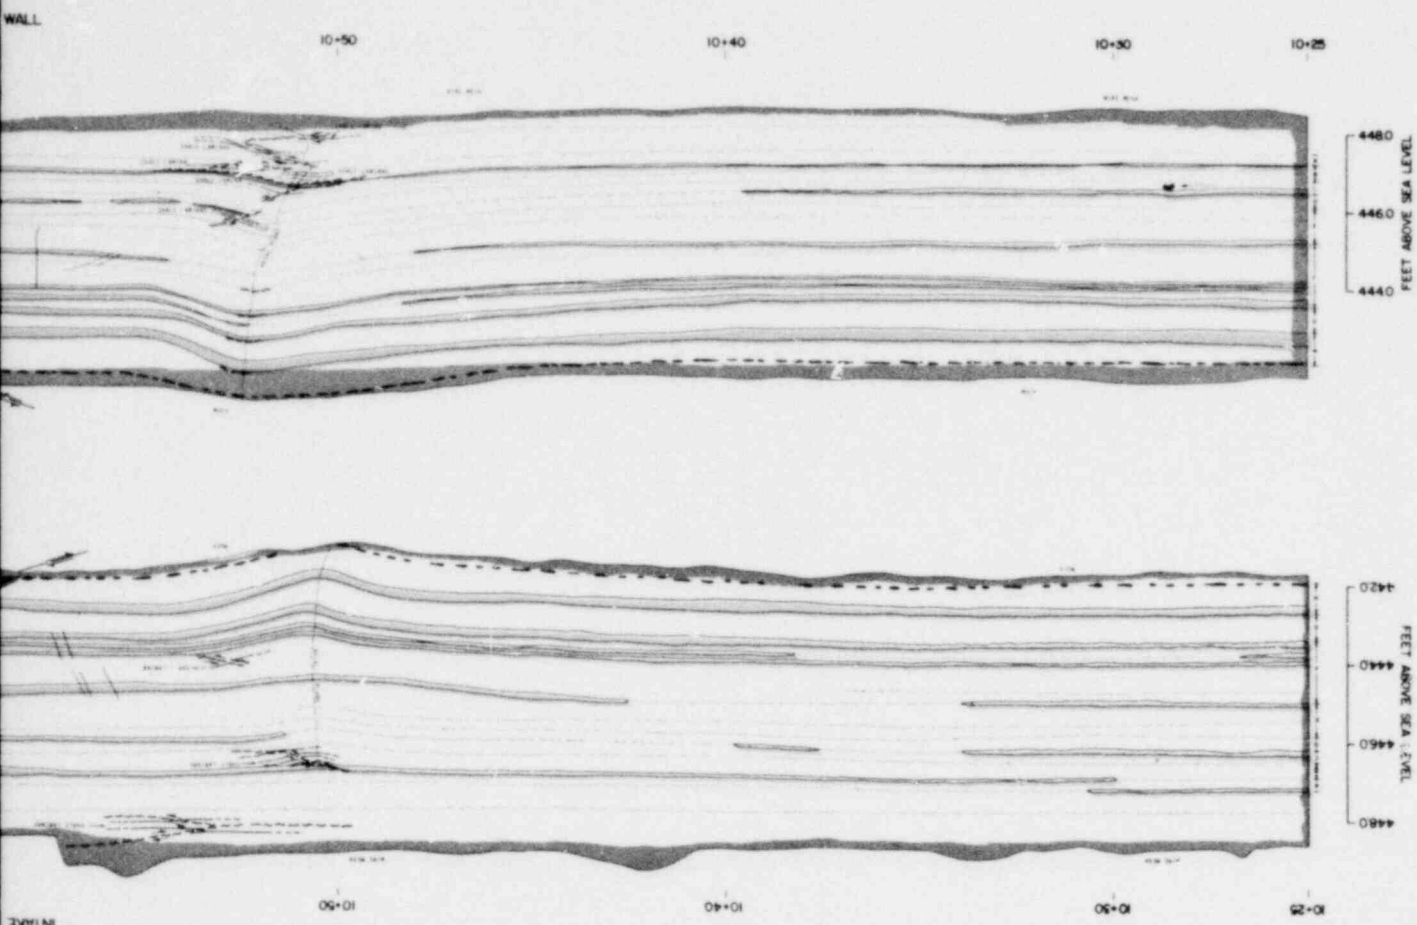
FIGURE 26

Detailed examination of the intake tunnel fault (Figure 26) indicates that the hanging wall is apparently more deformed than the footwall; deformation is brittle in nature and appears to diminish up section.

INTAKE TUNNEL WALL MAPS,
STATIONS 10+25-10+95

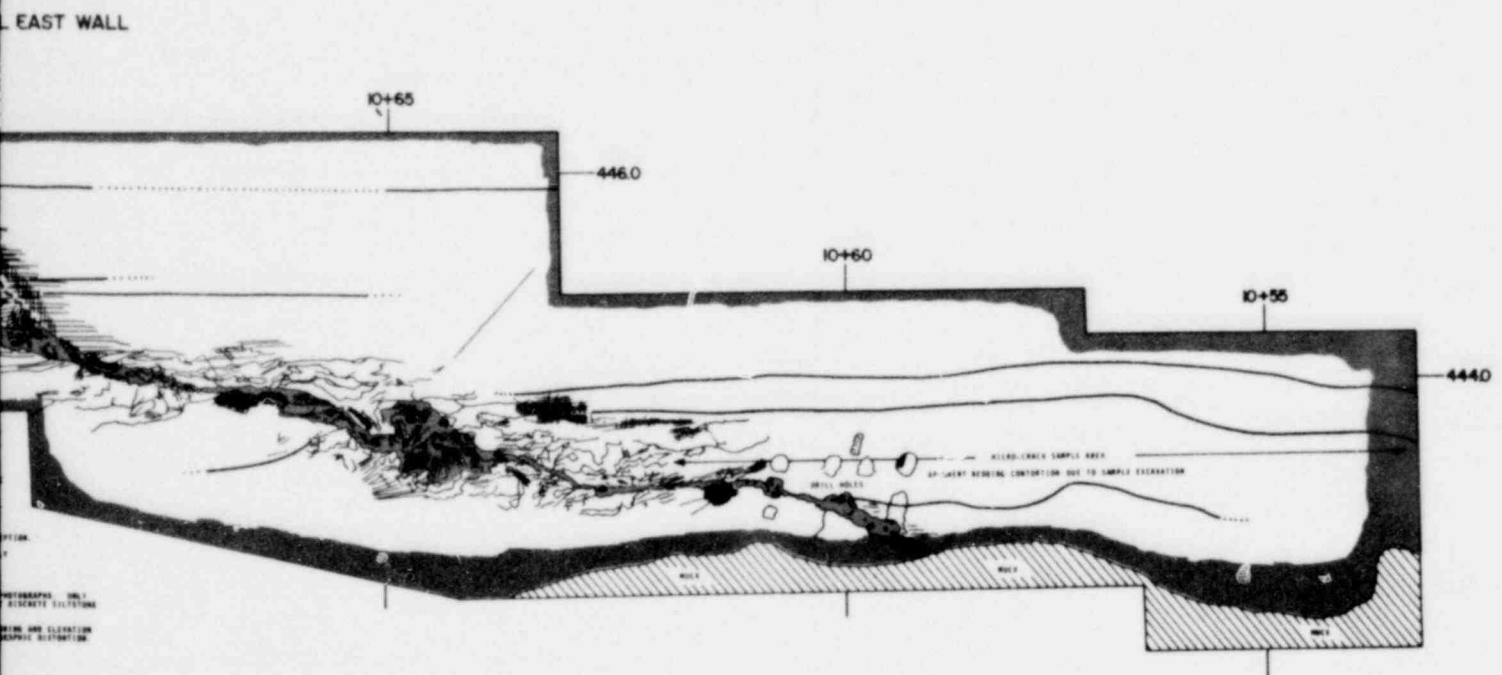
FIGURE 30

DETAILED MAP, INTAKE TUNNEL FAULT

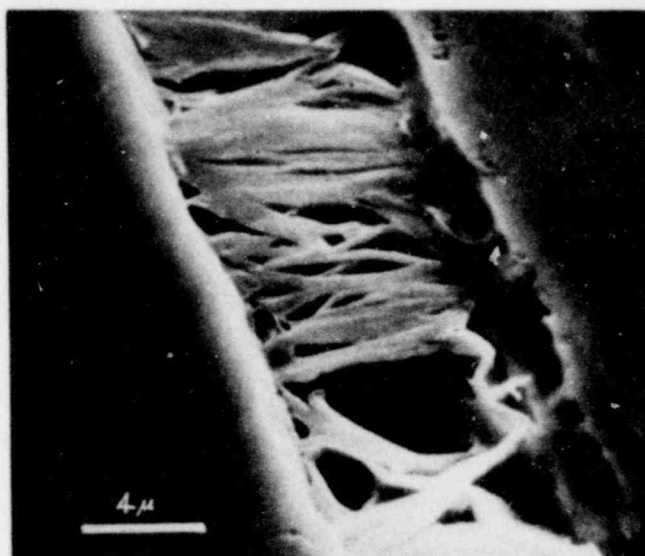
Figure 3 Partially healed microcracks from Ries Crater, Germany. SEM micrograph. Host grain is amphibole. New mineral growth is chlorite. The sample is described by Padovani *et al.* (1979).

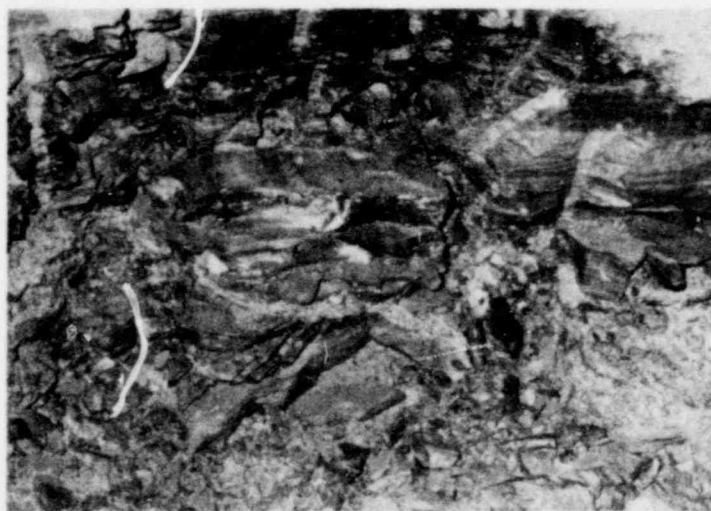
Figure 4 Sample number 4, partially outlined with holes that have been drilled with a jackhammer, still in situ. Note the gouge zone that is contained in this sample. The webs between the individual holes were later removed. A chisel was used to split a bedding plane at the base of the sample, freeing the sample completely.

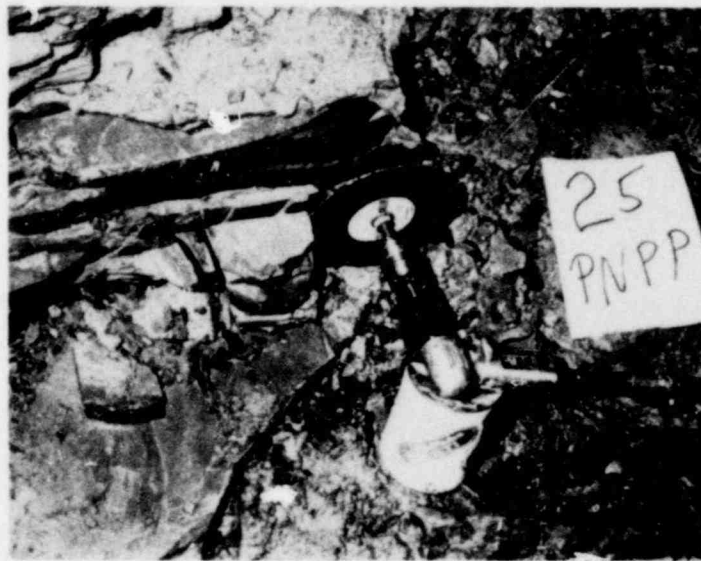
In the second procedure, we used a small masonry saw to remove completely, the specimen from the rock mass in situ. A series of photographs on Figure 5 illustrates the second technique. This procedure, though rather time consuming for large samples, was highly successful.

Figure 5 Sample number 25, partially sawn, still in situ. After the rear cut had been made, the sample was freed by splitting gently along a bedding plane. Note the gouge zone that extends diagonally across the sample.

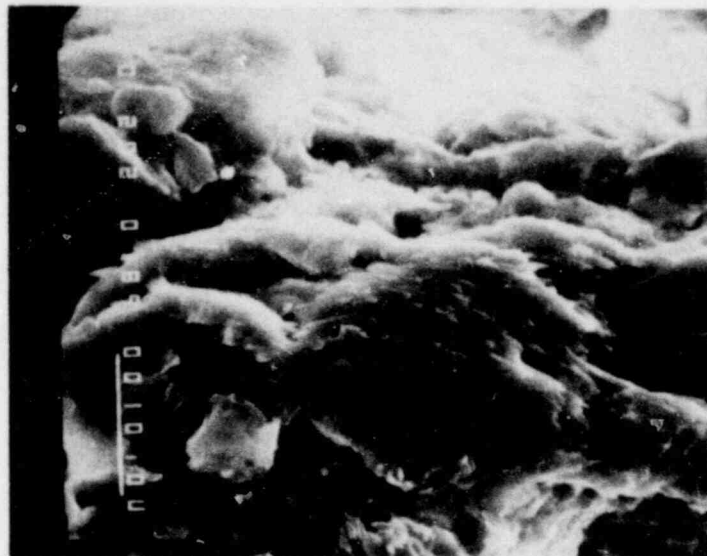
Figure 7 Typical micrograph obtained with a scanning electron microscope. PNPP sample 1. This image was made with a specimen from the gouge zone in the intake tunnel at the Perry Nuclear Site. The deformed crystals near the center of the micrograph are probably gypsum.

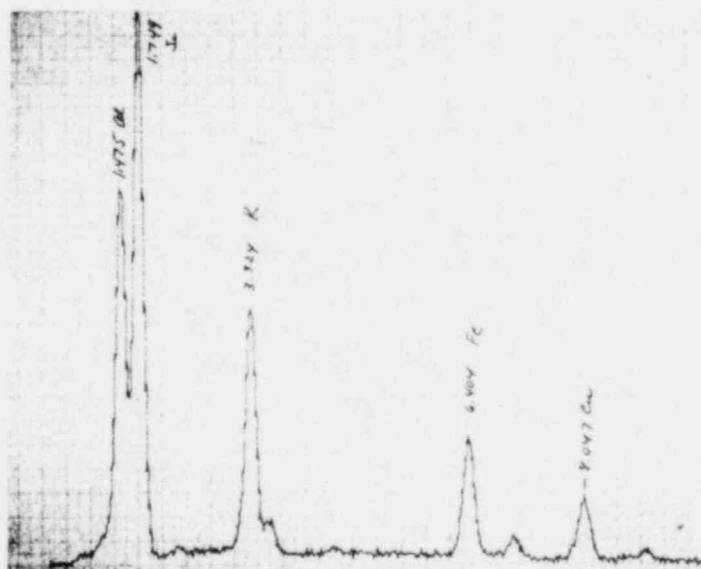
Figure 8 Typical x-ray spectrum obtained with energy dispersive systems. This spectrum was obtained from clay minerals in the gouge zone. The abscissa is energy (of x-rays) and the ordinate is counts per channel. The identification of the individual peaks is shown on the figure. The peak for copper is due to contamination within the system and not to the presence of copper in the specimen. The mineral is probably illite.

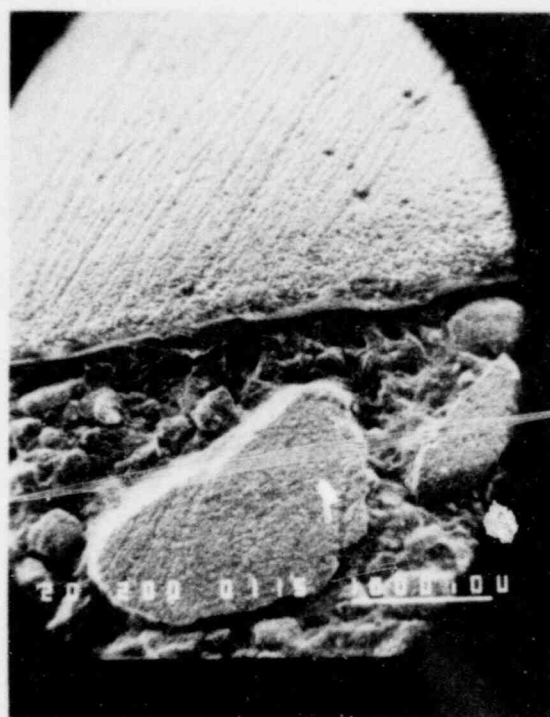
Figure 9 Figure 9a is an enlargement of an optical photograph and shows in small scale the many features that are present in the gouge and can be readily recognized on a freshly sawn surface. Note the abundant lithic fragments of shale that are set in the fine-grained matrix. Figure 9b is an SEM micrograph of the gouge (area differs from 9a).

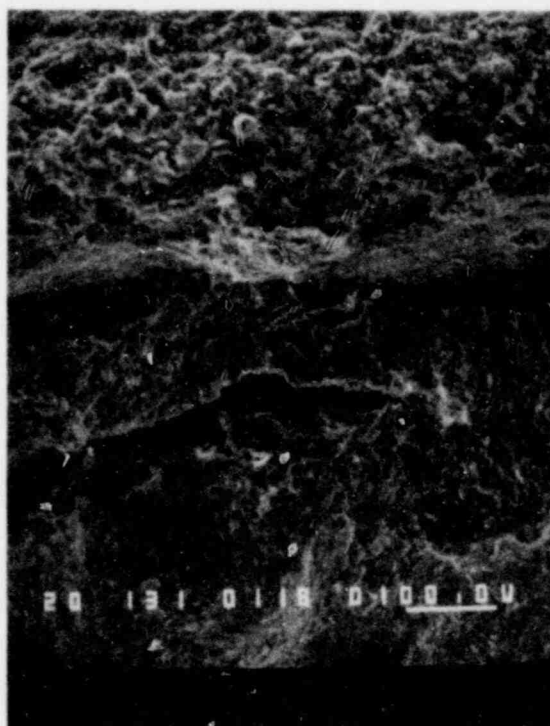
Figure 11 Crack produced during collection or specimen preparation.

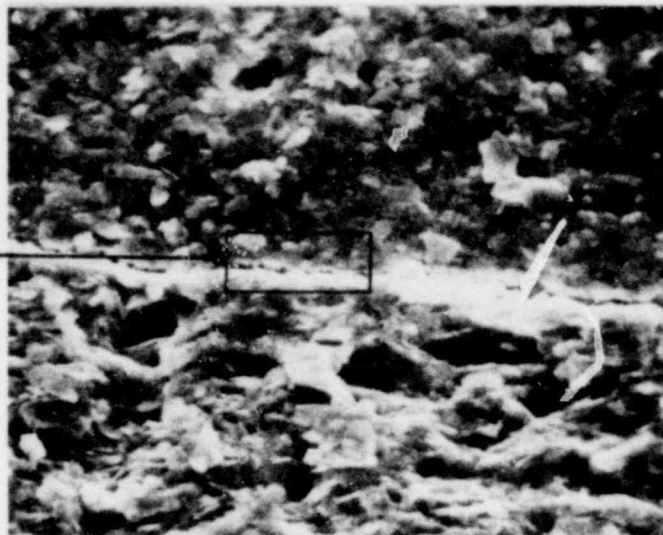
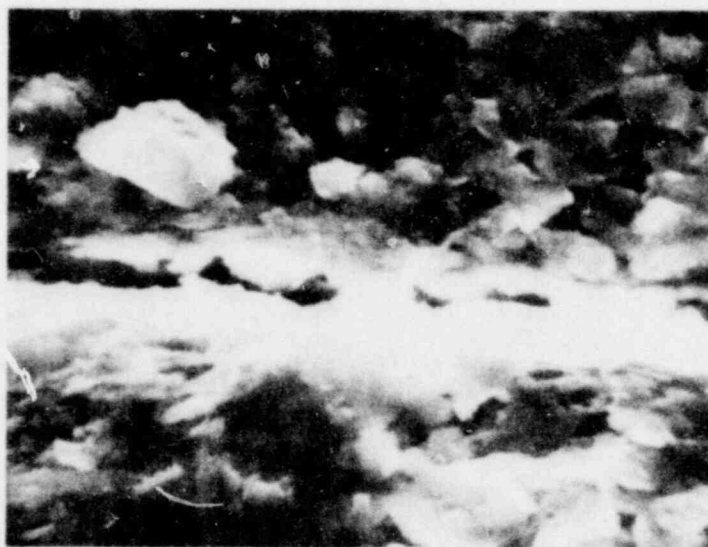
Figure 12 A typical microcrack in the Perry samples. This crack occurs along the boundary between the gouge zone and the adjacent country rock. The enlargement (12b) shows that new mineral growth has occurred with the crack, an indication that the crack was not disturbed during the collection and specimen preparation.

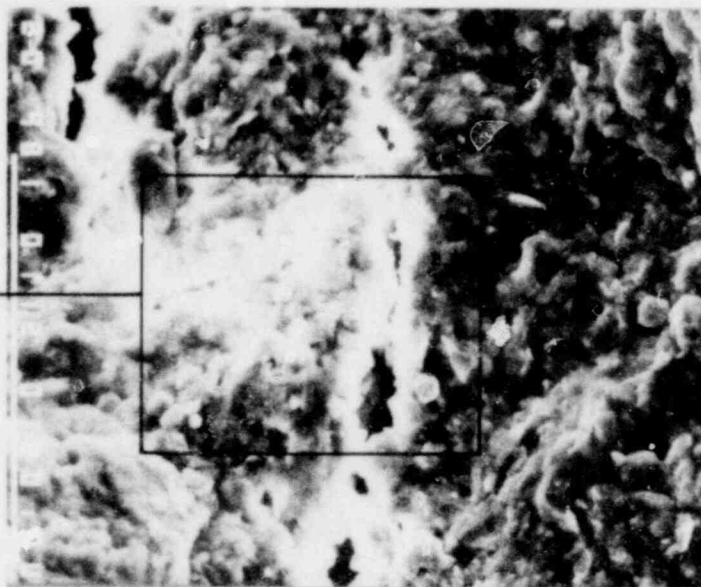
Figure 13 Microcrack in Perry sample. This variant for the microcracks in the Perry samples is relatively short and contains new mineral growths that span completely the microfracture. Note that many crystals can be seen projecting into the crack from the walls (13b).

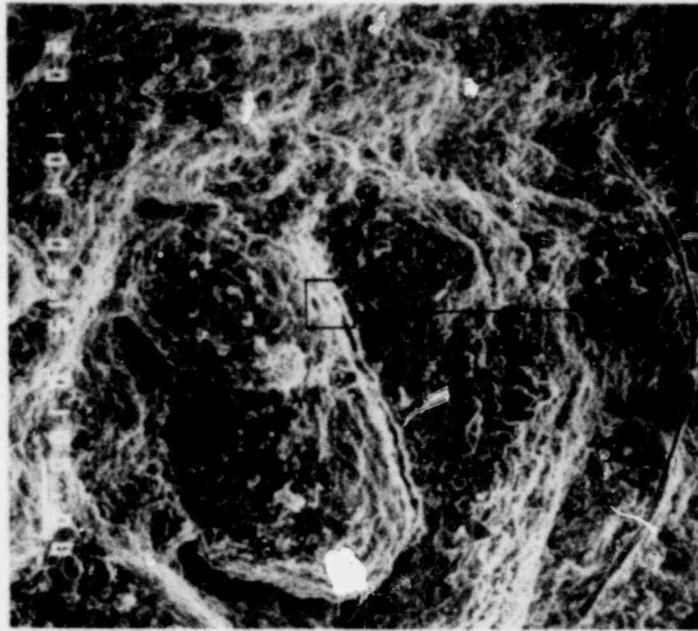
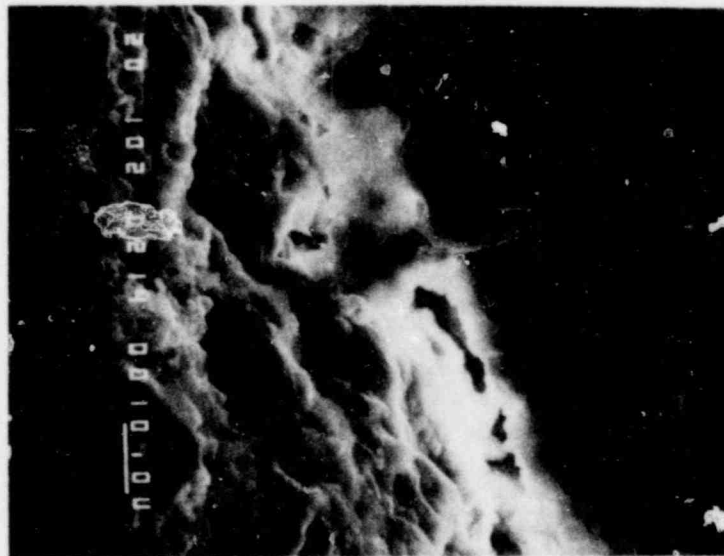
Figure 14 A microcrack in the Perry samples (14a) at higher magnification (14b).

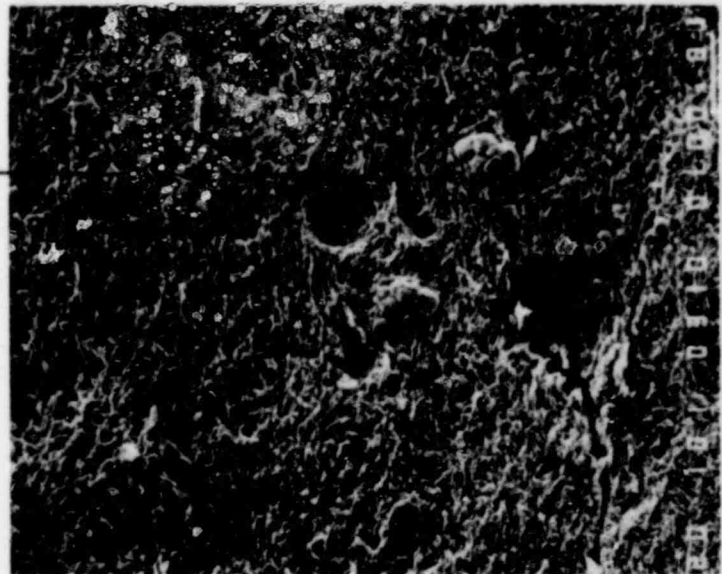
Figure 15 Slickensides in the Perry samples. The slickenslides appear to have been formed by pyrite grains that are stronger than the shale. In 15b, and 15c individual grains of pyrite can be readily observed.

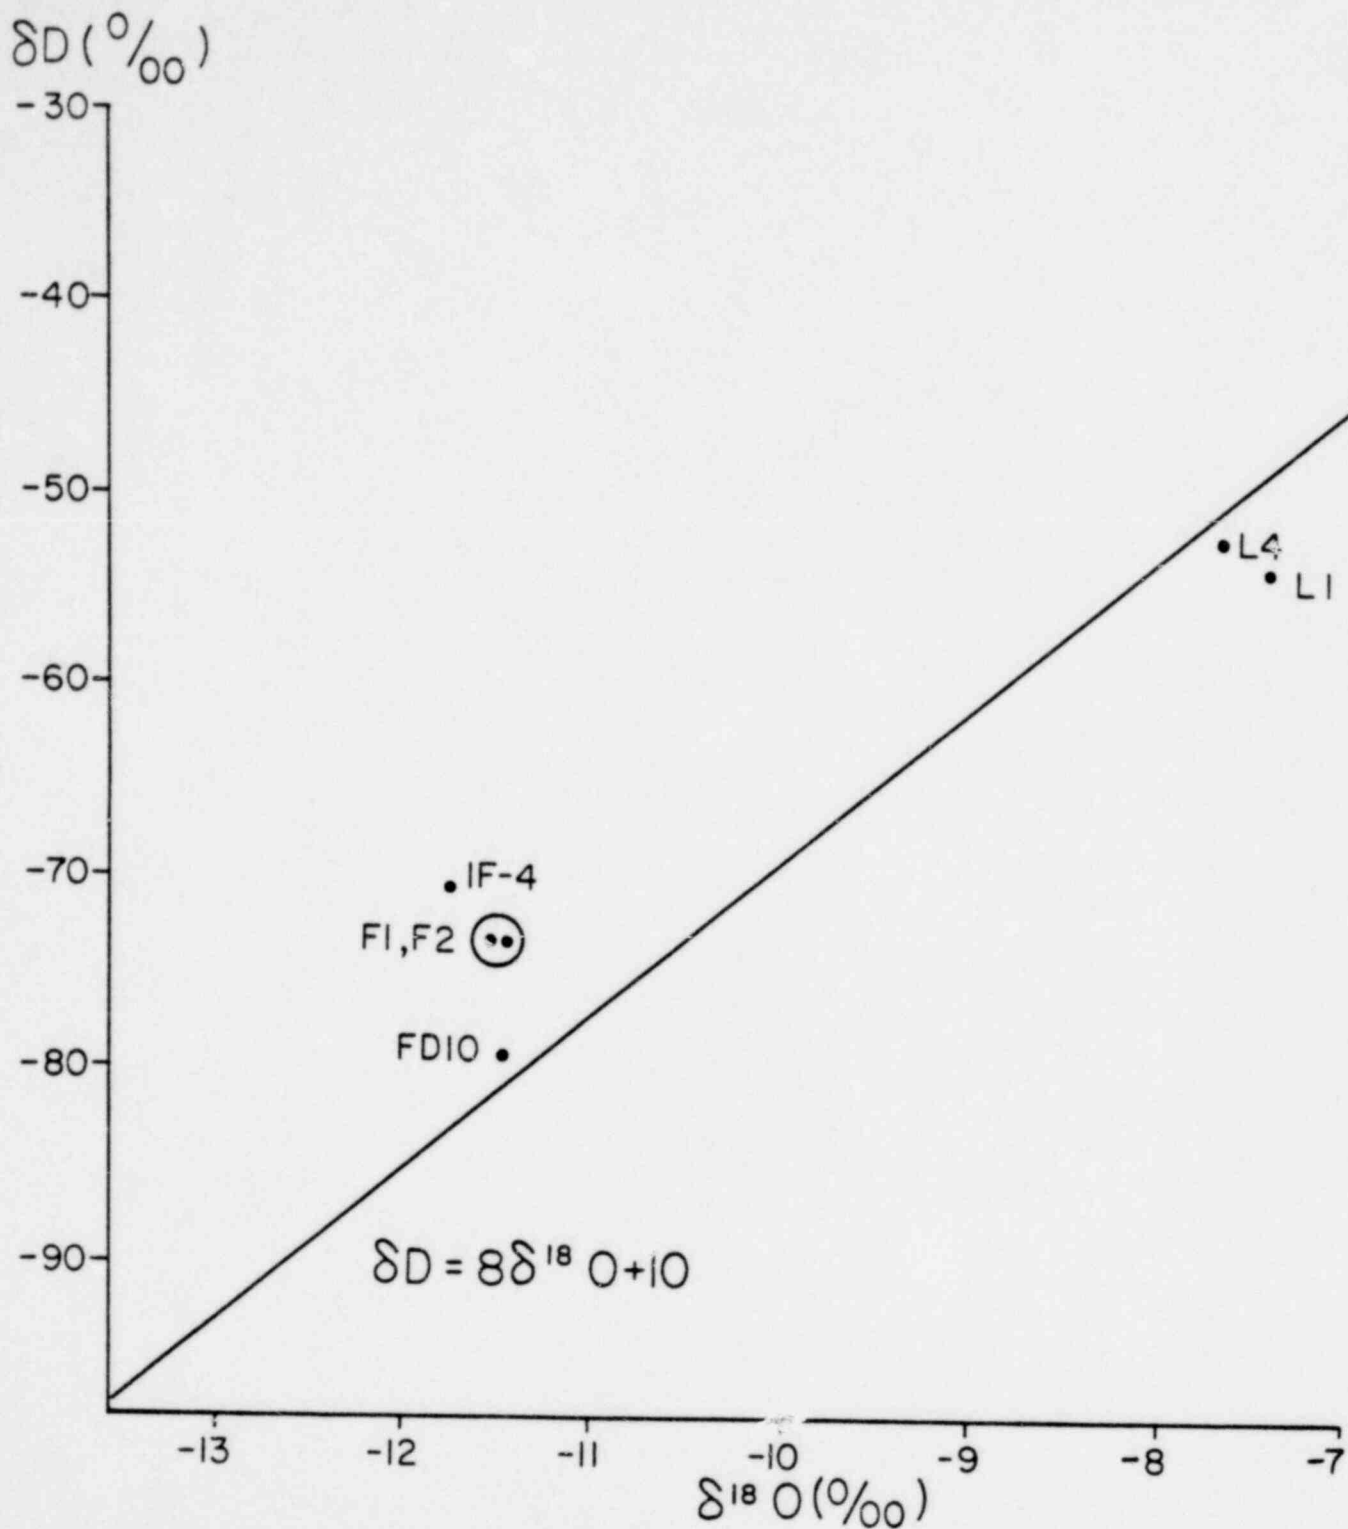
Figure 3. Isotopic compositions of the waters from PNPP. F1, F2, and IF-4 denote samples from the fault in the intake tunnel. FD10 denotes water from the fault in the discharge tunnel. L1 and L4 denote water from the top and bottom, respectively, of Lake Erie.

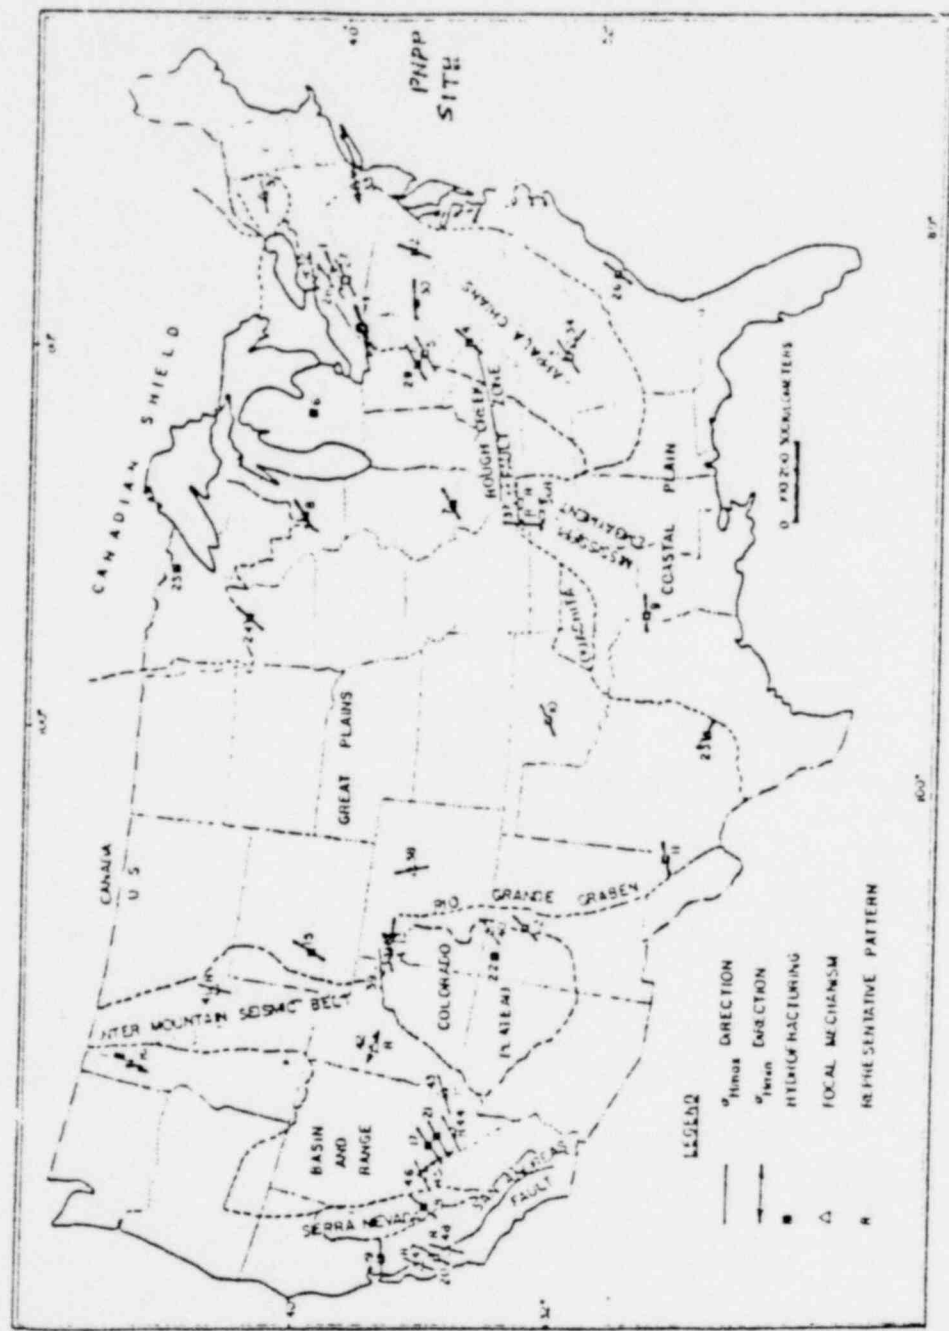
Fig. 5

The direction of maximum compression is east-northeast. The result on stress orientation was not wholly unexpected because stress orientations in western New York and southern Ohio were known to display similar trends (Fig. 5). Specific tests at the PNPP site were nonetheless considered necessary in the interests of safety. Figure 6 is a sketch map which illustrates the relation of the tunnel fault and other structures to various stress fields. Stresses at (a) and (b) refer to stress orientations theoretically associated with a northeast-striking thrust with (a) the condition just prior to faulting, and (b) the condition after faulting has occurred,

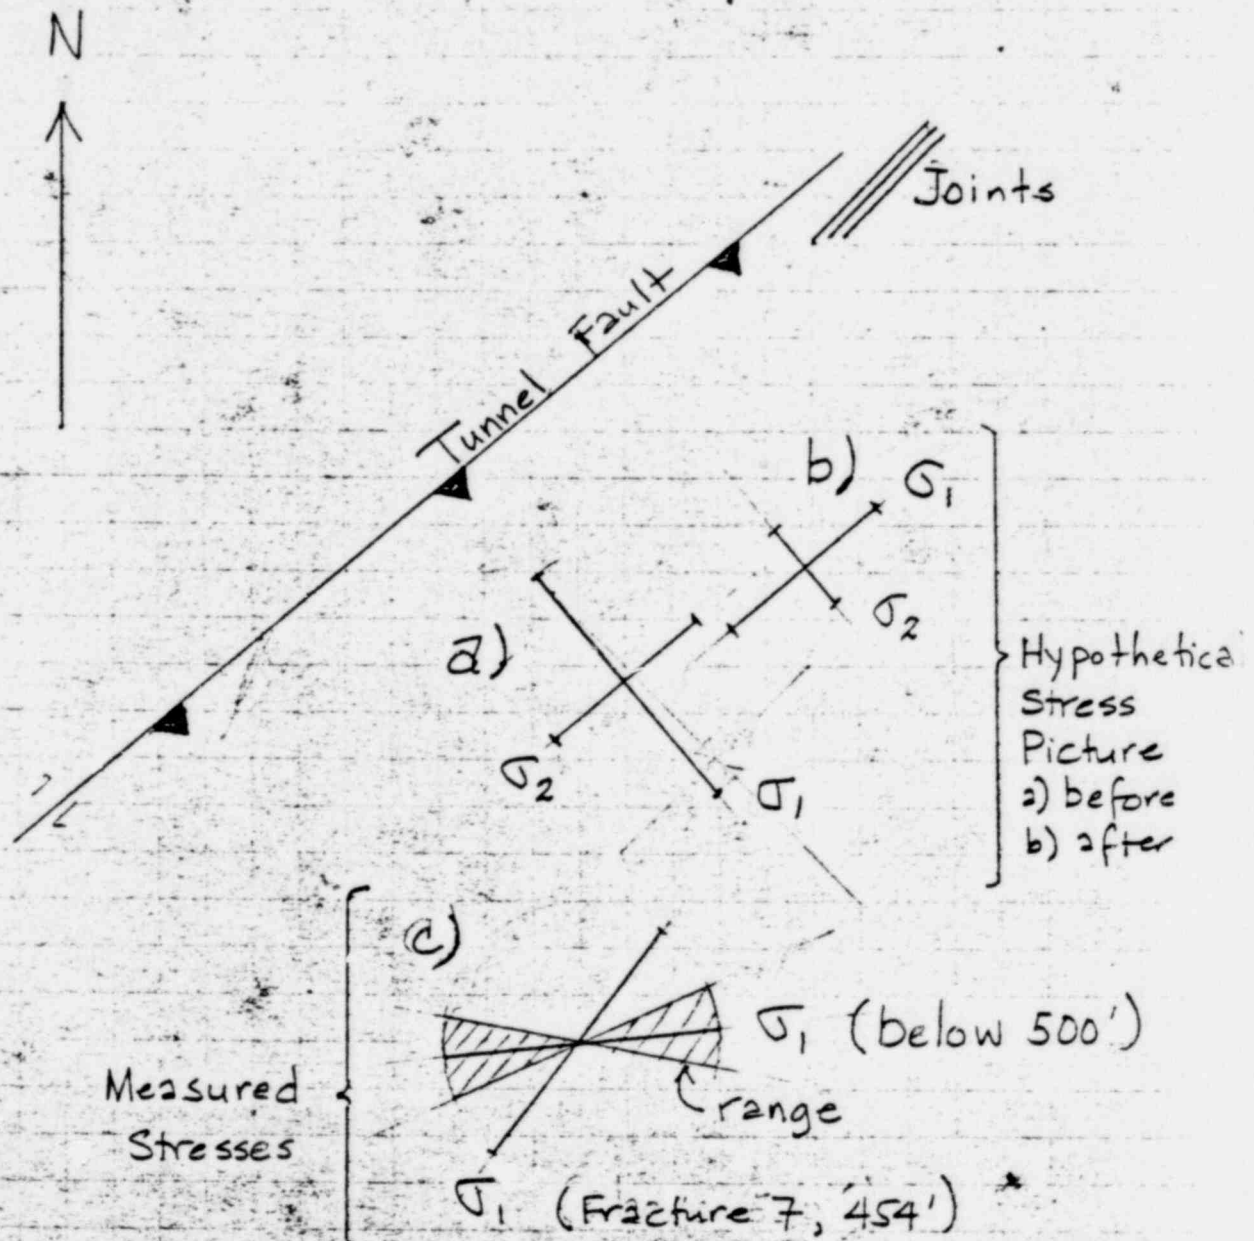
At face value the 085° orientation of σ_1 is evidently not compatible with the formation of an 050° thrust either by the analogy in Fig. 6 of (a) or (b), by directed pressure or stress-relaxation. There is no evidence of strong anisotropy in the rock mass which would permit structures to form at high obliquity to principal stresses. The present 085° orientation of σ_1 thus suggests that the local stress system formerly associated with the development of the tunnel fault has been altered. The stress field at the PNPP site closely corresponds now to a regional field that apparently extends from the upper Mississippi Valley area to New York. The tunnel fault is therefore considered to be older than the age of this regional stress system. Without doubt Pleistocene ice loading profoundly altered the stress systems in the upper crust, and the present stress system is considered

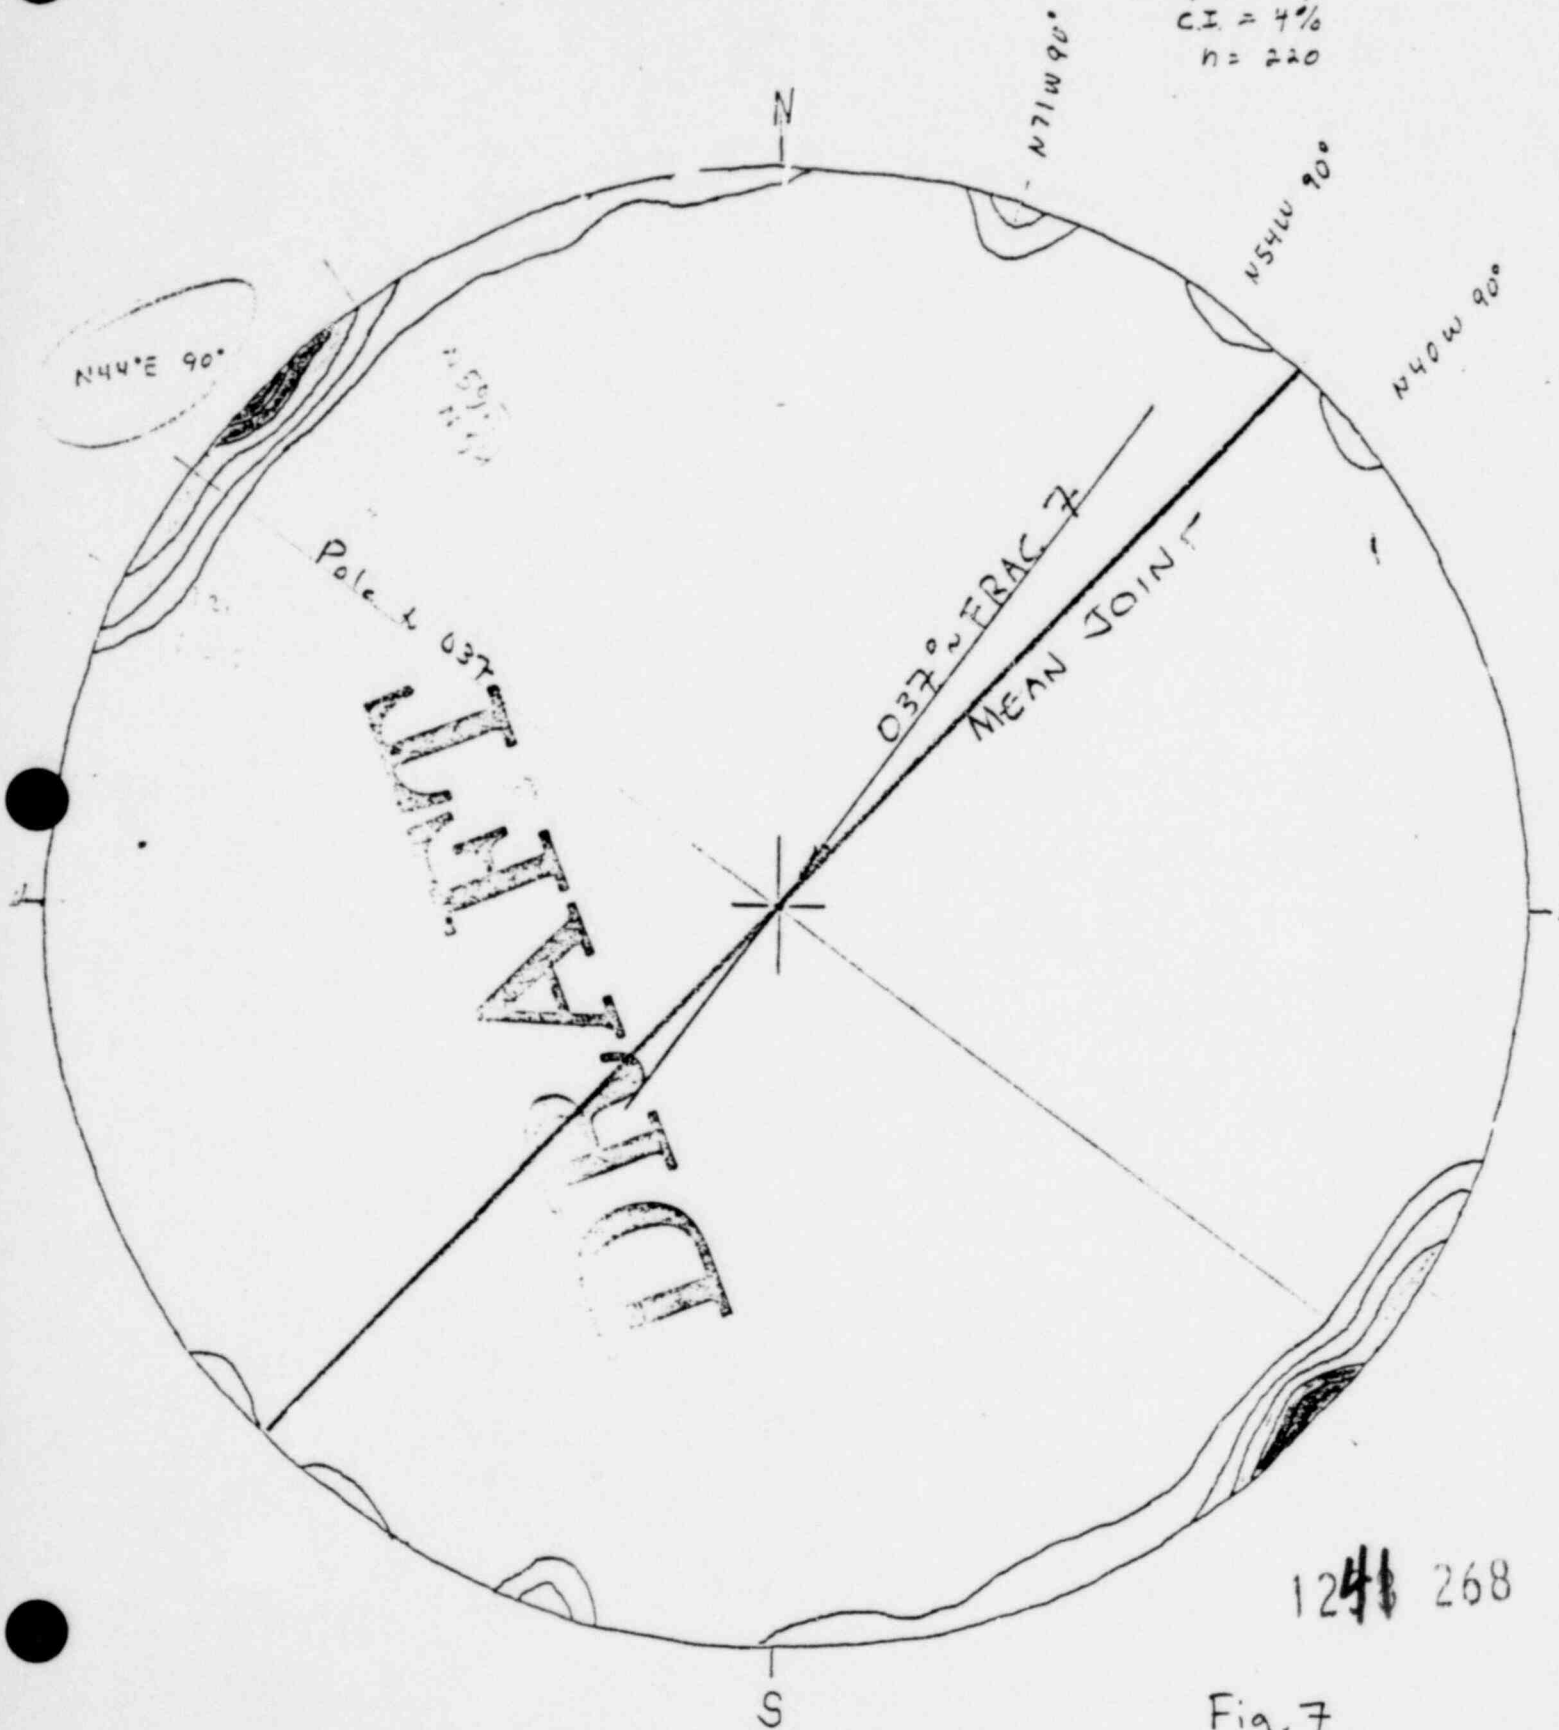
Fig. 7

The poorly defined fractures at 037° indicated for Fracture 7 differs from the 085° average from Fractures 3-6. This orientation permits an interpretation in terms of Figure 6(b), with 037° not greatly different from the strike of the tunnel fault. Fracture 7 lies above the proposed intersection point of the tunnel fault with TX-11, so that it may be possible to formulate an argument in regard to behavior of the hanging wall as distinct from the foot wall. On the other hand, it may be simplest to interpret Fracture 7 as influenced by pre-existing joints. The pole maximum of 220 foundation joints as compiled and plotted by WGC is associated with 044° , with 037° lying within the range of significant pole concentrations, e.g. $026-054^{\circ}$ (Fig. 7).

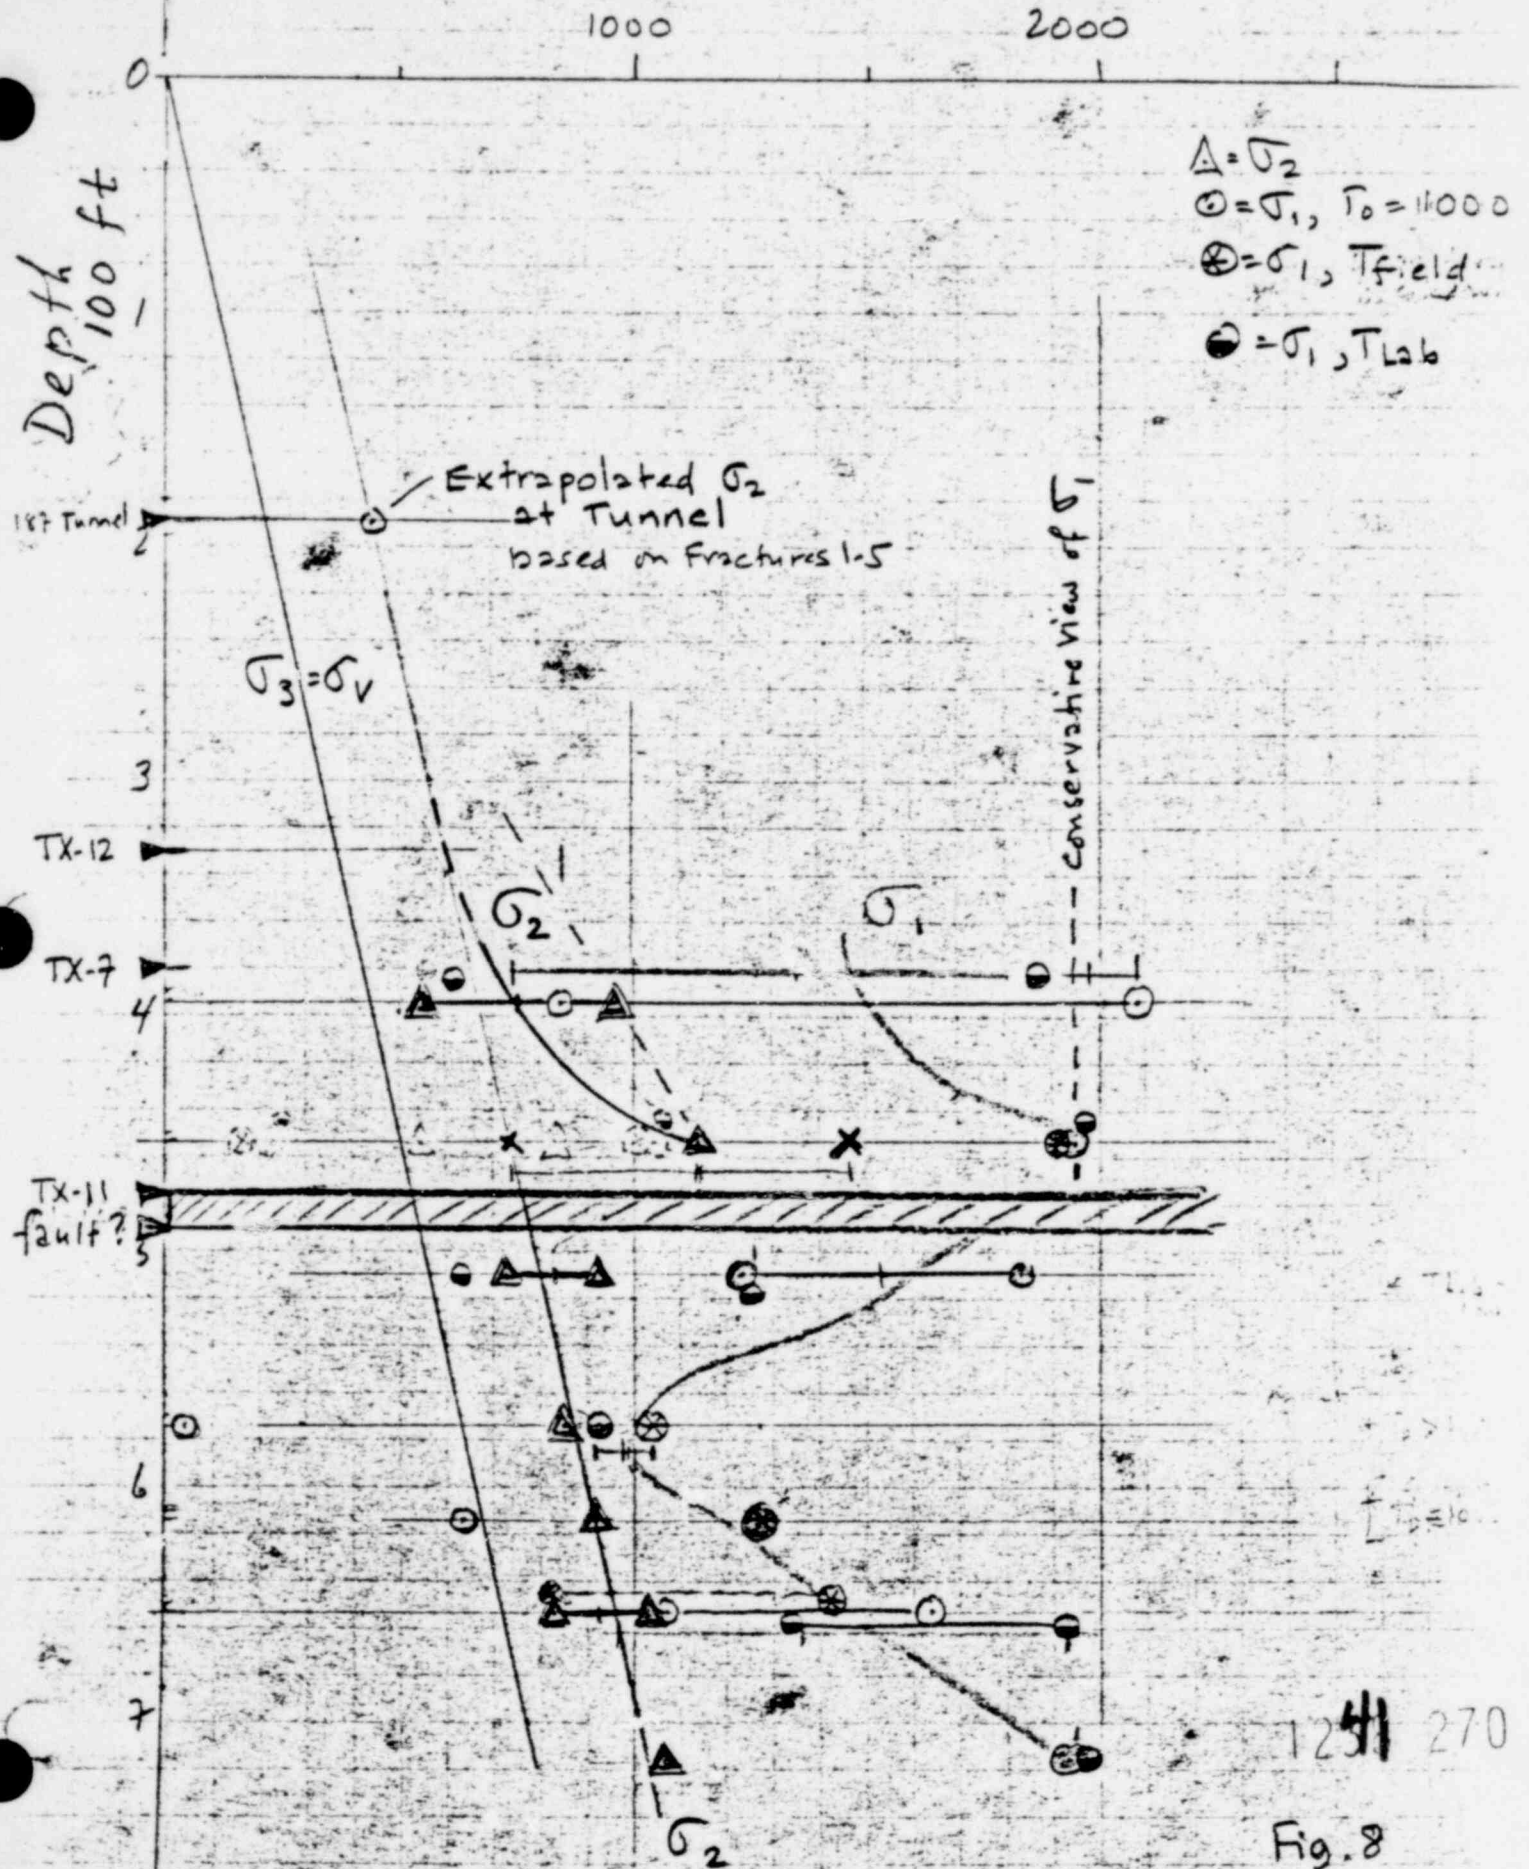
the data trend from Fractures 1 to 6 is considered to be a lower-bound. Upper-bound values are not clearly defined.

The reason for the apparent increase in stresses at and above 511 ft is not clear. One possibility, however, is that the tunnel fault indeed passes through TX-11 between Fractures 6 and 7. Higher horizontal stresses could therefore be interpreted as stress concentrations associated with this fault. One alternative possibility is to consider the high values as stress concentration effects below a downward-terminated stress-relief fault.
