FINAL REPORT
SERVICE WATER INTAKE STRUCTURE
SETTLEMENT EFFECTS AND RELATED WORK

VIRGIL C. SUMMER NUCLEAR STATION

OCTOBER 1979

PREPARED FOR:
SOUTH CAROLINA ELECTRIC & GAS CO.
COLUMBIA, SOUTH CAROLINA

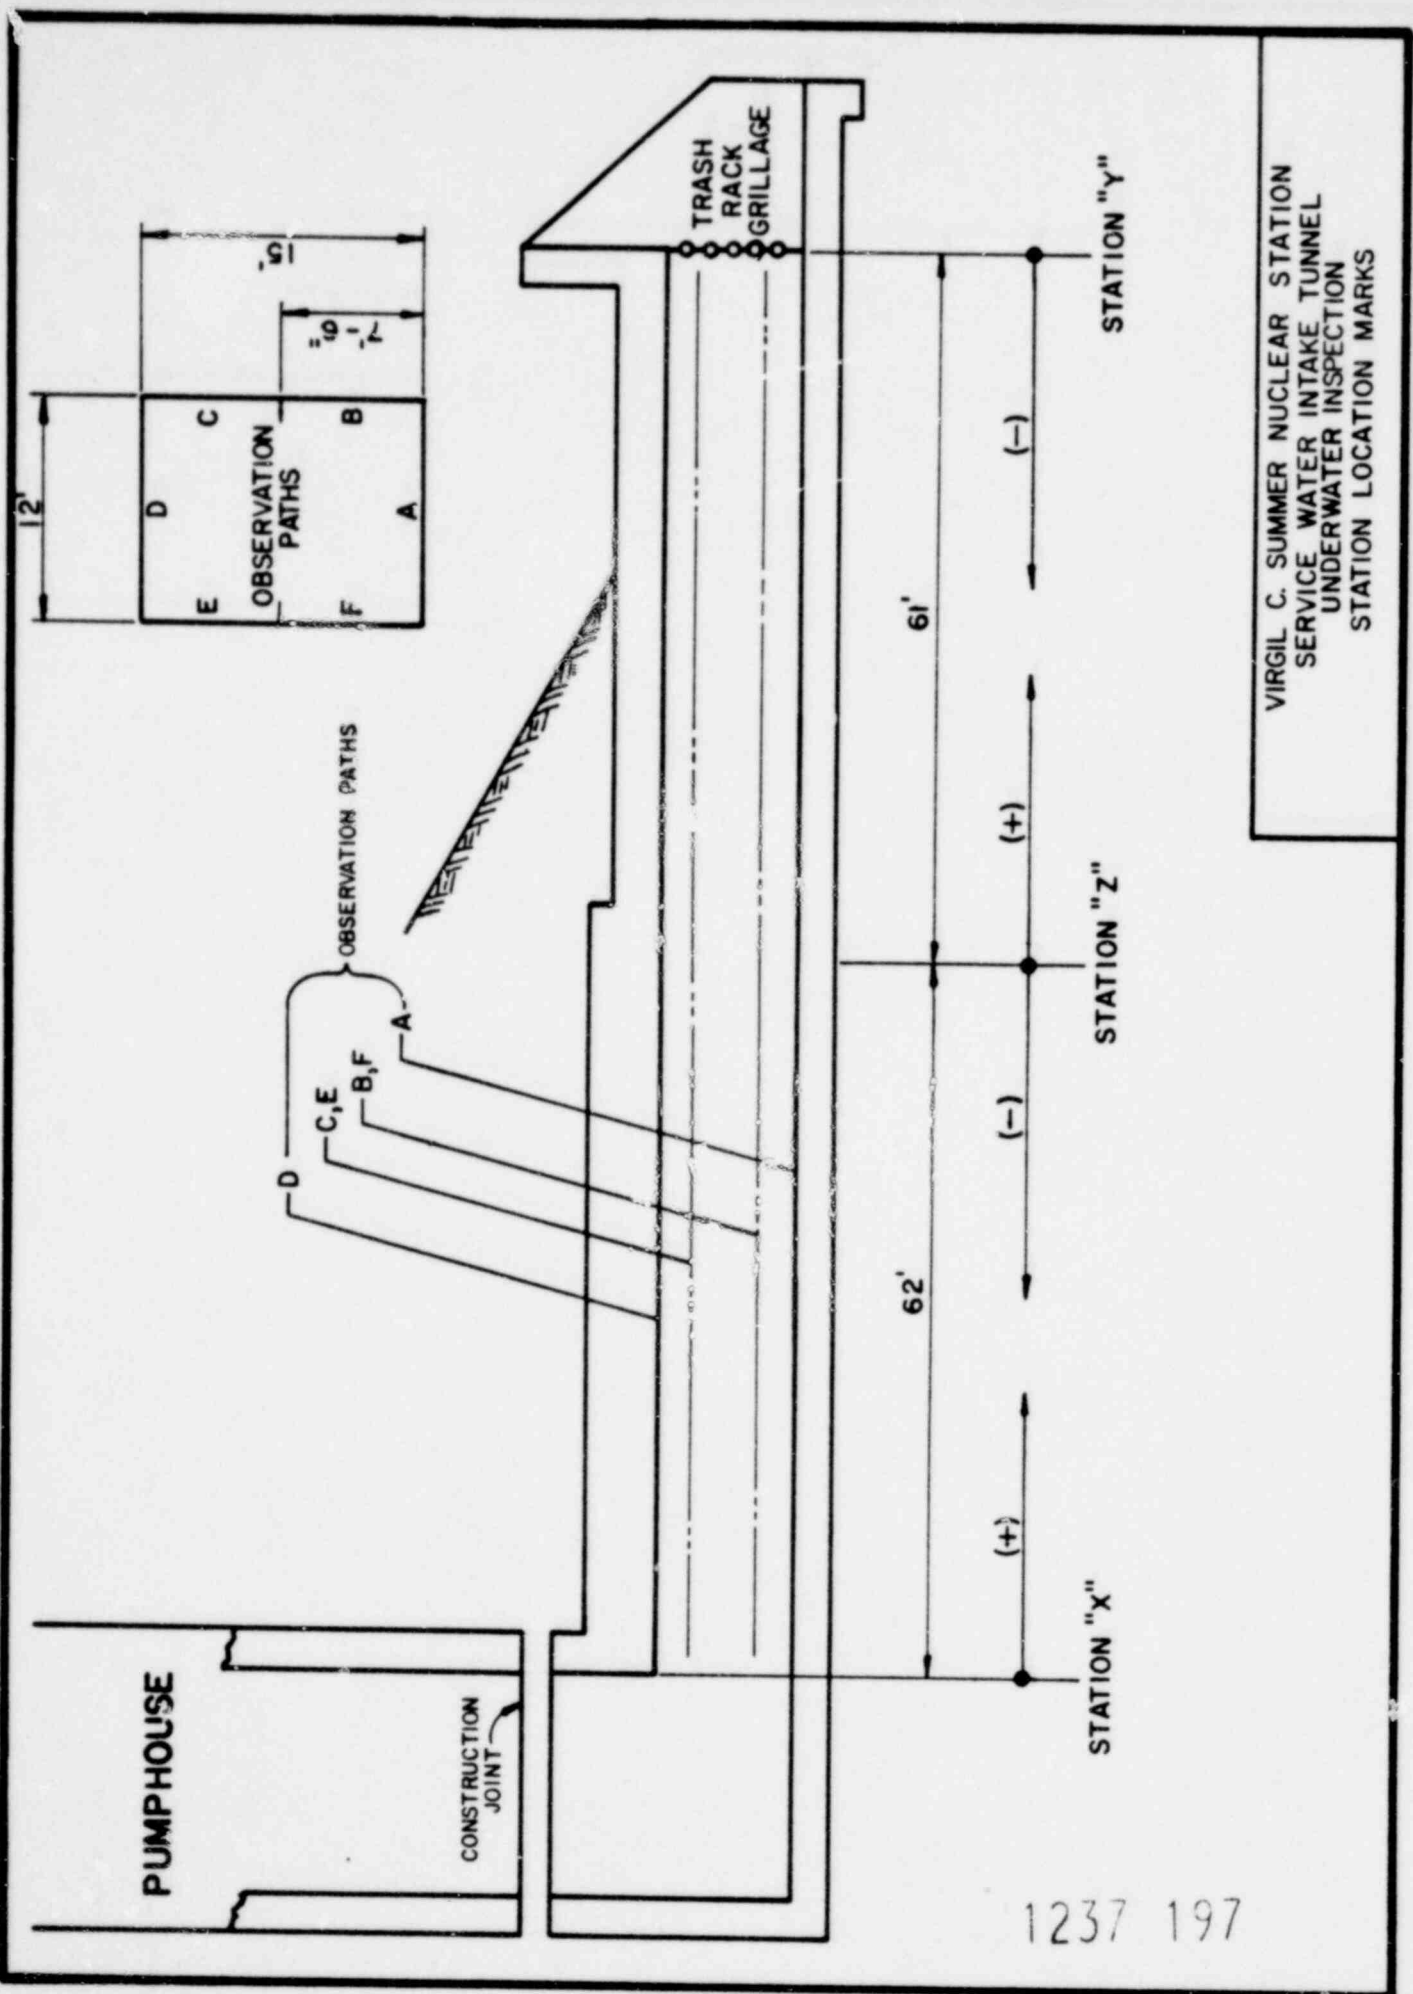
VIRGIL C. SUMMER NUCLEAR STATION
SERVICE WATER INTAKE TUNNEL
UNDERWATER INSPECTION
STATION LOCATION MARKS

As the divers were making their survey of the service water intake tunnel they found at Station Y-47'-0", F. section 3 feet up from A section, a 3/4" hole. Also at station Y-47'-6" F. section, 5 feet up from A section another 3/4" hole. These holes are plugged with wooden plugs. We were told at the job site that these holes were used to force grout into a crack found before flooding.

Survey began June 7 and ended June 15, 1979.
