Millstone Nuclear Power Station, Unit No. 2
Feedwater System Piping

MILLSTONE NUCLEAR POWER STATION, UNIT NO. 2

RESPONSES TO
ADDITIONAL INFORMATION REQUIRED
TO ASCERTAIN ACTIONS NECESSARY
REGARDING THE FEEDWATER SYSTEM PIPING

ASSESSMENT OF GROWTH OF FEEDWATER LINE FLAWS

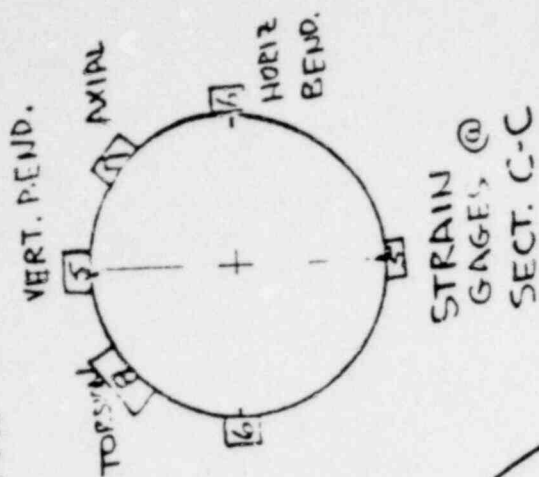
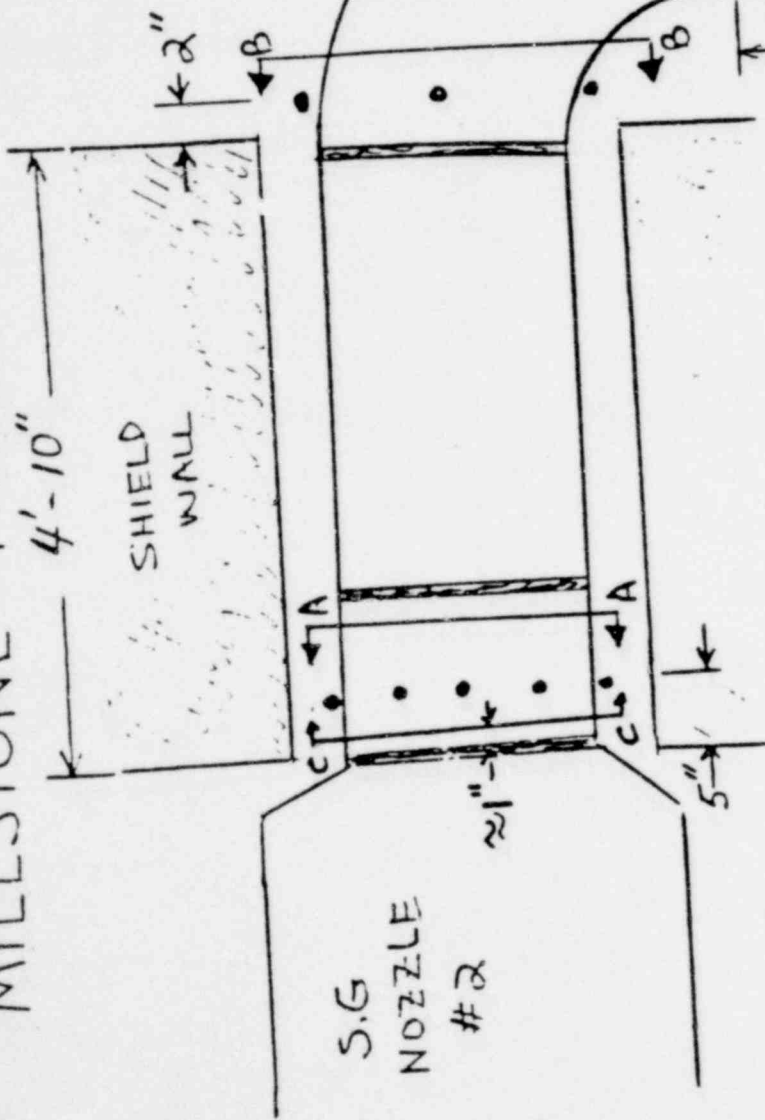
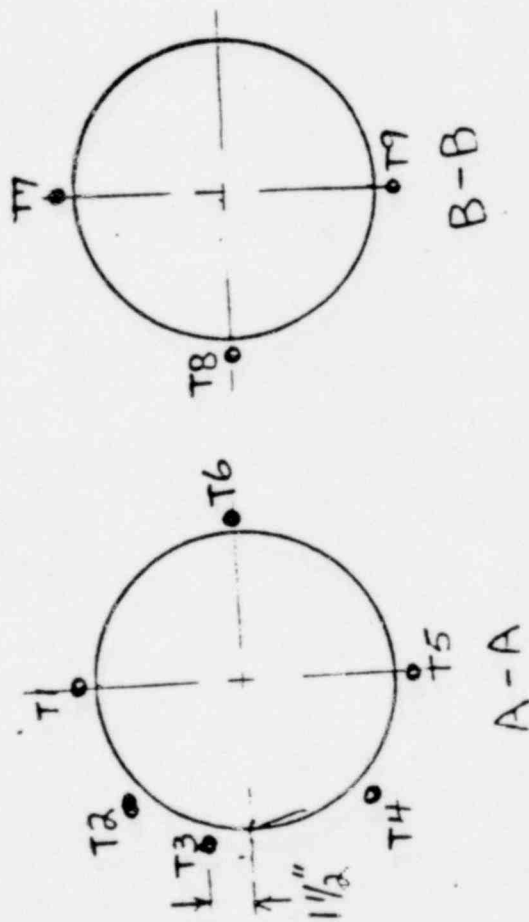
MILLSTONE TRANSDUCER LOCATIONS

STEADY STATE DYNAMIC STRAINS AND ACCELERATIONS

POWER LEVEL	ACCELERATION (G'S), 0 - PEAK			STRAIN ($\mu\epsilon$) 0 - PEAK			
	A1 (HORZ.)	A2 (HORZ.)	A3 (VERT.)	VERT. BEND.	HORZ. BEND.	AXIAL	TORSION
HOT STANDBY	0.12	0.22	0.12	7	5	5	5
50%	0.20	0.33	0.17	9	9	7	7
100%	0.25	0.41	0.22	6	5	4	3

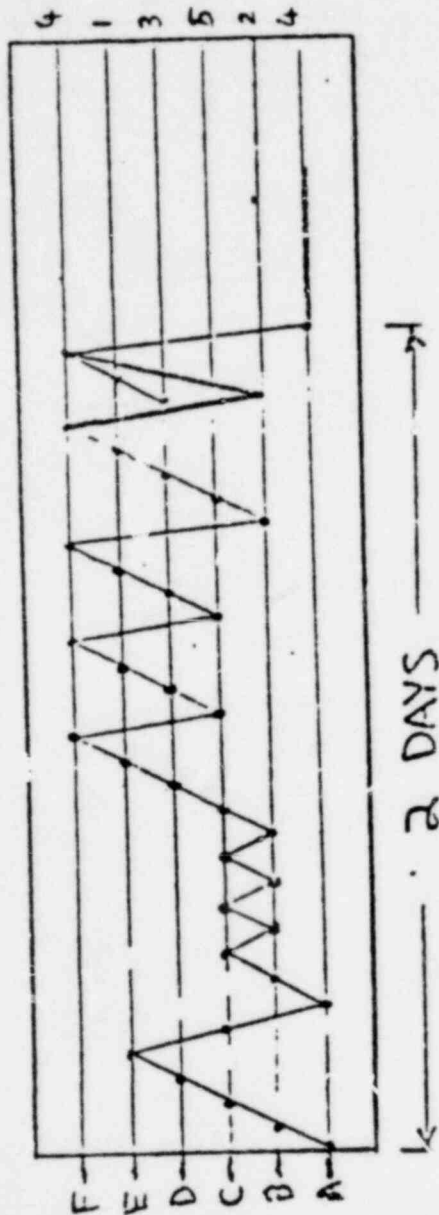
FIGURE 2 : SUMMARY OF TEMPERATURE PROFILE OCCURRENCES

As a result of the location of this flaw, instrumentation was installed to monitor the temperature fluctuations in one loop. Results showed that in a certain flow rate range the water stratifies, producing significant stresses which are potentially important for crack growth. The types of stratification produced were typical of those observed in other plants, but not as severe. The observed stratifications were classified under five different types, as shown in Figure 1. The temperature difference from top to bottom of the pipe for profile 1 was measured at about 350°F, whereas for other plants it has been found to be as high as 450°F.

To accomplish a fatigue crack growth analysis, the system design transients for normal, upset and test conditions were combined with the cycles of stress from stratification, which occurs during hot standby operation. As shown in Figure 2, there are approximately nine cycles of various degrees which for the purpose of this analysis, we will assume, occur each time hot standby occurs.

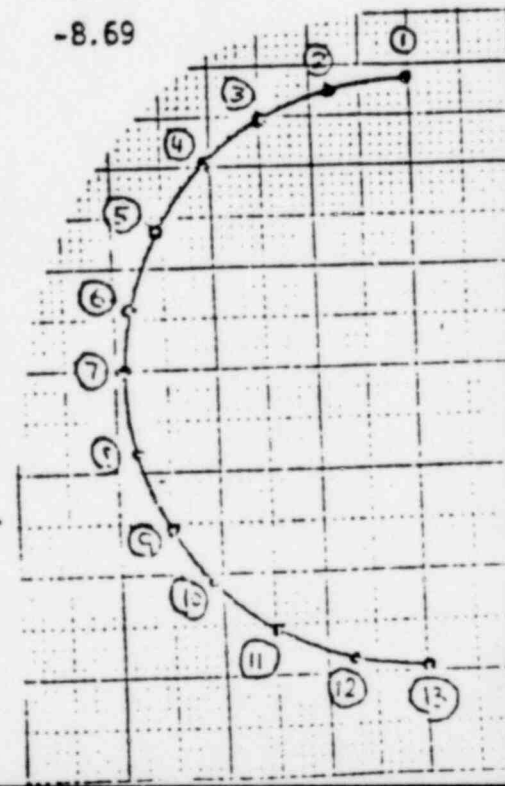
A tabulation of the cycle types used in the crack growth analysis, along with applicable stresses, is provided in Table 1. Tables 2 through 5 show the stresses at various locations around the pipe as a result of the stratification.

The actual stresses from the three dimensional analysis were used for the fatigue crack growth analysis, except in two cases, where compressive stresses far exceeded the yield stress in compression. The location is at the top of the pipe, and the condition occurs only when the pipe is nearly filled with cold water (profile 1) at low flow. For this case, tensile residual stress values were assumed to exist, equal to the yield strength. This is seen at locations 1 and 2 in Tables 2 and 4. This assumption is considered to be extremely conservative.

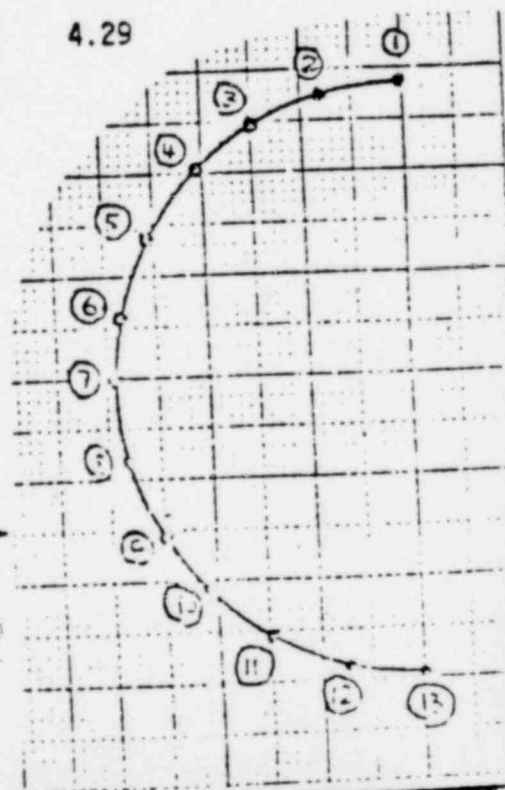
TABLE 4

STRESS RESULTS - AXIAL DIRECTION

CONDITION 2 + 1 - HOT STANDBY # 3

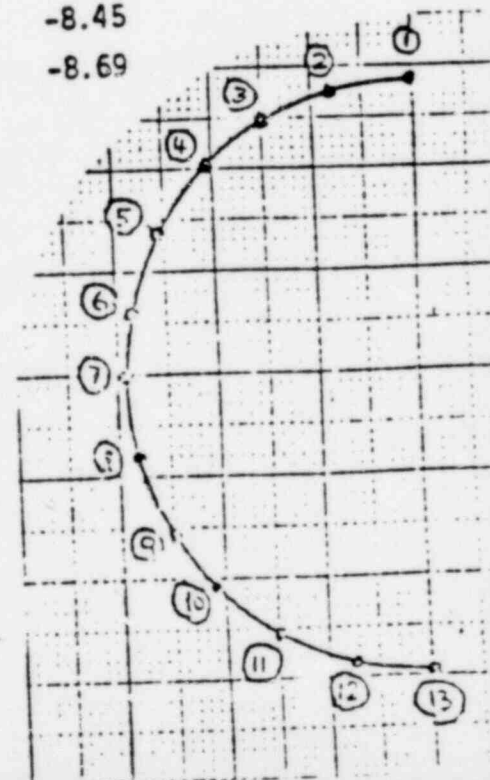
TABLE 5

STRESS RESULTS - AXIAL DIRECTIONCONDITION 2 - 4 - HOT STANDBY # 4
