CALVERT CLIFFS UNIT 1
CYCLE 4

November 12, 1979

PRELIMINARY REPORT OF POWER DISTRIBUTION EPISODE

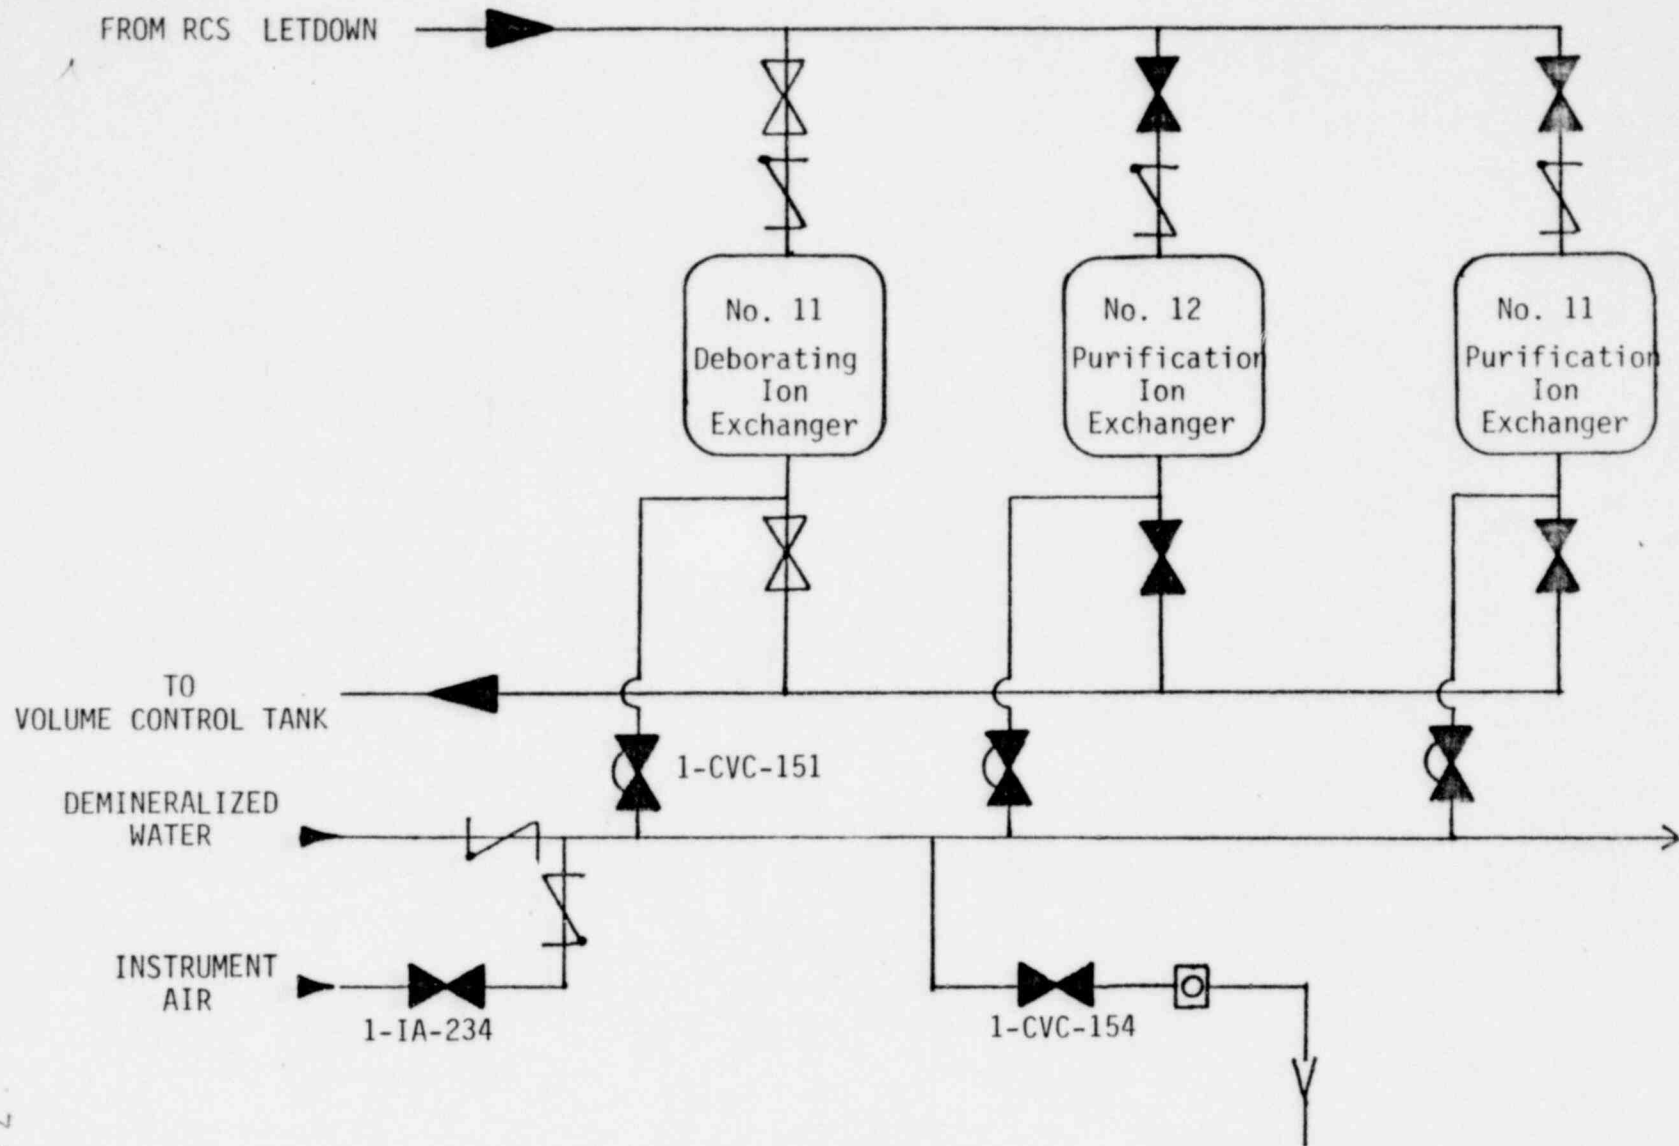
FIGURE 3

On October 26, the Plant Staff suspected the cause of the increasing pressure drop across the reactor core was due to an increasing crud deposition on fuel surfaces and began a search for sources of Oxygen to the Reactor Coolant System. During this time it was also observed that trend data indicated a lower than normal Hydrogen concentration in the Volume Control Tank. By October 29, the source of Oxygen had been identified and isolated. While Number 11 Deborating Ion Exchanger was in service (See Figure 3), it appears that air was introduced into the purification system via the Instrument Air header which is normally used to assist in spent resin transfer. Apparently, two (2) valves (1-IA-234 and 1-CVC-151) leaked by their seats allowing air to be introduced into the outlet of the ion exchanger. When sampled, the ion exchanger outlet had an Oxygen concentration of 300 ppb. The ion exchangers were bypassed and the Instrument Air header drain valve (1-CVC-154) was opened and left open to ensure that the header remained depressurized thereby precluding introduction of Oxygen into the Reactor Coolant System.
