Exhibit A to Report No. IE-116
by PARAMETER, Inc.
NRC Contract 05-77-186
PAR: NRC-IE-78/79, Task 03

EXAMINATION OF INCONEL
SAFE END FROM DUANE ARNOLD

January, 1979

V. Pasupathi, G.P. Smith, D.R. Farmelo, and J.S. Perrin

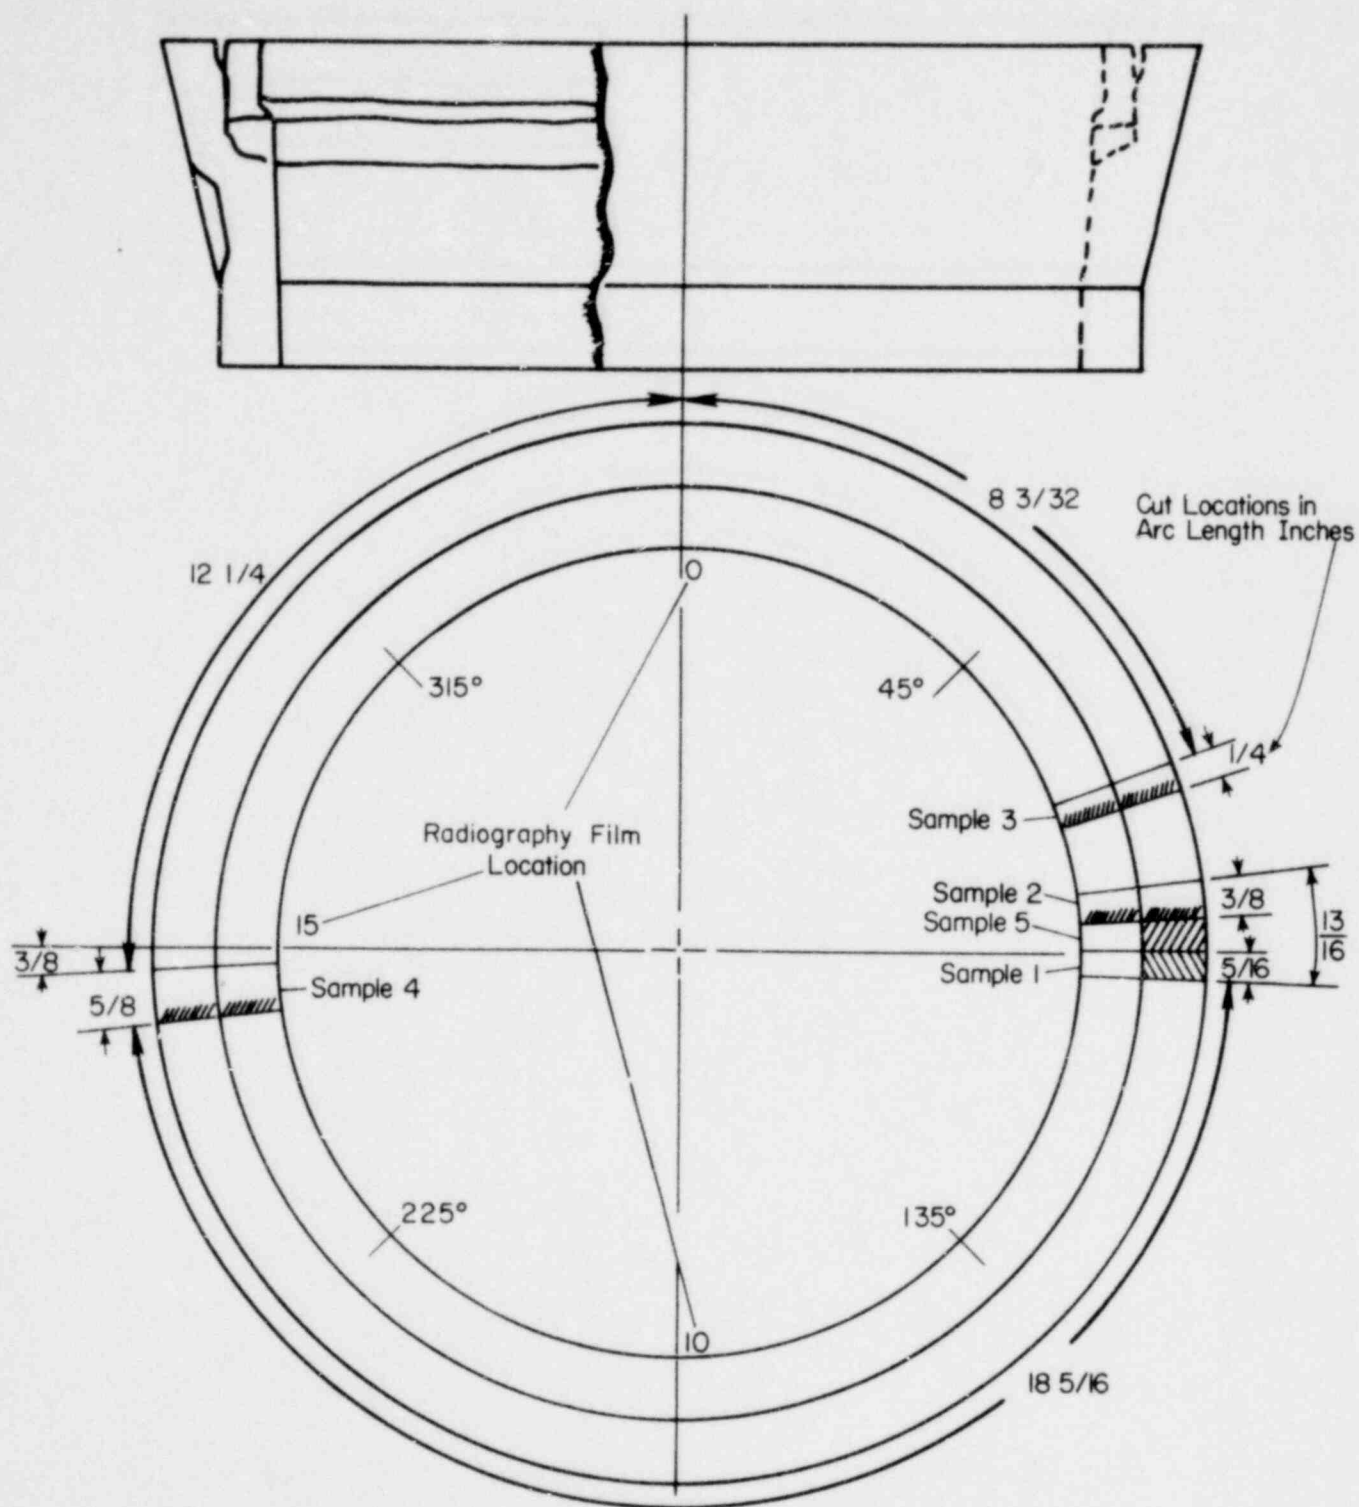
FIGURE 2. LOCATION OF METALLOGRAPHIC AND SEM SPECIMENS
ON DUANE ARNOLD SAFE END N2-E

2.4.1 Specimen Sectioning. The specimen was marked for sectioning according to the cutting diagram supplied by Parameter Incorporated. Five thin samples were cut with a band saw. Locations of the samples are shown in Figure 2. Figure 3 shows the samples cut from the safe end.

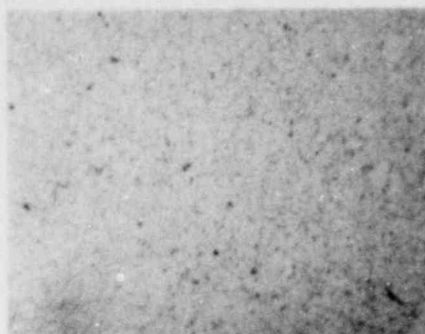
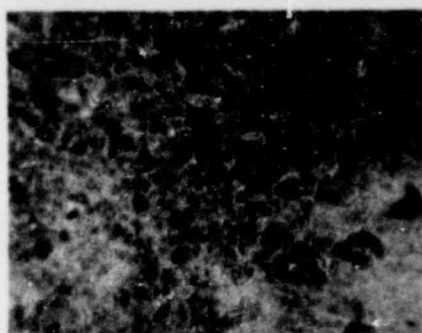
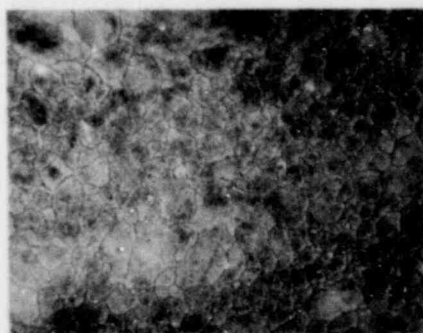
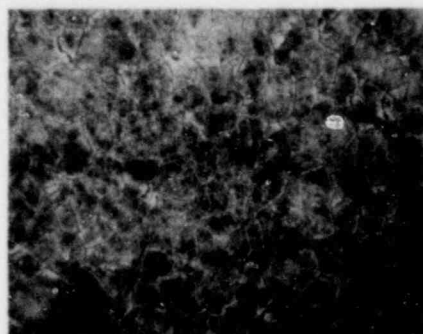
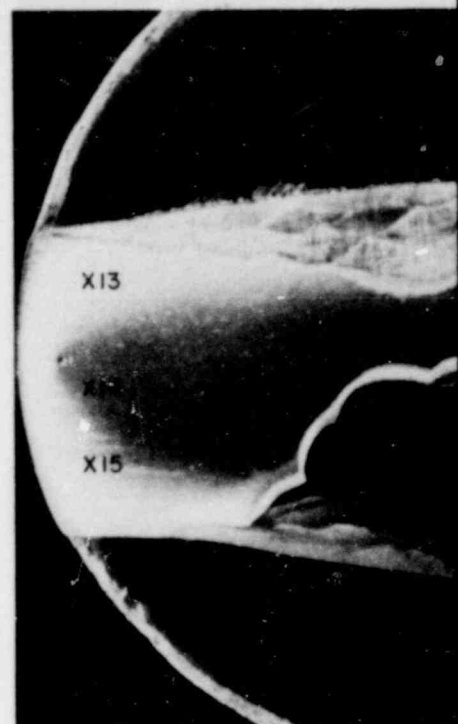
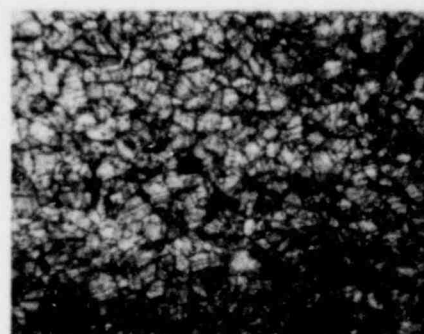
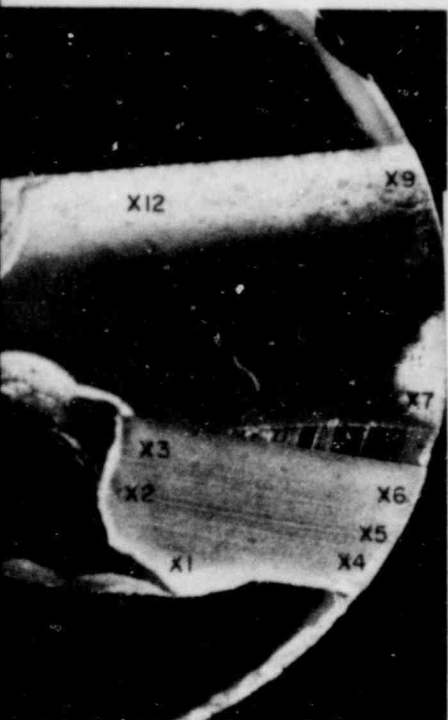
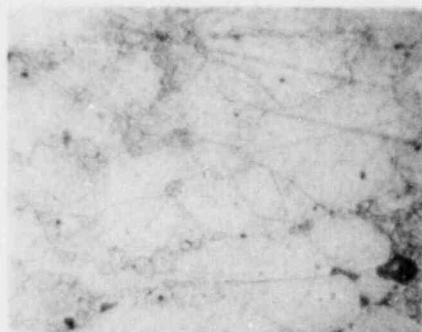
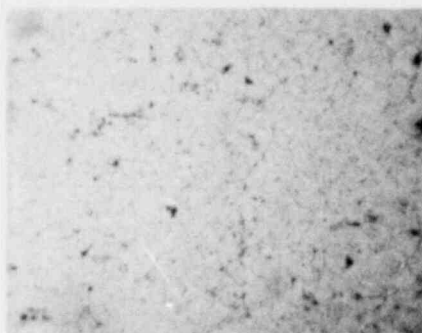
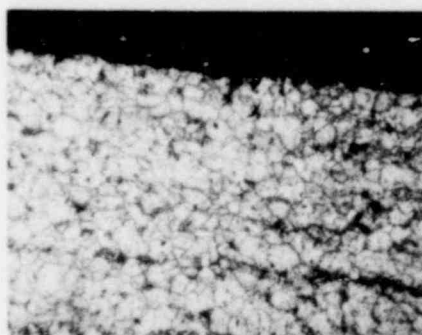
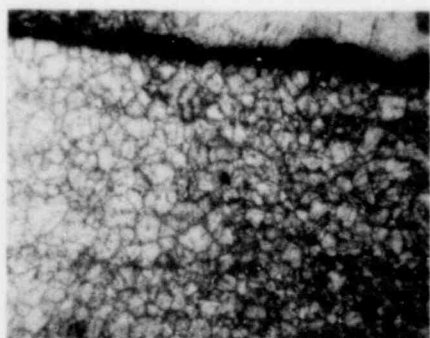
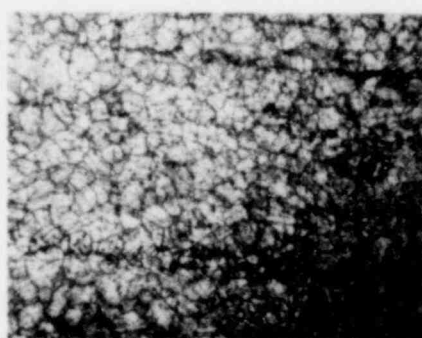
FIGURE 7. TYPICAL MICROSTRUCTURES AT VARIOUS LOCATIONS OF SAMPLE 3 CROSS SECTION

Sample 3 was examined in detail to characterize the microstructure of various parts of the sample. Figure 7 shows the results. The photomicrographs show that no major abnormalities are apparent in the microstructure of the safe end with the exception of sensitization near the sleeve to safe end weld. However, it appears that the thermal sleeve is sensitized (as evident from carbides precipitated at grain boundaries) rather uniformly even away from the weld.

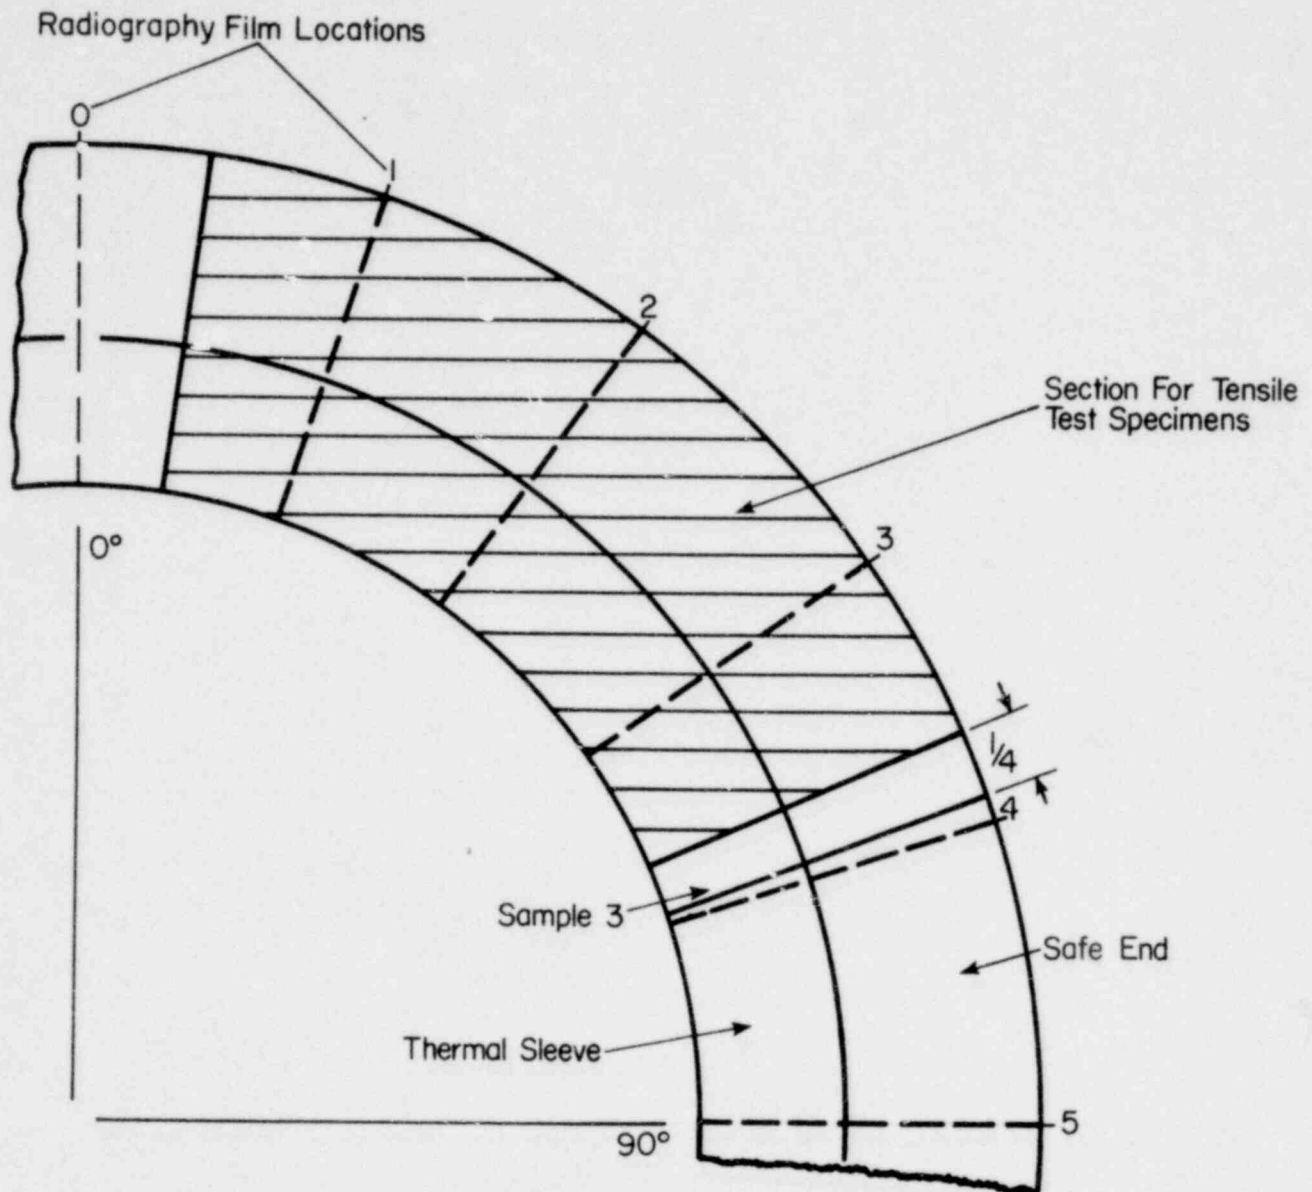
FIGURE 13. LOCATION OF THE SECTION FROM WHICH TENSILE TEST SPECIMENS WERE MACHINED

From the remaining parts of the Inconel safe end a large piece was sectioned so that specimens for tensile tests could be machined. The large piece was cut between radiography locations 0 and 4 as shown in Figure 13. The cut piece was decontaminated and ultrasonically cleaned and five tensile test specimens were machined. Figure 14 shows schematically the location of the specimens in the safe end and Figure 15 shows the dimensions of the tensile specimens used.

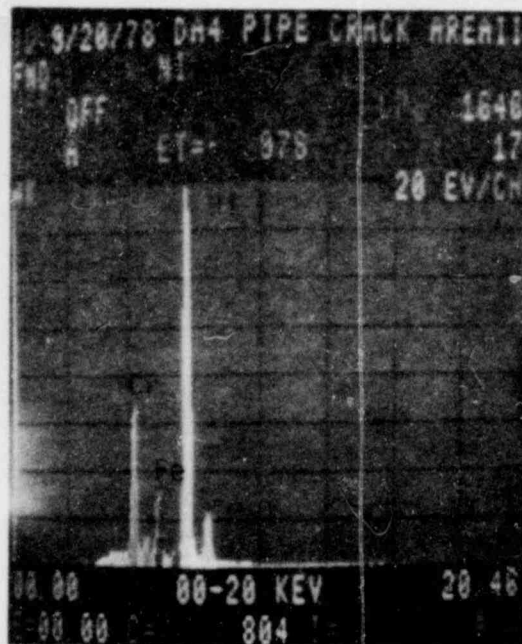
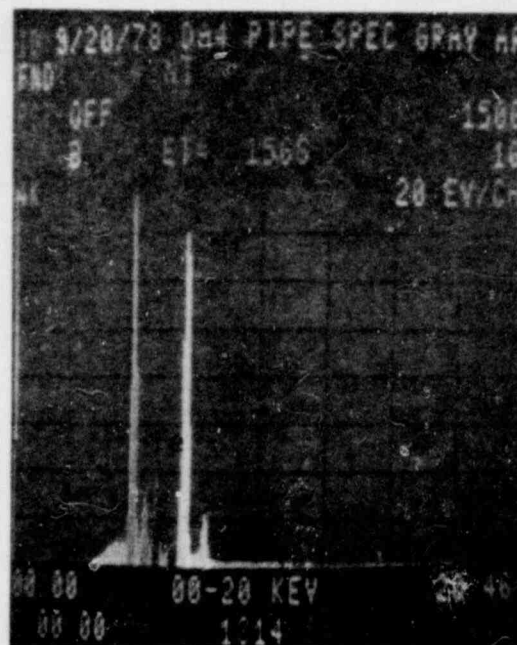
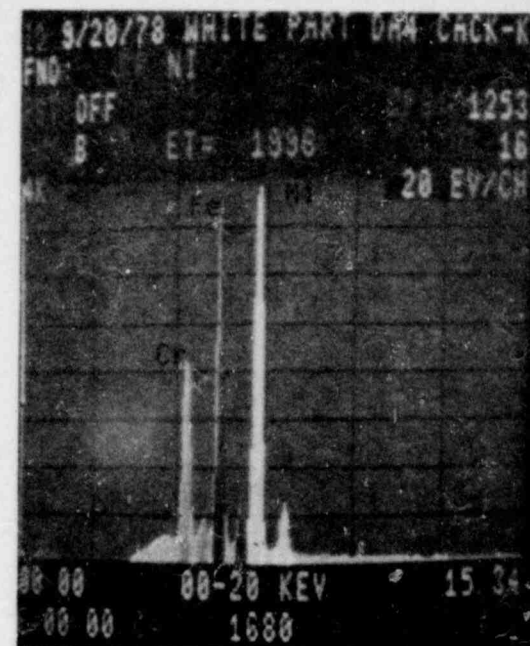
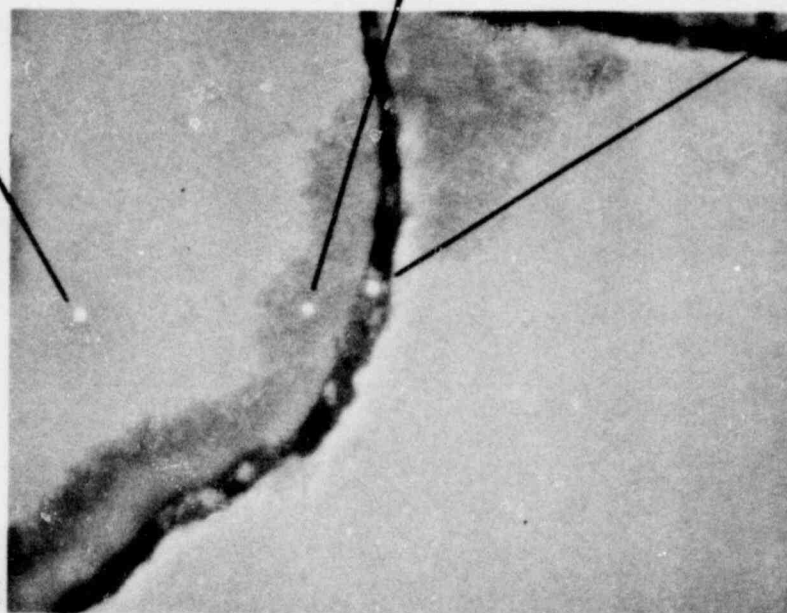
EDAX analysis of material observed within the crack both adjacent to the grey phase and in areas where no grey phase is found indicate an iron rich material relative to base metal compositions. Figures 17 and 18 present SEM micrographs and EDAX spot analysis performed well within the crack and at the crevice on Sample No. 4. As can be seen in Figure 17 the EDAX analysis of material within the crack indicates excessive iron relative to base metal analysis. However, no iron depletion can be observed in the material adjacent to the crack. EDAX analysis performed on material within the crevice (Figure 18) at a location near the crack origin indicate similar iron rich material. Comparison of the two relative iron contents from EDAX analysis at the crevice with analysis in the crack indicate a significantly higher iron content of material well within the crack.

FIGURE 17. SEM MICROGRAPH AND CORRESPONDING EDAX ANALYSES FROM SAMPLE 4
Area shown is located within the rectangular region highlighted in Figure 6

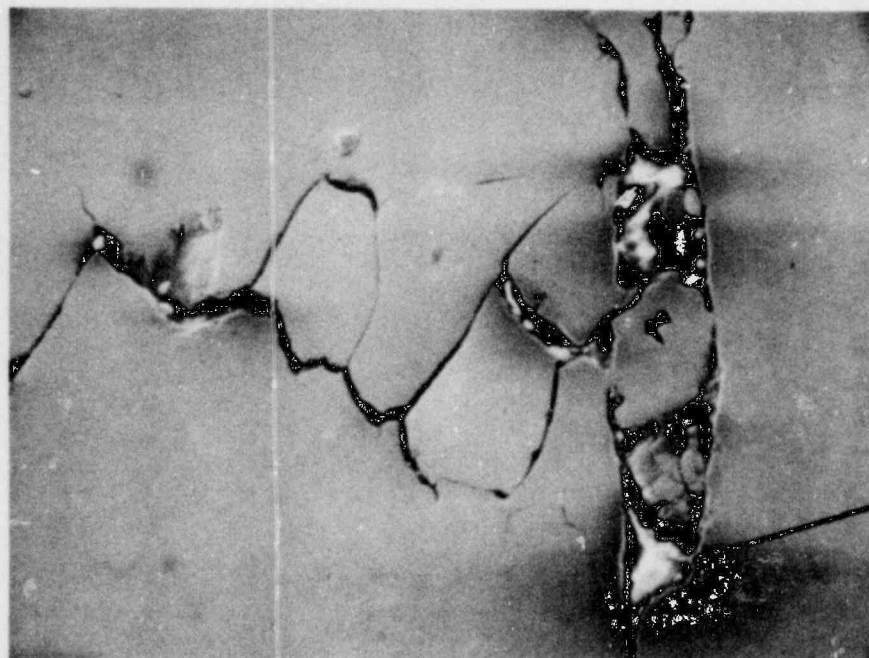
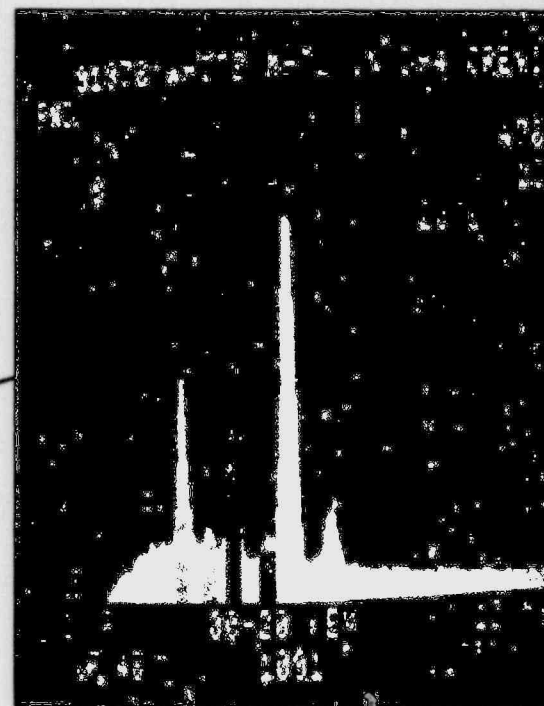
FIGURE 18. SEM MICROGRAPH AND CORRESPONDING EDAX ANALYSIS OF IRON RICH MATERIAL IN CREVICE OF SAMPLE 4

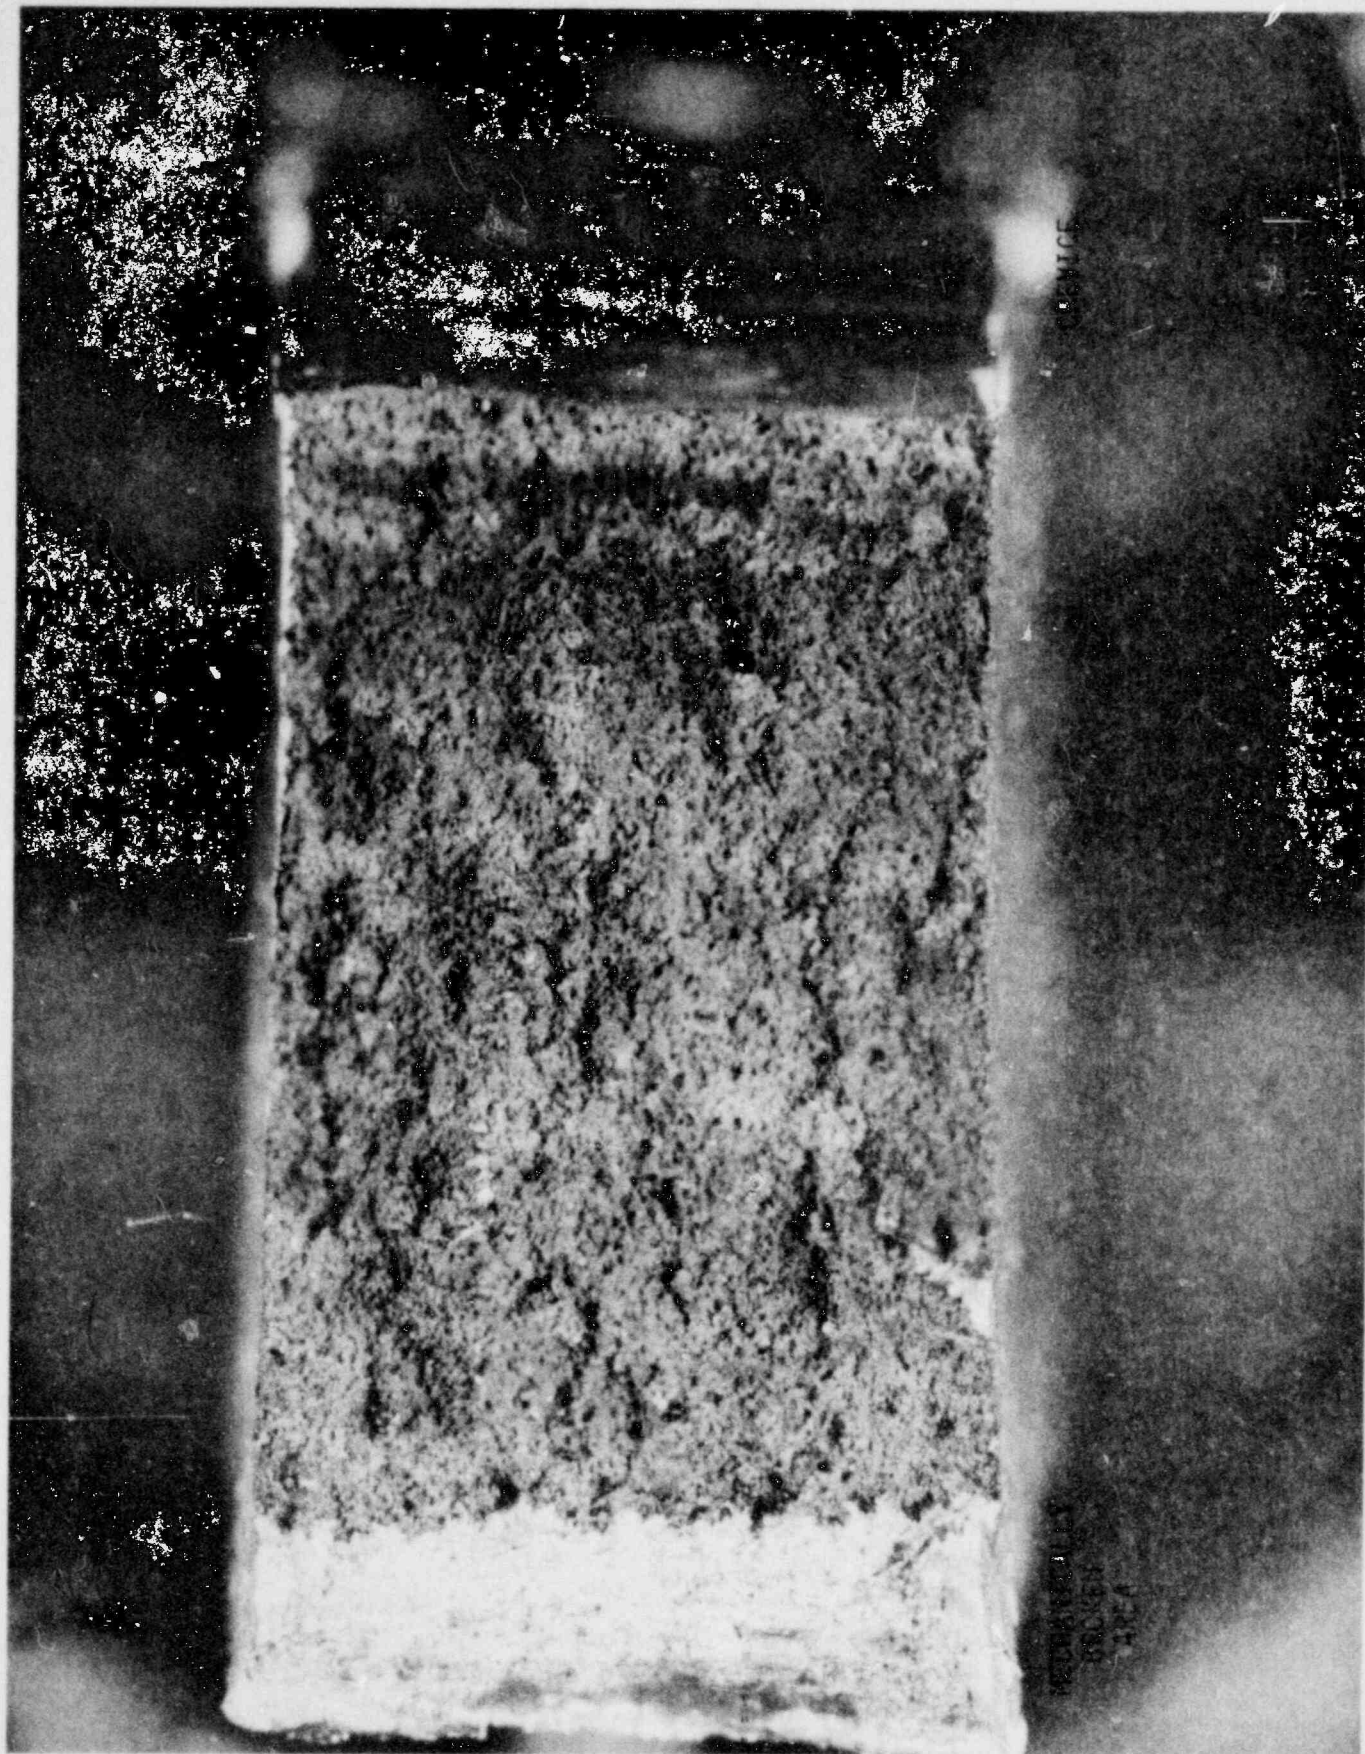
2.7.2 SEM Fractography. As stated previously, safe end Sample No. 5 was examined by SEM. Figure 20 presents a schematic of Sample No. 5 showing the fracture surface examined. In order to expose the fracture surface for examination the specimen was mechanically fractured. Figure 21 presents a photomicrograph of the fracture surface examined. The bright material to the left is the region of uncracked safe end wall thickness which was mechanically fractured. Examination of this region following fracture indicated the material to be ductile.

FIGURE 21. PHOTOMICROGRAPH OF FRACTURE SURFACE FROM SAMPLE 5

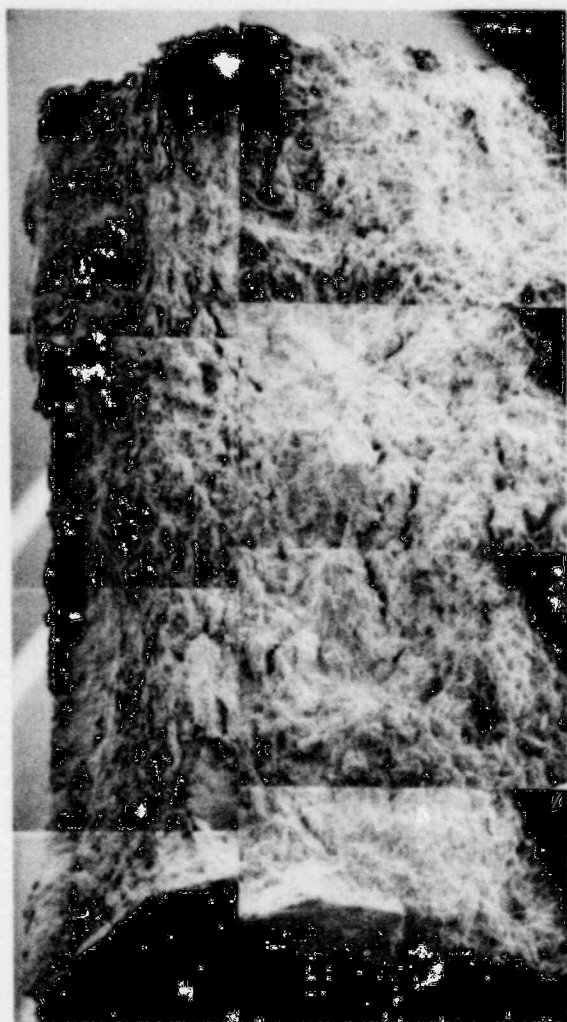
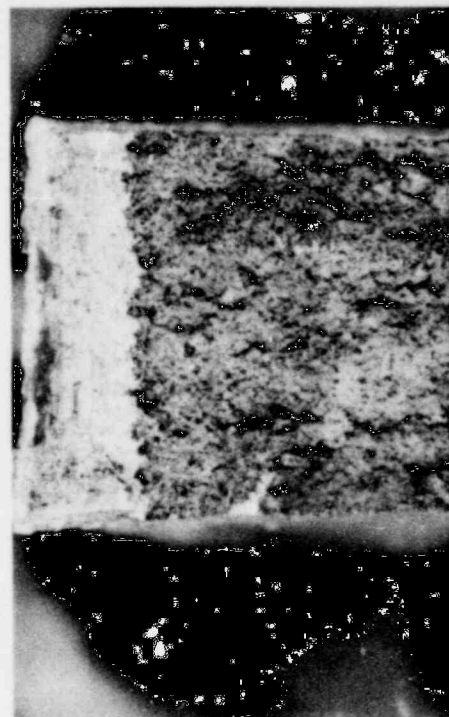
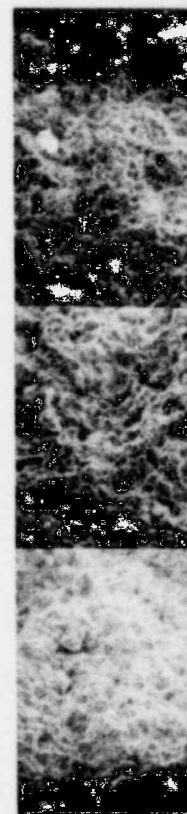
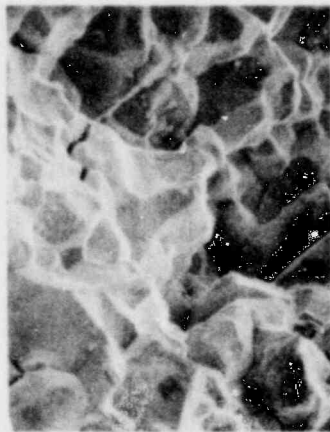
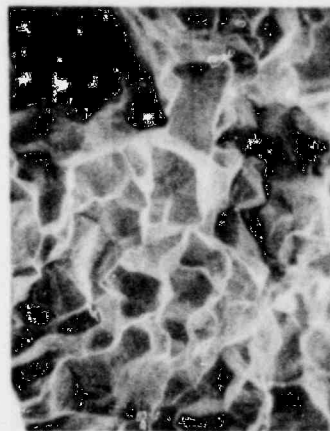
Detailed SEM examination was performed on the entire fracture surface. Figure 22 presents SEM fractograph montages at the beginning (near crevice) middle, and tip of the crack along the fracture surface. The mode of cracking, as indicated by the SEM fractographs, was intergranular fracture.

FIGURE 22. SEM MICROGRAPH MONTAGES OF SAMPLE 5
FRACTURE SURFACE (a) Crack Tip,
(b) Mid Fracture, (c) Near Crevice

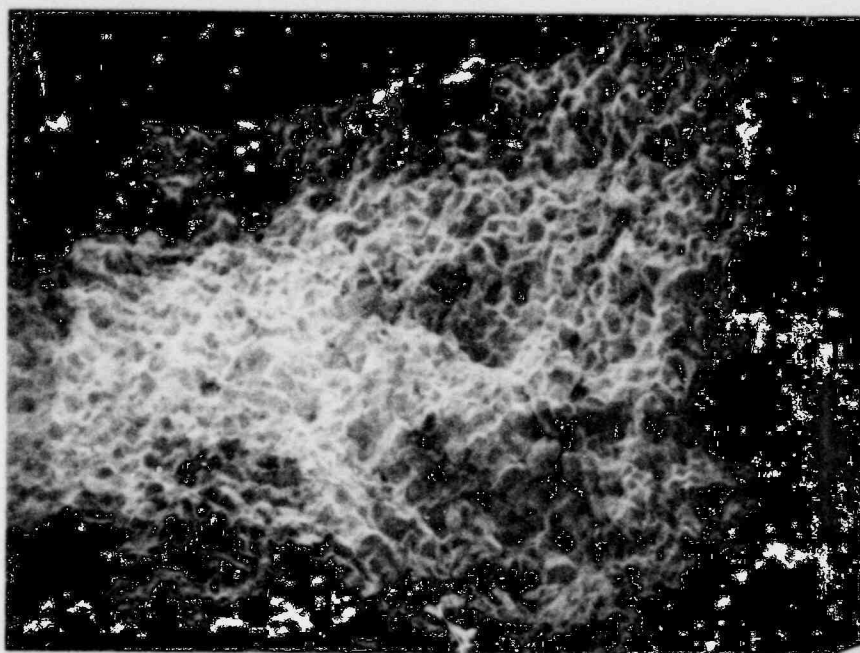
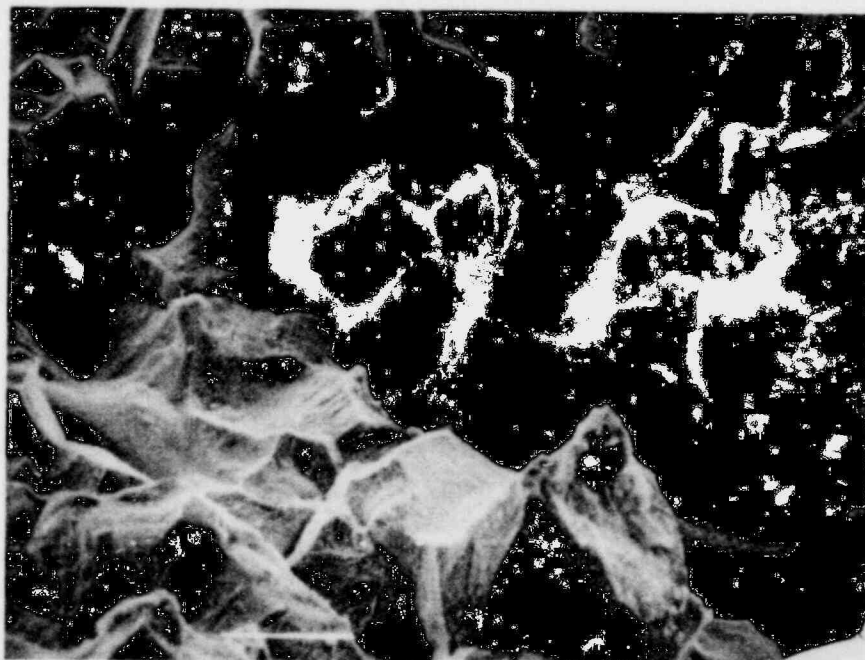
Numerous EDAX analyses were performed on several areas of the fracture and crevice. Figures 23, 24, and 25 present SEM fractographs illustrating typical areas chosen for EDAX analysis (i.e., Figures 23b, 24a, and 25b present actual areas examined by X-ray near the crevice, in the middle and at the tip of the fracture, respectively). In addition, Figure 24b presents a SEM micrograph of a grain facet (from Figure 24a) showing a network of needle-like corrosion products on which a spot EDAX analysis was performed.

(a) Typical area on fracture surface near crevice

(b) Actual area examined by EDAX analysis

FIGURE 23. SEM FRACTOGRAPHS OF SAMPLE 5 NEAR CREVICE

Results from EDAX analysis of Figures 23, 24, and 25 and other areas not shown indicate no significant variations from base metal composition. However, small amounts of sulfur were detected in almost all of the fracture and crevice EDAX analyses. Figure 26 presents SEM micrographs taken on the fracture surface near the crack tip. The crystalline material, magnified to 2000X in Figure 26b, was subjected to spot EDAX analysis. Results indicate high sulfur contents (~8 times greater than the highest sulfur content detected in area EDAX scans on the fracture surface). Similar crystalline structures were observed and analyzed on the crevice surface, and they too indicated relatively high sulfur content.

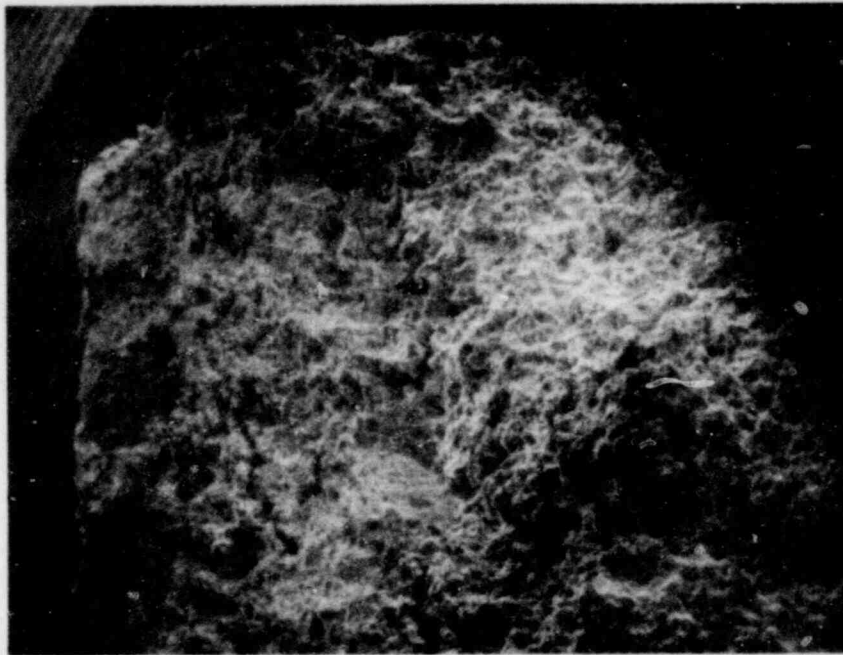
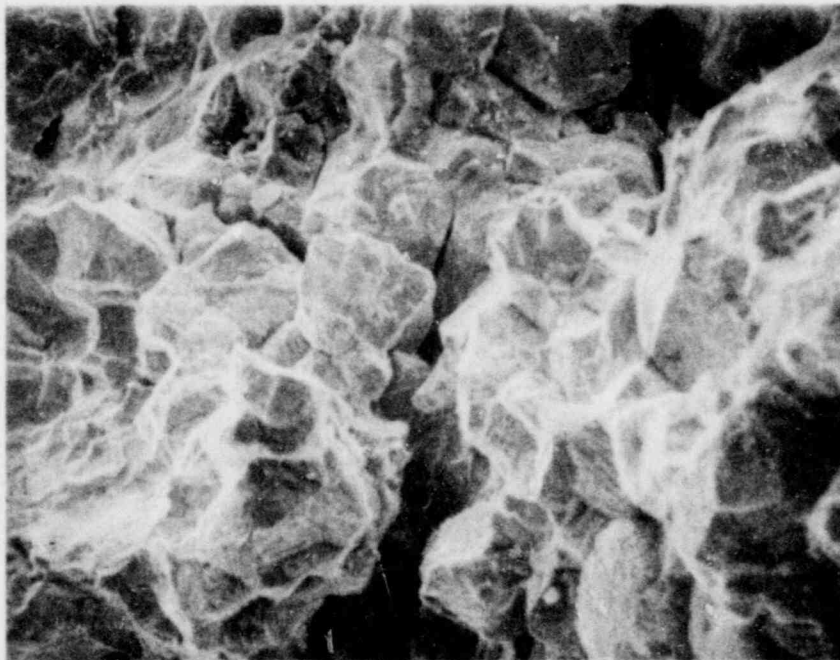
FIGURE 25. SEM FRACTOGRAPHS OF SAMPLE 5 AT CRACK TIP

(a) Typical area on fracture surface
at crack tip.

(b) Actual area examined by EDAX analysis.

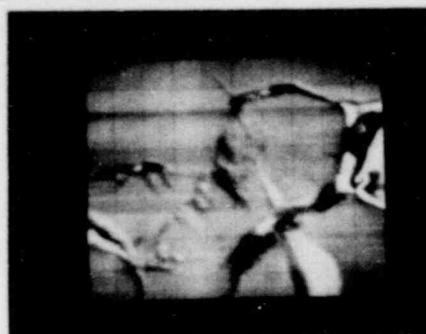
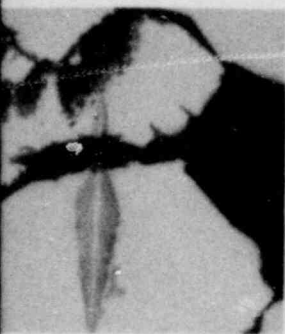
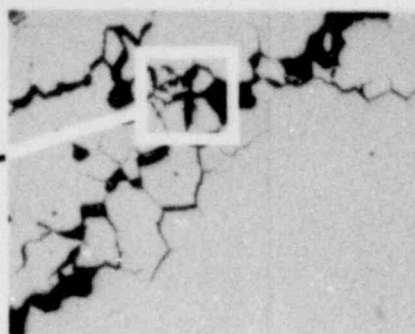
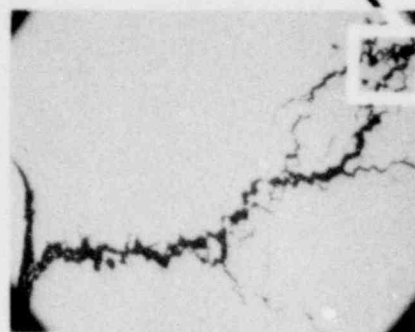
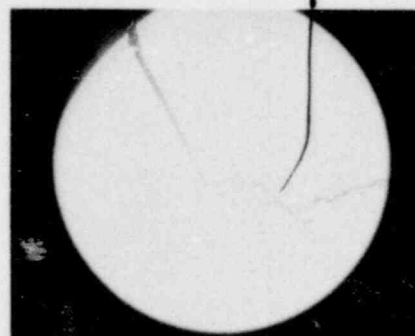
FIGURE 28. SAMPLE #2 - MICROPROBE RESULTS

X-ray mapping, as shown in Figure 28, compares the Ni, Cr, and Fe distribution in a grey phase-crack location. For orientation purposes the X-ray images must be compared with the electron backscatter (EBS) image, which in turn can be compared with the adjacent photomicrographs. The Ni X-ray map shows a decrease in Ni content in the Cr rich phase. The Cr image appears to indicate a slight intensity increase. Iron appears to follow the general area topography with relatively uniform distribution.

EBS
IMAGE
500X

Ni
X-RAY
IMAGE
500X

Cr
X-RAY
IMAGE
500X

Fe
X-RAY
IMAGE
500X
