FINAL REPORT ON  
REACTOR CONTAINMENT LINER  
OVERLAY PAD FILLET WELD  
AT  
BEAVER VALLEY POWER STATION - UNIT NO. 2

STONE & WEBSTER ENGINEERING CORPORATION

METALLURGICAL EXAMINATION OF  
REACTOR CONTAINMENT LINER  
OVERLAY PAD FILLET WELD CRACK  
AT BEAVER VALLEY POWER STATION - UNIT NO. 2

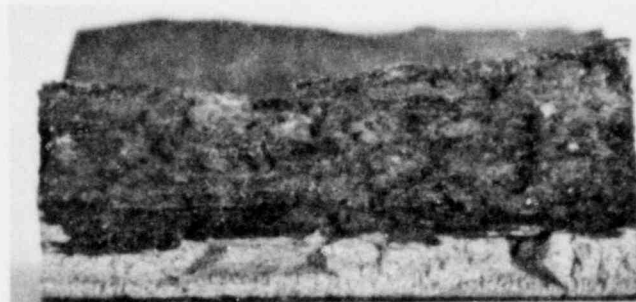
(LOCATION L - FIG. 8)

FIGURE 9  
VIEWS OF CRACK AT STUD/LINER/WELD/PAD JUNCTION
