**PERRY NUCLEAR POWER PLANT**

Geologic Map of  
Tunnel Excavations

Figure 2D-2 (Sheet 1 of 24)

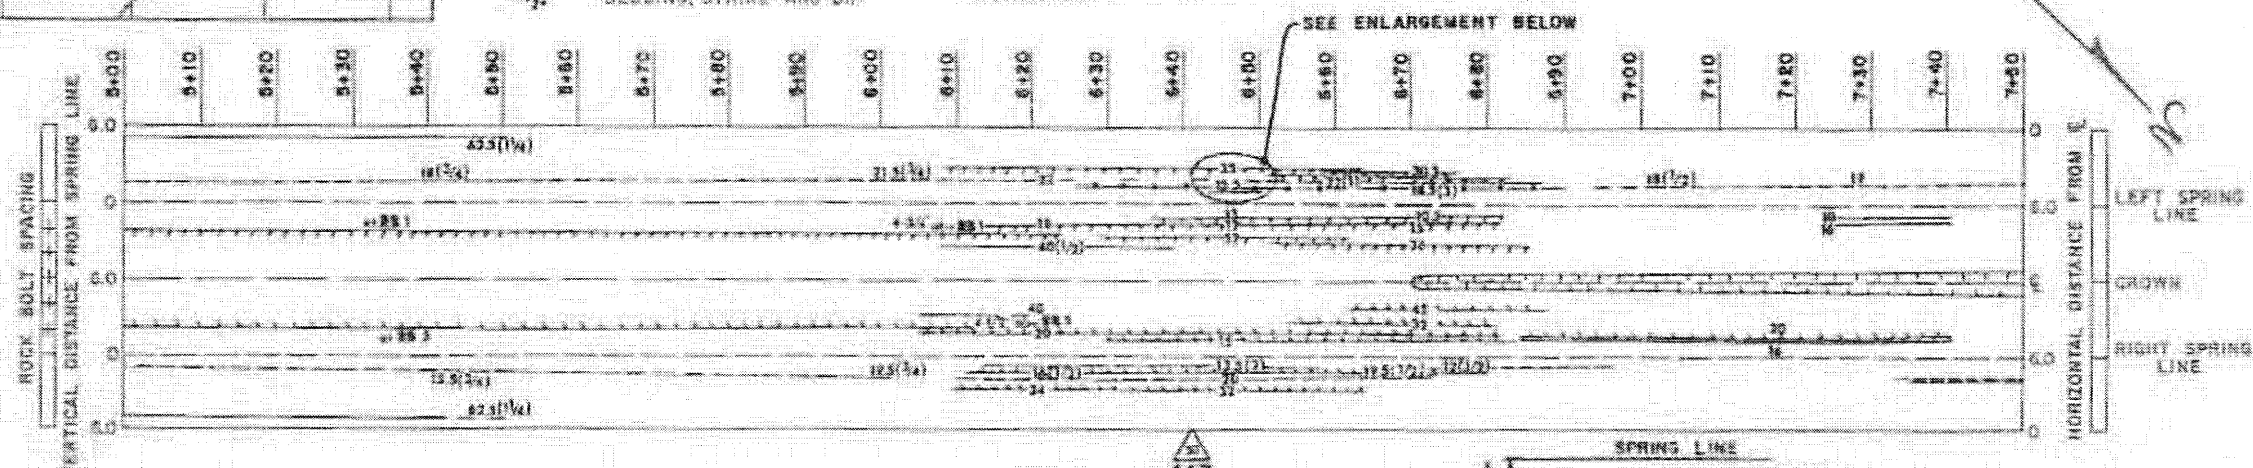
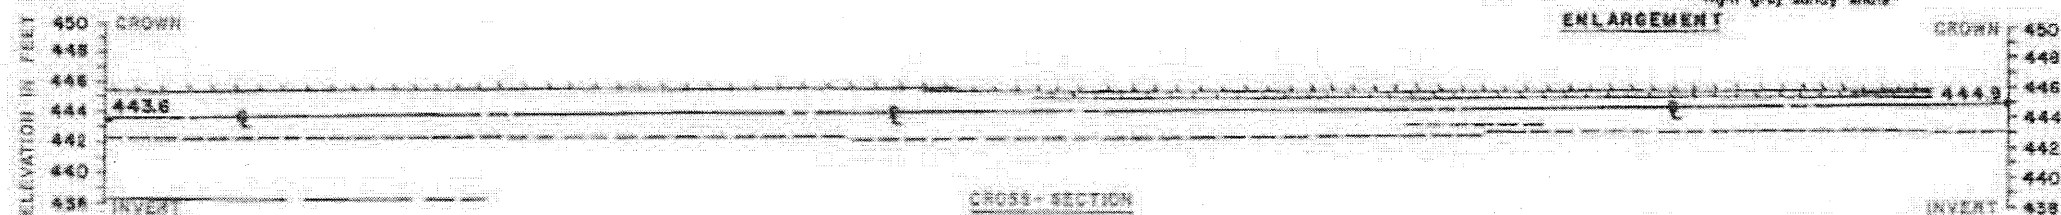
Geologic Map of  
Tunnel Excavations  
Figure 20-2 (Sheet 2 of 24)

1/2	1/2	1/2	1/2	1/2	1/2	1/2	1/2
No. 4							—No. 4— Spilling off main bed fracture starting on sta. 5170
5 back holes of 2" centers in 1/2" spaced, 2-3.5" apart covered by wire mesh							
1" x 4"							
Bedding fractures only							
No inflow							Slight moisture in known along bedding fractures
3 back holes of 2" centers in 1/2" spaced, 2-3.5" apart covered by wire mesh							5' water
1/2" x 4"							170' subhorizontal shale

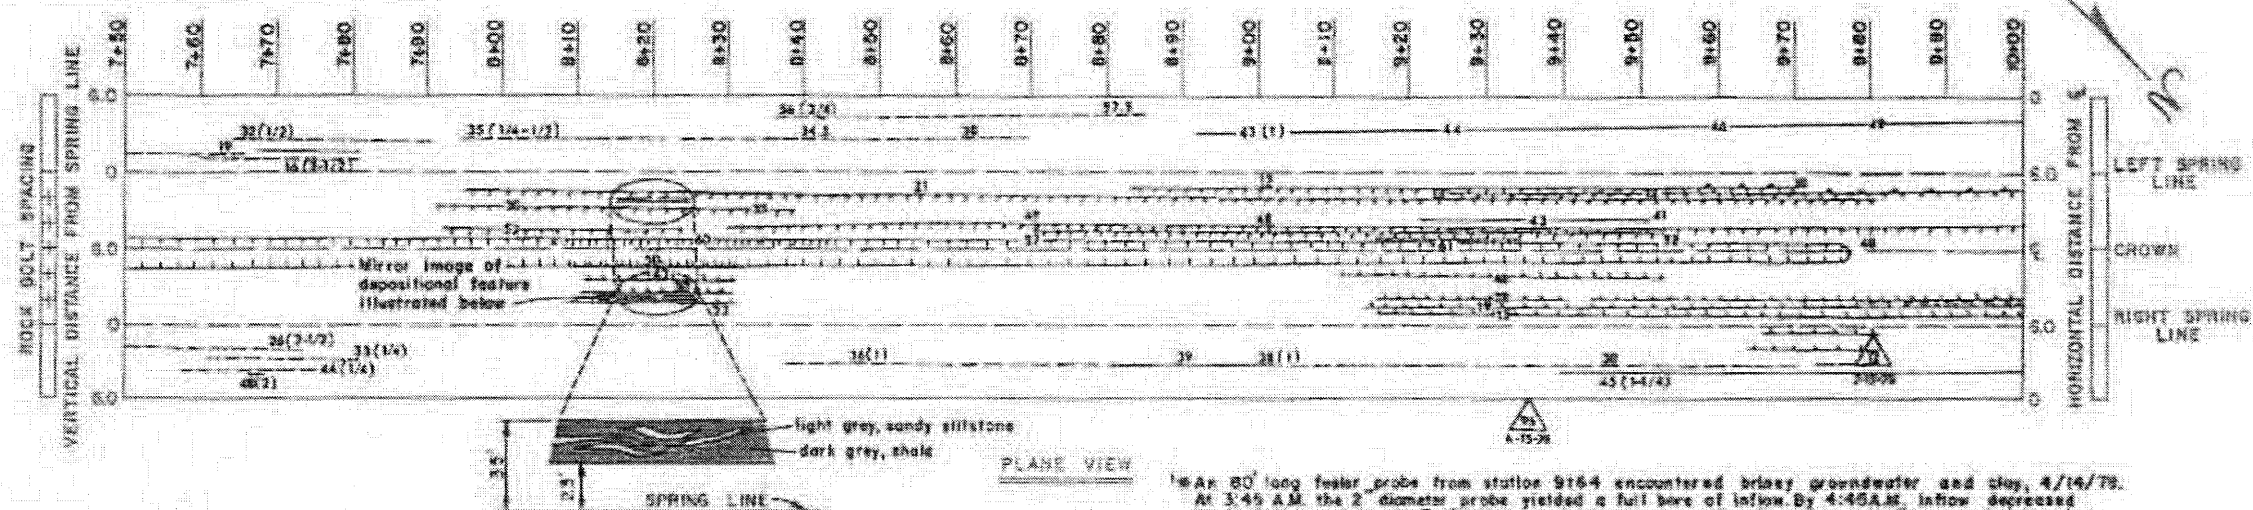
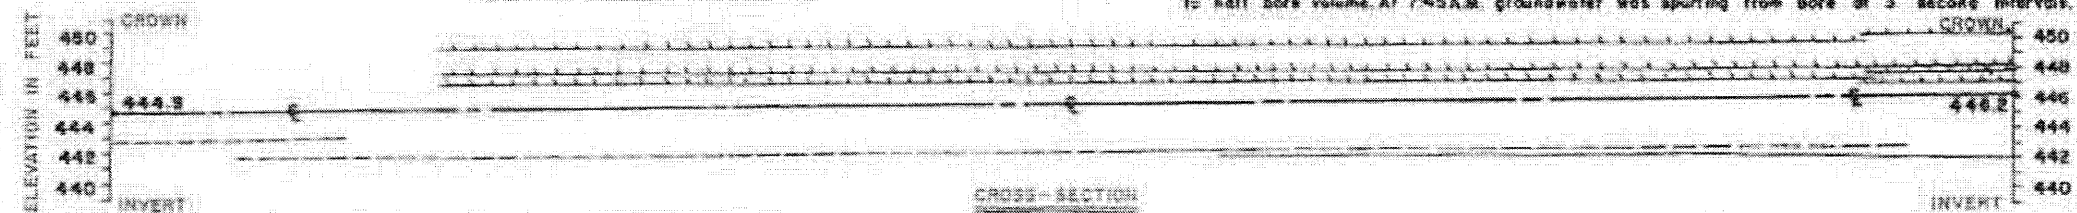
Geologic Map of  
Tunnel Excavations  
Figure 2D-2 (Sheet 4 of 24)

- FAULT SEOMETRY**
- a.) Apparent displacement - 22"
  - b.) Actual vertical displacement - 12"
  - c.) Strike - N 47° E
  - d.) Dip - approx 17°
  - e.) Width of broken rock (1 1/2" - 18")

No. 5-6		No. 7-8		No. 9-10		No. 11-12		No. 13-14	
5 rock bolts at 2' centers in steel ribs at 3-3.5' centers		0-24" of overbreak between rock bolt no 2-4		5 rock bolts at 2' centers in steel ribs at 3-3.5' centers spanned by wire mesh		full chauling		5 rock bolts at 2' centers in ribs at 3.5' centers spanned by wire mesh	
7'-10"		7'-8"		2'-2"		approx. 6'-14"		8'-15"	
No inflows		Bedding fractures 1/2 to 1/8" thick highly fractured fault zone w/ gouge		No inflows		Bedding fractures only, spaced as above		Slight inflow from rock bolts	
11.7' water (photo)		water dripping from chauling		2' inflows at approx. 1 gal/min		Slight moisture along approx. 20% of bedding fractures and rock bolts		10.3' water (photo)

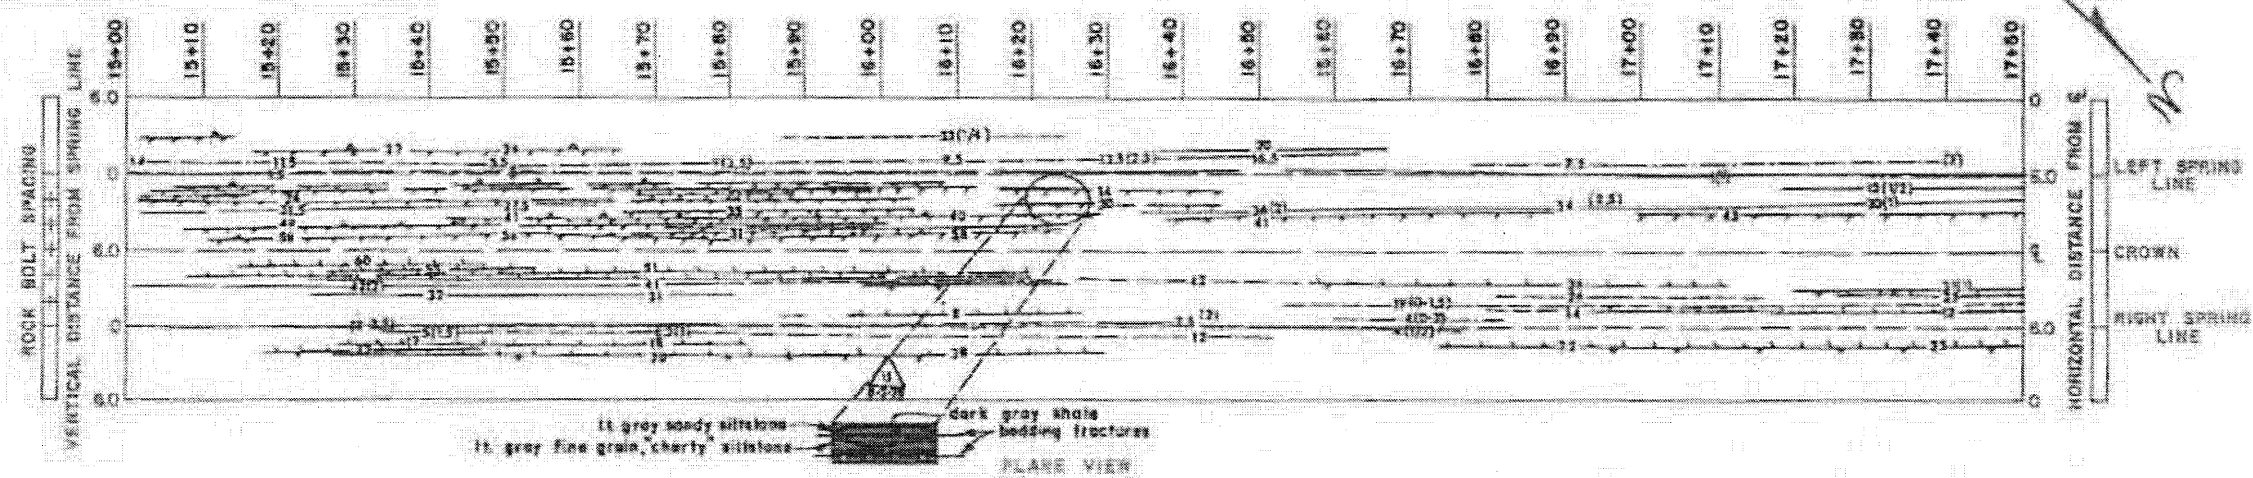
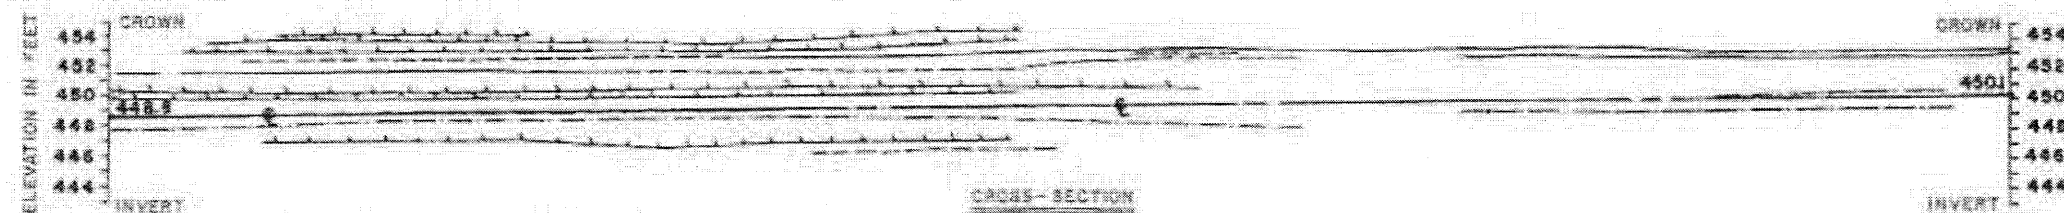
Figure 2D-2 (Sheet 7 of 24)

12 17	12 18	12 19	12 20	12 21
as 4	Slight scaling along crown for series length (between rock bolt 2 & 4)		Slight scaling from roof (0'-4')	as 4
	3 rock bolts at 2.0' centers in steel ribs at 2.5' to 4.0' centers, spanned by wire mesh		Some ribs at 4.0' centers	
	Approx. 8"	Approx. 4" to 10"	4" to 8"	
	Bedding fractures only			
	Traces of moisture along a couple bedding fractures			
			Slight moisture on approx. 60% of the excavation	
11.5' water			11.5' water	
101.5' subsurface (shale)			101.5' subsurface (shale)

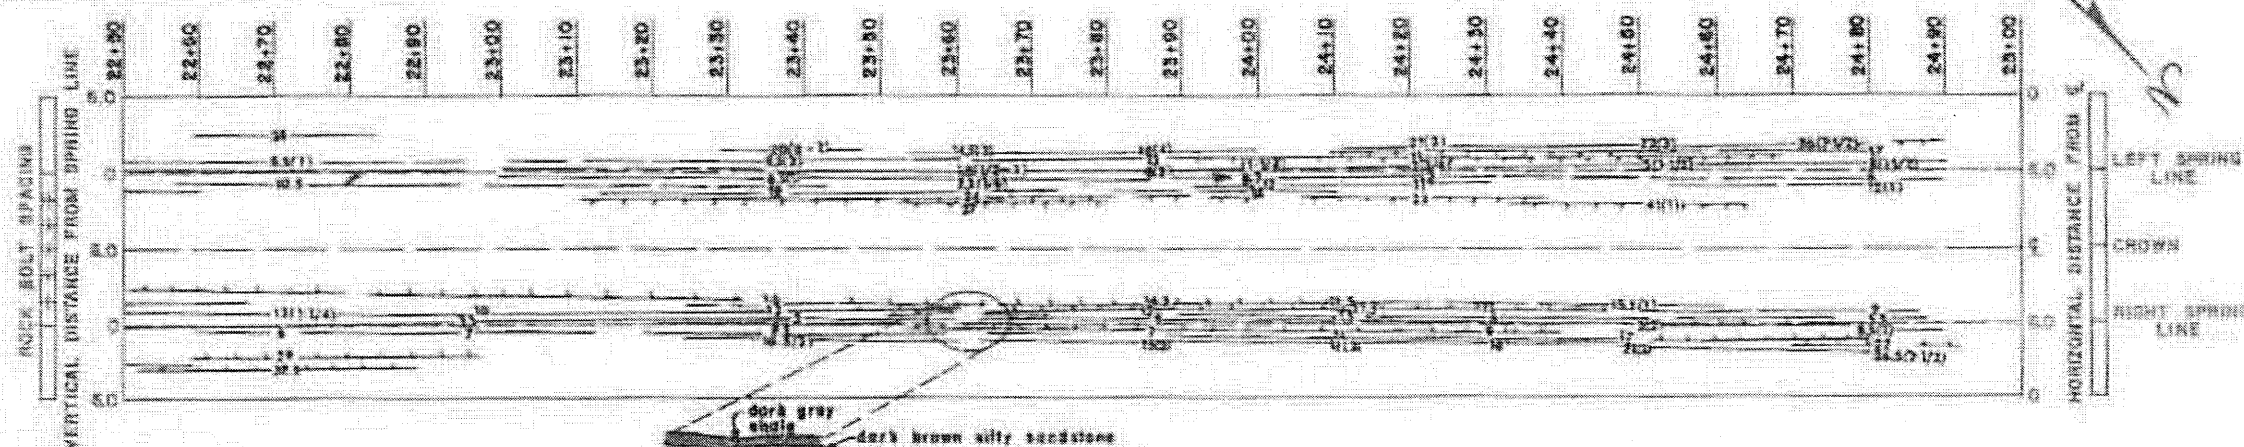
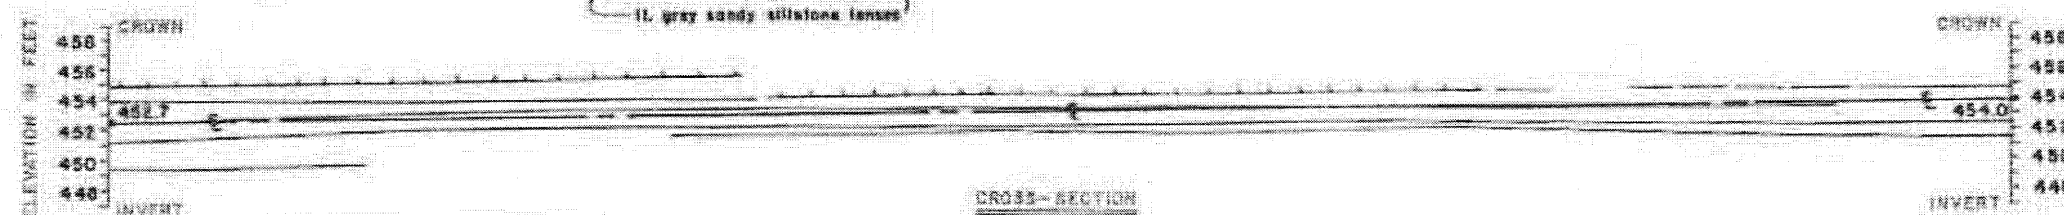
No. 4		No. 4	
Slightly weathered between rail bolt nos. 7 & 8, 10'-0" deep (max 24")		Slightly weathered between rail bolt nos. 7 & 8, 10'-0" deep (max 24")	
Track bolts in 7' centers in steel ribs at 1.5' to 4.0' centers, supported by wire mesh		Track bolts in 7' centers in steel ribs at 1.5' to 4.0' centers, supported by wire mesh	
3'-7"		1'-8"	
Bedding fractures only, located as above		No seepage	
Most bedding fractures, above springline along east wall		No seepage	
1.5' water		1.5' water	
K&S Substation (shown)		K&S Substation (shown)

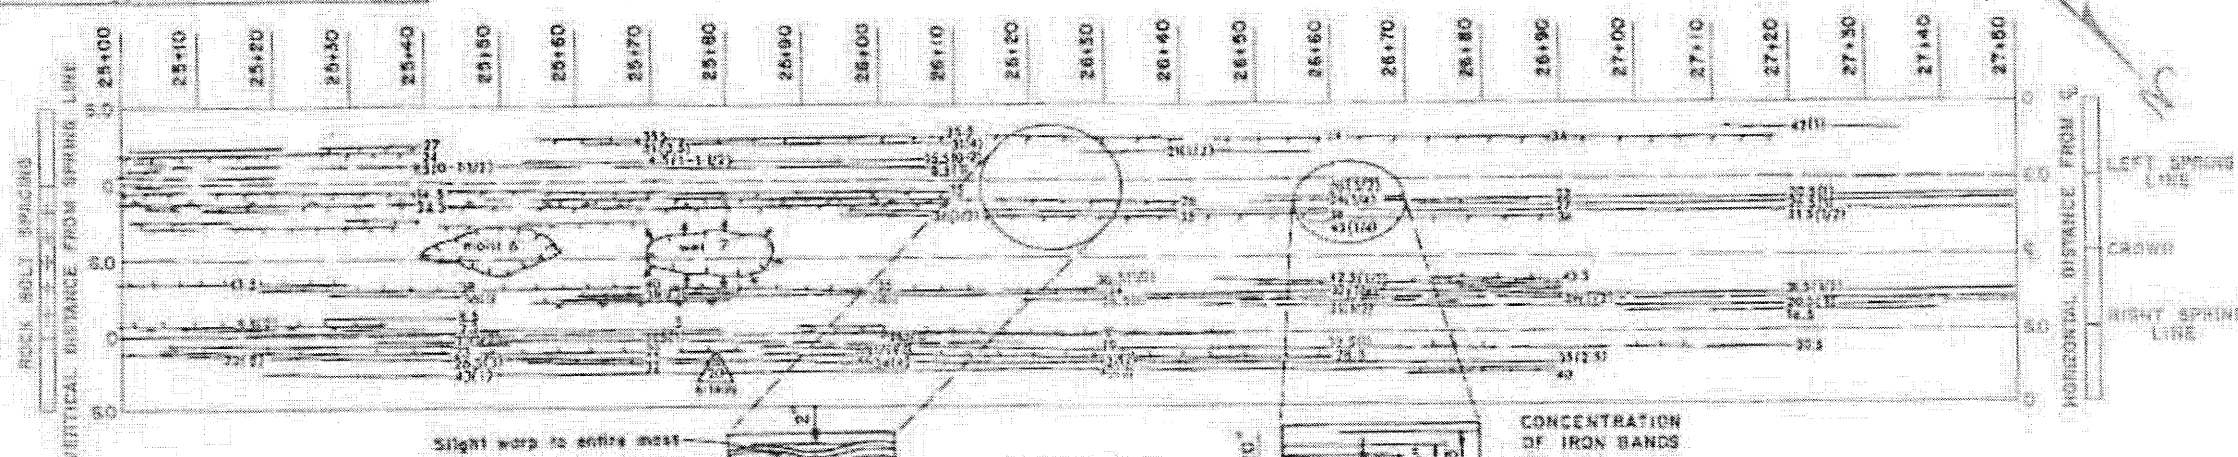
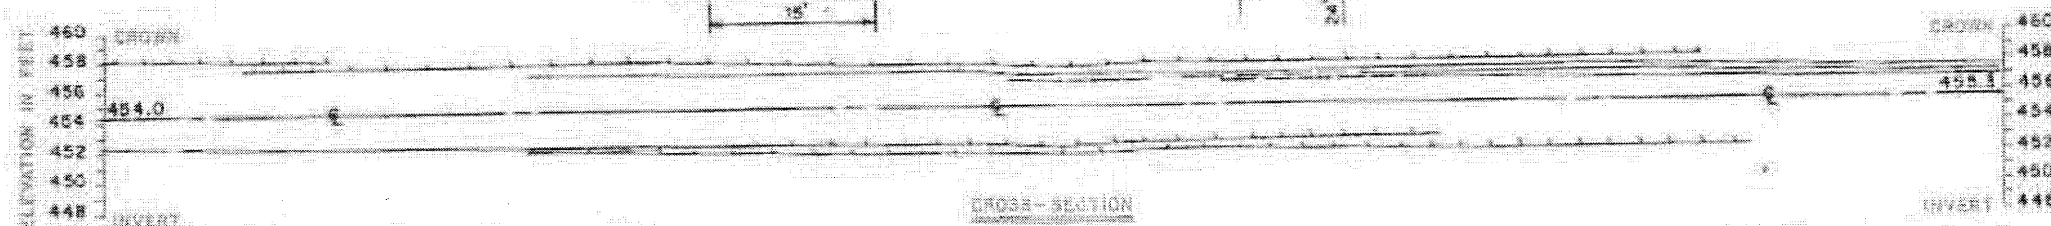
Figure 2D-2 (Sheet 13 of 24)

Slight overbreak along entire section 0' - 6' deep max 2'		Slight overbreak along entire section 0' - 6'		Slight overbreak along entire section 0' - 6'	
16' - 0' overbreak in crown max 1'	1' - 7'	1' - 7'	1' - 7'	1' - 7'	1' - 7'
Additional rock bolts and ribs added to prohibit additional overbreaks		Additional rock bolts and ribs added to prohibit additional overbreaks		Additional rock bolts and ribs added to prohibit additional overbreaks	
Bedding fractures only, spaced at 4' max		Bedding fractures only, spaced at 4' max		Bedding fractures only, spaced at 4' max	
Slight dip from overbreak in crown		Slight moisture along bedding fractures		No seepage	
3' - 5' water		3' - 5' water		3' - 5' water	
140' surface (thole)		140' surface (thole)		140' surface (thole)

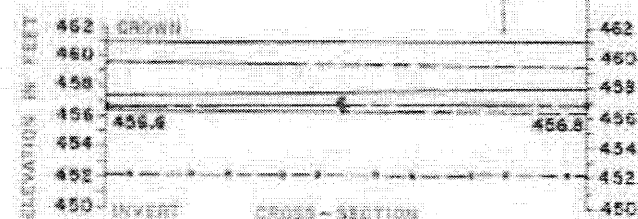
CROSS-SECTION A

EXCAVATION PROGRESS	ESTIMATED ROCK CONDITION (TERZAGHI NO.)
1-4	1-4
Slight overbreak along entire section	1-4
3 rock bolts at 2' centers in steel ribs at 4' centers spaced by wire mesh	1-4
4'-6"	1-4
Bedding fractures only, spaced as above	1-4
Slight moisture along all bedding fractures	1-4
22.5' water	22.5'
91.5' subsurface (scale)	91.5'

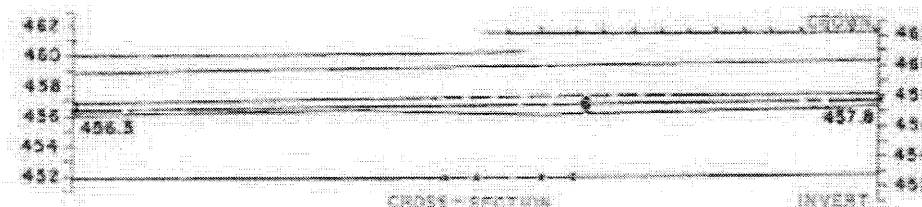
CROSS-SECTION B

EXCAVATION PROGRESS	ESTIMATED ROCK CONDITION (TERZAGHI NO.)
1-4	1-4
Slight overbreak along entire section	1-4
3 rock bolts at 2' centers in steel ribs at 4'-6.5' centers, spaced by wire mesh	1-4
3'-8"	1-4
Bedding fractures only, spaced as above	1-4
Slight moisture along all bedding fractures	1-4
22.5' water	22.5'
91.5' subsurface (scale)	91.5'

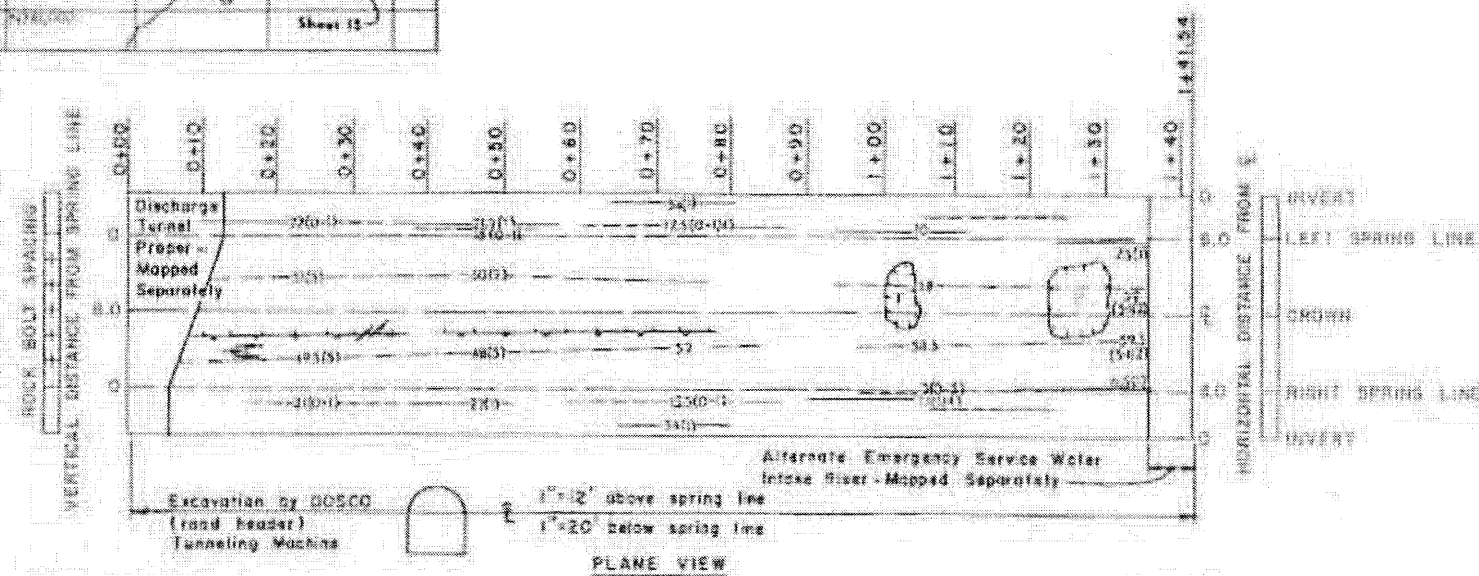
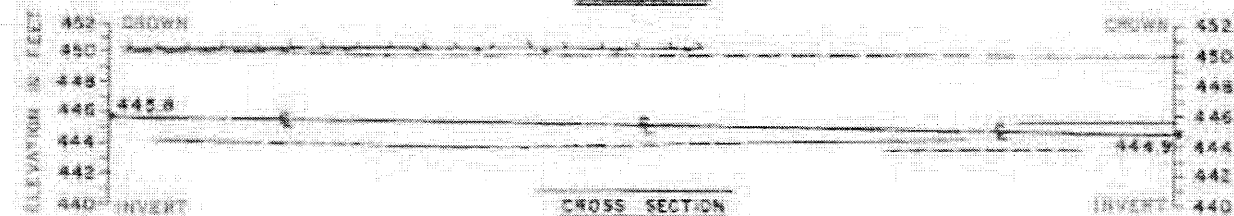
Figure 20-2 (Sheet 13 of 24)

1'	2'	3'	4'
rock			
3 rock bolts at 3' centers in steel ribs at 10'-11' centers, spanned by wire mesh			
1/2" x 1/2"	3" x 2"	1" x 2"	Approx. 1" x 1" openings
3" x 2"	Bedding fractures only, spaced as above		
Slight seepage from bedding parting along west wall		No inflows	
Approx. 31.5' limestone 27.5' granite sill		Approx. 27.5' limestone 27.5' granite sill	
11.7' shale		11.2' shale

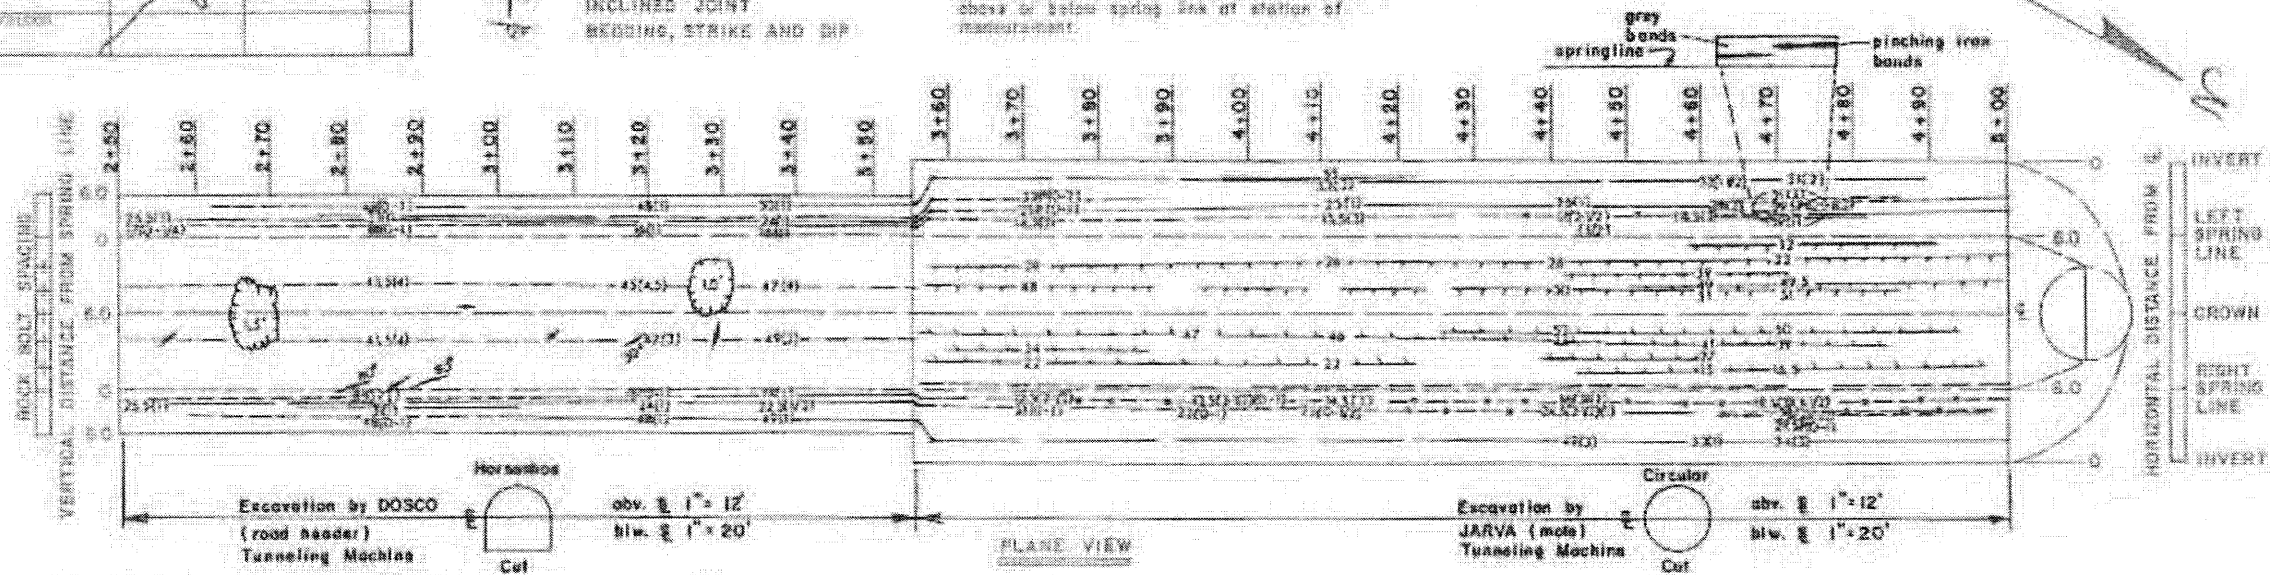
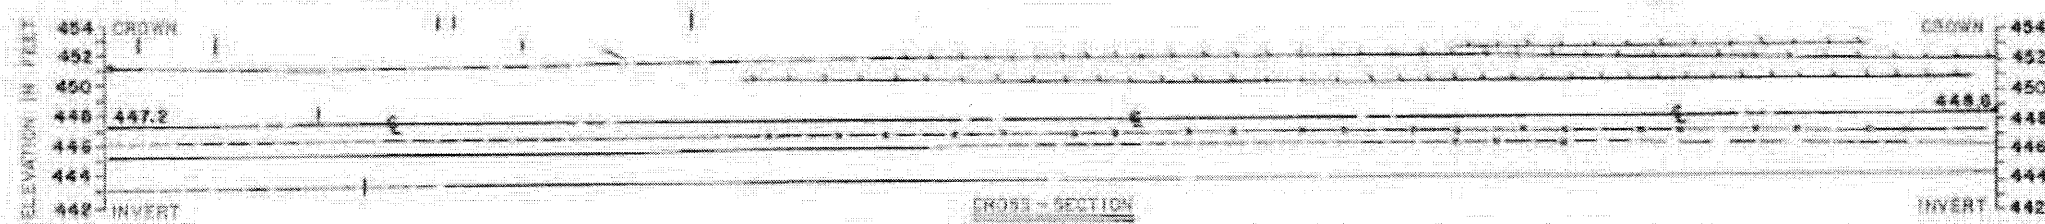
Figure 2D-2 (Sheet 15 of 24)

No. 4					
3 inch bolts at 2' centers in steel ribs at 30'±3.5' centers, spanned by wire mesh					
1'-4"	1'-5"	1'-6"	5'-8"	4'-8"	5'-11"
Approx. 5'±0"	Approx. 8'	Approx. 11'	Jointing less apparent in smooth circular bore excavation	Bedding fractures only, spaced as above	
No inflow					
Approx. 24' limestone & 14' glacial till + 11.8' shale			Approx. 2' of bench + 11.2' of shale

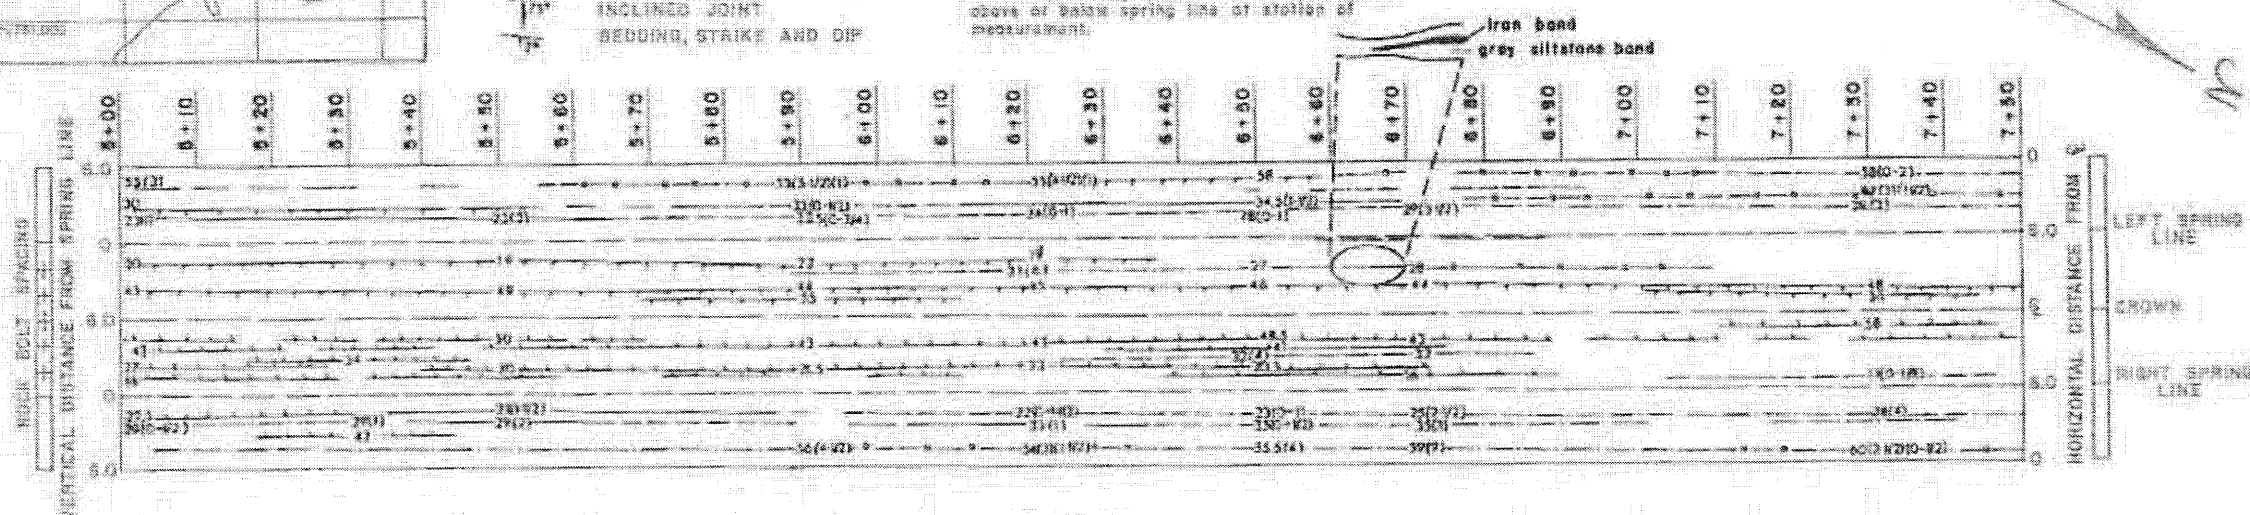
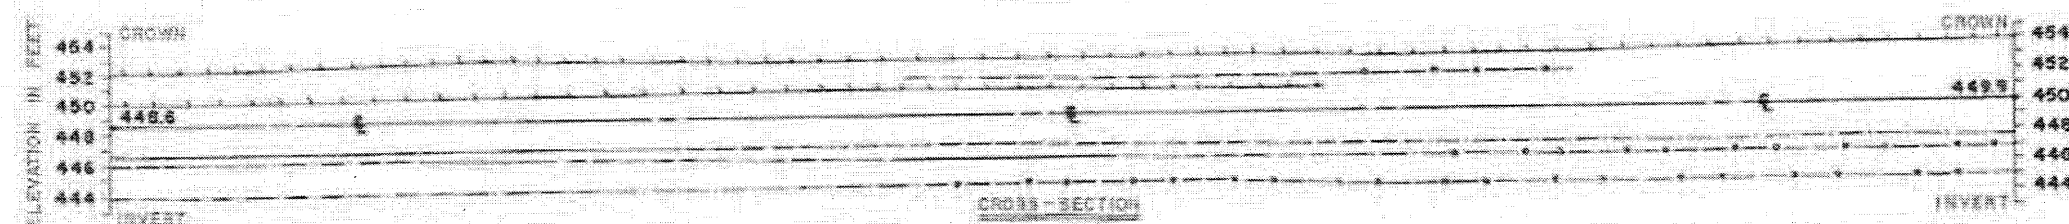
Figure 2D-2 (Sheet 17 of 24)

No. 4		No. 4	
3 rock bolts w/3 centers in steel ribs at 3.5'-4.0' centers spaced by wire mesh		Steel ribs at 3.5'-4.0' centers	
5'-11"		7'-12"	
Bedding fractures only, spaced as above		Bedding fractures only, spaced as above	
No inflows		No inflows	
Approx. 1' bench		2.5' bench	
10' 9" subsurface (drain)		10' 9" subsurface (drain)

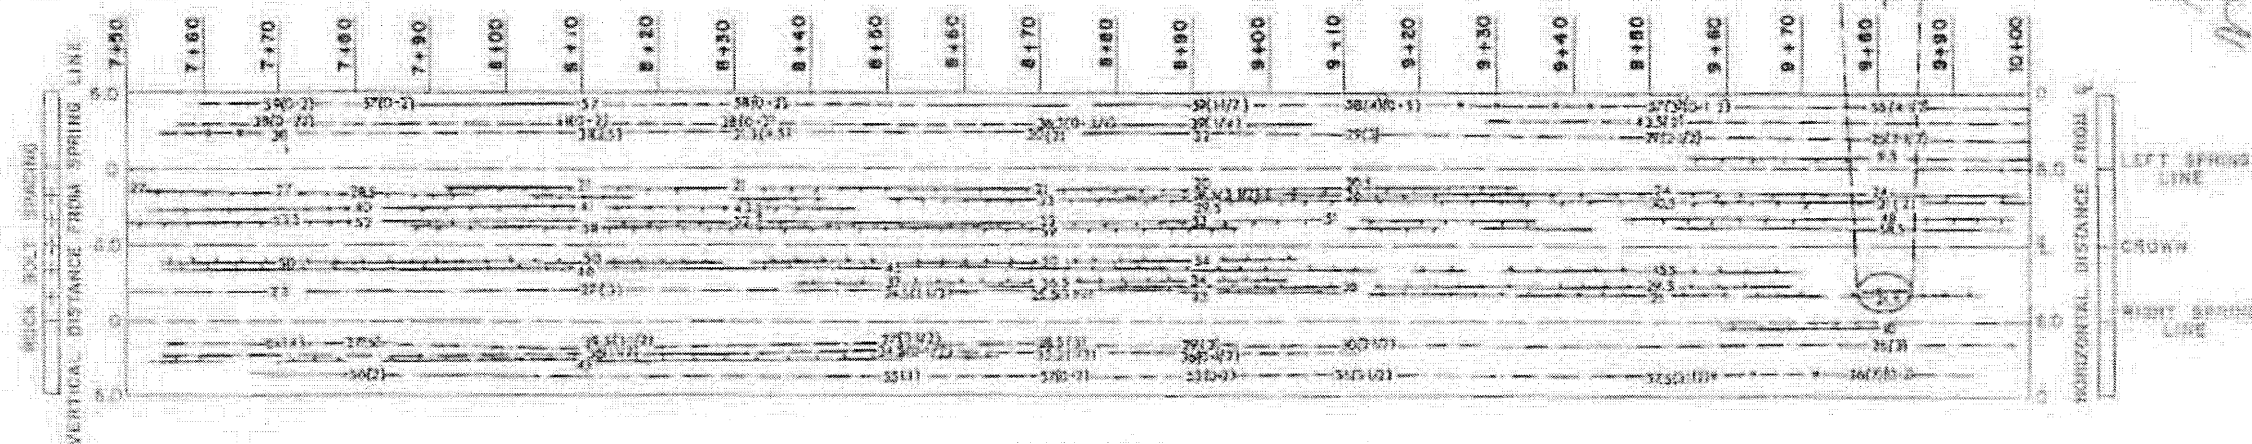
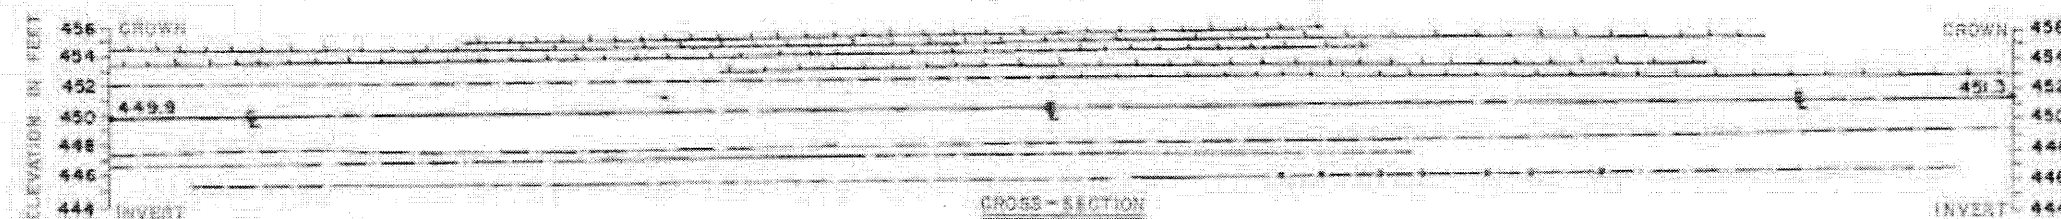
Figure 2D-2 (Sheet 18 of 24)

456	CROWN	456
454		454
452		452
450		450
448		448
446		446
444	INVERT	444
No. 4		
Stack bolts at 2' centers in steel ribs at 1'-6" centers, covered by wire mesh		
4" x 12"		
Bedding fractures only, spaced as above		
No inflow		
45' deep water		7.5' deep water
116.1' subsurface (hole)		111.7' subsurface (hole)

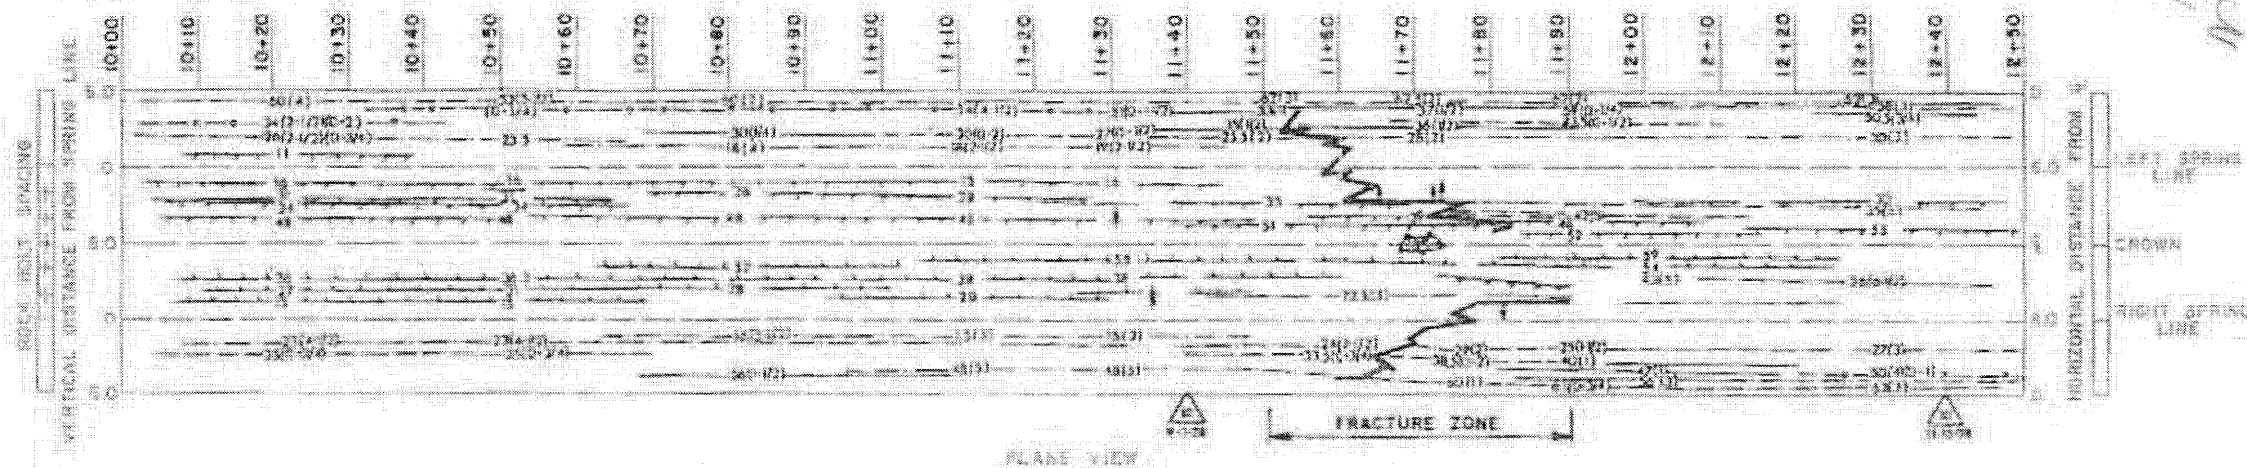
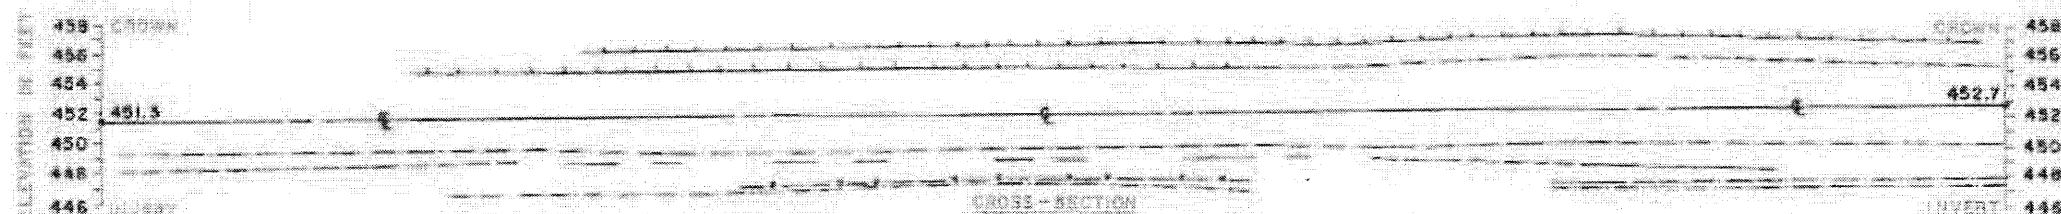
Figure 20-2 (Sheet 19 of 24)

No. 4 0" x 4" at overbreak, starting from crown			
3 rock bolts at 2' centers in steel ribs at 4.0' x 4.5' centers, spanned by wire mesh			
3" x 10"	6" x 6"		3" x 9"
Bedding fractures only, spaced as above		Bedding fractures only, spaced as above	
No inflows		Seepage from rock bolts	Seepage from bedding partings in fracture zone
No inflows		No inflows	
4.5' water (111.7' substructure (photo))		8.5' water (107.7' substructure (photo))

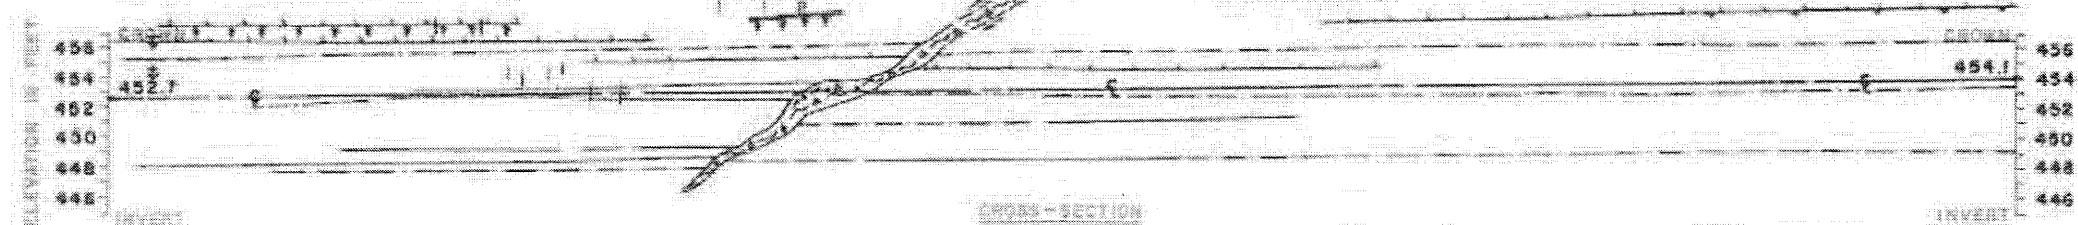
Figure 2D-2 (Sheet 20 of 24)

a.) Apparent displacement - 12" to 25" d.) Dip approx. 15.5°  
 b.) Actual vertical displacement - 8 1/2" to 11 1/2" e.) Width of broken rock (1 1/2" to 24")  
 c.) Strike - N66°E

no. 4		no. 4-a		no. 5	
5 rock bolts at 2' centers in steel ribs at 3.5' - 4' centers, spanned by wire mesh		Full shielding employed		5 rock bolts at 2' centers in steel ribs at 3.5' - 4' centers spanned by wire mesh	
Bedding fractures spaced as above, joints widely spaced		Ribs at 2' centers		Bedding fractures only, spaced as above	
Most bedding fractures where indicated		Several minor inflows in fractured areas		Several dripping flows along shielding	
8.5' water		101.9' subsurface (shale)		14.5' water

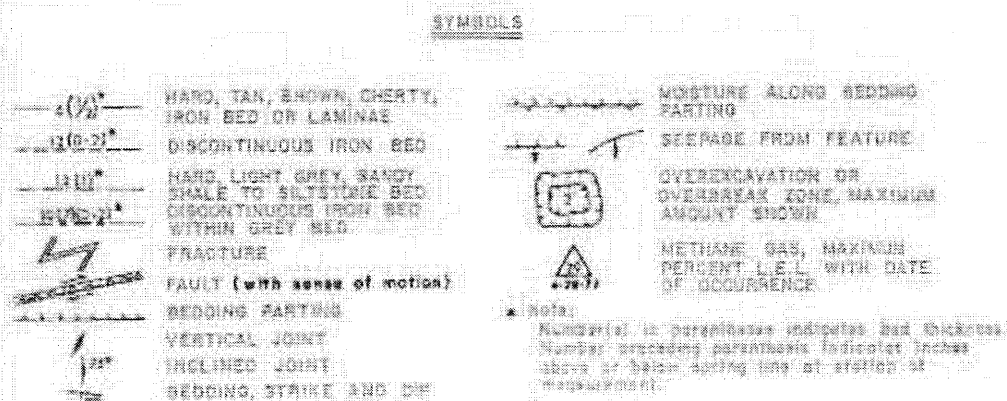
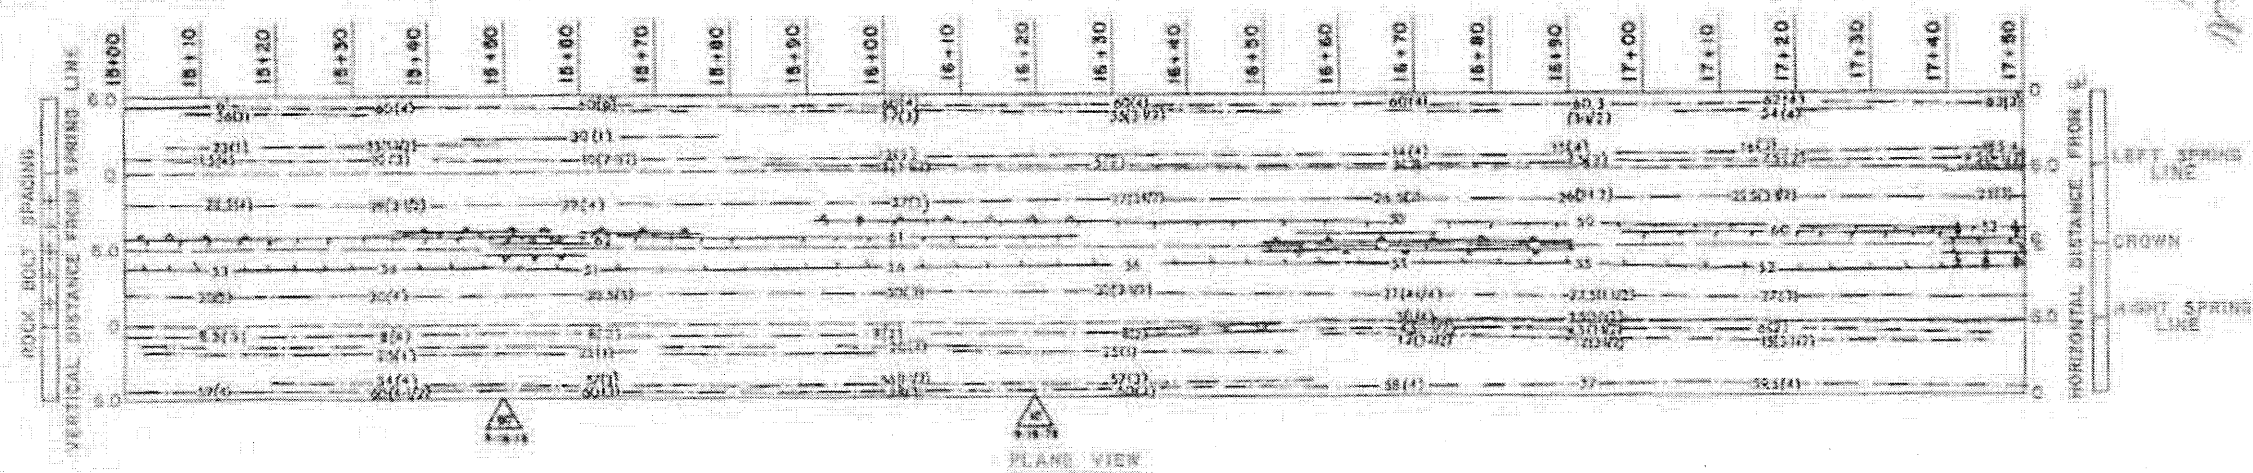
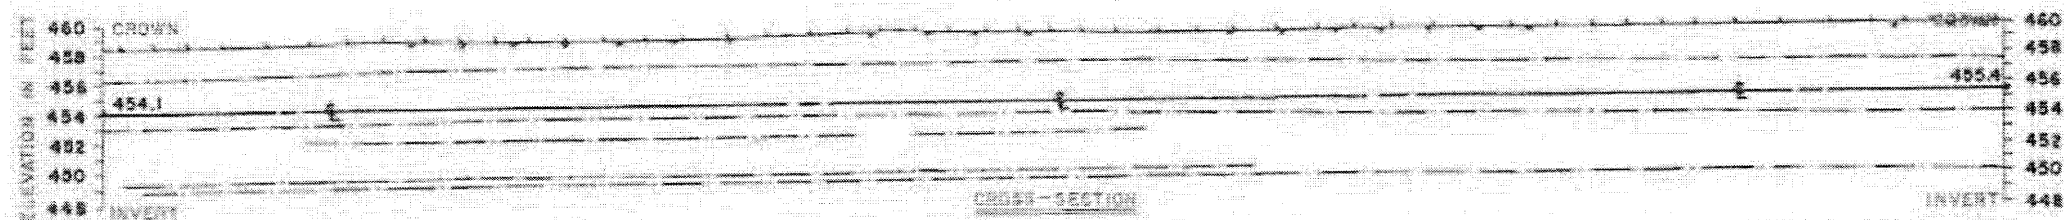
Figure 20-2 (Sheet 21 of 24)

Slight overbreak along entire excavation (0'-6")				ea. 4
3 rock bolts at 2' centers in steel ribs or 40'-42" centers spanned by wire mesh				
3'-9"	4'-2"		1'-10"	
Bedding fractures only, spaced at above				
Moisture from bedding parting	Moisture from bedding parting	Moisture from bedding parting	Moisture from bedding parting	Moisture from bedding parting
15.5' water	10.5' water	15.5' water	15.5' water	15.5' water
10.5' subsurface (shale)				15.5' water

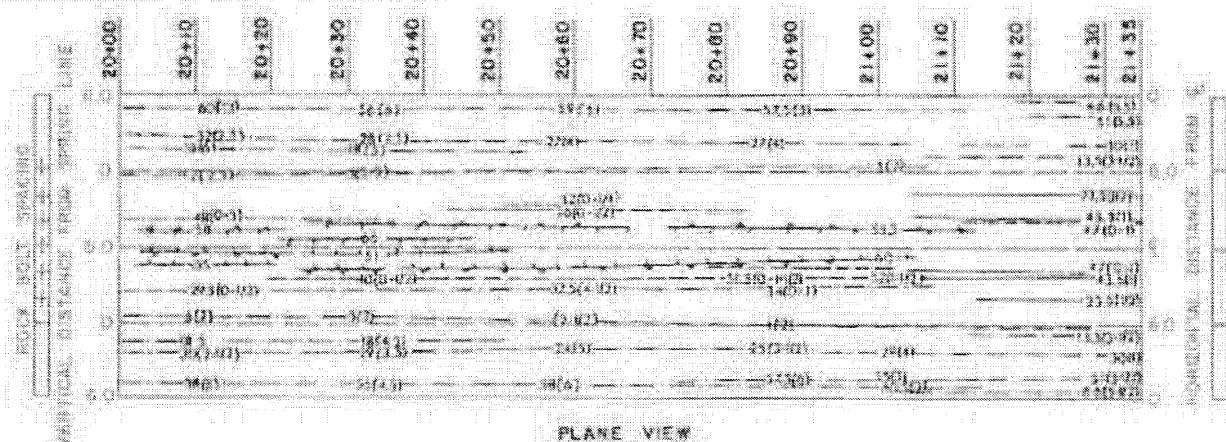
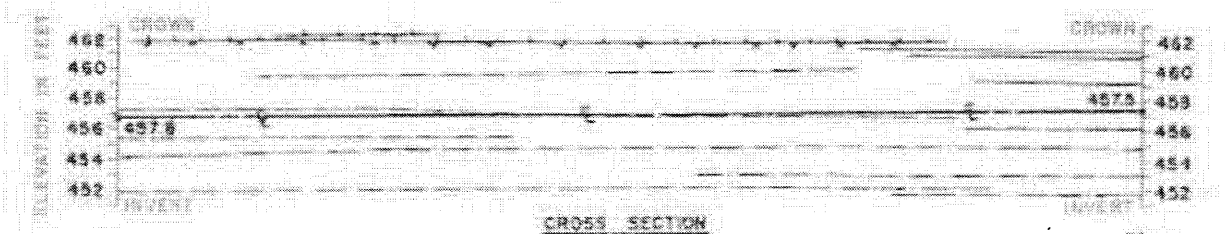
Figure 2D-2 (Sheet 22 of 24)

Excavation Progress	
ESTIMATED ROCK CONDITION (TERMINAL AND)	
TEMPORARY SUPPORT SYSTEM	
BEDDING SPACING	
FRACTURE SPACING	
WATER CONDITION	
DEPTH OF COVER	
18.5' water	21.5' water
2.5' subsurface (shale)	2.5' subsurface (shale)
