Annual Radioactive Waste Tank Inspection Program – 2018

June 2019

Savannah River Remediation
Savannah River Site
Aiken, SC 29808

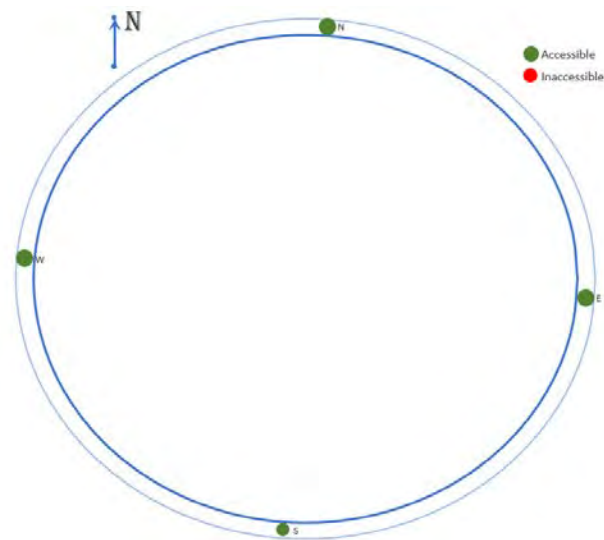
Annulus Inspection Location

Annulus Risers Available for Inspection: 4

Inspection Capability: 25%

Number of Known Leak Sites	Date of Discovery	Waste on Annulus Floor	Location	Elevation from Tank Bottom
No known leak sites	n/a	n/a	n/a	n/a

Conclusions following 2018 Inspections: No leakage, significant surface corrosion, or other anomalies were noted. The 2018 inspection confirmed the structural integrity and waste confinement capability of Tank 2.

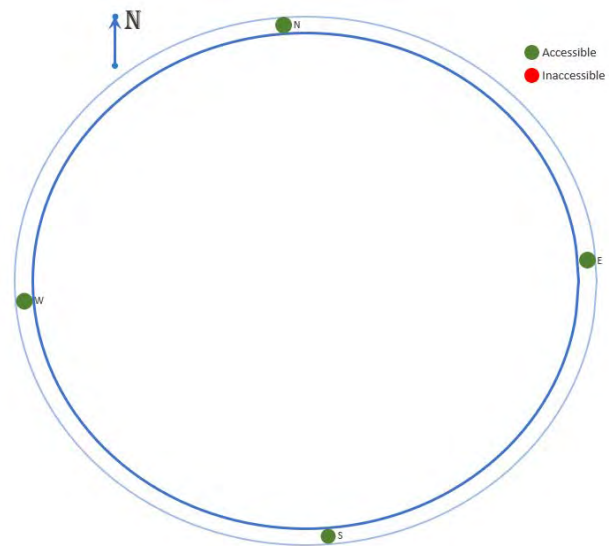
Annulus Inspection Location

Annulus Risers Available for Inspection: 4

Inspection Capability: 25%

Number of Known Leak Sites	Date of Discovery	Waste on Annulus Floor	Location	Elevation from Tank Bottom
No known leak sites	n/a	n/a	n/a	n/a

Conclusions following 2018 Inspections: No leakage, significant surface corrosion, or other anomalies were noted. The 2018 inspection confirmed the structural integrity and waste confinement capability of Tank 3.

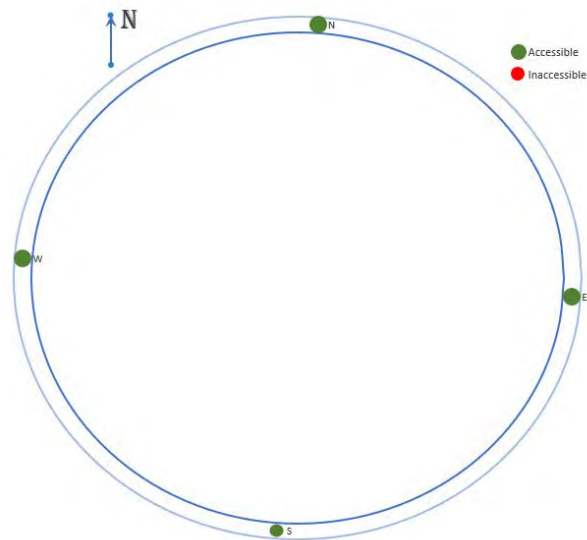
Annulus Inspection Location

Annulus Risers Available for Inspection: 4

Inspection Capability: 25%

Number of Known Leak Sites	Date of Discovery	Waste on Annulus Floor	Location	Elevation from Tank Bottom
4	Oct 2011	None	South	234 in.
	Sep 2013	None	North	234 in.
	Sep 2013	None	North	234 in.
	Sep 2013	None	North	234 in.

Summary of Visual Inspections: No changes were noted since the inspections in 2017.

Conclusions following 2018 Inspections: No leakage, significant surface corrosion or other anomalies were noted. The 2018 inspection confirmed the structural integrity and waste confinement capability of Tank 4.

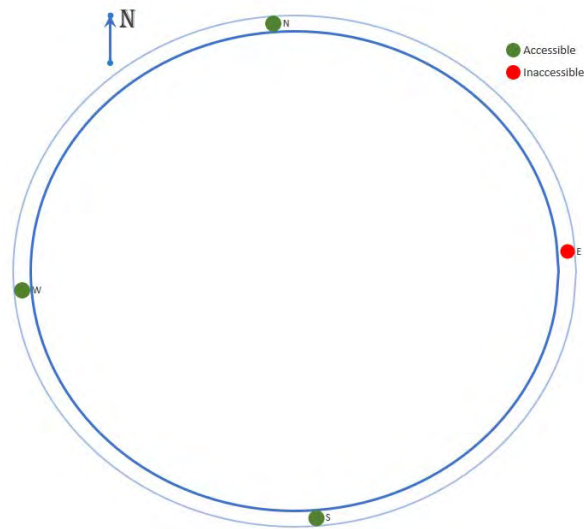
Annulus Inspection Location

Annulus Risers Available for Inspection: 3

Inspection Capability: 19%

Number of Known Leak Sites	Date of Discovery	Waste on Annulus Floor	Location	Elevation from Tank Bottom
No known leak sites	n/a	n/a	n/a	n/a

Conclusions following 2018 Inspections: No leakage, significant surface corrosion, or other anomalies were noted. The 2018 inspection confirmed the structural integrity and waste confinement capability of Tank 7.

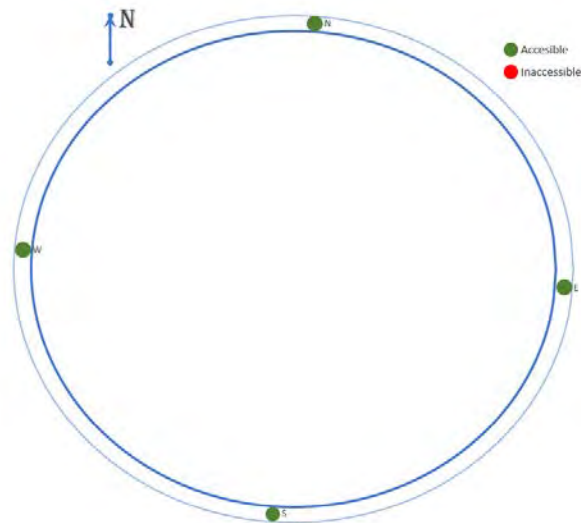
Annulus Inspection Location

Annulus Risers Available for Inspection: 4

Inspection Capability: 25%

Number of Known Leak Sites	Date of Discovery	Waste on Annulus Floor	Location	Elevation from Tank Bottom
No known leak sites	n/a	n/a	n/a	n/a

Conclusions following 2018 Inspections: No leakage, significant surface corrosion, or other anomalies were noted. The 2018 inspection confirmed the structural integrity and waste confinement capability of Tank 8.

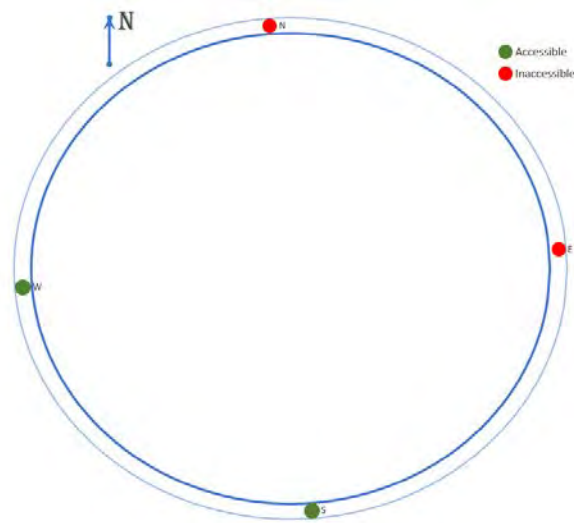
Annulus Inspection Location

Annulus Risers Available for Inspection: 2

Inspection Capability: 13%

Number of Known Leak Sites	Date of Discovery	Waste on Annulus Floor	Location	Elevation from Tank Bottom
≥ 4	Oct 1957	8-10 in. of salt deposits – 3 identified leak sites are not the source of the salt deposits in the annular pan; source has not been identified	West West South Unknown	276 in. 271 in. 269 in. Source of waste in pan unknown

Summary of Visual Inspections: No changes were noted since the inspections in 2017.

Conclusions following 2018 Inspections: No additional significant surface corrosion or other anomalies were noted. The 2018 inspection confirmed the structural integrity and waste confinement capability of Tank 9.

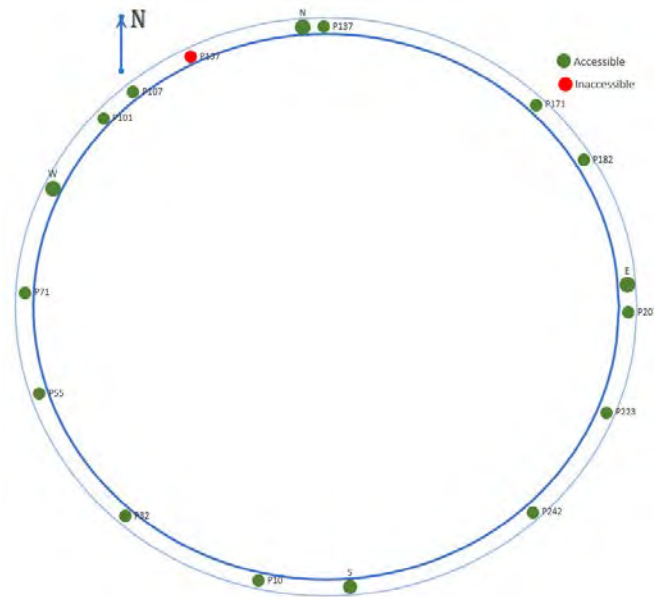
Annulus Inspection Locations

Conclusions following 2018 Inspections: No significant surface corrosion or other anomalies were noted apart from the eight new identified leak sites. The 2018 inspection confirmed the structural integrity and waste confinement capability of Tank 15.

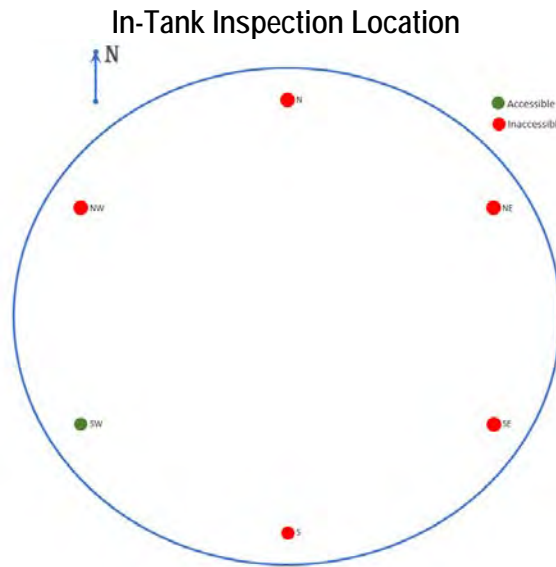
- Type IV Tank
- H Tank Farm

Summary of Visual Inspections: No areas of concern since last evaluated in 2017. Visual examinations of the steel liner have revealed corrosion, including rust and tubercles on the surface of the upper position of liner wall, but there is no evidence of failure. Broad and shallow pitting was observed. The dome was inspected and continues to meet ACI 318-95 code requirements

Conclusions following 2018 Inspections: No inleakage, additional surface corrosion, or other anomalies were noted. The 2018 inspection confirmed the structural integrity and waste confinement capability of Tank 23.

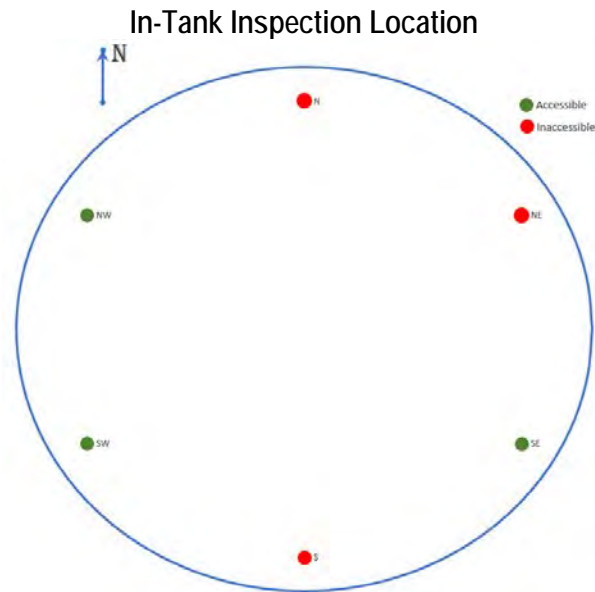
- Type IV Tank
- H Tank Farm

Summary of Visual Inspections: No areas of concern since last evaluated in 2017. No evidence of degradation of the concrete dome; continues to meet ACI 318-95 code requirements.

Conclusions following 2018 Inspections: No inleakage, significant surface corrosion, or other anomalies were noted. The 2018 inspection confirmed the structural integrity and waste confinement capability of Tank 24.

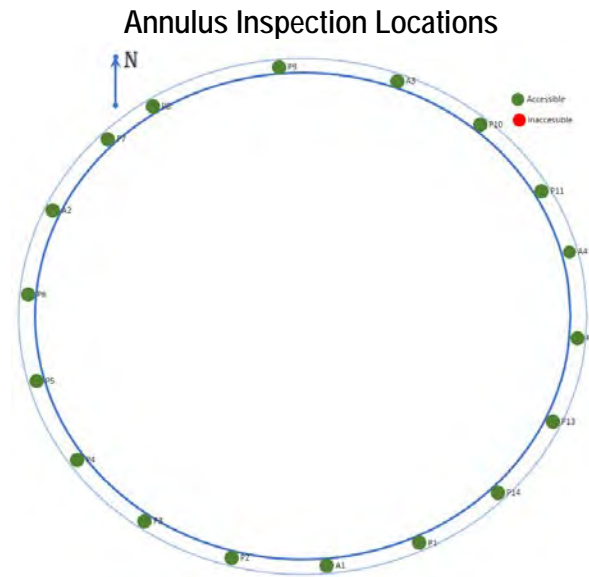
- Type IIIA Tank
- F Tank Farm

Ultrasonic Testing Inspections Results: No reportable thinning, pitting or stress corrosion cracking, or evidence of service-induced tank wall thinning on the primary tank wall. [SRNL-STI-2011-00495]

Conclusions following 2018 Inspections: No leakage, significant surface corrosion, or other anomalies were noted. The 2018 inspection confirmed the structural integrity and waste confinement capability of Tank 25.

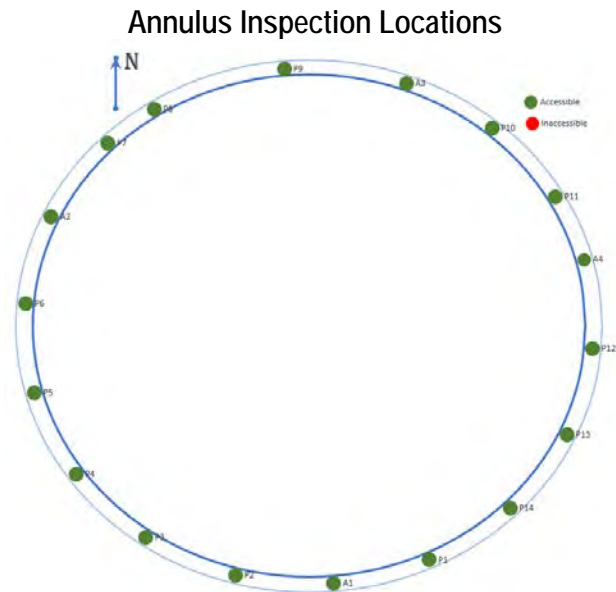
- Type IIIA Tank
- F Tank Farm

Ultrasonic Testing Inspections Results: No reportable thinning, pitting or stress corrosion cracking, or evidence of service-induced tank wall thinning on the primary tank wall. [SRNL-STI-2014-00328]

Conclusions following 2018 Inspections: No leakage, significant surface corrosion, or other anomalies were noted. The 2018 inspection confirmed the structural integrity and waste confinement capability of Tank 26.

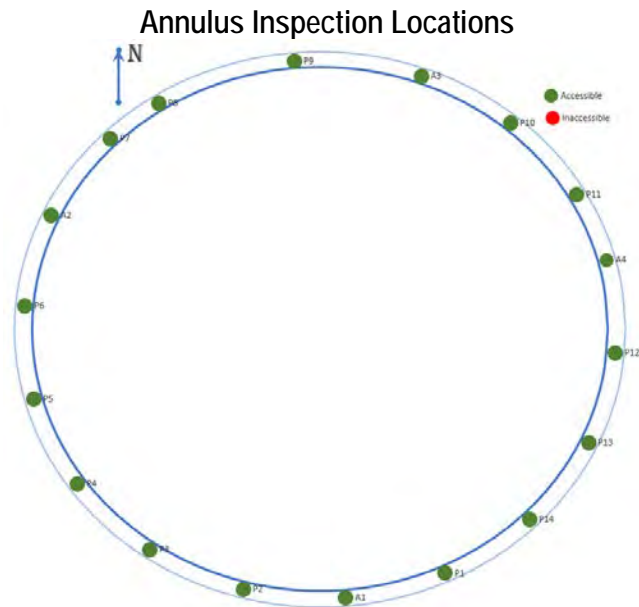
- Type IIIA Tank
- F Tank Farm

Ultrasonic Testing Inspections Results: No reportable thinning, pitting or stress corrosion cracking, or evidence of service-induced tank wall thinning on the primary tank wall. [SRNL-STI-2014-00328]

Conclusions following 2018 Inspections: No leakage, significant surface corrosion, or other anomalies were noted. The 2018 inspection confirmed the structural integrity and waste confinement capability of Tank 27.

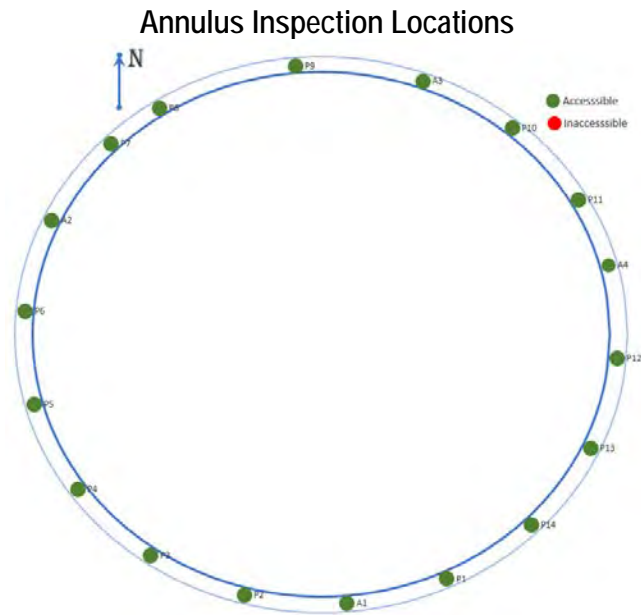
- Type IIIA Tank
- F Tank Farm

Ultrasonic Testing Inspections Results: No reportable thinning, pitting or stress corrosion cracking, or evidence of service-induced tank wall thinning on the primary tank wall. [SRNL-STI-2014-00328]

Conclusions following 2018 Inspections: No leakage, significant surface corrosion, or other anomalies were noted. The 2018 inspection confirmed the structural integrity and waste confinement capability of Tank 28.

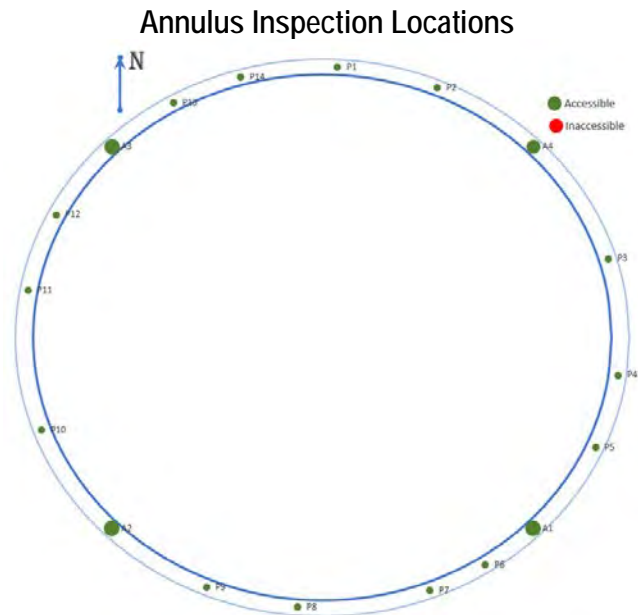
- Type III Tank
- H Tank Farm

Ultrasonic Testing Inspections Results: No reportable thinning, pitting or stress corrosion cracking, or evidence of service-induced tank wall thinning on the primary tank wall. Incipient pitting was detected in several locations, with the deepest pit measuring 0.063" deep. [SRNL-STI-2018-00457]

Conclusions following 2018 Inspections: No leakage, significant surface corrosion, or other anomalies were noted. The 2018 inspection confirmed the structural integrity and waste confinement capability of Tank 29.

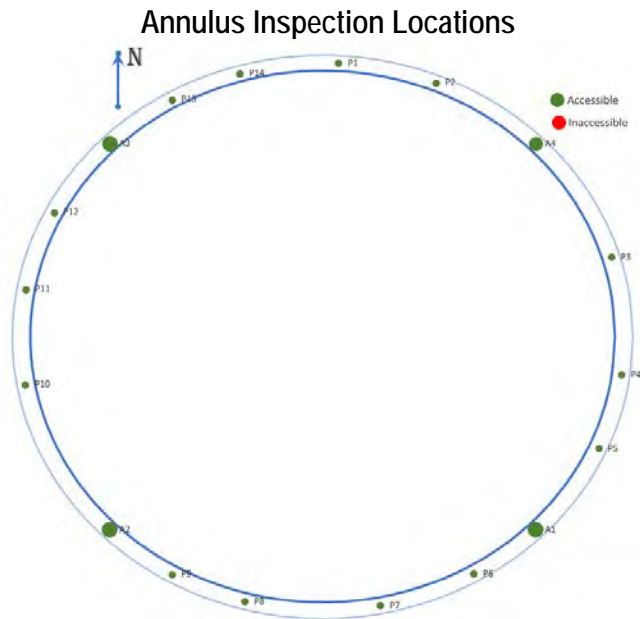
- Type III Tank
- H Tank Farm

Ultrasonic Testing Inspections Results: No reportable thinning, pitting or stress corrosion cracking, or evidence of service-induced tank wall thinning on the primary tank wall. Ten incipient pits were documented; however, all of the pits are consistent with pre-service pitting with no evidence of active corrosion or growth. [SRNL-STI-2018-00457]

Conclusions following 2018 Inspections: No leakage, significant surface corrosion, or other anomalies were noted. The 2018 inspection confirmed the structural integrity and waste confinement capability of Tank 30.

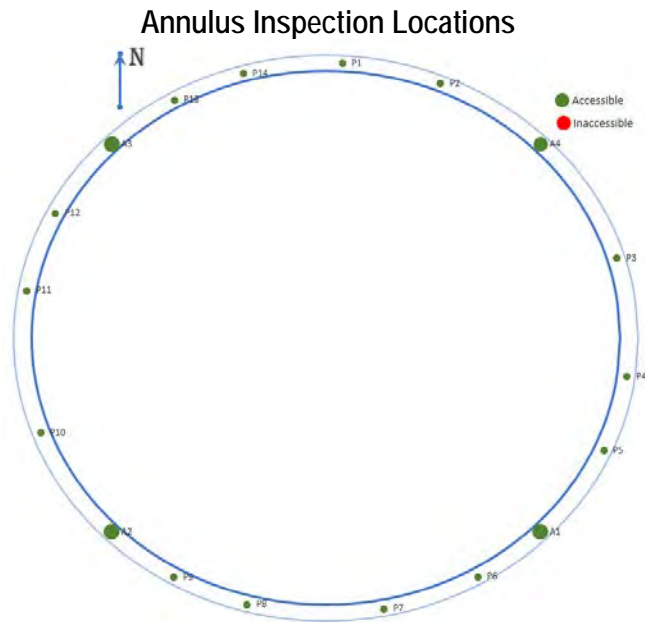
- Type III Tank
- H Tank Farm

Ultrasonic Testing Inspections Results: No reportable thinning, pitting or stress corrosion cracking, or evidence of service-induced tank wall thinning on the primary tank wall. Nine incipient pits were documented; however, all of the pits are consistent with pre-service pitting with no evidence of active corrosion or growth. [SRNL-STI-2018-00457]
