Subject: 2019 Annual Site Inspection and Monitoring Report for Uranium Mill Tailings  
Radiation Control Act Title II Disposal Sites

Enclosed are six copies of the *2019 Annual Inspection and Monitoring Report for Uranium Mill Tailings Radiation Control Act Title II Disposal Sites*. The report covers the annual inspections of the six Title II disposal sites managed by the U.S. Department of Energy Office of Legacy Management.

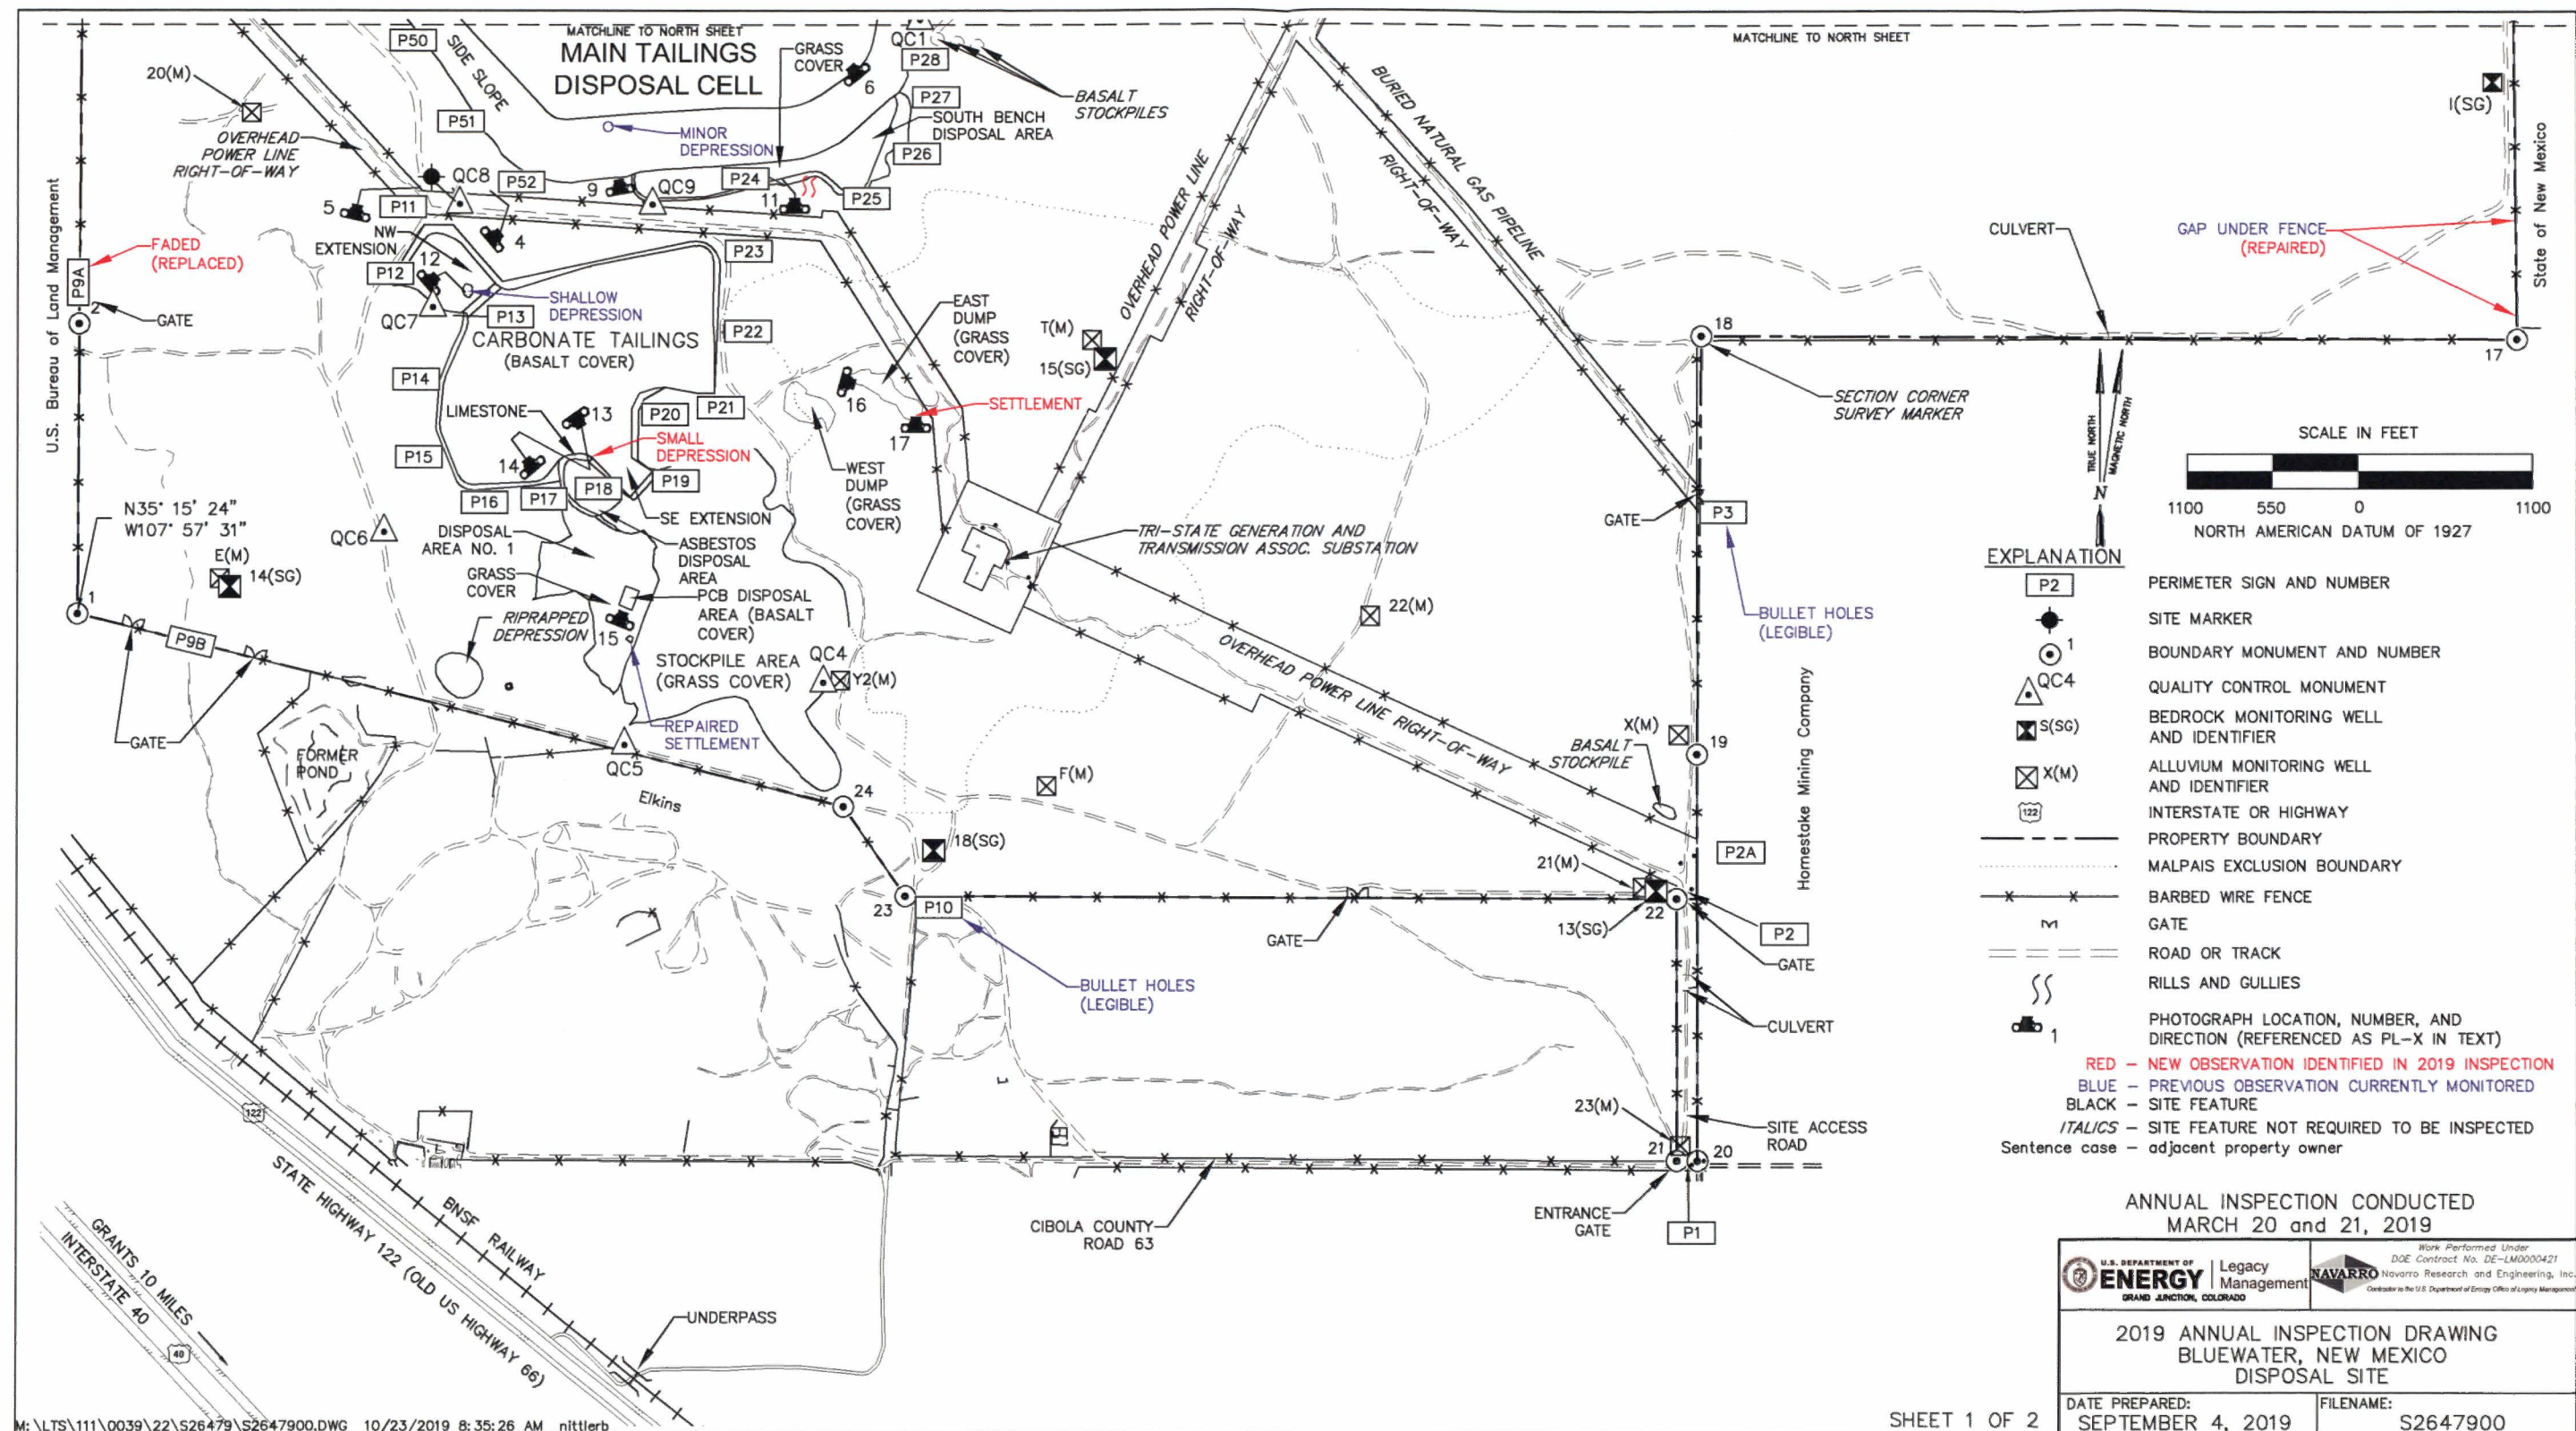
Figure 1-1. 2019 Annual Inspection Drawing for the Bluewater, New Mexico, Disposal Site (South Area)

Interior roads used to access LM assets consist of a dirt track covered at places with crushed basalt. The roads are susceptible to erosion and are repaired when they become impassable. Increased erosion continued to be observed on a road northwest of the main tailings disposal cell (PL-1 and PL-2). A gully intersecting the road at this location required maintenance in the past. Riprap previously was added to repair this section of the road; other repair options were evaluated in 2019. LM is proposing to repair the road in 2020 and to construct two armored low-level crossings to protect against future erosion. No other maintenance needs were identified.

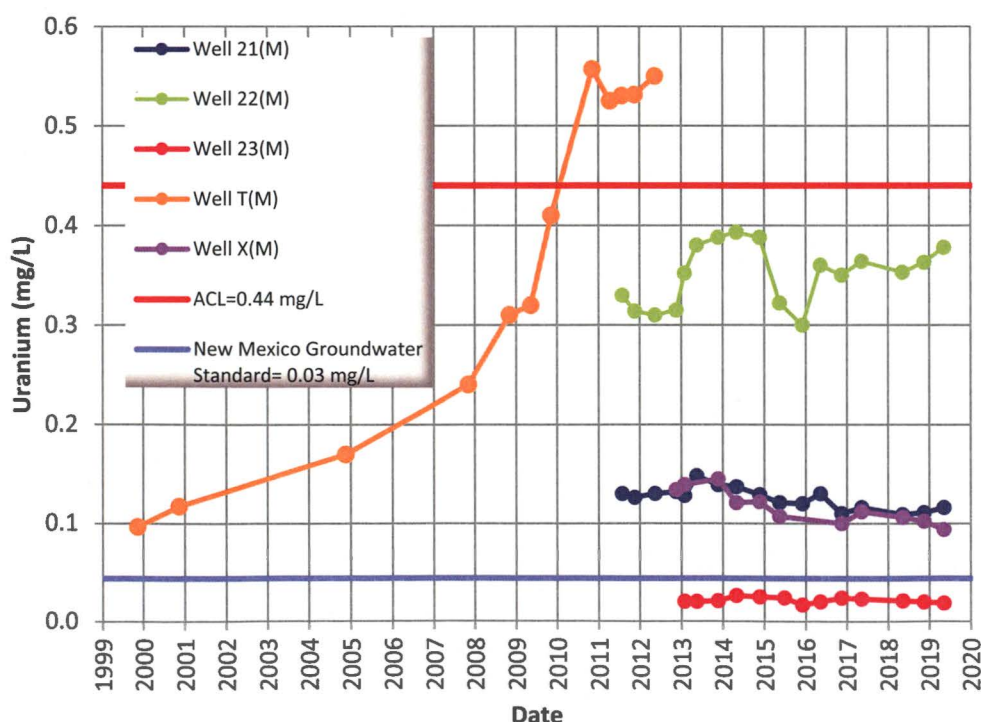
Figure 1-4. Uranium Concentrations in Alluvial Aquifer POC Well T(M) and Downgradient Wells at the Bluewater, New Mexico, Disposal Site

Figure 1-4 shows historical uranium concentrations measured at POC well T(M) and four additional wells screened in the alluvial aquifer. As this figure shows, the uranium concentration at well T(M) trended upward since LM began monitoring the well in 1999, and the November 2010 concentration of 0.557 mg/L was the first of five uranium concentrations that exceeded the ACL of 0.44 mg/L. LM notified NRC of the exceedance upon receiving the 2010 results from the laboratory. Well T(M) dried up following a May 2012 sampling because of drought and continuing declines of water levels in the well, and the well has since remained dry. Well 21(M) in the southeast corner of the site and POE well X(M) near the site's east boundary show a slightly decreasing trend in uranium concentration since 2013 (Figure 1-4). However, the elevated uranium concentrations at these two wells in recent years indicate that alluvial groundwater with uranium concentrations exceeding the New Mexico groundwater standard (0.03 mg/L) is discharging from the site toward the southeast. NRC requested that LM evaluate the performance of the main tailings disposal cell to assess whether seepage from the cell between 2005 and 2010 had increased to the extent it was responsible for the elevated uranium concentrations measured at POC well T(M) (see Figure 1-4) before it dried up. Based on an assessment of the disposal cell cover and an accompanying evaluation of the water balance for the main tailings disposal cell, the increase in uranium concentrations in well T(M) is not attributed to a compromise of the disposal cell's performance, and there was no surge of tailings-fluid seepage from the main tailings cell since it was closed (DOE 2014). It was further concluded that water levels in well T(M) decreased during the early 2000s below the contact between the alluvium and underlying Chinle Formation from 2008 to 2012. The simultaneous increase in uranium concentration was attributed to the declining water level and the influence of contaminated groundwater migrating through and interacting with weathered Chinle Formation materials, with the resulting fluids obscuring the water chemistry of groundwater in nearby portions of the alluvial aquifer that remained saturated (DOE 2014).

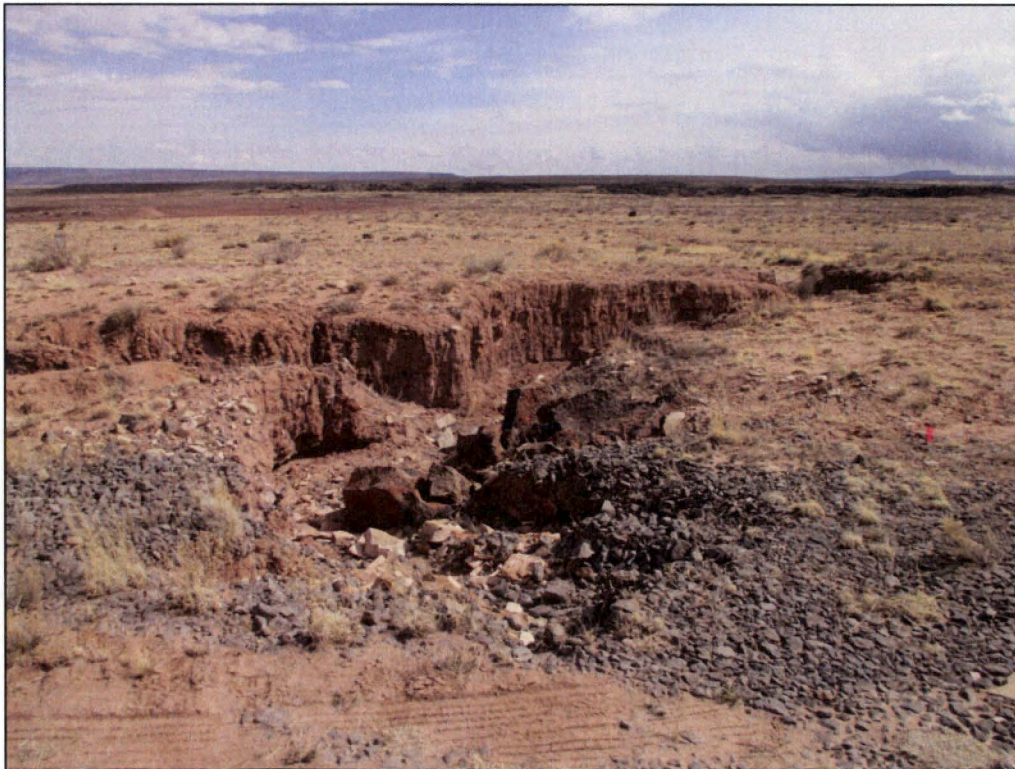
*PL-2. Erosion Near the Site Perimeter Road (North Area)*

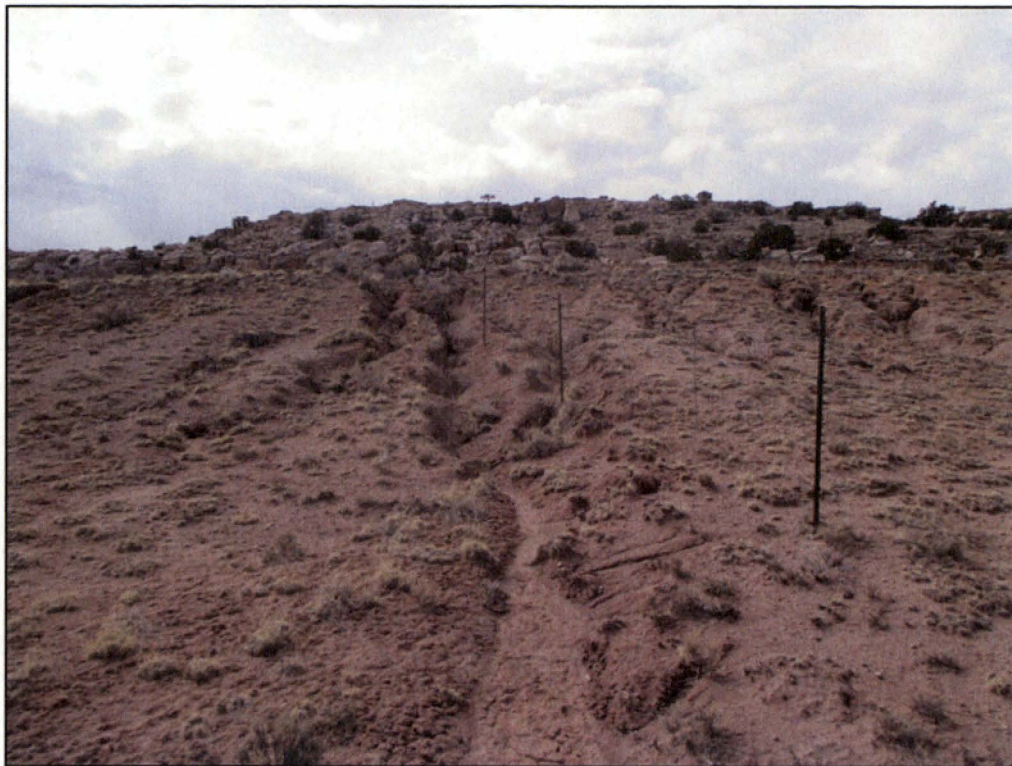
A four-strand barbed-wire fence encloses the site to facilitate land management by LM, which retains a local subcontractor to periodically check the site perimeter fence and remove trespassing cattle. Minor fence repairs are conducted as needed. Numerous sections of the fence are in remote areas of the site and cannot be observed from site access roads. The 2018 annual inspection report identified that fence repairs were needed in the northeast portion of the site where drifted sand had either accumulated or caused a large enough gap under the fence that cattle would be able to access the site. These gaps were repaired in 2019. During the 2019 inspection, damaged corner fence posts in the northeast portion of the site and several broken fence strands were identified as needing to be repaired. In April 2019 these areas of the perimeter fence were repaired including replacing two of the corner posts. Three additional corner posts were replaced in August 2019. An area of erosion was also identified northwest of the main tailings disposal cell where gullies from erosion parallel the perimeter fence line (PL-3). Inspectors will continue to monitor this area for damage to the perimeter fence.

*PL-3. Erosion Along the Perimeter Fence*

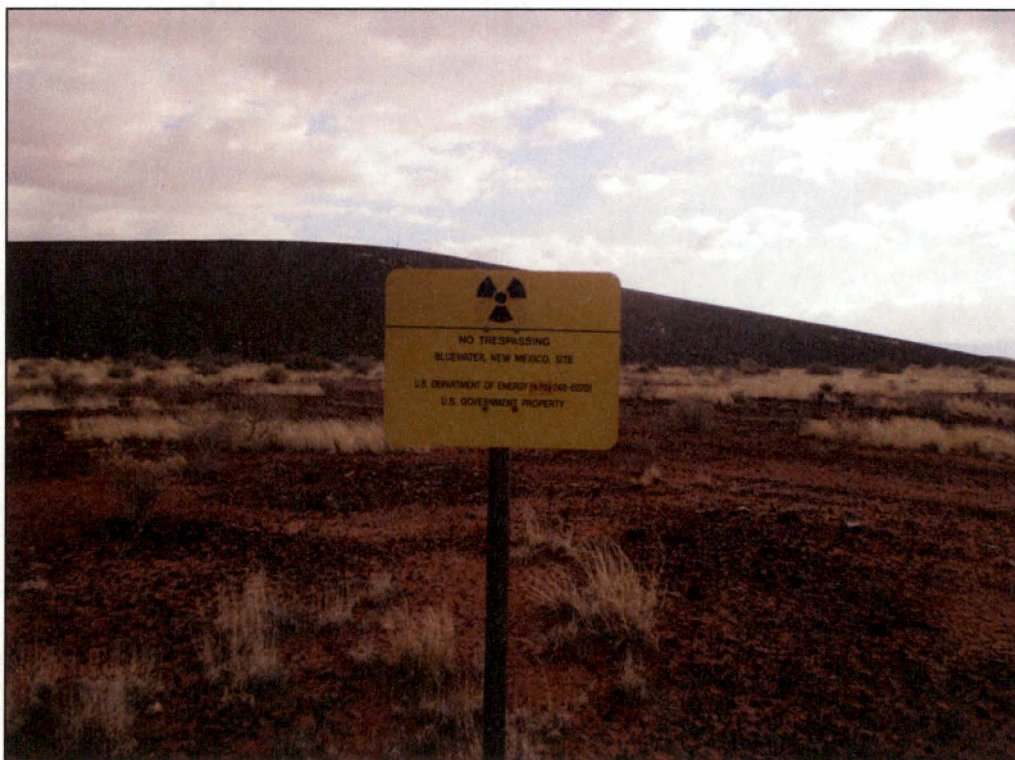
Fifty-five perimeter signs (warning and no-trespassing signs) are mounted on steel posts along the site boundary and around the main and carbonate tailings disposal cells (PL-4). Perimeter signs P3 and P10 have bullet hole damage but are legible. Perimeter sign P9A was faded and replaced following the inspection. No other maintenance needs were identified.

*PL-4. Perimeter Sign P52 and Southwest Corner of the Main Tailings Disposal Cell*

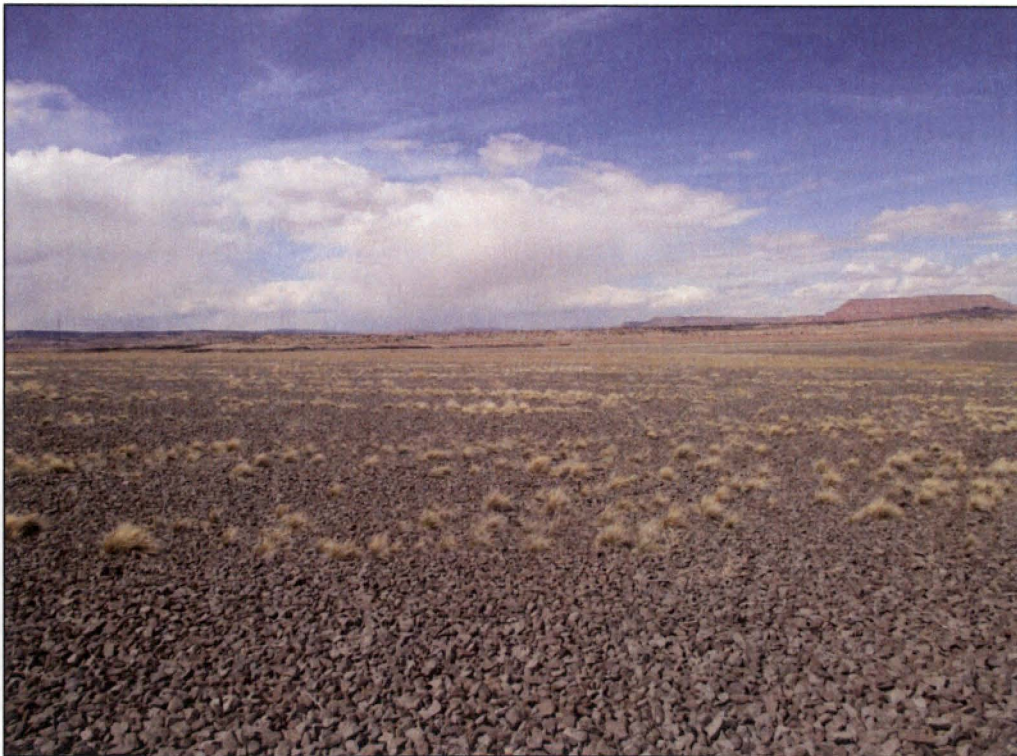
Plant encroachment (by annual weeds, perennial grasses and forbs, and scattered perennial shrubs) continues on the main tailings disposal cell top and side slopes (PL-6). Siberian elm saplings on the top slope are managed to prevent the establishment of trees that could damage the main tailings disposal cell cover materials; none were observed during the inspection.

*PL-6. Top Slope of the Main Tailings Disposal Cell*

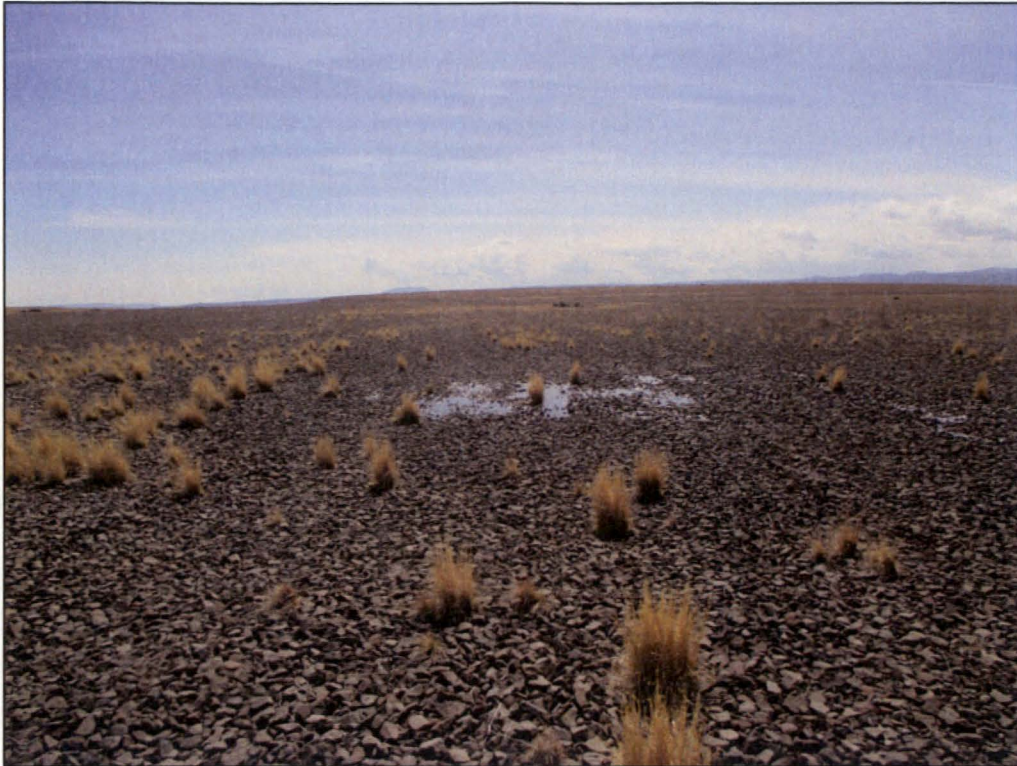
Ponds often develop in the depressions after rainfall and occasionally coalesce into one large pond after a series of rainstorms. The area of depressions is monitored continuously using a remotely operated webcam to detect the presence of ponded water. The top slope had minor ponding at the time of the inspection (PL-7). No algae was present during the inspection even though algae was noted in previous reports.

*PL-7. Ponding on the Top Slope of the Main Tailings Disposal Cell*

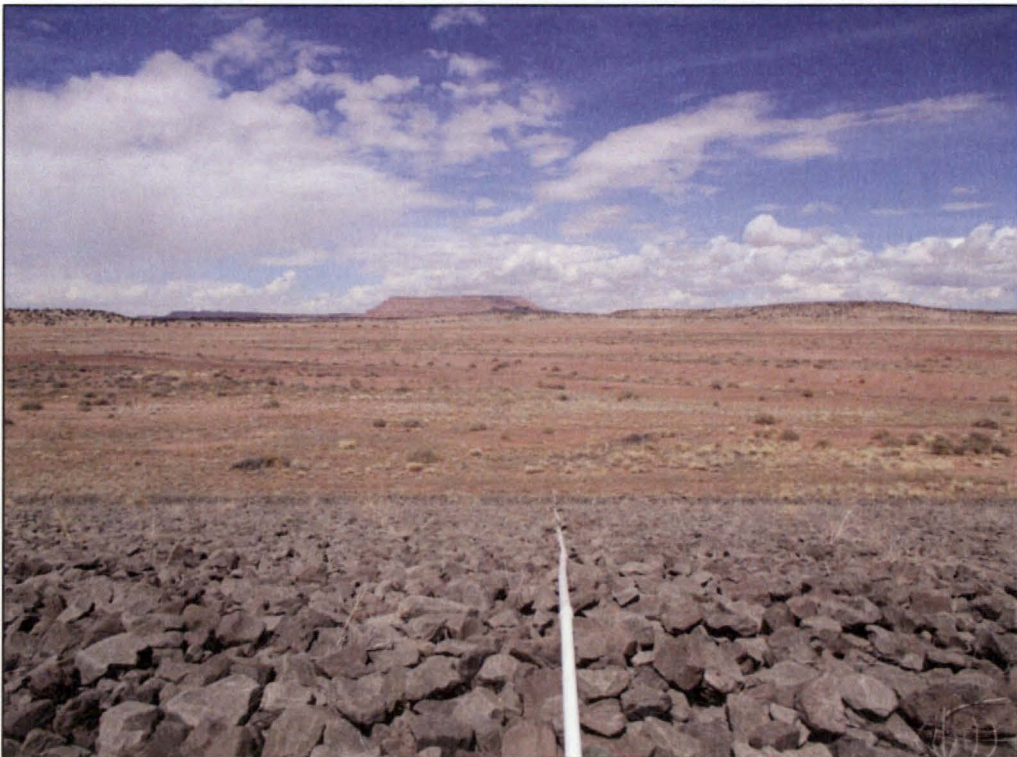
A 2-inch-diameter siphon was installed in fall 2015 to dewater as much of the ponded water as possible. The siphon is manually started when the webcam indicates that a large pond has developed. The intent is to avoid potential erosion of the main tailings disposal cell cover materials if the pond surface reaches an elevation high enough to spill over the north side slope of the disposal cell. Water would start to spill at the lowest point along the north edge of the top slope, and that could initiate erosion at that location. In 2018, LM developed a conceptual design to repair the depressions, regrade the north portion of the top slope, and construct a spillway on the north side slope to ensure positive drainage. LM will finalize the conceptual design through an interagency agreement with USACE.

*PL-8. Siphon on North Side Slope of the Main Tailings Disposal Cell*

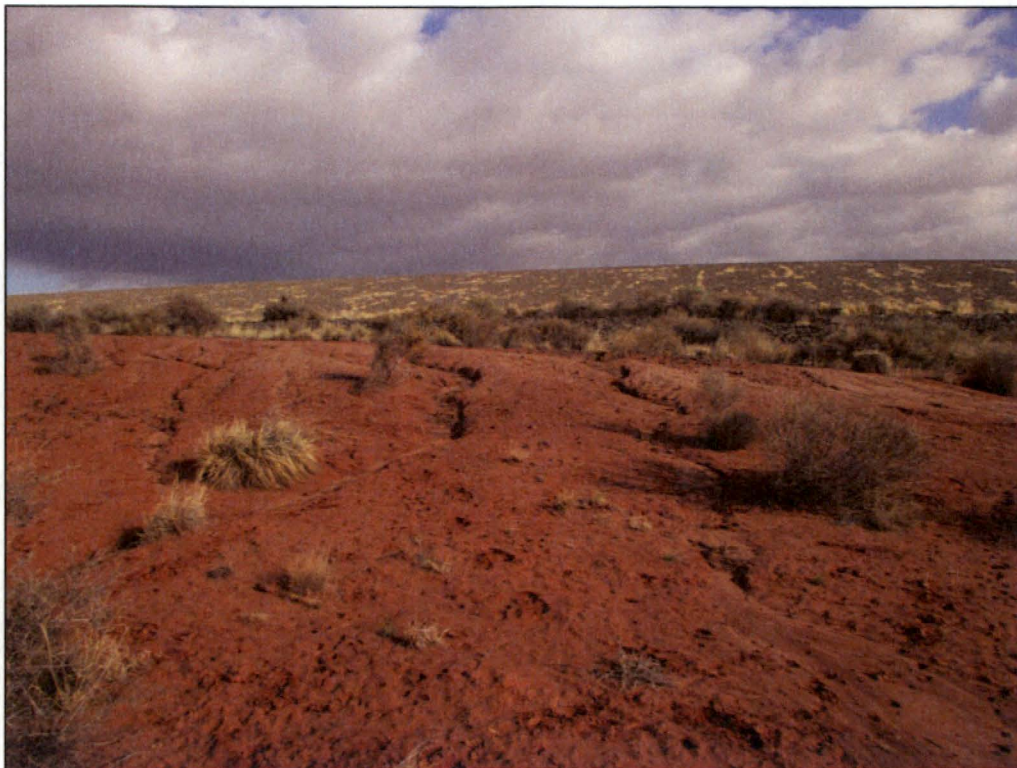
*PL-11. Rills at the Base of the South Bench Disposal Area*

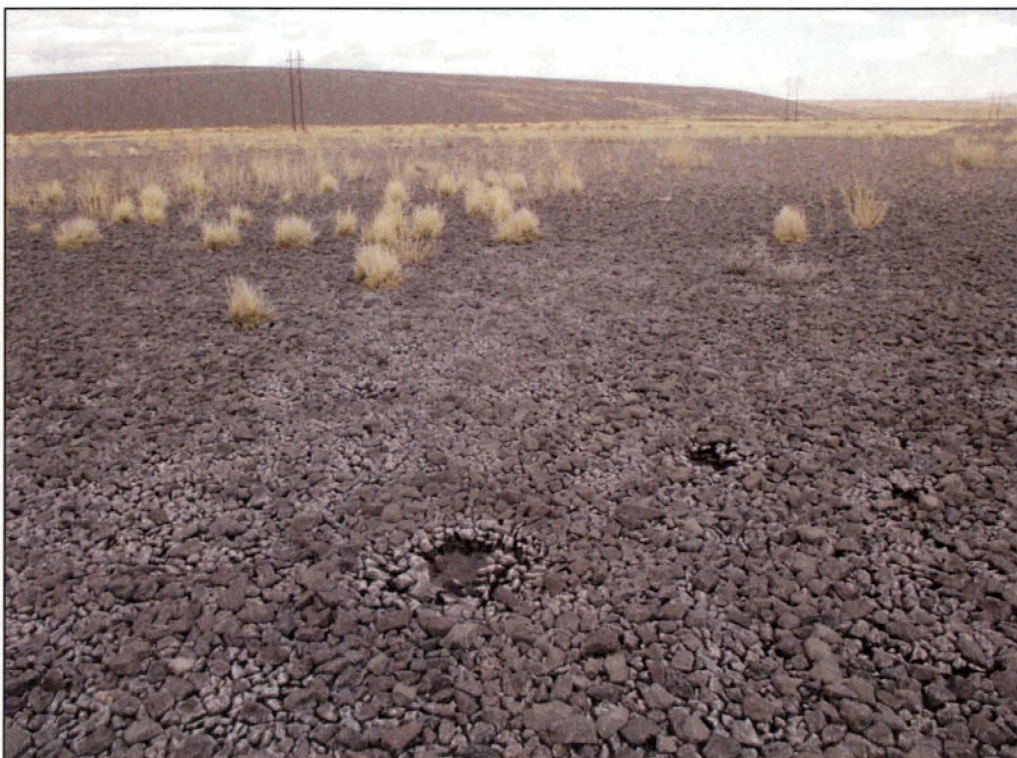
*PL-12. Minor Ponding in the Shallow Depression on the Northwest Extension of the Carbonate Tailings Disposal Cell*

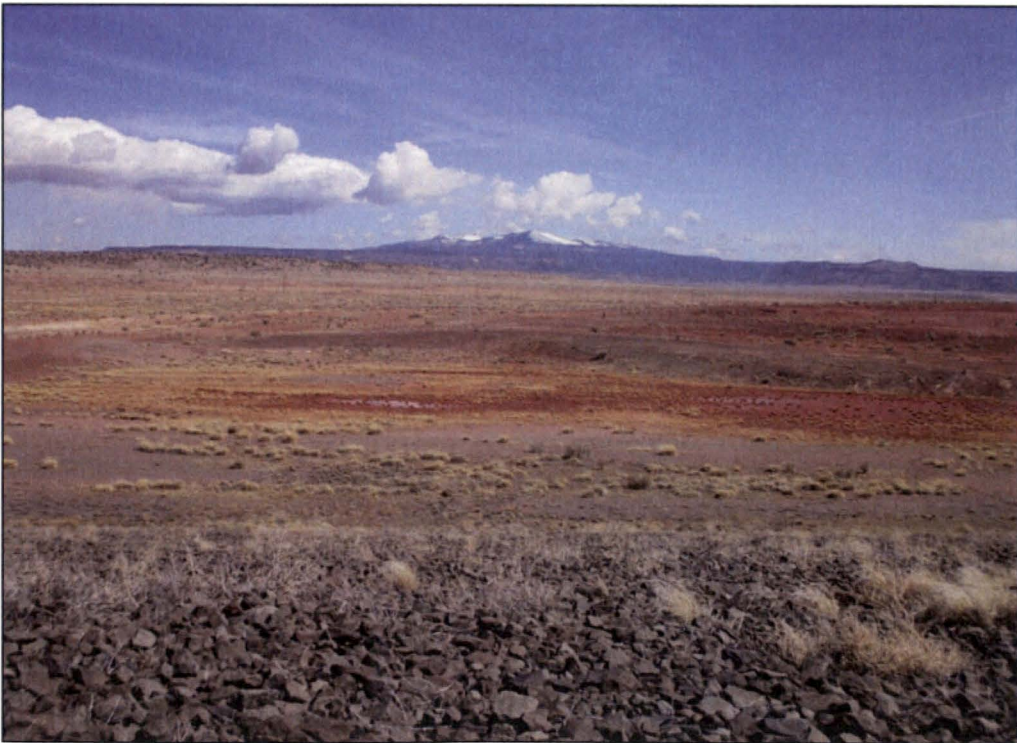
*PL-18. East Side Slope of the Main Tailings Disposal Cell and Ephemeral Ponds (Wet)*

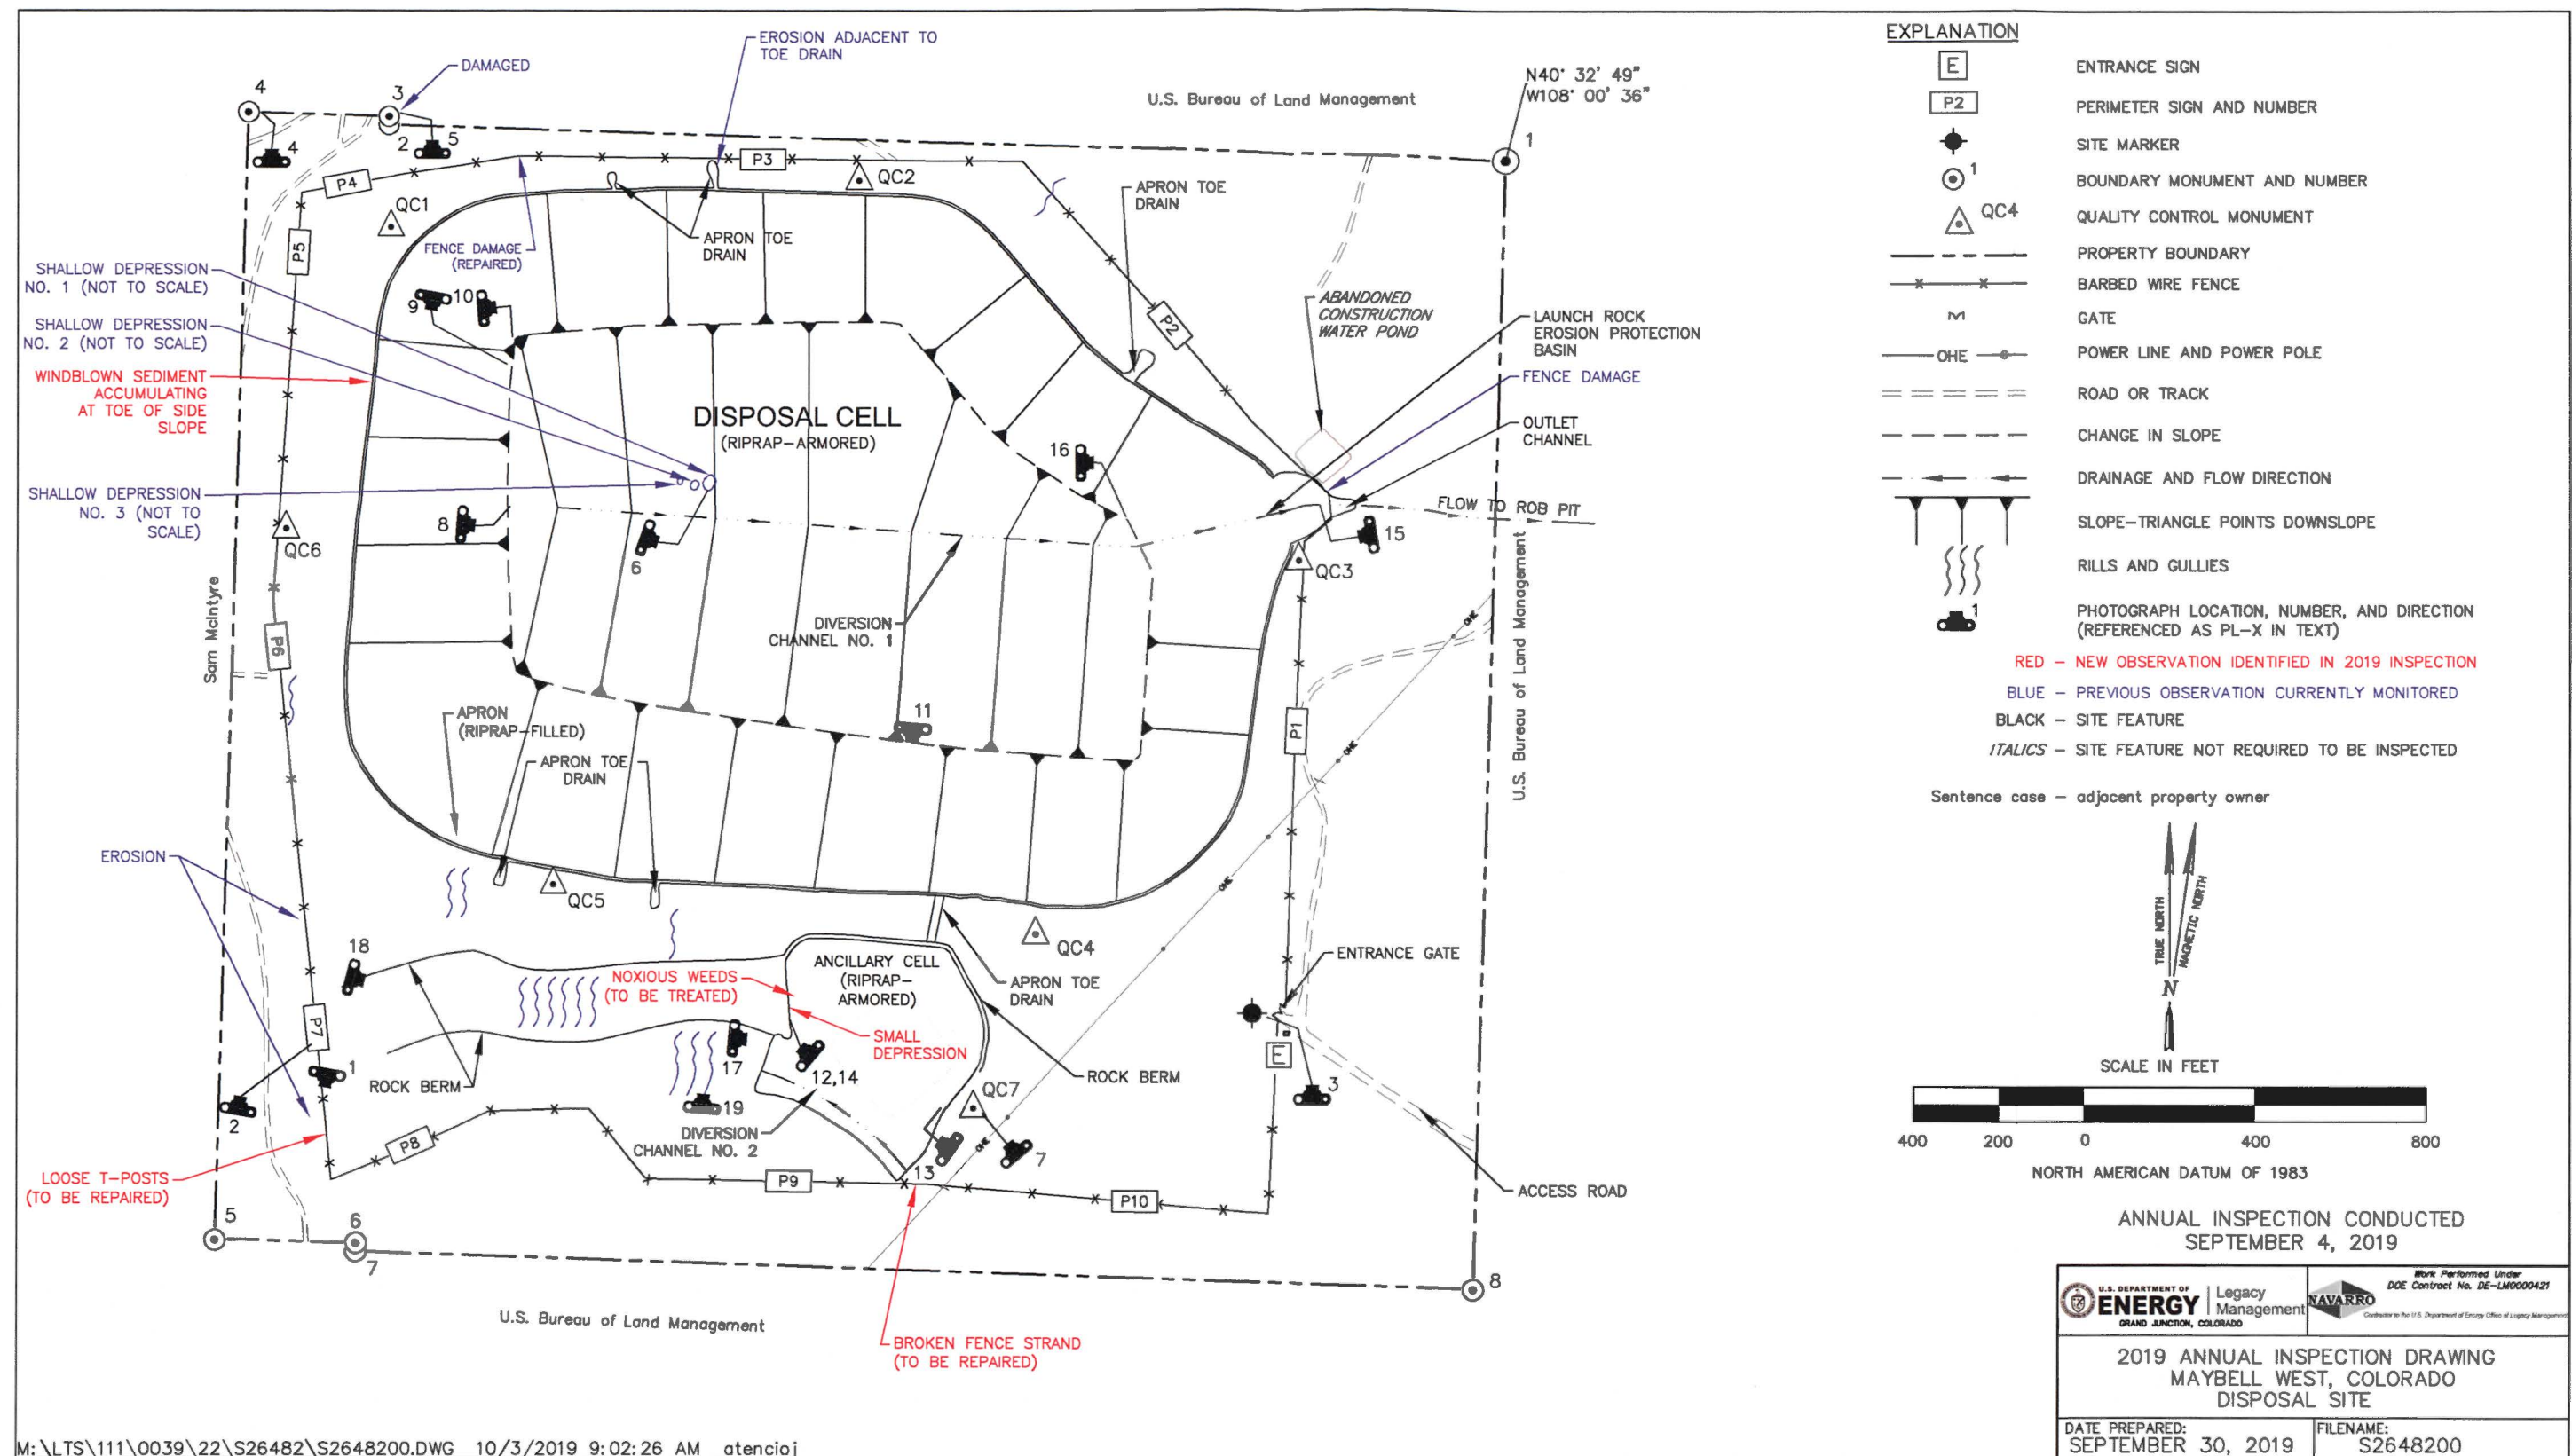
Figure 4-1. 2019 Annual Inspection Drawing for the Maybell West, Colorado, Disposal Site

Figure 4-1 shows the locations of site features in black, including site surveillance features and inspection areas. Site features that are present but not required to be inspected are shown in italic font. Observations from previous inspections that are currently monitored are shown in blue text, and new observations identified in the 2019 annual inspection are shown in red. Inspection results and recommended maintenance activities associated with site surveillance features are included in the following subsections. Photographs to support specific observations are identified in the text and in Figure 4-1 by photograph location (PL) numbers. The photographs and photograph log are presented in Section 4.9.

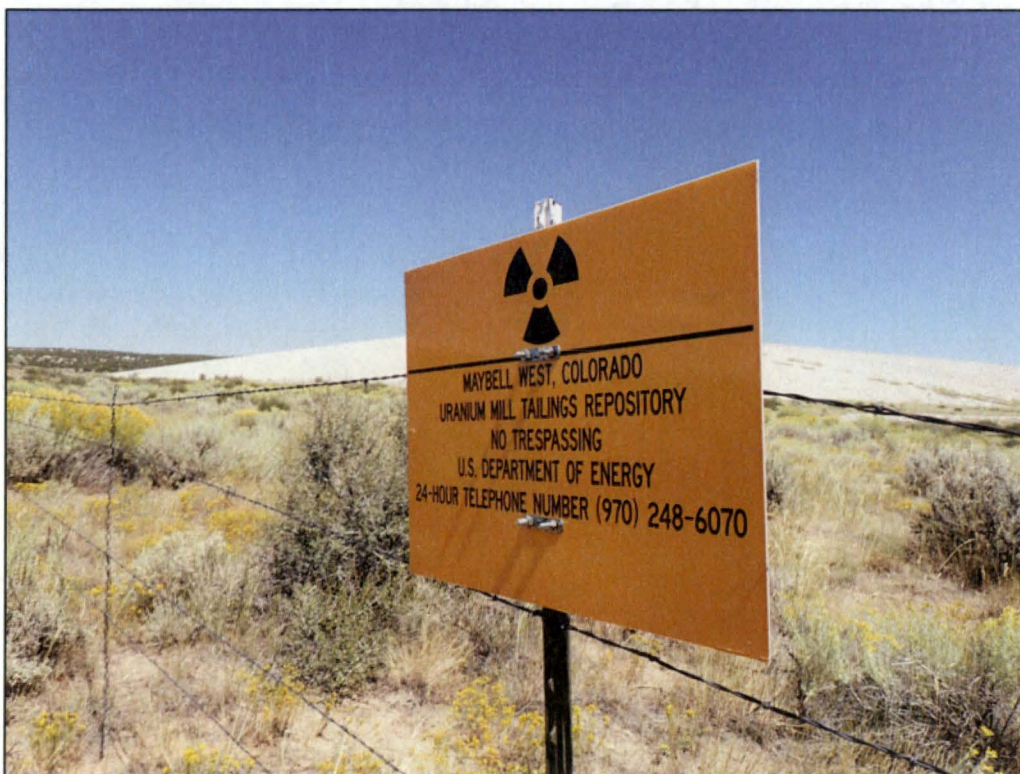
*PL-2. Perimeter Sign P7*

A four-strand barbed-wire fence encloses the disposal cell, the ancillary cell, the drainage structures, and much of the site. The fence primarily serves to prevent livestock trespass, because the site is surrounded by open rangeland used for cattle grazing. Minor damage to the perimeter fence occurs periodically because the site is in wintering grounds frequented by big game animals (primarily pronghorn, deer, and elk). Fence damage identified during the 2019 annual inspection consisted of one location where a strand was broken and one location where two fence posts were loose. Minor erosion continues to be observed between perimeter signs P6 and P8, resulting in loose T-posts (PL-1). Observation of this erosion will continue. Repairs to the loose T-posts and broken strand will be completed before the 2020 annual inspection.

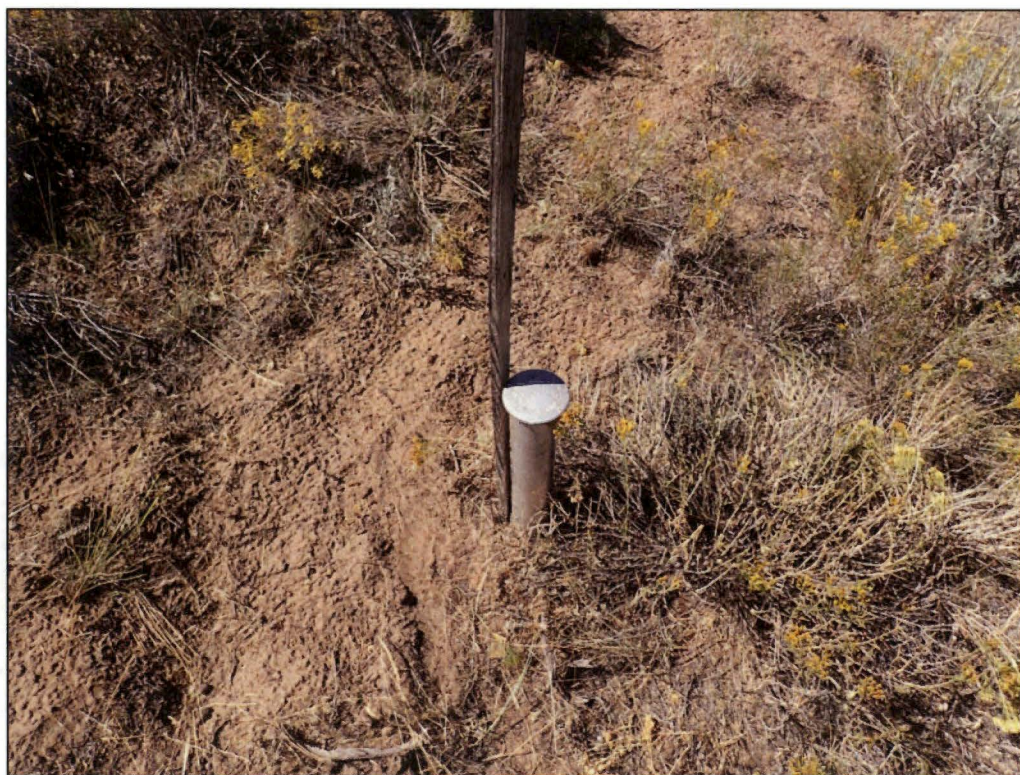
*PL-4. Boundary Monument BM-4*

Eight boundary monuments are on the site boundary outside the fenced area (PL-4). Four of the monuments are at the property corners, and the other four define an approximate 20-foot offset along the north and south boundaries where the private land that LM acquired in fee adjoins the BLM withdrawal area on the western portion of the site. Boundary monuments BM-3 and BM-6 (capped pieces of rebar) define the two 20-foot offsets. Boundary monument BM-3 (PL-5) was first observed to be bent during the 2017 annual inspection; since then attempts to straighten the monument were not successful, and repair or replacement options are being evaluated. No other maintenance needs were identified.

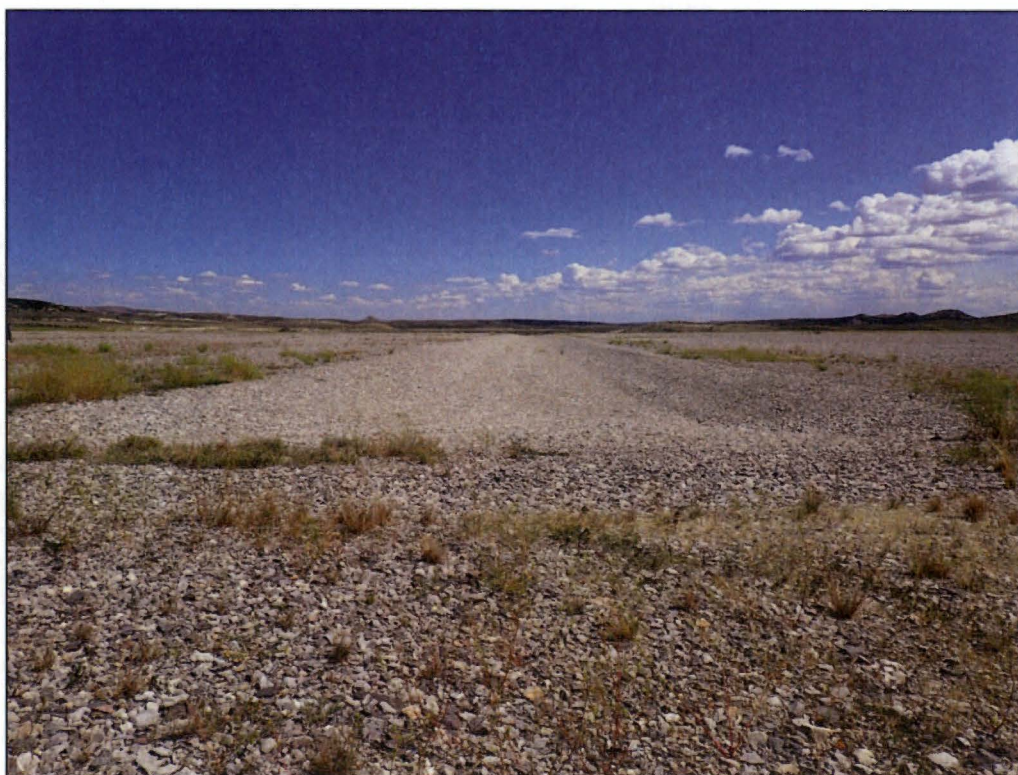
While various species of plants were present on the top slope of the disposal cell, no deep-rooted vegetation was observed (PL-8). If encroachment of deep-rooted vegetation is observed, an evaluation will be conducted as required by the LTSP to determine if any action is necessary. Noxious weeds are controlled in accordance with the LTSP.

*PL-8. Vegetation on Disposal Cell Top Slope and Diversion Channel No. 1*

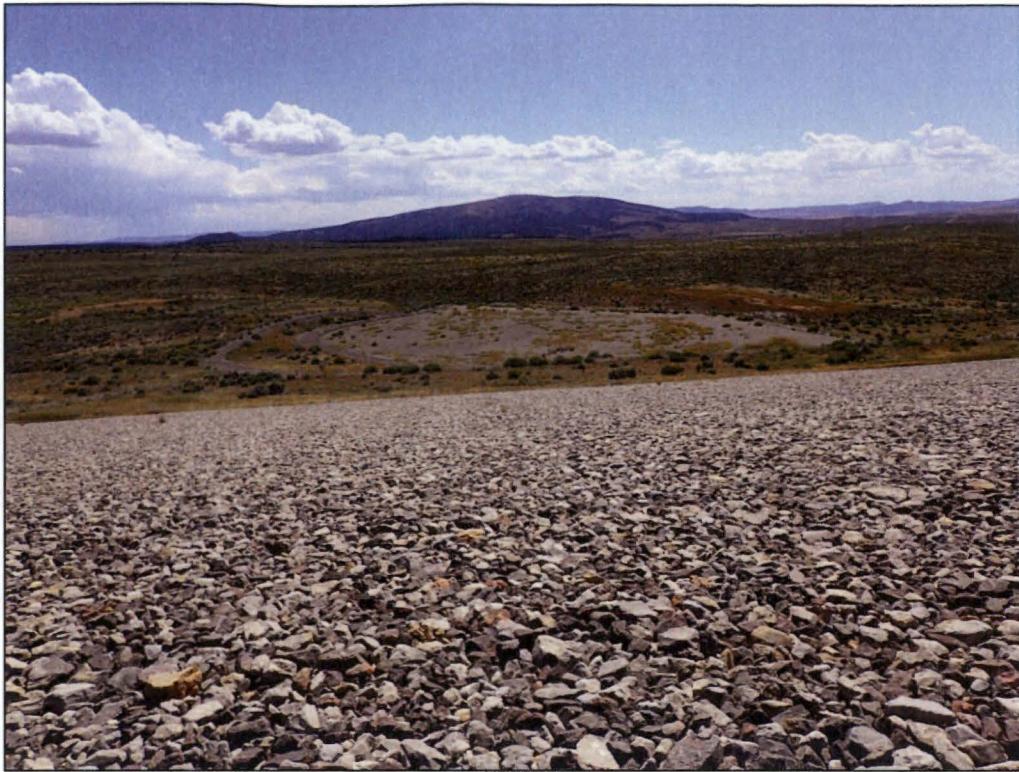
*PL-11. Ancillary Cell*

The ancillary cell (PL-11) was constructed to contain waste materials associated with the reclaimed evaporation pond area. It slopes gently toward the southwest. A rock berm wraps around its eastern and northern sides to protect it from surface water runoff. A small depression observed on the west end of the ancillary cell top slope is not impacting the performance of the cell, but it will continue to be monitored (PL-12). Various species of plants were present on the top slope of the ancillary cell (PL-13). Noxious weeds were also observed on the ancillary cell and will be controlled before the 2020 annual inspection (PL-14).

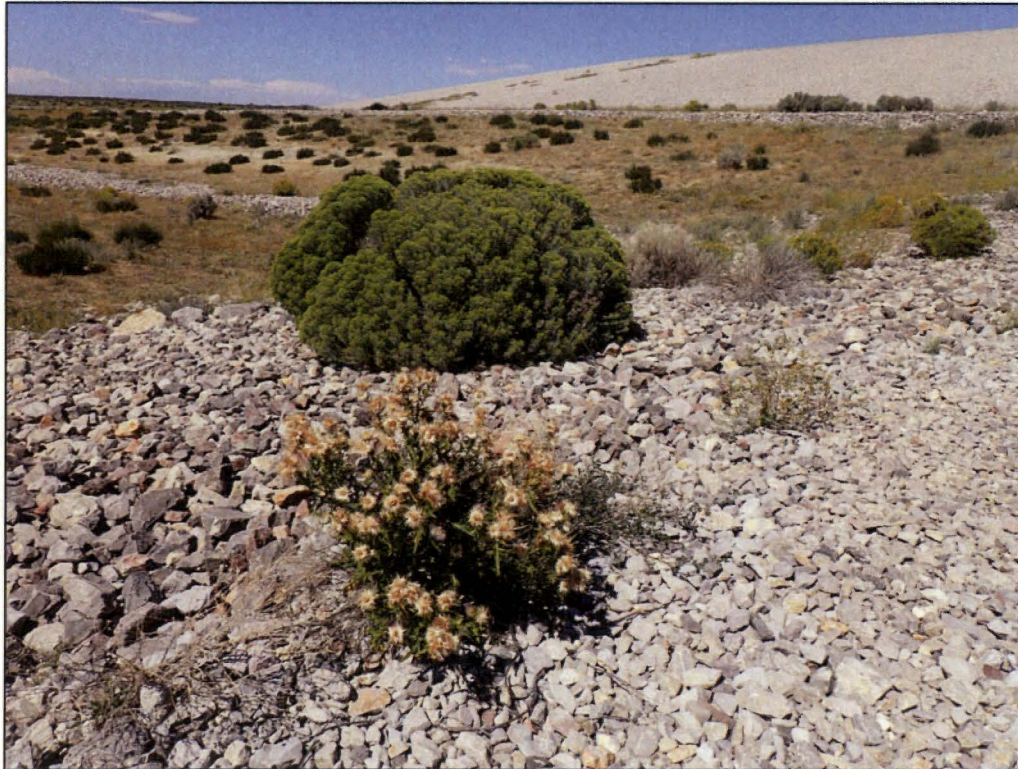
*PL-14. Noxious Weed and Rubber Rabbitbrush on Ancillary Cell*

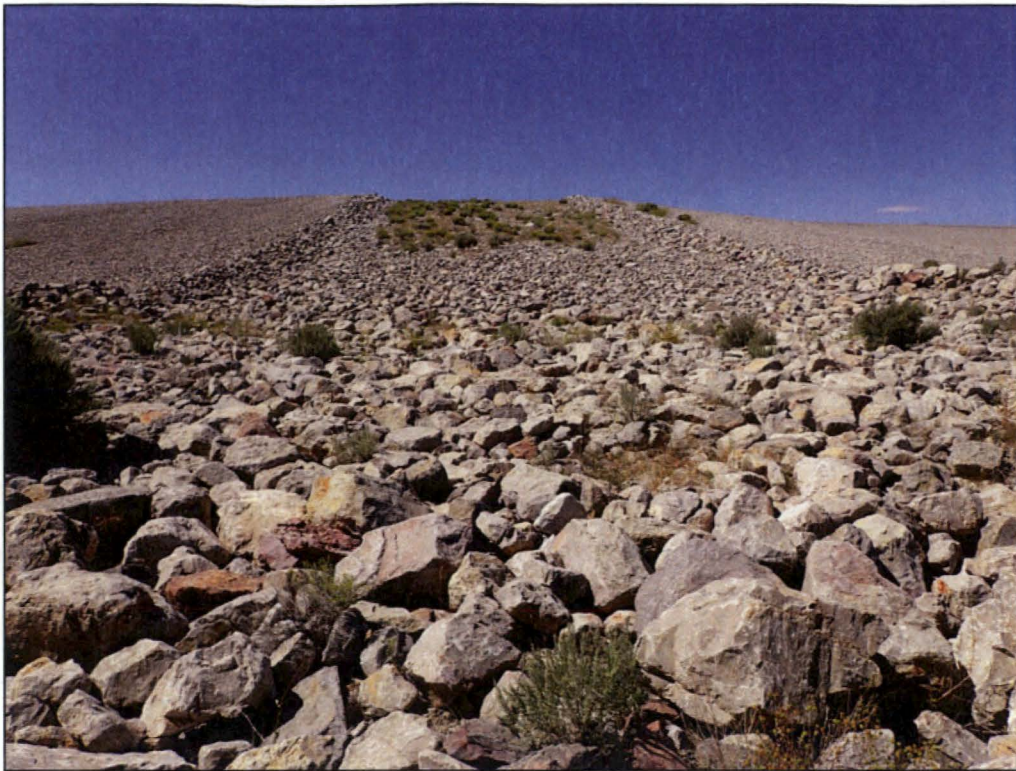
*PL-15. Launch Rock Erosion Protection Basin on Disposal Cell East Side Slope*
