Subject: 2019 Annual Site Inspection and Monitoring Report for Uranium Mill Tailings  
Radiation Control Act Title II Disposal Sites

Enclosed are six copies of the *2019 Annual Inspection and Monitoring Report for Uranium Mill Tailings Radiation Control Act Title II Disposal Sites*. The report covers the annual inspections of the six Title II disposal sites managed by the U.S. Department of Energy Office of Legacy Management.

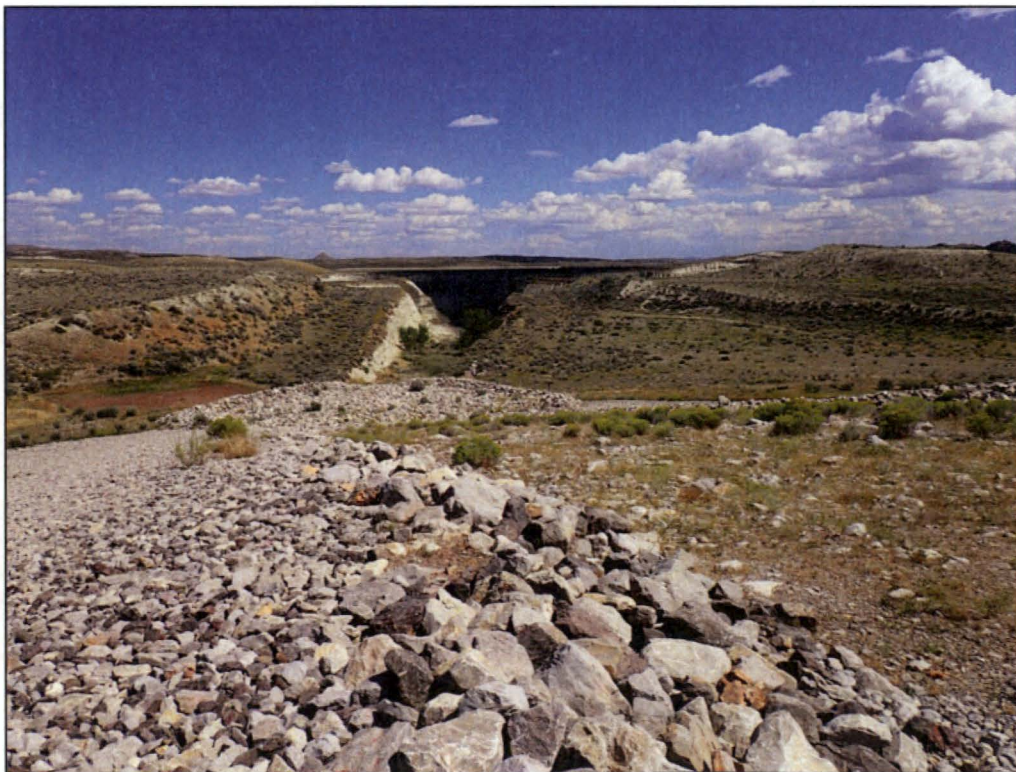
*PL-16. Launch Rock Erosion Protection Basin on Disposal Cell East Side Slope; Rob Pit in Background*

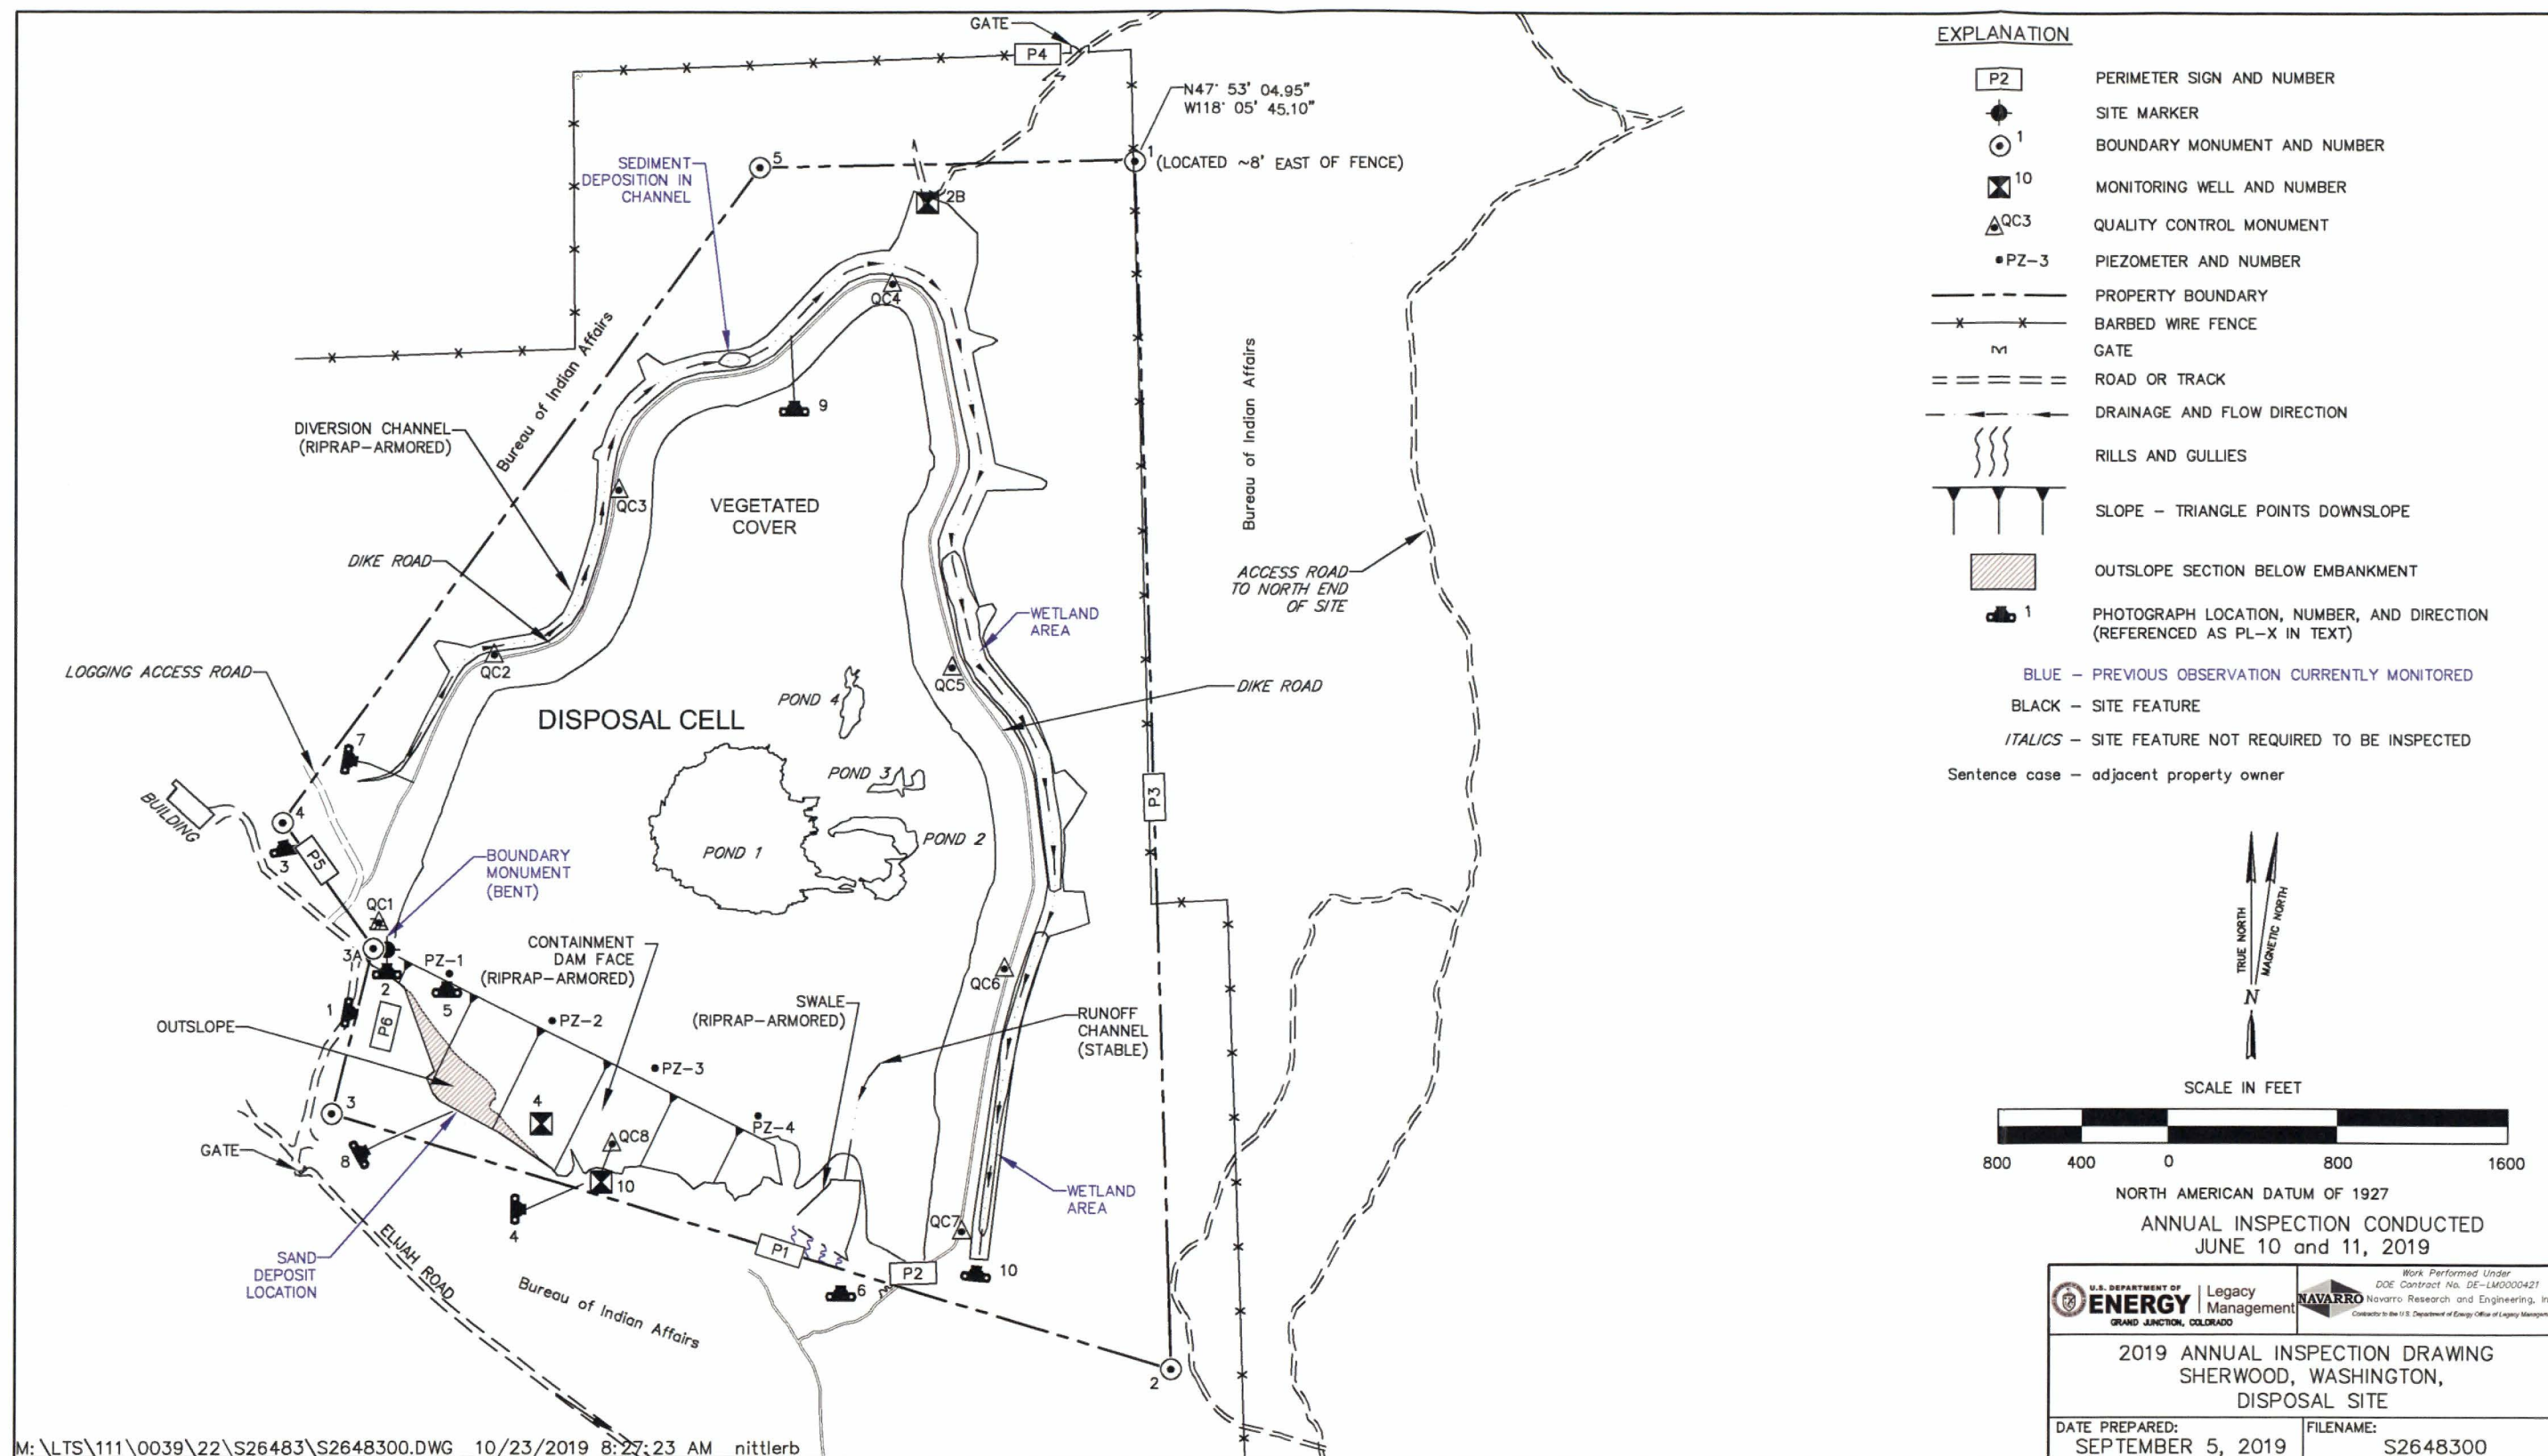
Figure 5-1. 2019 Annual Inspection Drawing for the Sherwood, Washington, Disposal Site

Figure 5-1 shows the locations of site features in black, including site surveillance features and inspection areas. Site features that are present but not required to be inspected are shown in italic font. Observations from previous inspections that are currently monitored are shown in blue text. There were no new observations in 2019. Inspection results and recommended maintenance activities associated with site surveillance features are included in the following subsections. Photographs to support specific observations are identified in the text and in Figure 5-1 by photograph location (PL) numbers. The photographs and photograph log are presented in Section 5.9.

During the 2016 annual inspection, one location at the base of the rock-covered containment dam face was found to have a deposit of sand that had washed out from underneath the rock cover as evidenced by a shallow rock-filled gully feature upgradient of the deposit (Figure 5-1). A subsequent follow-up inspection and evaluation identified that the sandy material was the same as natural undisturbed material nearby. During reclamation, this area of the mill site was used as a source for fill material used to contour the area below the toe of the containment dam. Review of original reclamation and as-built drawings showed that the toe of the containment dam is upslope from the area of erosion, which was confirmed during the follow-up investigations. Therefore, it was concluded that the washout area is in a portion of the dam defined as the outslope in the construction completion report and does not impact the containment dam (DOE 2018b).

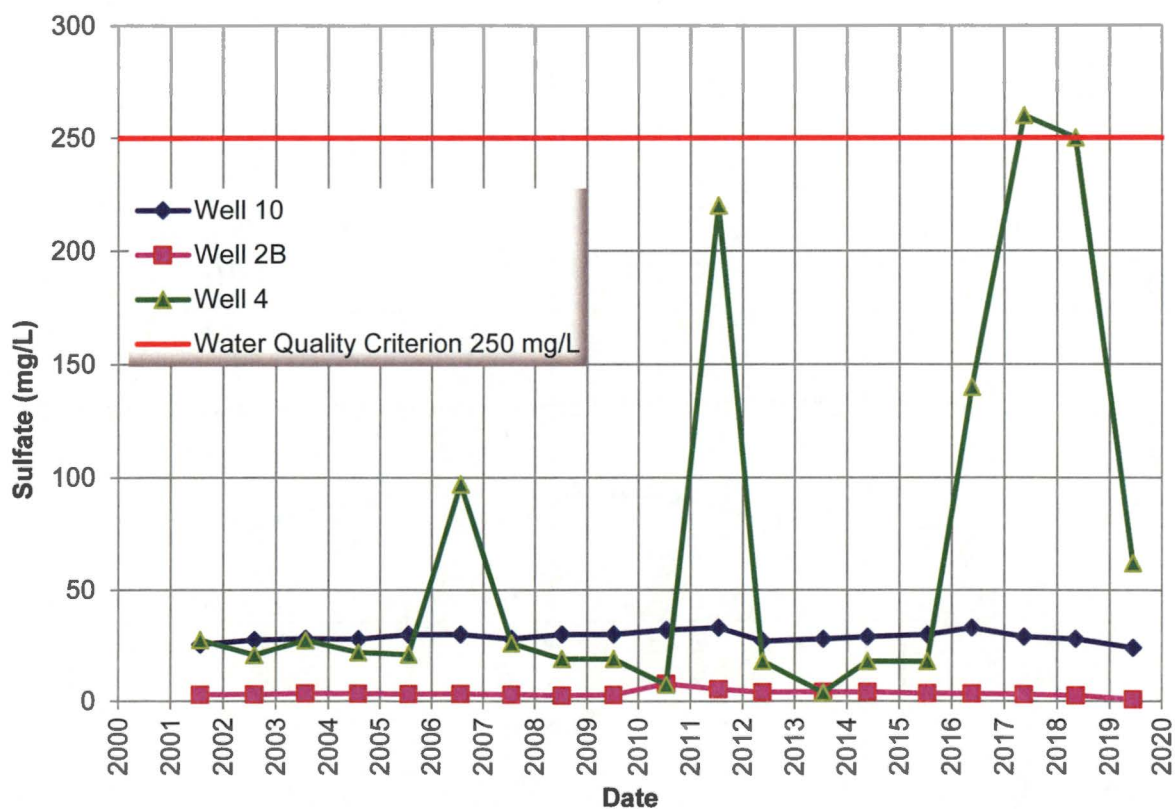
Figure 5-4. Sulfate Concentrations at the Sherwood, Washington, Disposal Site

A borehole camera was used in 2018 to evaluate conditions in the three monitoring wells, specifically to determine if any well issues could have caused the sulfate exceedance in monitoring well 4. The video showed that the inlet of the dedicated bladder pump used for low-flow sampling was buried in debris at the bottom of well 4. The well was redeveloped during the 2019 sampling event and the debris was removed; samples were collected before and after redevelopment with similar results for sulfate (54 and 62 mg/L, respectively). After sampling, a datalogger was placed in the well to collect periodic water level, temperature, and conductivity data until the 2020 sampling event. If the data indicate a correlation between higher water levels and increased conductivity, LM may propose to cease the best management practice annual water sampling as discussed in Kreie 2018.

Figure 5-3 and Figure 5-4 show concentrations of chloride and sulfate, respectively, in the three monitoring wells since 2001. Occurrences of slightly elevated chloride levels in well 4 correspond with the higher sulfate levels measured at the same location. Water elevations for each of the monitoring wells are shown in Figure 5-5 and Figure 5-6. Groundwater occurs in two hydrostratigraphic units: (1) the alluvium that lies on top of the bedrock surface and (2) the conductive bedrock, including weathered bedrock in the upper portion and unweathered or competent bedrock below. Monitoring well 10 is completed in the alluvium, and wells 2B and 4 are completed in the bedrock.

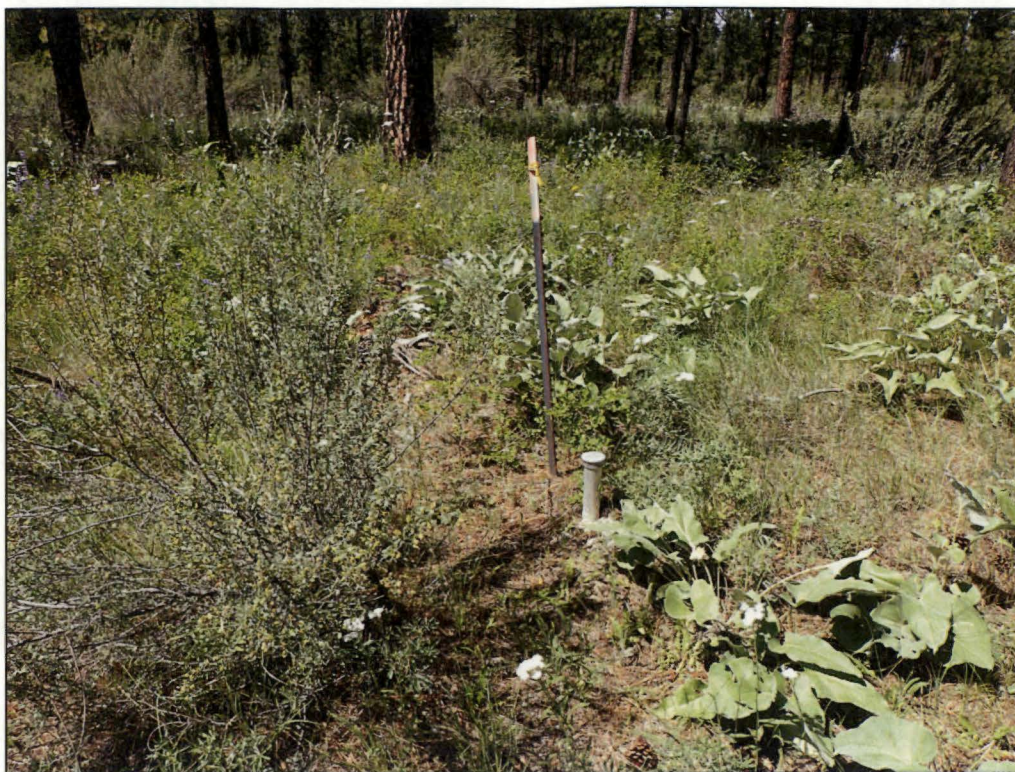
*PL-3. Boundary Monument BM-4*

Six boundary monuments set in concrete define the site boundary. Because surrounding vegetation has made it difficult to locate some of the monuments, metal T-posts were installed at each monument location (PL-3). All boundary monuments were inspected. No maintenance needs were identified.

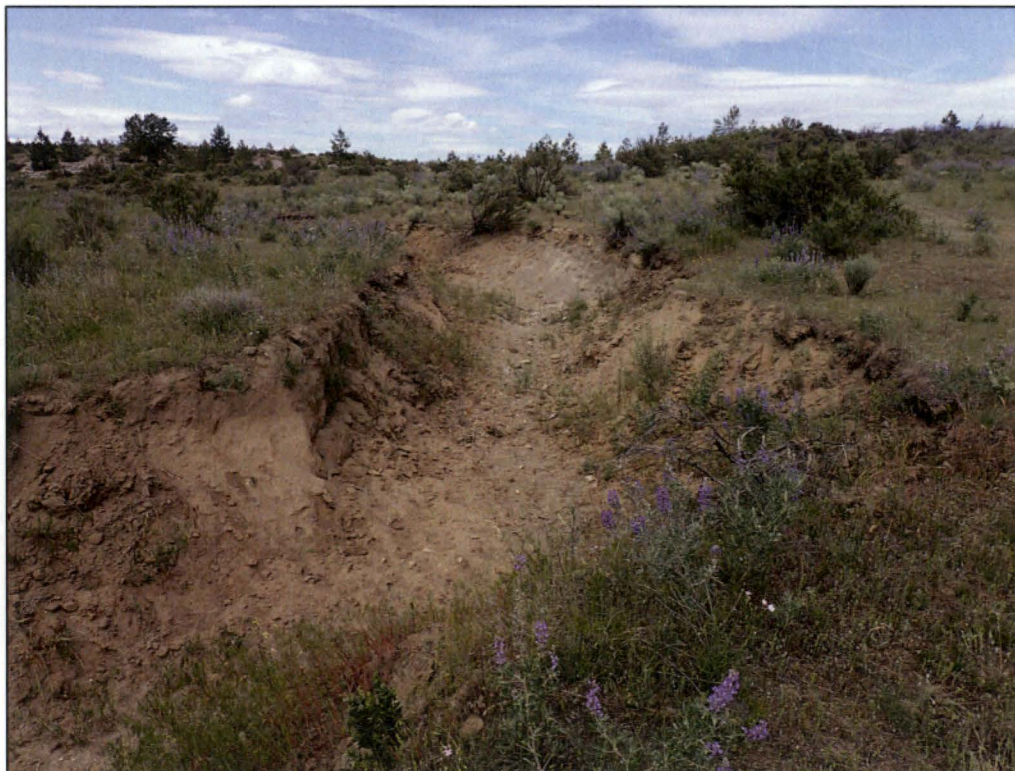
A gully just offsite was first observed in 2009 downgradient of the riprap-armored swale near perimeter sign P1. The gully is photographed periodically to monitor its development (PL-6). Although erosion continues to occur because of site drainage effects, the gully appears to be stabilizing as its grade reaches equilibrium with surrounding topography. The gully is not impacting site features or access but will continue to be monitored. No maintenance needs were identified.

*PL-6. Gully Downgradient of Riprap-Armored Swale (Near Perimeter Sign P1)*

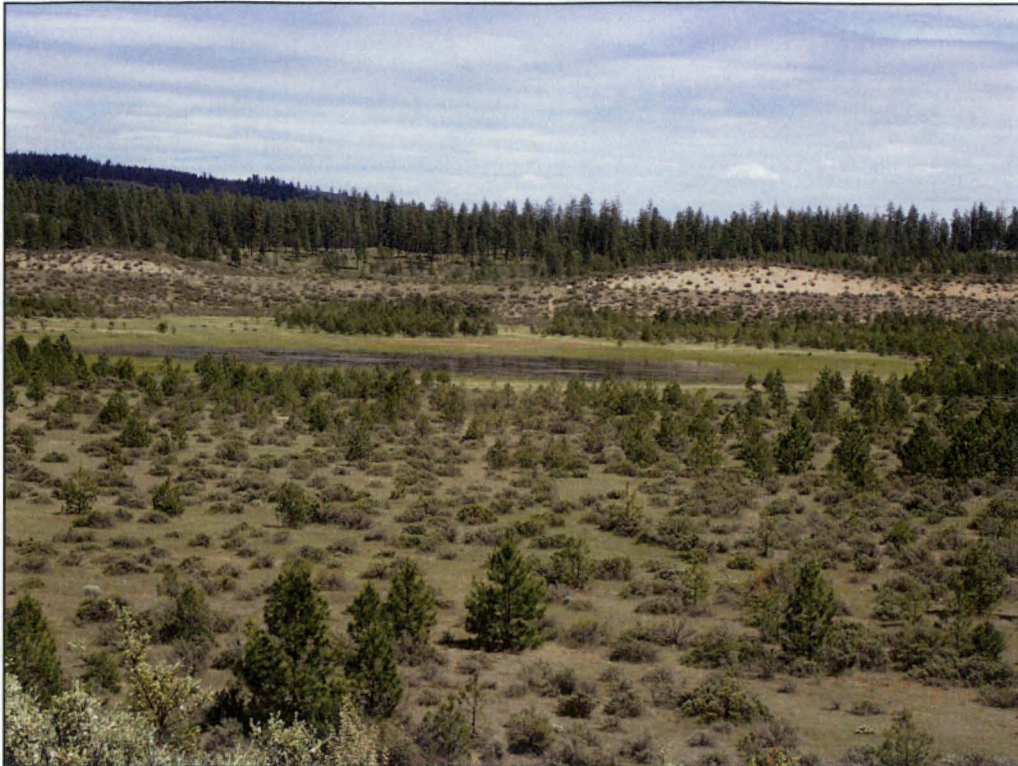
and settlement (DOE 2001). The largest area of settlement is referred to as Pond 1 (PL-7). The plant species present indicate the presence of year-round moisture below the surface of the pond area. Other minor depressions—designated as Ponds 2, 3, and 4—are often dry. An evaluation of topographic surveys conducted in 2016 and 2017 indicated that settlement up to 4.4 ft has occurred near the ponds since construction of the disposal cell. The cover was designed to withstand up to 10 ft of settlement (DOE 2018a). The shallow ponds are considered to be favorable features on the disposal cell cover, but LM will continue to monitor the surface for unusual settlement features to verify the cover’s integrity and ensure that the disposal cell is performing as designed. No maintenance needs were identified.

*PL-7. Pond 1 on Disposal Cell Top Slope*

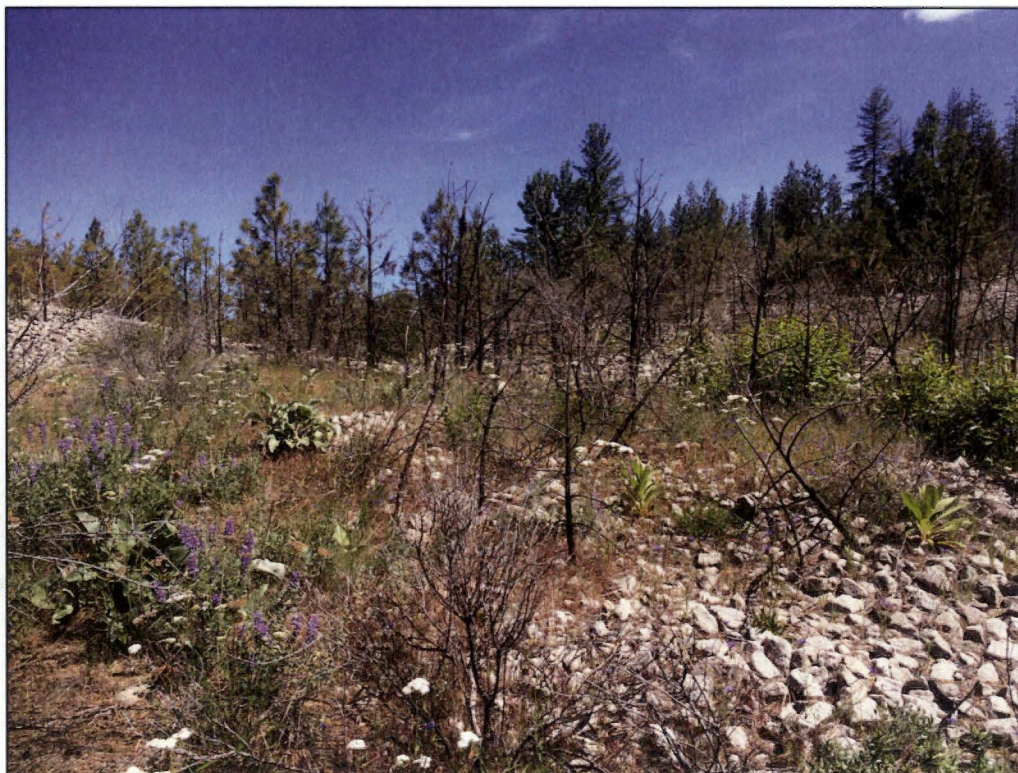
A riprap-armored diversion channel surrounds the disposal cell and diverts runoff away from the disposal cell surface. The diversion channel was designed to allow trees to grow and stabilize the surfaces, and the presence of trees in the diversion channel is not expected to hinder the diversion channel's ability to convey design flows. The intrusion of volunteer plants, including trees, is evident in most areas of the diversion channel (PL-9). Sediment deposition is found in places on the west leg of the diversion channel but does not interfere with the diversion channel's design function. Upslope areas that have contributed to the sedimentation have stabilized with vegetation. Wildlife trails cross the diversion channel at numerous locations and have displaced the diversion channel riprap in several places. These disturbances will be visually monitored for erosion but are not in areas that would impact the disposal cell. No evidence of erosion was observed downgradient of the diversion channel outlet (PL-10). No maintenance needs were identified.

*PL-10. Diversion Channel Outlet*

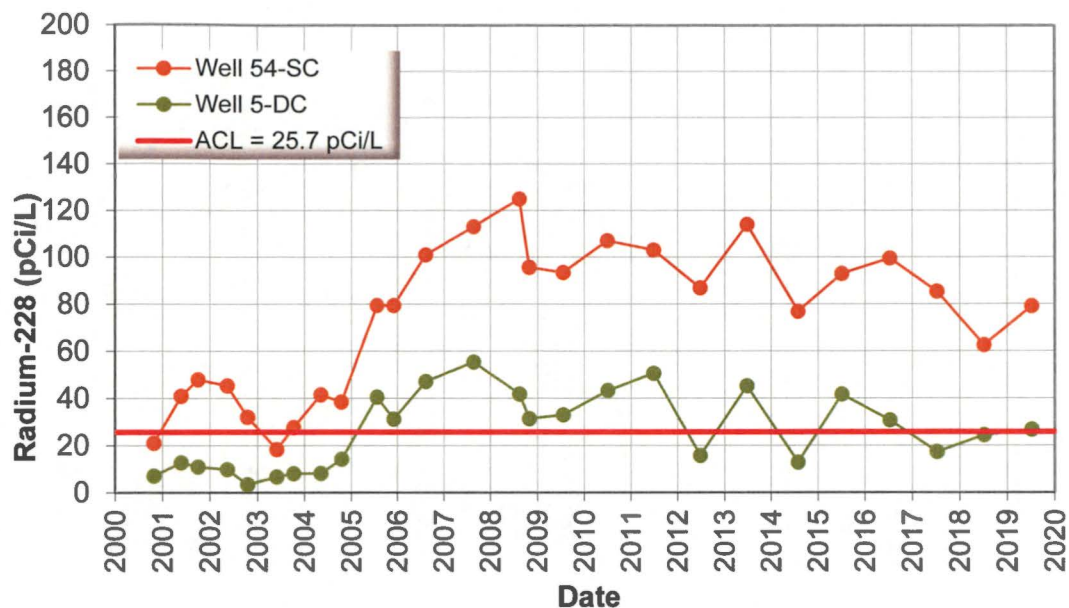
Figure 6-3. Radium-228 Concentrations in Wells 5-DC and 54-SC Since Completion of the Disposal Cell at the Shirley Basin South, Wyoming, Disposal Site

Well 5-DC first exceeded the ACL for  $^{228}\text{Ra}$  in 2005, after which concentration remained above the ACL until 2012. More recently  $^{228}\text{Ra}$  concentrations have been variable; before the ACL exceedance this year, the last exceedance was in 2016. Although the  $^{228}\text{Ra}$  concentration was elevated in well 54-SC, it is lower than the highest concentration measured in this well in the early 1990s (greater than 180 pCi/L) during site groundwater remediation activities. Radium-228 is a decay product of thorium-232 ( $^{232}\text{Th}$ ), which is highly immobile. Because the half-life of  $^{228}\text{Ra}$  is relatively short,  $^{232}\text{Th}$  sources must be near monitoring wells 5-DC and 54-SC. Additionally,  $^{226}\text{Ra}$  concentrations over time have been consistently above the ACL in well 110-DC since 2009 (Figure 6-4). LM attributes the elevated  $^{226}\text{Ra}$  and  $^{228}\text{Ra}$  in the site wells to natural mineralization in the sand units, rather than concluding it is evidence of diminished disposal cell performance or contaminant plumes migrating offsite (DOE 2011). Both the upper and main sand aquifers at the site were dewatered during mining and remediation and are still recovering. Consequently, periodic increases in some constituent concentrations in the groundwater, such as  $^{228}\text{Ra}$ , may represent a reestablishment of equilibrium of groundwater with naturally occurring constituents in the sand units (Figure 6-3 and Figure 6-4) (DOE 2011).

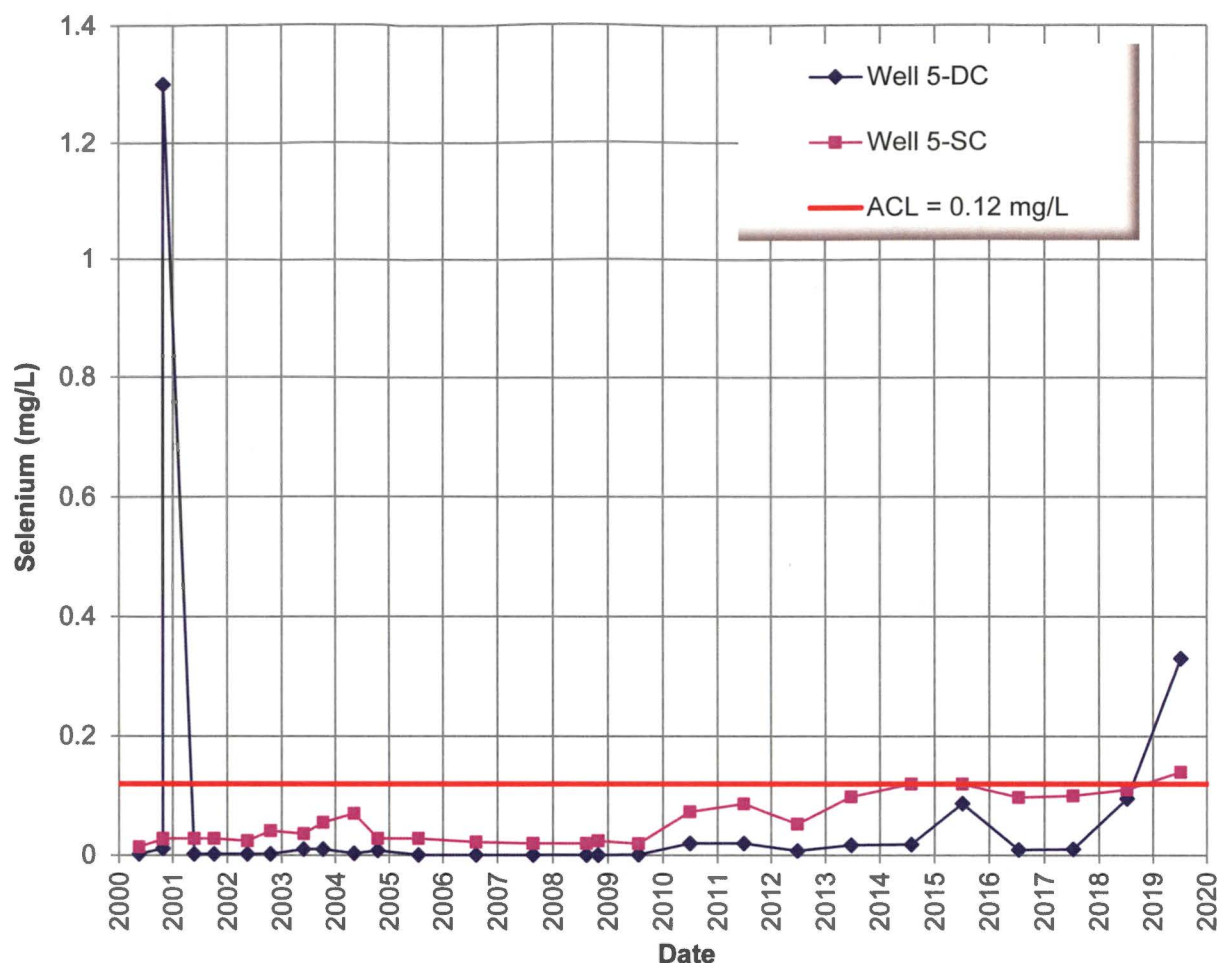
Figure 6-5. Selenium Concentrations at the Shirley Basin South, Wyoming, Disposal Site

Selenium time-concentration plots from 2000 to 2019 for wells 5-DC and 5-SC are shown in Figure 6-5. Selenium concentrations were measured at the ACL of 0.12 mg/L in well 5-SC in 2014 and 2015. The 2019 sampling event was the first ACL exceedance for selenium in well 5-SC. Aside from an anomalously high selenium concentration of 1.3 mg/L in 2000, well 5-DC did not exceed the ACL until 2019. An expanded characterization of the site's

hydrologic and geochemical processes is planned for 2020 and will examine possible mechanisms for increasing selenium trends near wells 5-DC and 5-SC.

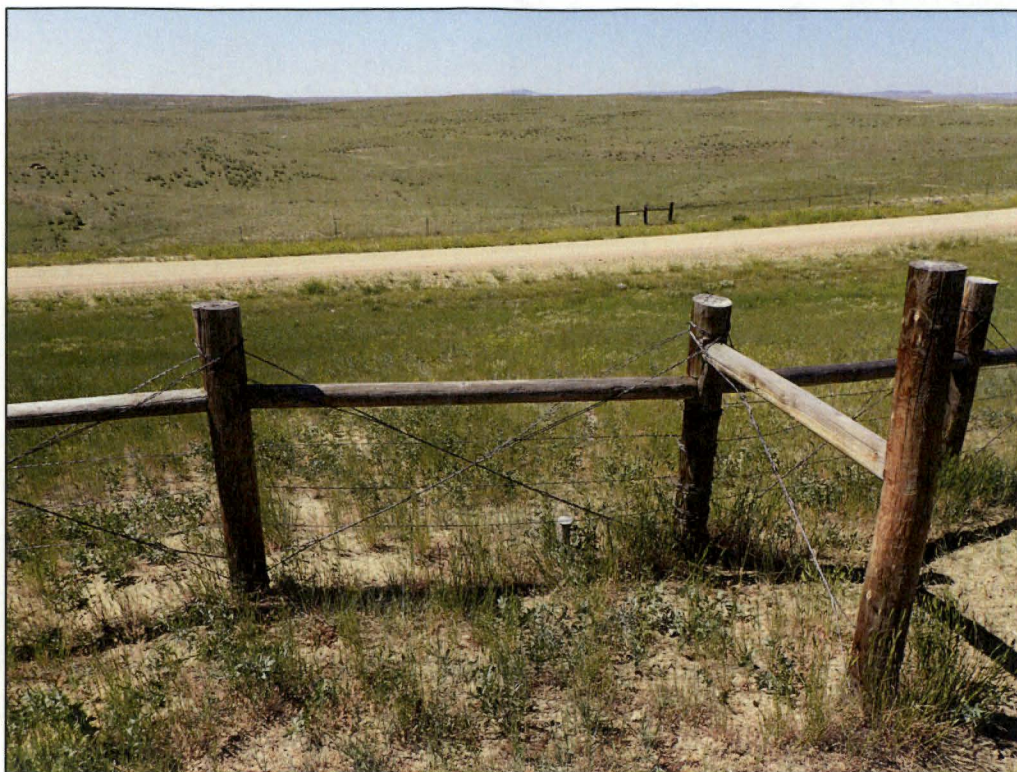
*PL-5. Boundary Monument BM-15*

There are 27 boundary monuments delineating the site property boundary (PL-5). All boundary monuments were inspected. No maintenance needs were identified.

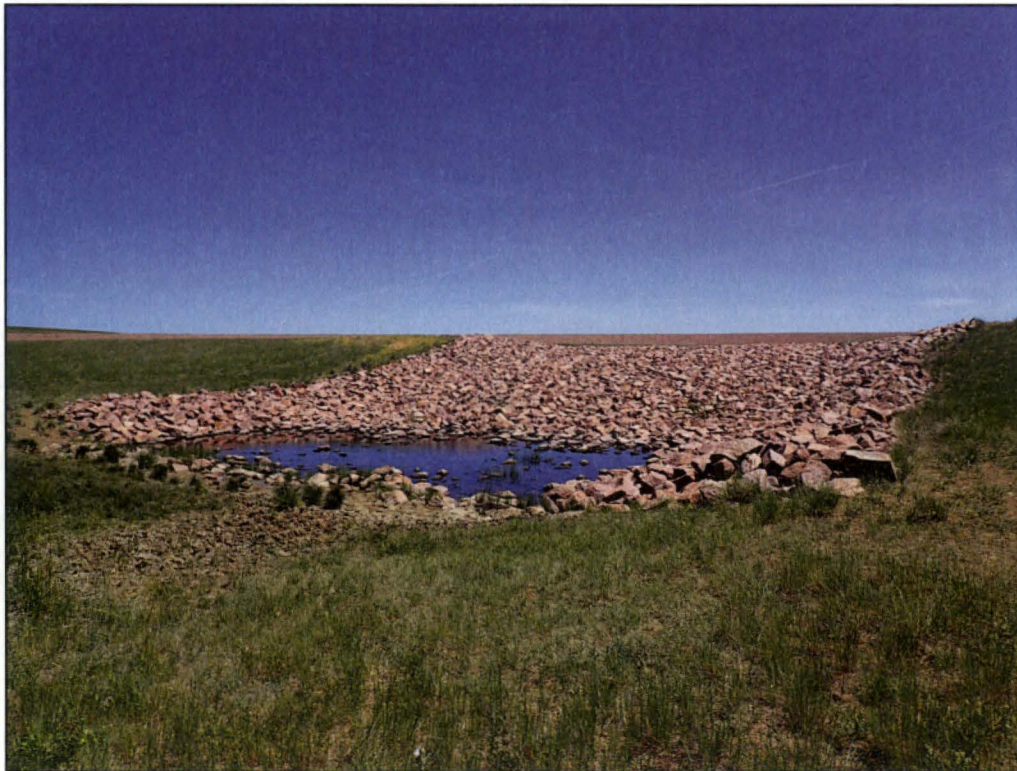
*PL-8. North Swale Discharge Point (Runoff Present)*

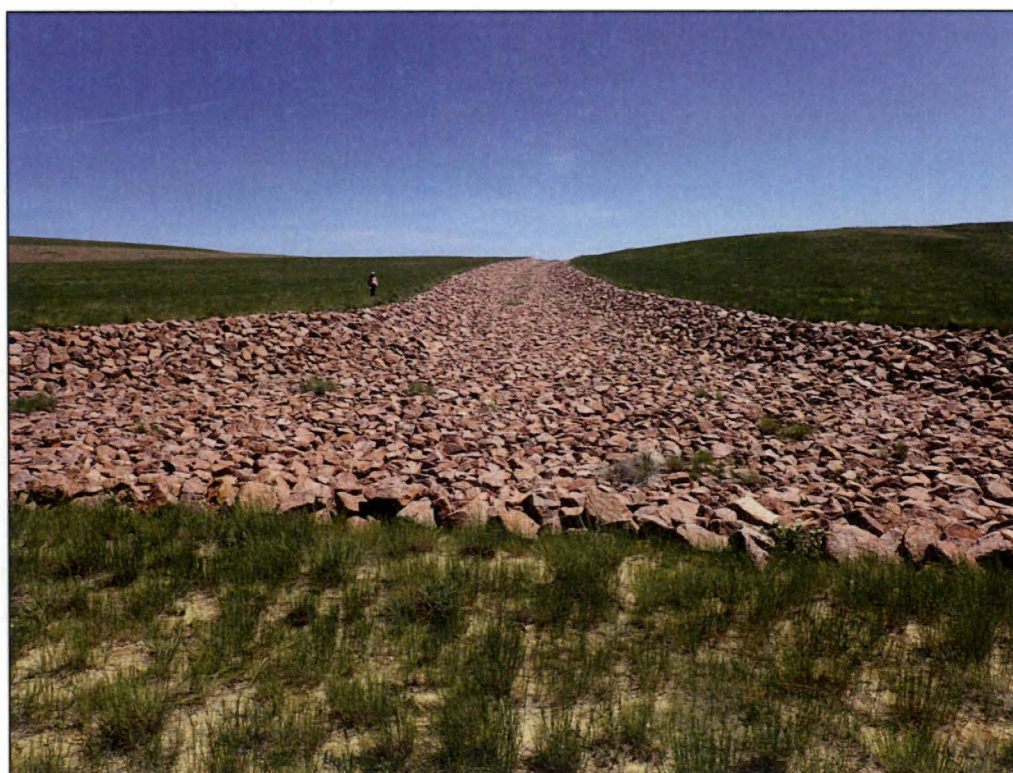
*PL-12. Riprap-Armored Diversion Channel*

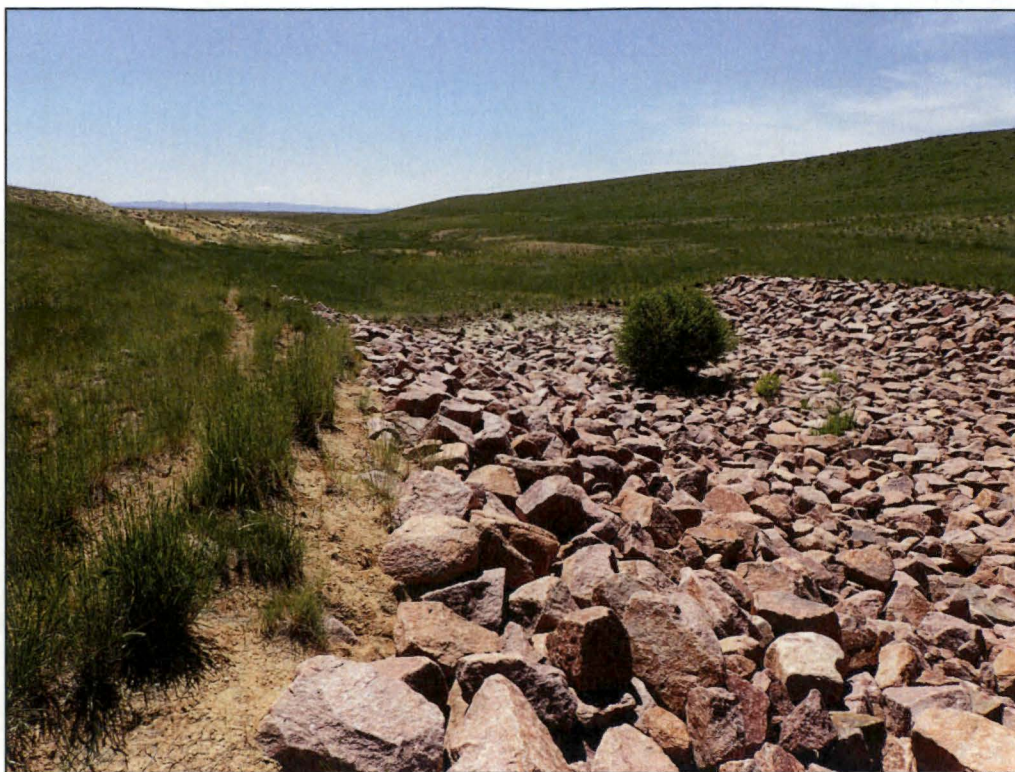
*PL-13. Outlet of Riprap-Armored Diversion Channel*

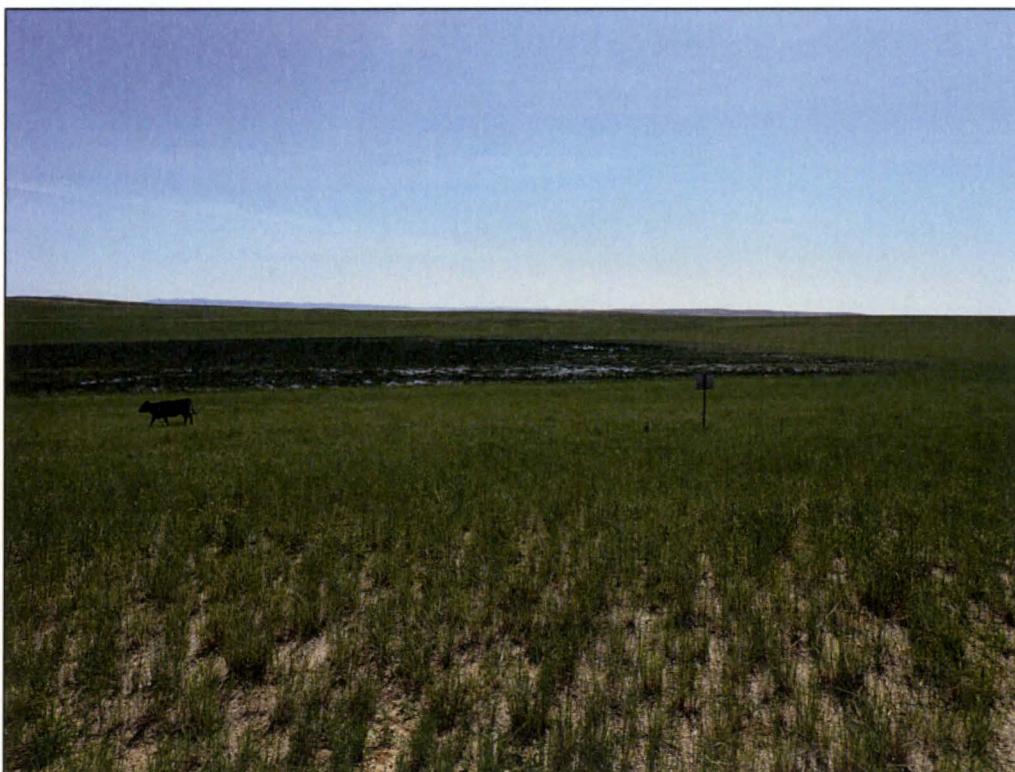
*PL-14. East Drainage Basin (Standing Water)*

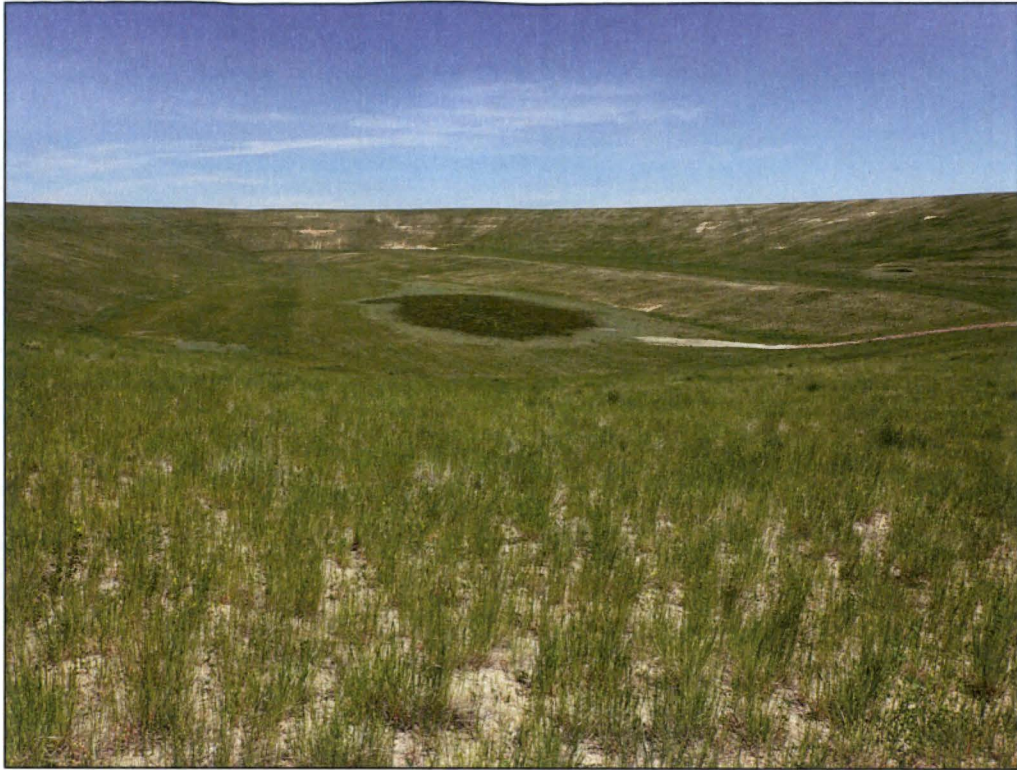
*PL-15. Pit 4 and Wetland Area*
