**ANALYSIS OF "B"
& "C" 1989
DIESELS FAILURE**

SEA-CW-037

ROOT CAUSE FAILURE ANALYSIS OF "B" AND "C" DIESELS: 1989

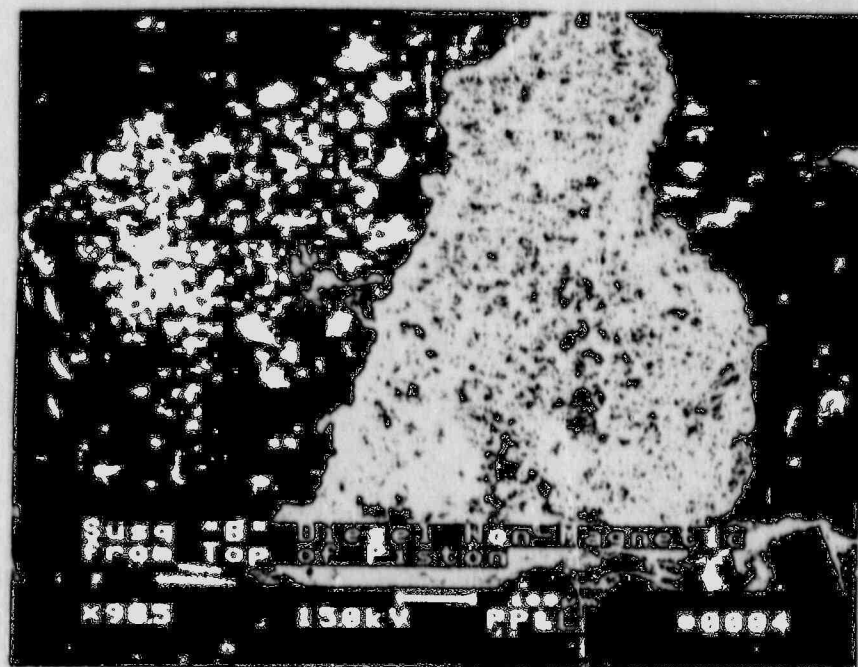
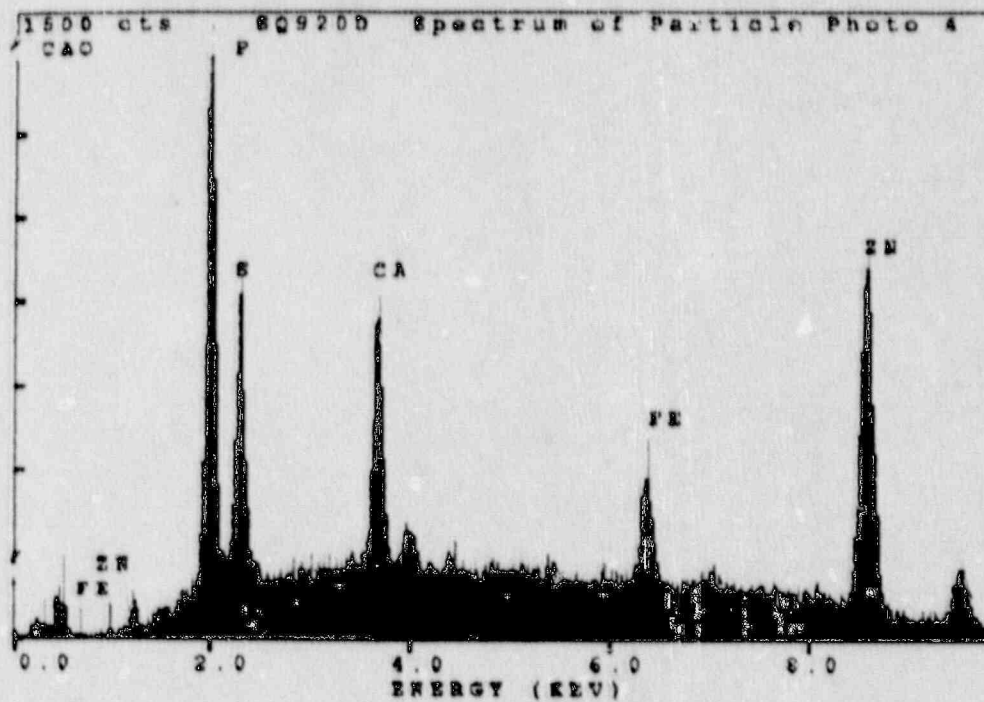
Figure B-4. Micrograph and EDS analysis results of non-magnetic debris taken from the head of the B diesel 7L piston.

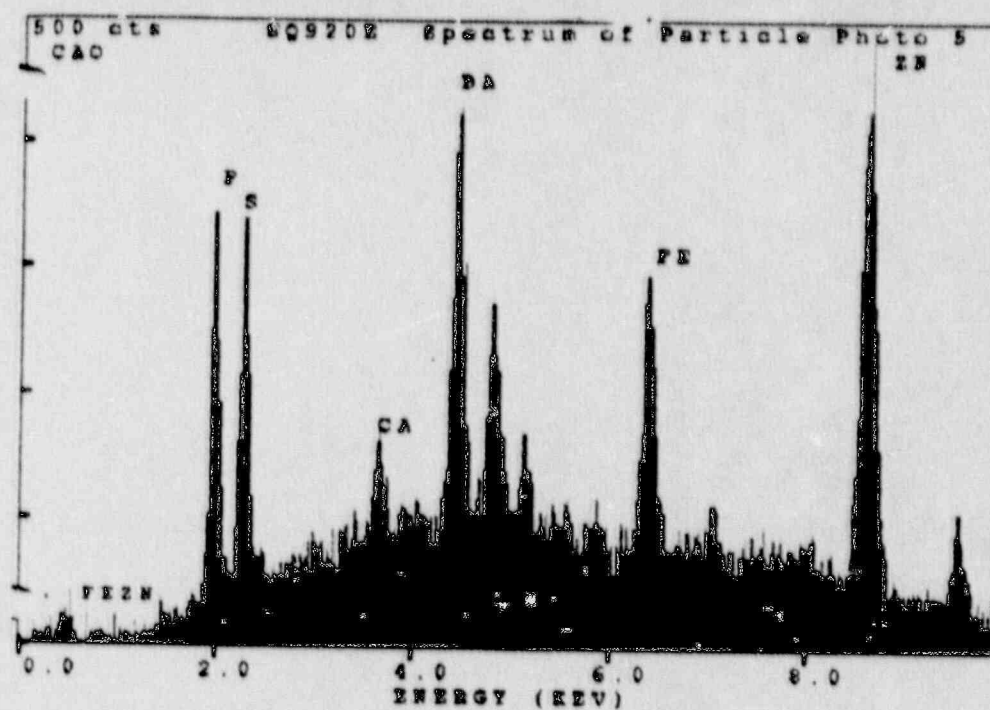
Figure B-5. Micrograph and EDS analysis results of non-magnetic debris taken from the head of the B diesel 7L piston on another particle from that analyzed in the figure B-4.

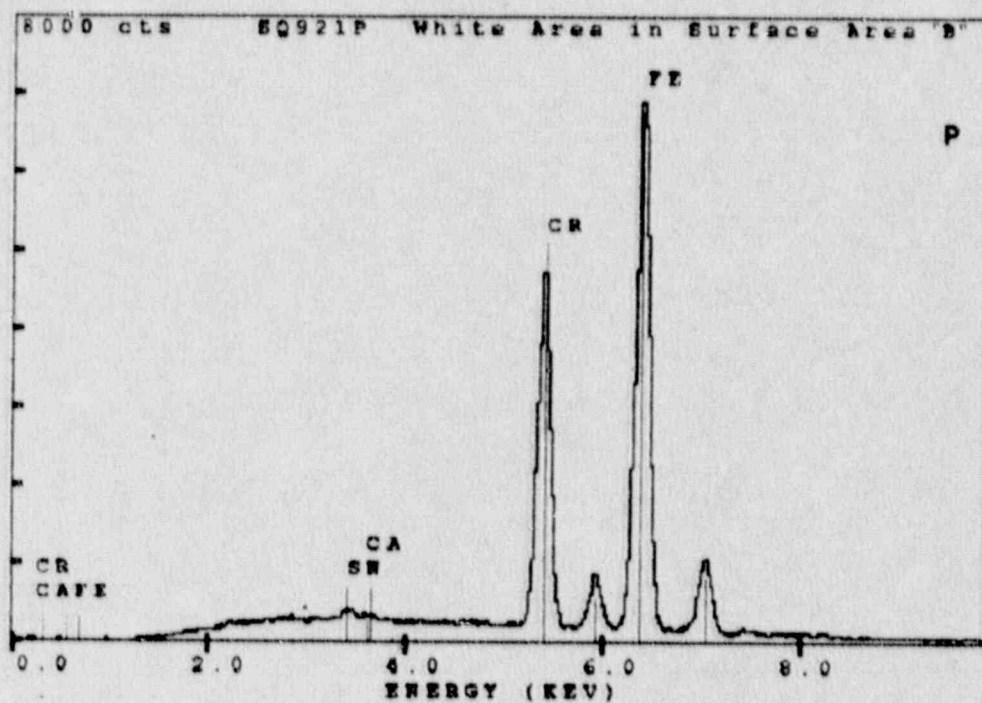
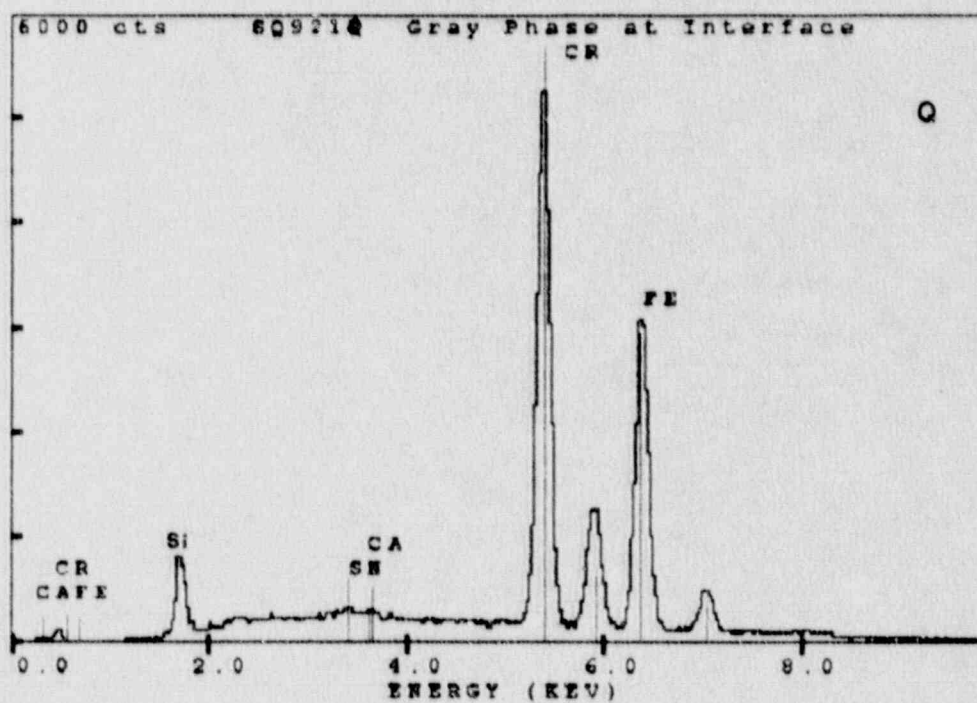
Figure B-8. EDS analysis of areas 'P' and 'Q' in figures B-7 and B-6.

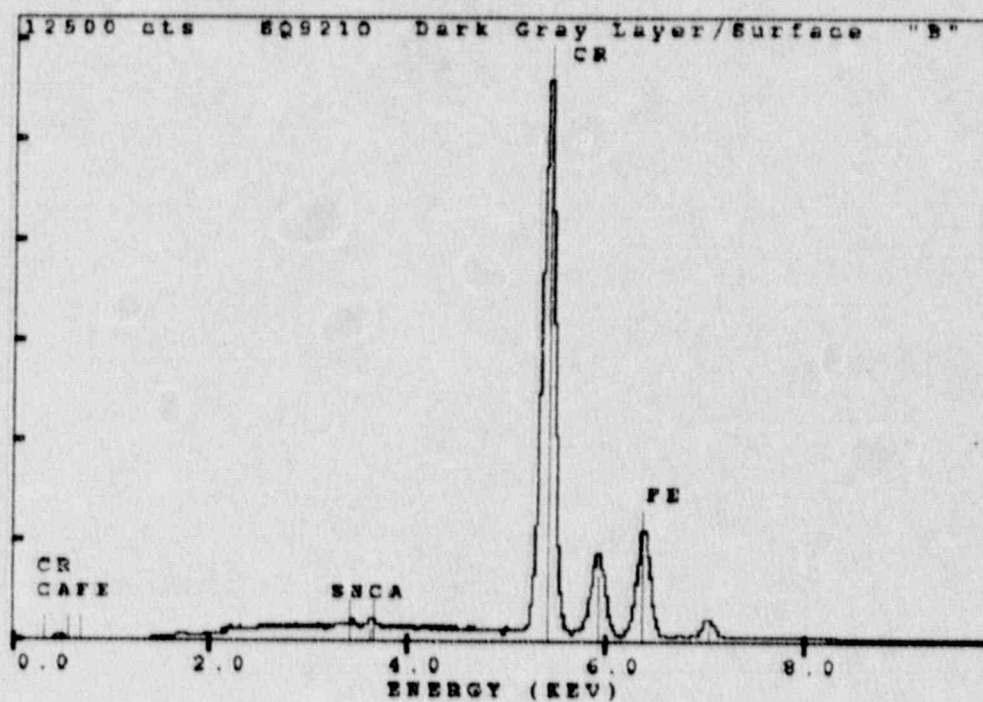
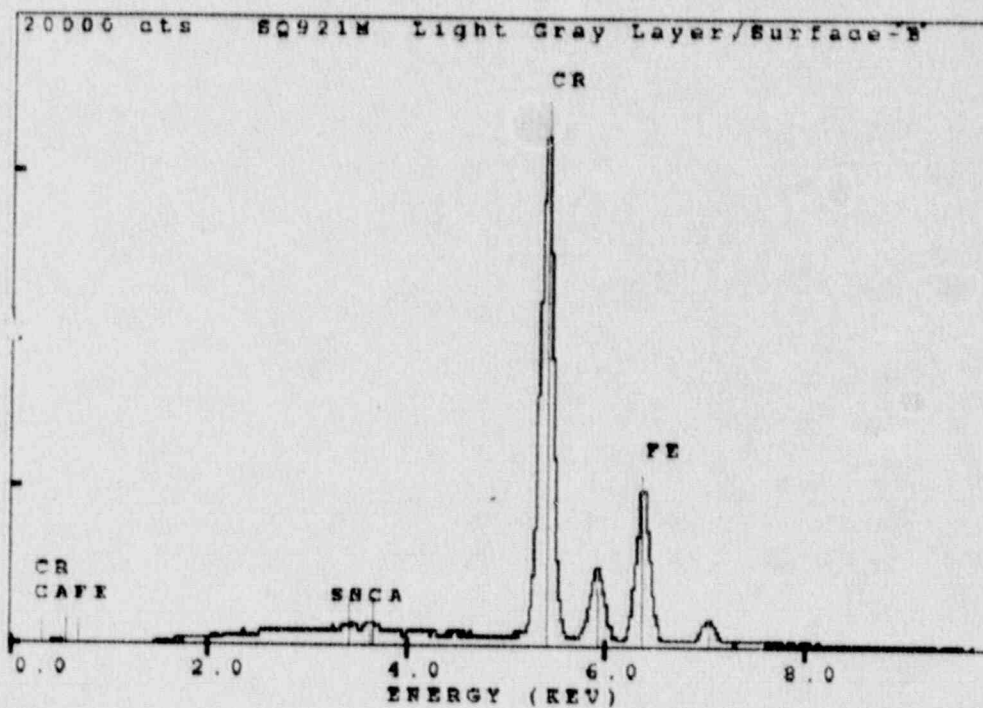
Figure B-9. Spectra of the light and dark phases in figure B-7.

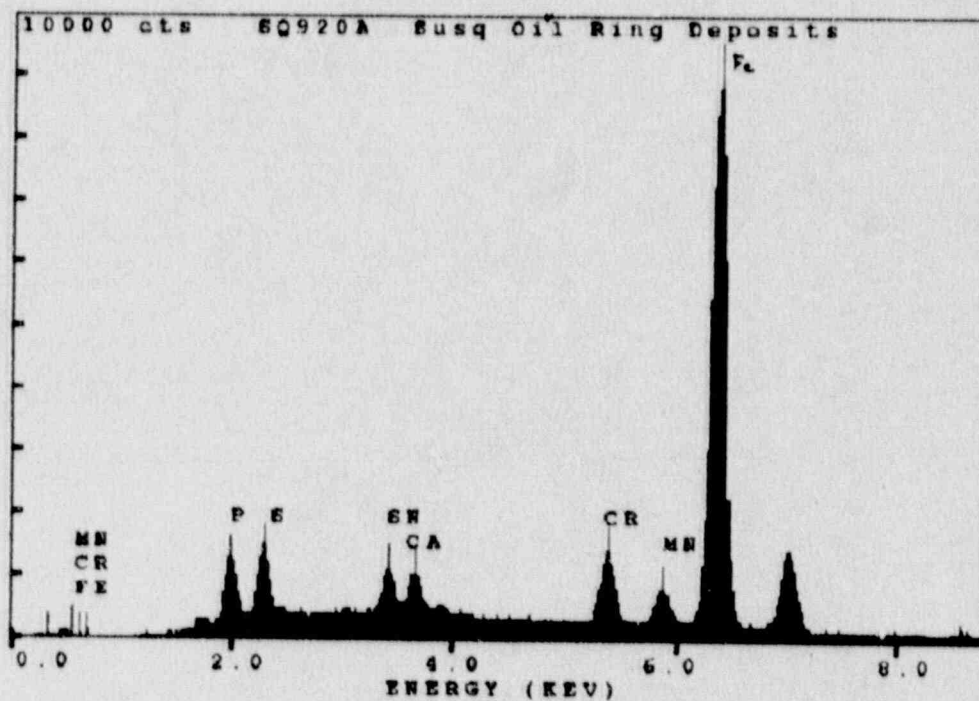
Figure B-14. Debris EDS analysis from the spring behind the lower oil ring from the B diesel 7L piston.

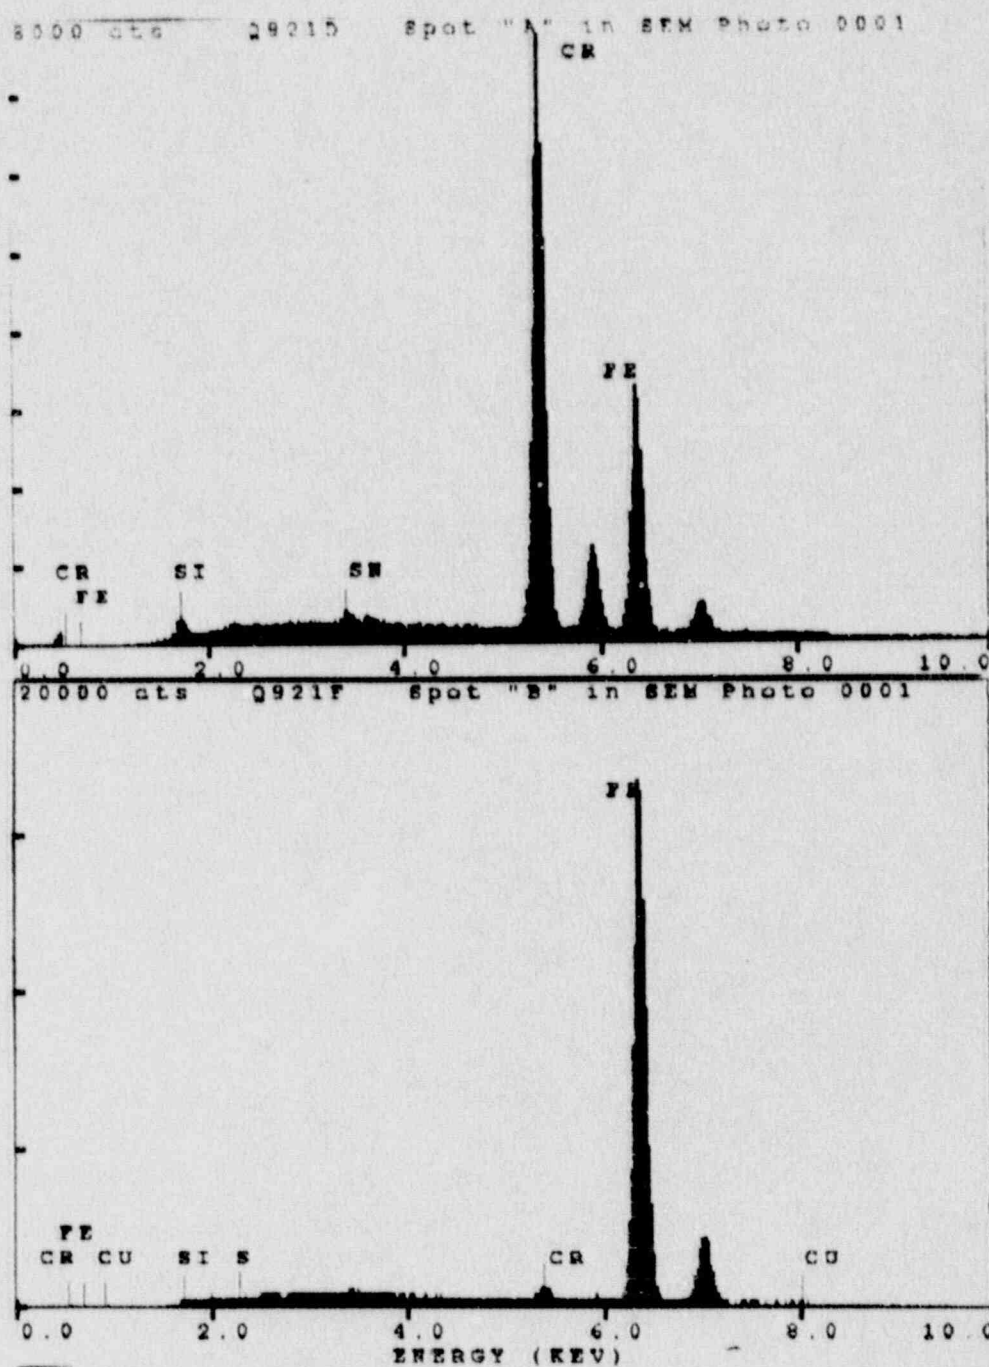
Figure B-16. EDS analysis of the #4 compression ring from the B diesel 7L piston in areas 'A' and 'B' of Figure B-15.

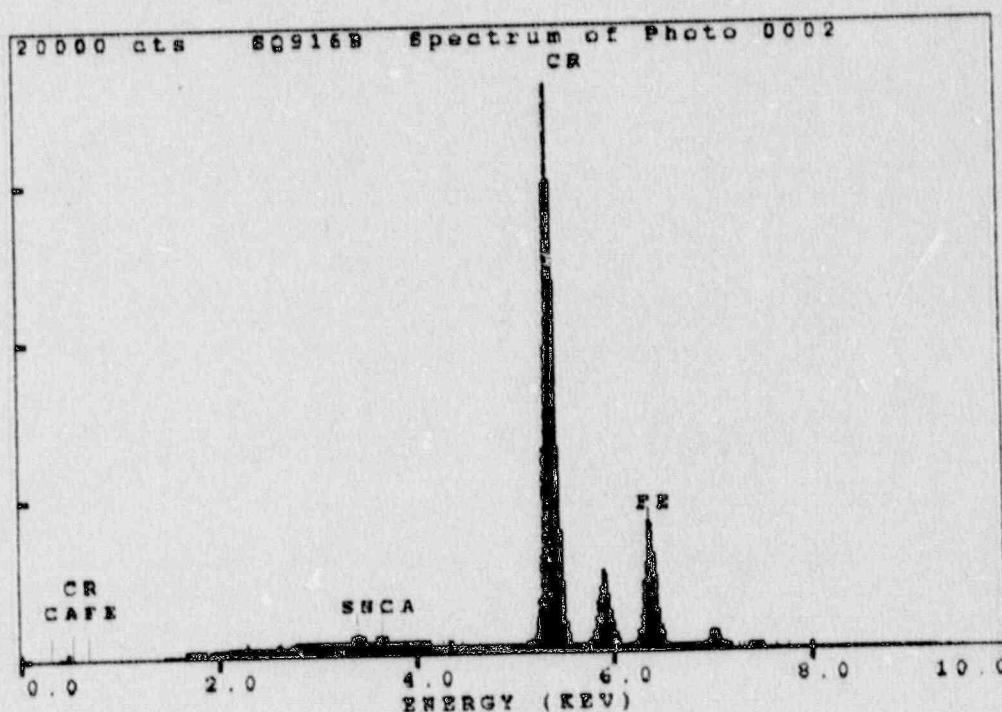
Figure B-20. Particle of smeared metal removed from pin end cap 'B' from the B diesel 7L piston. The EDS analysis shows that it consists primarily of Cr with some Fe and a trace of Ca and Sn.

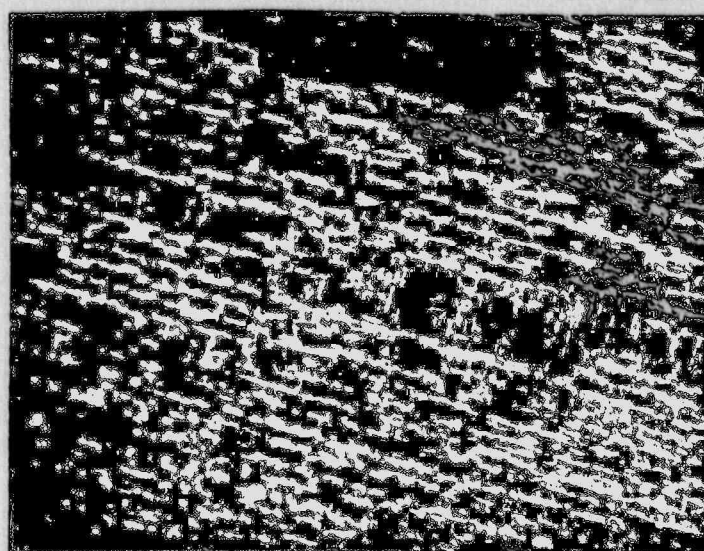
Figure B-23. B diesel 7R end cap showing the least amount of wear, but does show that the cap was touching the surface of the liner as evidenced from the light scratch marks on the surface perpendicular to the machining marks.

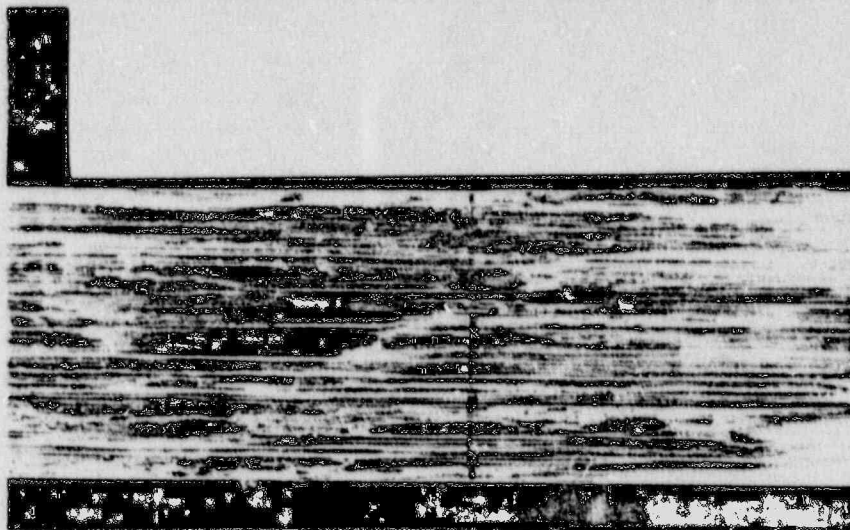
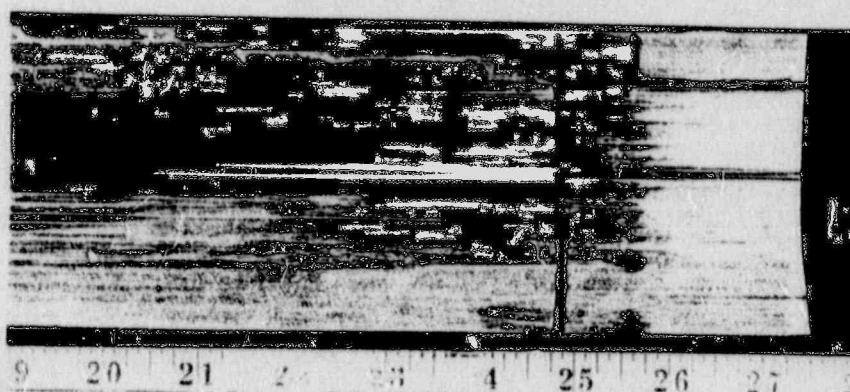
Figure B-32. Views of the length of the B diesel 7L cylinder liner in the area of pin end cap scraping (part B-2) showing heavy longitudinal marks and overheating over 20.5 inches of the center section.

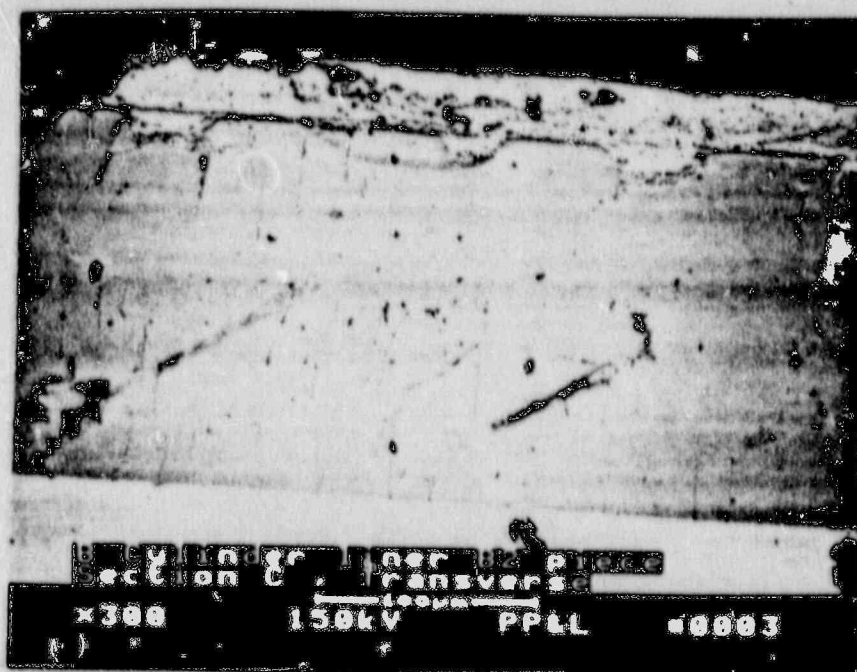
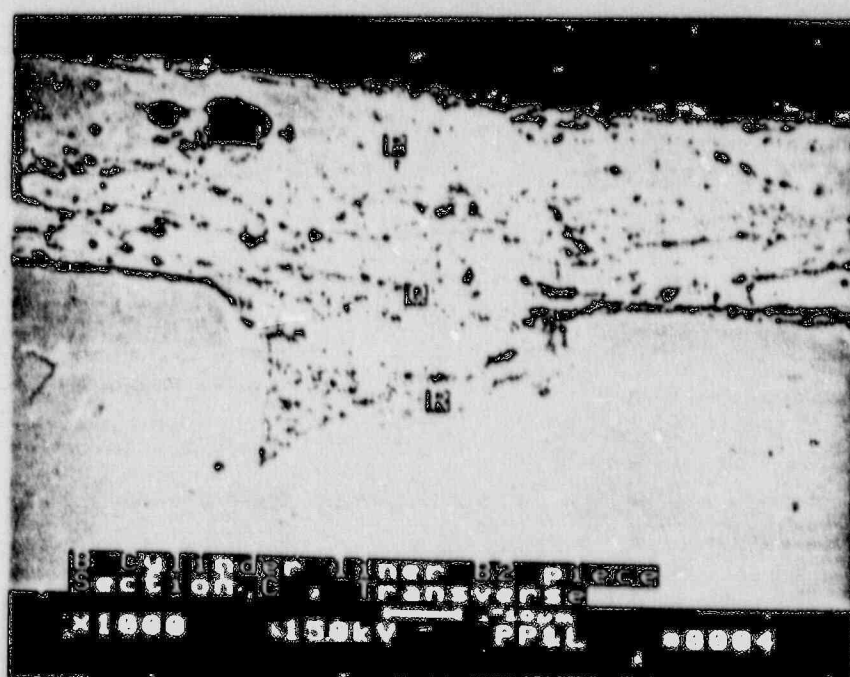
Area	Elements(greatest to least)
'R' Base of pit	Cr, Fe, and Sn
'Q' Top of pit	Fe, Sn, and Cr
'P' Center layer	Fe, Cr, and (Sn)
'P' Topmost layer	Fe, cr, and Si

Figure B-35. Transverse cross-section of the B diesel 7L liner (labeled 'C' of part B-2) showing areas of metal buildup and filling of pores with Cr, Sn and Fe.

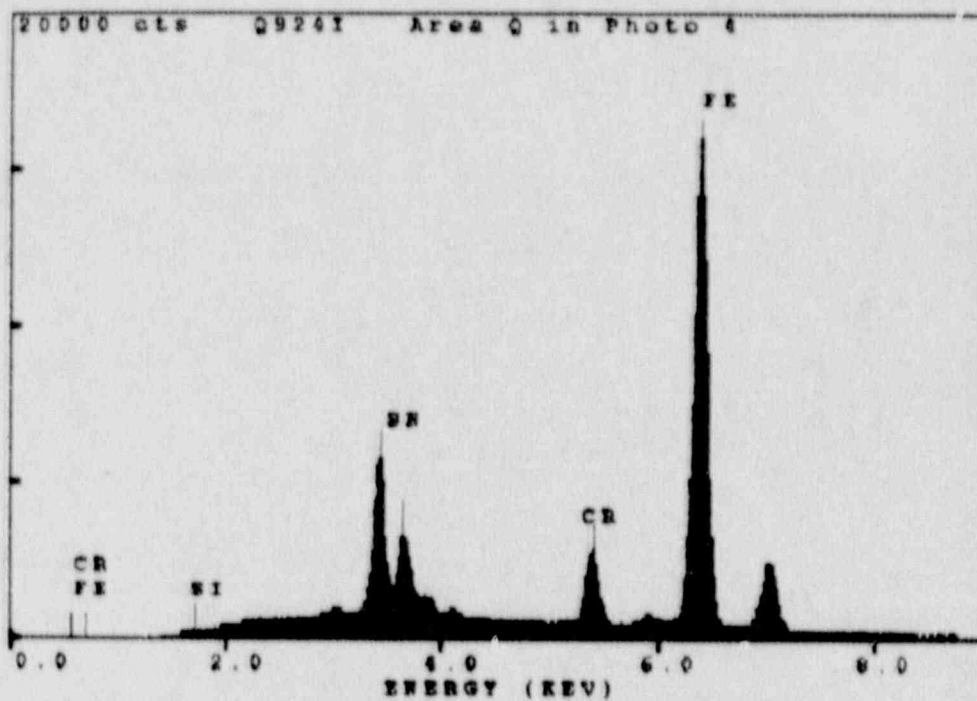
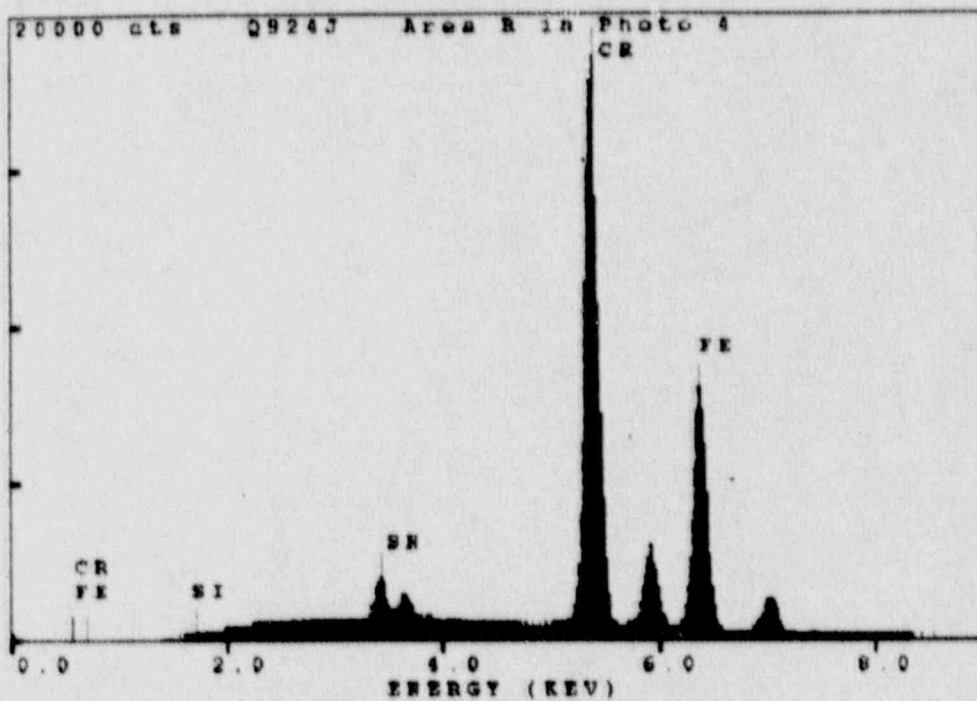
Figure B-36. EDS analysis of areas Q and R shown in figure B-35.

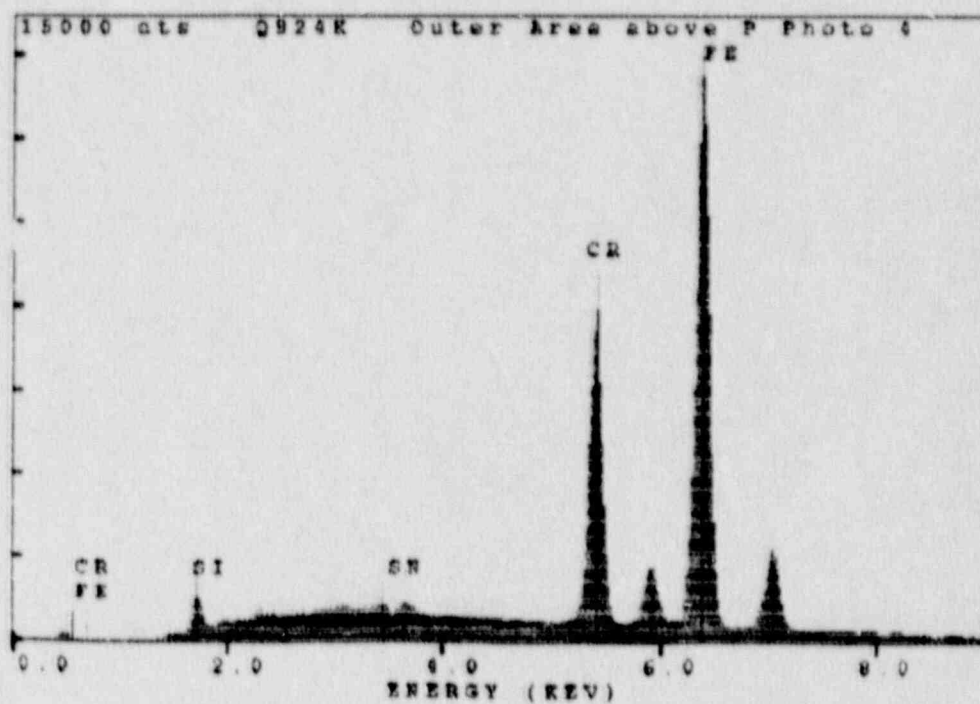
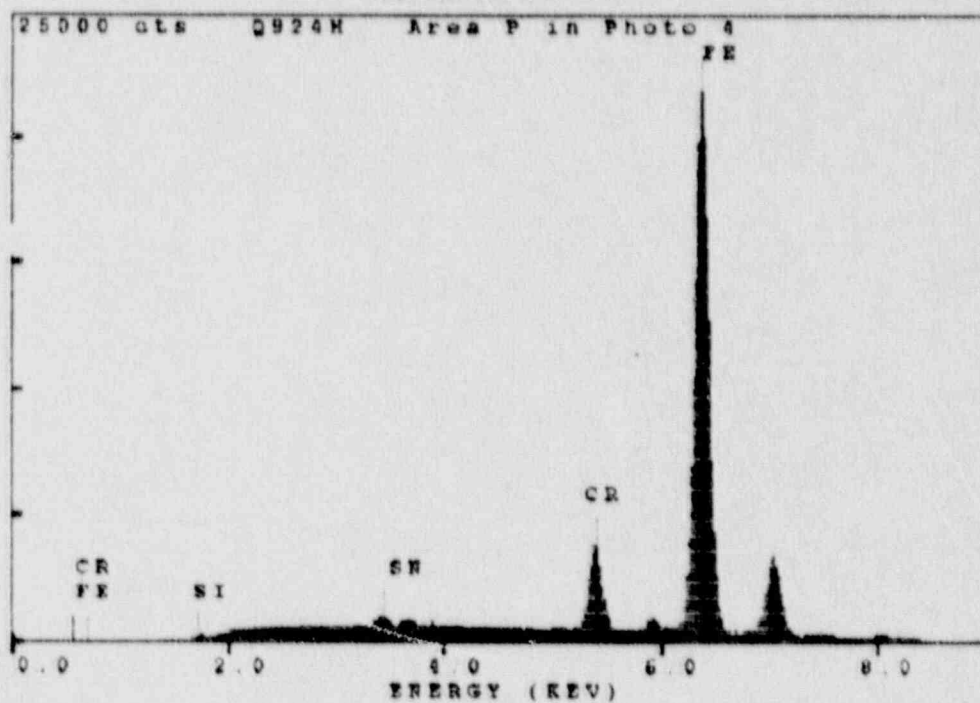
Figure B-37. EDS analysis of area P and the Dark layer above P in figure B-35.

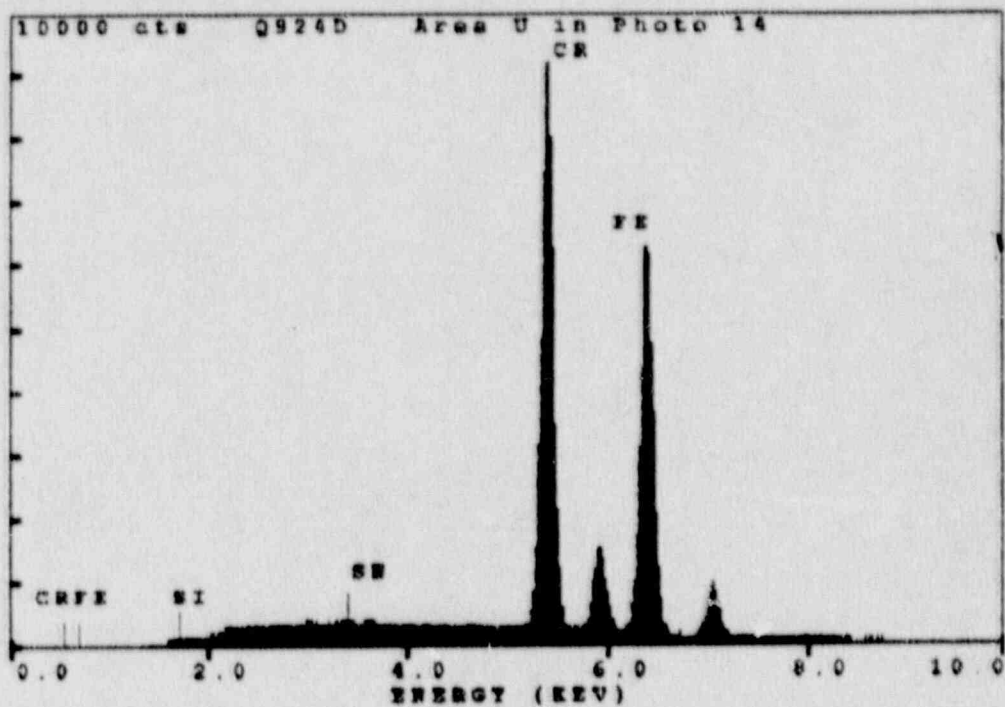
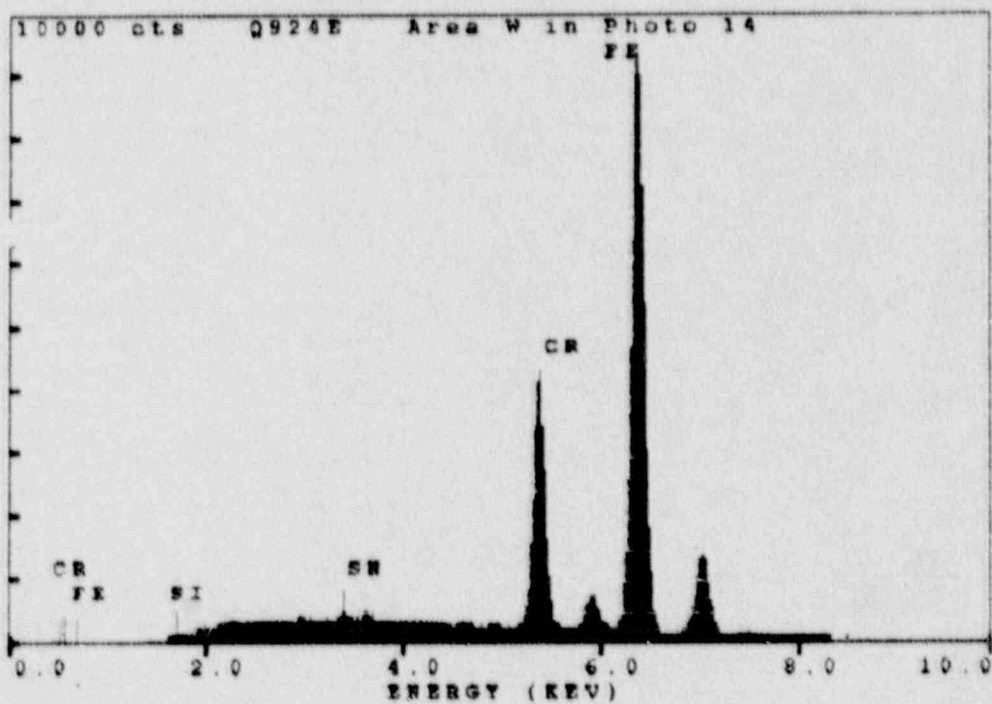
Figure B-41. EDS analysis of areas U and W shown in figure B-40.

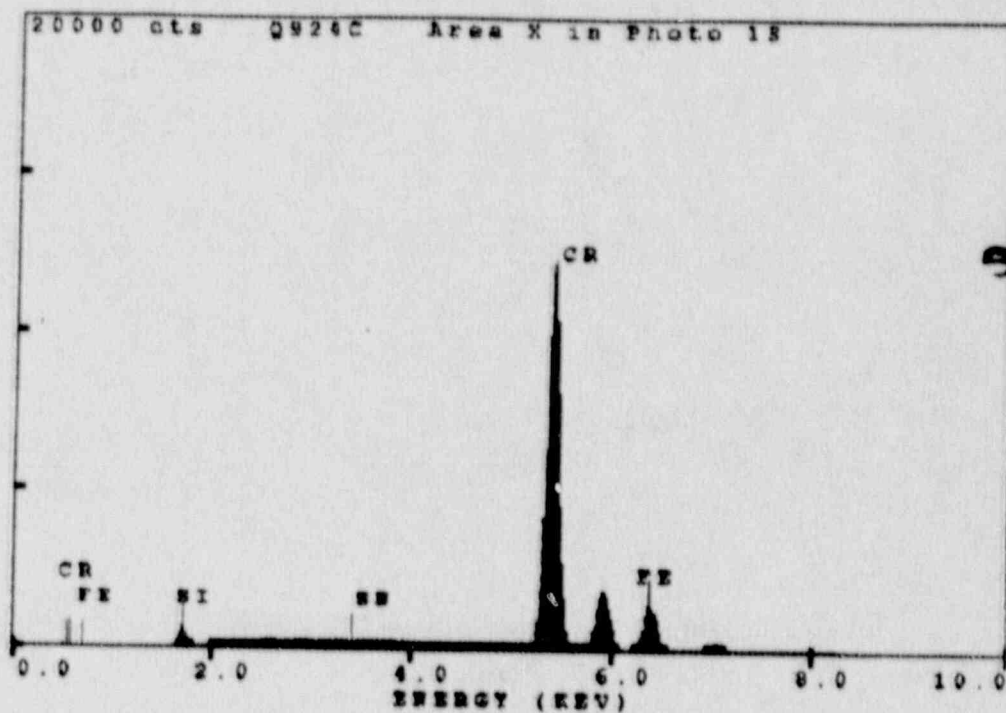
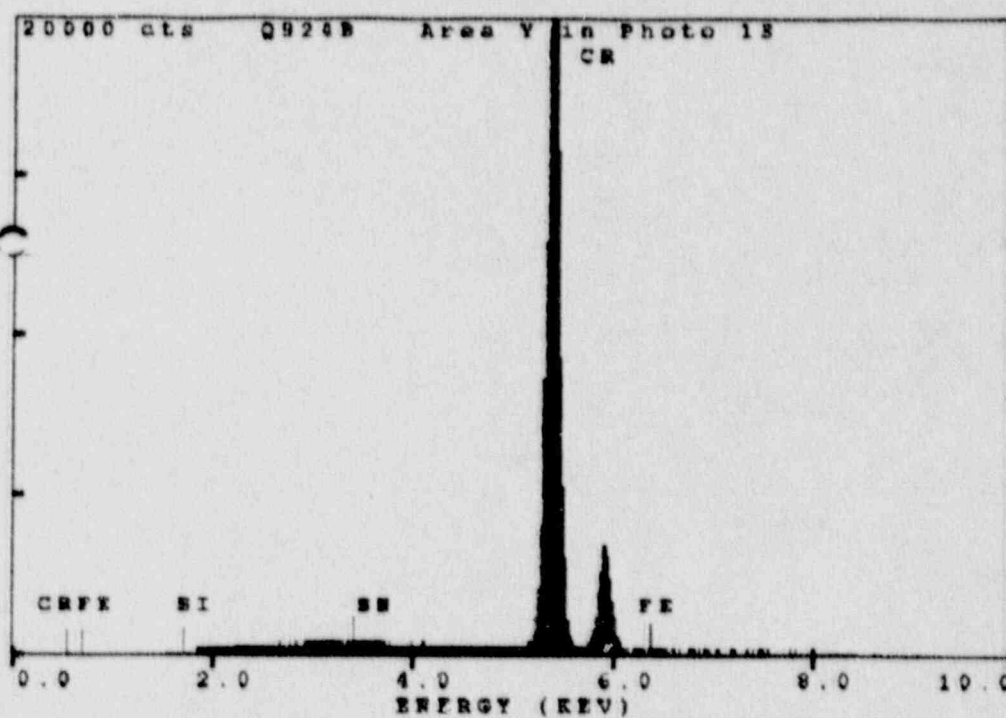
Figure B-42. EDS analysis of areas x and y shown in figure B-41.

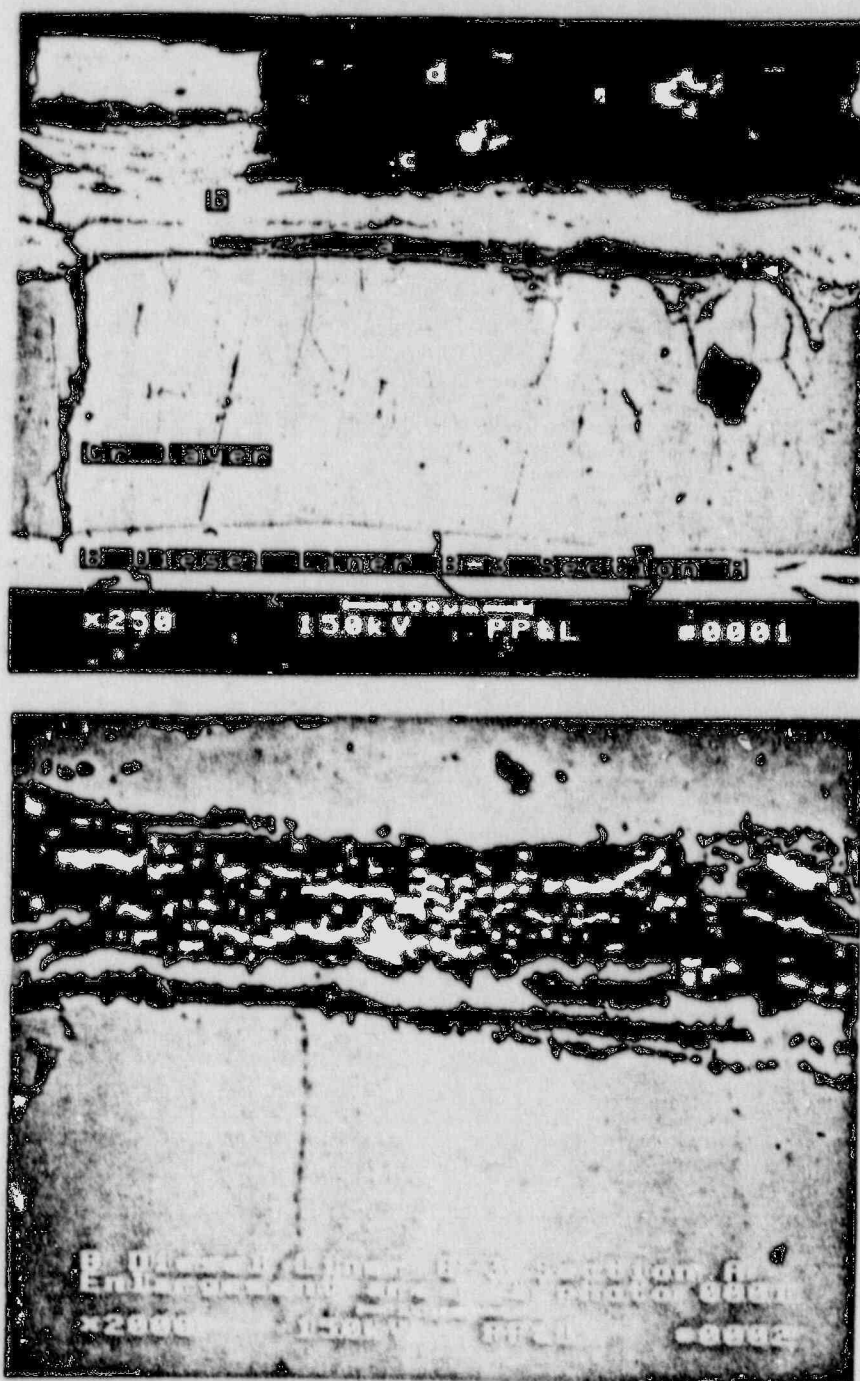
Figure B-46. Longitudinal section of the B diesel 7 L liner taken from an area 7 5/8 to 8 3/8 inches from the bottom. EDS analysis results are shown in figures B-47 and B-48.

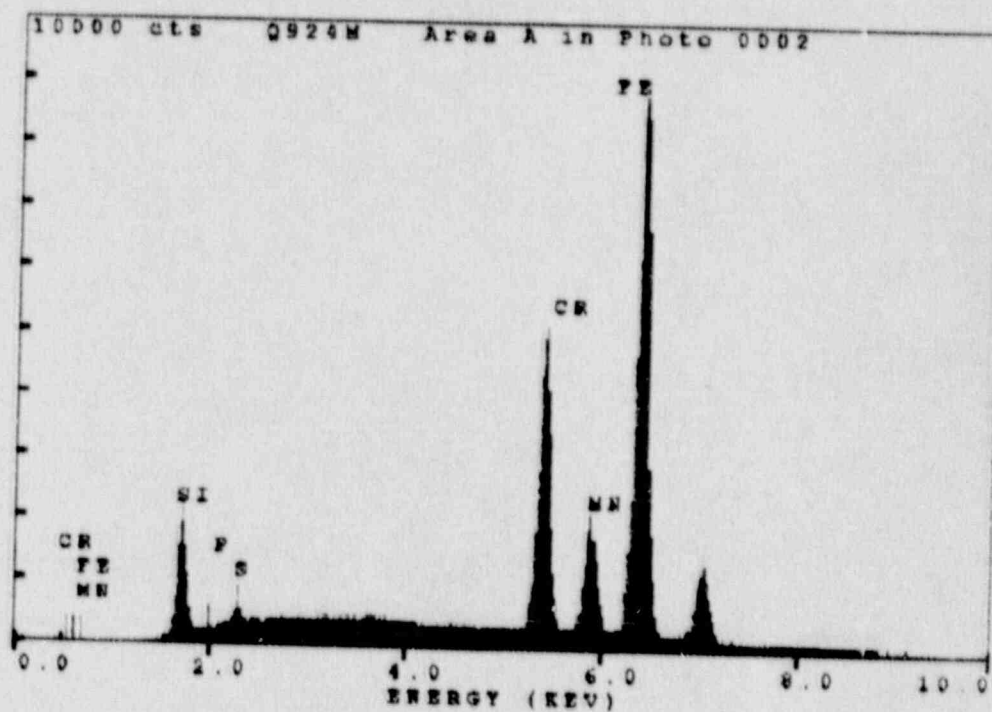
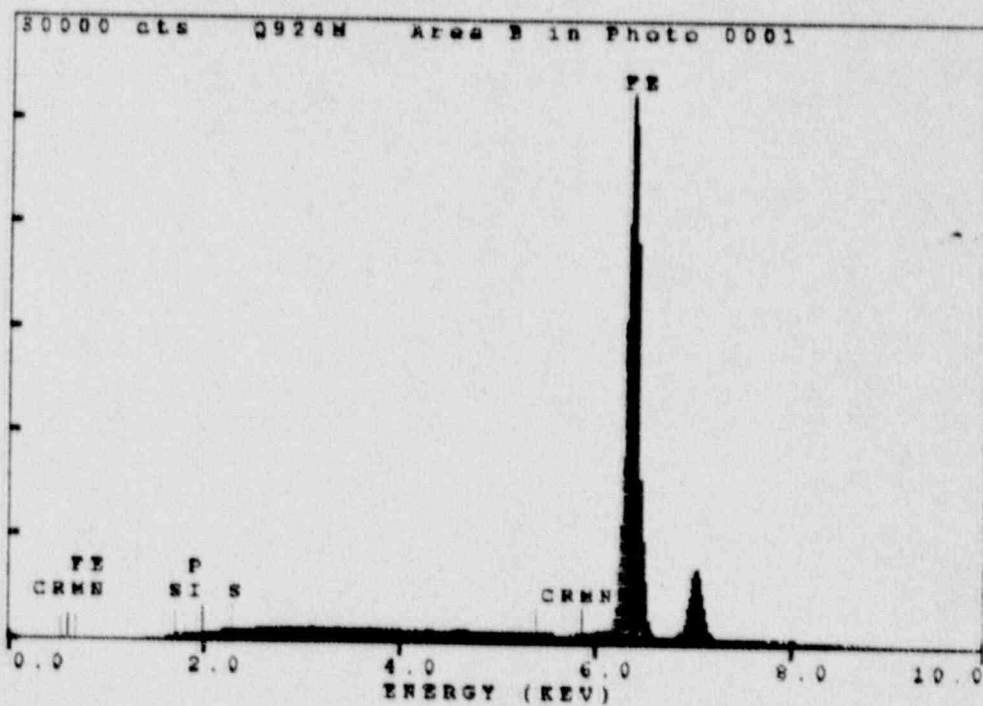
Figure B-47. EDS analysis of areas a and b in figure B-46.

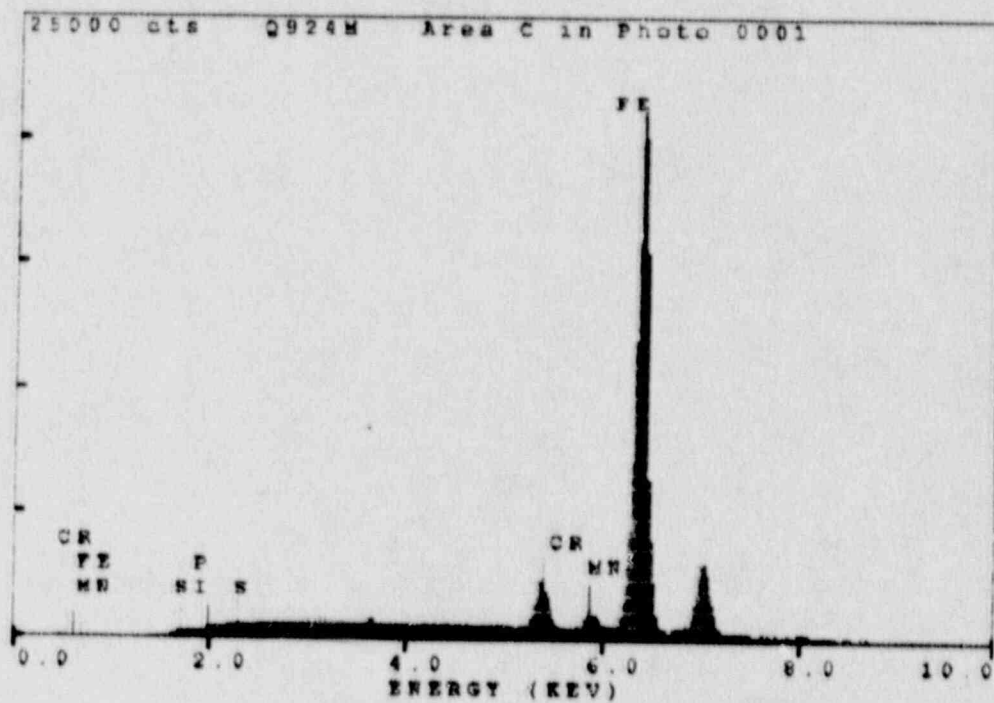
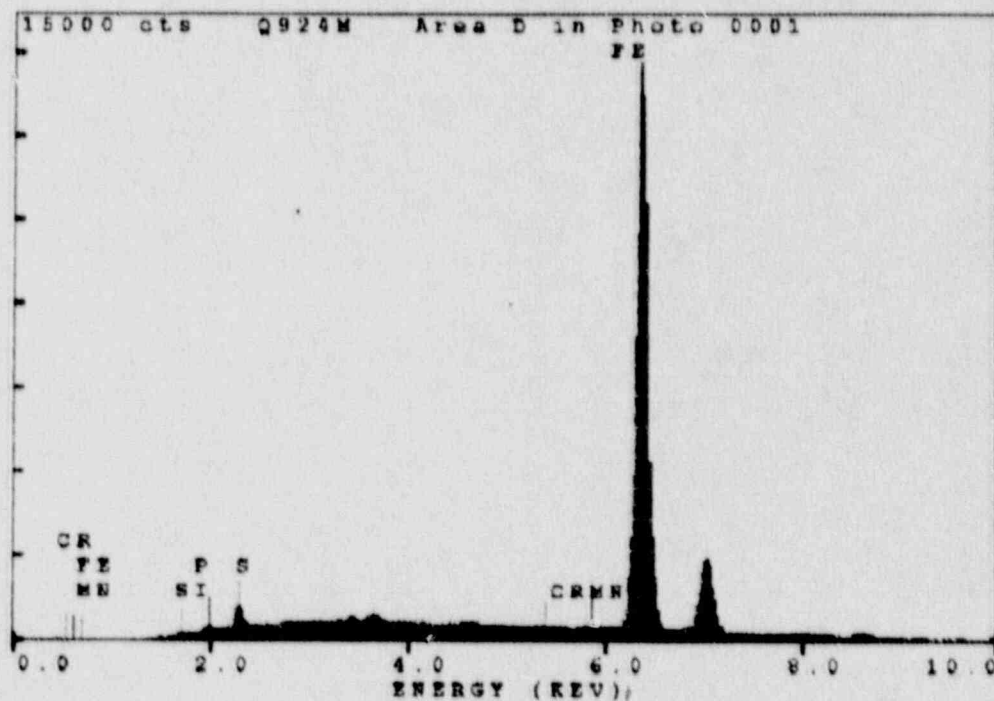
Figure B-48. EDS analysis of areas c and d in figure B-46.

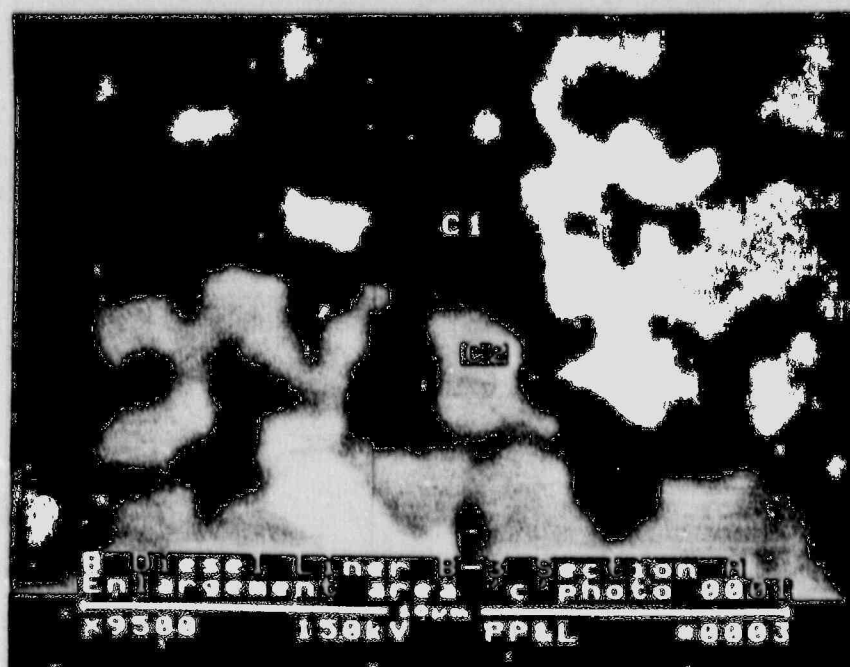
Figure B-49. Enlargement of area c in figure B-46 showing light and dark phases present. EDS analysis of these areas are shown in figure B-50.

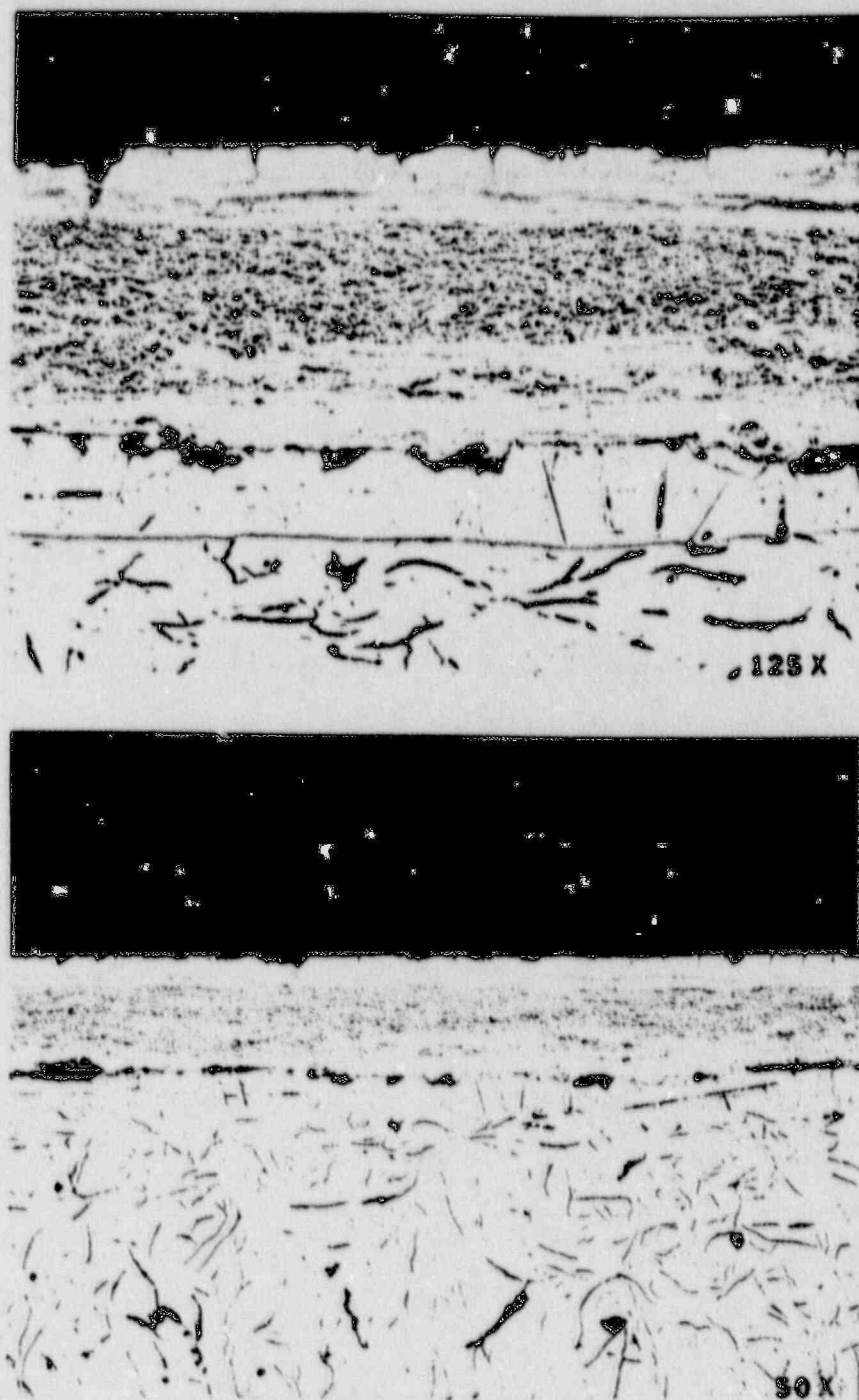
Figure B-51. Longitudinal cross-section of the B diesel 7L liner taken 7 5/8 inches from the bottom showing a very thick layer of metallic deposits covering the chromium plating.

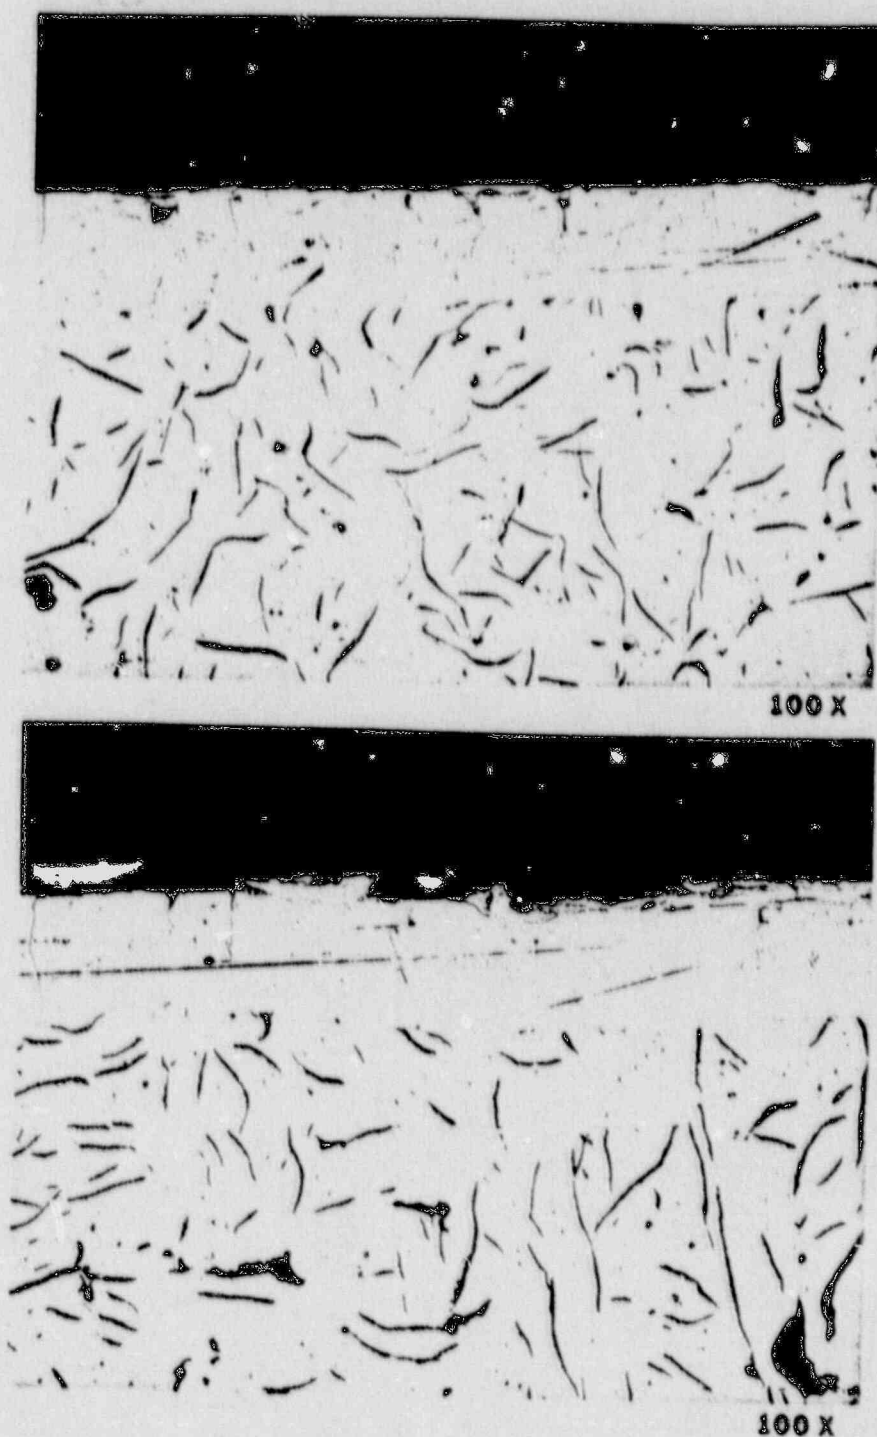
Figure B-52. Transverse cross-section of a typical area of the non-thrust side of B diesel 7L liner 16 inches from the bottom (B-3 area B) showing the filled pores and the deposited metal from this location.
