**ANALYSIS OF "B"
& "C" 1989
DIESELS FAILURE**

SEA-CW-037

ROOT CAUSE FAILURE ANALYSIS OF "B" AND "C" DIESELS: 1989

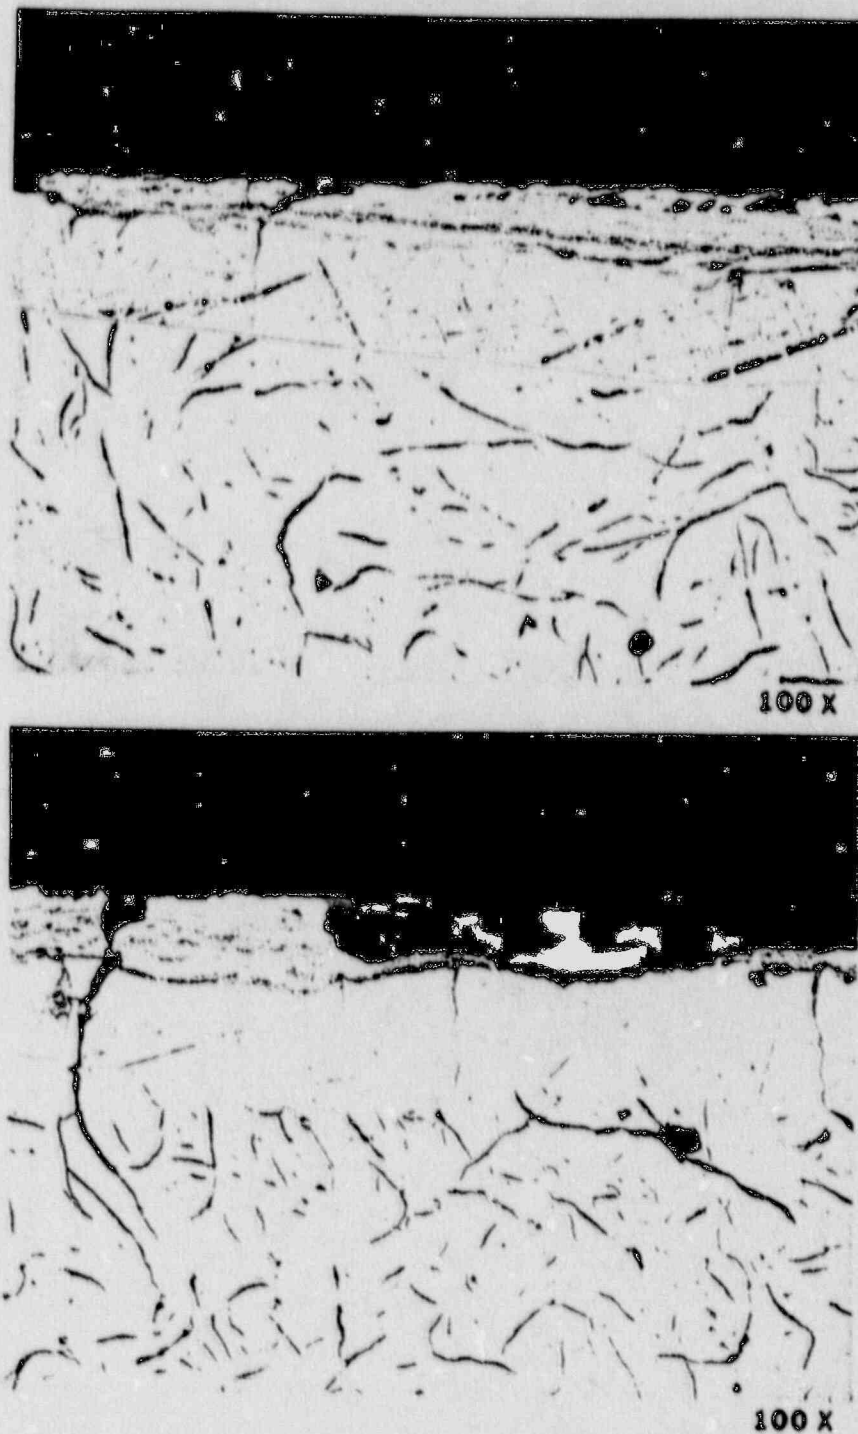
Figure B-53. Longitudinal cross-section of the non-thrust side of the B diesel 7L liner taken 16.5 inches from the bottom of the liner. Typical examples of the metal deposited from the piston and rings on the Cr plating.

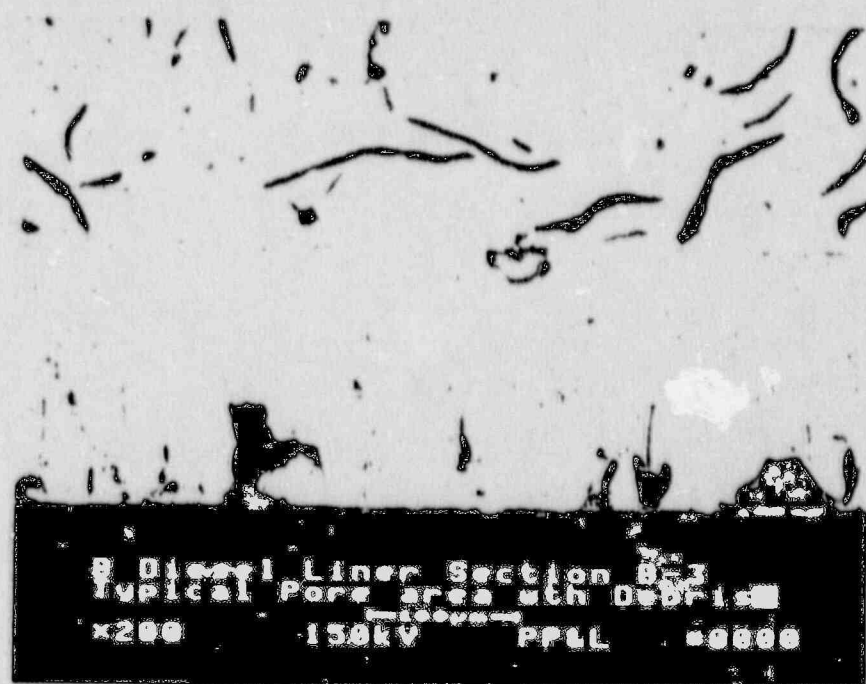
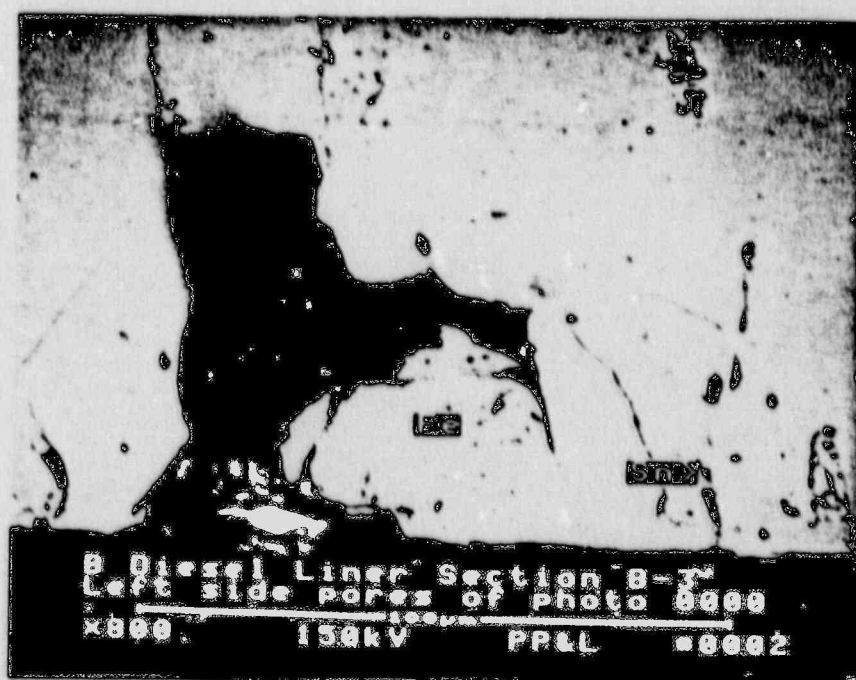
Figure B-54. SEM micrographs of longitudinal cross-section 'C' part B-3 of the B diesel liner at a level 16.5 inches from the bottom. Elements shown were identified as being present in the pores indicated.

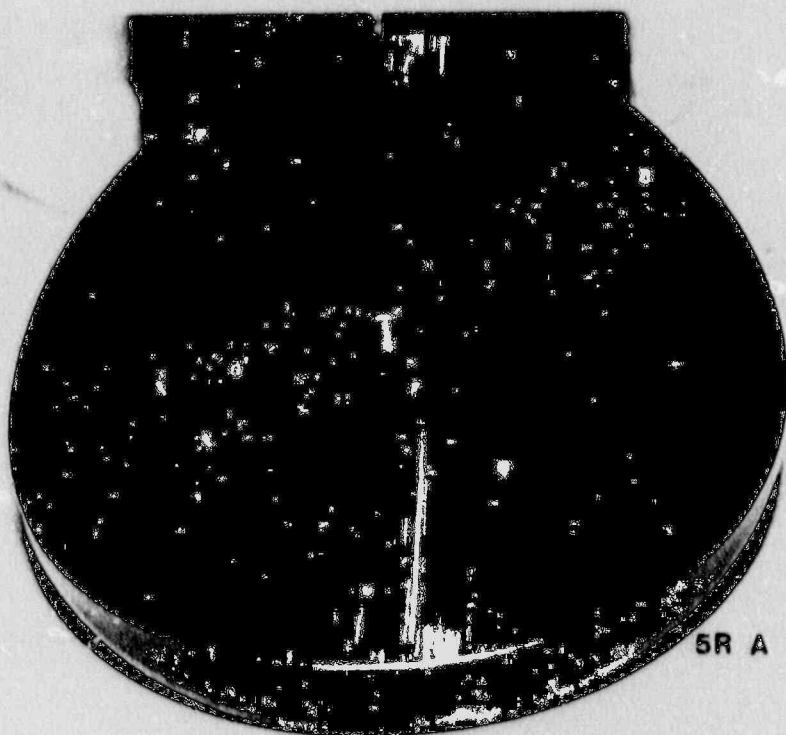
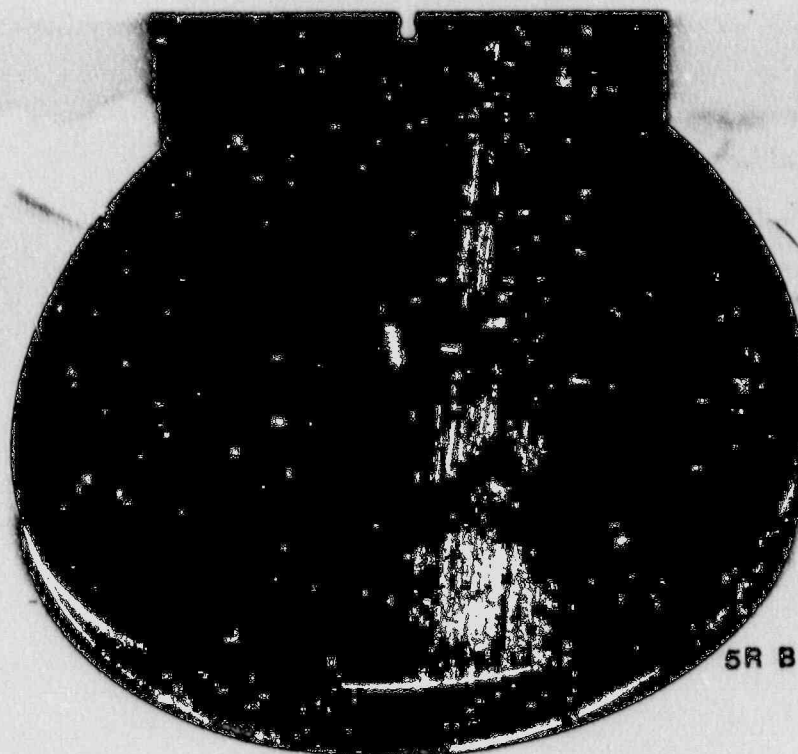
Figure C-2. Photographs of the 5R end caps, C diesel, showing the discoloration and minor scoring.

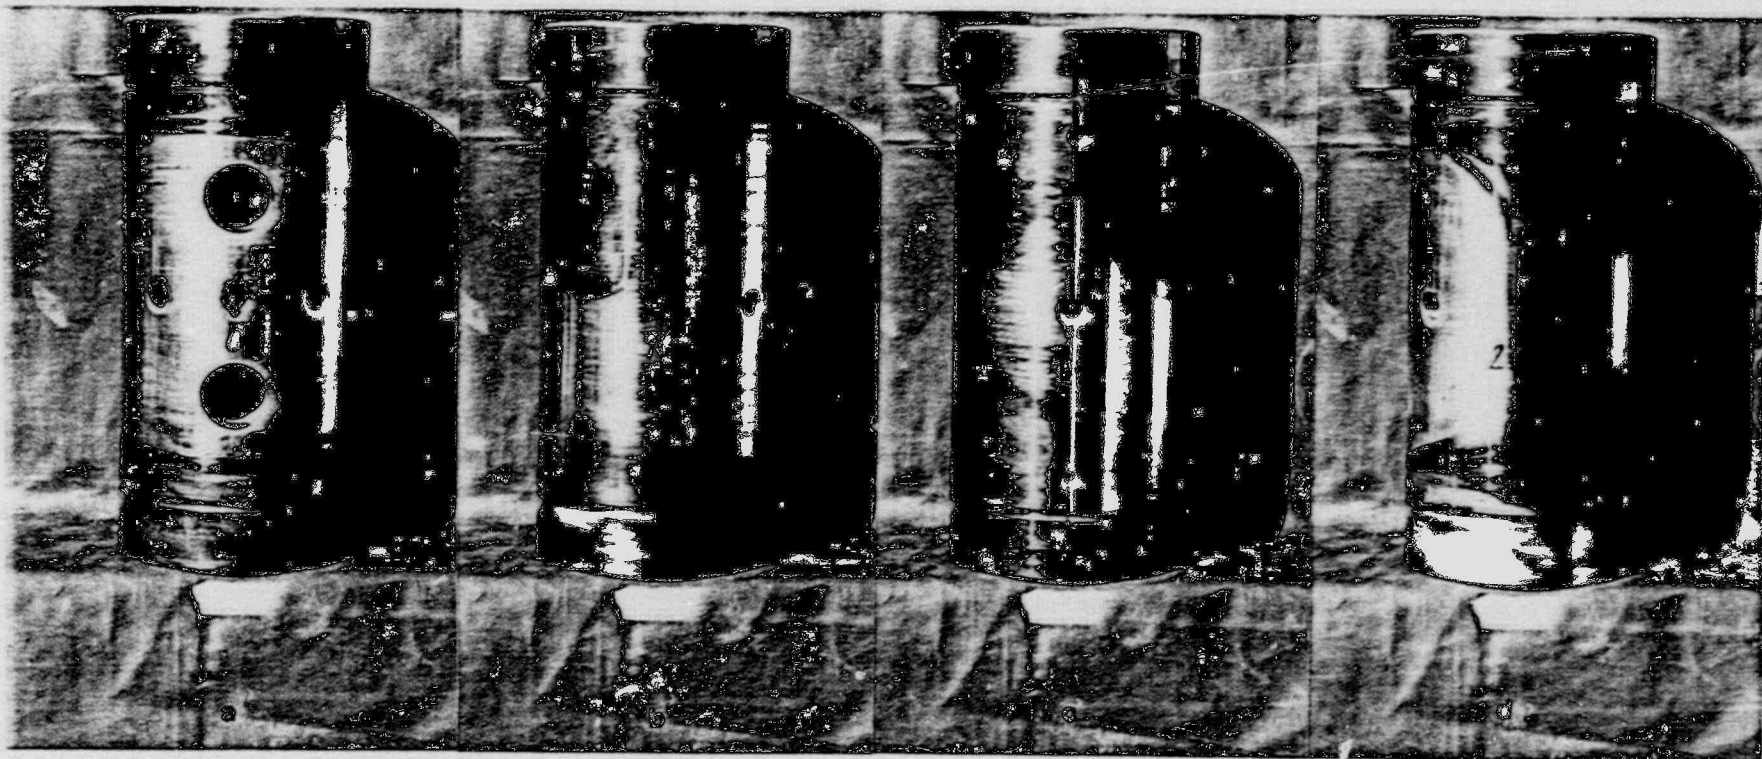
1.2.1 The 5R piston characteristics were similar to those of the 7L piston from the "B" D/G failure on September 16, 1989 - the blackened areas with scratched and smeared metal, worn rings, rings with caked debris, piston skirt cracking. The piston damage caused by the lack of lubrication and overheating is shown in photographs in Figures C-6, C-7 and C-8. The major differences were (1) the end caps were only slightly scratched, (2) the piston skirt contained two deep holes, and (3) the piston wrist pin and its bushing suffered major overheating (bluing). The bushing had broken free from its bore in the piston due to the contact between the pin and bushing caused by the pin expansion and loss of lubrication from the heating. From the heat, the bushing flowed into the shape of the oil grooves at the pin ends. There was so much contact between the pin and bushing that they had to be cut apart. The pin exhibited normal wear patterns at the interface between the pin and connecting rod, indicating no loose connections (Figure C-5a). Photos in Figures C-3, C-4 and C-5 show the damage to the pin and bushing.

Figure C-5. a) thru d) Photographs of the discoloration (bluing at various positions around the pin from the 5R piston, C diesel.

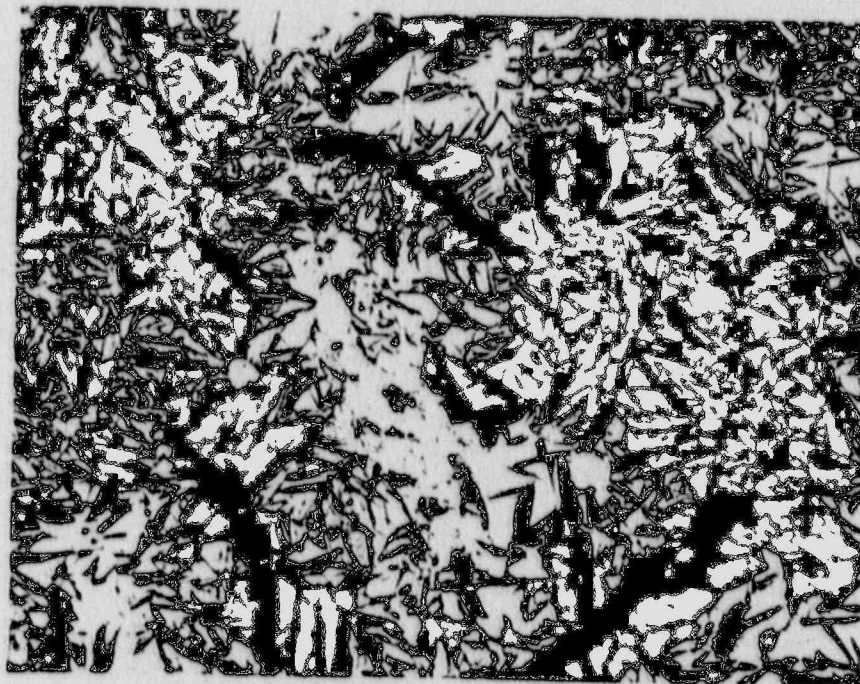
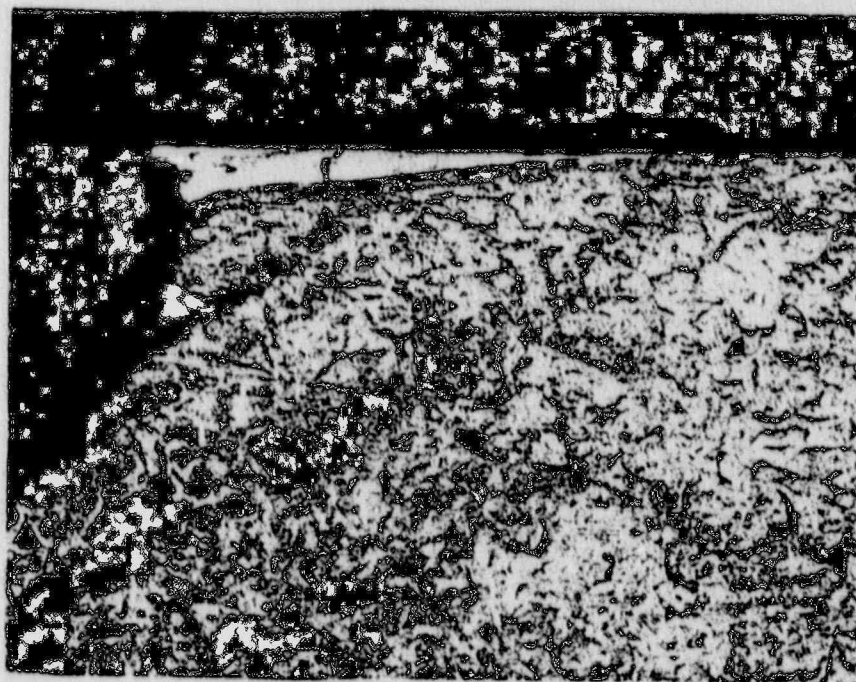
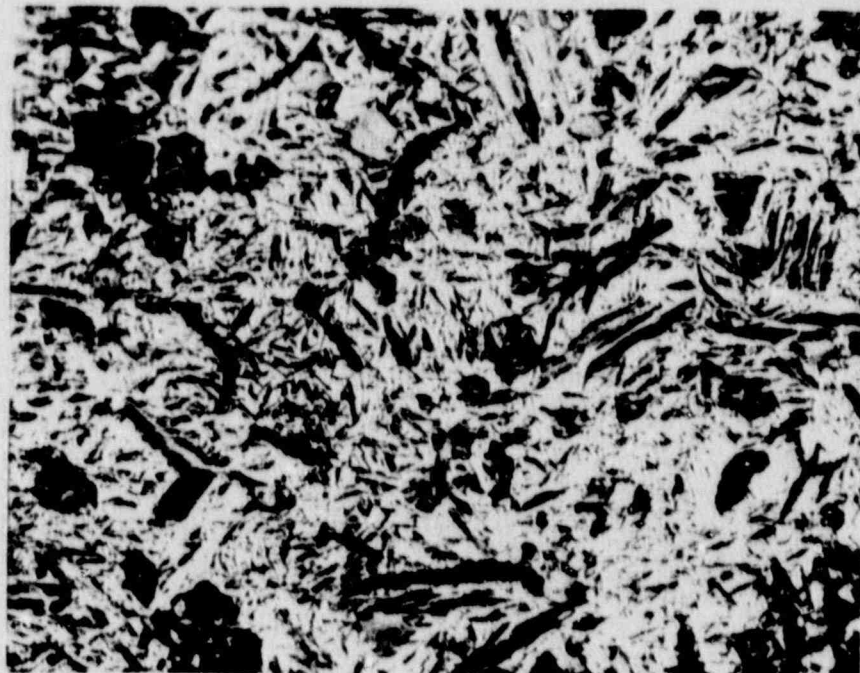
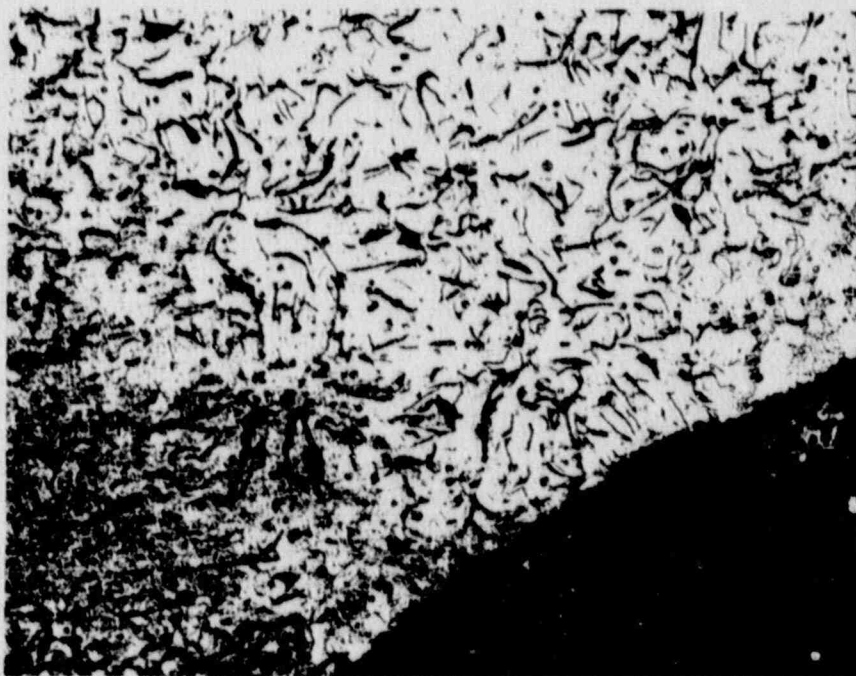
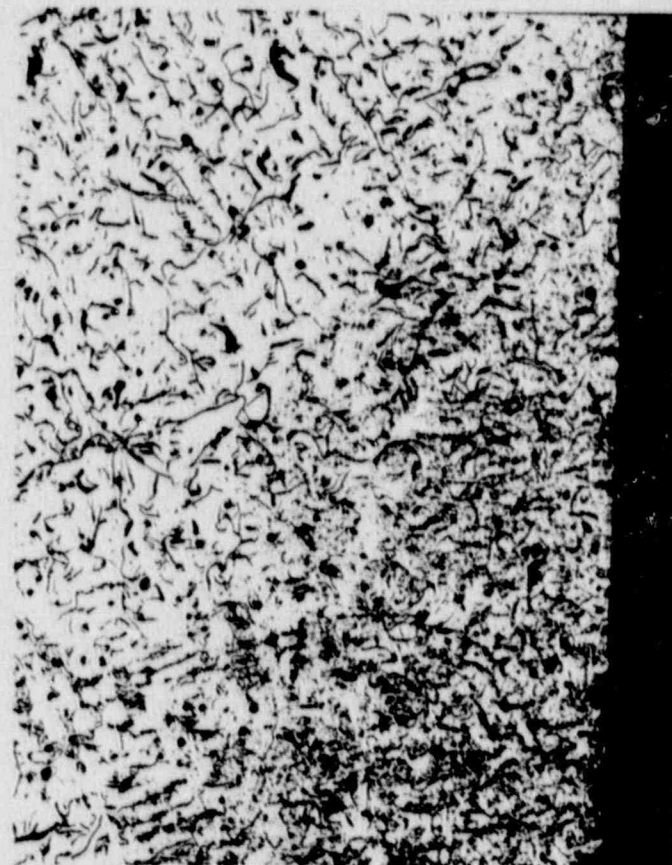
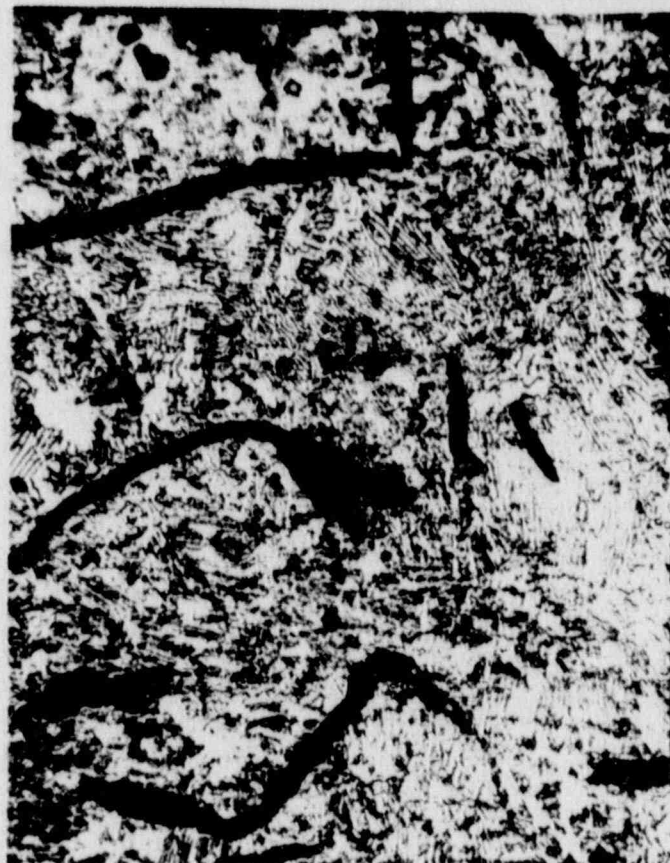
Figure C-11. Microphotographs of typical areas around hole 'A' in the 5R piston skirt. See Figure C-10 for locations, a) Area KM at 800C showing a coarse martensitic structure; b) Area K-J at 50X showing coarse martensitic and smear metal layer of iron chrome and tin on surface of hole 'A' c) Area H-G at 50X showing transition from a martensitic to a pearlite structure; d) Area C-B at 800X showing coarse martensitic structure; e) Area B-Q at 800X showing pearlite structure around graphite stringers; f) Area A-B at 50X showing a mixed structure of fine pearlite and martensite.

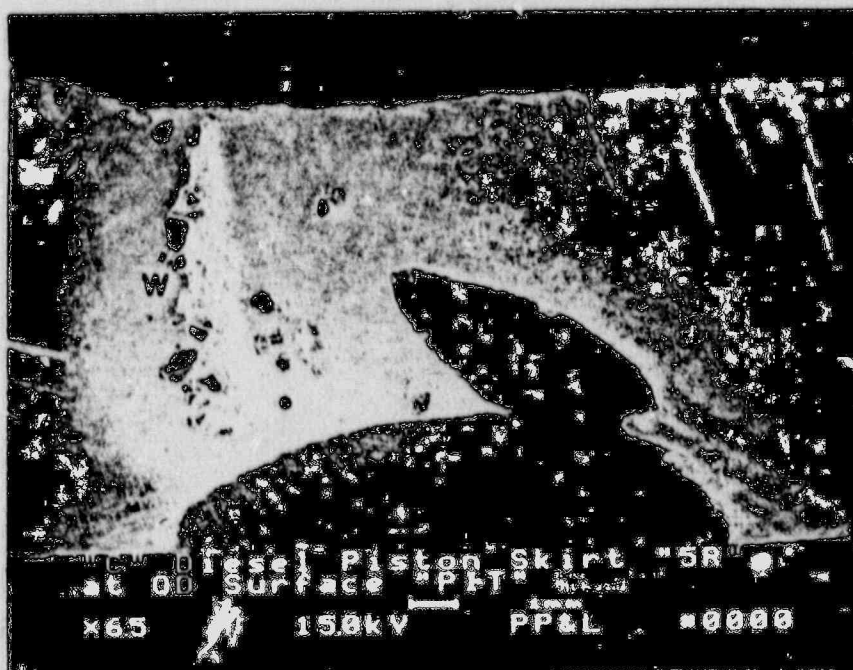
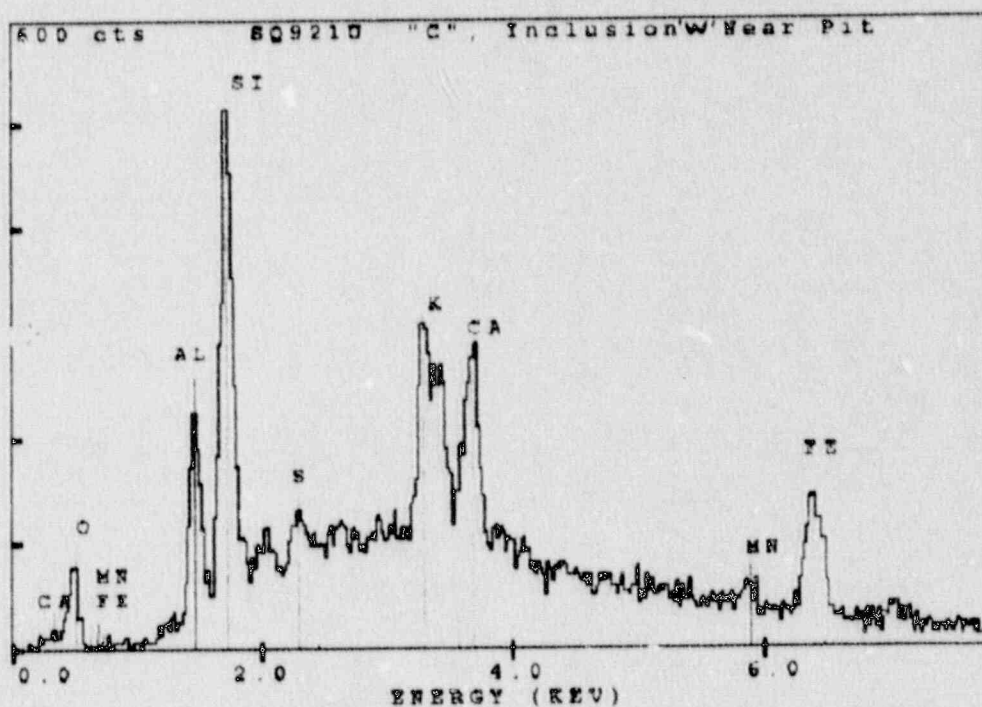
Figure C-12. S.E.M./E.D.S. analysis of inclusion 'W' below hole 'A' in 5R piston skirt a) SEM photo at 6.5X showing inclusion 'W' b) Spectrum of the elements in the inclusion 'W'.

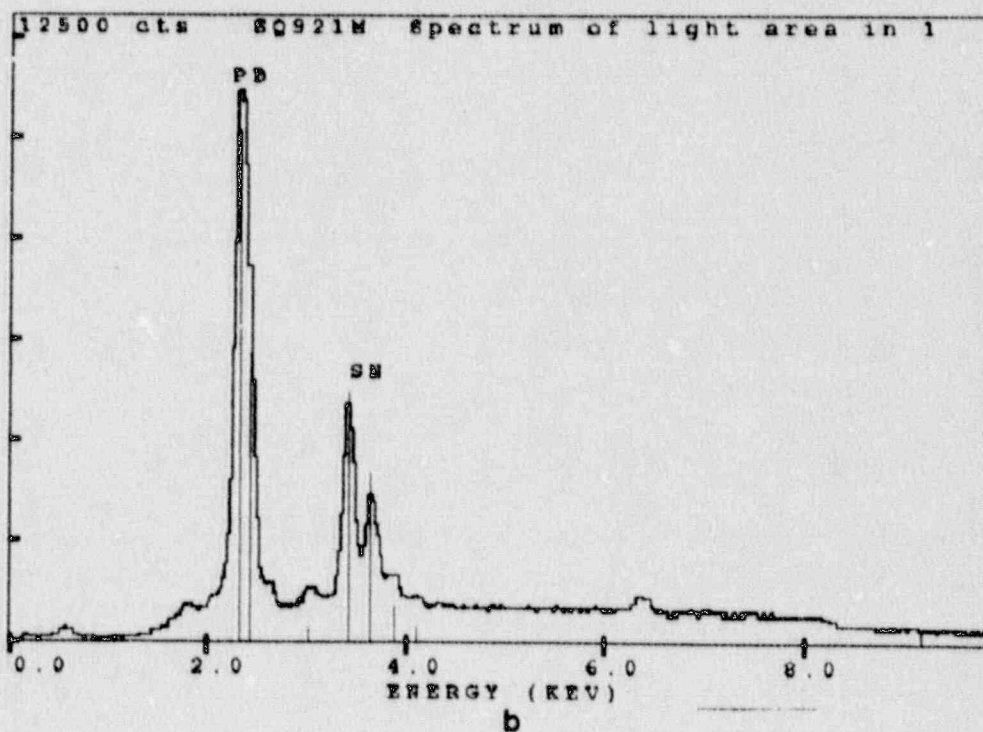
- 3.2 The piston skirt contained two holes in the non-thrust side. These holes were created as part of the casting process for the piston. The presence of a lead/tin eutectic indicated that this area was repaired with solder during the manufacturing process. Cooper's QC records indicated that solder was used to fill the voids in the piston skirt. Also this portion of the liner extends beyond the bottom of the skirt at the end of the downstroke and any debris from this area would eject into the sump. Thus, these holes in the piston skirt had no impact on the failure.

Figure C-13. S.E.M./E.D.S. analysis of the Lead-Tin Eutectic on the surface of hole 'A' in 5R piston skirts a) SEM photo at 1300X showing the Pb-Sn Eutectic on surface of hole; b) Spectrum of the elements in the light area in a above.

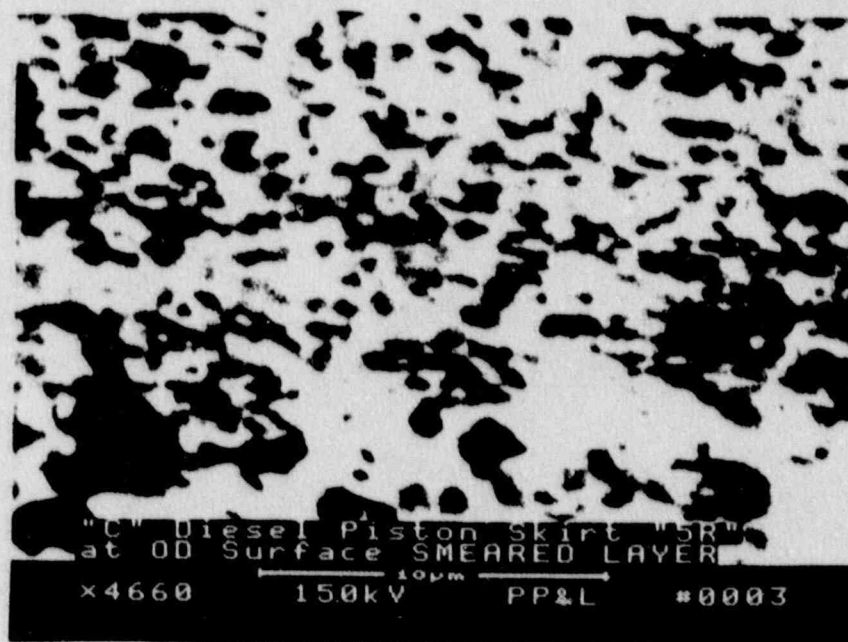
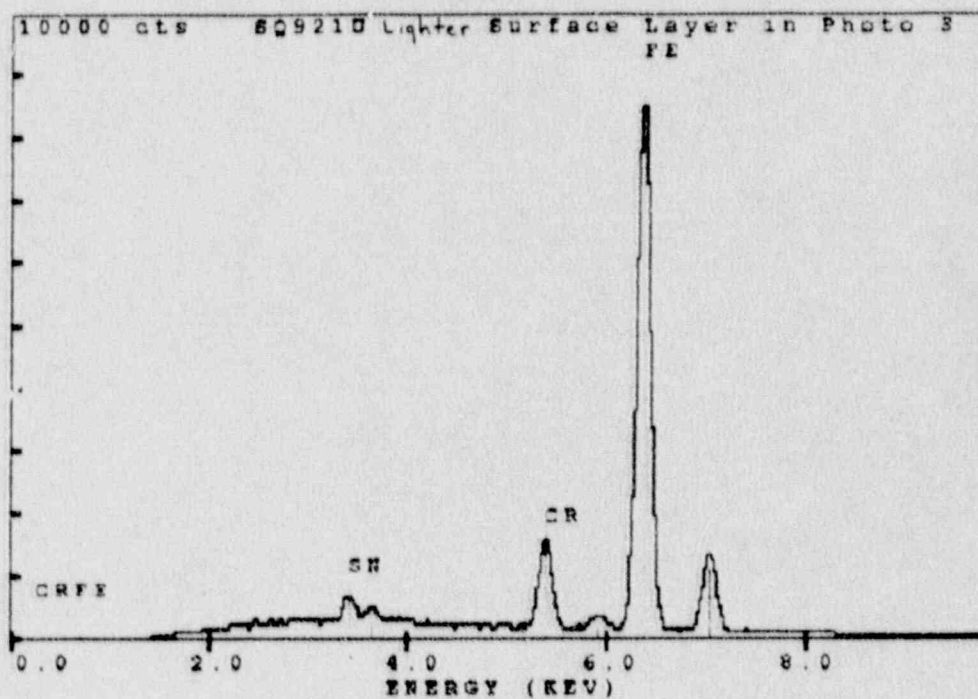
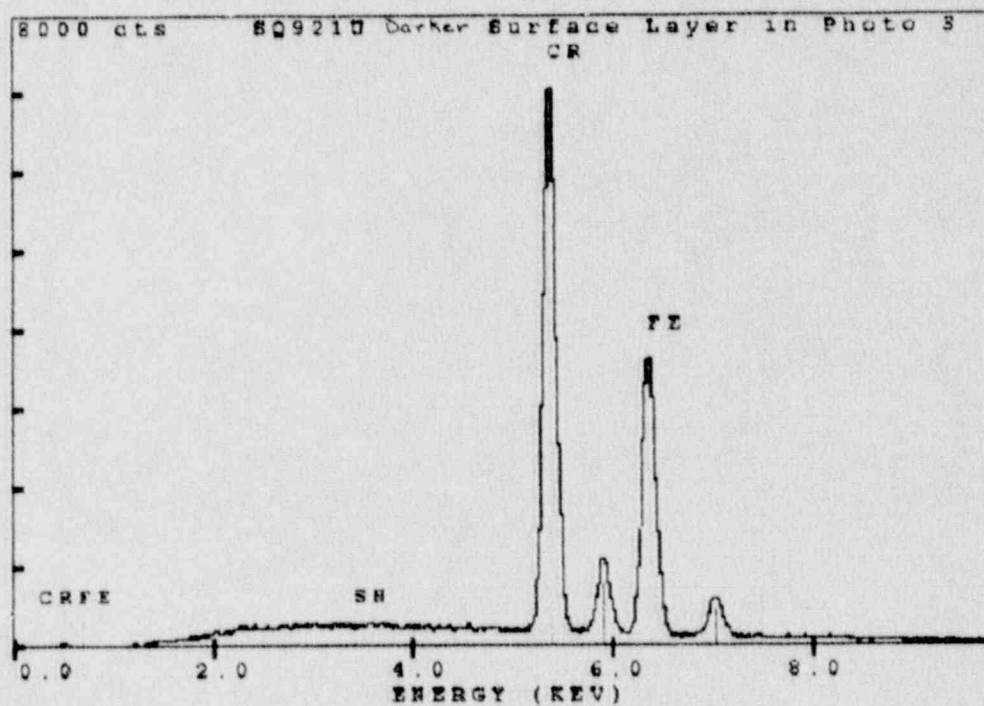
Figure C-14. S.E.M./E.D.S. analysis of smeared metal layer on surface of 5R piston skirt at Area J (see Figure C-10) photo at 4660X of smeared metal layer; b) Spectrum of LIGHTER AREA in photo in C-14a above; c) Spectrum of darker area in photo in C-14a.

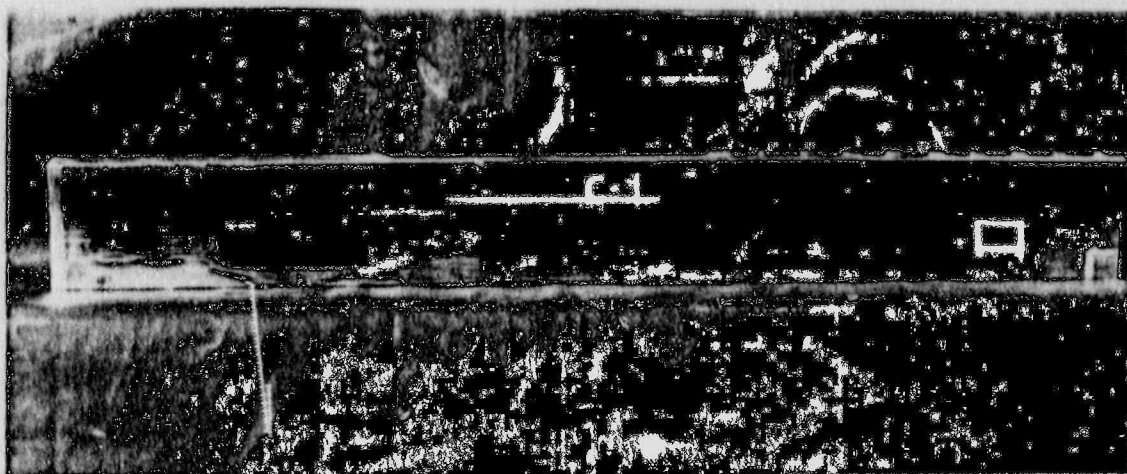
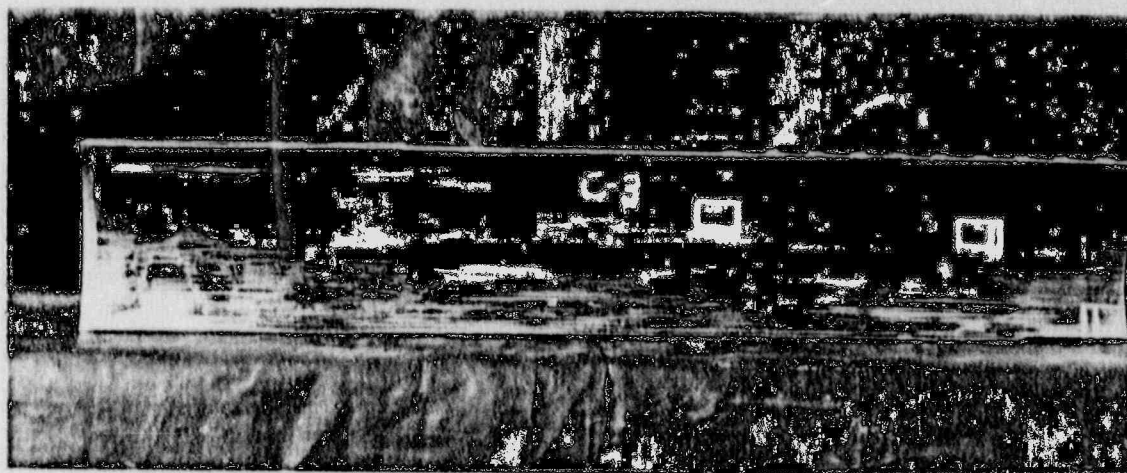
Figure C-15. Photos of 5R liner sections C-1, C-2 and C-3; a) liner section C-1 longitudinal section taken from thrust side; b) Liner section C-2 longitudinal section taken from end cap side; c) Liner section C-3, longitudinal section taken from the non-thrust side.

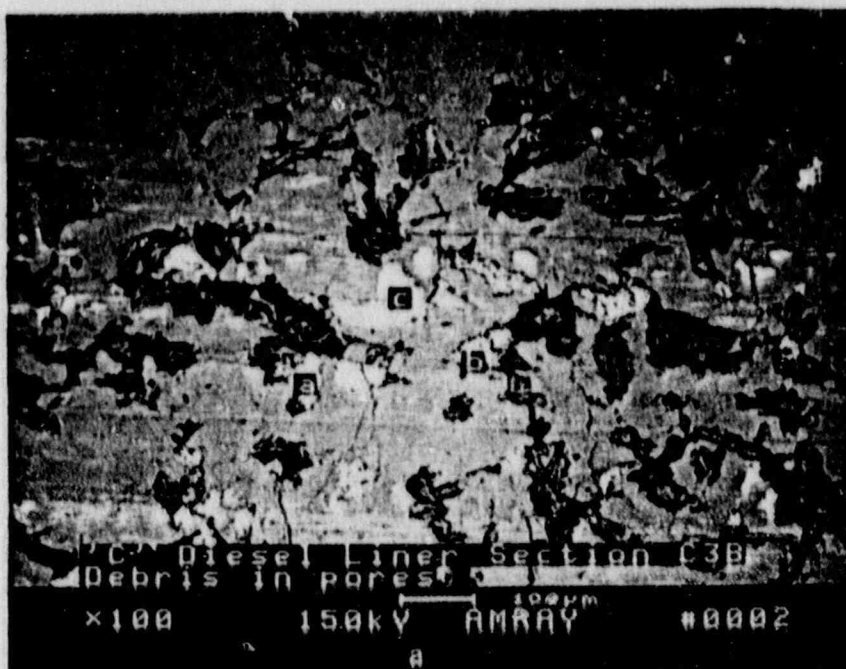
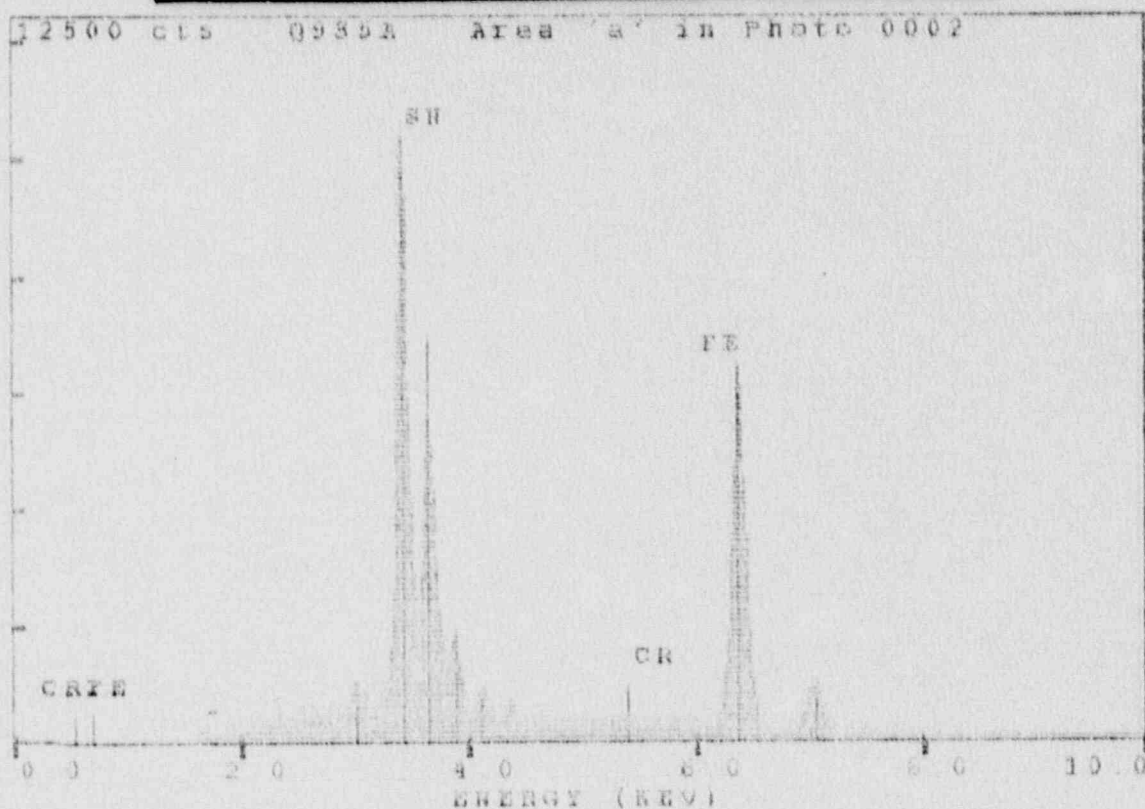
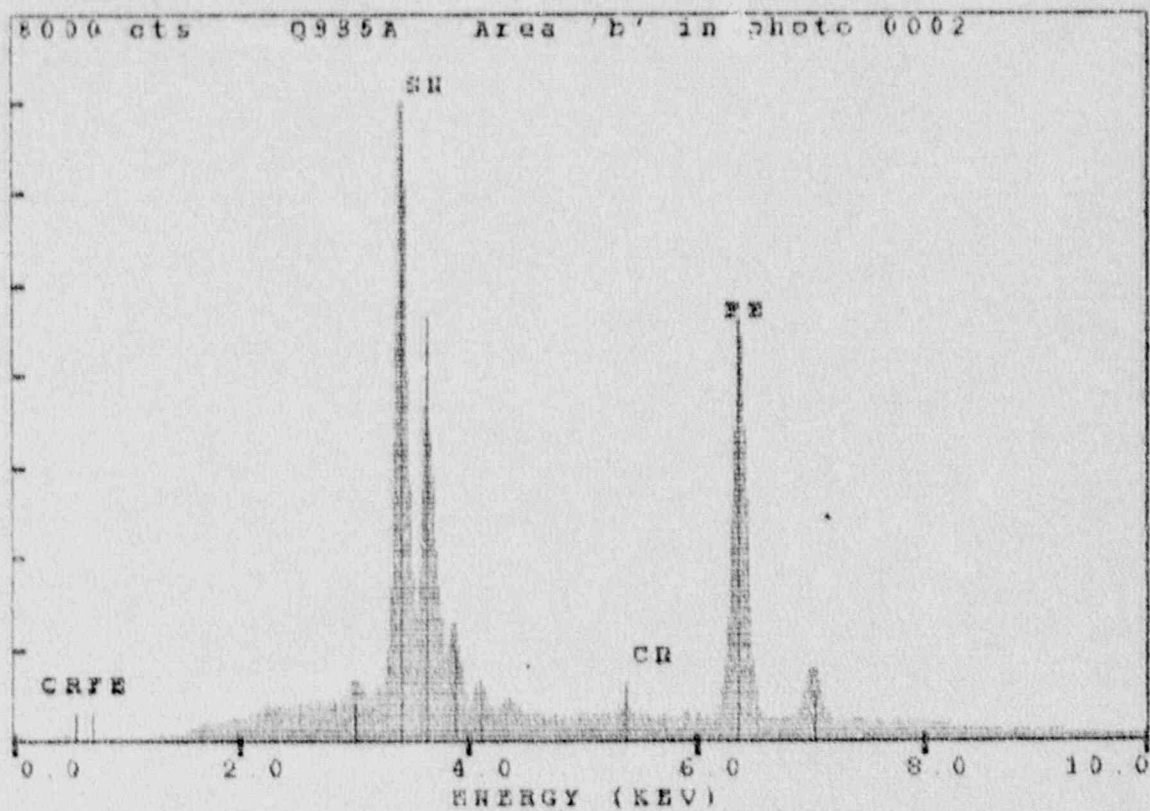
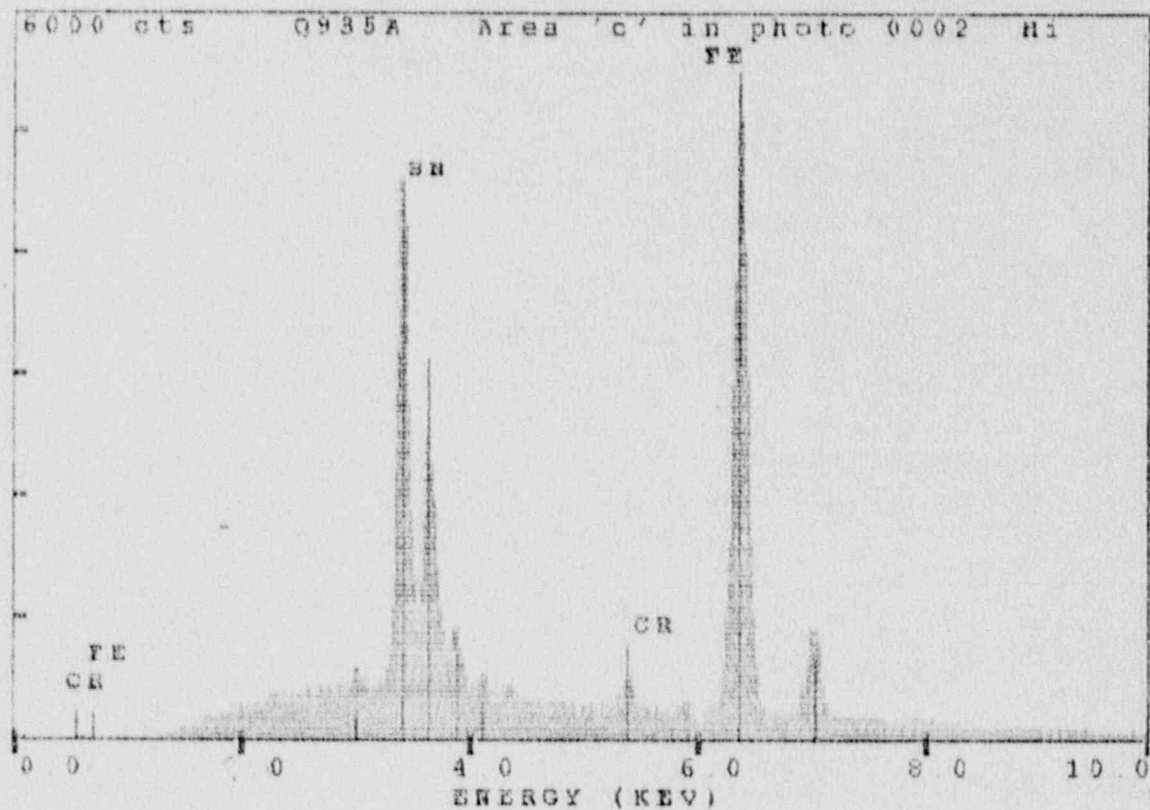
Figure C-17. S.E.M./E.D.S. analysis of the debris in the pores in liner section C-3B (see Fig. C-16); a) S.E.M. photo at 100X of section C-3 denotes area a, b, & c for analysis on E.D.S.; b) Spectrum of area 'a' showing the presence of mostly tin and iron; c) Spectrum of area 'b' showing mostly tin and iron with a small peak of chrome; d) Spectrum of area 'c' showing mostly iron and tin with a small peak of chrome.

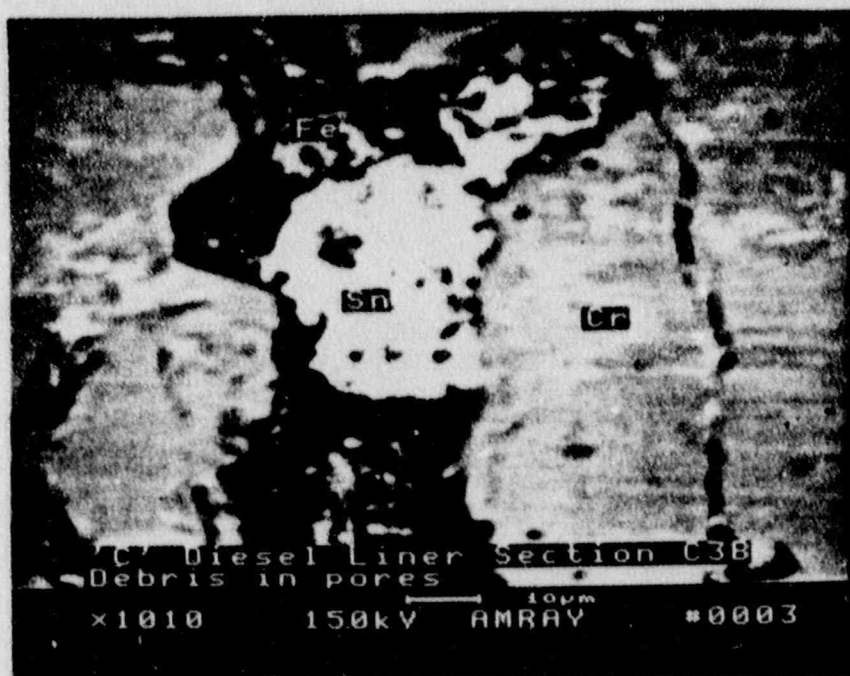
Figure C-18. Microphoto from S.E.M. 1010X showing the iron and tin particles in a pore in the chrome layer on liner section C-3B.

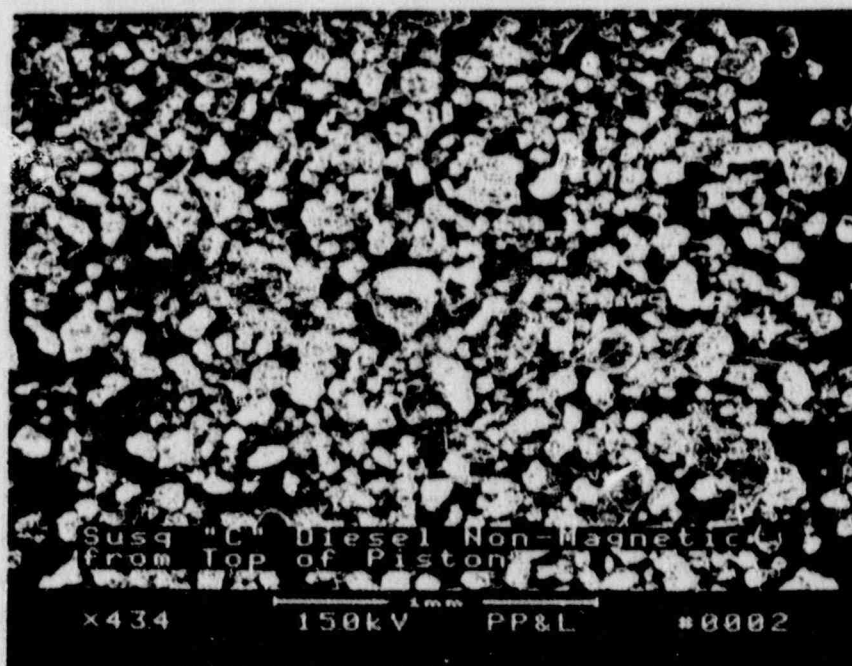
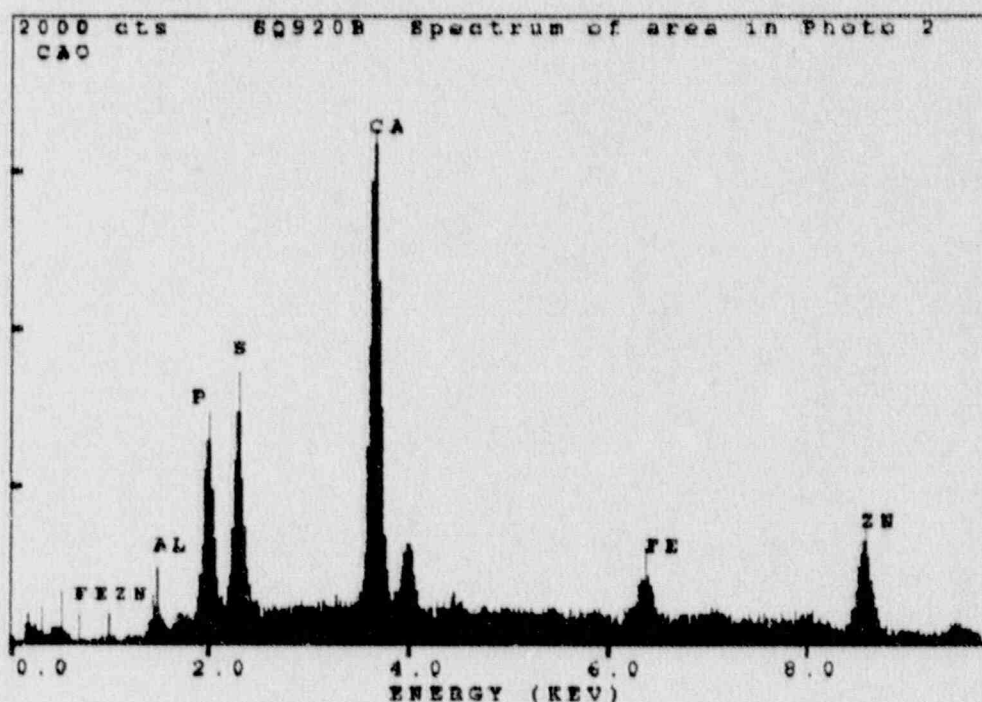
Figure C-19. S.E.M./E.D.S. analysis of non-magnetic particles taken from the top of the 5R piston, C diesel; a) S.E.M. photo of 43.4X of non-magnetic particles; b) Spectrum of area in the S.E.M. photo.

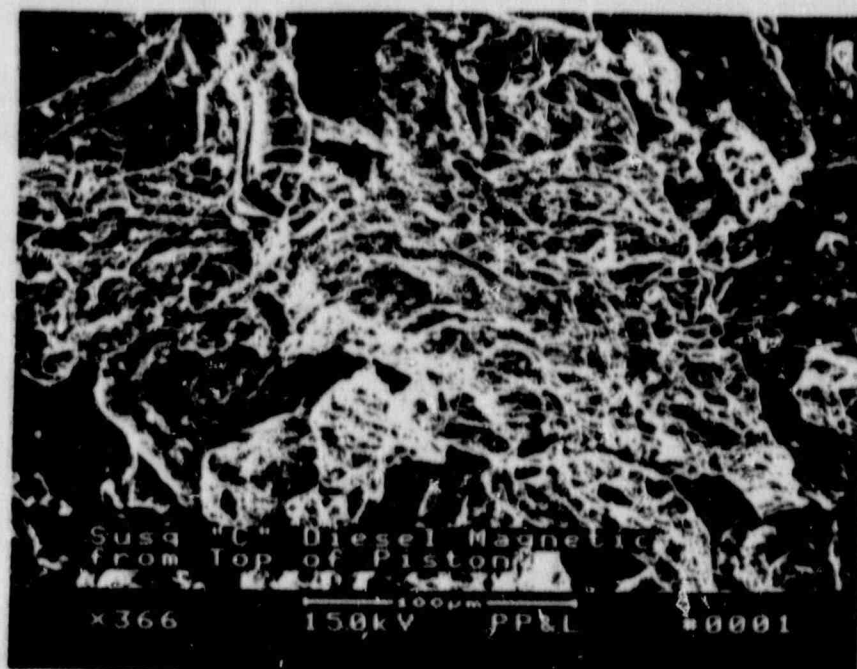
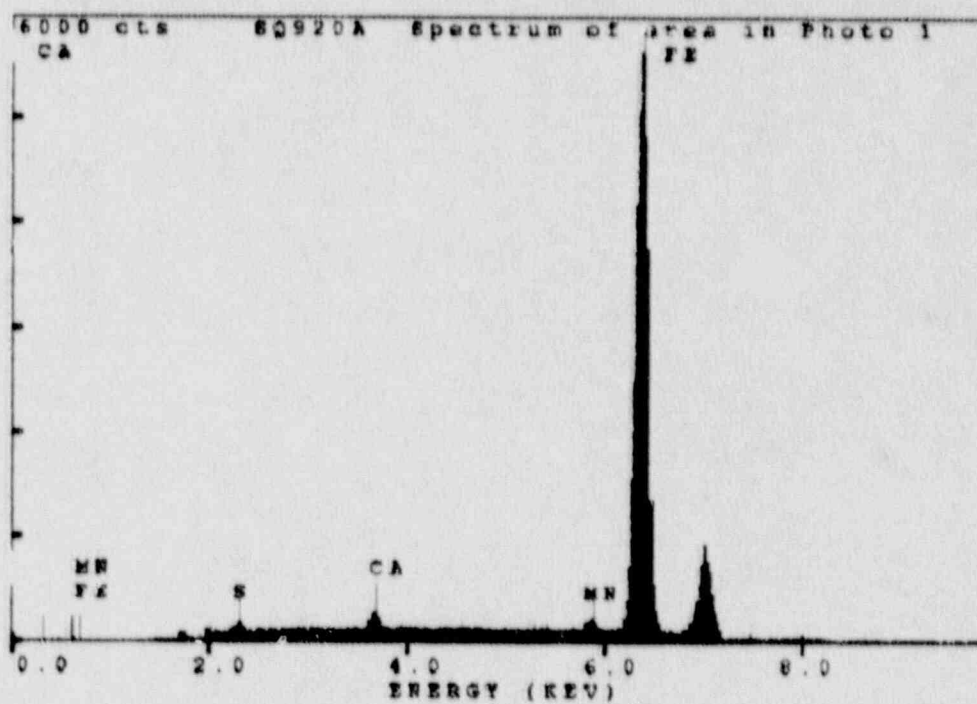
Figure C-20. S.E.M./E.D.S. analysis of magnetic particles taken from the con of the 5R piston, C diesel, a) S.E.M. photo at 366X of magnetic particles; b) Spectrum of area in S.E.M. photo.

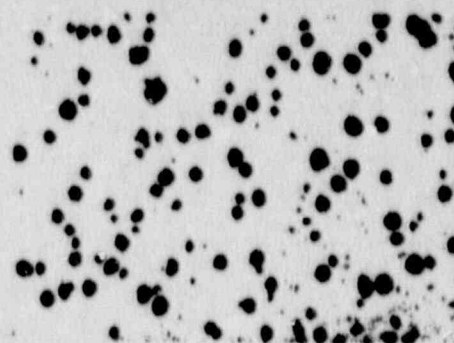
100X Unetched
Spheroidal type of graphite

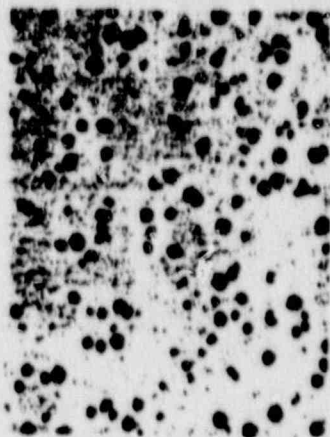
Centrifugally Cast - 100X - Unetched
Spheroidal type of graphite.

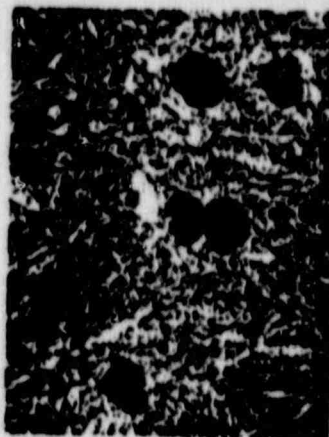
Centrifugally Cast - 500X - Picral Etch
Tempered martensite matrix.

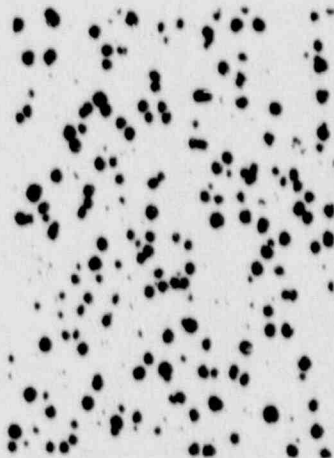
Centrifugally Cast - 100X - Unetched
Spheroidal type of graphite.

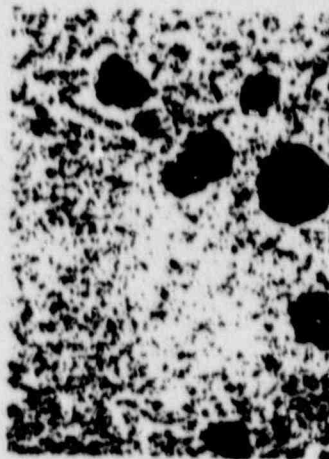
Centrifugally Cast - 500X - Picral Etch
Tempered martensite matrix.

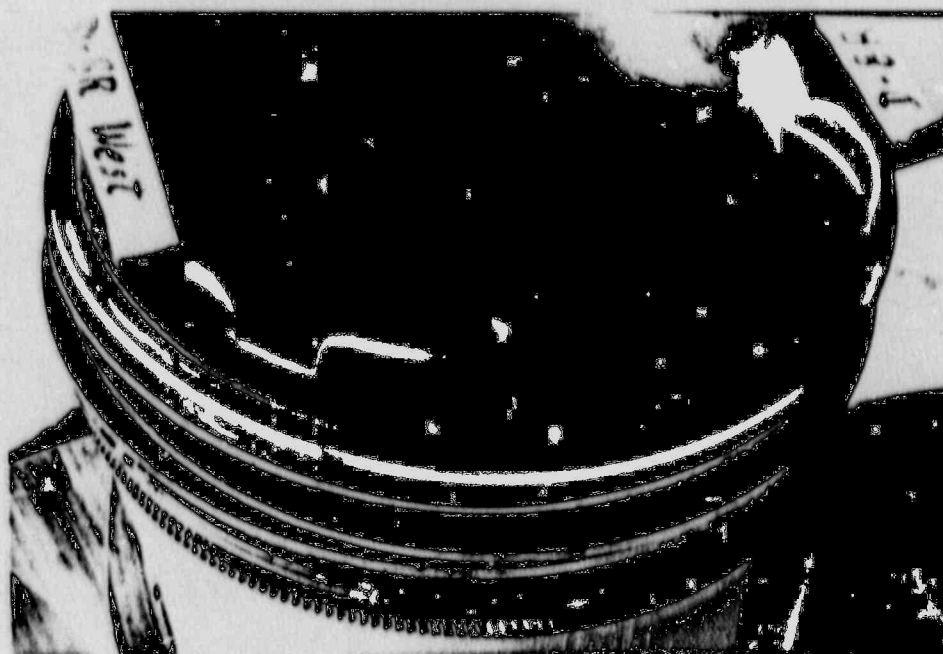
Figure D-1. (c) Thrust (south) side of BR piston showing no deposits on head. (d) East (generator end) of BR piston - note complete removal of tin coating on left side.
