**ANALYSIS OF "B"
& "C" 1989
DIESELS FAILURE**

SEA-CW-037

ROOT CAUSE FAILURE ANALYSIS OF "B" AND "C" DIESELS: 1989

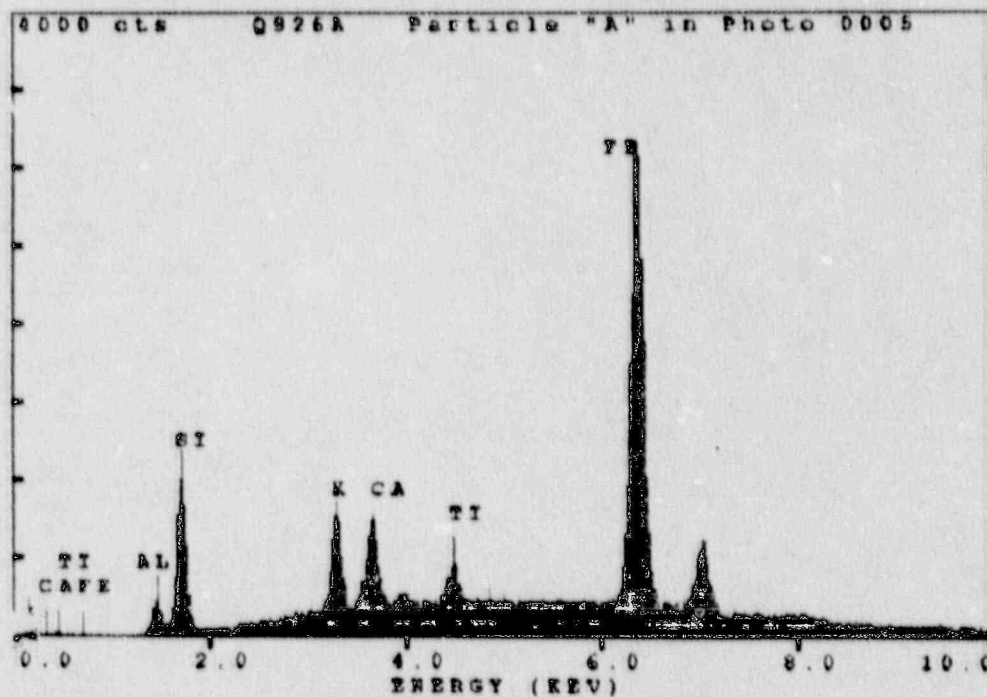
Figure D-2. (a) Caked deposits from the top compression ring of the 8R cylinder. (b) EDS analysis of deposits from area "A."

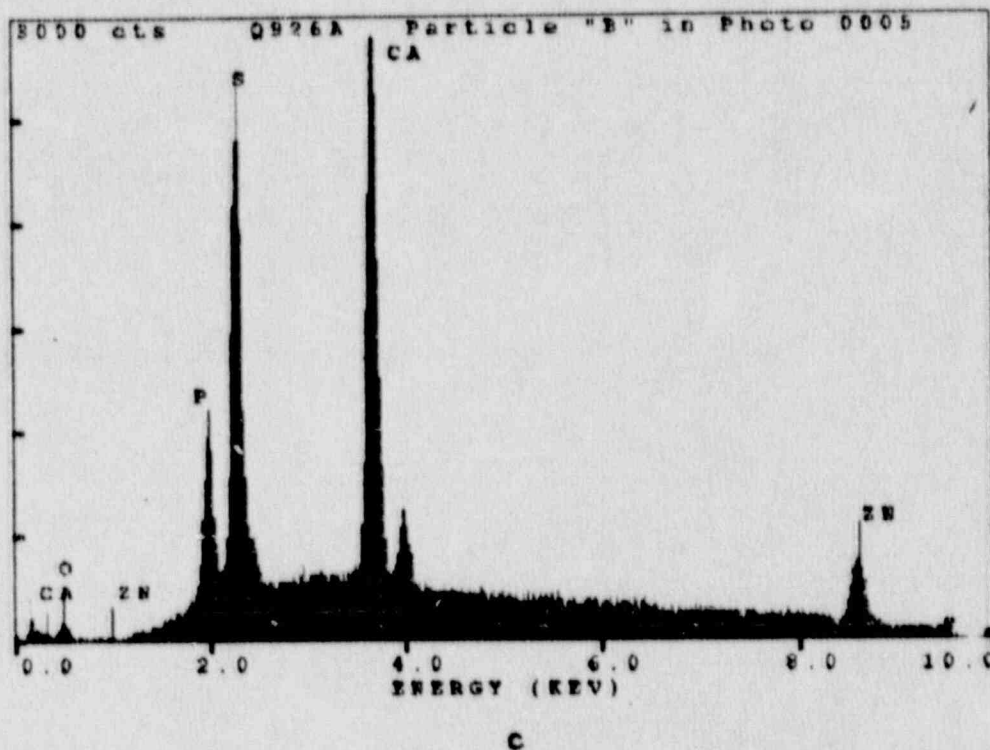
Figure D-2c. EDS analysis from area "B" of Figure D-2A.

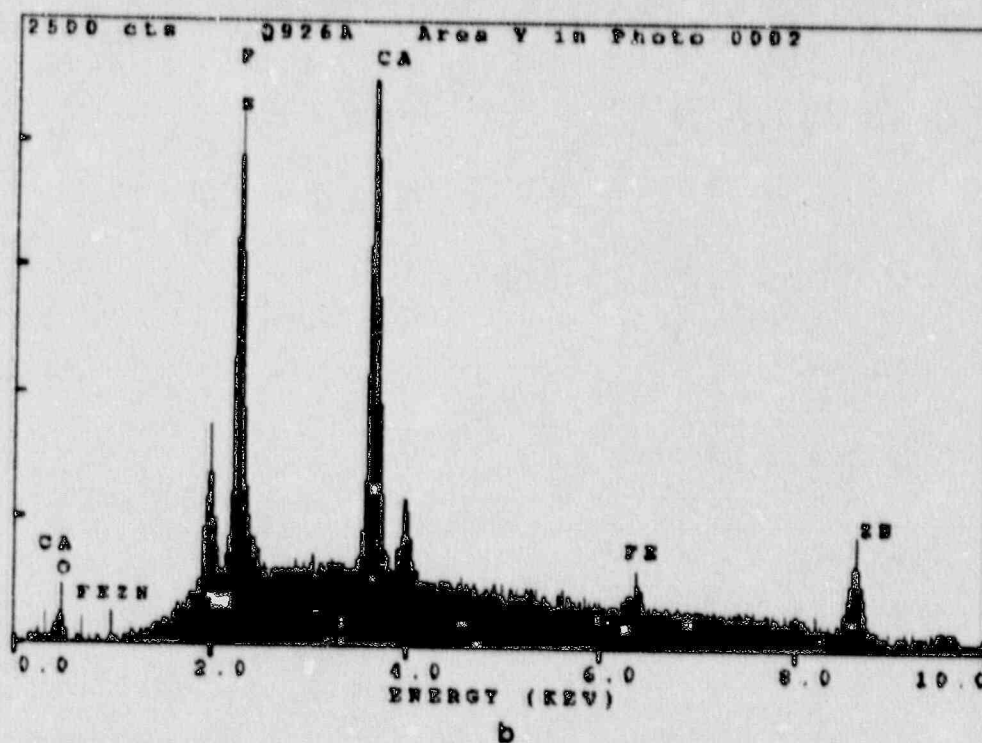
Figure D-3. (a) Debris from behind the No. 2 compression ring. (b) EDS of debris (area "Y") showing presence of P, S, Ca, and Zn.

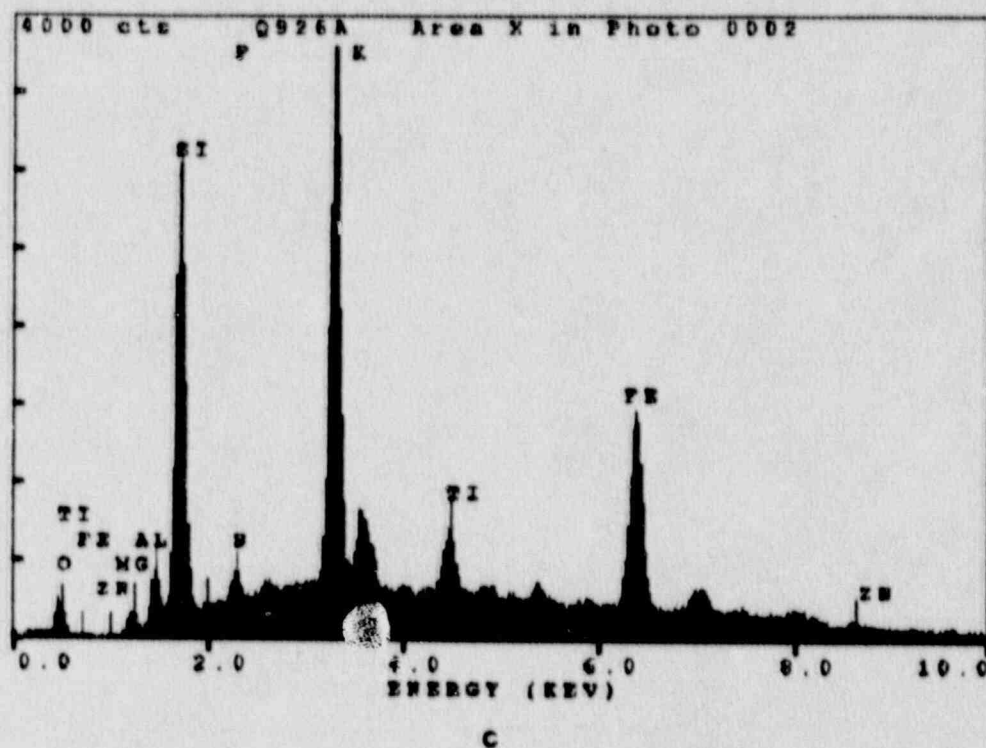
Figure D-3C. EDS of debris (area "X") in Figure D-3a showing the presence of K, Si, Fe, Ti, S, Al and Mg.

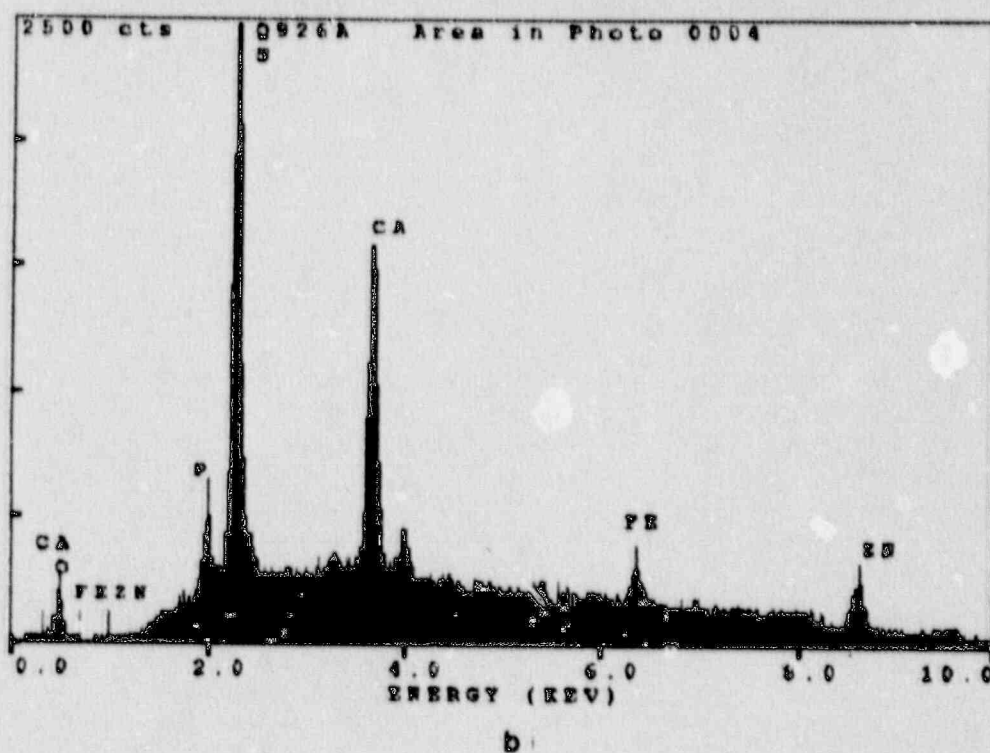
Figure D-4. (a) Debris from the lower oil ring of the "D" diesel 8R cylinder. (b) EDS analysis showing the elemental content of the debris in (a).

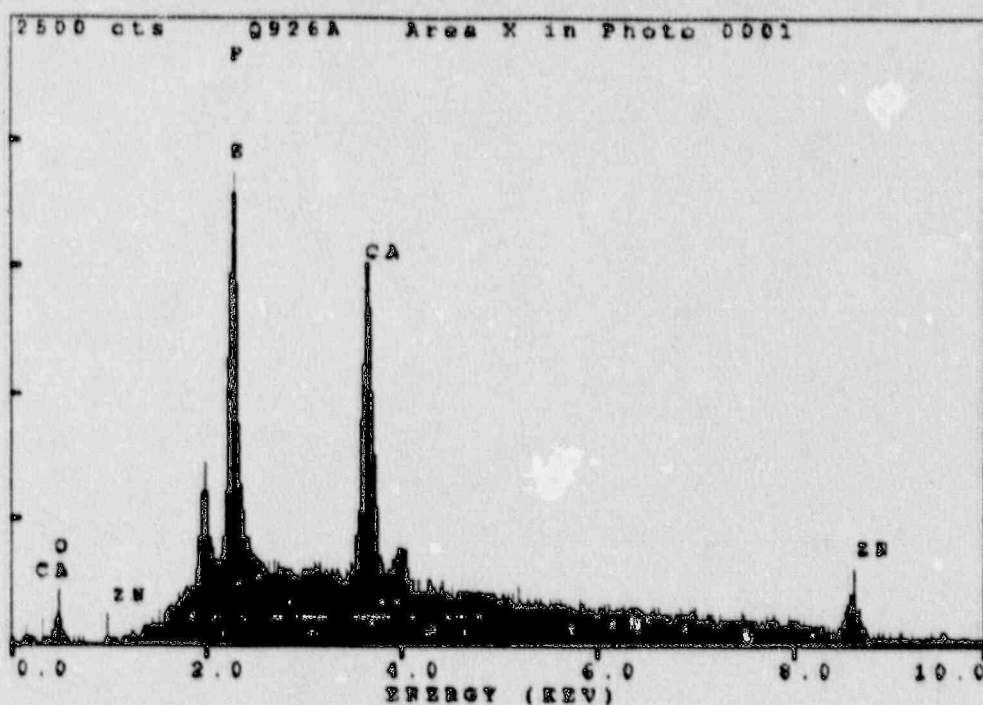
Figure D-5. (a) Oil deposits from the top compression ring of the "D" diesel 8R piston. (b) EDS analysis of particle "X" in picture (a) showing the presence of S, Ca, P and Zn.

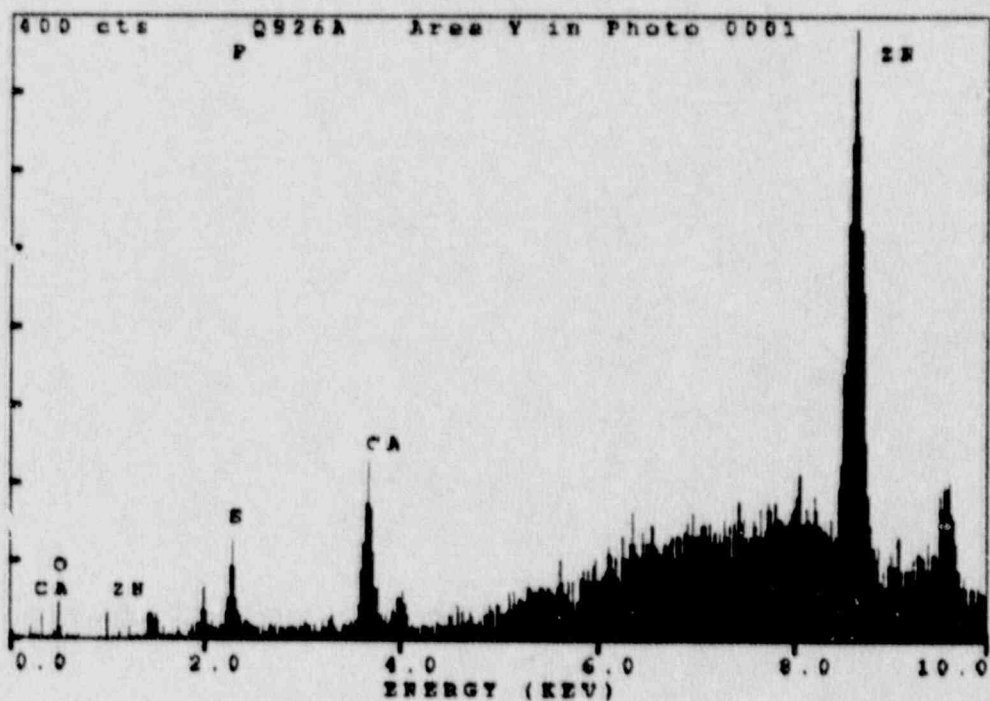
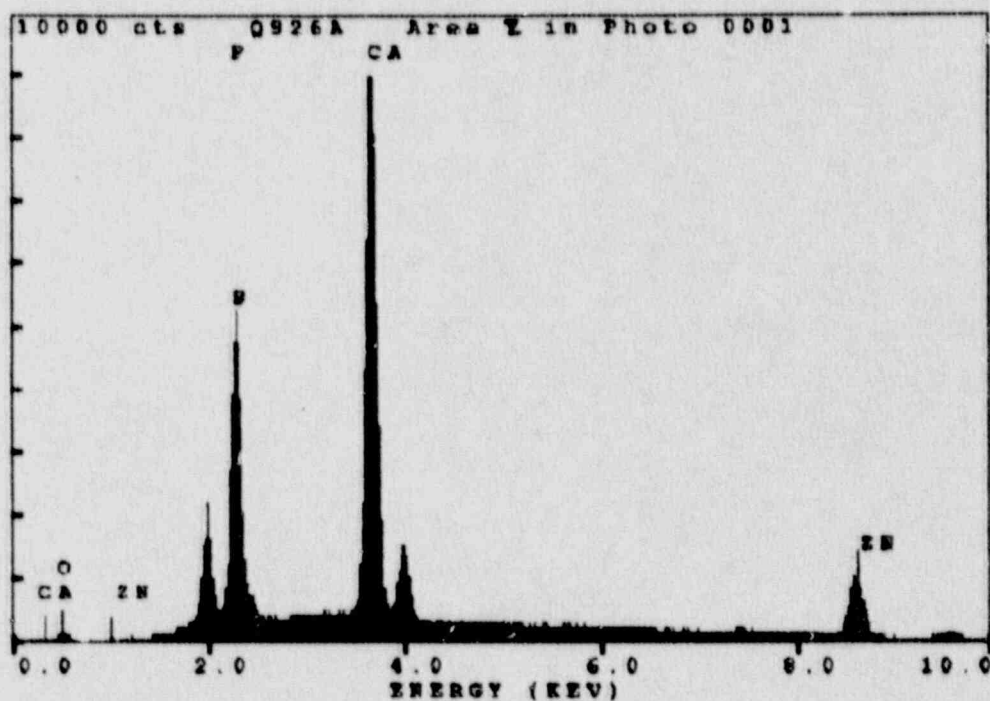
Figure D-5. (c) EDS elemental content of area "Y" in (a) showing the presence of Zn, Ca and S. (d) EDS elemental content of area "Z" in (a) showing the presence of Ca, S, P and Zn.

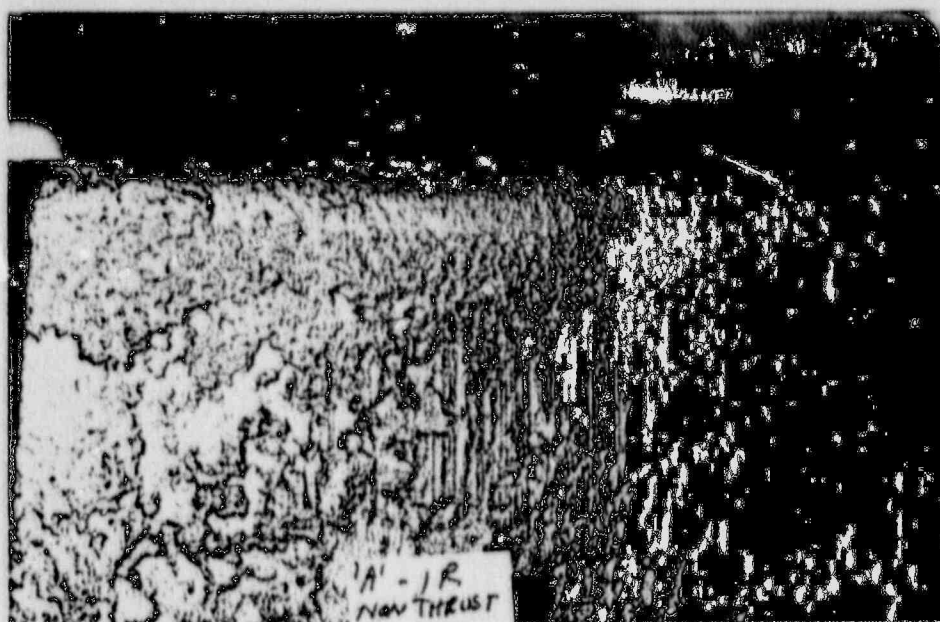
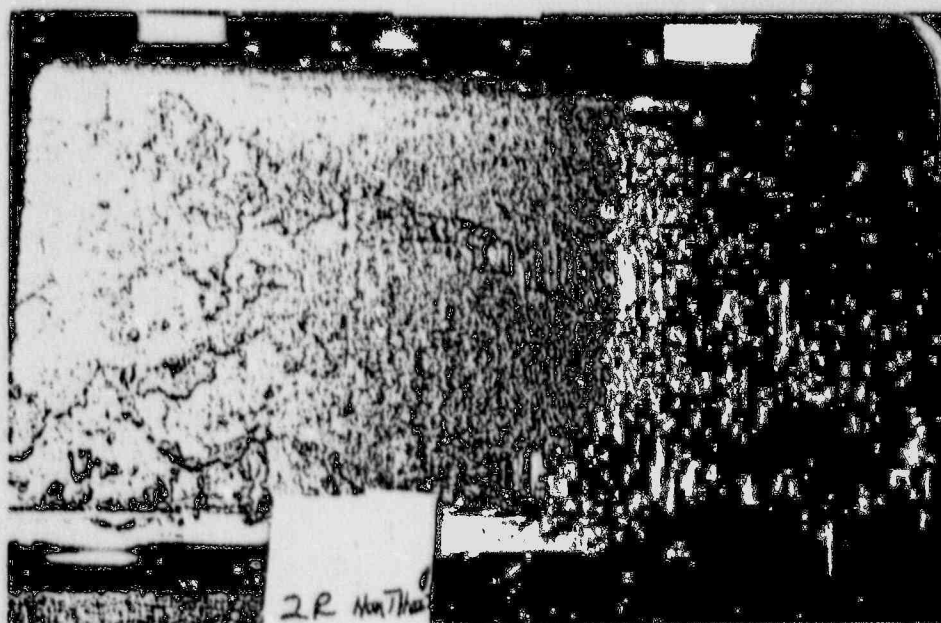
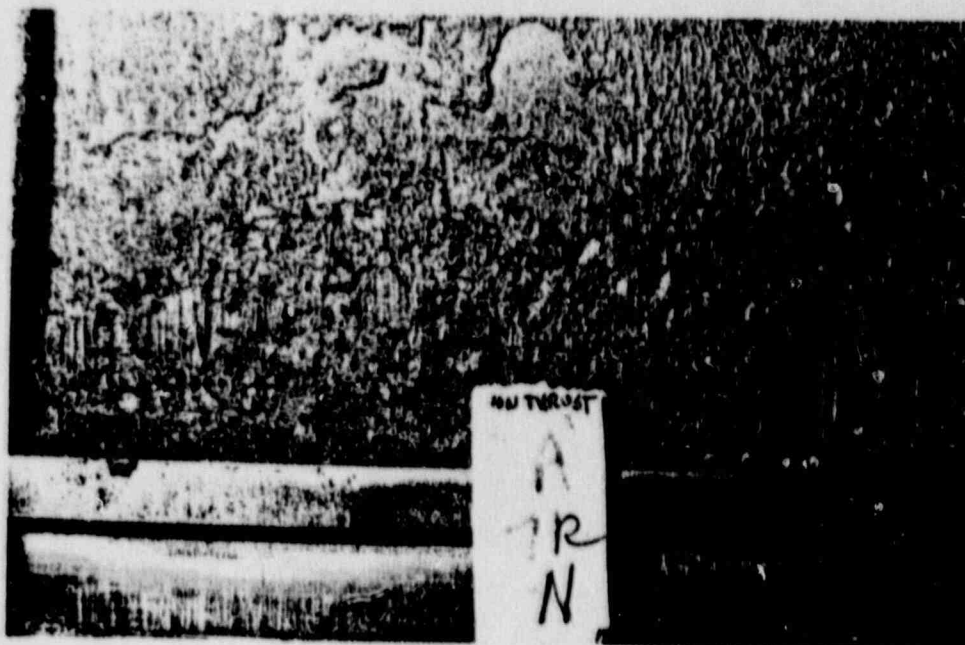
Figure A-1. Closeup photos of debris on the non-thrust side of pistons 1R, 2R and 7R (a, b and c, respectively).
