## DUKE POWER COMPANY

Re: Oconee Nuclear Station  
Docket No. 50-269

Report Number: RO-269/81-11

Identification of Occurrence: Core Barrel Assembly Thermal Shield Bolts  
Broken

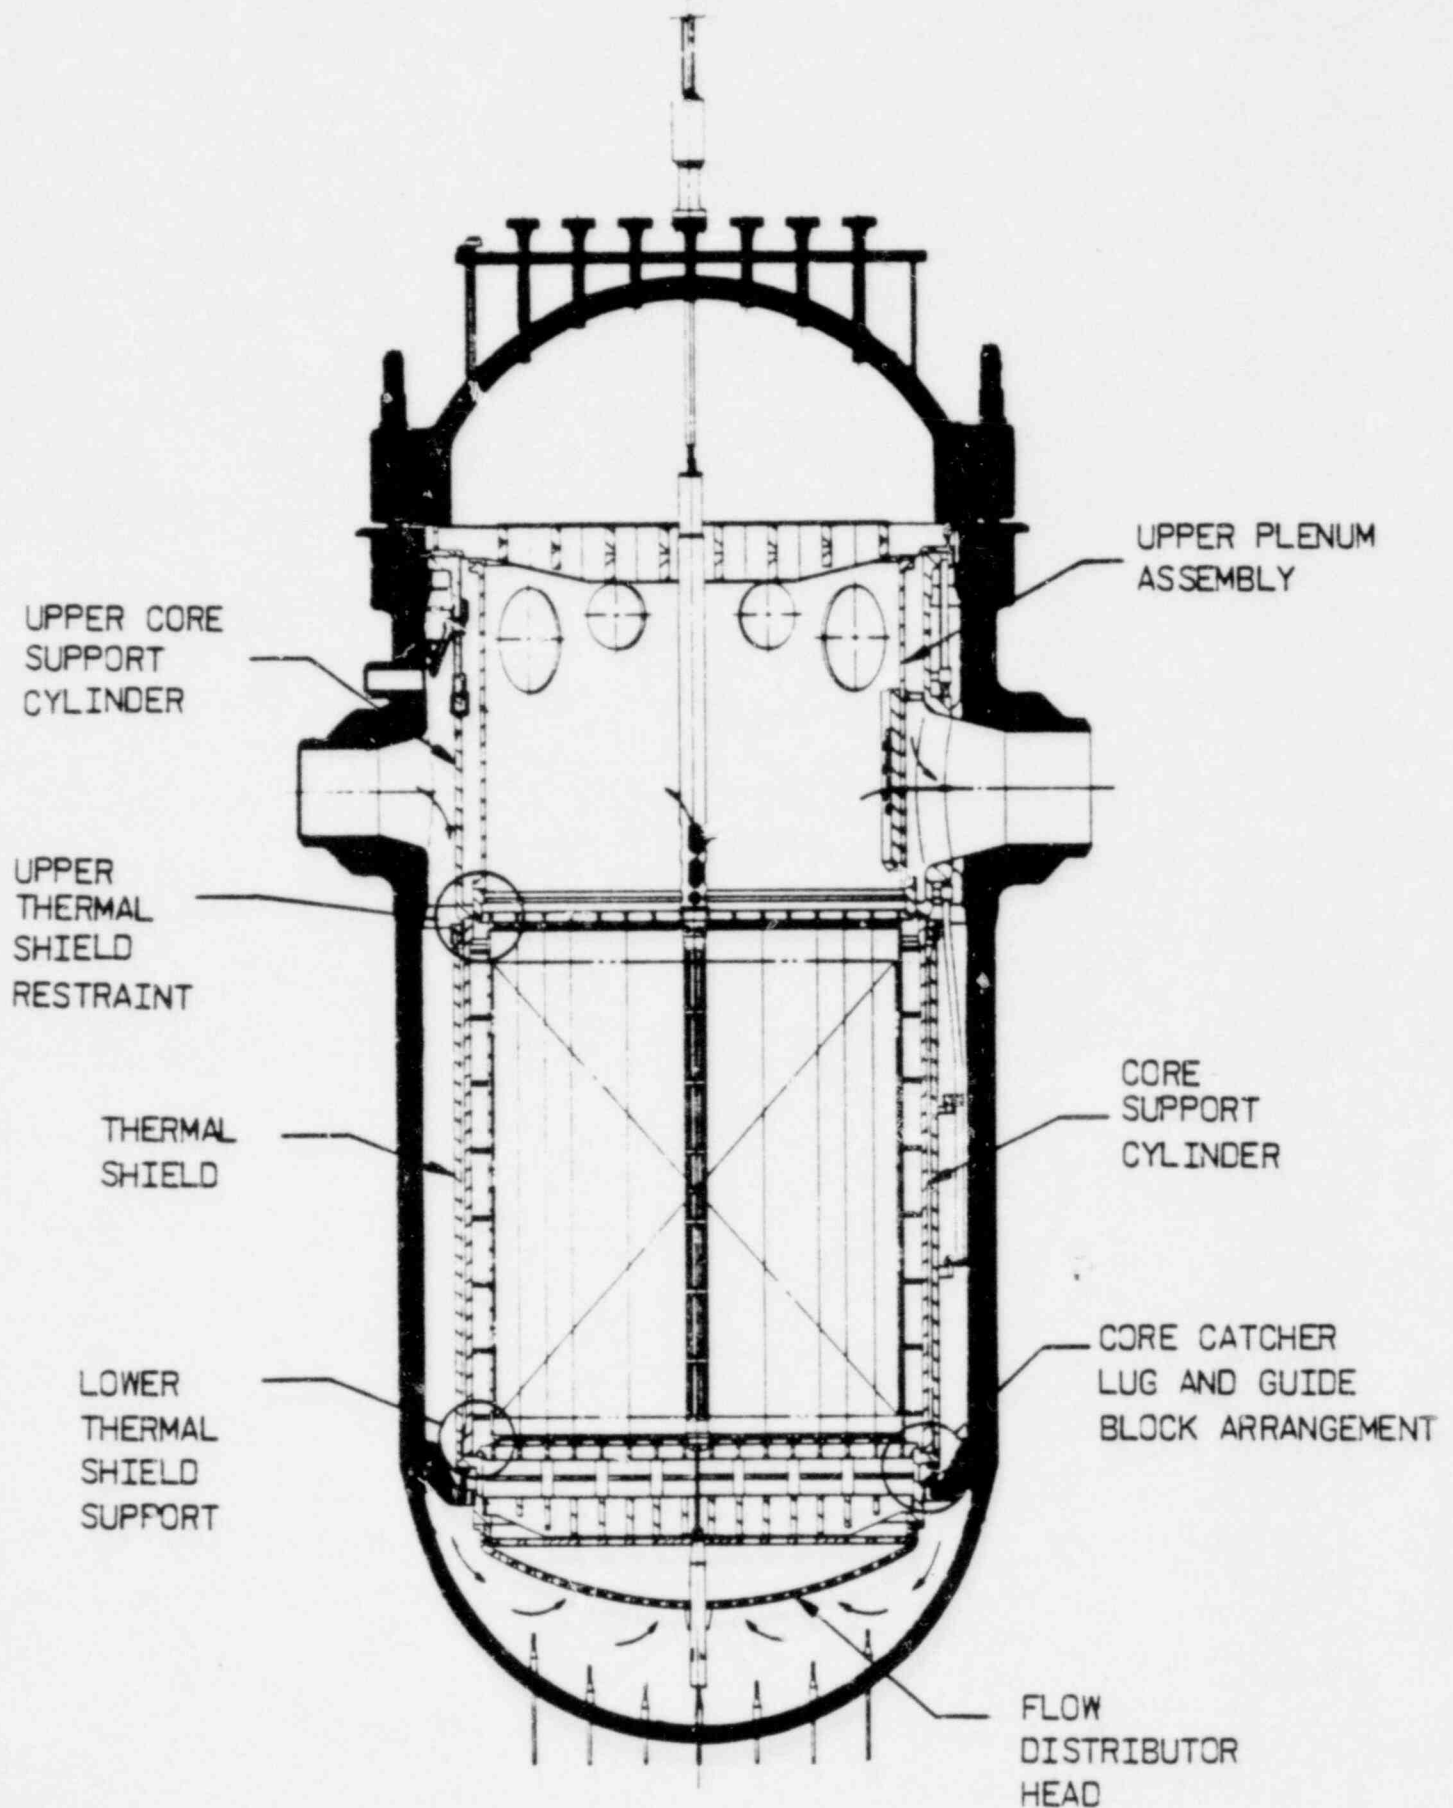
## THERMAL SHIELD LOWER SUPPORT

in Attachment 4. The ID of the thermal shield is machined to clear the bottom flange of the core barrel and to engage the lower grid with a diametral interference fit. Ninety-six 1-inch-diameter, high-strength bolts secure the bottom end of the thermal shield to the lower grid plate. (The four missing bolts were from this location.)
