Examination and Test of Crystal River Unit No. 3 Power-Operated Relief and Safety Valves PWR Safety and Relief Valve Test Program

EPRI NP-80-13-LD
Project V102-31
Interim Report
December 1980
Limited Distribution
Copy Number *223*

Prepared by
MPR Associates, Inc.
Washington, D.C.

In February 1980, an abnormal transient occurred at the Crystal River Unit No. 3 (CR-3) Nuclear Generating Station. The cause of this transient was an electrical system malfunction which opened the power operated relief valve (PORV) on the pressurizer and held it open electrically for approximately 5 to 7 minutes until the PORV was isolated by closing the upstream block valve. A reactor trip, system blowdown to about 1350 psig, and automatic initiation of high pressure injection into the reactor coolant system occurred within the first few minutes of the transient. The addition of high pressure injection flow filled the pressurizer, increased reactor coolant system pressure, and eventually resulted in actuation of one of the two spring-loaded safety valves installed on the pressurizer. This safety valve subsequently cycled open and closed over a period of up to 2 hours. During the course of the transien

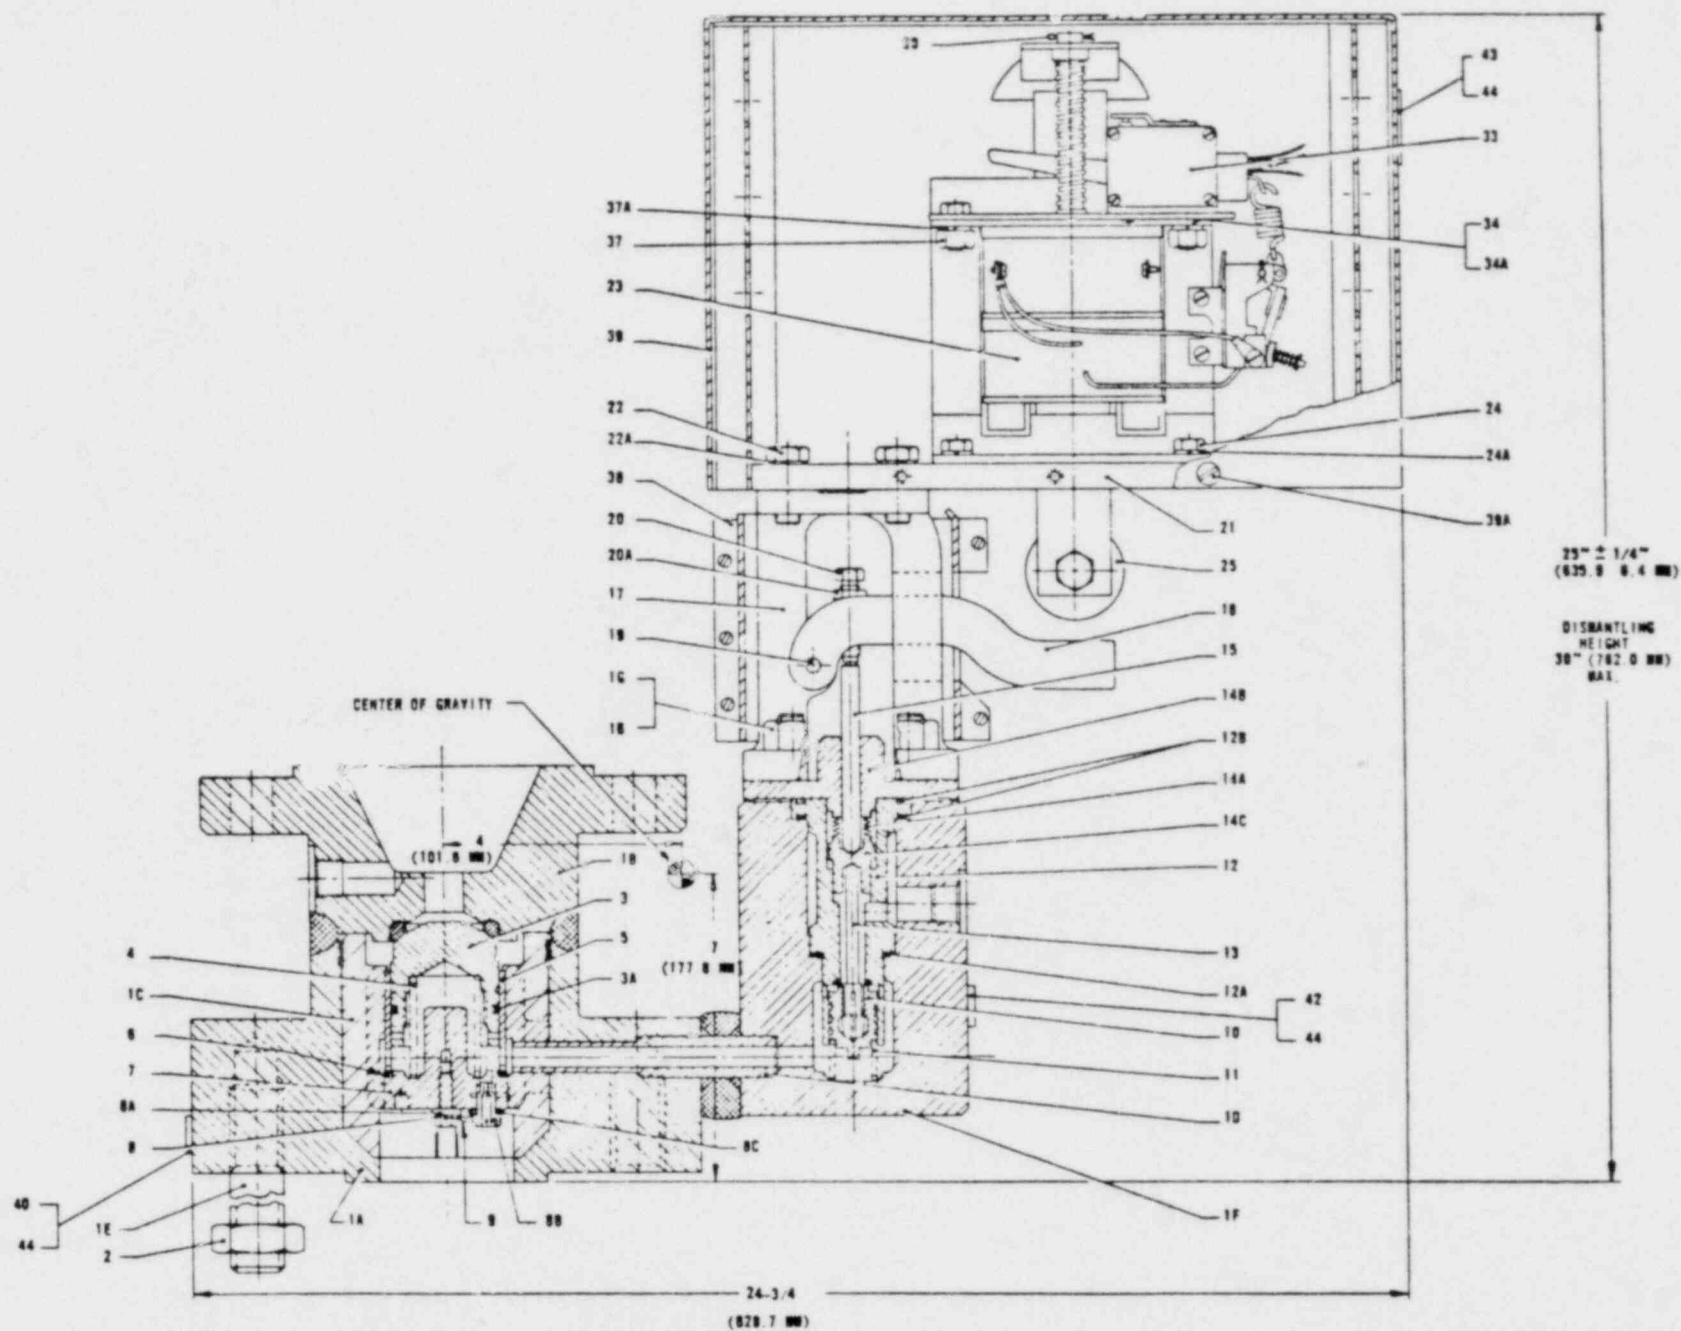
Figure 1. SAFETY VALVE AND PORV INSTALLATION
ON PRESSURIZER

1. Visual examination of the PORV and its operator, including the solenoid linkages, showed no abnormal conditions or evidence of damage. The operator linkages were in the normal, closed position.
2. Electrical actuation tests were made which confirmed that the solenoid and linkage to the PORV pilot operated properly when energized and de-energized repeatedly from the control room.
3. Visual examinations of the discharge piping for the PORV and the adjacent spring-loaded safety valves (RCV-8 and -9) indicated no damage or deformation to the piping or supports. A portion of this piping and supports is shown in Figure 1.

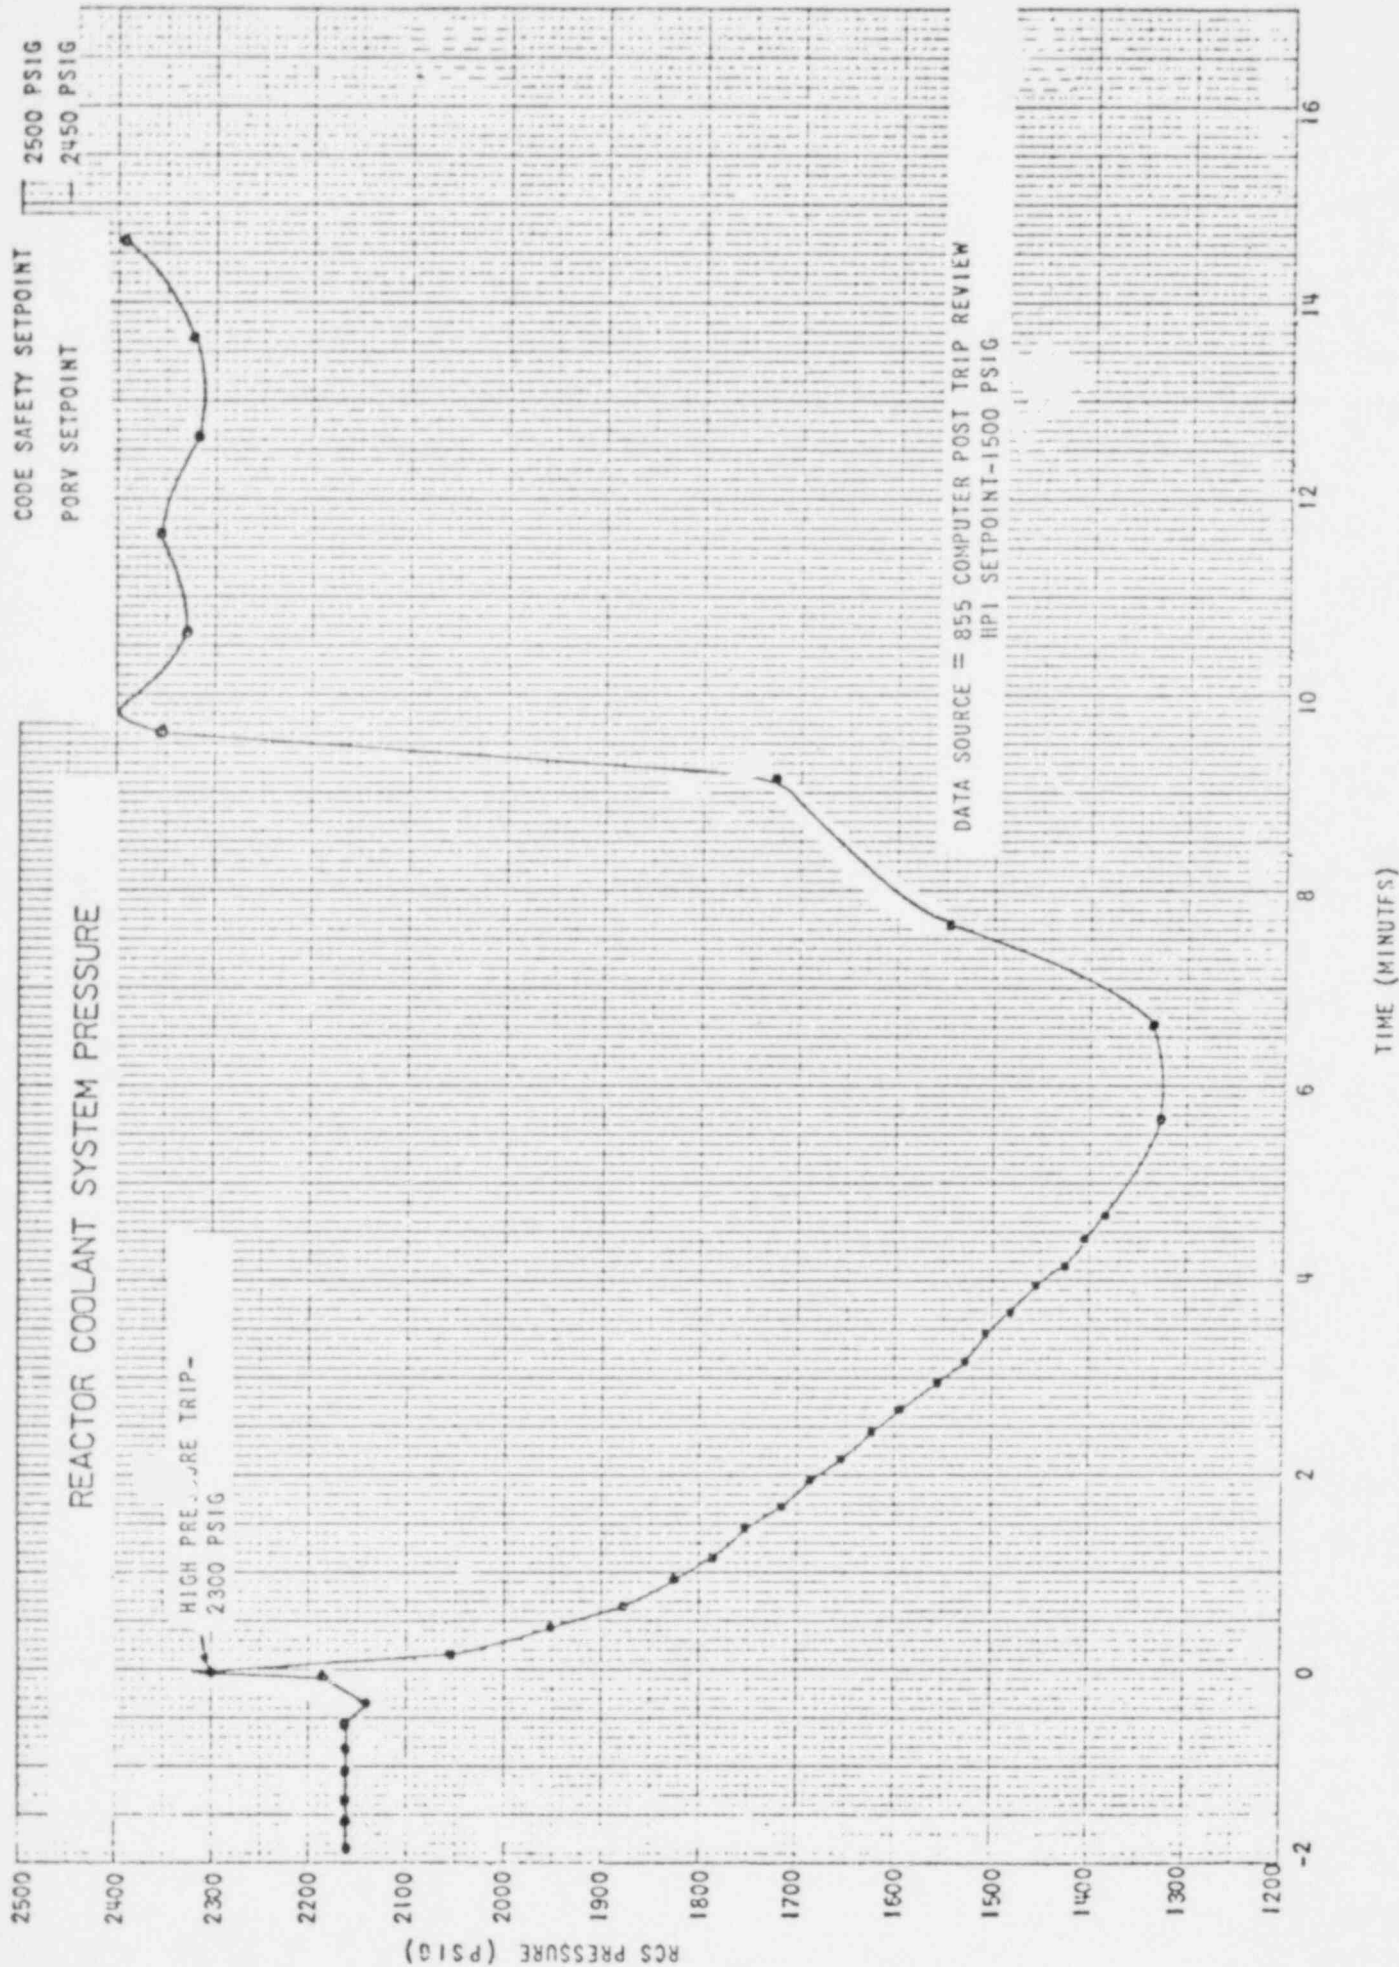
With the high pressure injection pumps still on and the PORV isolated, the reactor coolant system pressure increased. After approximately 9-1/2 minutes into the transient, safety valve RCV-8 opened at a pressure of about 2400 psig. For the next 20 minutes, it appears that RCV-8 remained open and then reclosed at approximately 2300 psi. A portion of the transient is shown in Figure 4.

saturated steam during the approximately 5 to 7 minutes that it was discharging. This is consistent with the pressure trace given in Figure 4. However, there is a possibility that the pressurizer could have filled solid while the PORV was still open (at about 6 minutes into the transient) and that the PORV was isolated at about 9 minutes into the transient. In this eventuality, the PORV could have discharged saturated or slightly sub-cooled water.

3. Safety Valve RCV-8 - Safety valve RCV-8 opened initially at 2400 psig, which is about 100 psi below its initial set pressure. A reasonable interpretation of the pressure trace given in Figure 4 is that after PORV isolation, at about 6 minutes after transient initiation, the pressurizer filled solid at about 9 minutes. Safety valve RCV-8 opened after about 9-1/2 minutes. In this case, RCV-8 would have opened on water and discharged saturated and sub-cooled water over the next two hours. It is possible that a small amount of steam was present in the pressurizer nozzle under safety valve RCV-8 during its initial "pop." It is very likely, however, that the second and any subsequent "pops" of RCV-8 occurred with only water in the pressurizer and safety valve nozzle and that RCV-8 discharged water for essentially all of the time it was open.

CONTROL ROOM STRIP CHART OF RC PRESSURE - (WIDE RANGE)

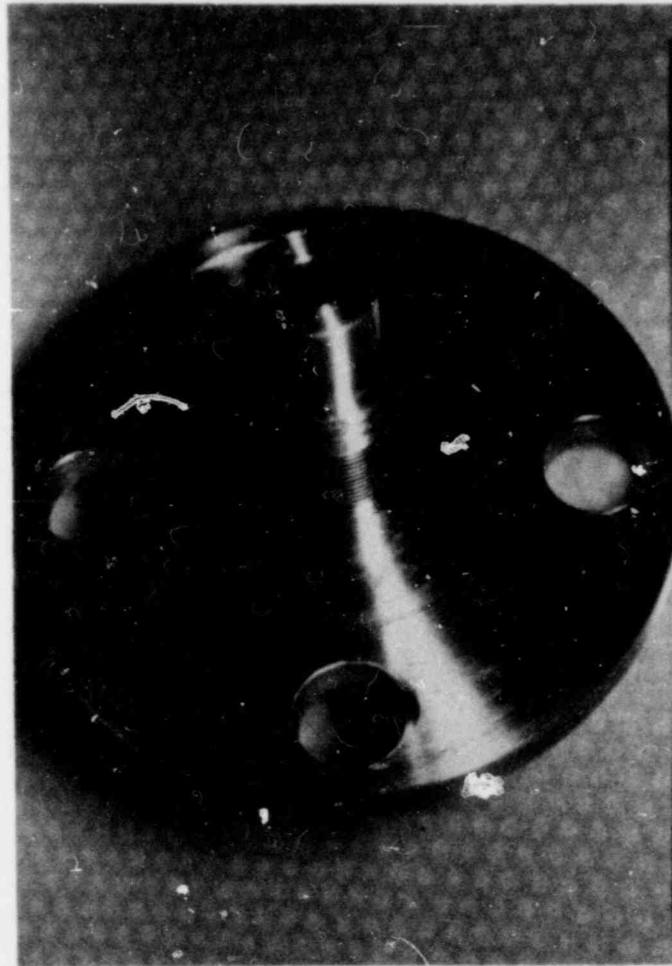
Figure 7. PILOT BELLOWS ASSEMBLY (Part 14)

Photographs of selected parts as-disassembled are shown in Figures 6 through 10.

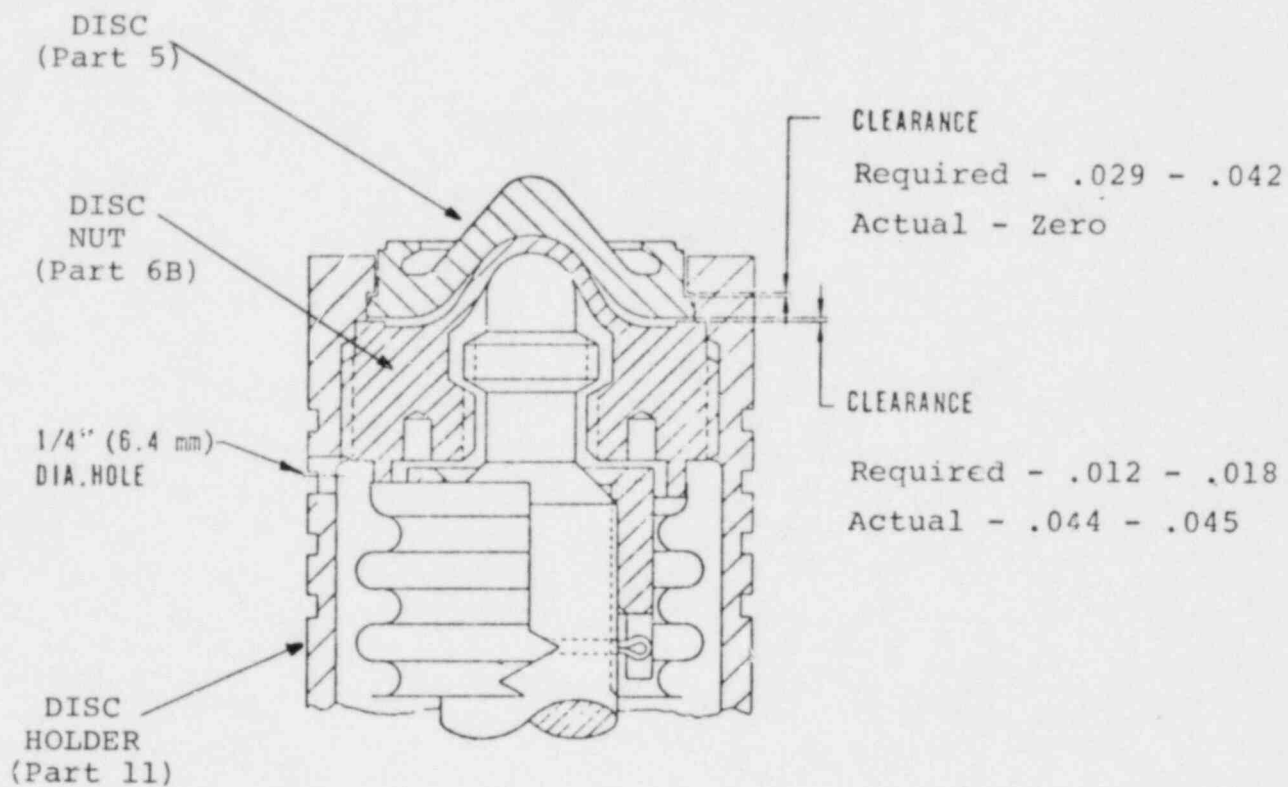
Figure 14. DISC TO BELLOWS
CLEARANCE

• Two abnormal conditions were found. First, the anti-rotation pin (identified as Part 8d in Figure 3) was found dislodged inside the bonnet cavity. This pin was bent and had become disengaged from the upper spring washer and fallen into the valve bonnet cavity. This anti-rotation pin serves no functional purpose in the valve. Rather, its purpose is to prevent rotation of the upper spring washer (Part 8c) during adjustment of the set pressure compression screw (Part 9). Since the upper spring washer does not move during valve operation, the deformation of the pin had to have occurred due to improper alignment of the pin and the mating slot in the bonnet during the initial assembly and compression of the main spring. According to the Dresser representative (Mr. Bolger), this problem has occurred in a number of applications and this feature of the valve design has been changed in later valves. Binding of this anti-rotation pin on the bonnet during set pressure adjustment could lead to misalignment of parts and thereby promote leakage (which obviously did occur), but it would not appear that this pin would have any effect on valve operation (subsequent tests of the valve without the pin confirmed this). Second, the clearances between the disc holder (Part 11), disc (Part 5) and disc nut (Part 6B) were incorrect. Figure 14 shows the bellows assembly and indicates the clearances that are specified between the disc, disc holder and disc nut to permit slight movement or rocking of the disc on top of the disc nut in order that the disc can self-align with the seat. Inspection of this assembly showed that insufficient clearance was available to permit any rocking or self-aligning of the disc. The inspection showed that assembly of the disc holder on the disc nut firmly retained the disc in the assembly. As a result, the disc was not able to self-align readily on the seat. The differences between the specified and actual clearances could be due to initial assembly errors or deformation of the parts in service. This dimensional discrepancy could explain the observed valve leakage history, but would have no effect on the operation of the valve or its response to steam or water flow.

Results of dimensional measurements of this assembly are shown in Figure 14 and explain why there was insufficient clearance to prevent motion of the disc in the assembly.

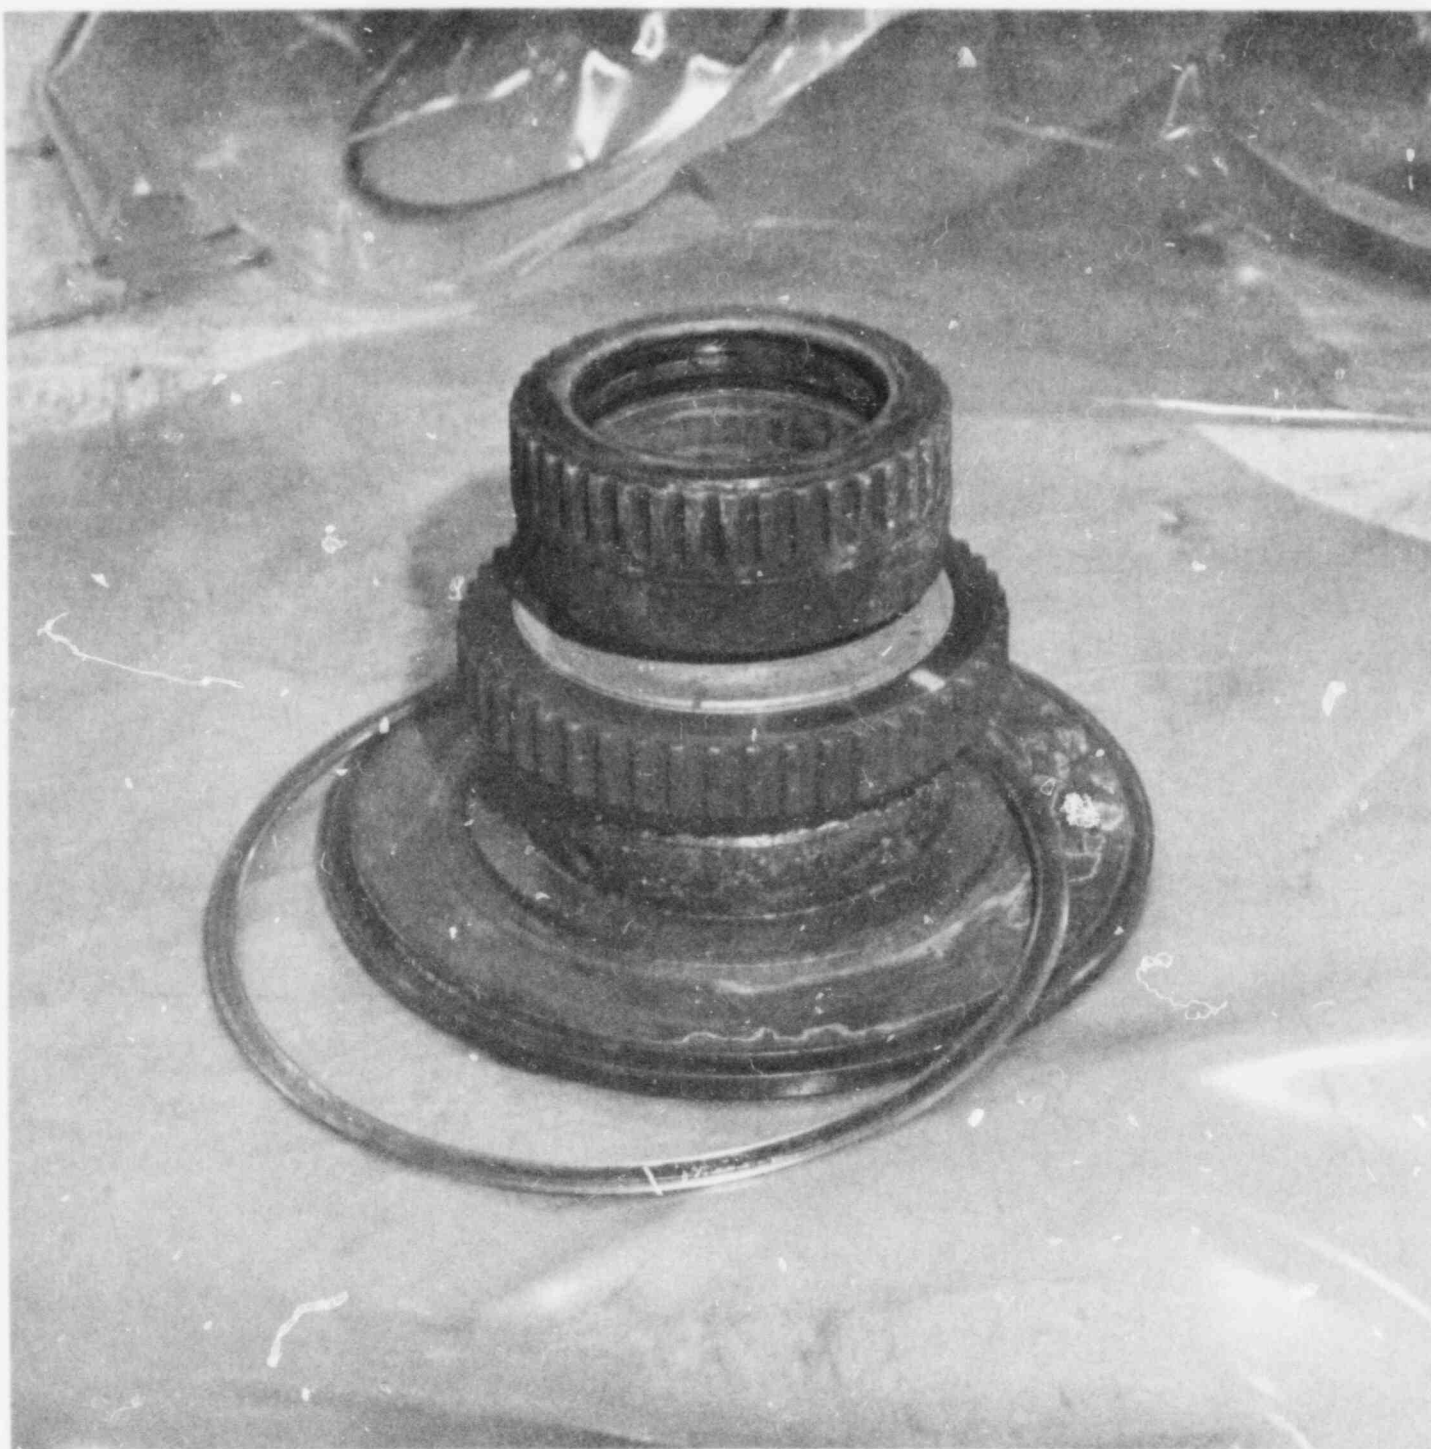
Figure 15. PRE-TEST INSPECTION
OF RCV-8

Photographs of RCV-8 parts after disassembly are given in Figures 15 through 18.
