ENGINEERING EVALUATION REPORT: INVESTIGATIONS AND  
GROUTING OF LEAKS ASSOCIATED WITH TENDON SHEATHS H32-009 AND H32-011  
UNIT 2 CONTAINMENT BUILDING  
PALO VERDE NUCLEAR GENERATING STATION

JOB NUMBER 10407  
BECHTEL POWER CORPORATION  
NORWALK, CALIFORNIA  
JUNE, 1983

DEFICIENCY EVALUATION REPORT 82-72

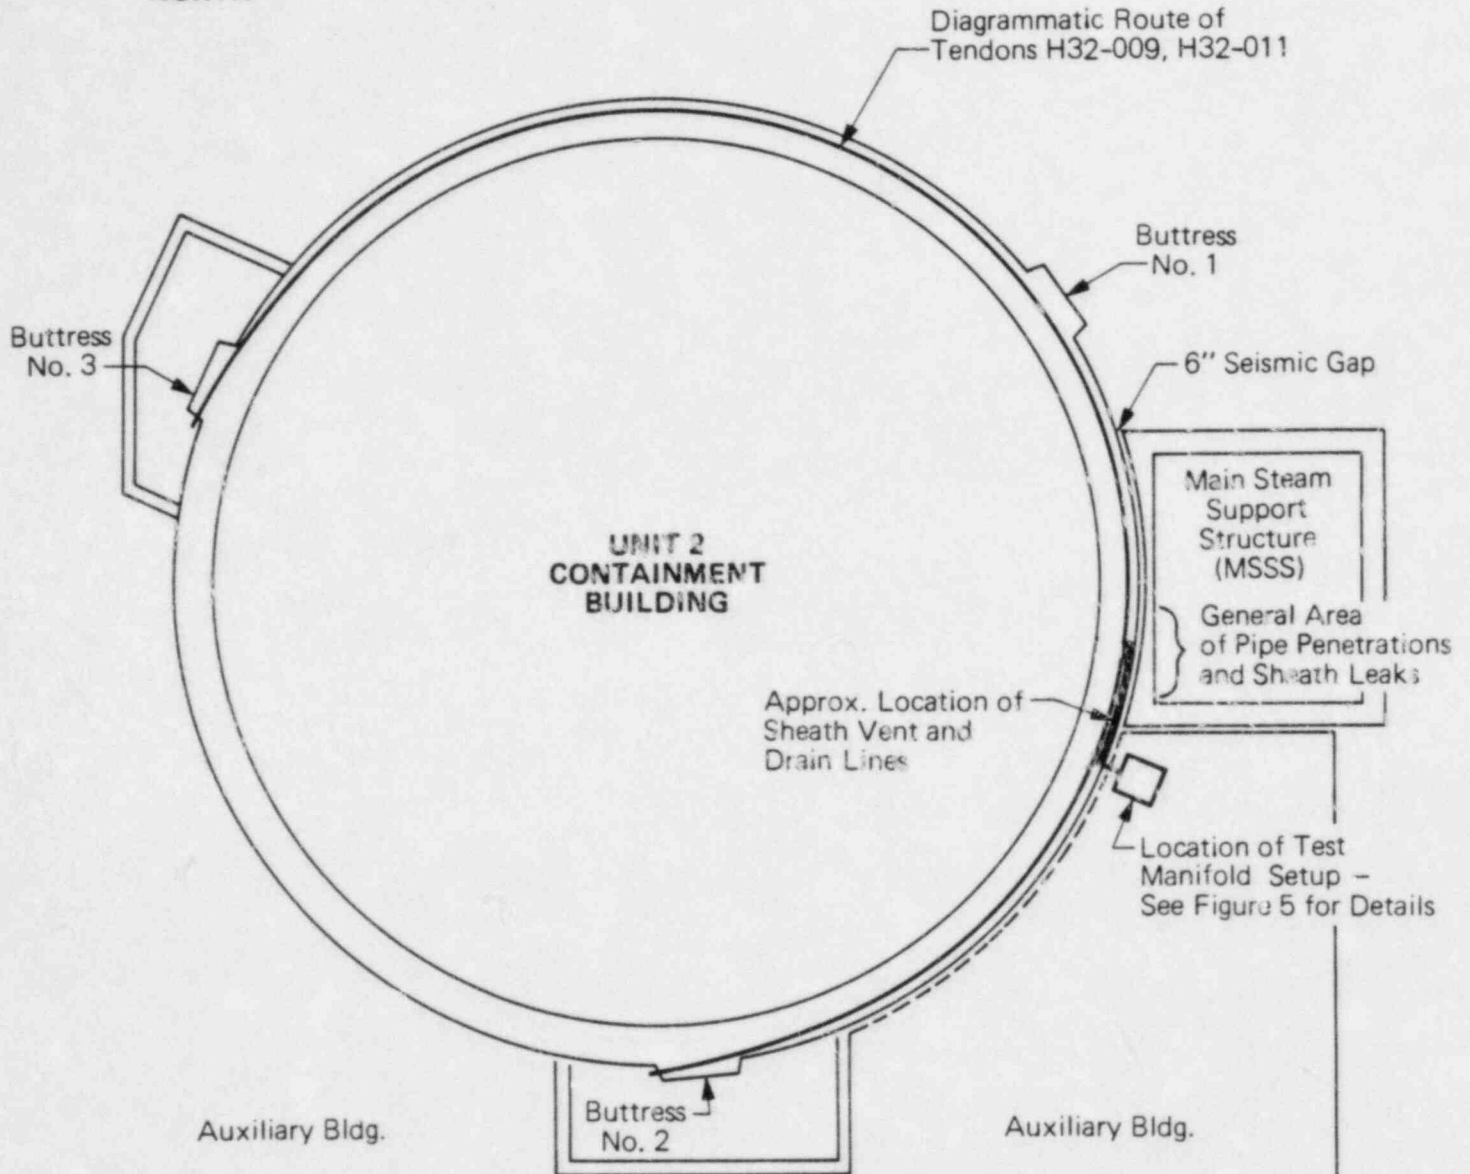
**FIGURE 1**

Tendons H32-009 and H32-011 are horizontal tendons which extend from buttress no. 3 to buttress no. 2. Figure 1 is a schematic plan of the layout. Figure 2 is an elevation view of these tendons in the area of the main steam pipe penetrations. When these tendons had been installed and tensioned, the preliminary air tests conducted prior to greasing showed that air was escaping from one sheath and emerging in the other, as well as escaping to the outside through a crack in the exterior surface of the concrete wall. The location of this crack was in the 6-inch seismic gap between the Containment wall and the Main Steam Support Structure (MSSS). The location of this crack is shown in figure 2. The same result was obtained when pumping air into either sheath.

Having accurately determined the locations of the leaking portions of the two sheaths, air and water testing of the leak pathways was conducted. This testing employed the packer systems described above, but rather than introducing air through the rear packer to the test interval from a source at buttress no. 2, air and then water were introduced in the space between packers through existing tendon sheathing vent and drain fittings with both packers plugged. In the case of sheath H32-009, access was through a drain line which entered the bottom of the sheath within the leaking interval. For sheath H32-011 access was provided by a vent line which entered the sheath in the leaking interval. These features are shown schematically in figure 5. Both the vent and drain lines exited the Containment building wall at accessible locations in the adjacent wrap-around portion of the Auxiliary building (see figure 1).

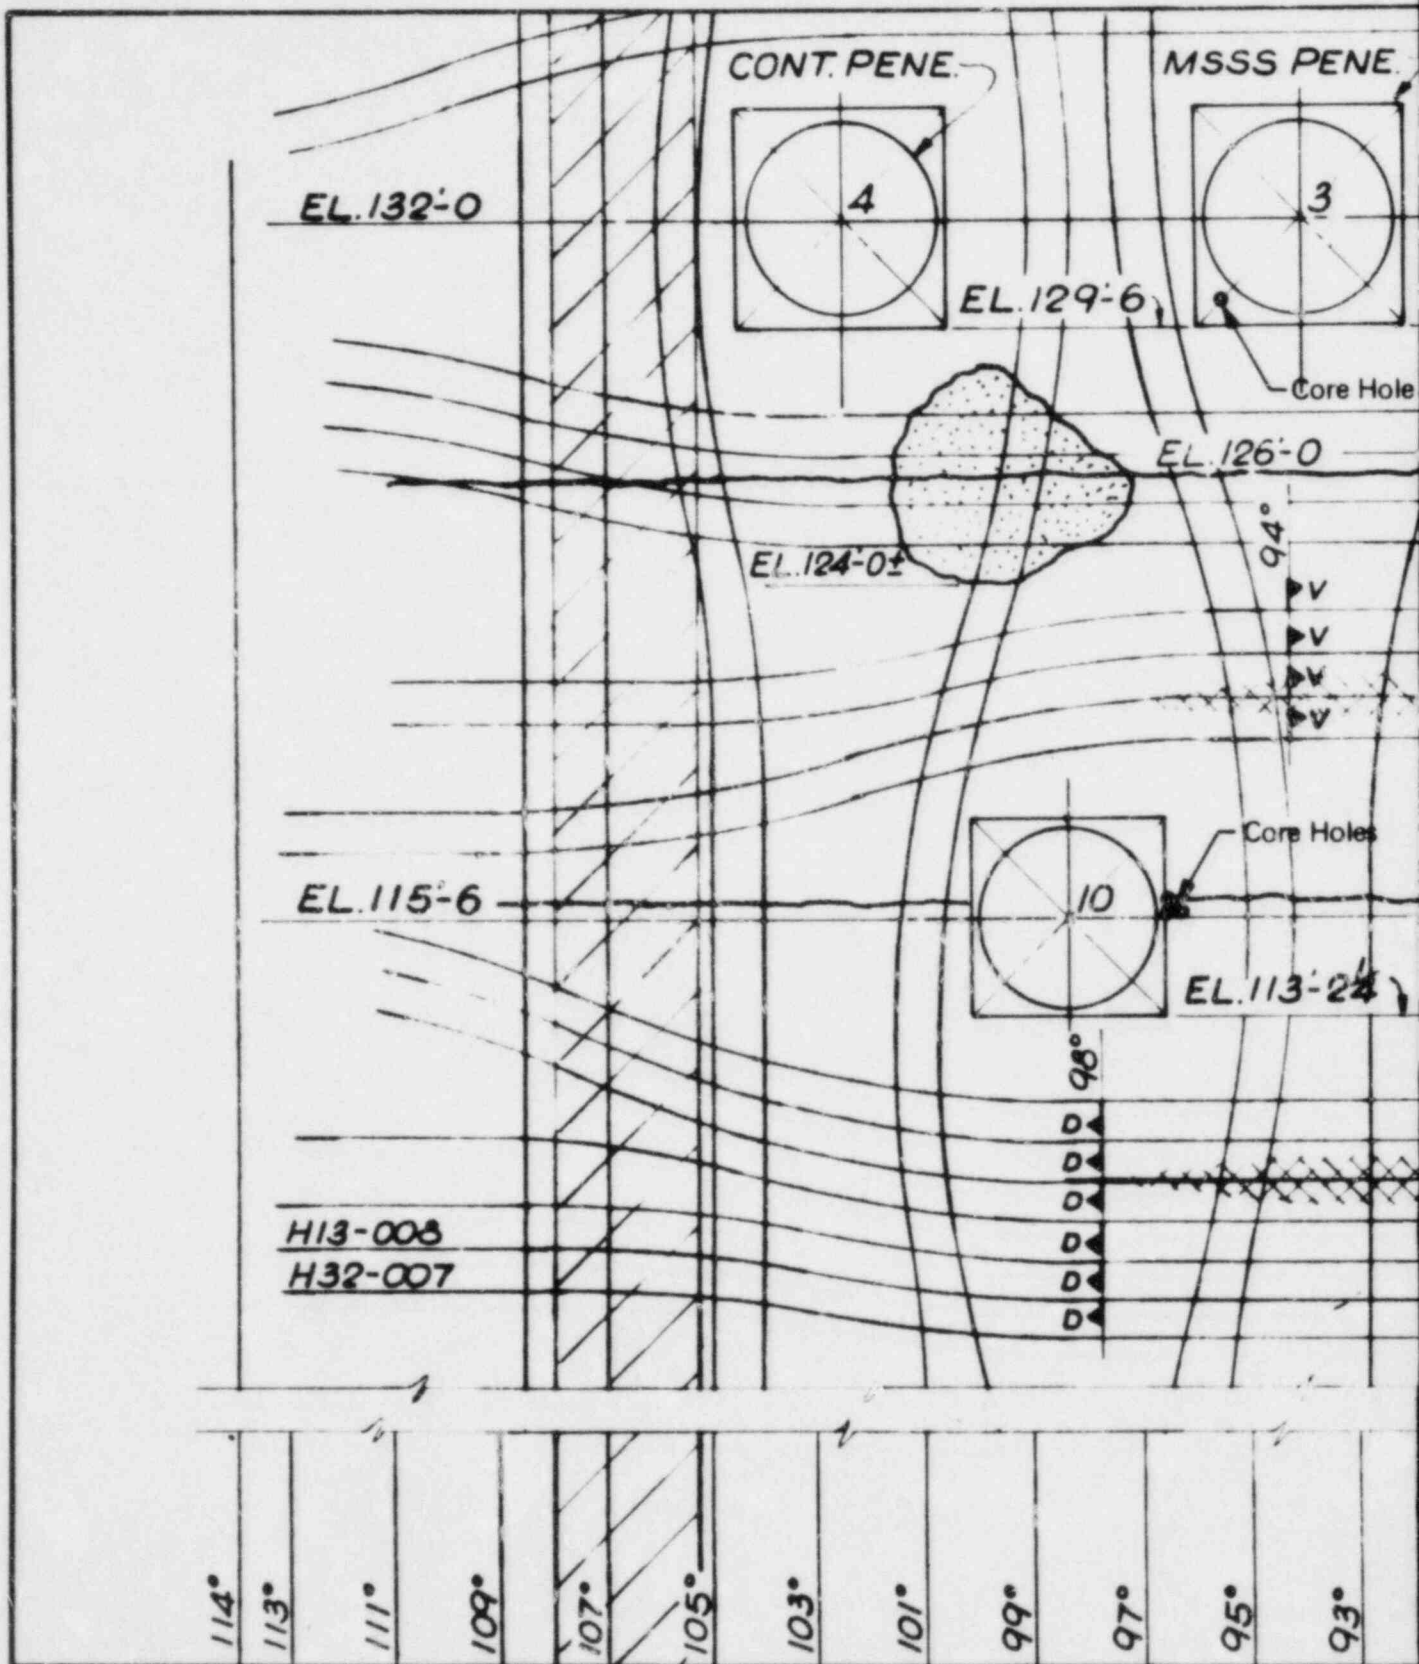
FIGURE 2

The testing described in section 4.1.1 demonstrated the presence of a single leak in sheath H32-009, and a single leak in sheath H32-011. In sheath H32-009 a large leak begins at approximately  $91^{\circ} 30'$  (see figure 2), continues to  $94^{\circ}$ , then tapers to a small leak which terminates at approximately  $97^{\circ} 40'$ . In sheath H32-011, the leak begins as a small leak at  $81^{\circ} 15'$ , then increases to a large leak at approximately  $83^{\circ}$ . This large leak continues to approximately  $93^{\circ} 10'$ , where it decreases to a small leak terminating at about  $98^{\circ}$ .

Air testing of the leak pathways as described in section 4.1.2 verified cross-communication between the sheaths. Vigorous air flow was observed escaping from the crack in the chipped area just below and slightly to the north of penetration no. 4 (see figure 2), and from the core hole drilled into the Containment wall adjacent to penetration no. 3. The subsequent water tests discussed below proved to be a more positive indicator of additional very small leak exits which were not detected during the air test.

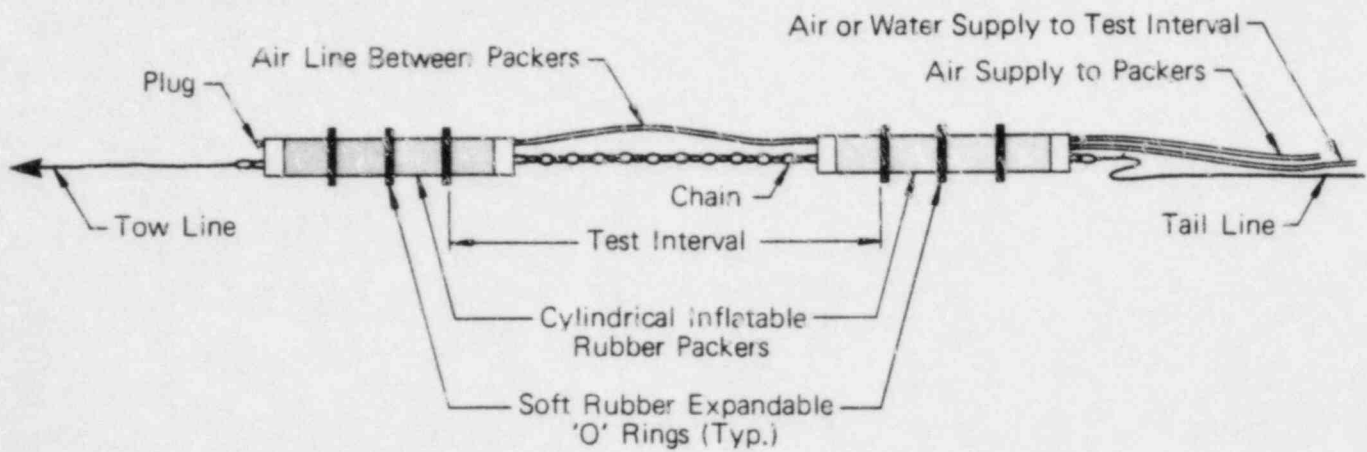
DIAGRAM OF PACKER ASSEMBLY

The key pieces of equipment for successful testing were the packer systems, because without an effective means of isolating the leaks within the tendon sheaths, no definitive testing would have been possible. The packer systems consisted of two pairs of packers attached by means of chains and air lines as described earlier and as shown in figures 3 and 4. The packers consist of cylindrical inflatable rubber elements clamped to a rigid steel tube with end caps. The overall length of each packer is approximately 3 feet and the uninflated diameter is 3-1/2 inches.

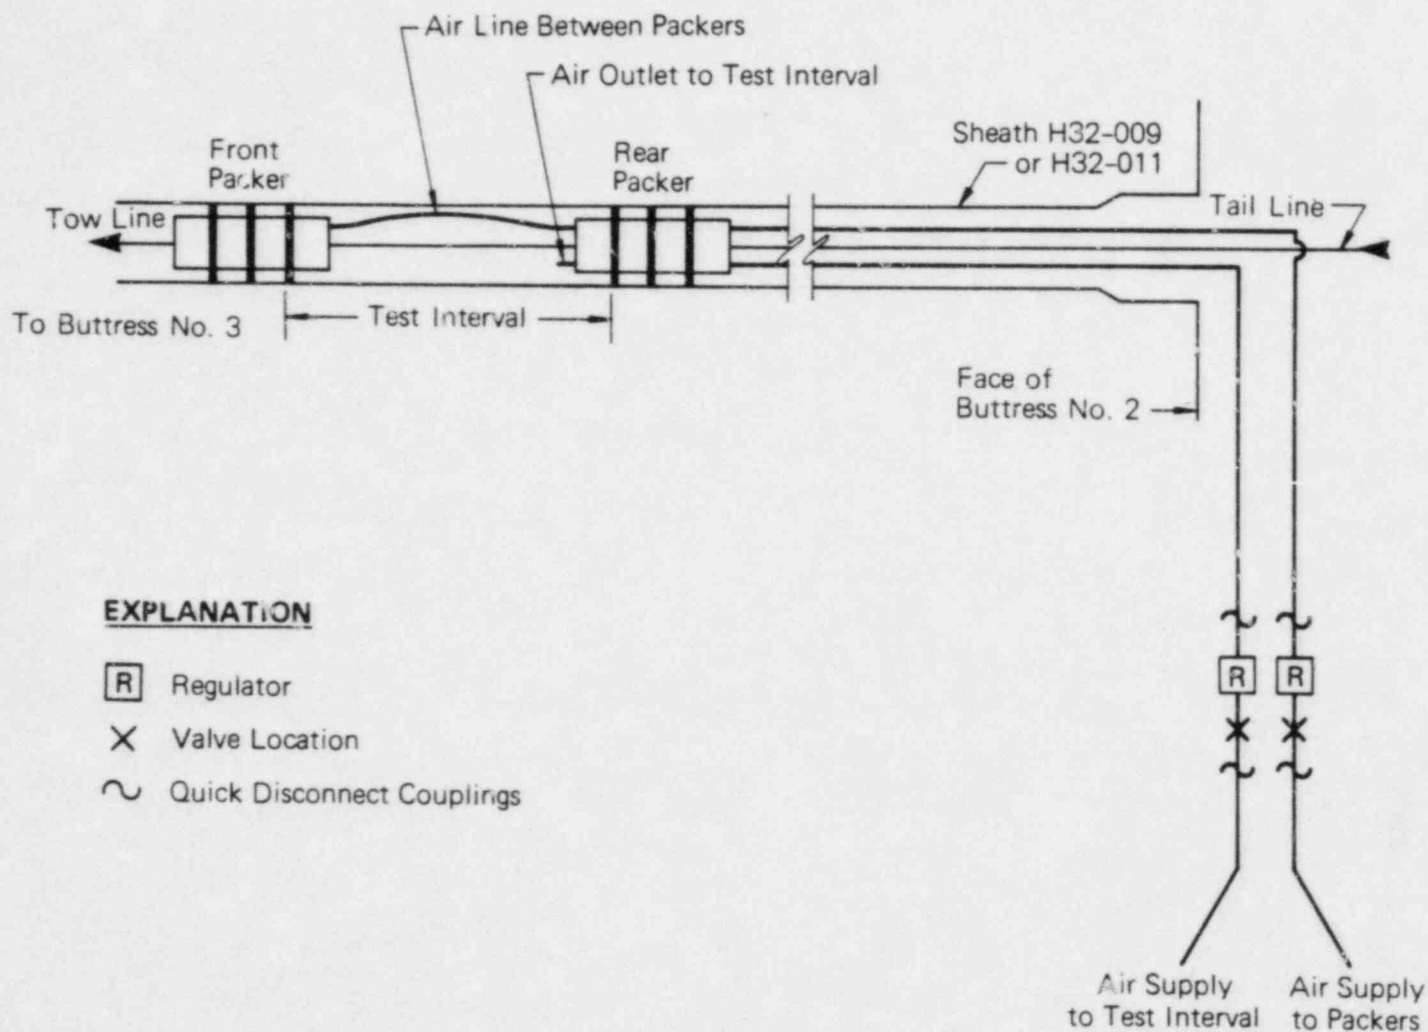
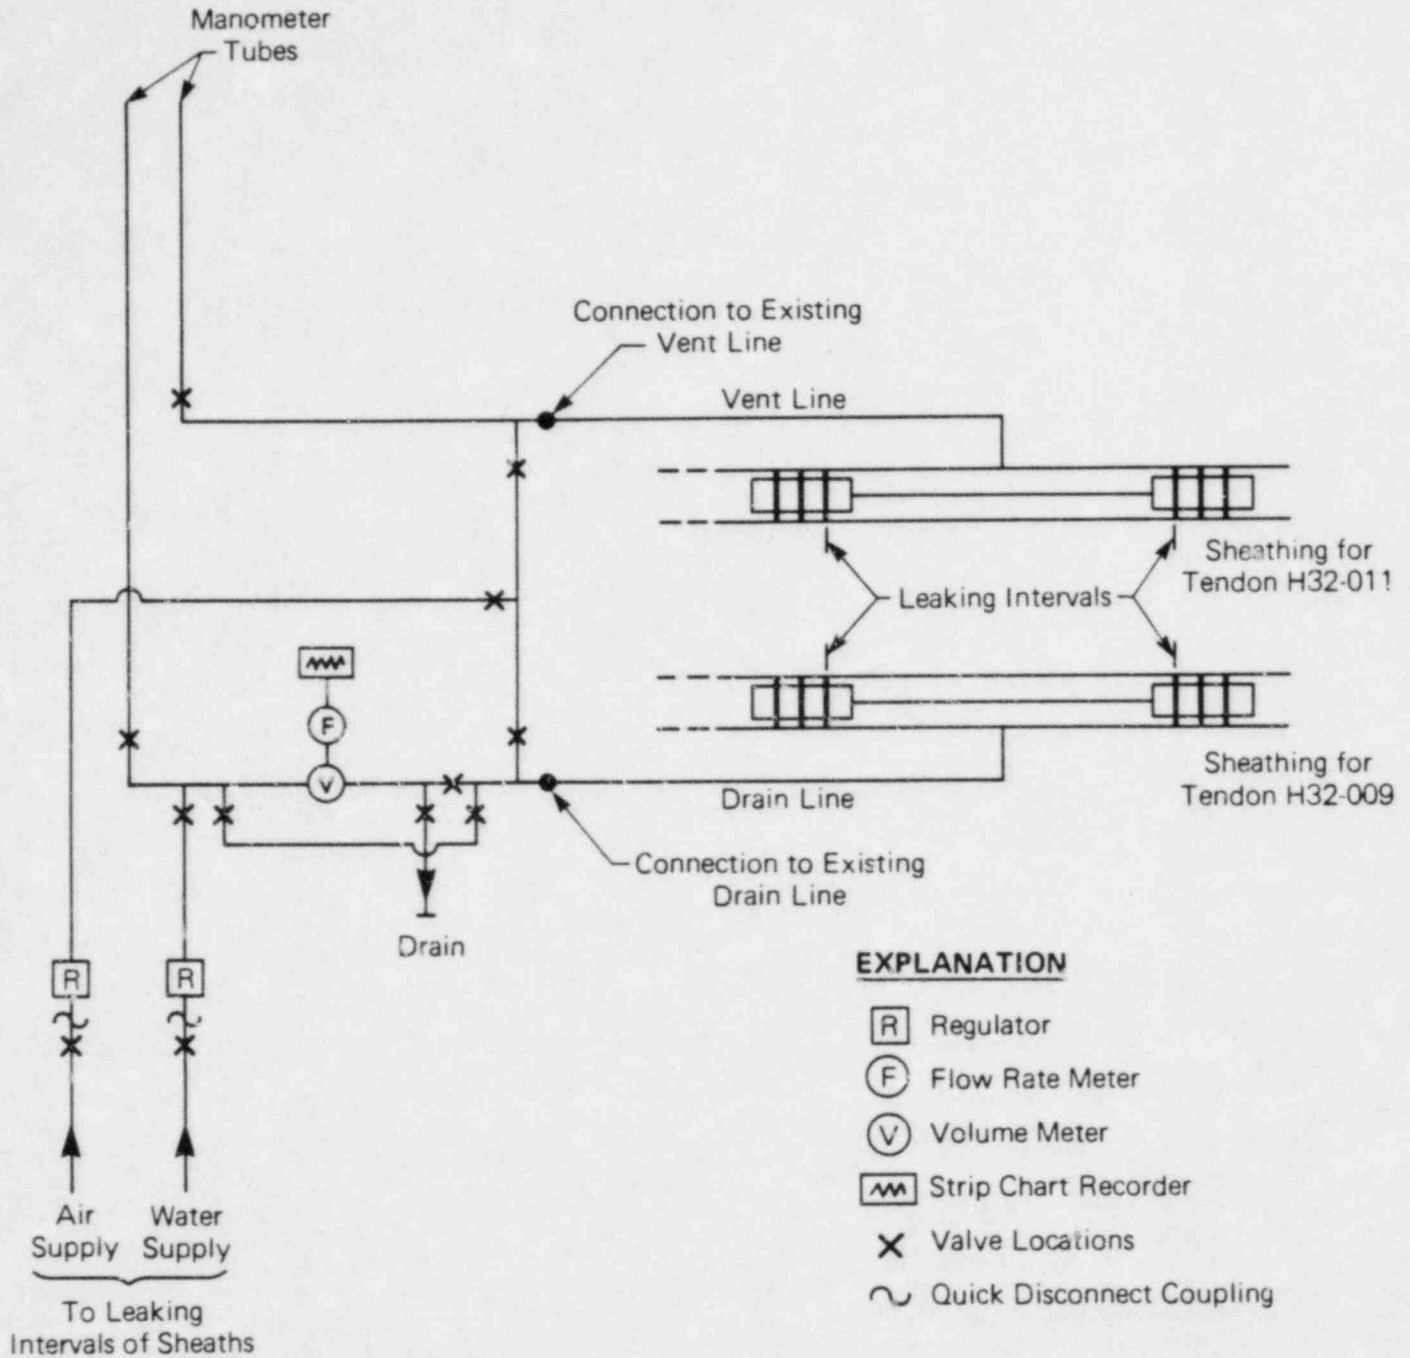
The layout of equipment and instrumentation is shown schematically in figures 3 through 5. The following paragraphs describe pertinent features of the equipment and instruments.

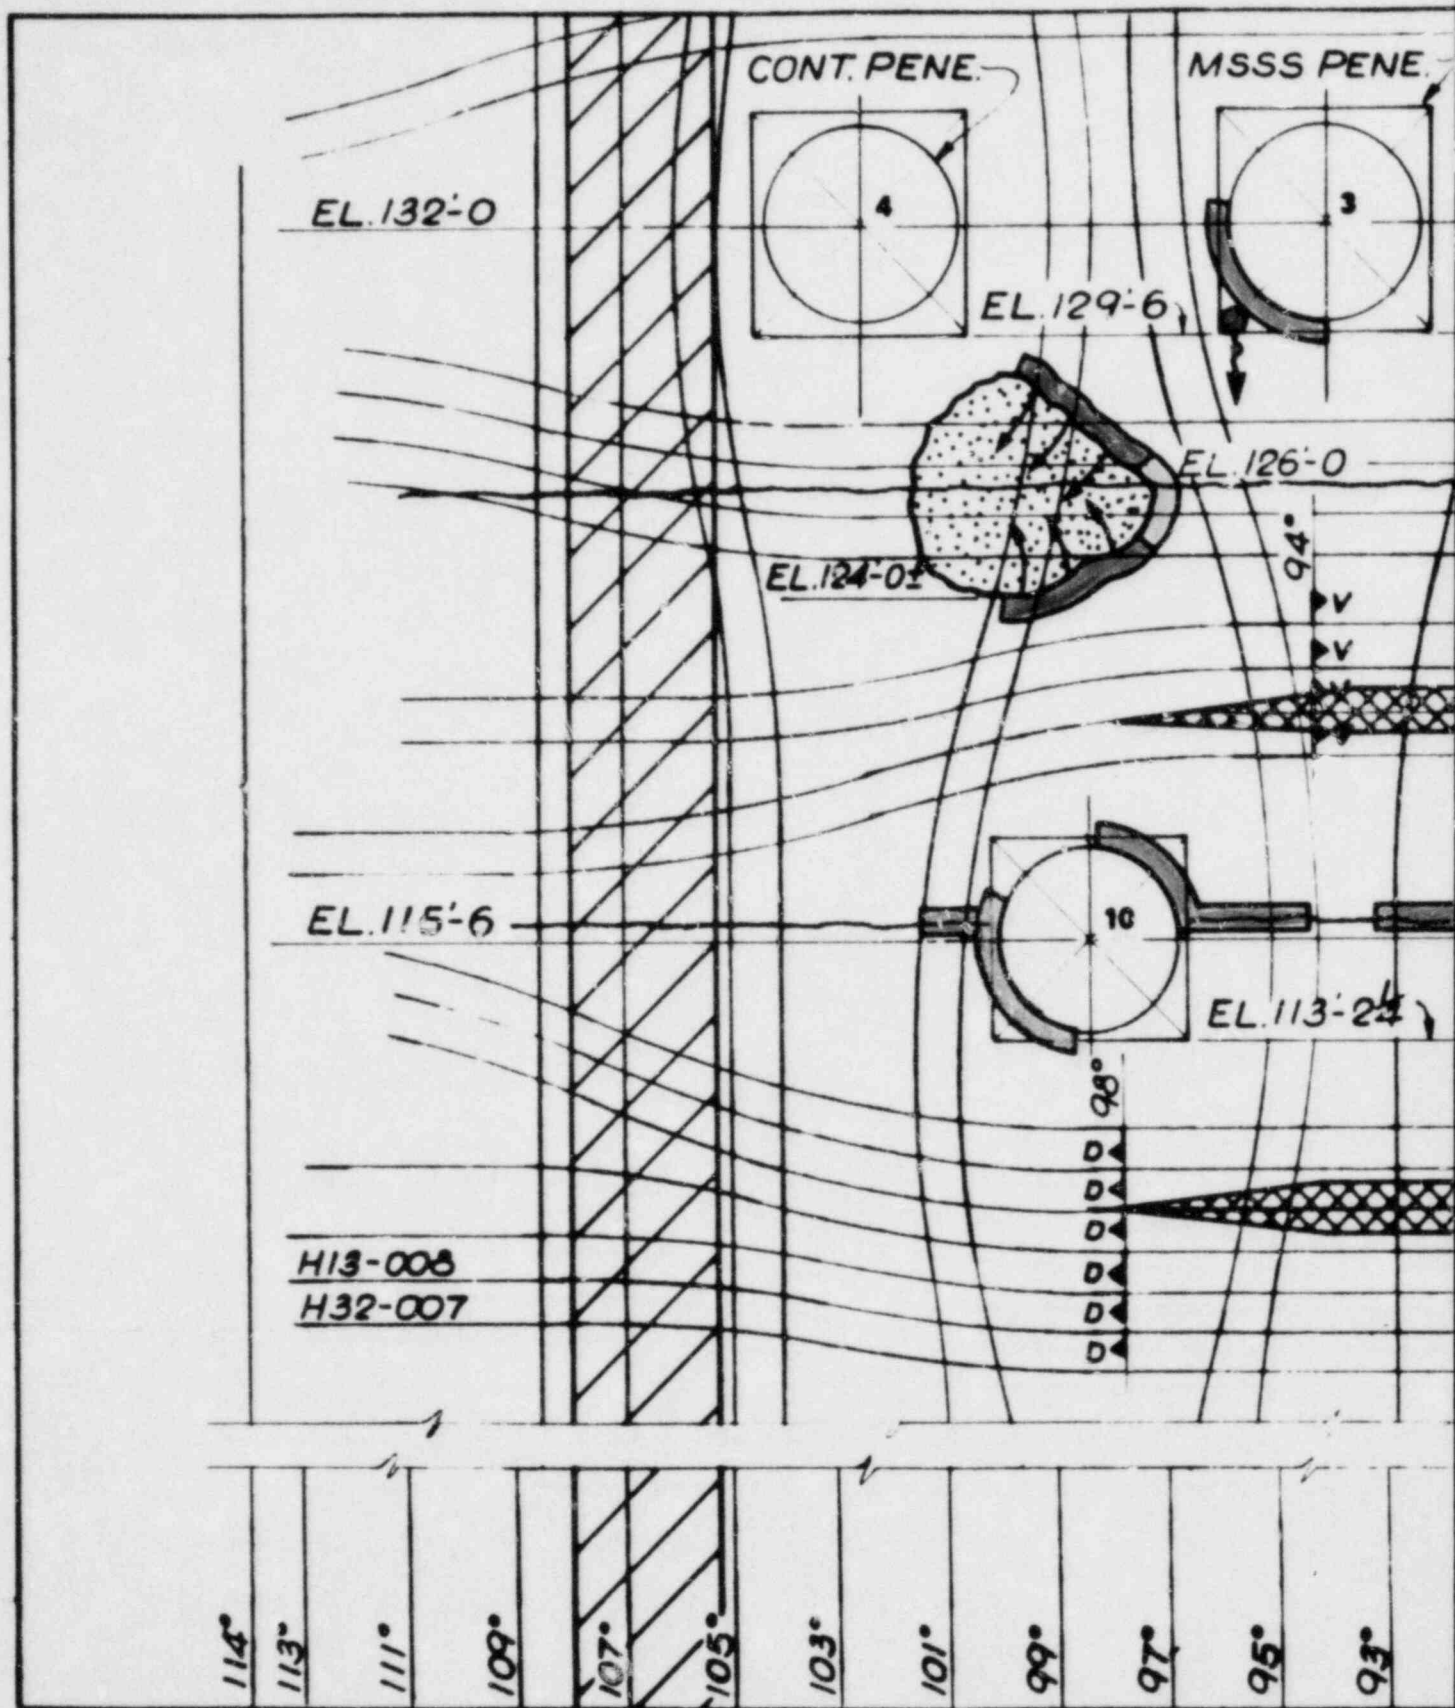
Figure 6 is an elevation view similar to figure 2 which shows the locations of all leak exits on the Containment wall. Figure 6 is a composite of the results from all five tests. As is seen in figure 6, minor leakage occurred around the penetration sleeve at penetration no. 10 and along the construction joint in this area. Very minor seepage occurred around the sleeve at penetration no. 8. Major leakage occurred from the crack in the chipped area and from the core hole adjacent to penetration no. 3. Minor seepage occurred around the sleeves in penetrations no. 2 and no. 3.
