Subject: 10CFR21 Reporting of Defects and Non-Compliance -
Engine Systems, Inc. Report No. 10CFR21-0128, Rev. 0

Selenium Surge Suppressor, EMD P/N 8403049

Report No. **10CFR21-0128**

COMPONENT: Selenium Surge Suppressor
P/N 8403049

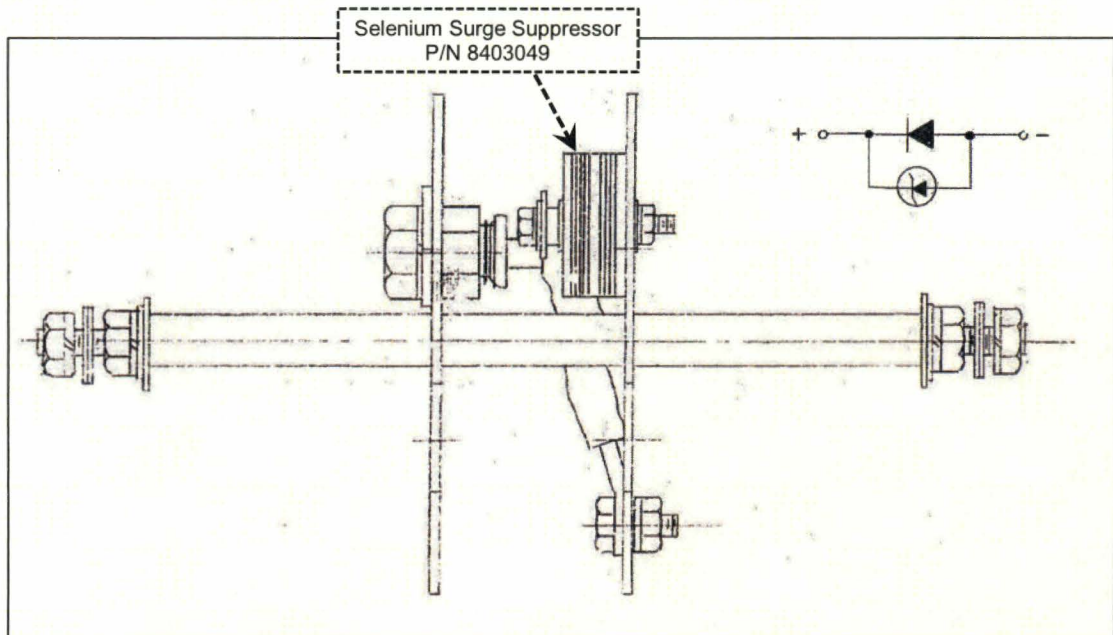
Figure 2: Rectifier Assembly P/N 8334736 (containing P/N 8403049)

The selenium surge suppressor is a subcomponent of rectifier assembly P/N 8334736 (see Figure 2) used in the Vickers voltage regulator system. The rectifier assembly is shown as components CR1 through CR6 in Figure 3 and each function as a half wave rectifier, used in the static exciter, to furnish DC voltage for excitation of the generator field. The selenium surge suppressor protects the diode from surges by clamping at a voltage below the critical voltage for the diode, thus conducting around the diode at high energy levels.

Use of this thread modifier significantly reduces the strength of the mounting threads. Failure of the mounting threads creates the possibility of the suppressor dislodging with the potential to electrically short between the positive and negative plates of the rectifier assembly. An electrical short would affect output of the voltage regulator system which may prevent the emergency diesel generator set from performing its safety-related function. This issue is therefore considered to be a reportable defect as defined by 10CFR-part 21.

- For surge suppressors installed, these are functionally acceptable but may be structurally compromised. The concern is the mounting nut may have unknowingly been tightened beyond the allowable strength of the bolt which could eventually cause the mounting system to fail. ESI recommends inspection and/or replacement at the next opportunity.*
- For surge suppressors not installed, ESI recommends they be returned for replacement.*
