July 5, 1972

MONTICELLO NUCLEAR GENERATING PLANT  
Docket No. 50-263 License No. DPR-22

Inspection of Support Hangers for Emergency Core  
Cooling System Suction Header

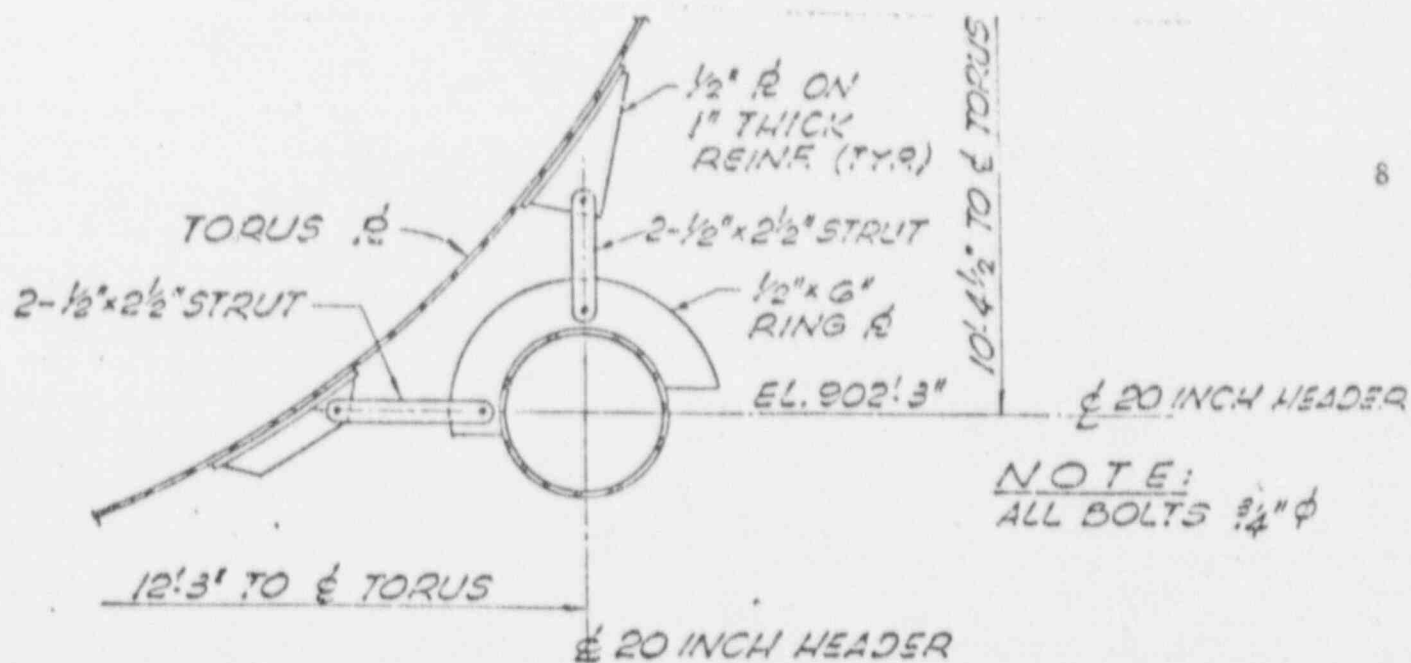
TABLE 1

<u>Section</u>	<u>Upper Vertical</u>	<u>Lower Vertical</u>	<u>Outboard Horizontal</u>	<u>Inboard Horizontal</u>
1	Torch cut and partially drilled	Drilled	Drilled	Drilled
2	Drilled	One Torch cut. One drilled	Web Drilled and Strap Torch Cut.	Drilled
3	Drilled	One Drilled and one Torch Cut	One Drilled and one Torch Cut	Web Drilled and Strap Torched
4	<u>Torus Suction Header Supply Line - No Additional Supports</u>			
5	Drilled	Drilled	Drilled	Drilled and Partial Torch Cut
6	Drilled	Drilled	Drilled	Drilled
7	Drilled	Drilled	Drilled	Drilled
8	<u>Torus Suction Header Supply Line - No Additional Supports</u>			
9	Drilled	Torch Cut	Drilled	Web and Strap Torch Cut
10	Drilled	Drilled	Drilled	Drilled
11	Drilled	One Drilled and one Torch Cut	One Drilled and one Torch Cut	Drilled
12	<u>Torus Suction Header Supply Line - No Additional Supports</u>			
13	One Torch Cut and One Drilled	One Torch Cut and One Drilled	One Torch Cut and One Drilled	Drilled
