**Commonwealth Edison**

September 9, 1982

Subject: Byron Station Units 1 and 2  
Braidwood Station Units 1 and 2  
Waterhammer Prevention  
NRC Docket Nos. 50-454, 50-455,  
50-456 and 50-457

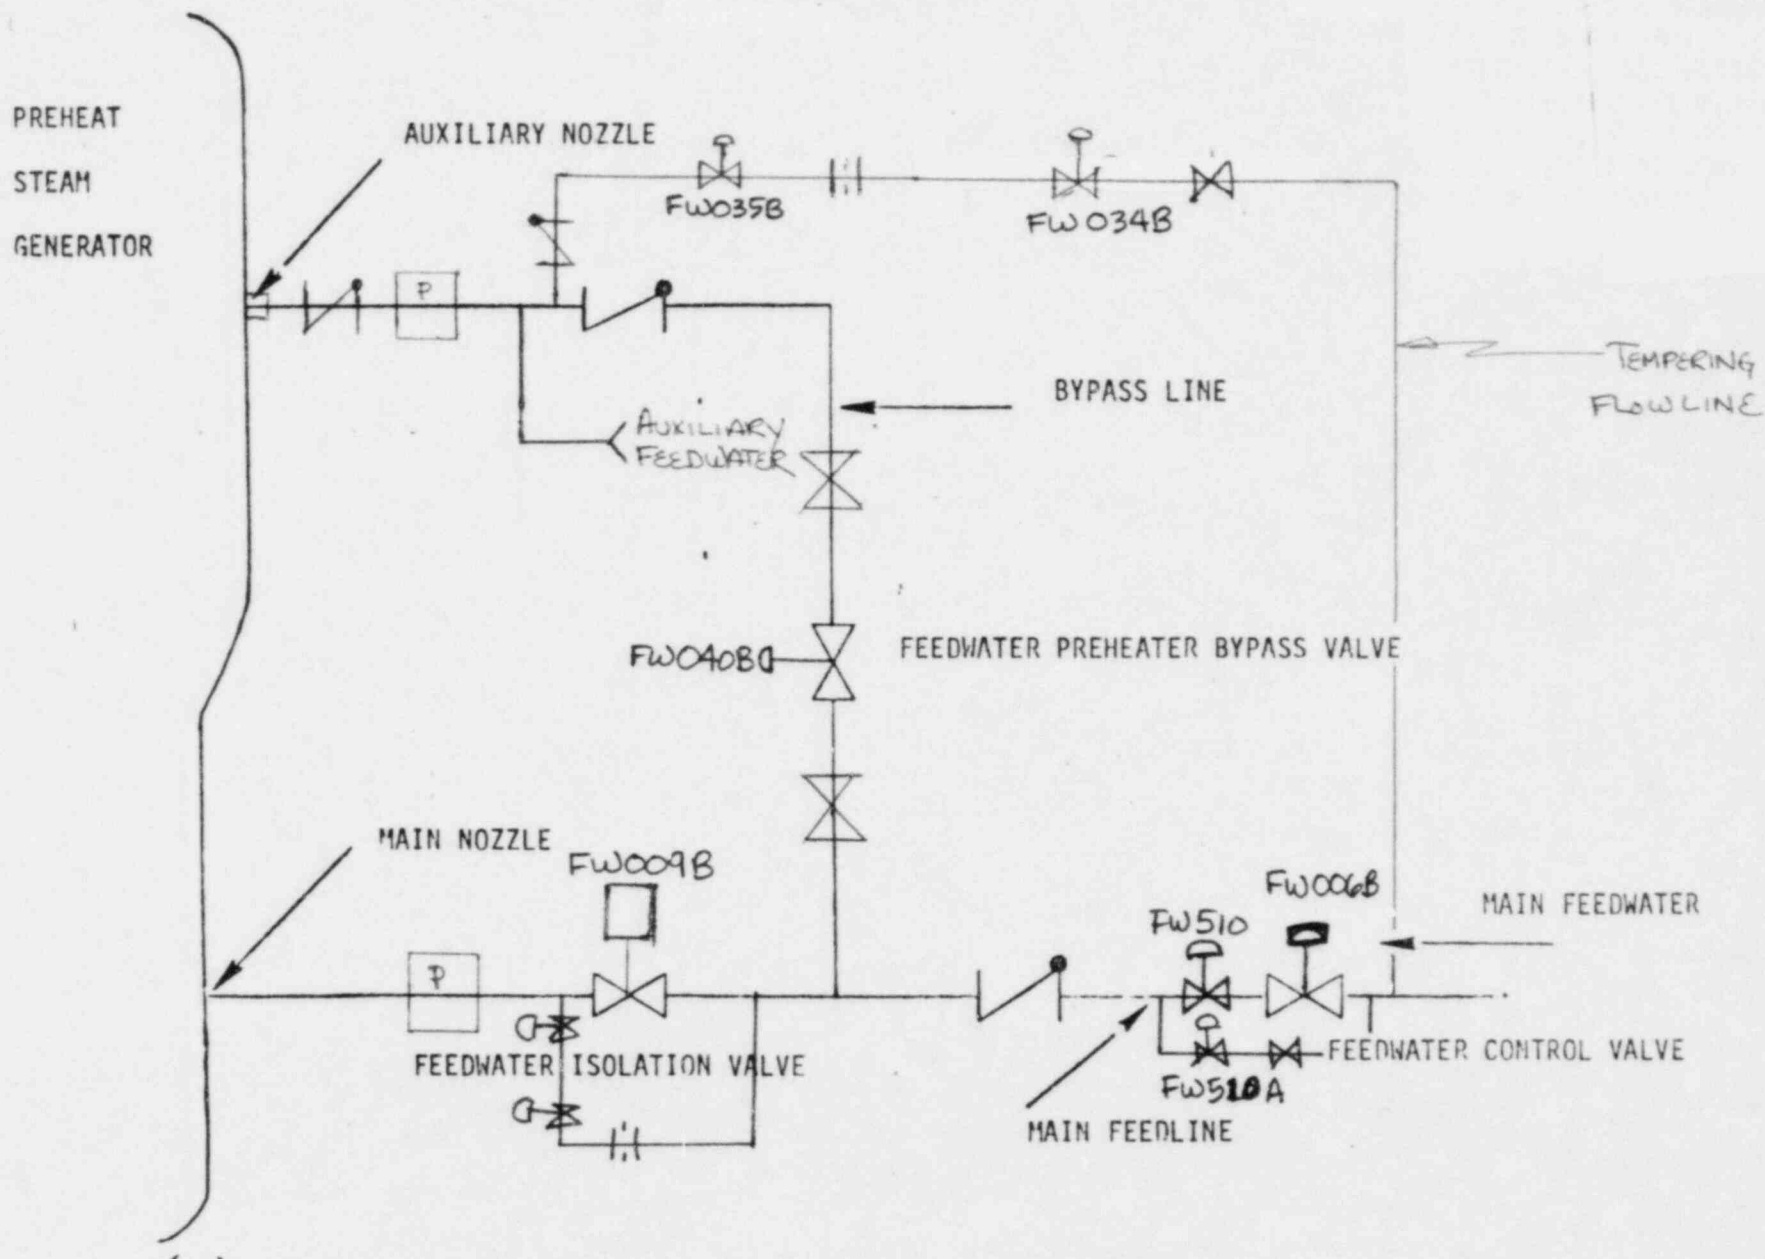
FIGURE 7

Figures 6 and 7 are simplified diagrams of the B/B AF and main feedwater systems. Detailed P&ID's accompany this response. The following table lists the valves that are controlled from the control room.

The remainder of the valves shown in Figures 6 and 7 are either manual valves, automatically operated valves or locally operated valves.

FEEDWATER BYPASS SYSTEM  
SIMPLIFIED FLOW DIAGRAM

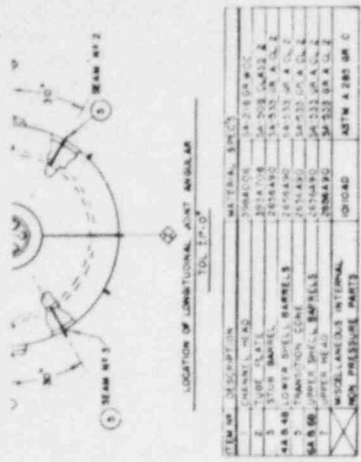
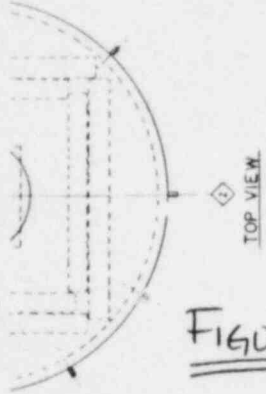
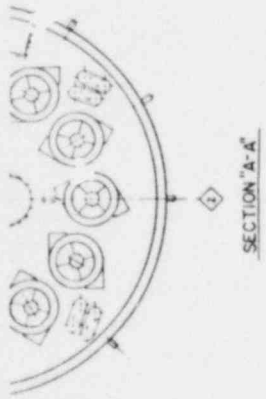
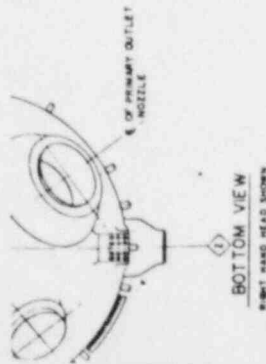
Figure 8

The internals of the B/B models D-4 and D-5 are shown in figures 8 and 9 respectively. Figures 8 and 9 show the auxiliary nozzle and internal extension and actual water level for 100 percent power.
