UNITED STATES OF AMERICA  
NUCLEAR REGULATORY COMMISSION

AFFIDAVIT OF LESLIE A. BOWEN

Subject: Byron Station Units 1 and 2  
Braidwood Station Units 1 and 2  
Waterhammer Prevention  
NRC Docket Nos. 50-454, 50-455,  
50-456 and 50-457

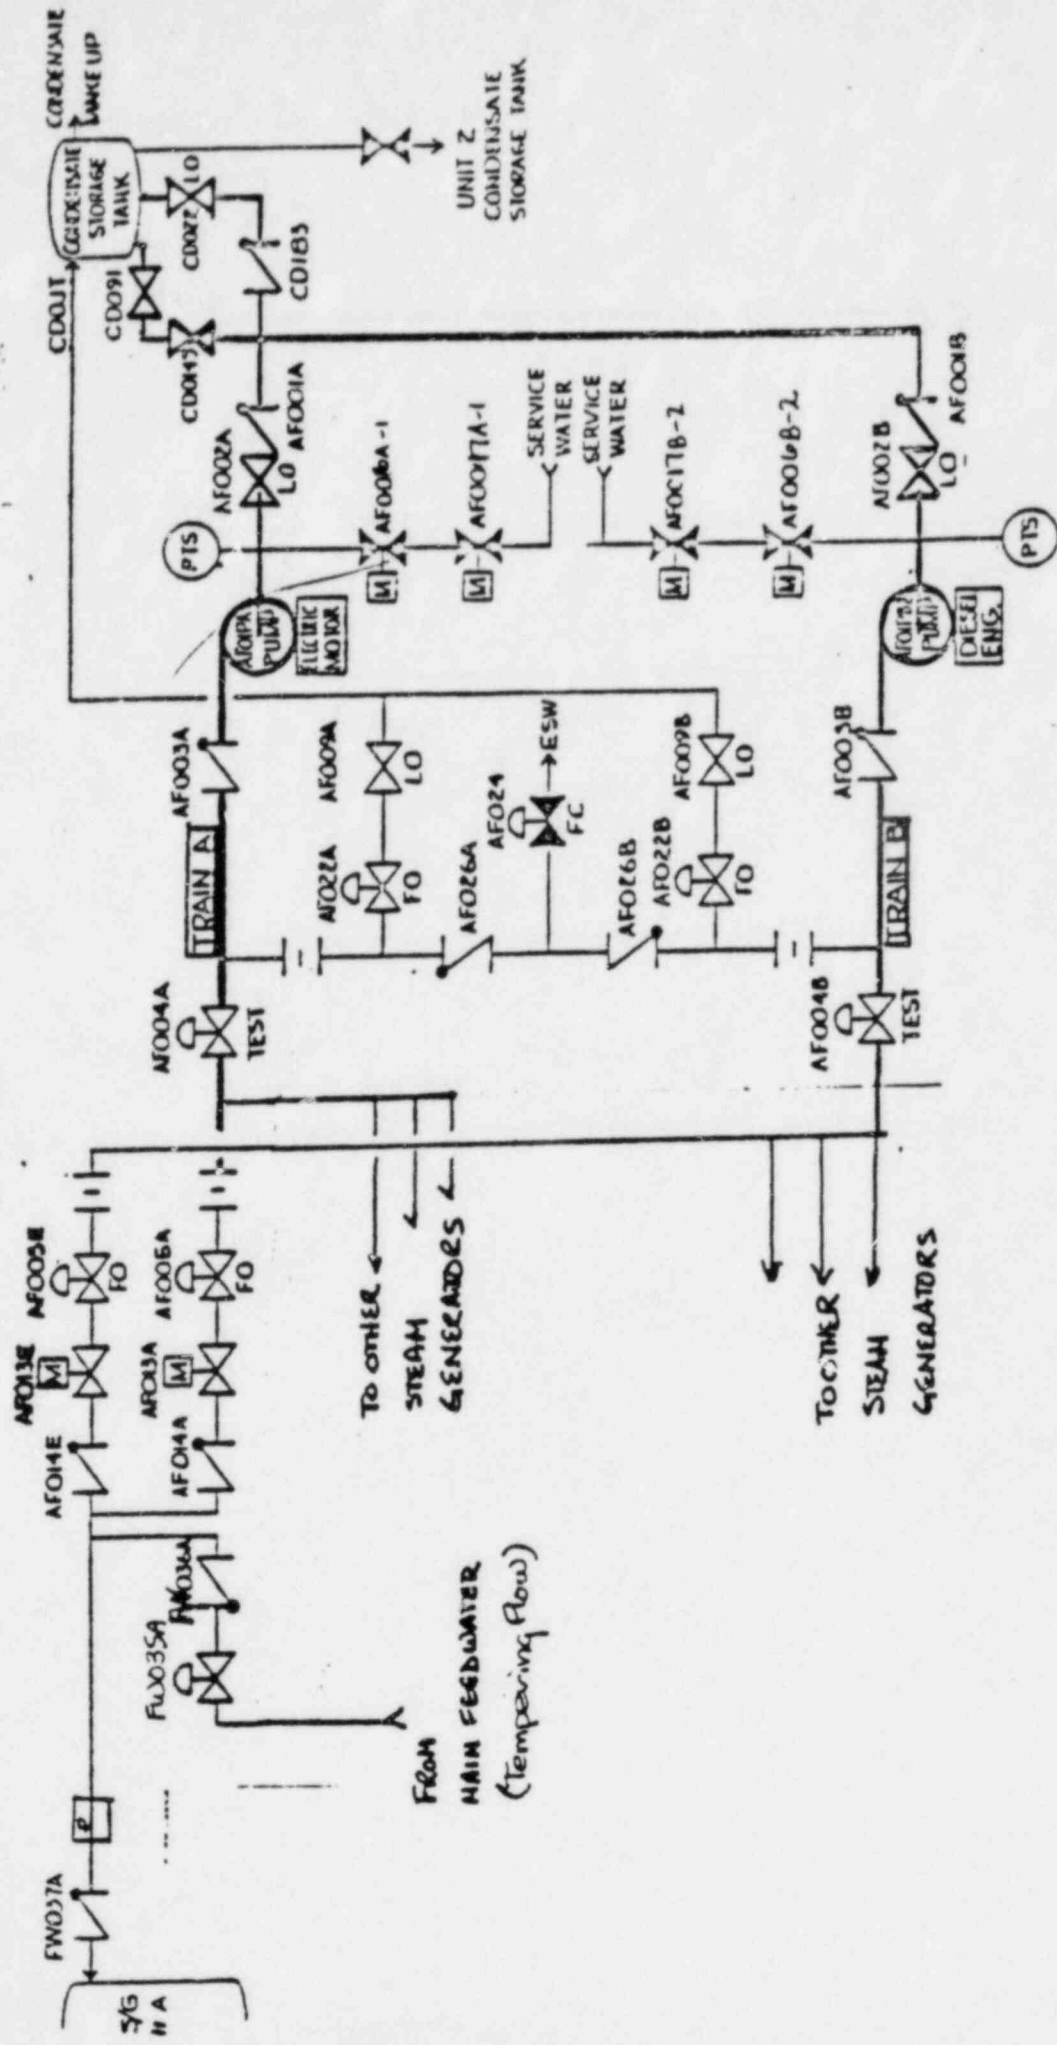
FIGURE 6

Figures 6 and 7 are simplified diagrams of the B/B AF and main feedwater systems. Detailed P&ID's accompany this response. The following table lists the valves that are controlled from the control room.

The remainder of the valves shown in Figures 6 and 7 are either manual valves, automatically operated valves or locally operated valves.

BYRON AFW SYSTEM

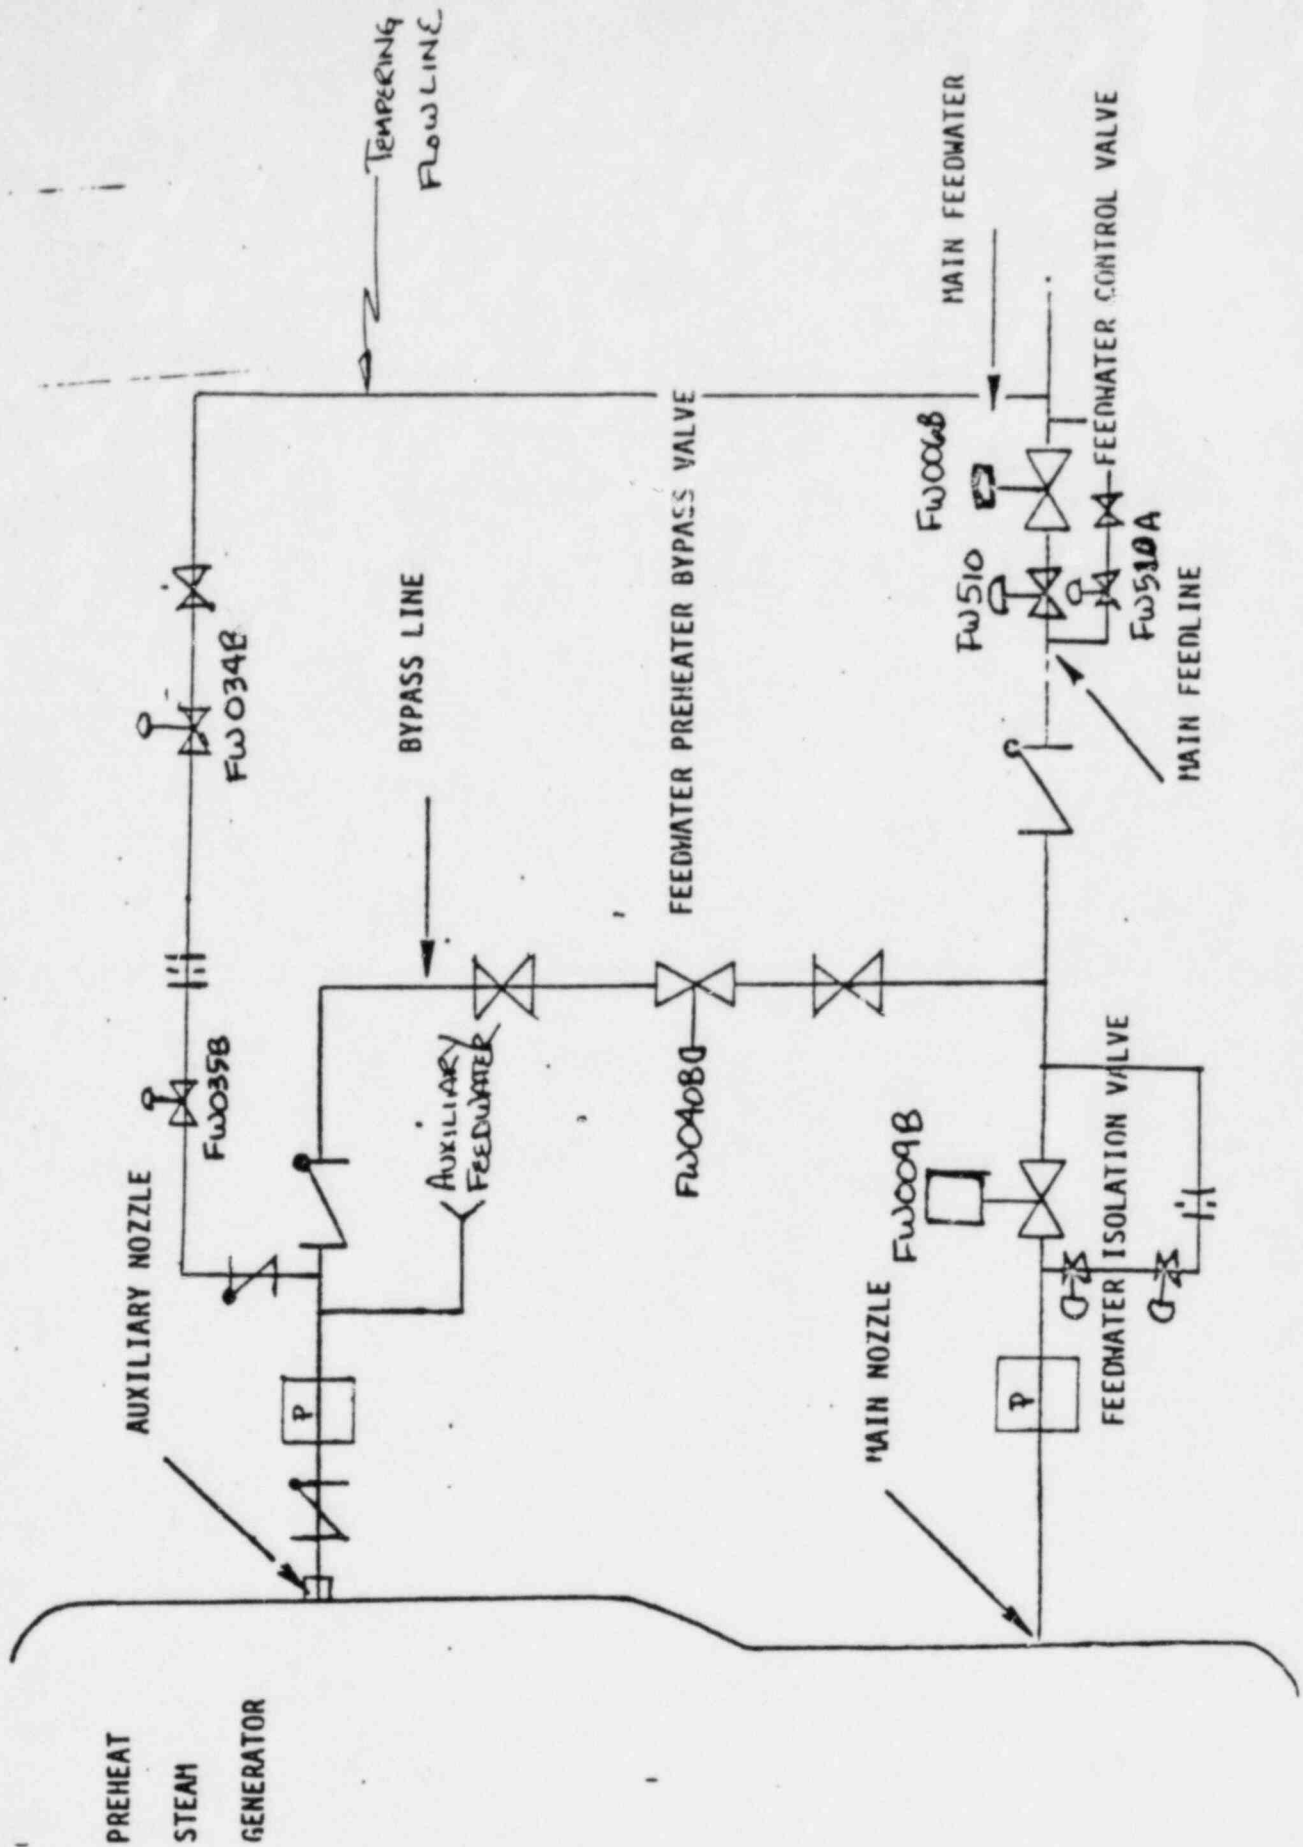
FIGURE 7

FEEDWATER BYPASS SYSTEM  
SIMPLIFIED FLOW DIAGRAM

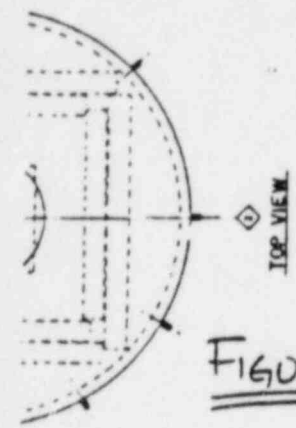
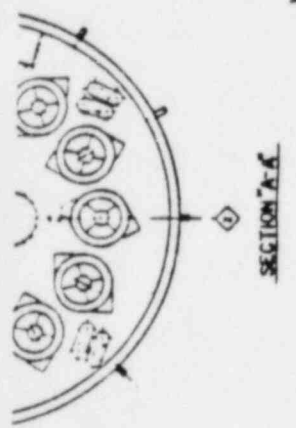
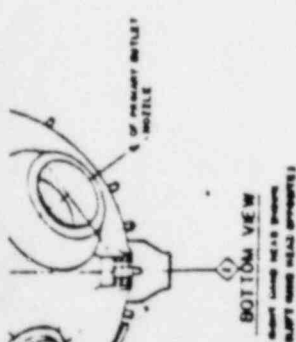
FIGURE 8

The internals of the B/B models D-4 and D-5 are shown in figures 8 and 9 respectively. Figures 8 and 9 show the auxiliary nozzle and internal extension and actual water level for 100 percent power.
