Subject of this Document: Investigation of Failed Tubes from "B" Steam Generator of the R. E. Ginna Nuclear Power Plant

Investigation of Failed Tubes from "B" Steam Generator
of the R. E. Ginna Nuclear Power Plant*

Carl J. Czajkowski

May 1982

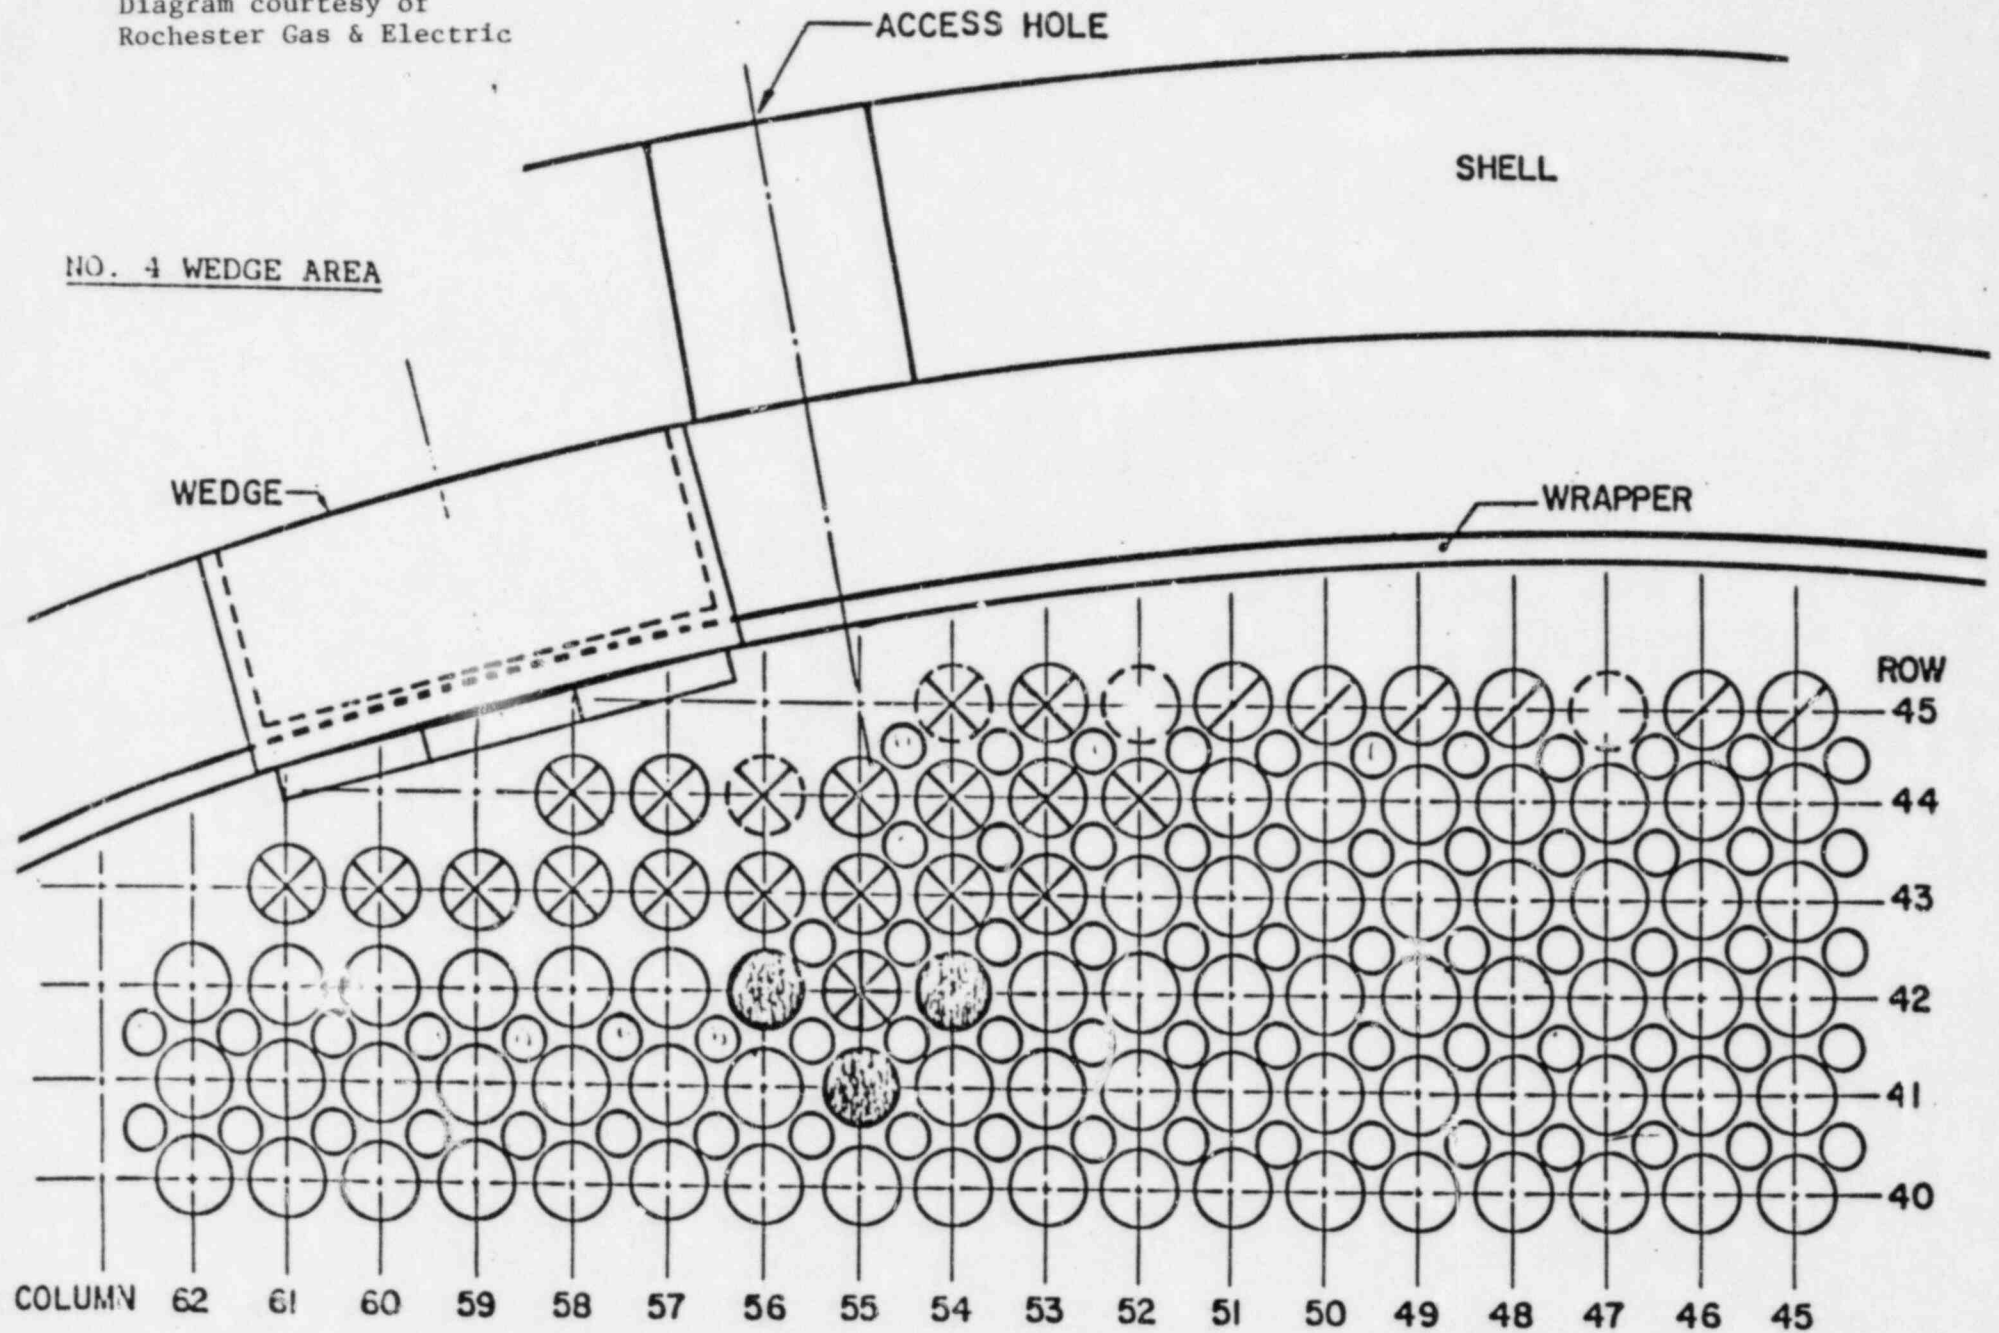
Figure 7. Diagram of Number 4 Wedge Area - Steam Generator "B" Hot Leg Side.

The photographs (Figures 2-6) portray areas of the various tubes which have been worn away by a probable abrasion mechanism. These tubes are on the inner rows of the steam generator (Figure 7) and the longitudinal wear patterns (with circumferential striations) are consistent with two tubes rubbing together for an extended period of time.

One of the tube sections received (R44-C57), had an area of full collapse in the area of the tube sheet junction (Figure 8). This tube is in the outer periphery of the tube bundle (Figure 7) and the concave portion of the collapse faces the shell of the steam generator. The next two photographs (Figures 9-10) show an impact and wear mechanism which occurred on tubes away from the area of the leak (#4 wedge area) in the #6 wedge area. (Fig. 11) The severest damage occurred on the tube where its circumference faced the steam generator shell. The wear patterns were consistent with the rubbing of one tube by another tube of approximately 7/8" outside diameter.

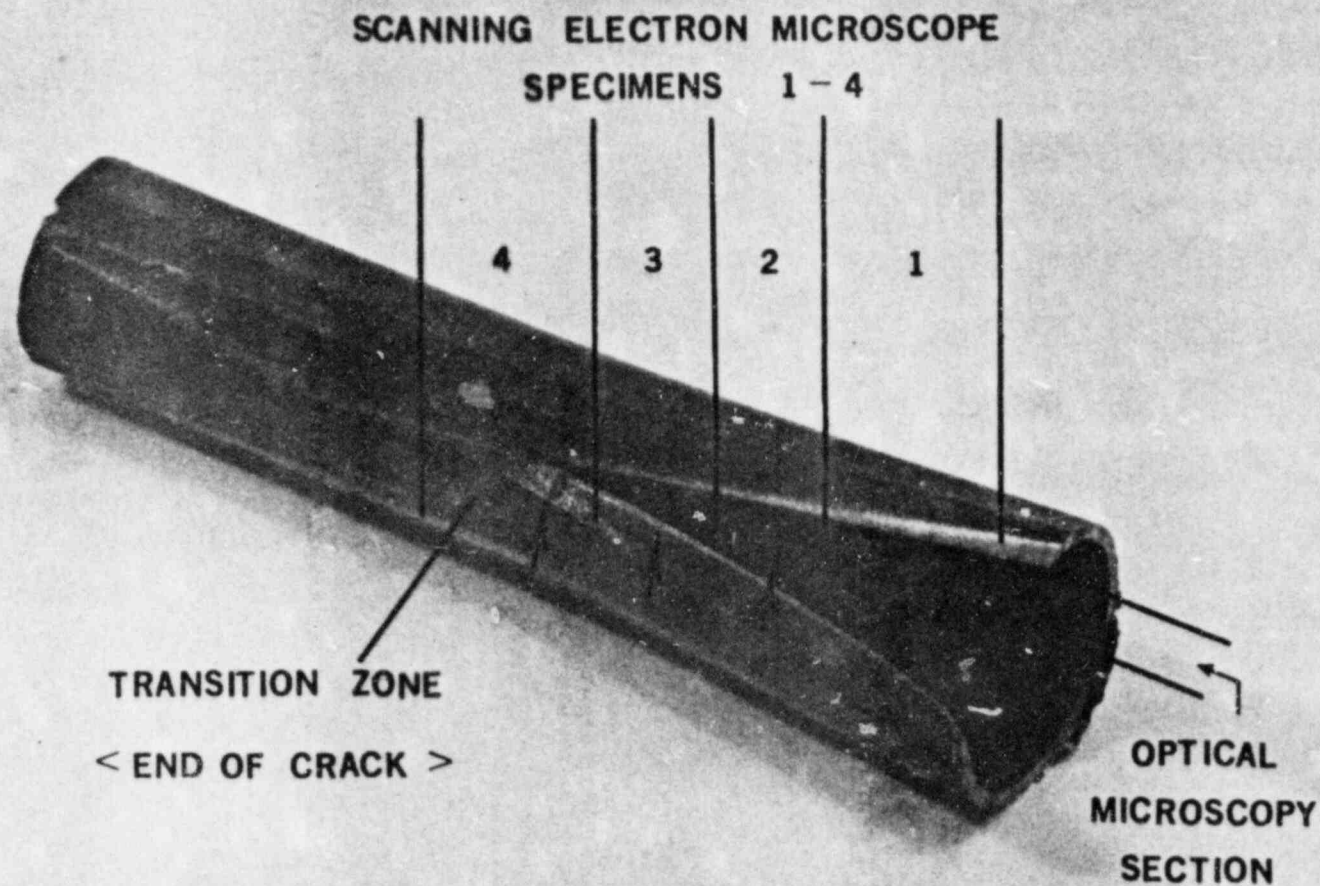
Figure 15. Photograph of "fish mouth" crack
in tube R42-C55 (GINNA)

The bottom half of the "fishmouth" fissure (R42-C55) is displayed in Figure 15. Longitudinal wear scars (with circumferential striations) are quite evident in the photograph. These wear patterns are consistent with similar areas found on other inner steam generator tubes. There were no areas of impact evident on this tube.

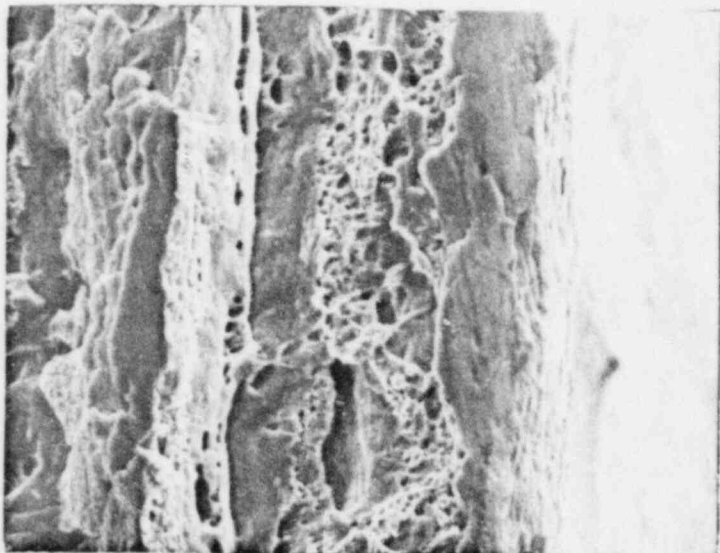
The "fishmouth" fissure on tube R42-C55 was sectioned (Figure 16) for both SEM and optical examinations. Figures 17-24 are typical SEM photographs of the face of the "knife edge" fissure starting near the center of the "fishmouth" and moving along its length to the crotch of the crack. It is clearly seen in Figures 17 and 18, that the mode of failure was a ductile overload mechanism. The normally circular dimples (if a uniaxial tensile test were performed) are somewhat elongated, which is evidence of a pipe bulge prior to break. The elongated dimpled structure of the fracture disappeared the farther away the "fishmouth" was scanned from the center of the fissure, as seen in Figures 19-22. An impacted area was noted in specimen #3 (Figure 21), which appeared to have occurred after the tube failed. This occurrence would be consistent with the postulation that loose objects were present in the steam generator at the time of failure. Figures 23 and 24 are SEM photographs of the transition zone (end of crack) in specimen #4. It is evident by the photographs, that the end of the crack also displayed ductile overload features with no evidence of fatigue contribution.

Figure 18. SEM photo of knife edge on R42-C55. Elongation of dimples less pronounced. Specimen #2

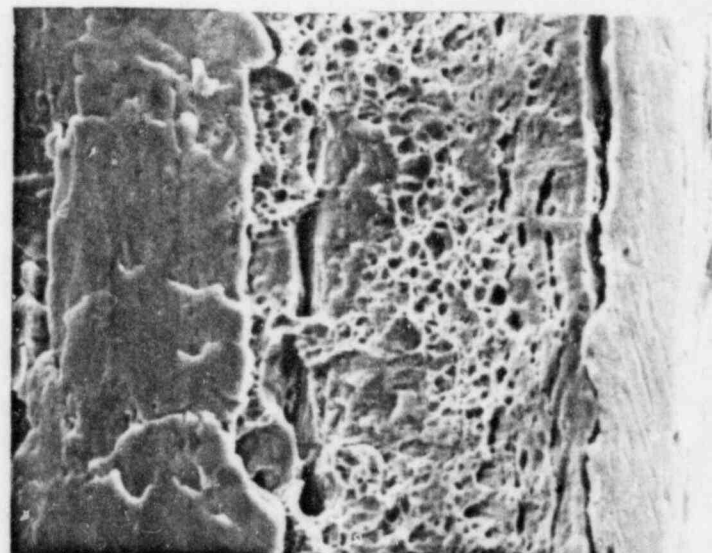
Figure 19. SEM photo of knife edge on R42-C55. Higher magnification. Specimen #2.

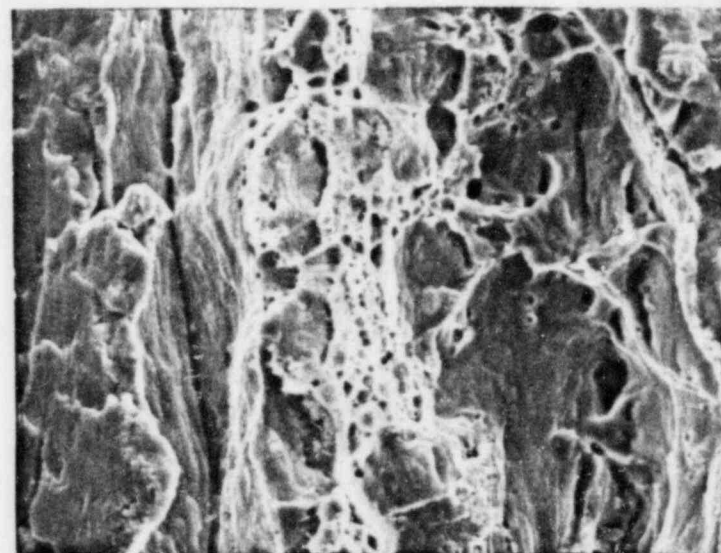
Figure 21. SEM photo of knife edge on R42-C55 depicting impact after break. Specimen #3

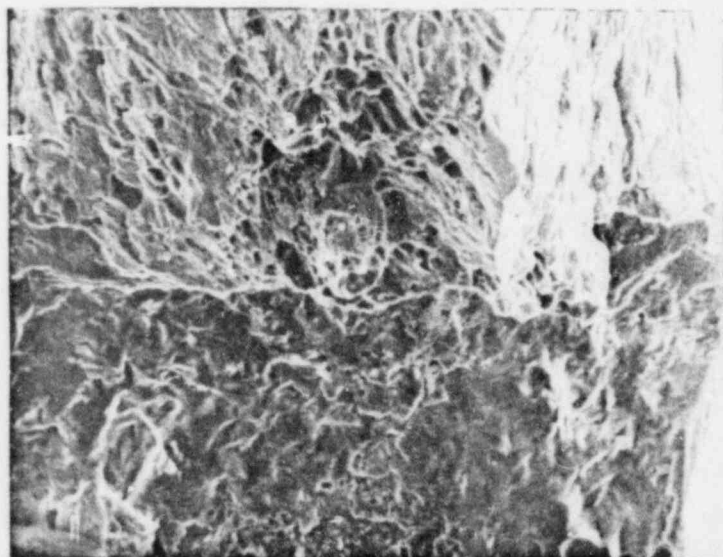
Figure 22. SEM photo of knife edge on R42-C55. Specimen #4

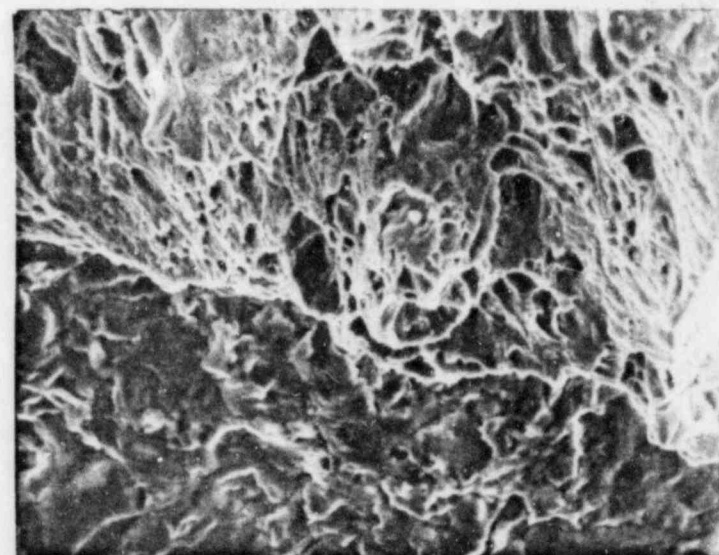
Figure 23. SEM photo of transition of knife edge on R42-C55. Specimen #4

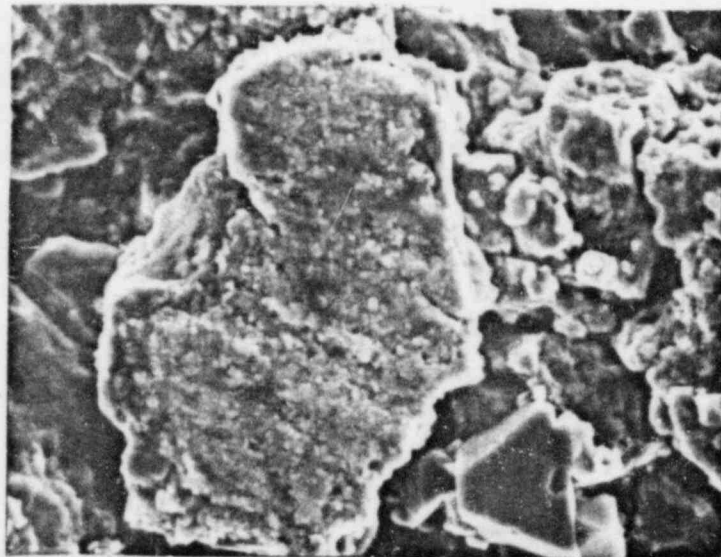
Figure 30 is an SEM photograph of a typically abraded and impacted section of tube R11-C91. Although some wear lines are evident, the section has no predominant distinguishing features.

Figure 30. SEM photo of outside surface of abraded tube R11-C91

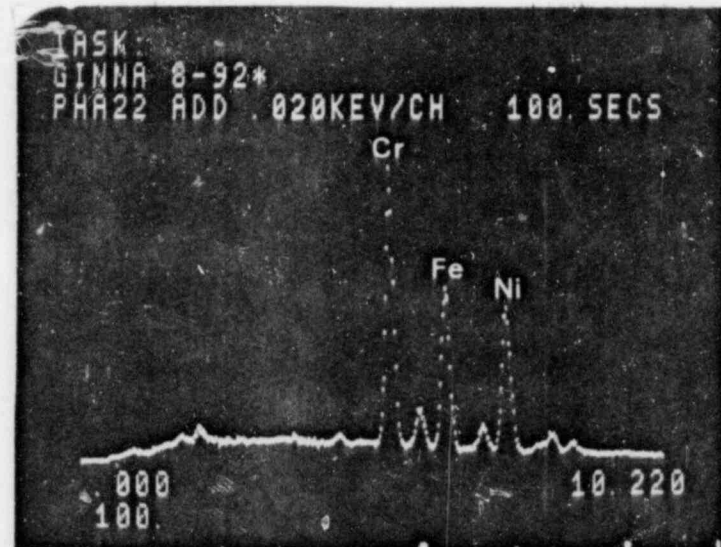
Various EDS scans were performed on the outside surface of the impacted specimens of tubes, and on the inside surfaces of the impacted sections (adjacent to any breaks in the tube), in the hopes of obtaining information on the composition of the impacting object. Figures 31 and 32 are typical of the scans encountered on tube R8-C92 and are representative of the majority of scans taken.

Figure 31. SEM photo of particle on inside surface of tube R8-C92 near rubbed area

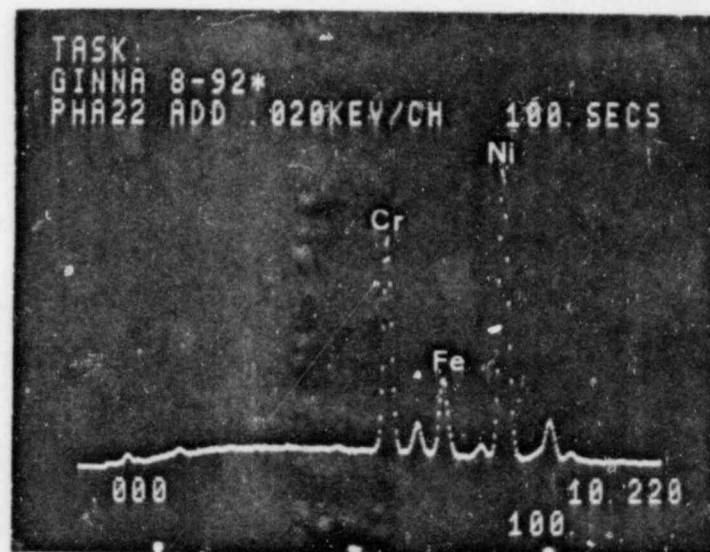
Figure32. SEM photo of inside surface
of tube R8-C92 depicting area
of wall collapse

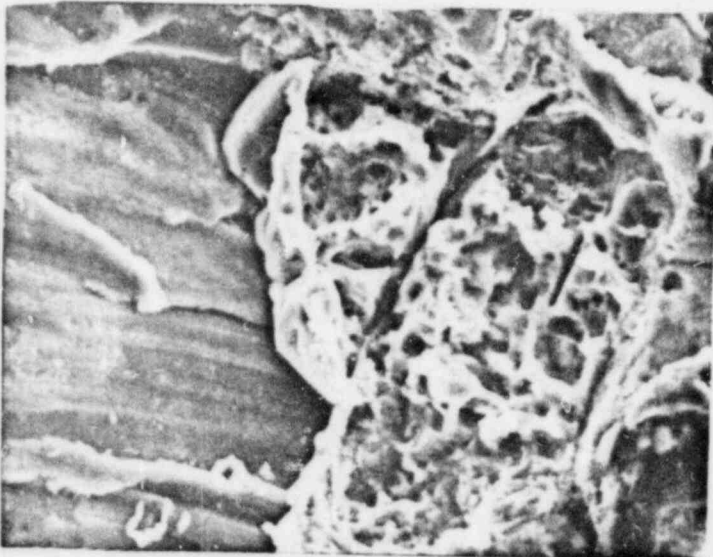
The last set of EDS scans (Figures 34, 35, and 36) display the constituents found on two smears on an impacted area on the outside surface of tube R43-C59. The scan (Figure 34a) is typical of that found on both of the smears and shows an extremely high peak of iron (Fe) relative to chromium and nickel. Since tube R43-C59 is an outer periphery tube, this finding appears to corroborate the hypothesis that the outer periphery tube damage occurred as a result of impact with a carbon steel foreign object.

Figure 34a. EDS scan of imbedded particle found on R43-59
