**Florida
Power**
CORPORATION

Subject: Crystal River Unit 3
Docket No. 50-302
Operating License No. DPR-72
Licensee Event Report No. 89-039-01

FACILITY NAME (1) CRYSTAL RIVER UNIT 3										DOCKET NUMBER (2) 0 5 0 0 0 3 0 2										PAGE (3) 1 OF 11																		
TITLE (4) Personnel Error Results in Operation Outside the 10 CFR 50 Appendix R Separation Design Basis																																						
EVENT DATE (5)						LER NUMBER (6)						REPORT DATE (7)						OTHER FACILITIES INVOLVED (8)																				
MONTH			DAY			YEAR			YEAR			SEQUENTIAL NUMBER			REVISION NUMBER			MONTH			DAY			YEAR			FACILITY NAMES						DOCKET NUMBER(S)					
																											N/A						0 5 0 0 0					
0 3 2 9			9 0			8 9			0 3 9			0 1 0			4 3 0 9			0			N/A						0 5 0 0 0											
OPERATING MODE (9) 5						THIS REPORT IS SUBMITTED PURSUANT TO THE REQUIREMENTS OF 10 CFR 5: (Check one or more of the following) (11)																																
POWER LEVEL (10) 0 0 0						20.402(b)						20.406(c)						60.73(a)(2)(iv)						73.71(b)

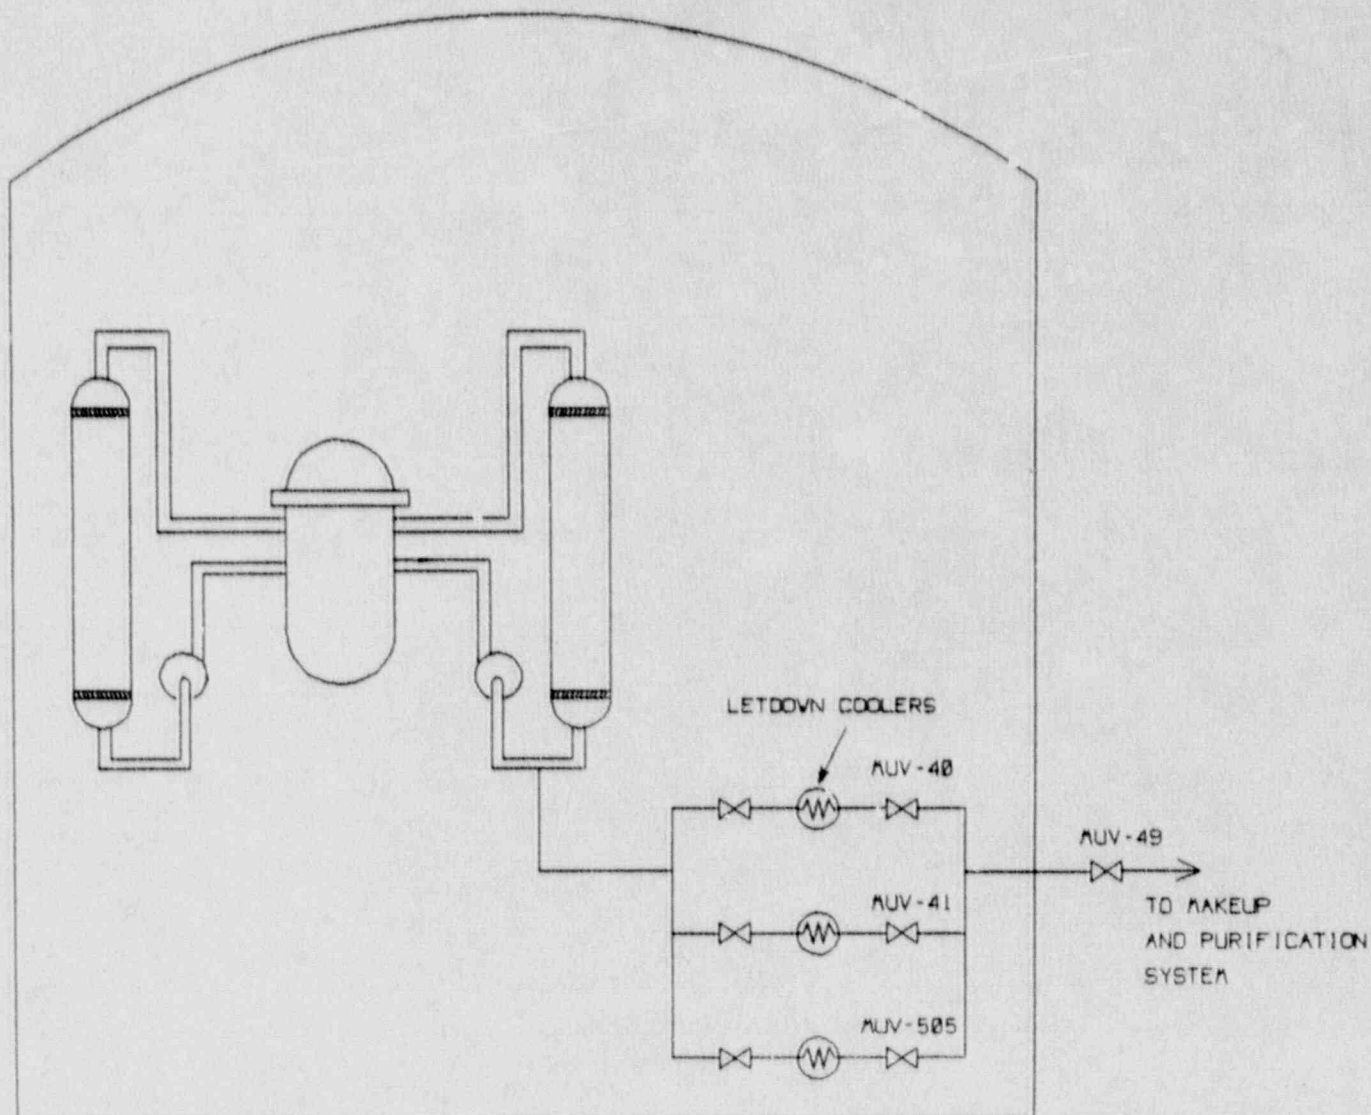
FIGURE 1

On November 7, 1989, Crystal River Unit 3 was in MODE 1, POWER OPERATION, at 855 MWe. The control circuits for two valves [ISV] in the Make-up System [CB] (MUV-40 and MUV-41) that isolate Reactor Coolant System (RCS) [AB] letdown are located on the 124' elevation of the Control Complex [NA]. These two valves, both inside the Reactor Building [NH], comprise one train of letdown isolation (see Figure 1). The valves are part of the equipment required for safe shutdown of CR-3 in the 10CFR50 Appendix R design for a fire on the 124' elevation of the Control Complex. The redundant train is the single isolation valve outside the Reactor Building. For the design fire on the 124' elevation, the outside isolation valve control circuitry is assumed failed. At 1515, it was determined the control circuits for the two inside valves did not meet 10CFR50 Appendix R separation criteria from the outside valve. The valves and control circuits were operable at the time of the event and no equipment failures occurred.

It was immediately confirmed that a roving fire watch patrol was in effect. This was considered to be an effective fire protection measure which would reduce the potential for a major fire and the actions required by the 10CFR50 Appendix R fire study. The roving fire watch and the action listed for each item were considered adequate compensatory measures until the deficient circuits could be modified. The six deficient circuits will be modified to meet the 10CFR50 Appendix R separation criteria.
