Millstone Nuclear Power Station, Unit No. 2
Request for Enforcement Discretion
Reactor Coolant System - Structural Integrity
Limiting Condition for Operation

Use of a Proposed Alternative to
ASME Section XI in Accordance with the
Requirements of 10CFR50.55a(3)(ii)

UNIT: Millstone Unit 2 NCR # 293-026 DATE: 1/25/93
TIME: 09:50

System: Service Water Supply to Vital AC Switchgear Rooms Cooling Coils X-181A & 181B

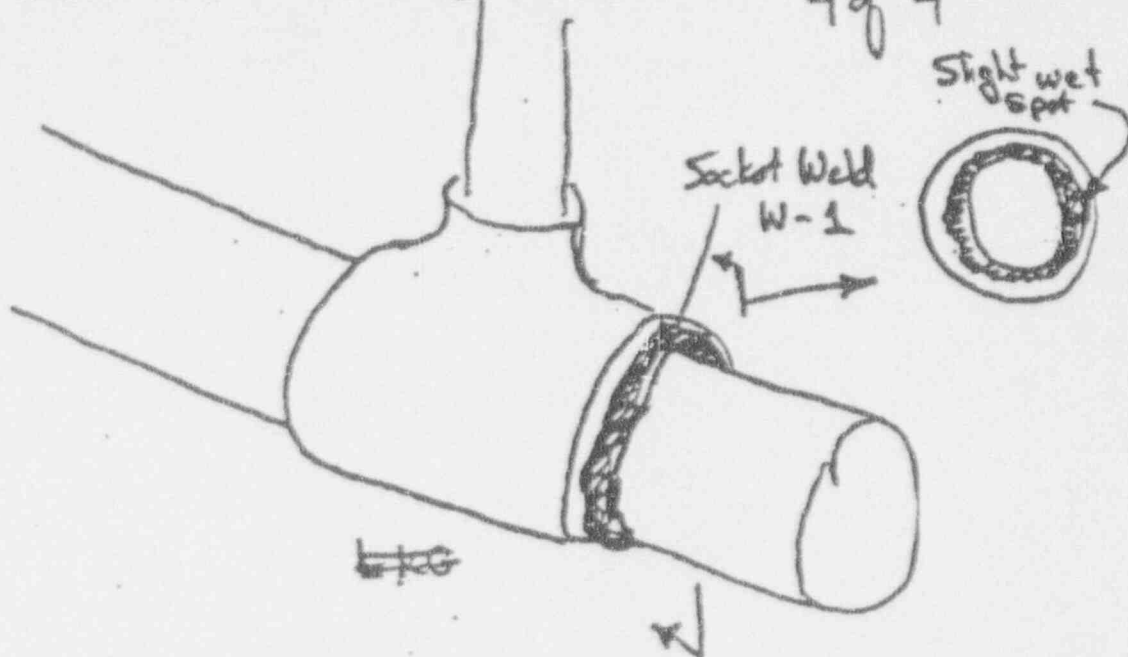
AWO M2-92-17685
weld Map

At the hydrostatic test pressure of 110 psig, the leak did not spray any water. The water wept from the weld at a very low rate. The water seeping from the pinhole drips onto the floor inside of the cooling coil water cofferdam.

During the recent LOCK test the maximum pressure at the 6" branch connection to the cooling coils was approximately 65 psig. The connection is located at approximately elevation 17'. The leak is located approximately 20' above the 6" take-off. The 20' of elevation difference and normal line losses (i.e. pipe friction, throttled valve(s)) will reduce the pressure at the leak. With these losses, the pressure at the leak will be approximately half of the hydrostatic test pressure. Therefore, under operational pressure no leakage is expected.

During the hydrostatic pressure test the leak did not spray any water. If the leak were to enlarge and start to spray, it would be directed towards the cooling coils and air plenum and not towards any electrical equipment. Operation personnel walkdown the switchgear room at least once a shift. If the leak was to become worse, operation personnel would become aware of the condition and notify maintenance personnel. If the leak was to start spraying water a spray shield and/or a soft patch, would be installed to ensure that no vital equipment could be sprayed.

AWO M2-93-01582 has been written to rework the leak at the next available opportunity (i.e. plant non-operational). The joint will be repaired in accordance with ASME Section XI and the following steps;

- The weld in the area of the leak will be excavated and if necessary the entire weld will be removed.
- The excavated area will be LP inspected, to ensure solid base metal is present.
- The weld will be repaired in accordance with the WUSCO weld manual.
- The weld will be visually inspected per CWS-004.
- Once the weld is reworked the pipe will be hydrostatic pressure tested in accordance with SP-21219.
