NATIONAL BOARD BULLETIN

THE CHINESE FLANGE
INVESTIGATION

1992 • VOLUME 48 • NUMBER 2

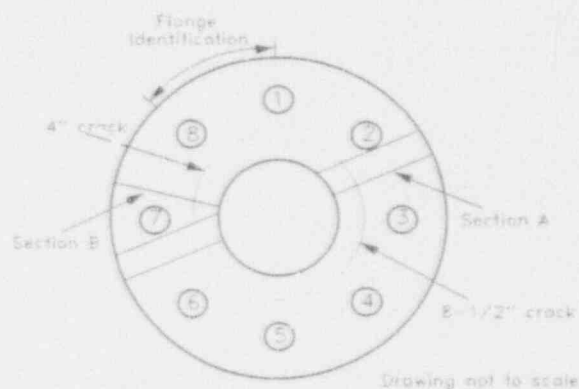
Figure 1, Flange layout and sample locations

When the flange was first received, a visible crack was evident at the transition between the flange and the weld neck. There also appeared to be machining grooves in this same vicinity. To verify the extent of cracking, the flange was subjected to penetrant testing. As can be seen in Figures 2 and 3 below, there was more cracking evident than could be detected visually. In fact, more than 75% of the circumference exhibited cracking.

Section A was removed from the region identified in Figure 1. This section was polished and etched to for metallurgical examination. Of initial interest was whether the flange had been fabricated from more than one piece of material. Once the etched surface was visually examined, it was apparent that the flange had been machined from a single piece of metal.

To obtain some additional information, a second section was removed at location B (see Figure 1). At this location, a crack had been noted during penetrant testing; however, it appeared to be much tighter than that appearing at Section A. Once removed, this section was also subjected to metallurgical polishing and etching. The result appears in Figure 5.

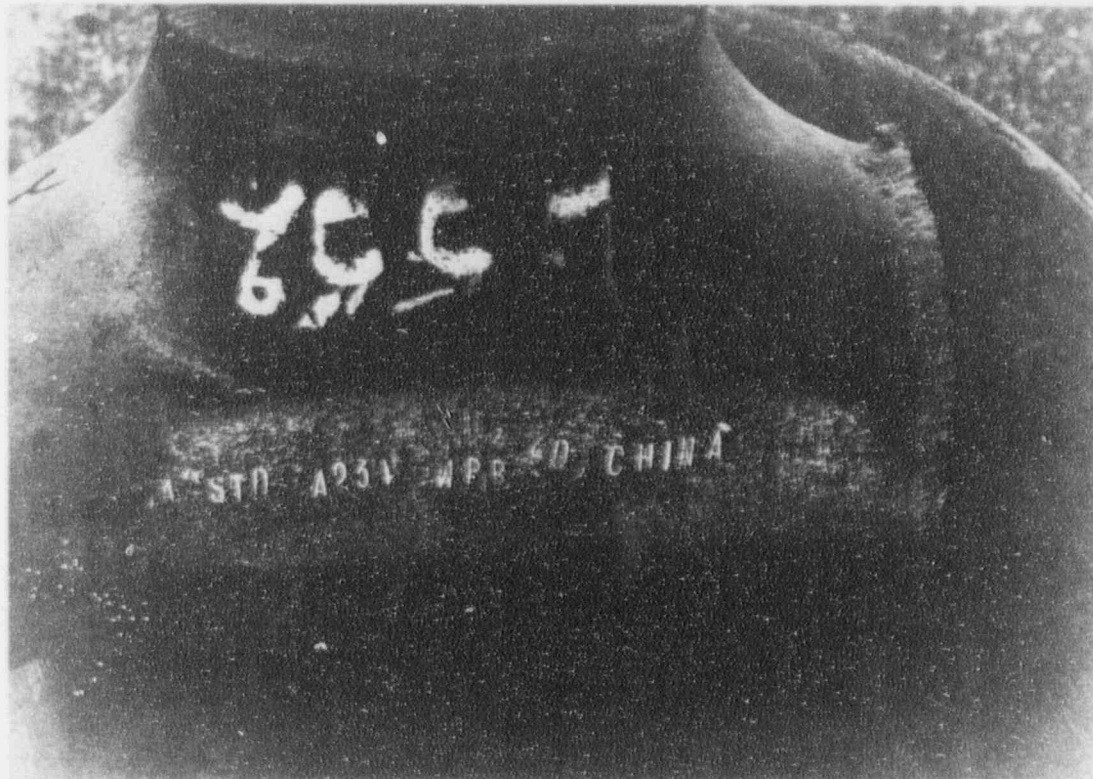
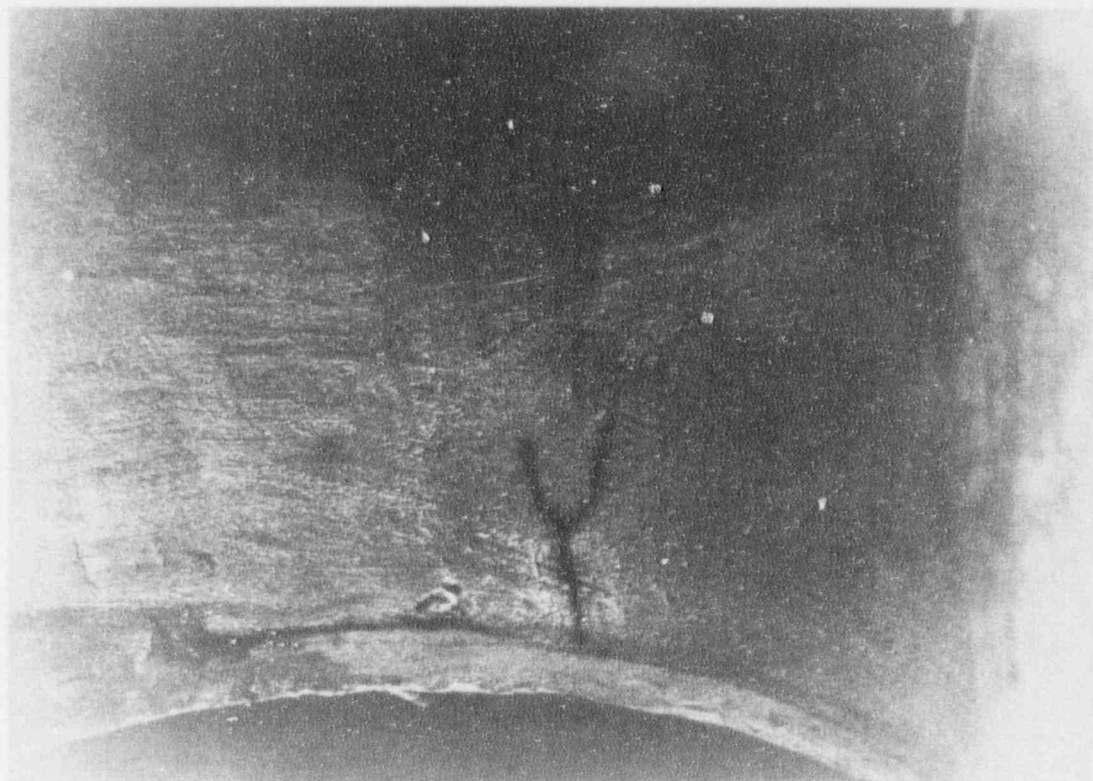
Fig. 2. This is a 4" Tee Joint that leaked during hydrostatic testing.

MARKING: 4" STD A 234 WPB (D) CHINA

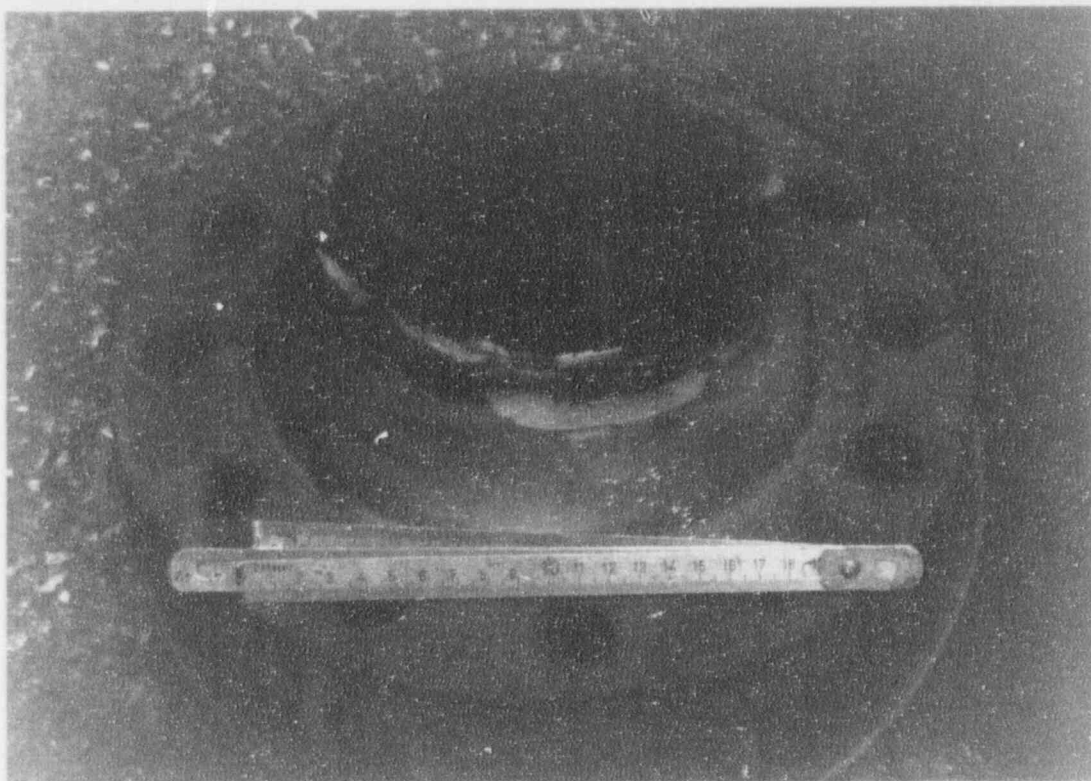
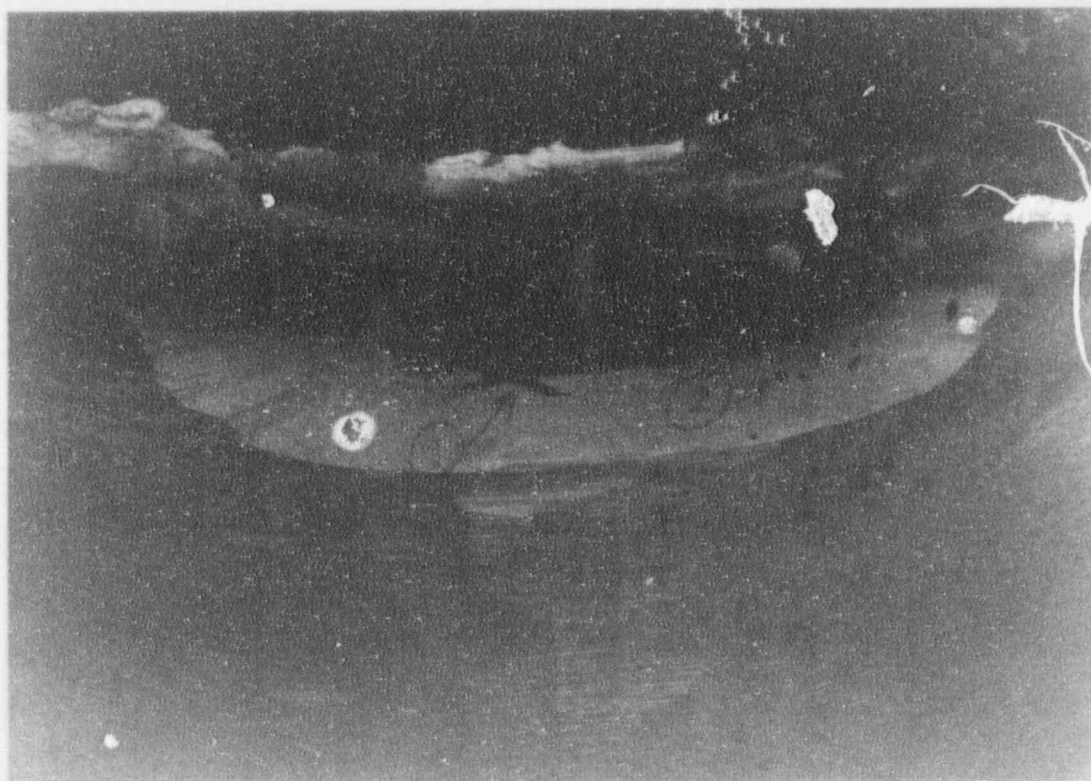
6" Weld Neck Flange

Fig. 1. This is a 6" weld neck flange that leaked during hydrostatic testing. An attempt was made to remove and weld repair the defect but because it went deeper into the neck, the attempt was abandoned.

- ① Crack-like feature
- ② Porous-like feature

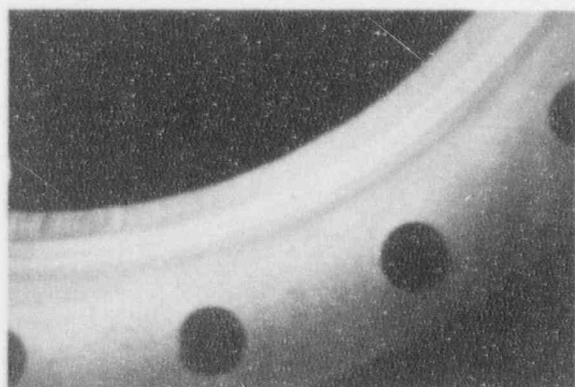
1. The signature on this report is not the flange manufacturer. It is reported to be a trading company representative.
2. The sum of the chromium and molybdenum is .35% Maximum permitted by A-105 is .32%.
3. Flange exhibits inclusions.
4. Tian Gong (trading co.) representative reported that Tai Gong is not the producing mill.
5. The trading company reported that Ding Xiang Flange Company did not use A-105 but instead used 25MN to produce all of its flanges (117-139 ions).

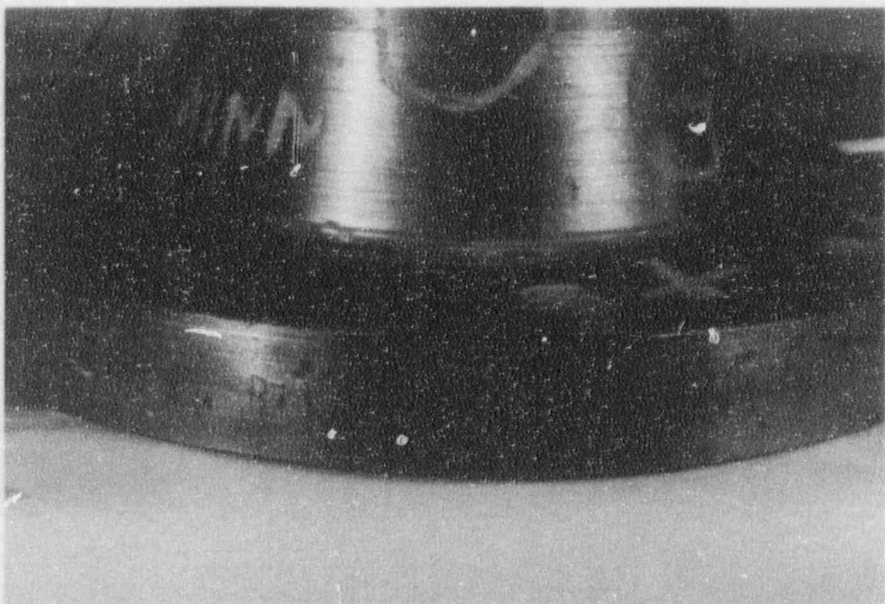
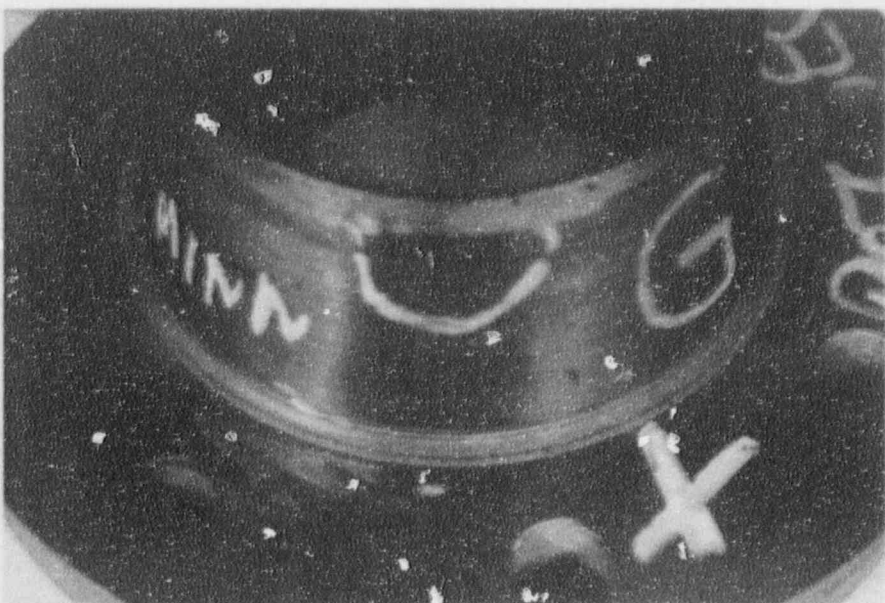
Flange exhibits laps or seams to an edge depth of approximately 50% of wall thickness.
