Carolina Power & Light Company

Brunswick Stream Electric Plant

BRUNSWICK STEAM ELECTRIC PLANT, UNIT NOS. 1 AND 2
DOCKET NOS. 50-325 & 50-324/LICENSE NOS. DPR-71 & DPR-62
REPLY TO NOTICE OF VIOLATION

BRUNSWICK STEAM ELECTRIC PLANT, UNITS 1 AND 2
NRC DOCKET NOS. 50-325 & 50-324
OPERATING LICENSE NOS. DPR-71 & DPR-62
REPLY TO NOTICE OF VIOLATION

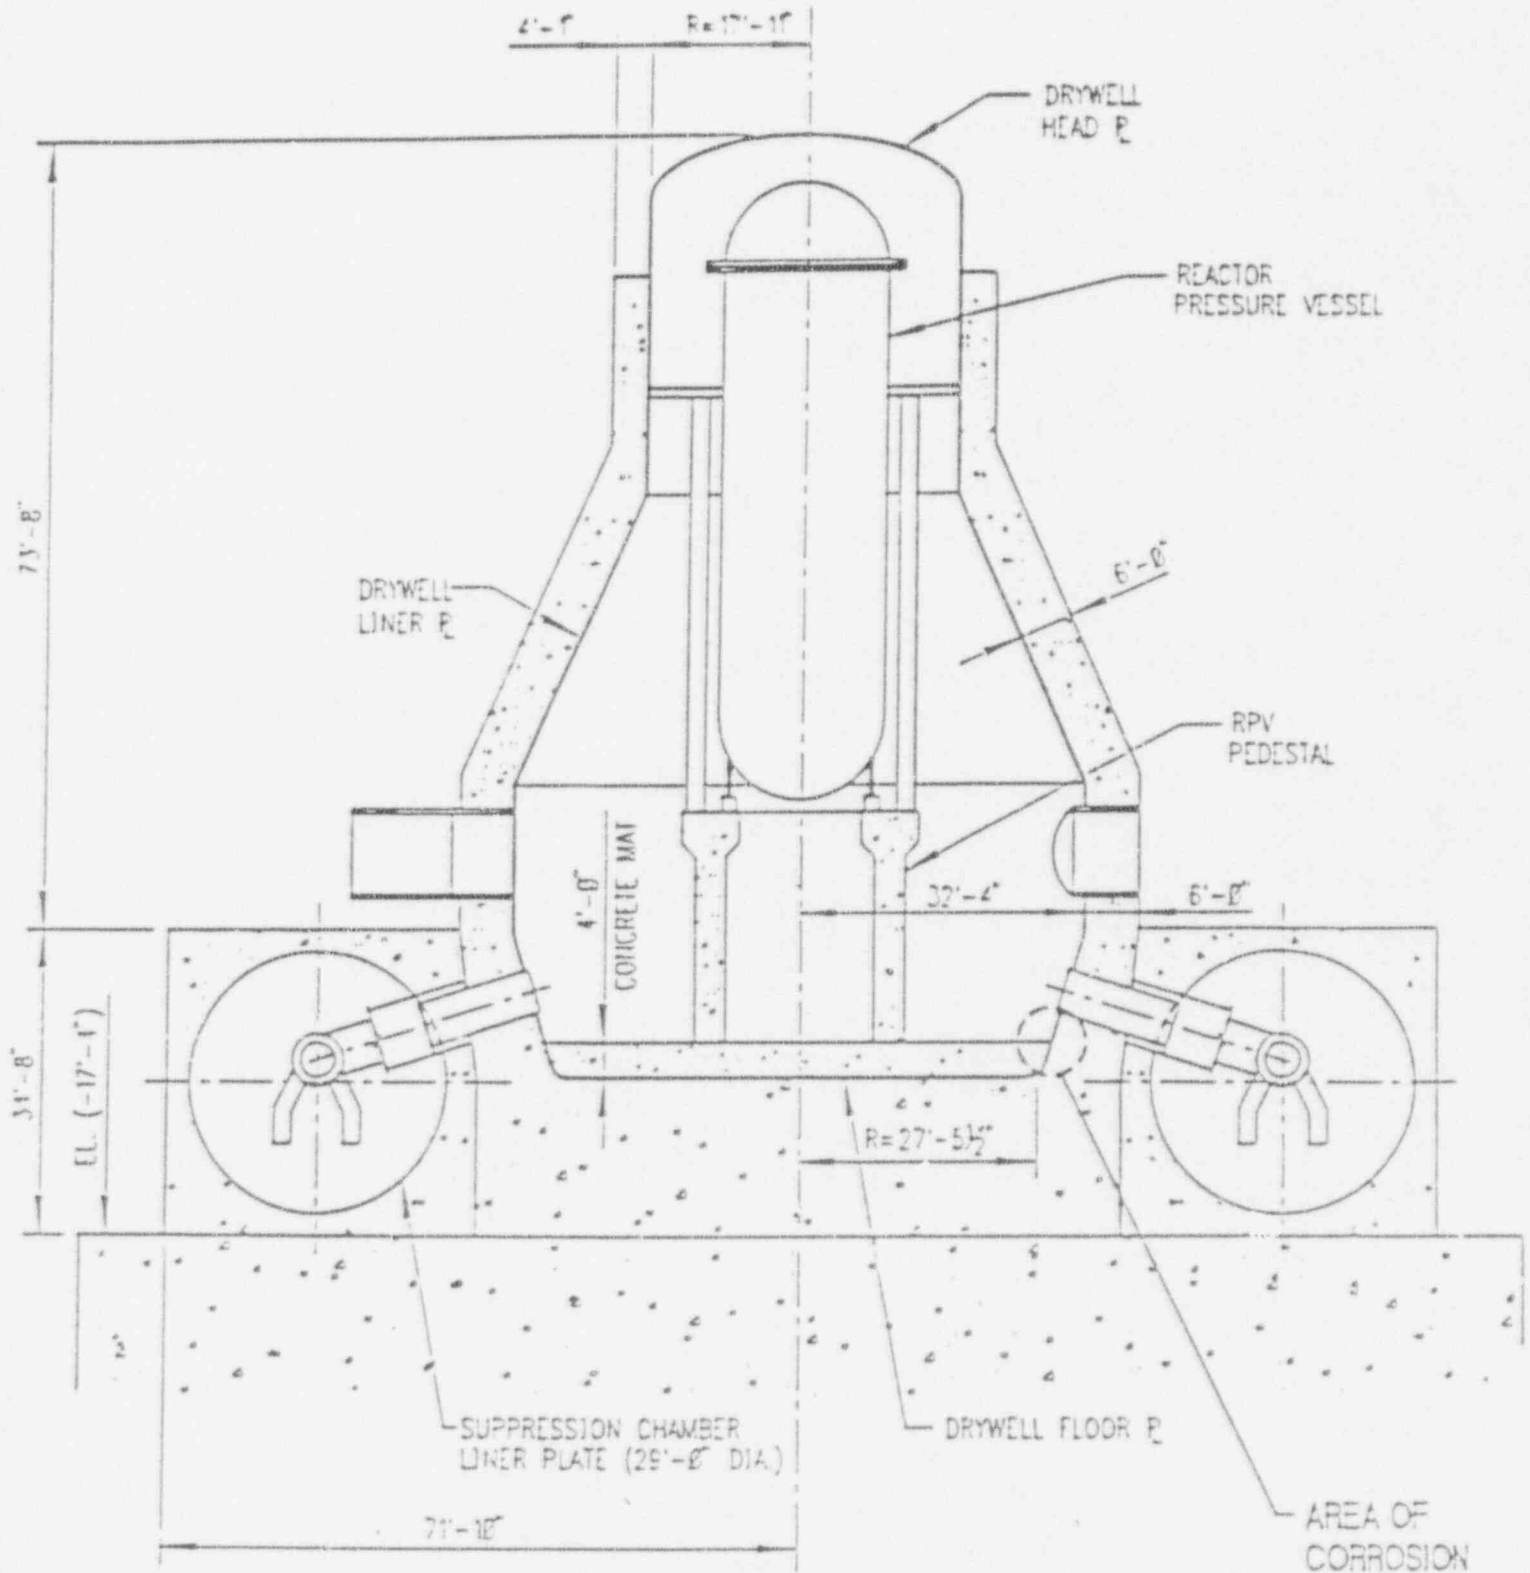
ATTACHMENT 1

Special Procedure OSP-93-010, Drywell Liner Corrosion Examination, was developed to quantify the extent and depth of the liner corrosion (see Attachment 1). The procedure provides instructions for cleaning the liner plate, designation of inspection zones, and instructions for measuring the base metal plate thickness and the depth of pits in the corroded areas. The plate thickness is measured using Ultrasonic Testing (UT) methods in unaffected areas adjacent to the corroded area. The depth of corrosion is measured using dental molding compound.

SECTION THROUGH PRIMARY CONTAINMENT STRUCTURE
