# Duquesne Light Company

**Subject: Beaver Valley Power Station, Unit No. 2  
Docket No. 50-412, License No. NPF-73  
Request for Relief for a Non-Code  
Repair on 2-SWS-EJM-237A and 2-SWS-EJM-237B**

DUQUESNE LIGHT COMPANY  
Nuclear Power Division  
Beaver Valley Power Station, Unit 2

Request for Relief for Non-Code  
Repairs on 2-SWS-EJM-237A and 2-SWS-EJM-237B

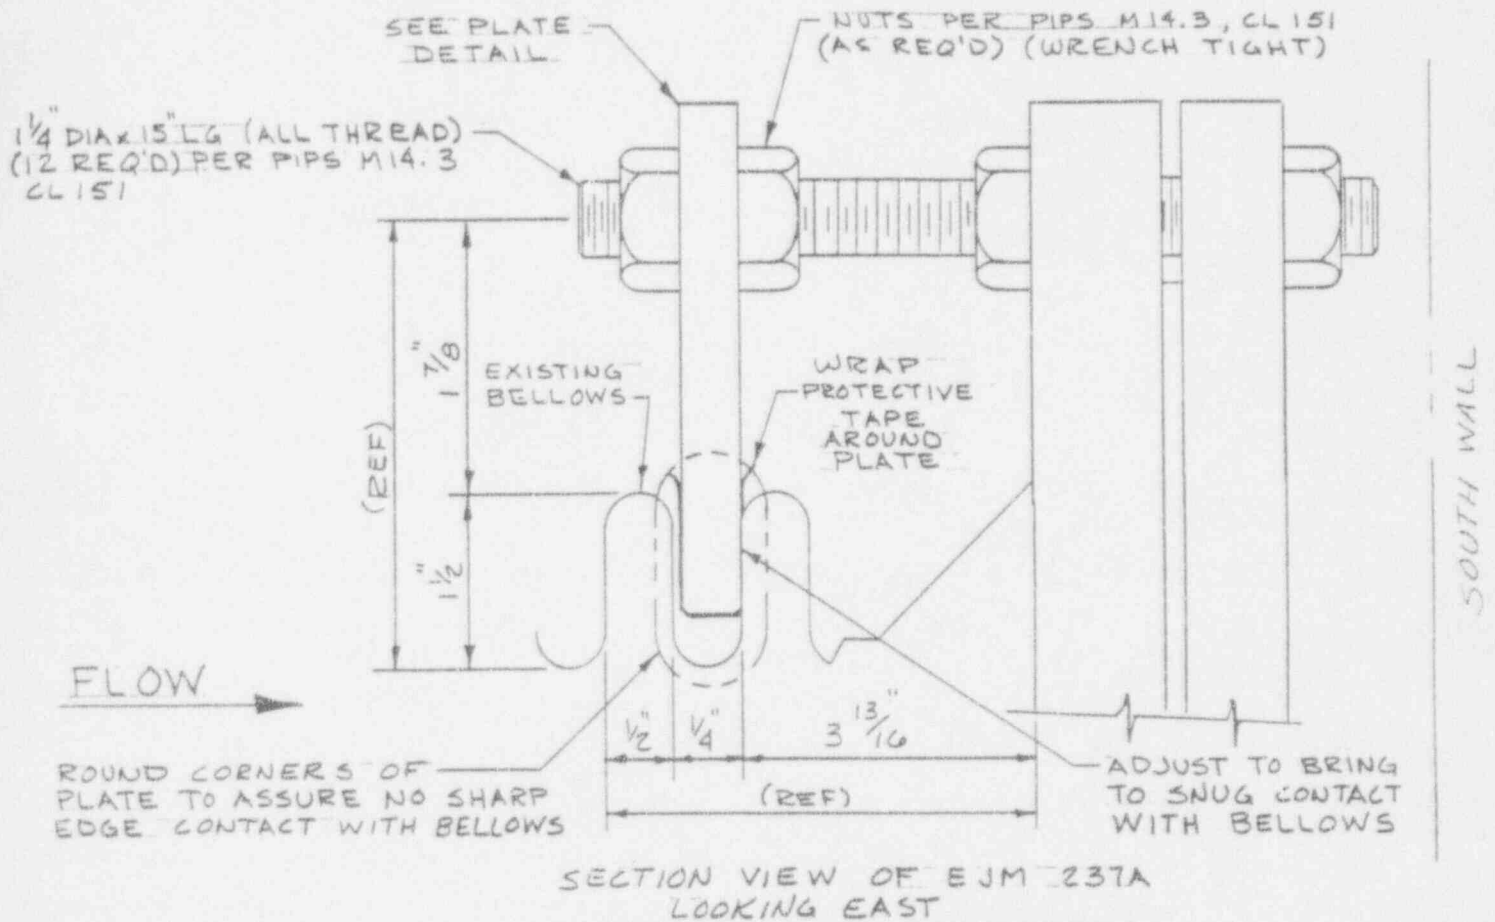
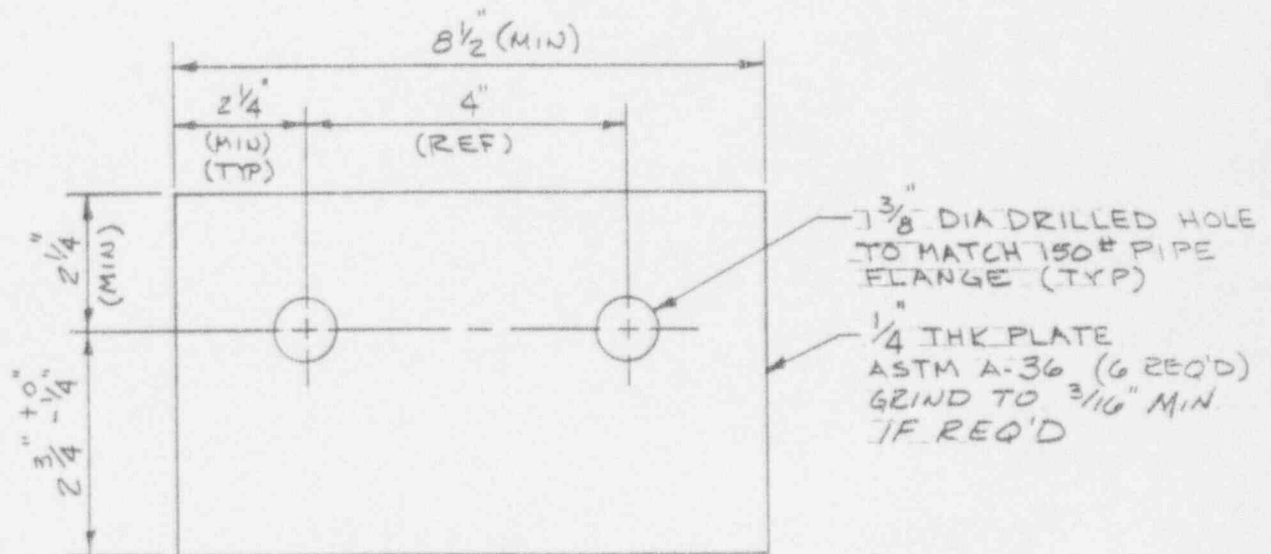
FIGURE 2

DETAIL A

1. A fiberglass reinforced epoxy resin material wrapped completely around the joint between the bellows and the flange. This material is pressure rated and will seal the joint and prevent gross leakage or water spray.
2. In order to prevent the possibility of the bellows from disengaging from the flange, six (6) dogs (see Figures 2 and 3) will be bolted to the flange joint. These dogs will hold the first bellows convolution in place. In the unlikely event of a complete weld failure, this modification will hold the bellows inside of the flange joint. This modification will not prevent the bellows from performing its normal function.

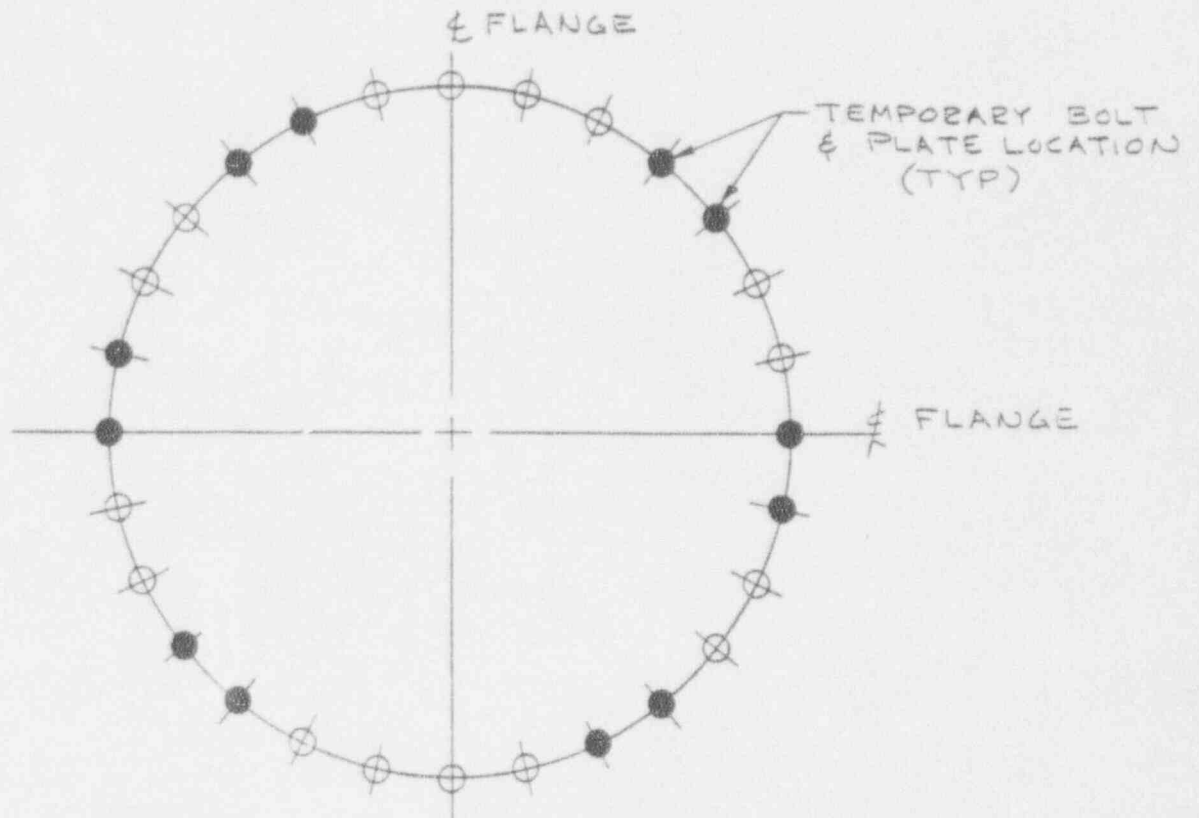
FIGURE 3

FLANGE BOLT ORIENTATION  
LOOKING SOUTH
