REPORT AND SAFETY EVALUATION  
OF THE  
BROWNS FERRY UNIT 3 PARTIAL SCRAM FAILURE  
OF JUNE 28, 1980

DIVISION OF NUCLEAR POWER  
July 6, 1980

prepared by  
TENNESSEE VALLEY AUTHORITY  
Reactor Engineering Branch

REPORT ON  
THE BROWNS FERRY 3  
PARTIAL FAILURE TO SCRAM EVENT  
ON JUNE 28, 1980

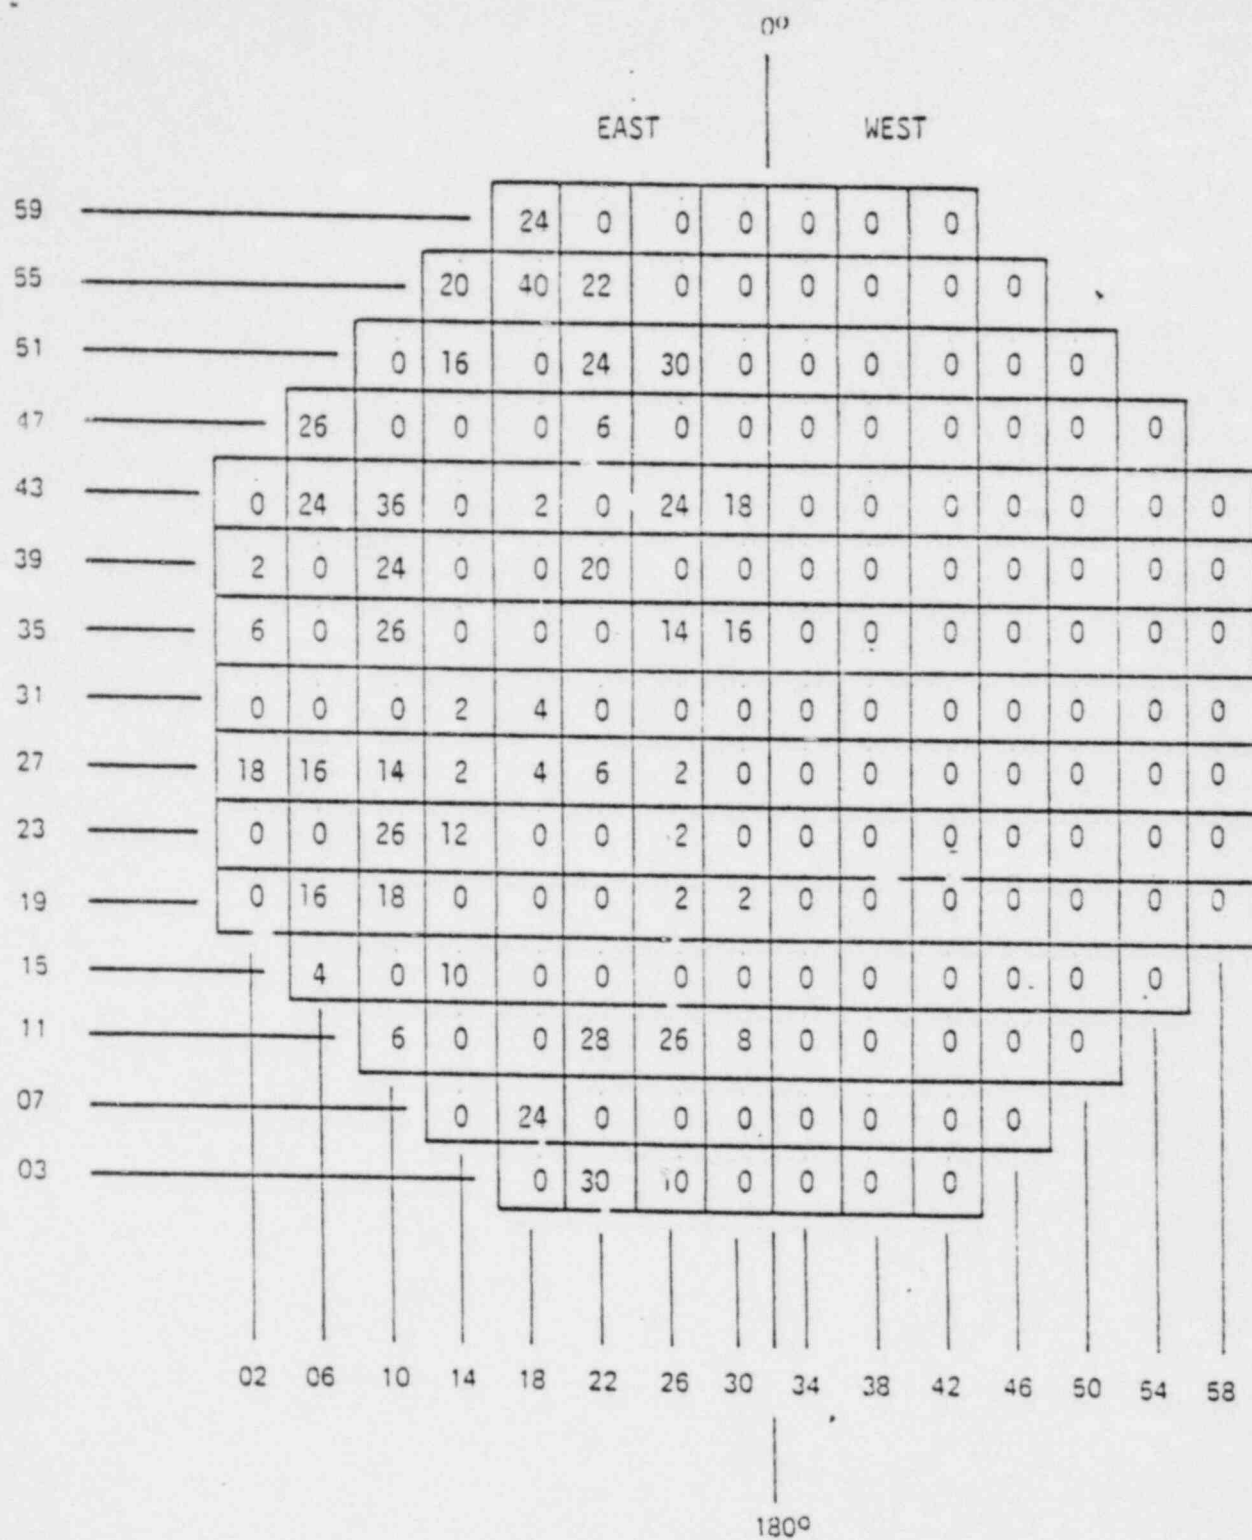
Figure 2-4 Control Rod Positions After Third Scram

<u>Scram No.</u>	<u>Drain Time from Previous Scram, Sec.</u>	<u>Total Positions Inserted</u>	<u>Positions Per CRD</u>
2	93	956	10.2
3	53	402	4.3
4	160	800	8.6

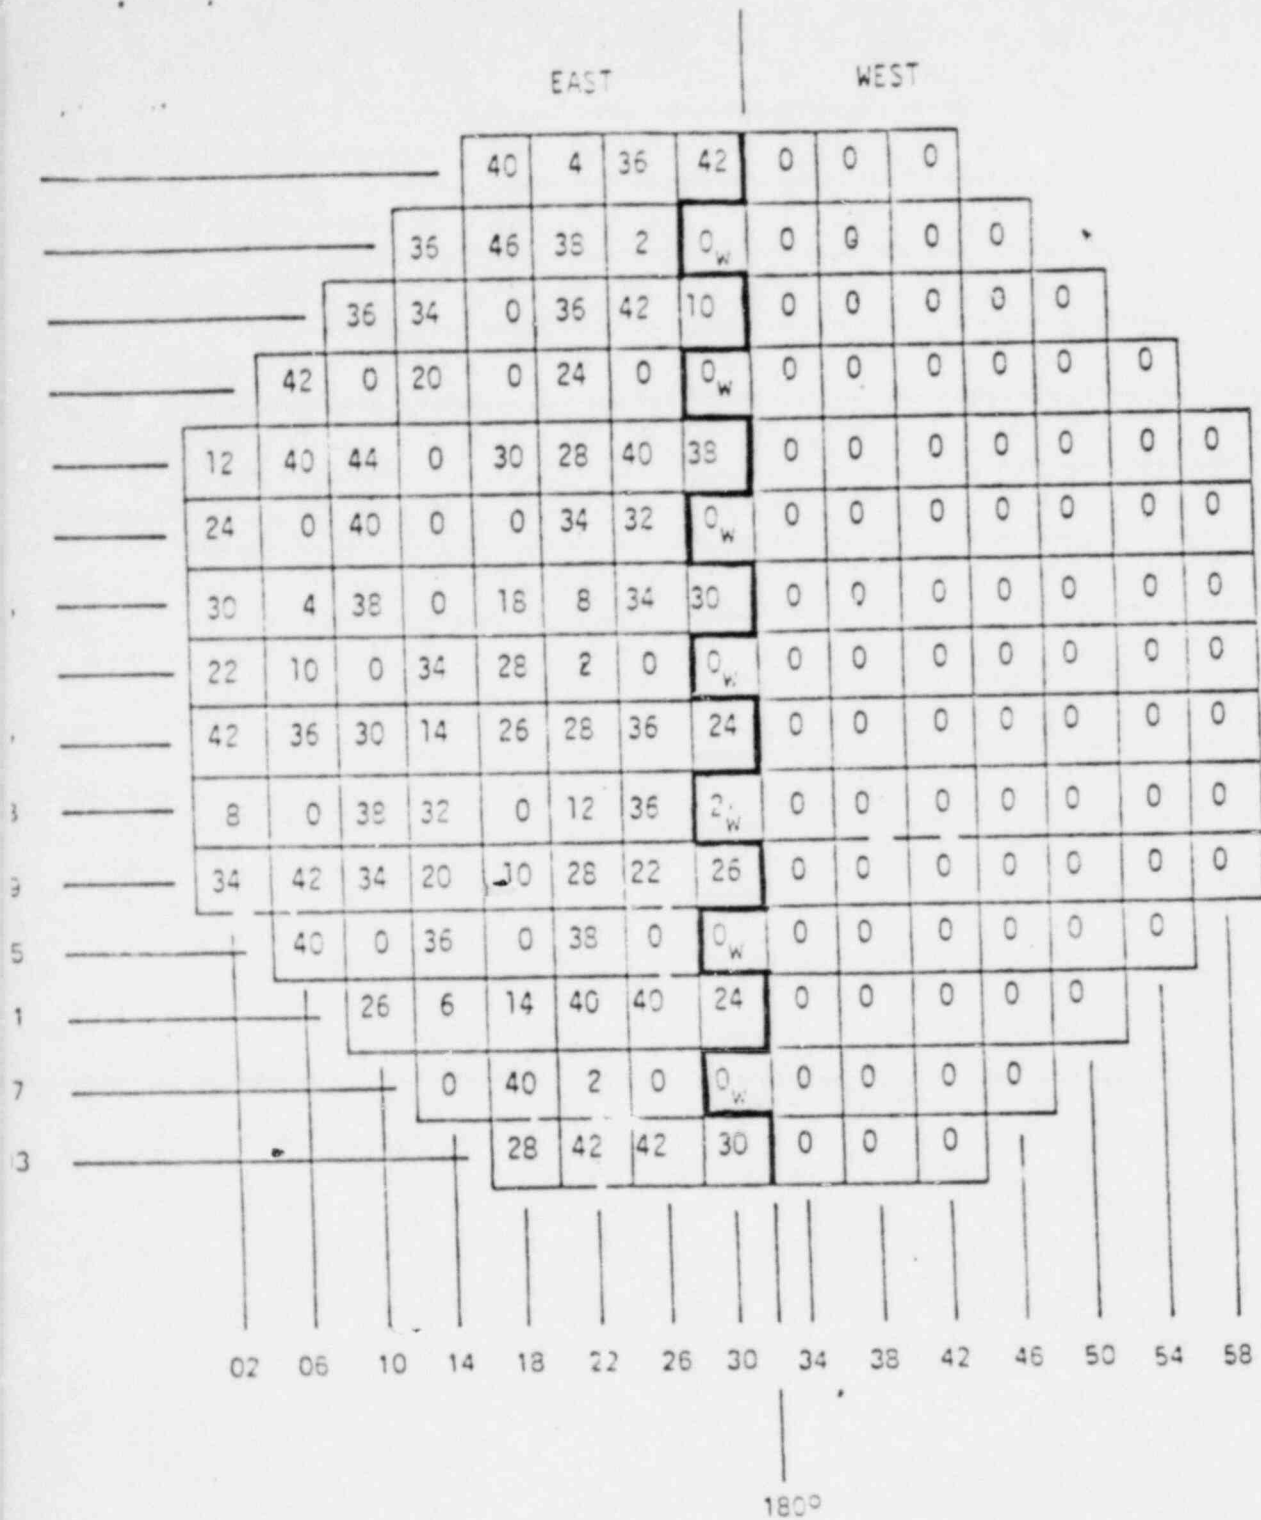
Figure 3.1 Control Rod Positions After First Scram

On June 28, 1980, power was being reduced by the control room operator at the Browns Ferry-3 nuclear reactor in preparation for a scheduled shutdown for feedwater maintenance. At 1:30 a.m., the operator initiated a manual reactor scram from about 30% power (i.e., 390 MWe). The control room instrumentation verified that all scram valves were open. However, the control rod position indicating instruments showed that 76 rods were not fully inserted. Figure 3.1 shows the rod positions after the manual scram. All but one of the west side rods (out of 92 total) were fully inserted and the one rod was essentially full in at position "U2". On the east side, 75 rods (out of 93 total) were not inserted fully ranging from "46" to "U2" withdrawn ("48" corresponds to fully withdrawn). Later evaluation of the neutron instrumentation indicates that the east side of the core was at less than 2% power. Since the

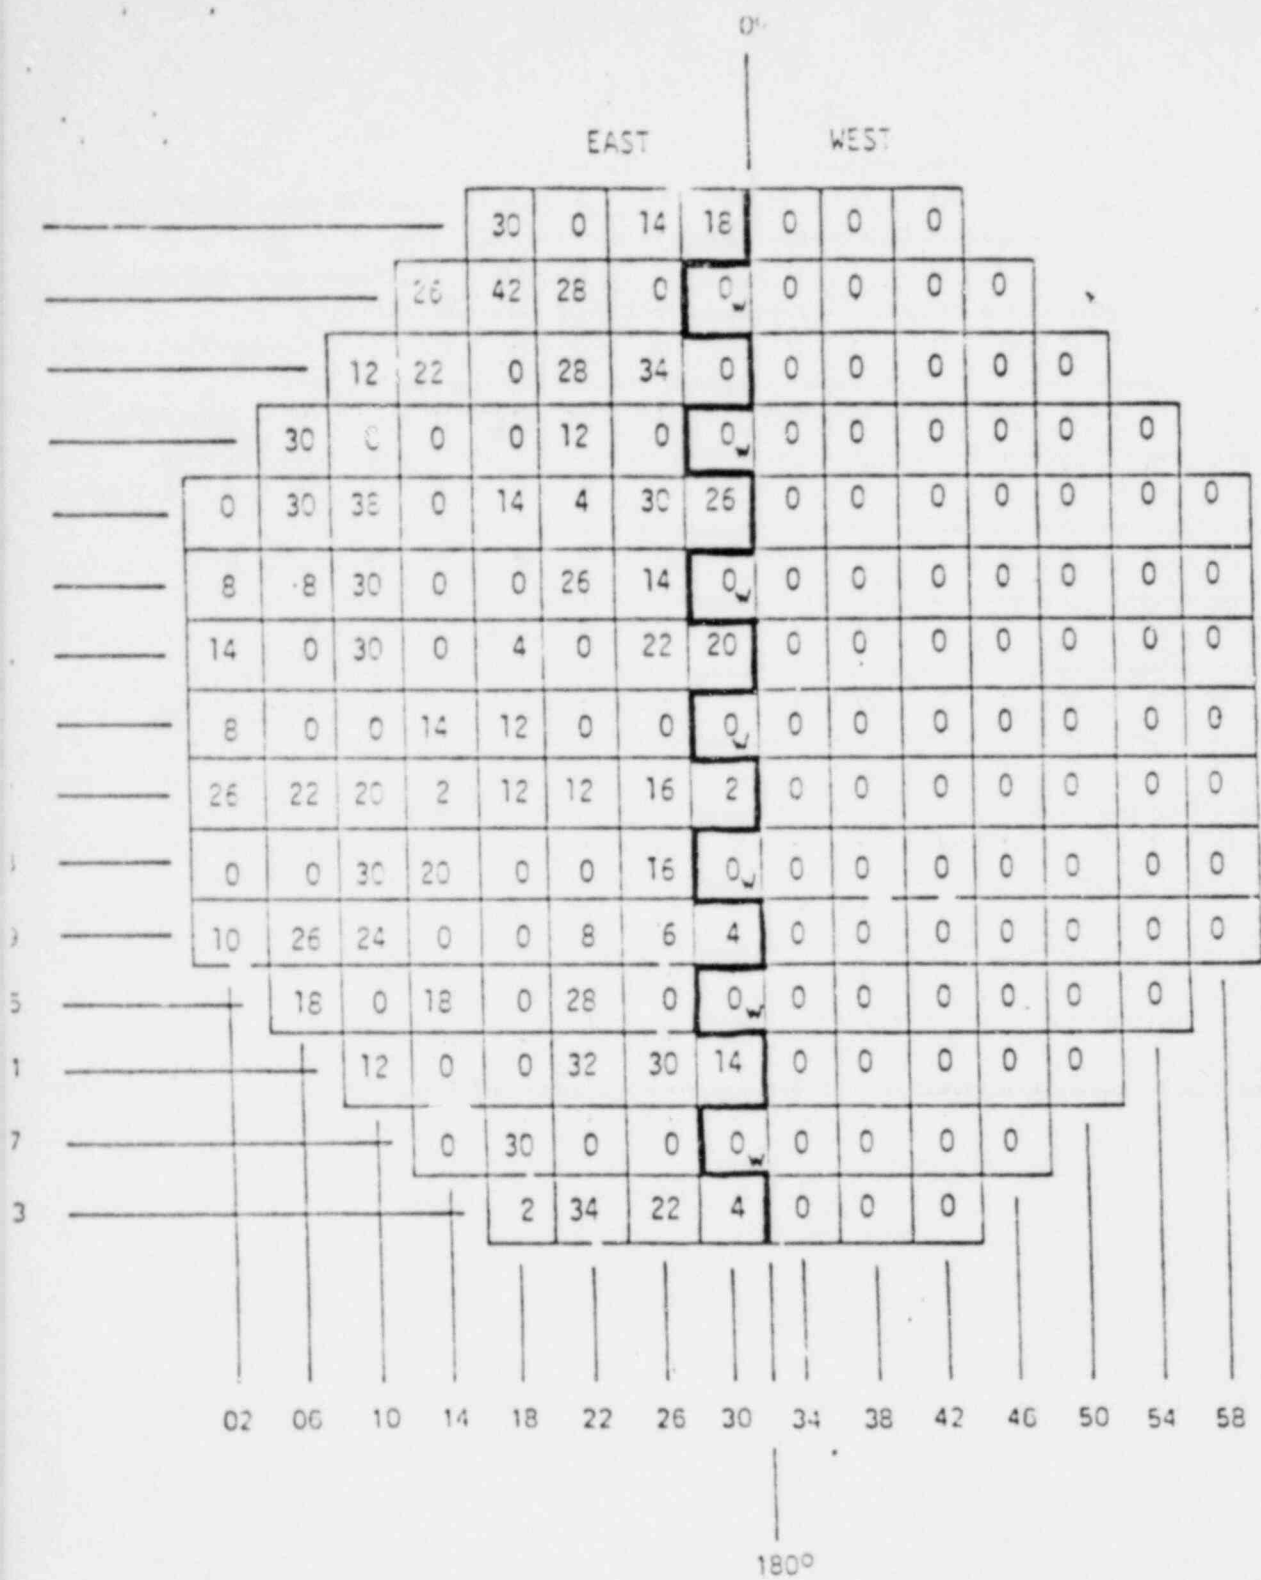
Figure 3.2 Control Rod Positions After Second Scram

A second manual scram was initiated by the operator approximately six minutes after the first manual scram. Rod positions after the second scram are shown in Figure 3.2. All west side rods were fully inserted and 33 of the 93 east side rods were fully inserted. This left 60 east side rods not inserted fully ranging from "42" to "02" withdrawn.

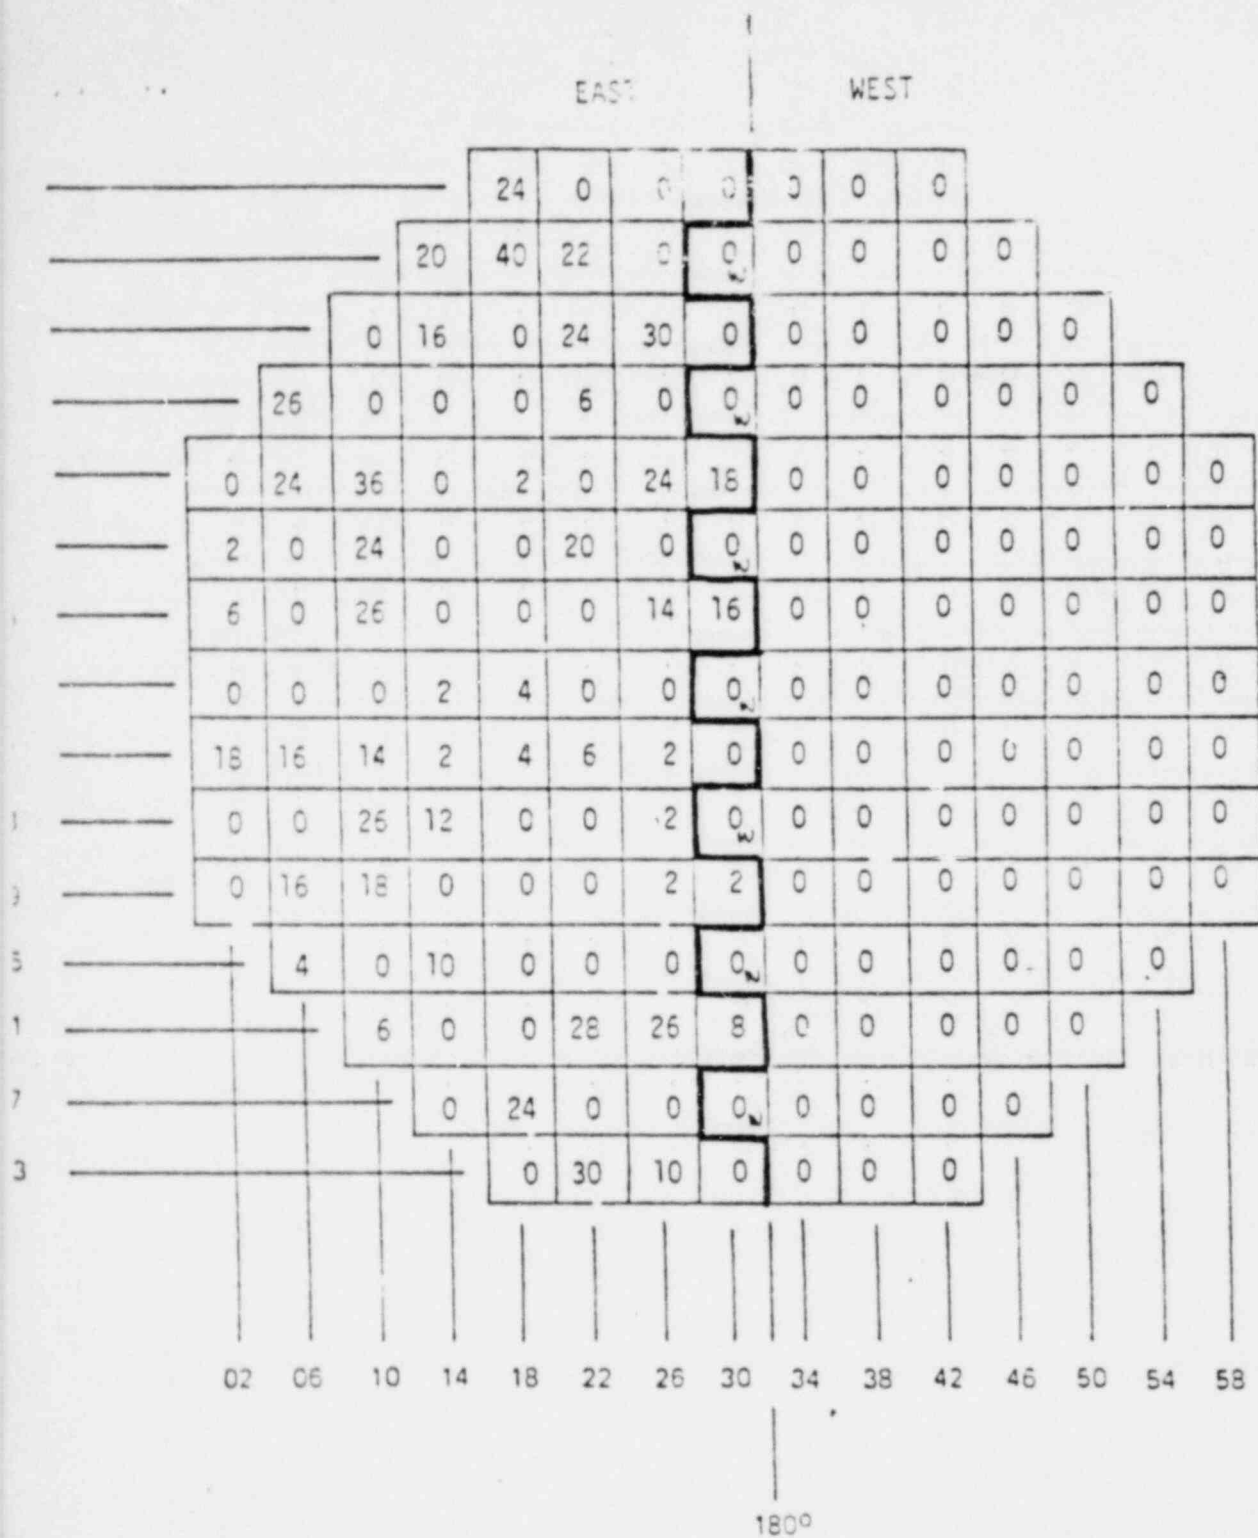
Figure 3.3    Control Rod Positions After Third Scram

The second manual scram was reset and a third manual scram initiated approximately 2 minutes after the second scram. Rod positions after the third scram are shown in Figure 3.3. Of the 93 east side rods, 47 were fully inserted and 46 were inserted from "40" to "02".

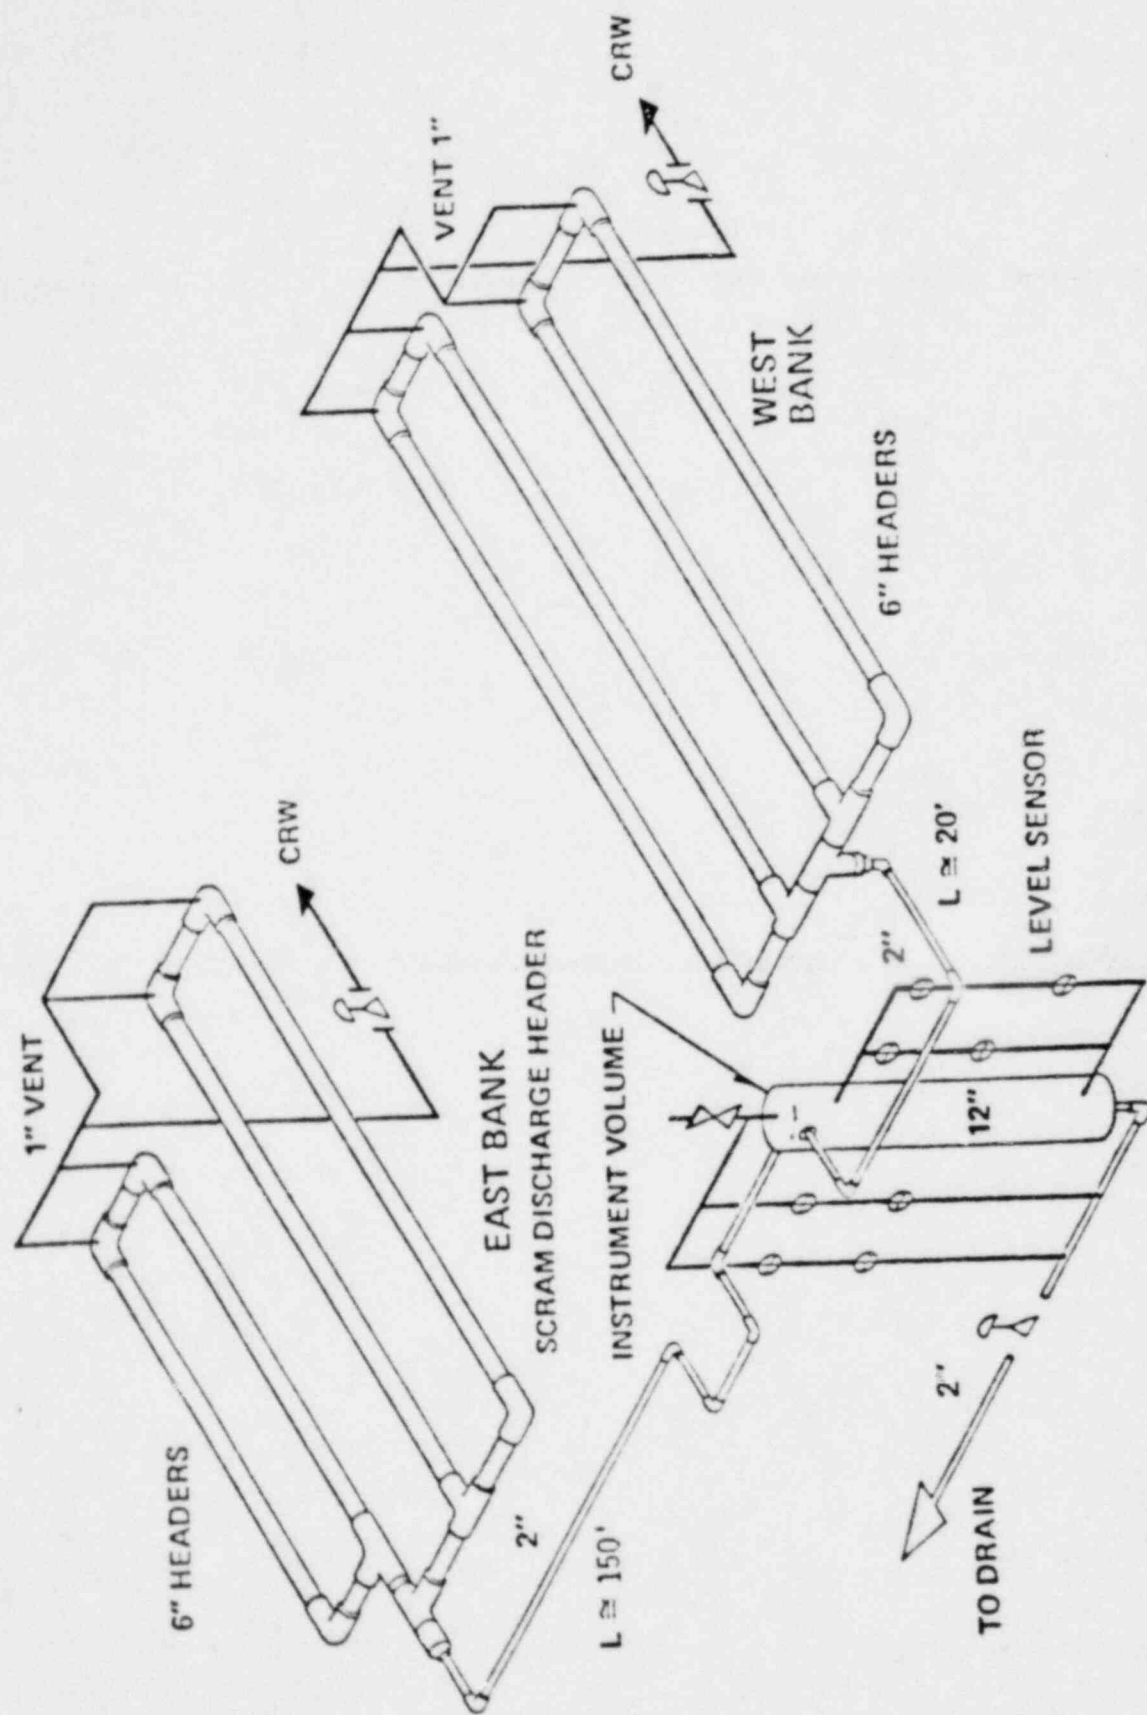
FIGURE 3.4 BROWNS FERRY SDV EQUIPMENT LAYOUT (ISOMETRIC VIEW)

Chapter 3 describes the incidents at the reactors. The presumed cause of the failure of approximately half of the Browns Ferry control rods to scram was due to insufficient available volume in the scram discharge header due to poor design of the scram discharge header vent, drain, and instrument system. Testing has shown that the scram discharge header can drain significantly slower than the scram discharge instrument volume. The presence of water in the scram discharge header due to normal leakage into the header from valves or water from previous scrams may not be sensed in the scram discharge instrument volume.

Figure 3.4 shows an isometric view and Figure 3.5 shows an elevation view of the Browns Ferry equipment layout. Notice in Figure 3.4 that the west side SDV drains through approximately 20' of 2" piping to the SDIV while the east side SDV drains through approximately 150' of 2" piping. This creates considerably higher flow resistance for gravity draining of the east side SDV. Additionally, notice that in Figure 3.5 the SDV vent lines are not open to atmosphere but are piped into the Reactor Building Equipment Drain Sump. This creates the potential for inadequate venting if the equipment drain header is filled with water.

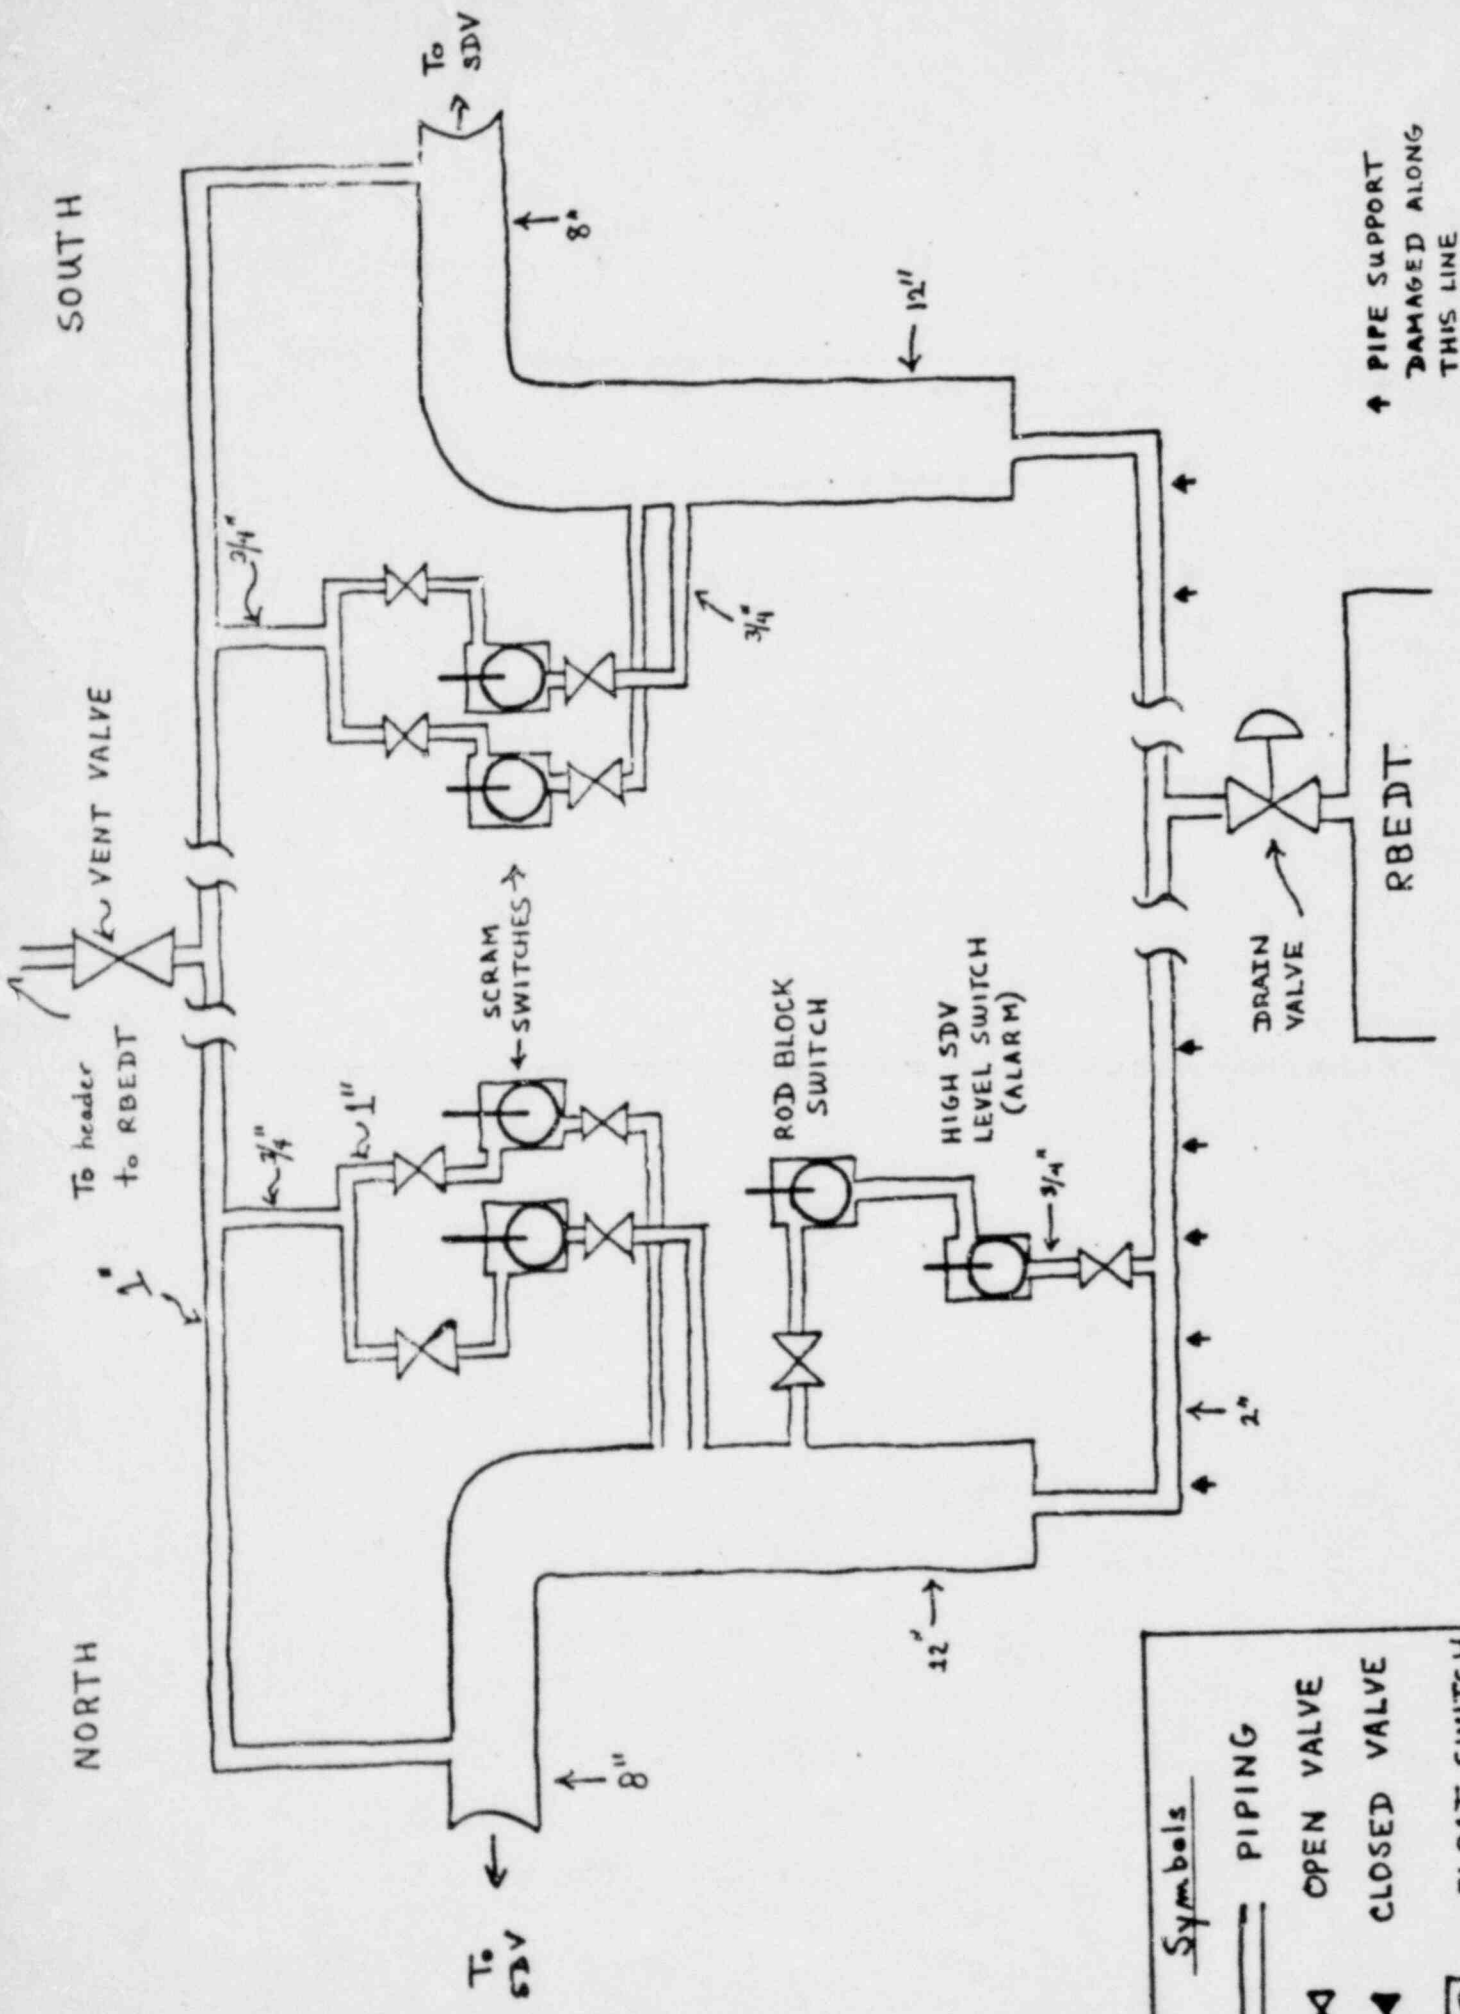
FIGURE 3.10 SCRAM DISCHARGE INSTRUMENT VOLUME  
BRICKSWICK UNIT #1

drain to a single SDIV. Other BWR's have two SDV's and two SDIV's located near the SDV's. Newer designs have the SDIV as an integral part of the SDV's. This is the design for Brunswick and the layout is shown in Figure 3.10.

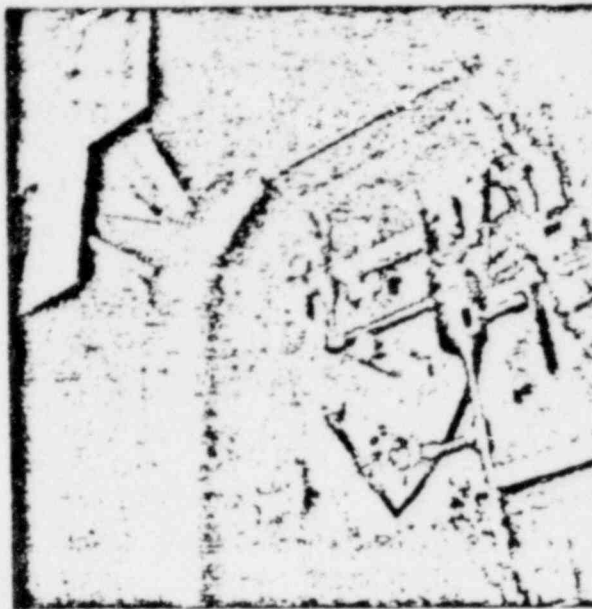
FIGURE 3.13a SCRAM DISCHARGE INSTRUMENT VOLUME

The presumed cause of the failure of the scram discharge instrument volume scram float switches (crushed floats) and damaged pipe supports at Brunswick 1 is water hammer (both flashing of steam and momentum energy transfer of water to structures) in the scram discharge instrument volume. The instrument volume and its ball float switches were not designed for the turbulent flow of water through the system since the instrument volume drain valve was designed to close during scram conditions. A faulty solenoid prevented the instrument volume drain line valve from closing as designed. The valve closed during the incident while water was flowing through the scram discharge instrument volume and drain line.
