FINAL REPORT
IN RESPONSE TO PETITION MADE BY
THE OFFICE OF THE ATTORNEY GENERAL, STATE OF ILLINOIS,
IN THE MATTER OF REINFORCING STEEL DAMAGED DURING
THE INSTALLATION OF CORED AND DRILLED HOLES
AND THE MATTER OF THE OFF- GAS BUILDING ROOF
FOR LASALLE COUNTY, UNITS 1 & 2

Commonwealth Edison Company
Chicago, Illinois

May 7, 1982

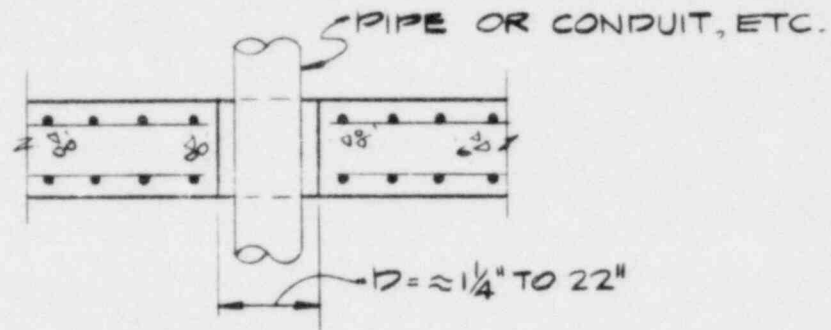
FIGURE 2.2-1

- A. Holes which pass through a concrete element to allow for passage of an electrical or mechanical component, as illustrated in Figure 2.2-1. These holes vary from 1-1/4" to 22" in diameter.
- B. Holes which partially penetrate a concrete element for the installation of a grouted anchor bolt, as shown in Figure 2.2.-2. Grouted anchor bolts were utilized primarily to anchor

CORED HOLE PASSING THROUGH CONCRETE

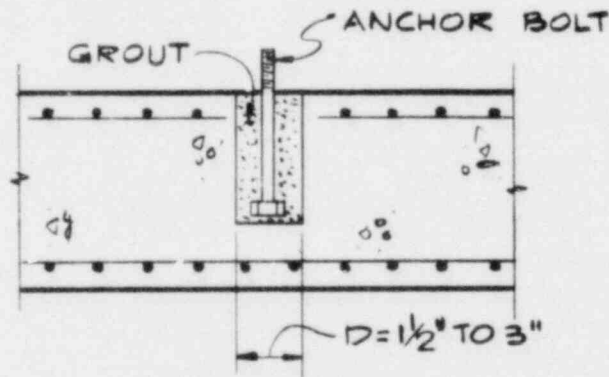
FIGURE 2.2-2

CORED HOLE PARTIALLY PENETRATING CONCRETE

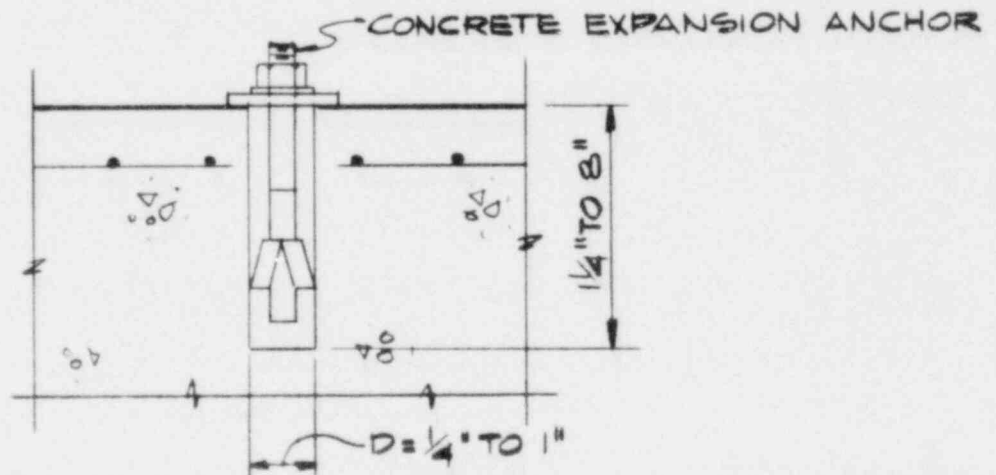
FIGURE 2.2-3

Holes were drilled in concrete for the installation of concrete expansion anchors. The diameter of drilled holes varies with the diameter of the expansion anchor, and ranges between 1/4" to 1". Such holes vary from 1-1/4" to 8" in depth. See Figure 2.2-3 for an illustration of a drilled hole.

DRILLED HOLE IN CONCRETE FOR EXPANSION ANCHOR INSTALLATION

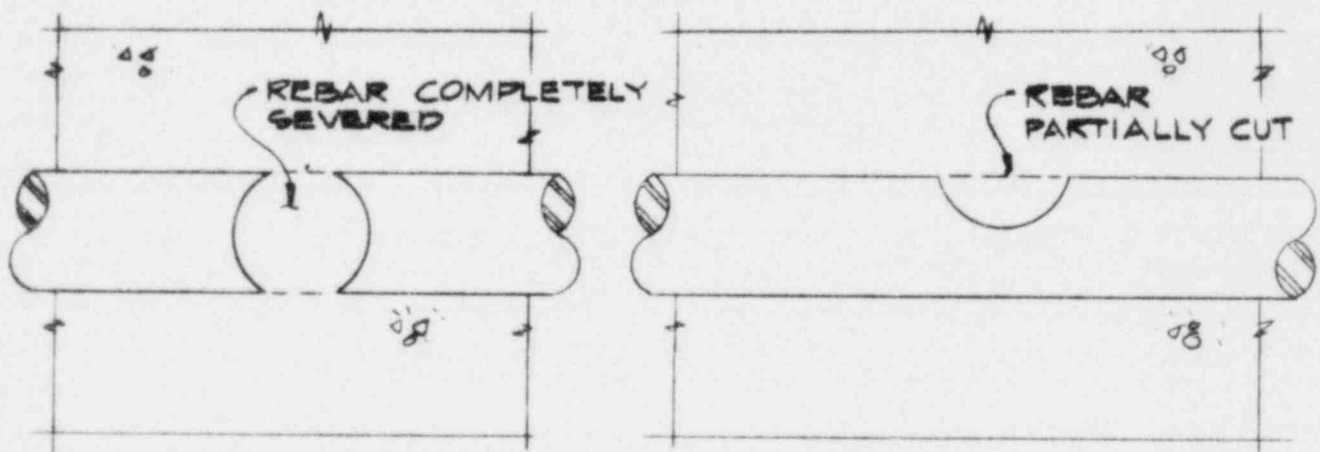
FIGURE 2.2-5

- A. No reinforcing steel was contacted.
- B. Reinforcing steel was partially contacted, and a segment of the bar was cut (see Figure 2.2-5).

C. Reinforcing steel was totally contacted by the core drill, and the reinforcing steel was completely severed (see Figure 2.2-5).

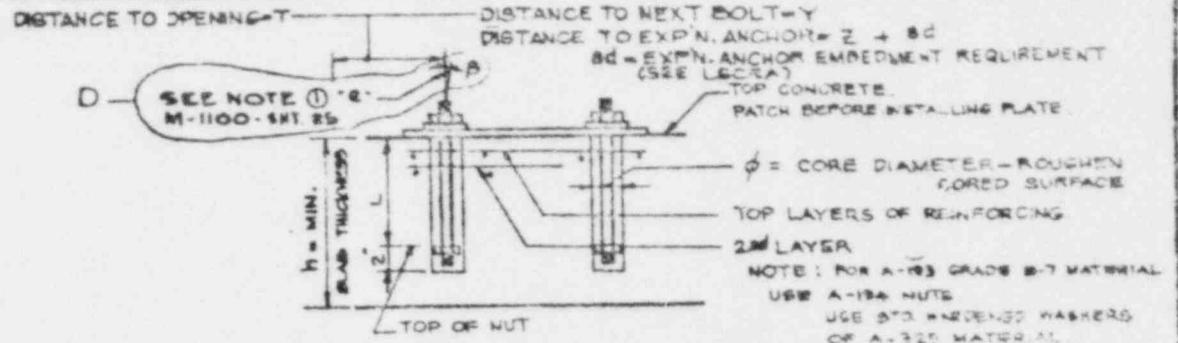
the summer of 1980. Prior to these coring operations, Mechanical Drawing No. M-1100, Sheet 23, issued in January, 1980, placed strict controls on the coring operations to preclude reinforcing steel damage. (See Figure 2.4-3). This drawing required the contractor to carefully notch the concrete to expose the reinforcing steel in both directions prior to coring the hole to avoid damage to the reinforcing steel. This provision implicitly prohibited the contractor from cutting through the reinforcing steel in this situation. Commonwealth Edison Company has verified that the contractors have utilized this procedure.

- (1) CAREFULLY NOTCH CONCRETE $\geq 1\frac{1}{2}$ " WIDE UNLESS MORE NEEDED IN BOTH DIR. TO LOCATE FB-BARS IN TOP LAYERS. LOCATE PLATE TO AVOID CUTTING EXPOSED REINFORCING. EXPOSE 2ND LAYER WHERE APPLICABLE.
- (2) ADD 6" TO "L" TO DETERMINE ROD LENGTH. THREAD ROD 6" TOP AND BOTTOM.
- (3) AFTER INSTALLING RODS, FILL CORES WITH "EMBECCO 63G GROUT" AS MANUFACTURED BY MASTER BUILDERS AND IN ACCORDANCE WITH MANUFACTURER'S RECOMMENDATIONS. DO NOT TIGHTEN NUT OR APPLY TENSION TO RODS UNTIL AFTER 7 DAYS OF PLACING GROUT. NEATLY PATCH NOTCHES.
- (4) AFTER 7 DAYS FROM PLACING GROUT TIGHTEN NUTS FINGER TIGHT AND $\frac{1}{4}$ " TURN.
- (5) INSTALL ATTACHMENT AT ϕ OF PLATE ± 1 " TOLERANCE.
- (6) SEE GHT 25 FOR ANCHOR BOLT LOCATION AND INSTALLATION TOLERANCES.

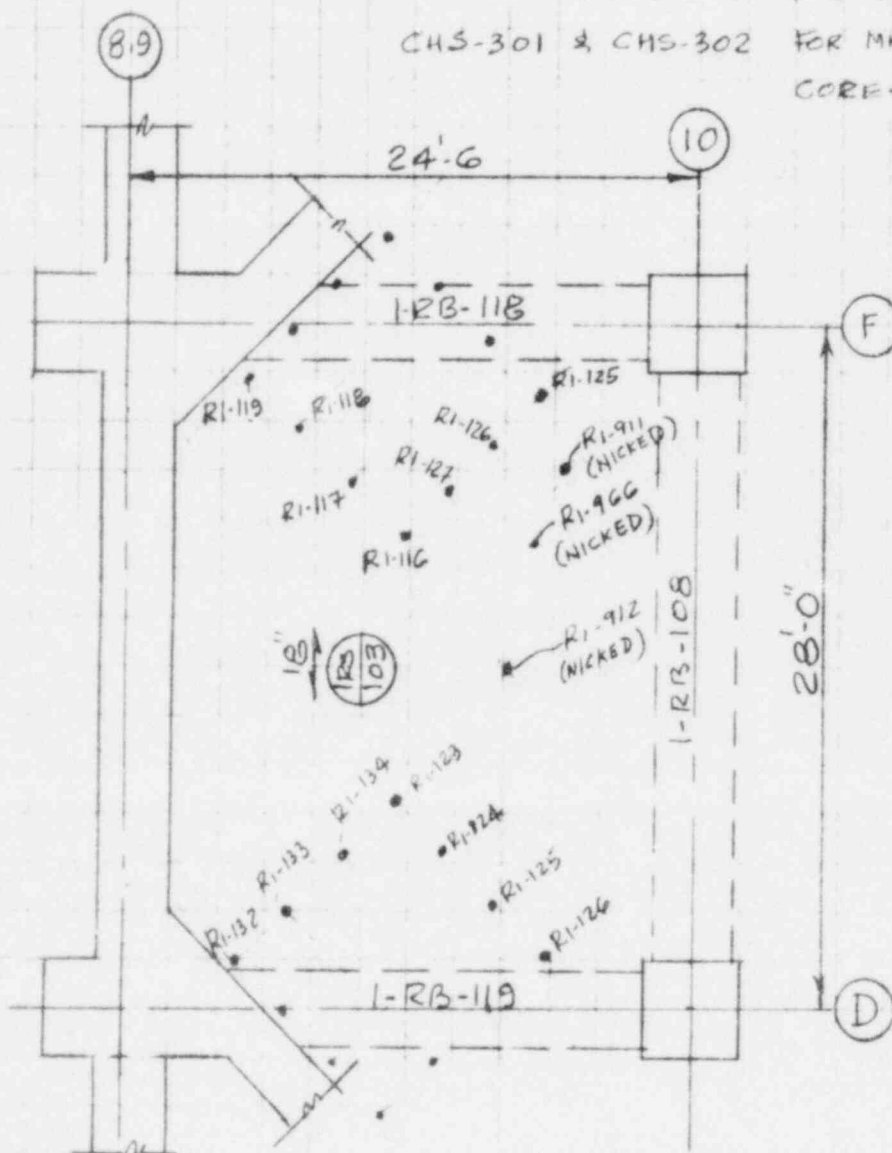
(DWG. **S-206 & 207**)

FOR C.S.C.S AREA COOLER & FAN FOUNDATION (SEE DWG M-1590 SHT. 8 NO (62))
3"Φ X 1'-2" CORED HOLES (MARKED ON DWG. CHS-301 - R₁-123, 124, 125, 126
132, 133 & 134 - 7 LOCATIONS)

DUE TO ABOVE CORED HOLES ONLY TOP RE-BARS ARE DAMAGED.
POSSIBLE TOTAL RE-BARS DAMAGED = 7

FOR C.S.C.S AREA COOLER & FAN FOUNDATION (SEE DWG M-1590 SHT. 8 NO (61))
3"Φ X 1'-2" CORED HOLES (MARKED ON DWG CHS-302 - R₁-116, 117, 118, 119, 125, 126 & 127
7 LOCATIONS)

DUE TO ABOVE CORED HOLES ONLY TOP RE-BARS ARE DAMAGED.
POSSIBLE TOTAL RE-BARS DAMAGED = 7 ✓
