Iowa Electric Light and Power Company

Subject: Duane Arnold Energy Center
Docket No: 50-331
Op. License No: DPR-49
"D" Outboard MSIV Relief Request, RR-
002, Revision 1
Reference: Letter from J. Franz (Iowa Electric) to
T. Murley (NRC) dated September 11, 1993
(NG-93-3831)
File: A-100, A-286

SUPPORTING INFORMATION FOR RELIEF REQUEST RR-002, REVISION 1

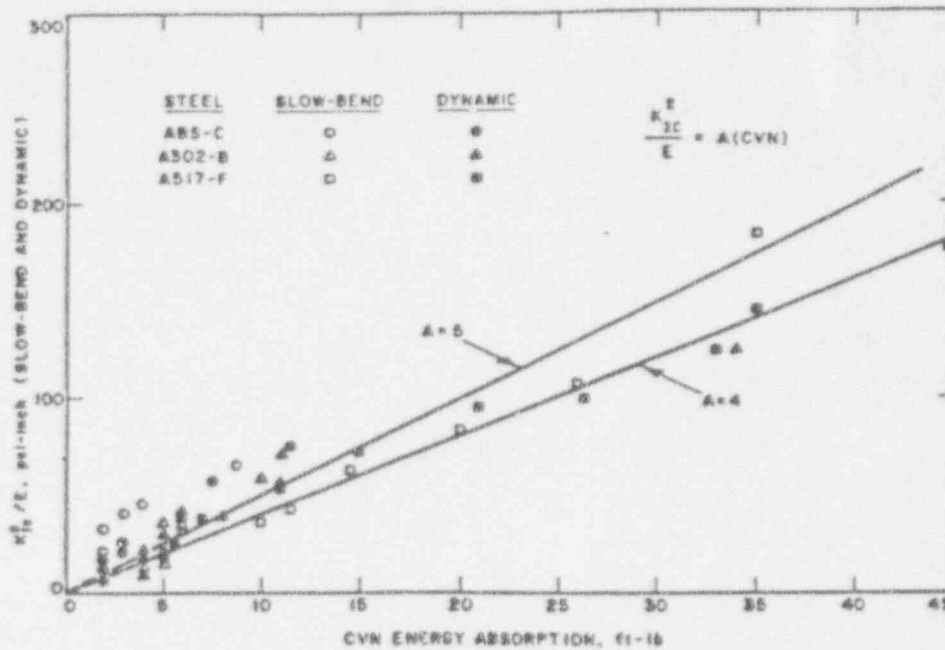
Figure 1 K_{IC} -CVN CORRELATION IN THE TRANSITION TEMPERATURE REGION

The material of the valve body is ASTM A216 (SA216) Cast Carbon Steel. Toughness properties of this material are comparable to that for SA106 GrB carbon steel piping. Although no plant specific information for the DAEC MSIV material is available, there is Charpy data for similar valve material in more recent plants. Table 1 shows a collection of Charpy energy data for several plants and several valve vendors. It is seen that an average value of 30 ft-lb at 60°F is reasonable. Since the temperature corresponding to 30 ft-lb is often used for RT_{NDT} shift calculations, it is reasonable to assume 60°F as an upper bound RT_{NDT} value. This compares with the requirement of 30 ft-lb at 40°F for the DAEC vessel plate material. By using the higher RT_{NDT} of 60°F (corresponding to the 30 ft-lb temperature for A216) the use of the low alloy steel fracture toughness curve is validated. This approximation can be verified by comparing the Section XI, ASME Code K_{Ic} value with that predicted using the commonly available K_{Ic} -CVN correlations in the transition range. Figure 1 shows the Rolfe-Corten relationship in the transition temperature regime. The fracture toughness is given by $K_{Ic}^2/E = 5$ (CVN) where K_{Ic} is in $\text{ksi}\sqrt{\text{in}}$, CVN is the Charpy energy in ft-lb and E is the Youngs Modulus in psi. Substituting CVN = 30 ft-lb and $E = 30 \times 10^6$ psi, the calculated K_{Ic} value is 67 $\text{ksi}\sqrt{\text{in}}$. Figure 2 shows the fracture toughness curves in Section XI, ASME Code for low alloy steel. Assuming an RT_{NDT} value of 60°F is approximately 54 $\text{ksi}\sqrt{\text{in}}$. Clearly, using the code K_{Ic} value for low alloy steel and assuming an RT_{NDT} of 60°F provides a conservative fracture prediction.

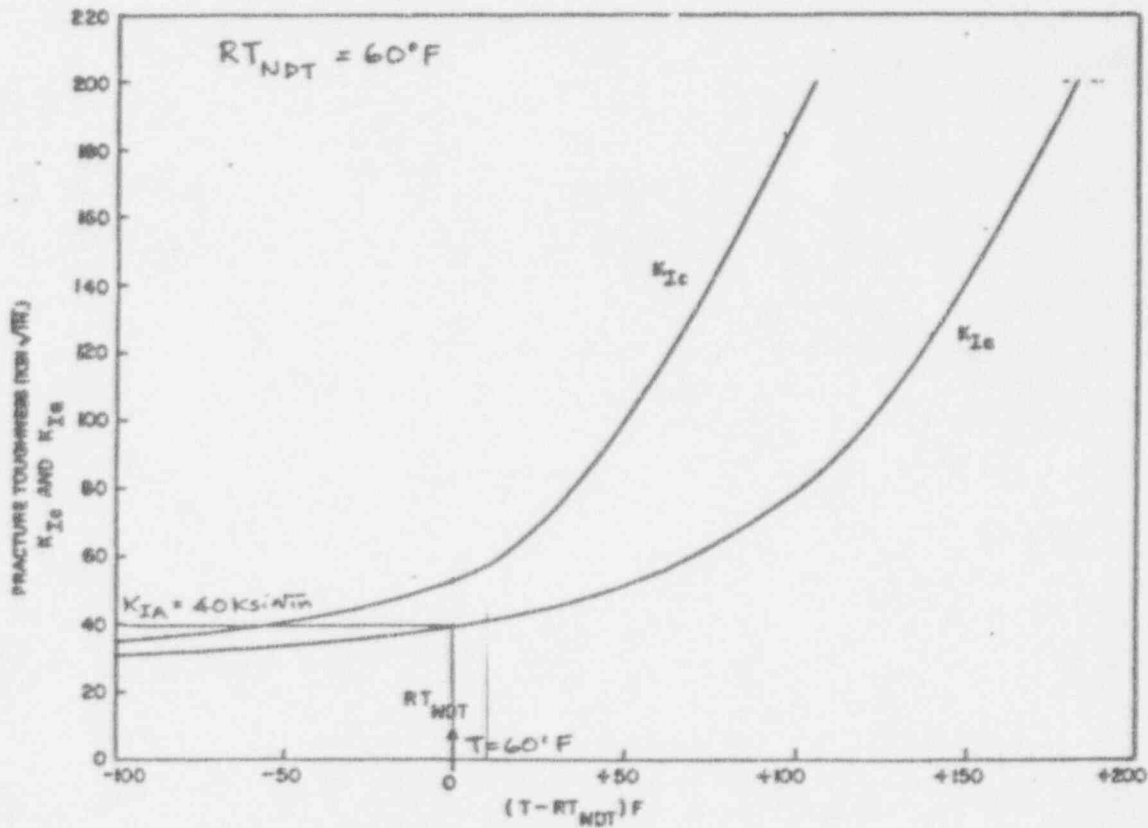
Figure 2 FRACTURE TOUGHNESS OF LOW ALLOY STEEL AS A FUNCTION OF $T - RT_{NDT}$ (FROM REFERENCE 2)

The limiting MSIV condition for normal operation occurs during the system leak test, where temperature as low as 180°F may occur with normal operating pressure. Assuming a conservative RT_{NDT} of 60°F for the MSIV body and internals materials, Figure A-4200-1 shows allowable toughness K_{IA} of 100 ksi- $\sqrt{\text{in}}$. Temperatures at which the MSIVs experience the faulted condition loadings are high enough that the valve carbon steel materials are in the ductile condition, or $K_{IA}=K_{IC}=200$ ksi- $\sqrt{\text{in}}$. For the room temperature test condition, the K_{IA} on Figure A-4200-1 of Reference 2 is 38 ksi- $\sqrt{\text{in}}$. IWB-3612 requires that the K_I associated with the final flaw depth must be less than $K_{IA}/\sqrt{10}$.
