INDIAN POINT UNIT 2 - FINAL REPORT  
ON THE STEAM GENERATOR INSPECTION,  
REPAIR, AND RESTORATION EFFORTS  
DURING THE 1990 MID-CYCLE INSPECTION

ISSUE DATE: JULY 1990

PREPARED FOR CONSOLIDATED EDISON COMPANY

WESTINGHOUSE ELECTRIC CORPORATION  
NUCLEAR SERVICES DIVISION  
P. O. BOX 355  
PITTSBURGH, PENNSYLVANIA 15230

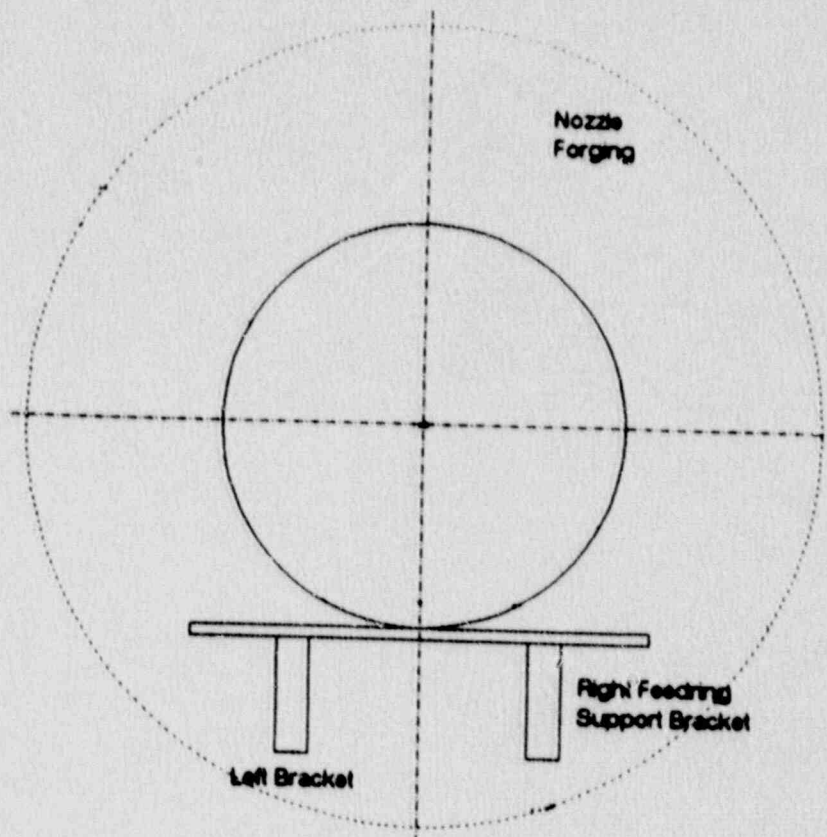
As a result of finding cracks surrounding the nozzle shelf brackets, inspections were expanded to all feedwater ring supports in all four steam generators. A depiction of these supports, their orientation relative to the feedwater nozzle and their designations is shown in Figure 2.4-1 and a detail of an A, B or C bracket is shown in Figure 2.4-2. The method of detection was either PT or, where access was available, by MT.

The feedring thermal sleeve support consists of two triangular support brackets spanned by a shelf plate. These brackets were welded to the shell with a full penetration and a fillet weld all around. The shelf was welded to the brackets with fillet welds. A general arrangement of this configuration is shown in Figure 2.4-1.

In the case of the shelf brackets for Steam Generators 21, 22, 23, and 24 the brackets were removed and placed outside of the nozzle forging onto the steam generator wall. In all cases, welding techniques employed and acceptance NDE used was consistent.

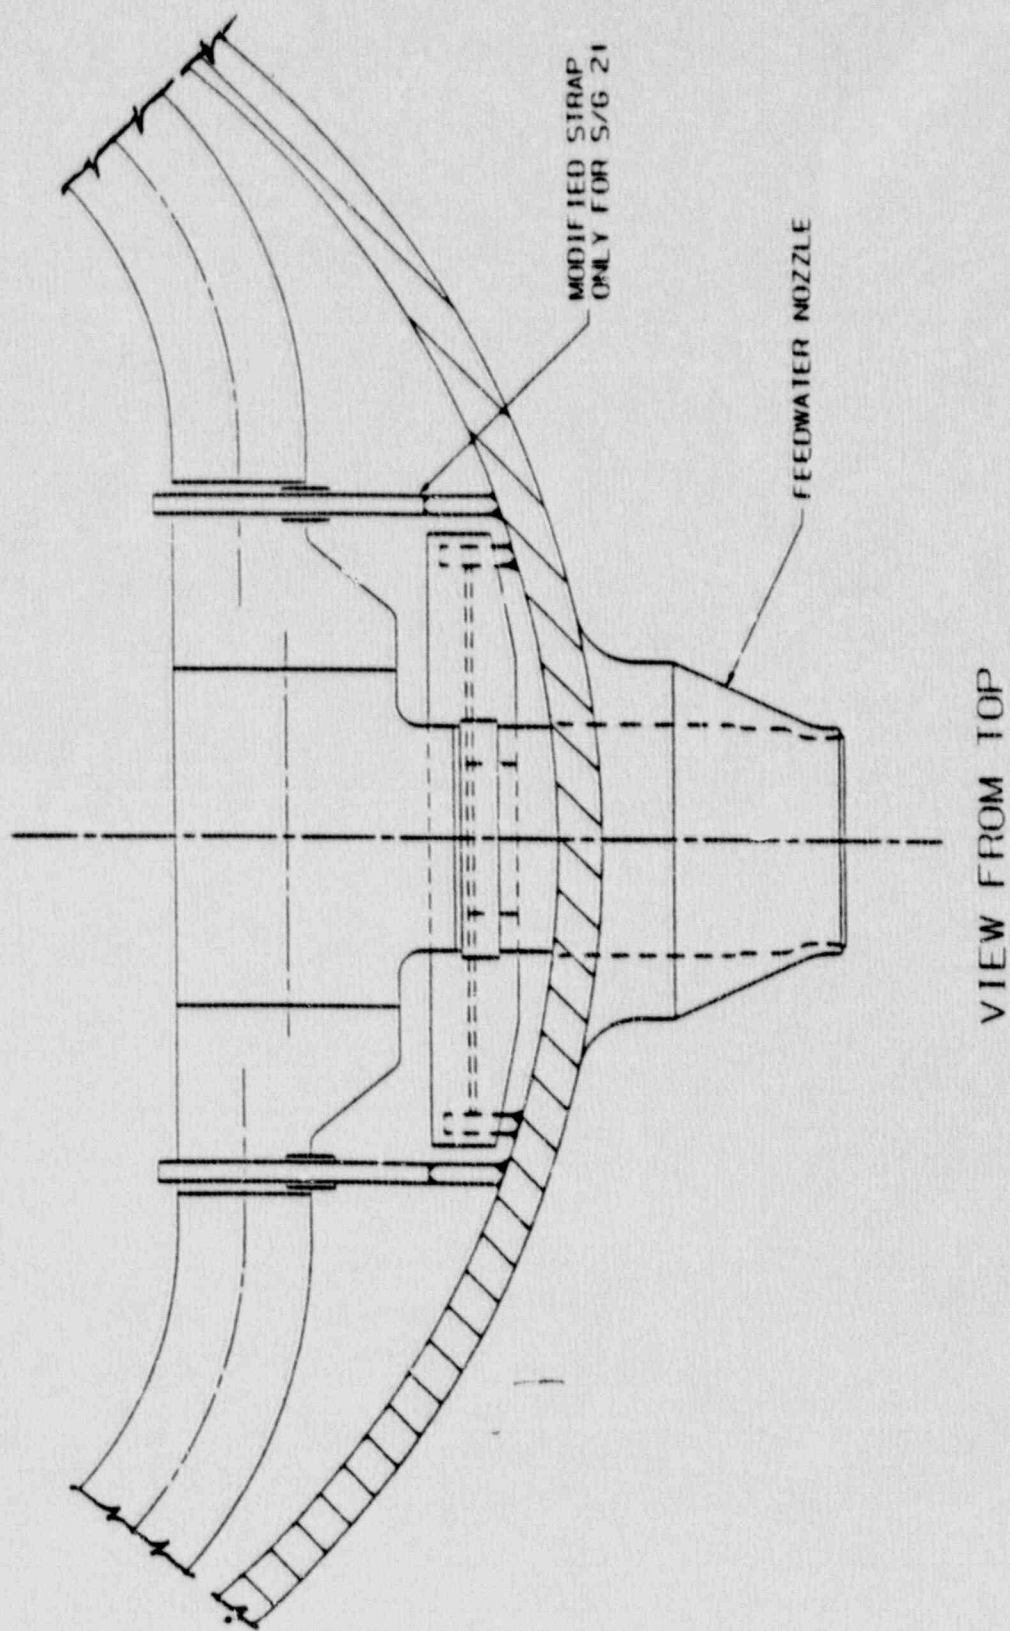
FIGURE 5.2.2-1. PLAN VIEW OF MODIFIED/RELOCATED BRACKET SUPPORT

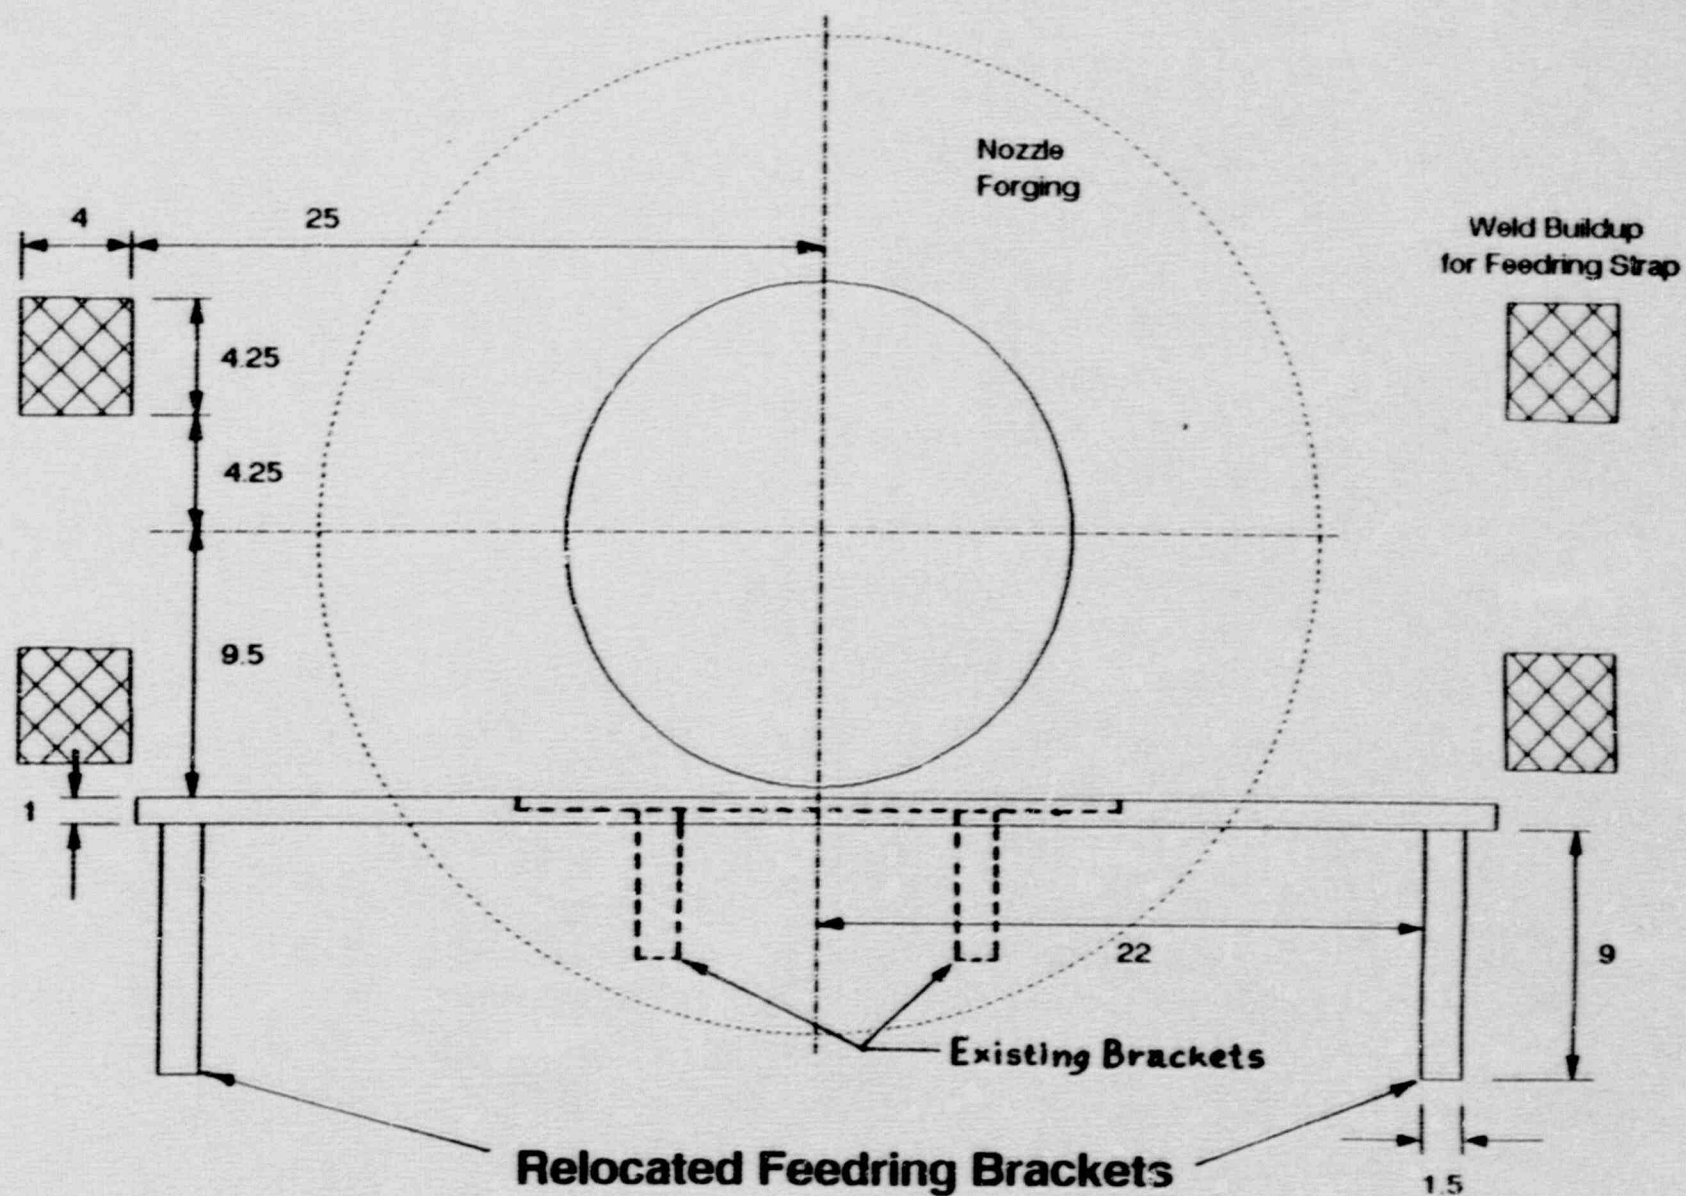
FIGURE 5.2.2-2. EXISTING & RELOCATED BRACKET SUPPORT LOCATIONS

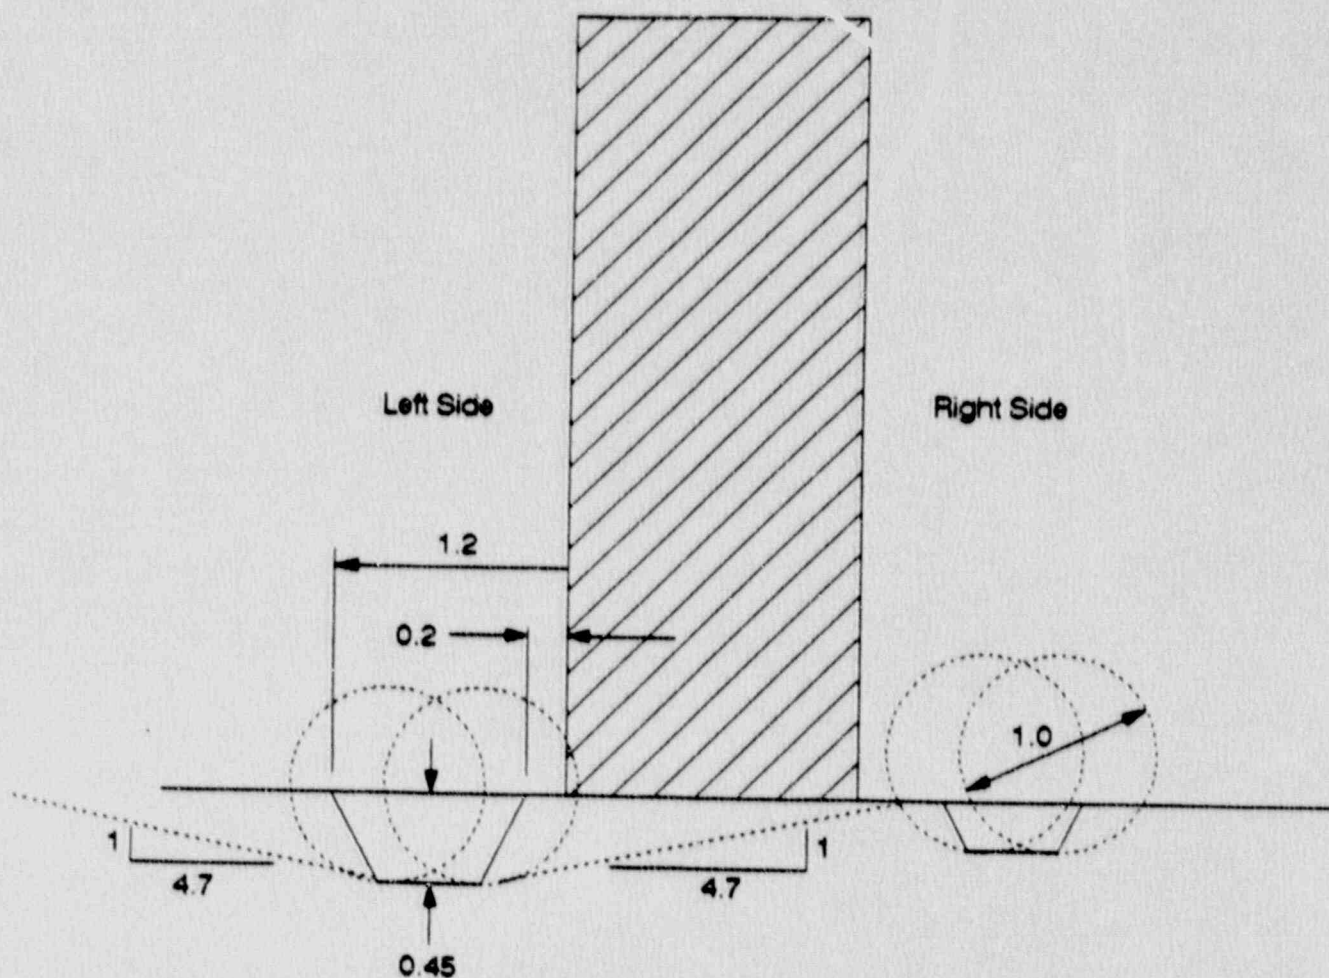
FIGURE 5.2.2-5. Grind Contour Acceptability for S/G 21, Bracket C

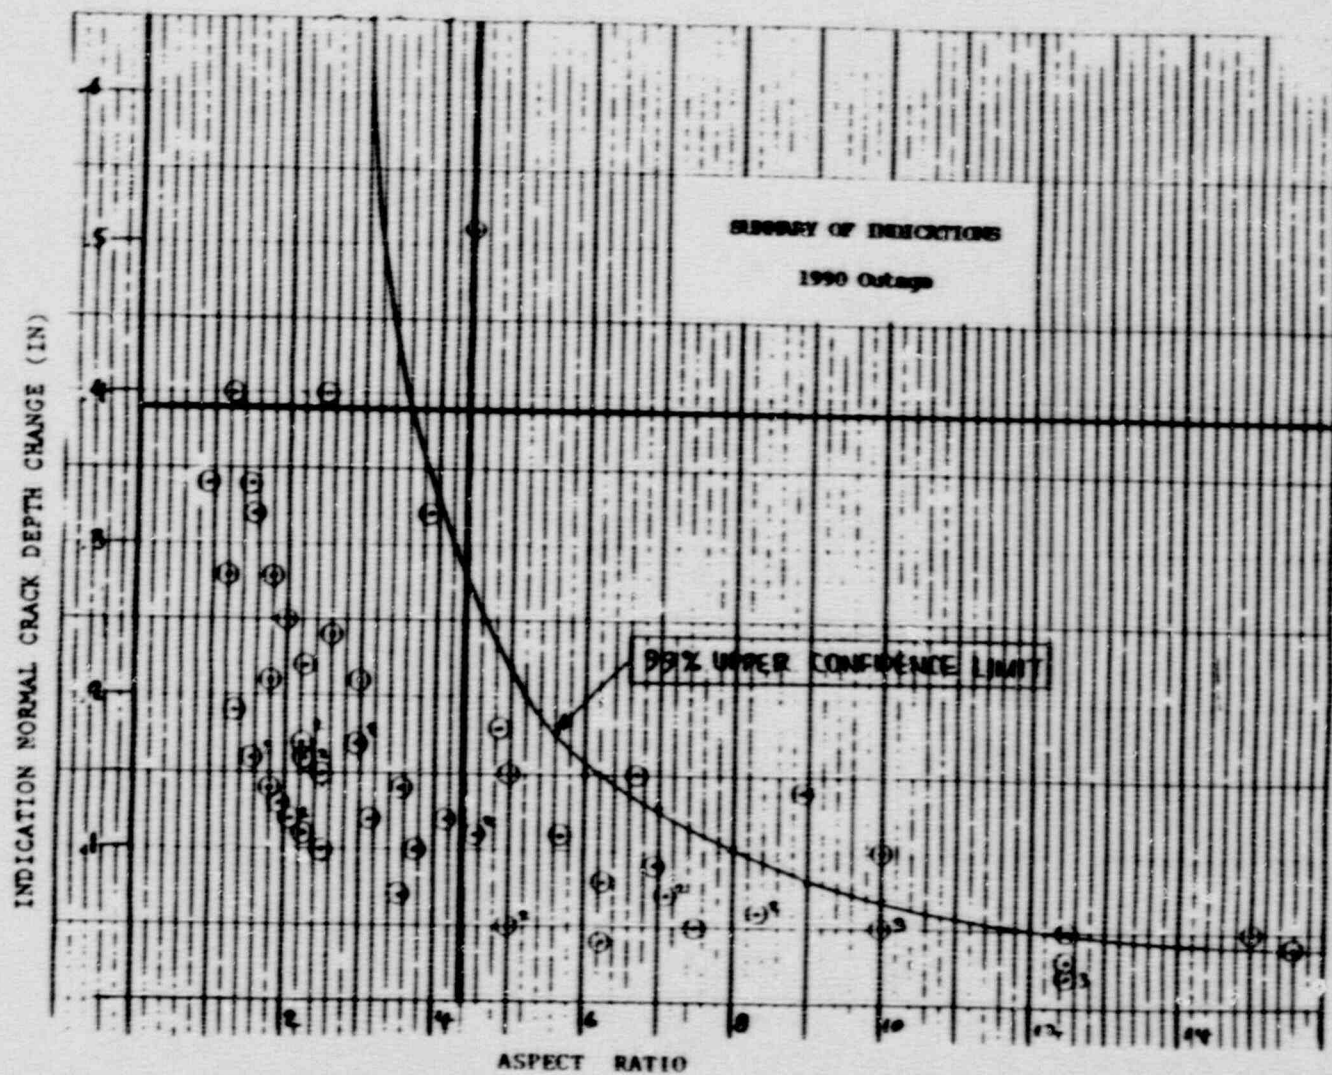
Unit/ Indication	2a	a/t	s	$\delta=s+a$	$\delta/t$	l
SG 21, #12	0.524"	0.069	0.95"	1.212"	0.319	2.5"
SG 22, #8/60	0.26"	0.034	0.22"	0.35"	0.092	3.00"
SG 22, #1	0.26"	0.034	1.35"	1.48"	0.389	7.00"
SG 22, #12	0.44"	0.058	0.22"	0.44"	0.116	2.50"
SG 22, #6	0.349"	0.046	0.218"	0.393"	0.103	2.125"
SG 22, #8/45	0.349"	0.046	0.131"	0.306"	0.081	1.25"
SG 24, #16	0.262	0.034	0.131	0.262	0.069	1.625
SG 24, #18	0.437	0.058	1.44	1.659	0.436	1.5

Figure 5.3-1  
Summary of Indications from the 1990 Outage, Showing the 99 Percent Upper  
Confidence Limit on Flaw Shape as a Function of Depth

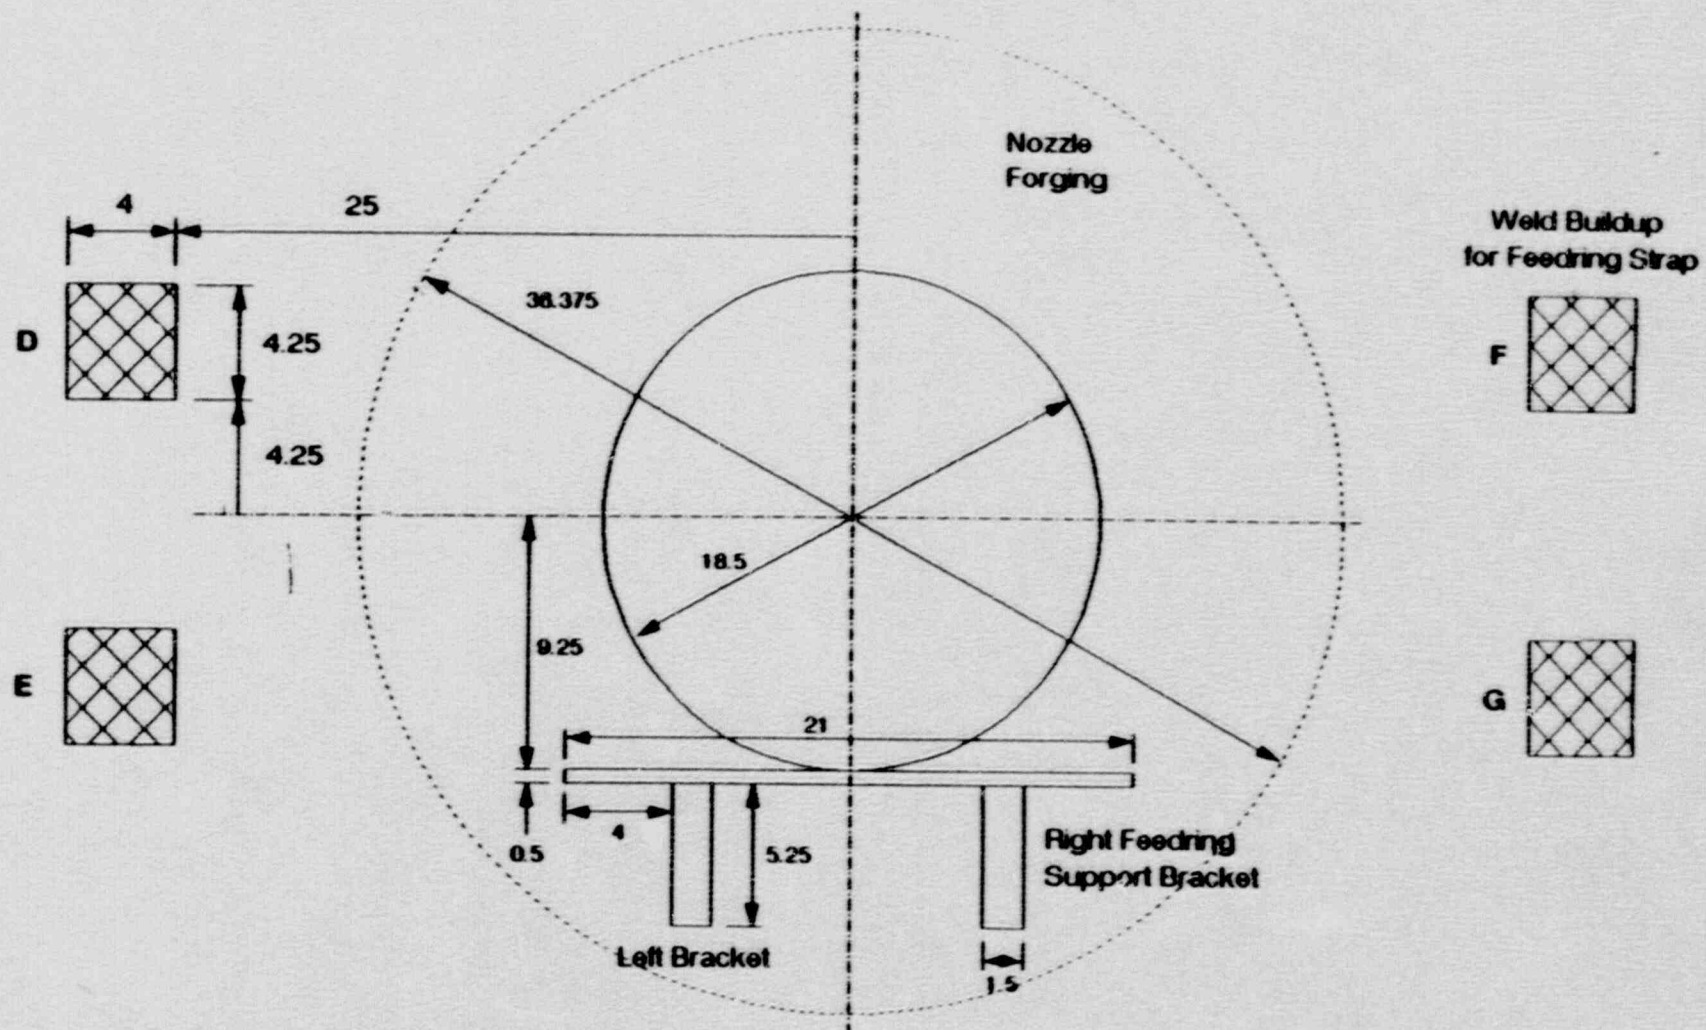
Figure 6.2-1 is a sketch of the feeding supports in the vicinity of the feedwater nozzle. The support brackets are welded to the shell face of the nozzle forging. Since extensive cracking had been found around these brackets in all four steam generators, they were removed and relocated as described in Section 5.2.2.1. All indications were removed by grinding and filled in with weld metal to restore the surface to the original contours. Stresses from the feedwater nozzle model of Reference 1 are thus appropriate for use in the fracture evaluation. Table 6.2-1 lists the maximum stress components for the analysis sections of Figure 6.0-2 near the support brackets. Of these, ASN's 123, 124, 133, and 134 are the closest. The one with the highest stresses (ASN 134) was used for the fracture analysis.

Figure 6.2-1  
Feeding Support Geometry at Nozzle

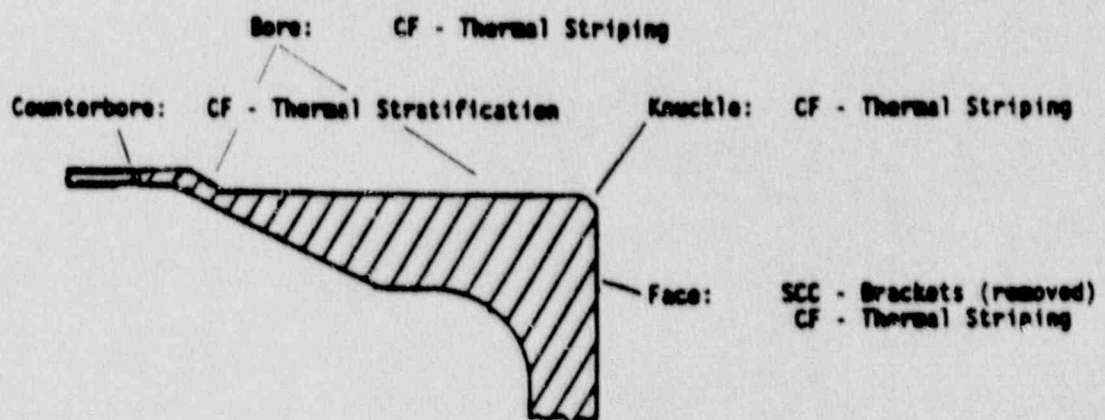
Figure 6.3-3  
Feedwater Nozzle Showing the Predominant Loading  
and Mode of Crack Propagation at Each Location

The major source of cracking in the feedwater face (without brackets), knuckle and bore has been identified as a corrosion fatigue by thermal striping occurring during feedwater cycling at hot standby with by-pass flow behind the thermal sleeve. Cracking at the counterbore is attributed to thermal stratification.

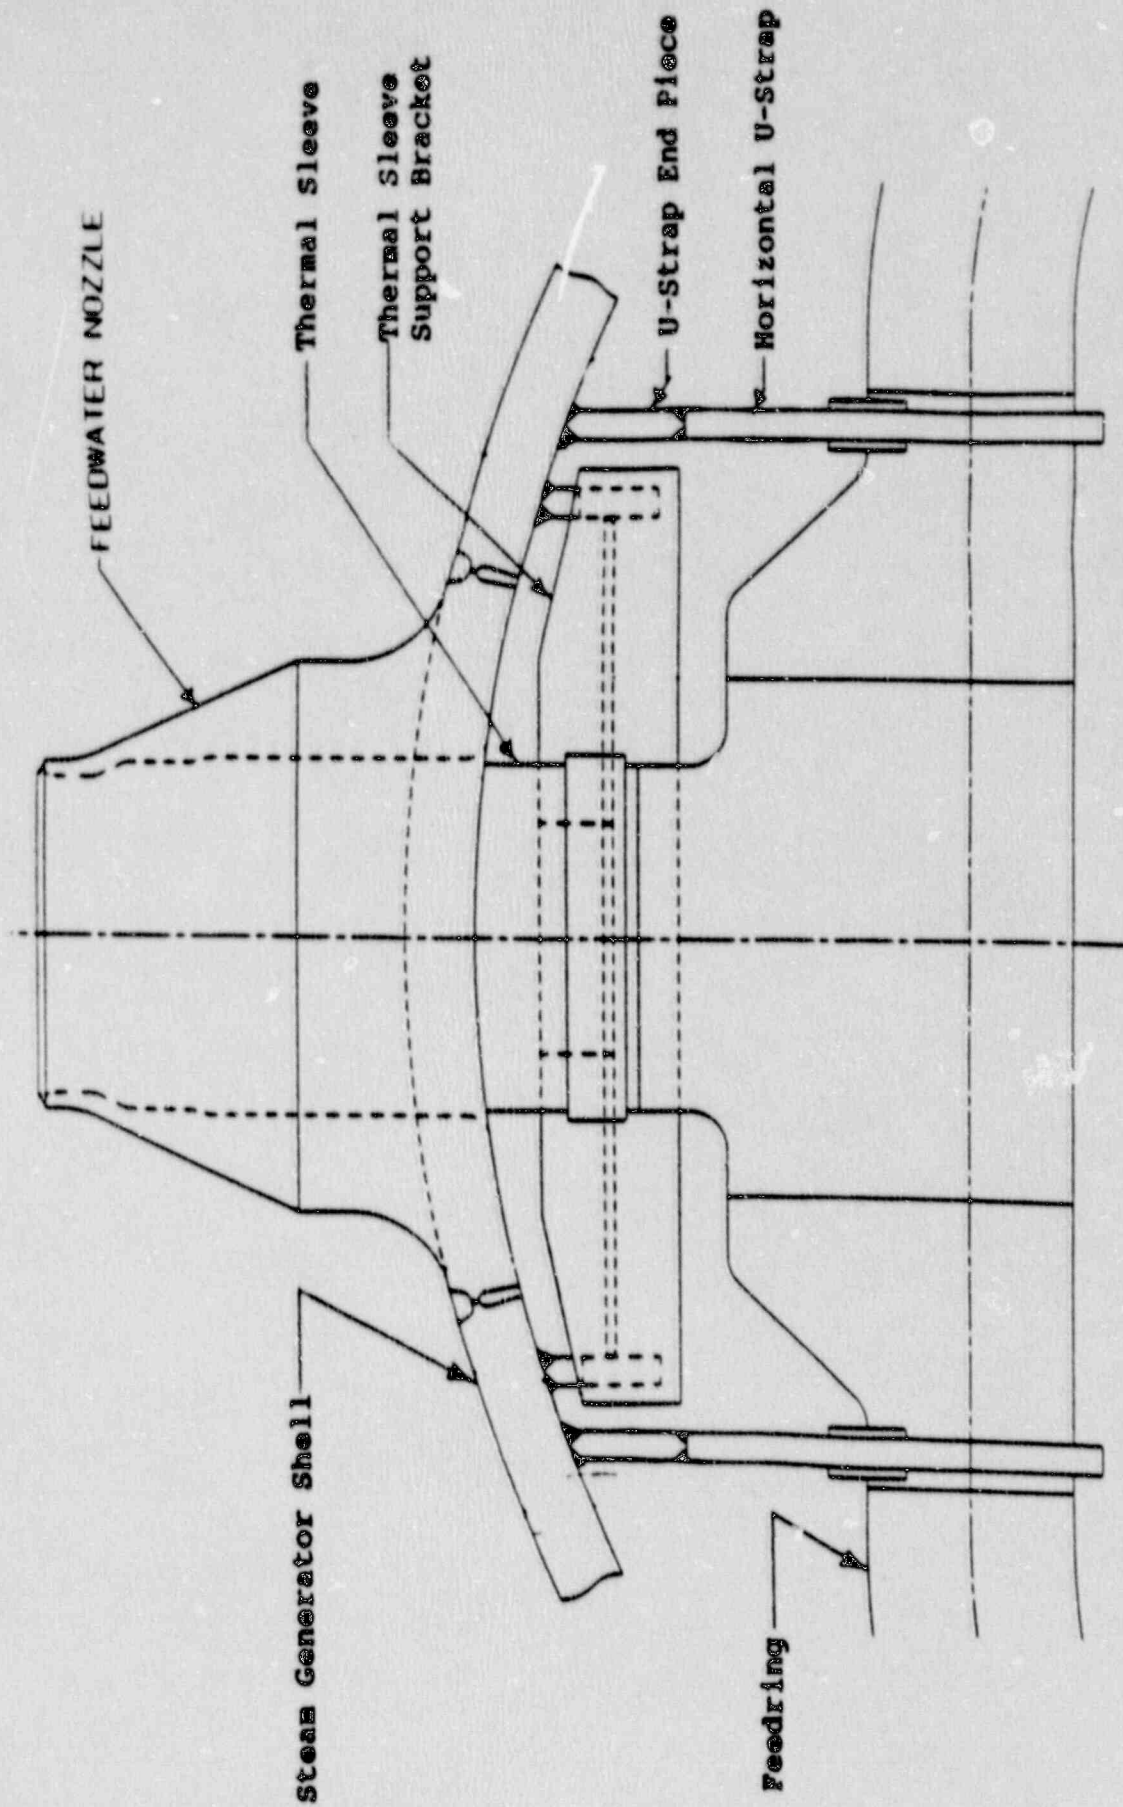
Figure 1.2-1  
Feeding Thermal Sleeve Support Bracket and  
Horizontal U-Strap (S/G 21) - Plan View

The horizontal U-Straps in Steam Generator 21 are shown in Figures 7.2-1 and 7.2-3. The principal difference between these U-Straps and those installed in the other three steam generators are the fabrication of the ends of the U-Straps (approximately 6 inches long) from an ASME Code material. This is to permit welding of the ends of the U-Straps directly to the steam generator shell, and not to weld buildups as was done in the other three steam generators.

The replacement bracket is shown in Figures 7.2-1 and 7.2-2. The principal changes to the feedring thermal sleeve bracket, compared with the originally installed bracket, are shelf length increase, addition of a shelf support and support bracket relocation to avoid welding on the feedwater nozzle forging.

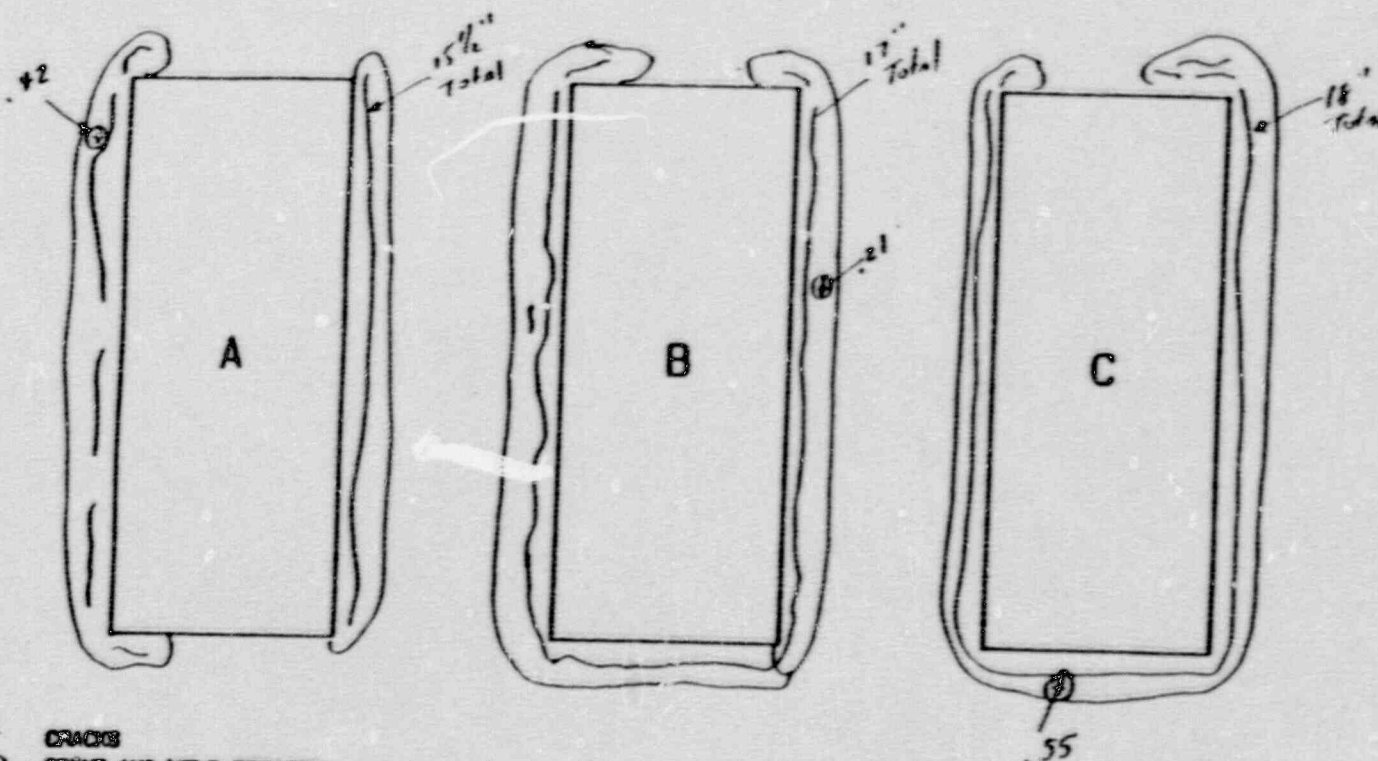
# INDIAN POINT 2 STEAM GENERATOR 24 FEED RING SUPPORT BRACKETS

CRACKS

GRIND AND WELD REPAIRS

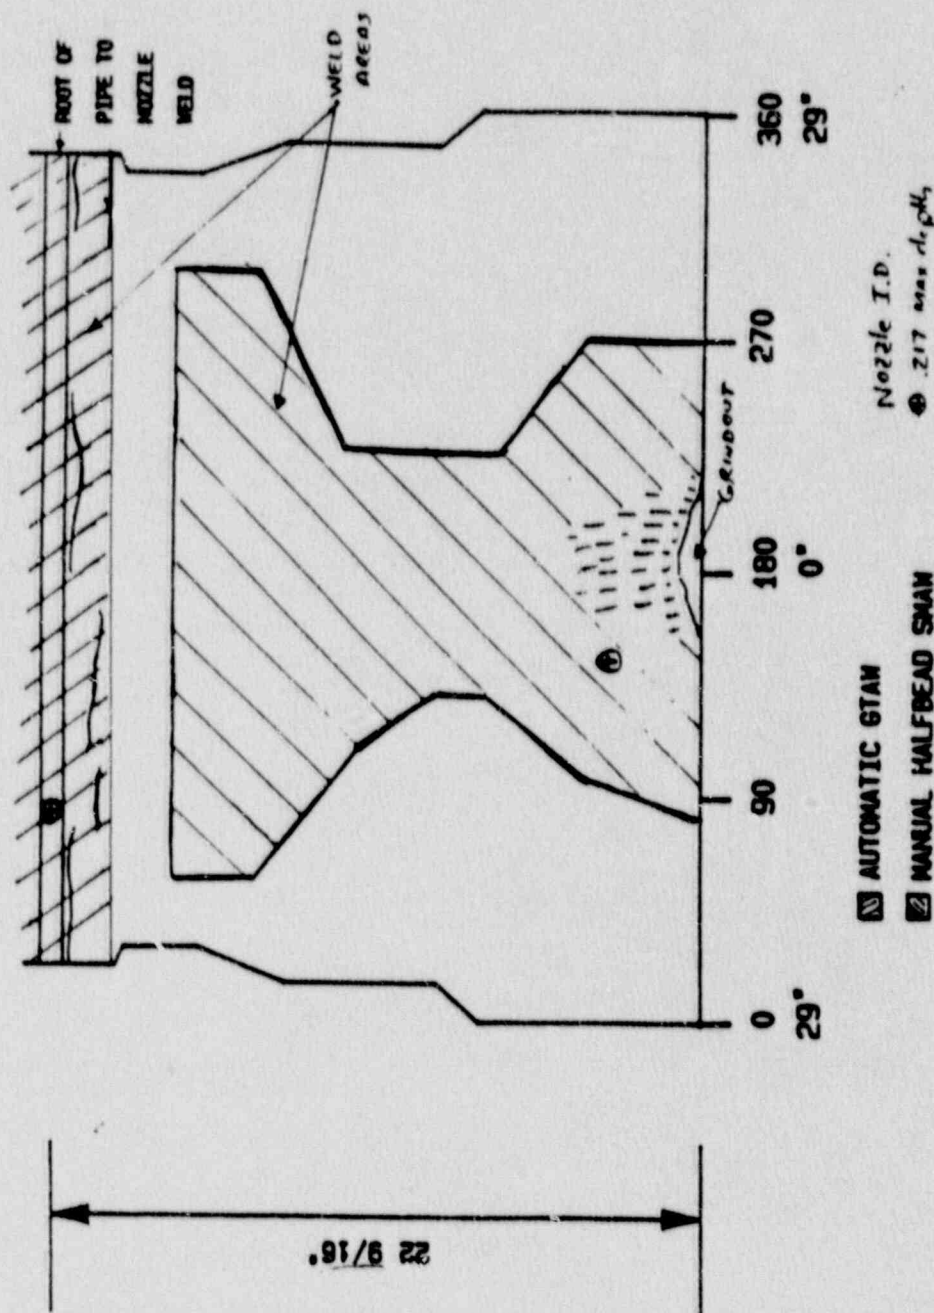
# STEAM GENERATOR 23 FEEDWATER NOZZLE

File to nozzle weld  
(3) 200" max depth

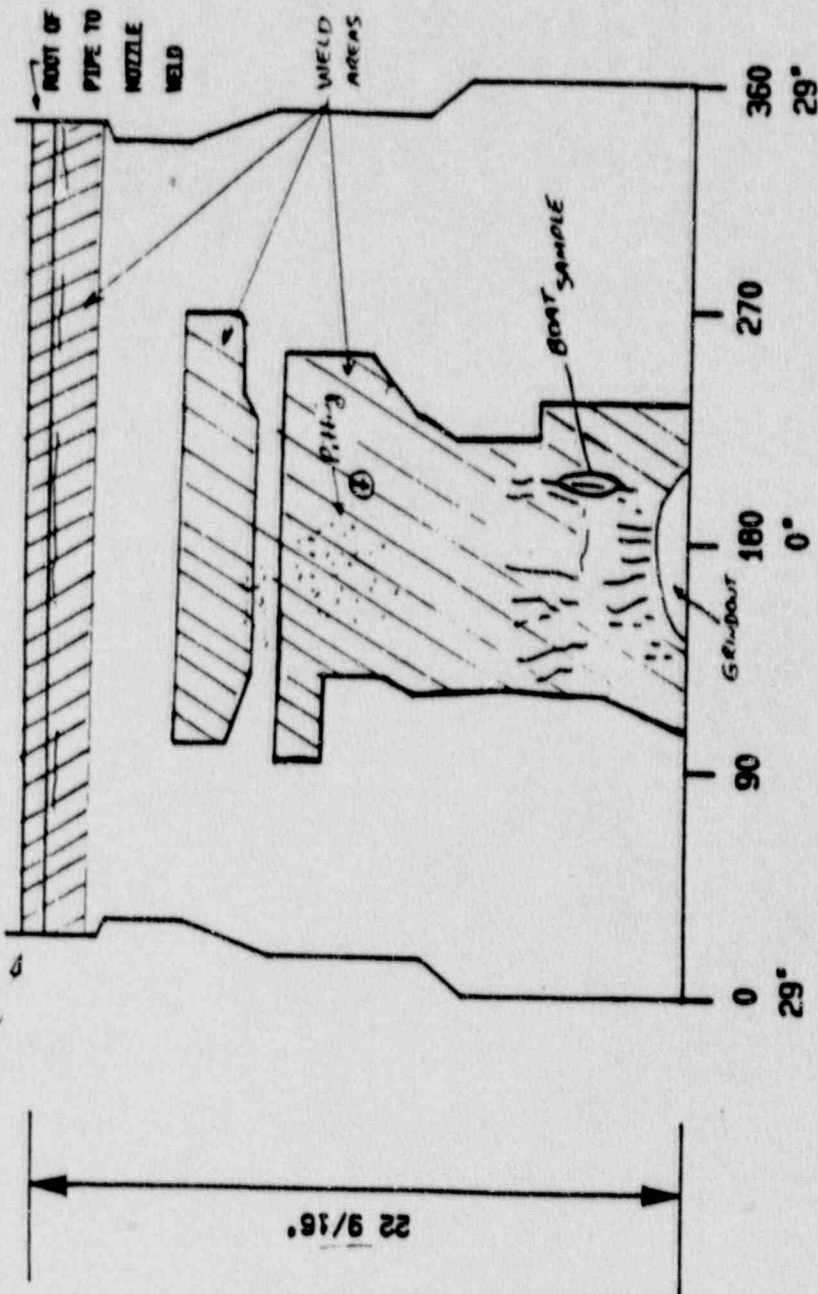
# STEAM GENERATOR 24 FEEDWATER NOZZLE

pipe to nozzle weld  
-270 max depth

- AUTOMATIC GTAW
- MANUAL HALFBEAD SHAW
- NOZZLE I.D.
- ④ .346" max depth

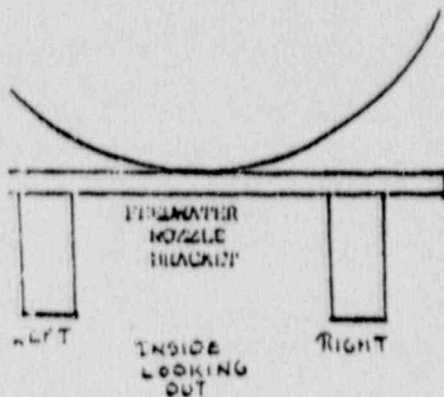
Dimension and location of Excavated  
Areas on the Feedwater Nozzle  
Annulus Bracket \* \* Side

NOTE: EXCAVATED AREAS HAVE NOT BEEN CONTOUNDED OR PREPARED FOR WELDING

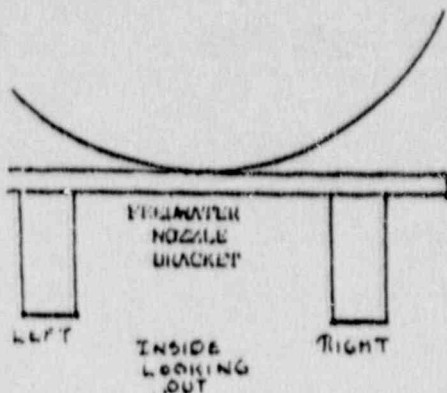
NOTE: EXCAVATED AREAS HAVE NOT BEEN CONTOURED OR PREPARED FOR WELDING

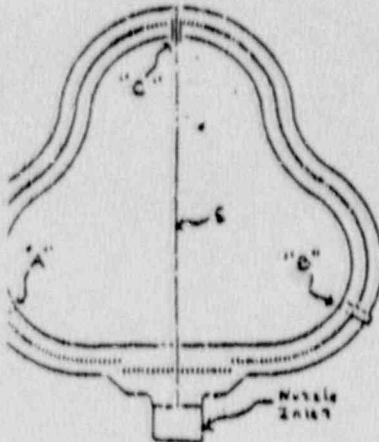
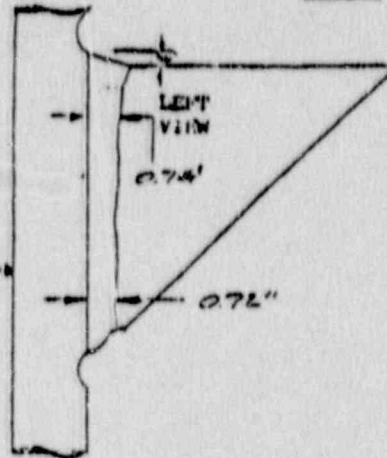
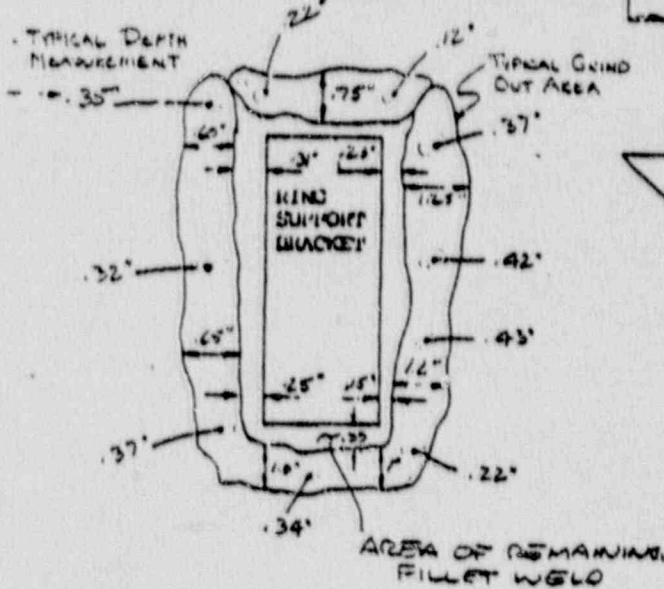
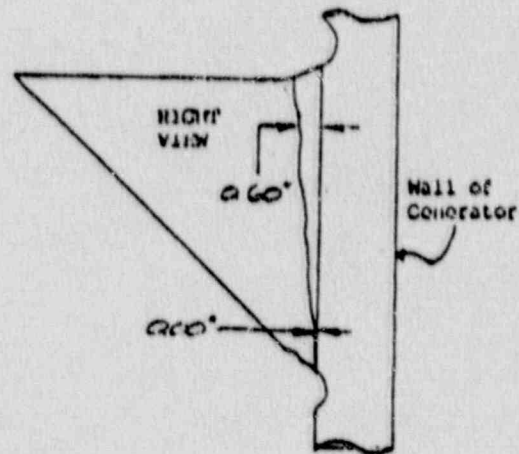
Dimension and Location of Excavated Areas on the Feedwater Ring Support Attachment Bracket "A"

NOTE: CAVITIES NOT  
 OUTPOURED OR PREPARED  
 FOR WELDING.

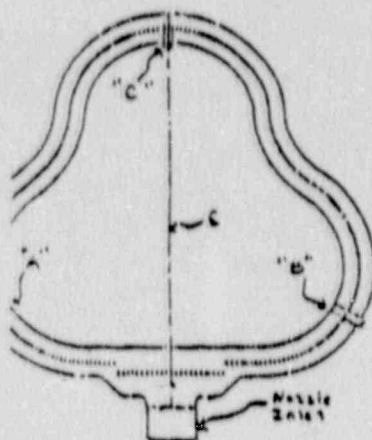
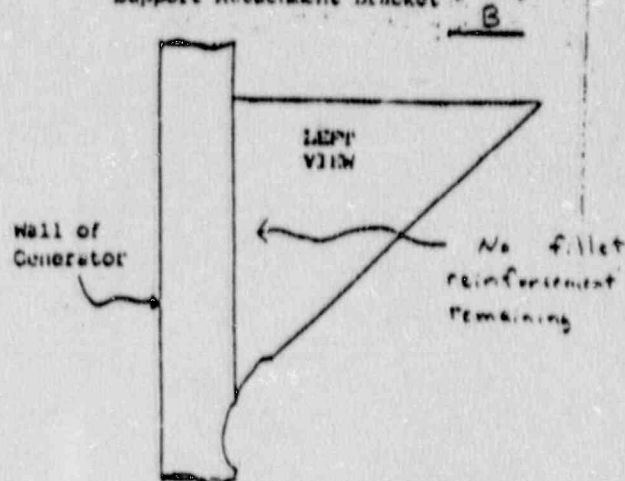
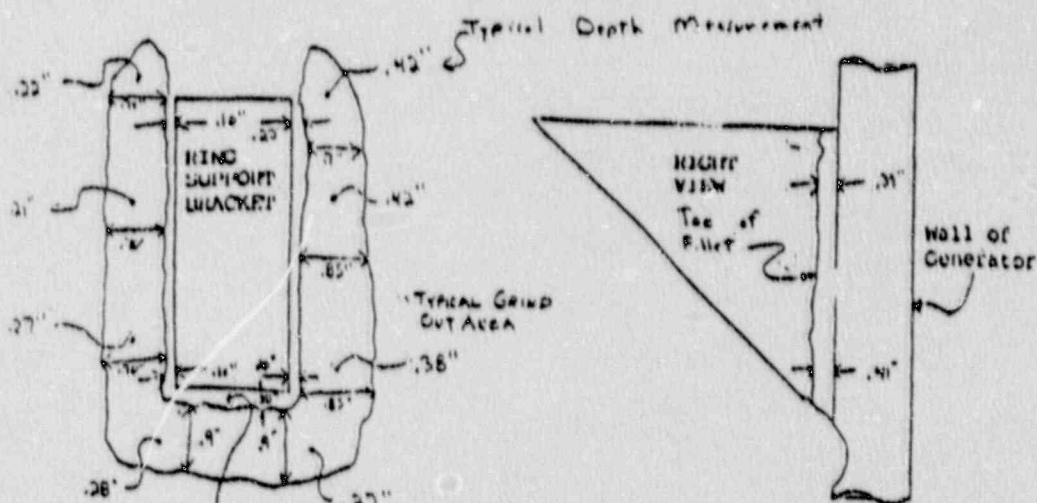
Dimension and Location of Excavated Area on the Feedwater Ring Support Attachment Bracket

Areas of excavation have been contoured for welding to a 2:1 slope.

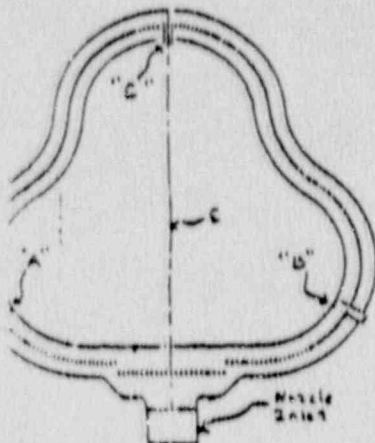
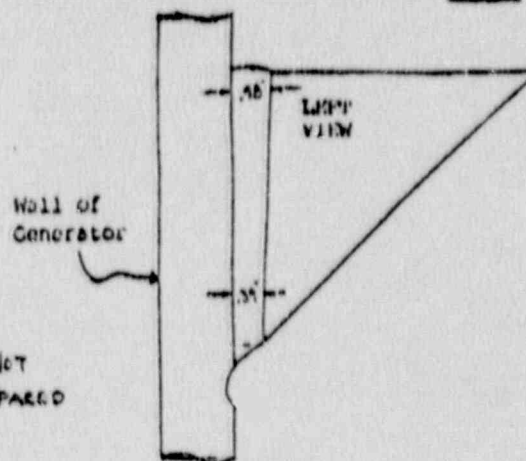
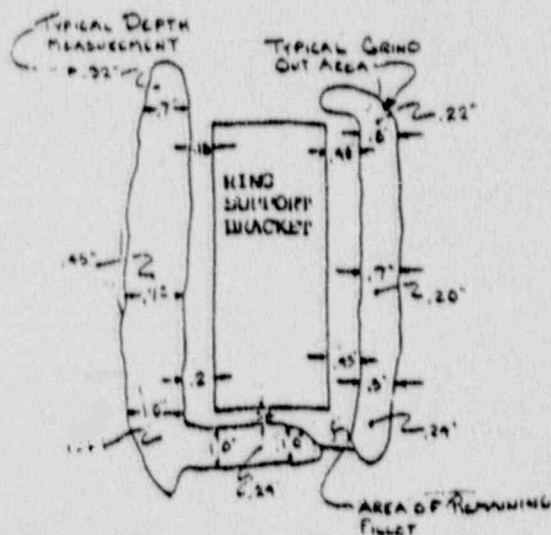
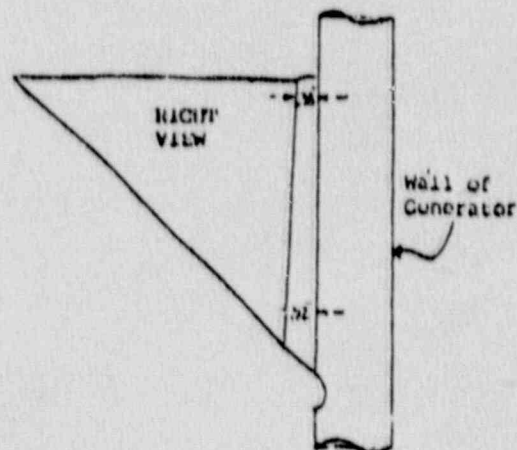
Dimension and Location of Excavated Areas on the Feedwater Riser Support Attachment Bracket " " "

NOTE: EXCAVATED AREAS HAVE NOT BEEN CONTOURED OR PREPARED FOR WELDING.

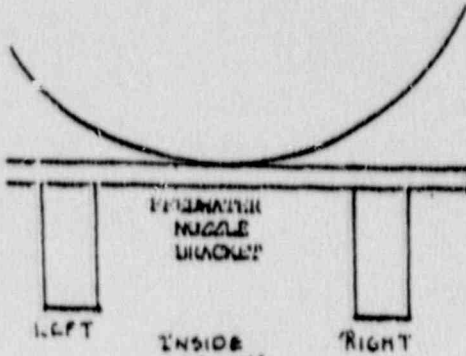
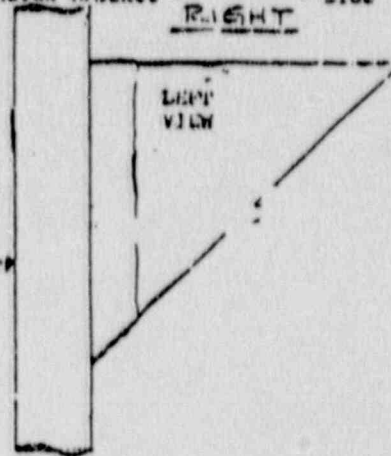
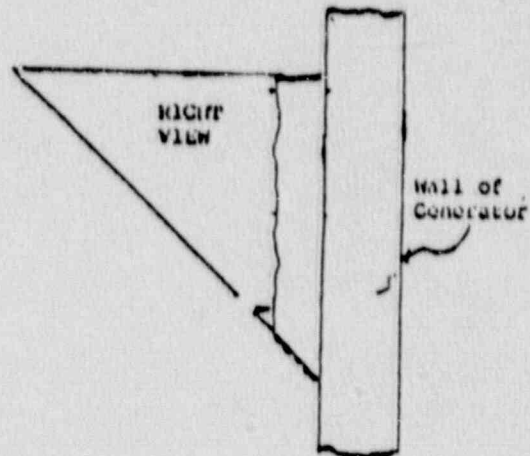
Dimension and location of Excavated Areas on the Feedwater Nozzle Minimum Bracket "RIGHT" Side

NOTE: CAVITIES NOT OUTLINED BY PREVIOUS WORK.

No INDICATIONS

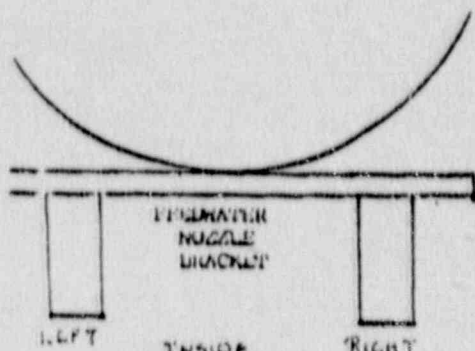
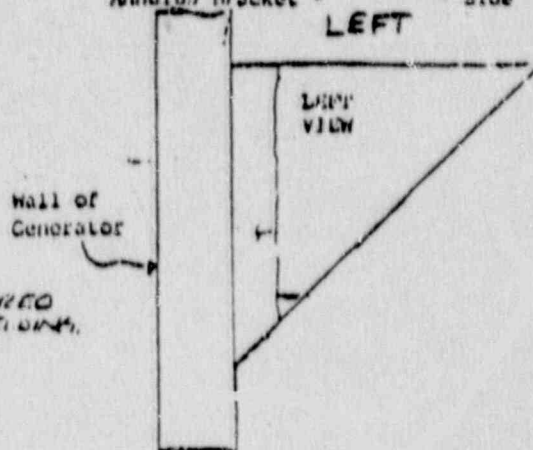
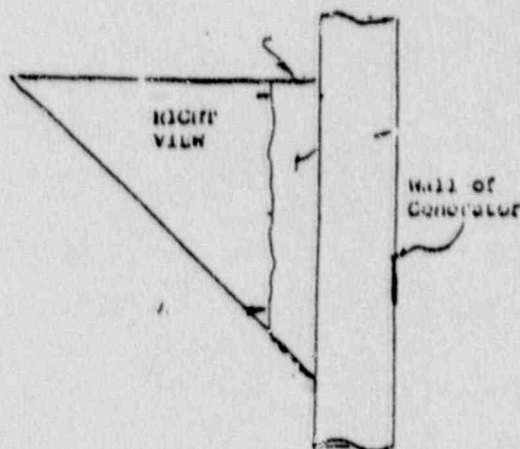
Dimension and location of Excavated  
 Areas on the Feedwater Nozzle  
 Annular Bracket " Side

NOTE: CAVITIES NOT DIMENSIONED  
 EX. DIMENSIONED FOR SECTION.

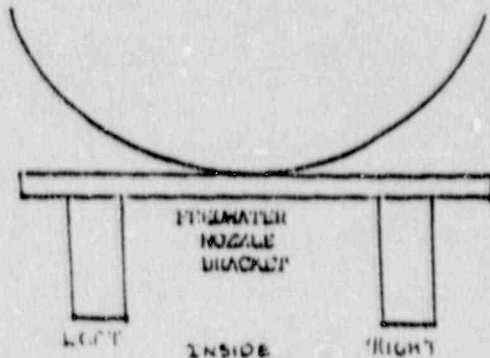
NOTE: CAVITIES NOT CONFOURED OR PREPARED FOR WELDING.

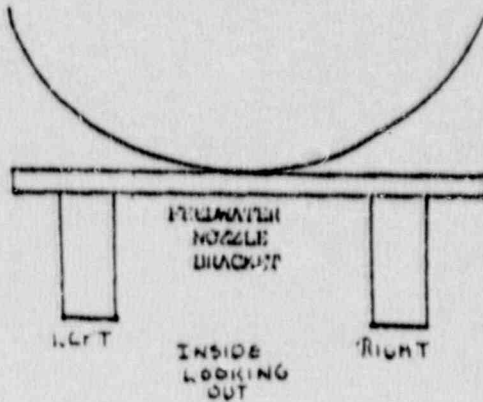
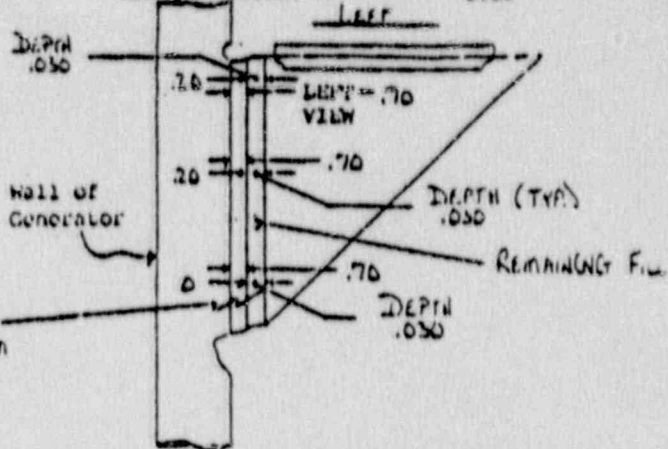
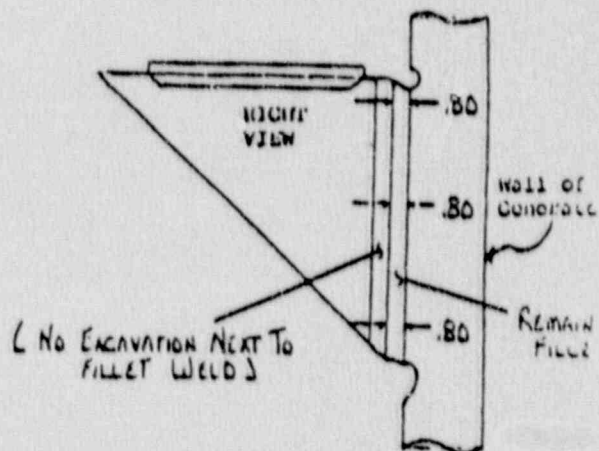
Dimension and location of excavated  
area on the Feedwater Nozzle  
Annulus Necked "Side"

NOTE: CAVITIES NOT CONTOURED  
OR TREATED FOR WELDING.

(SEE ATTACHED FOR GENERATOR  
WALL GRIND OUT.)

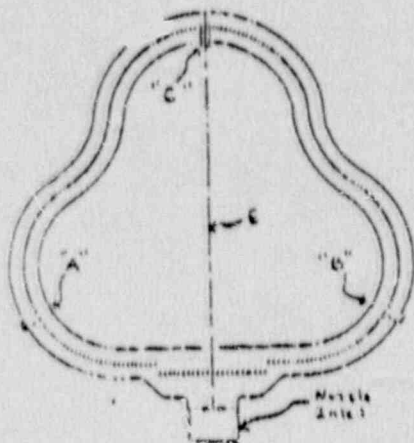
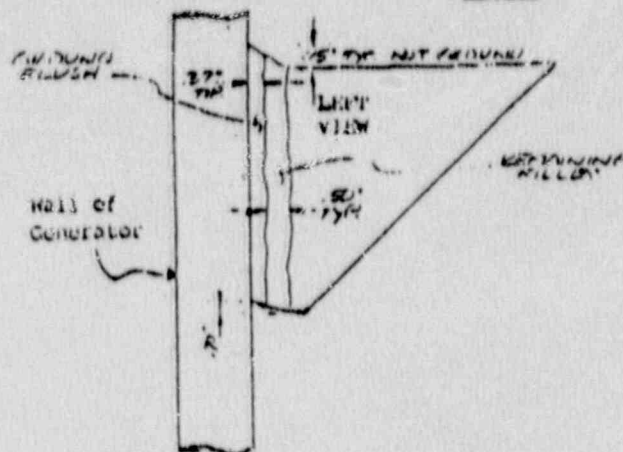
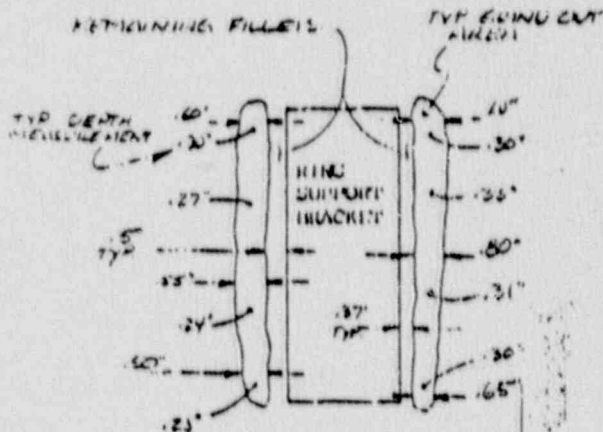
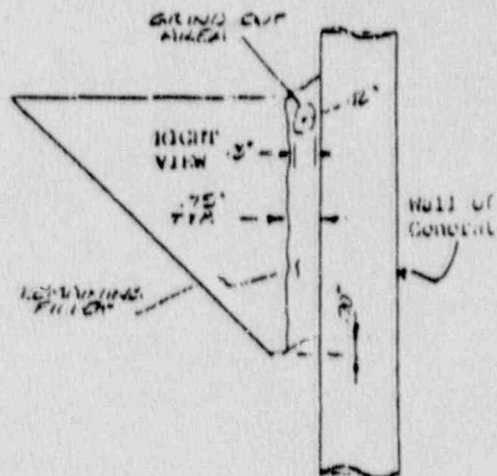
Dimension and Location of Excavated Area on the Feedwater Ring Support Attachment Bracket "A"

NOTE: CAVITIES NOT CONTIGUOUS  
 USE MILLER 1/2" FILLER WELDING

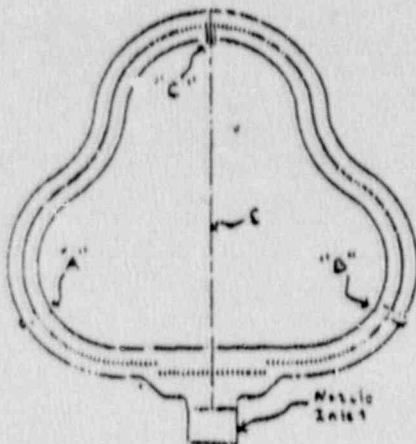
Dimension and Location of Excavated Areas on the Feedwater Ring Support Attachment Bracket " " "

NOTE: CAVITIES NOT CONTAINED  
OR PREPARED FOR WELDING
