INDIAN POINT UNIT 2 - FINAL REPORT  
ON THE STEAM GENERATOR INSPECTION,  
REPAIR, AND RESTORATION EFFORTS  
DURING THE 1990 MID-CYCLE INSPECTION

ISSUE DATE: JULY 1990

PREPARED FOR CONSOLIDATED EDISON COMPANY

WESTINGHOUSE ELECTRIC CORPORATION  
NUCLEAR SERVICES DIVISION  
P. O. BOX 355  
PITTSBURGH, PENNSYLVANIA 15230

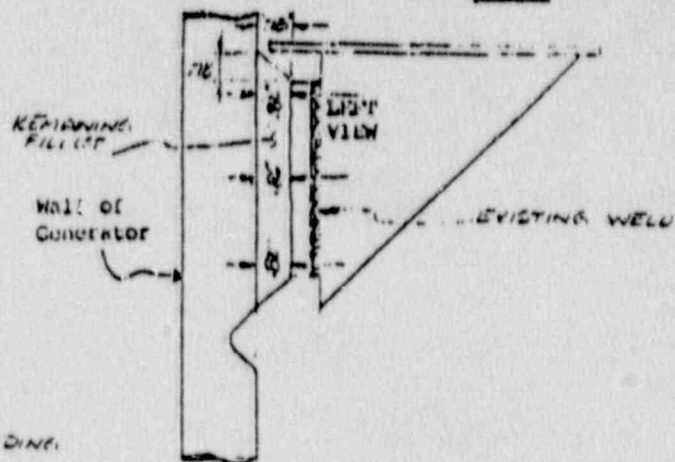
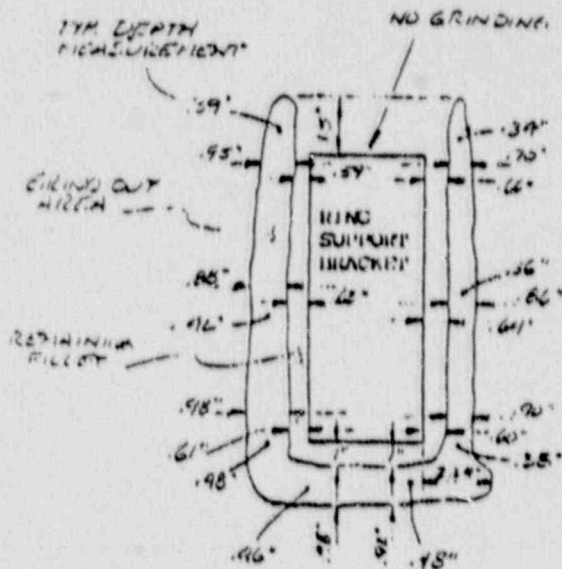
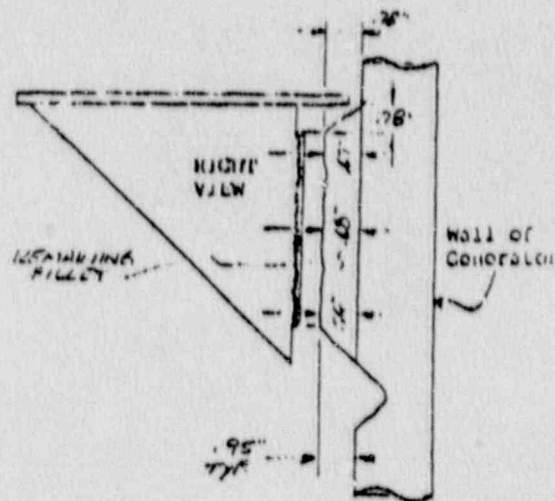
NOTE: CAVITIES NOT CONTAINED  
OR PREPARED FOR WELDING

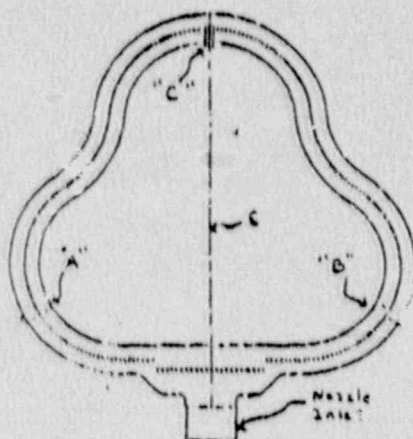
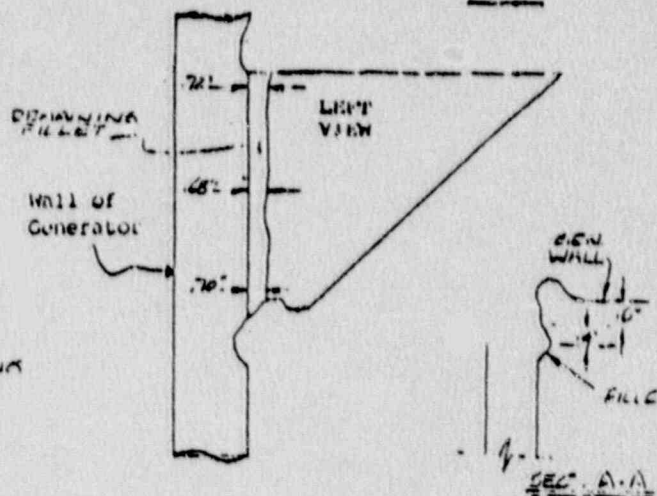
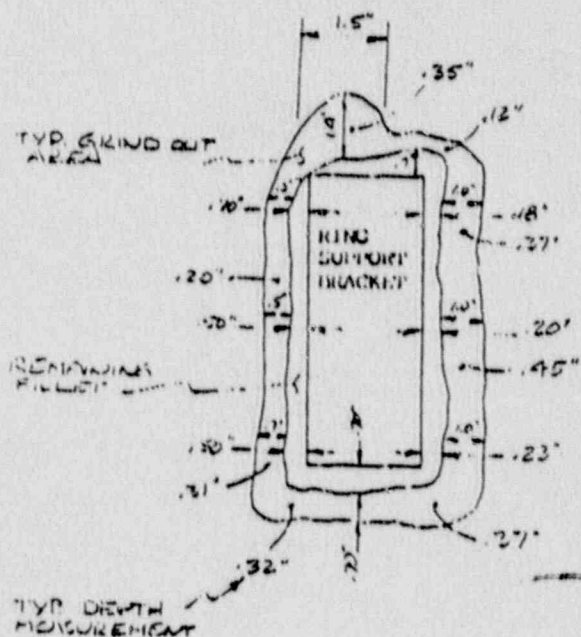
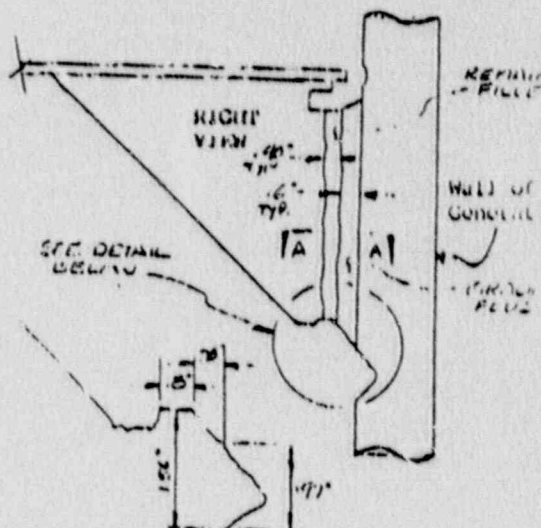
Dimension and Location of Excavated  
Areas on the Feedwater Ring  
Support Attachment Bracket " " "

NOTE CAVITIES NOT CONToured  
OR PREPARED FOR WELDING

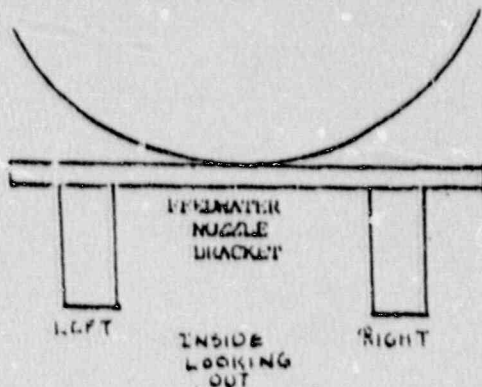
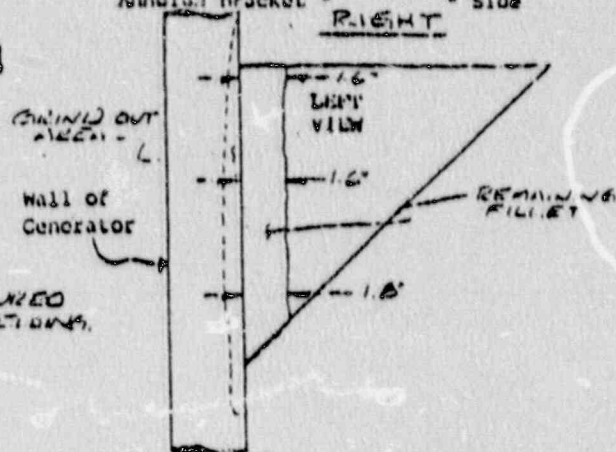
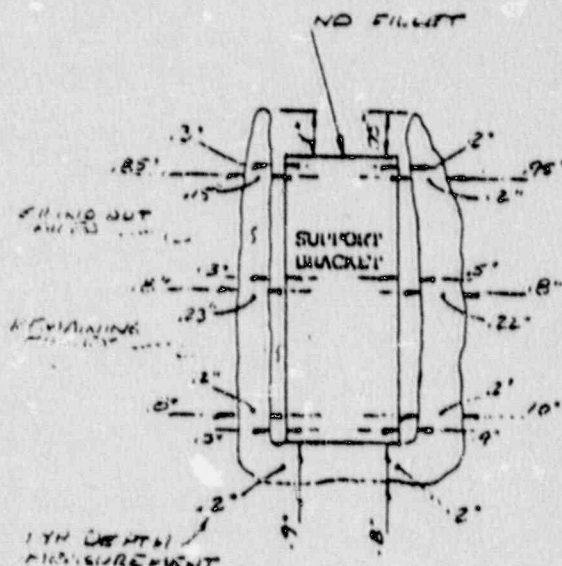
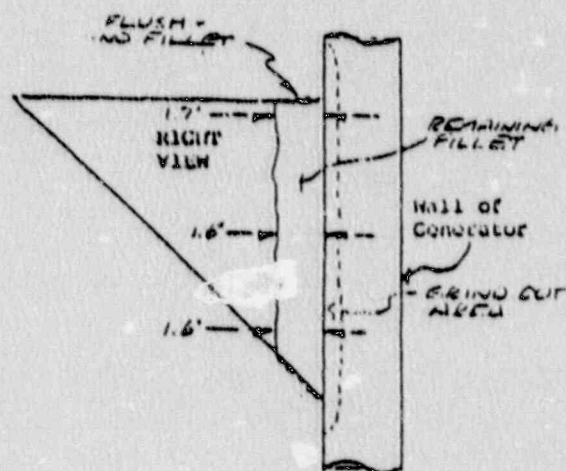
Dimension and location of Excavated  
Areas on the Feedwater Nozzle  
Annular Bracket " " Side

NOTE: CAVITIES NOT STOUTURED  
BY MECHANIZED OR WELDING.

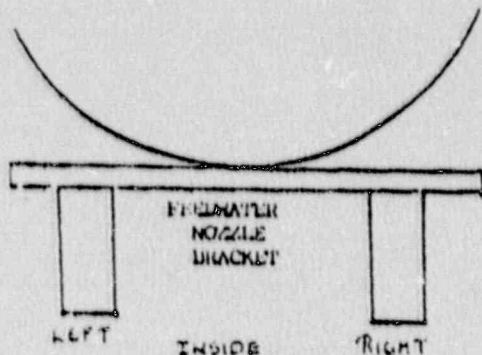
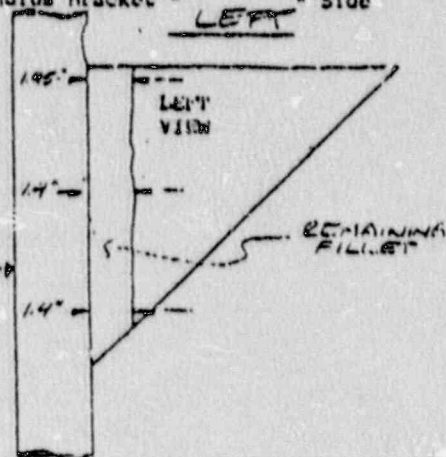
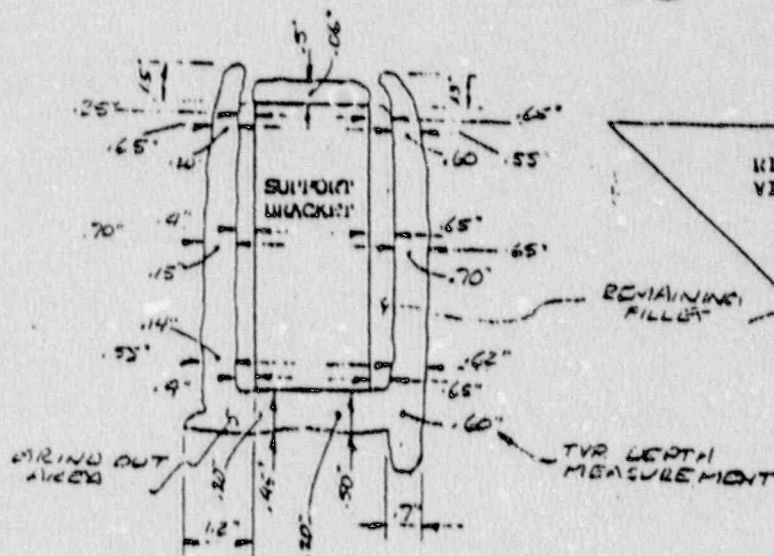
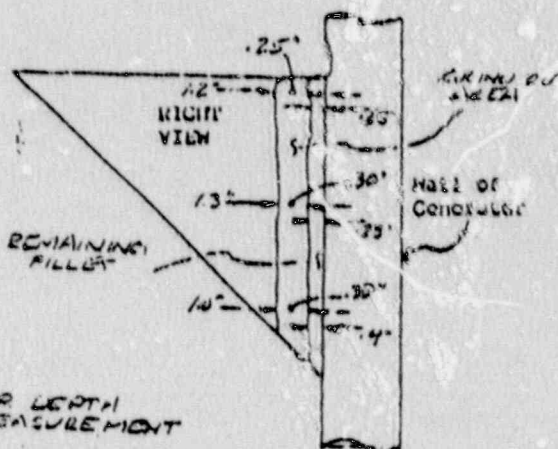
Dimension and location of Excavated Areas on the Feedwater Nozzle Annulus Bracket "LEFT" Side

NOTE: CAVITIES NOT CONTIGUOUS OR REPAIRED FOR WELDING

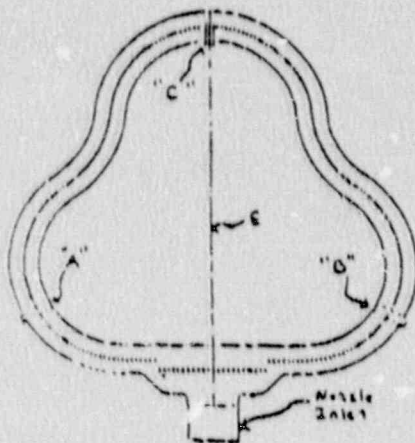
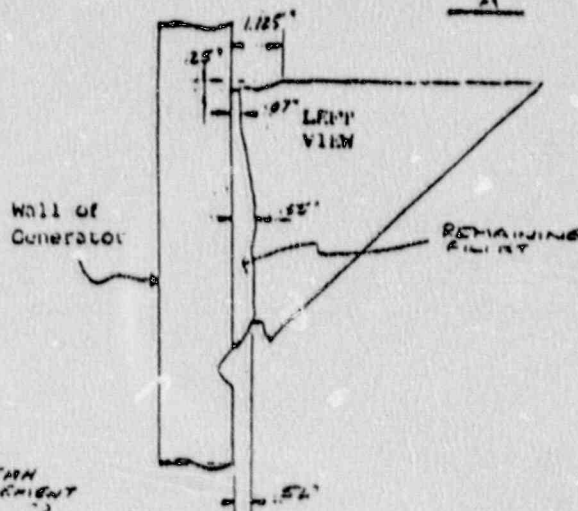
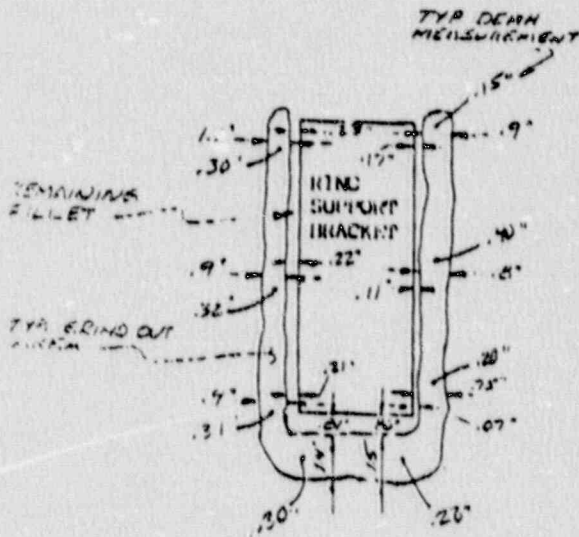
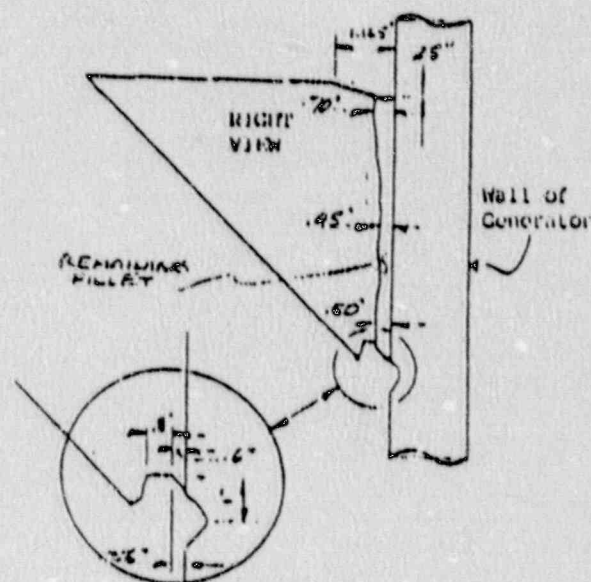
Dimension and Location of Excavated Areas on the Feedwater Ring Support Attachment Bracket "A"

NOTE: CAVITIES NOT CONTOURED OR PREPARED FOR WELDING.

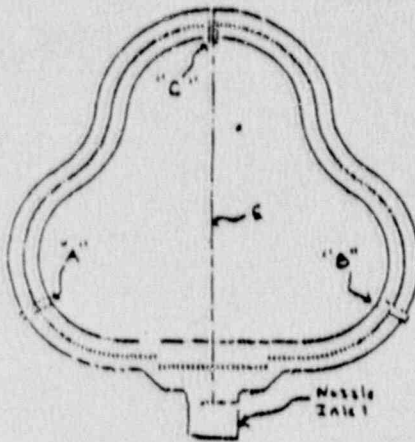
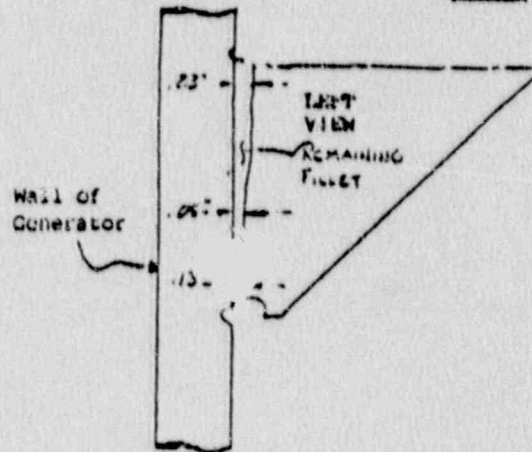
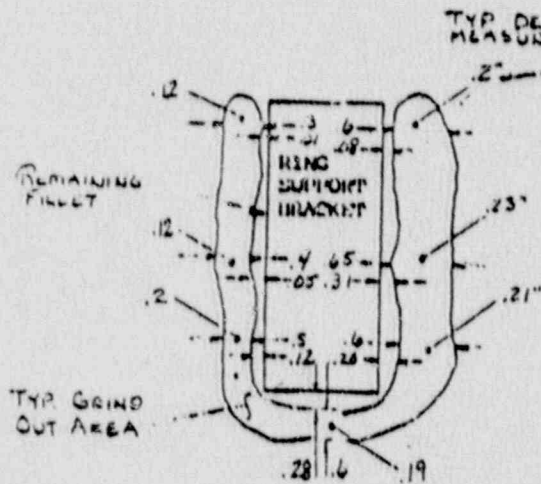
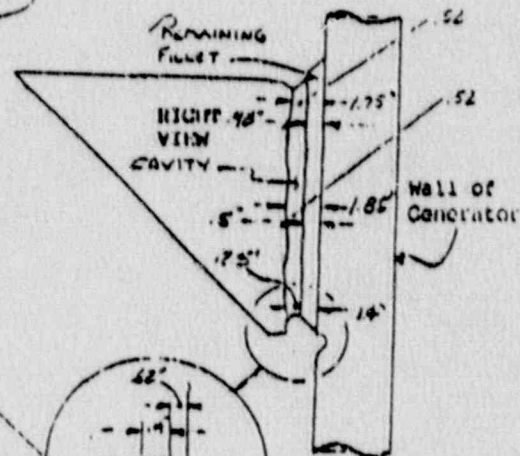
Dimension and Location of Excavated Areas on the Pedestal Ring Support Attachment Bracket "B"

NOTE: CAVITIES NOT CONTOURED OR PREPARED FOR WELDING.

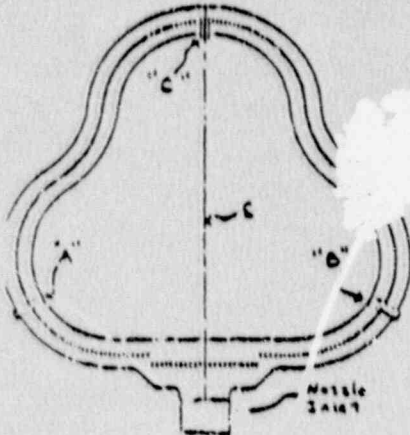
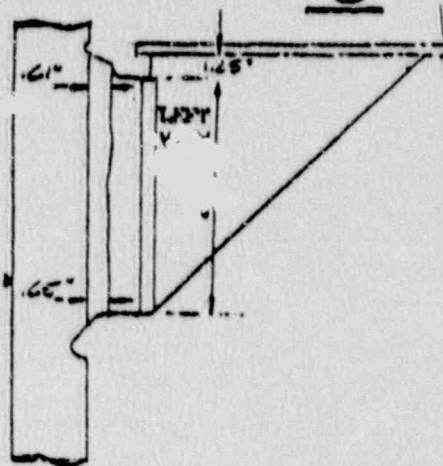
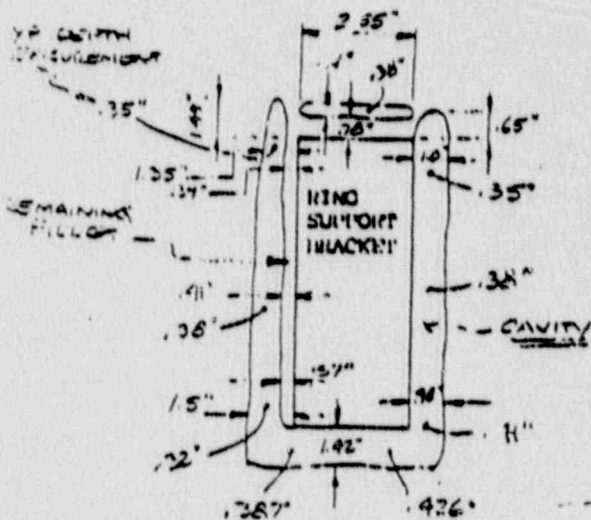
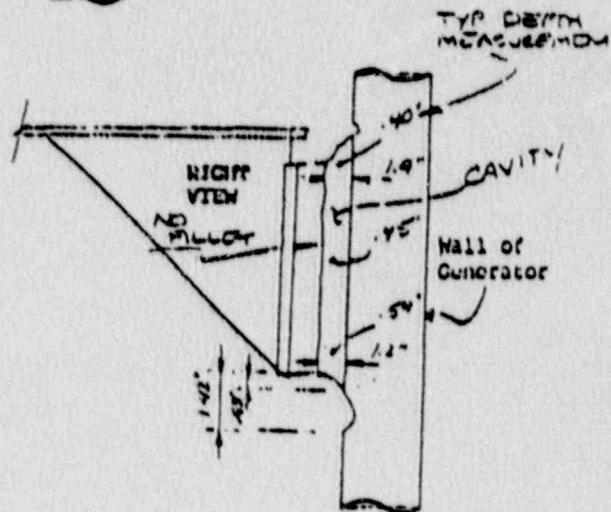
Dimension and Location of Excavated Areas on the Feedwater Ring Support Attachment Bracket "C"

NOTE: CAVITIES NOT CAPTURED OR PREPARED FOR WELDING.
