FAILURE ANALYSIS OF INCONEL 600®
TUBES FROM OTSG A AND B OF
THREE MILE ISLAND UNIT-1

GPU-NUCLEAR

June 30, 1982

BATTELLE
Columbus Laboratories
505 King Avenue
Columbus, Ohio 43201

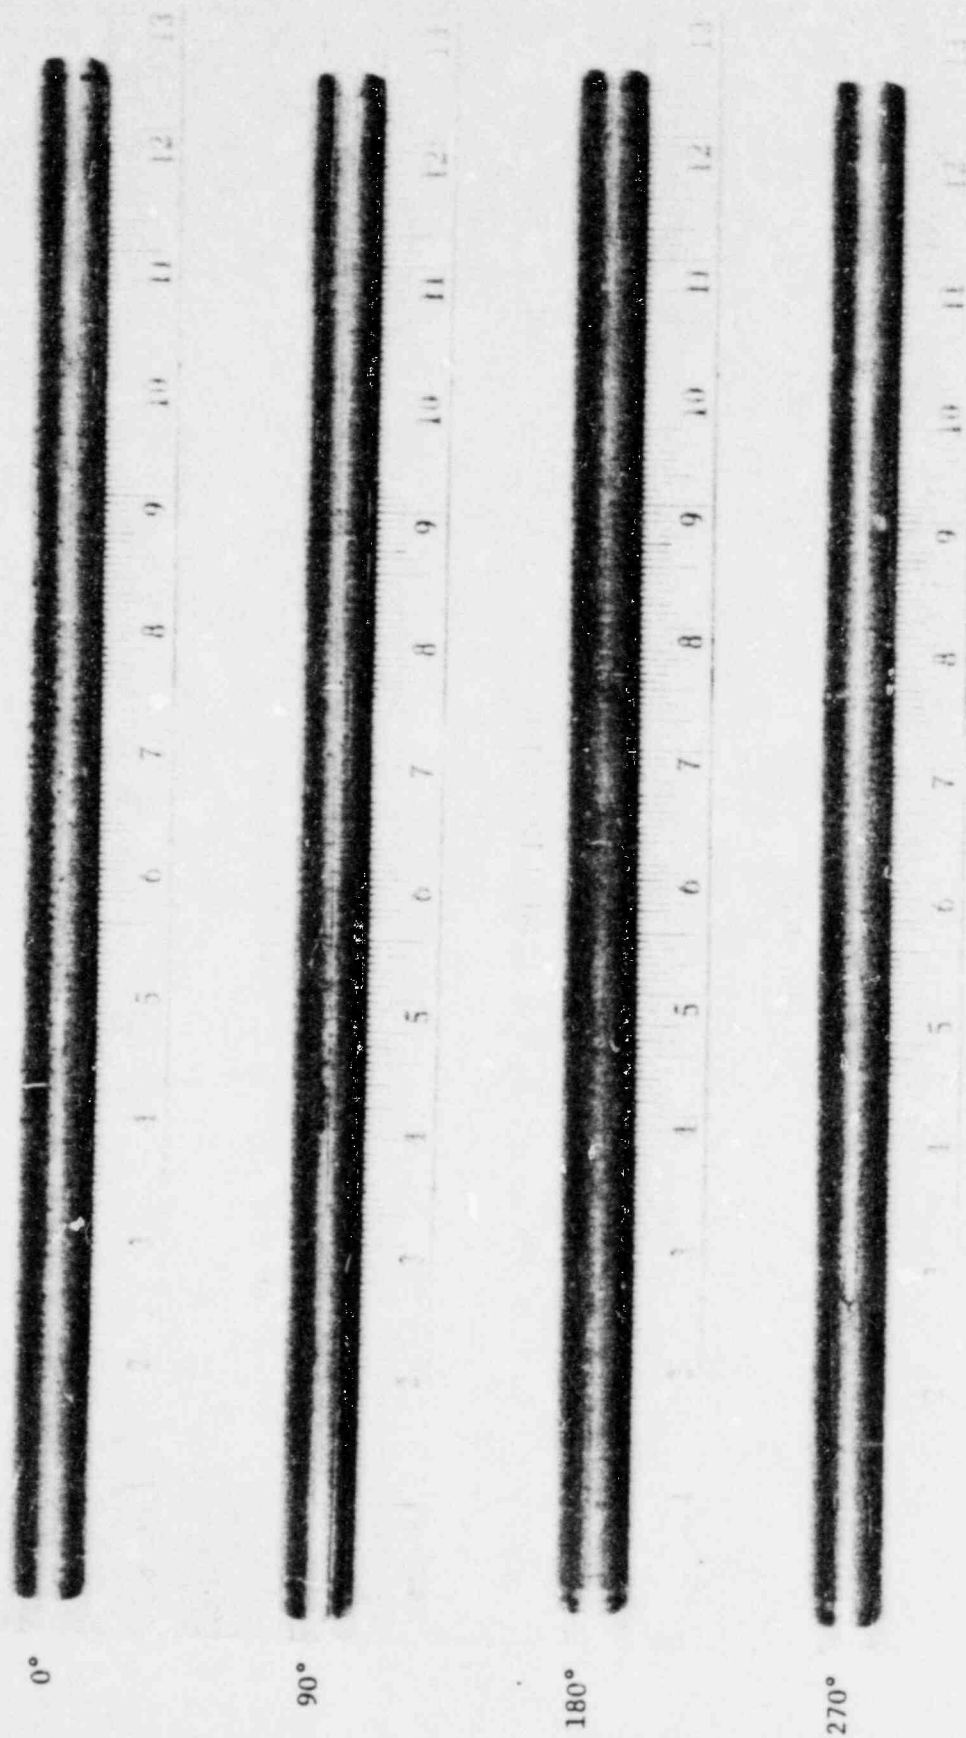
FIGURE 7. APPEARANCE OF AS-RECEIVED TUBE A-71-126 SEGMENT 2 AT 0, 90, 180 AND 270 DEGREE POSITIONS

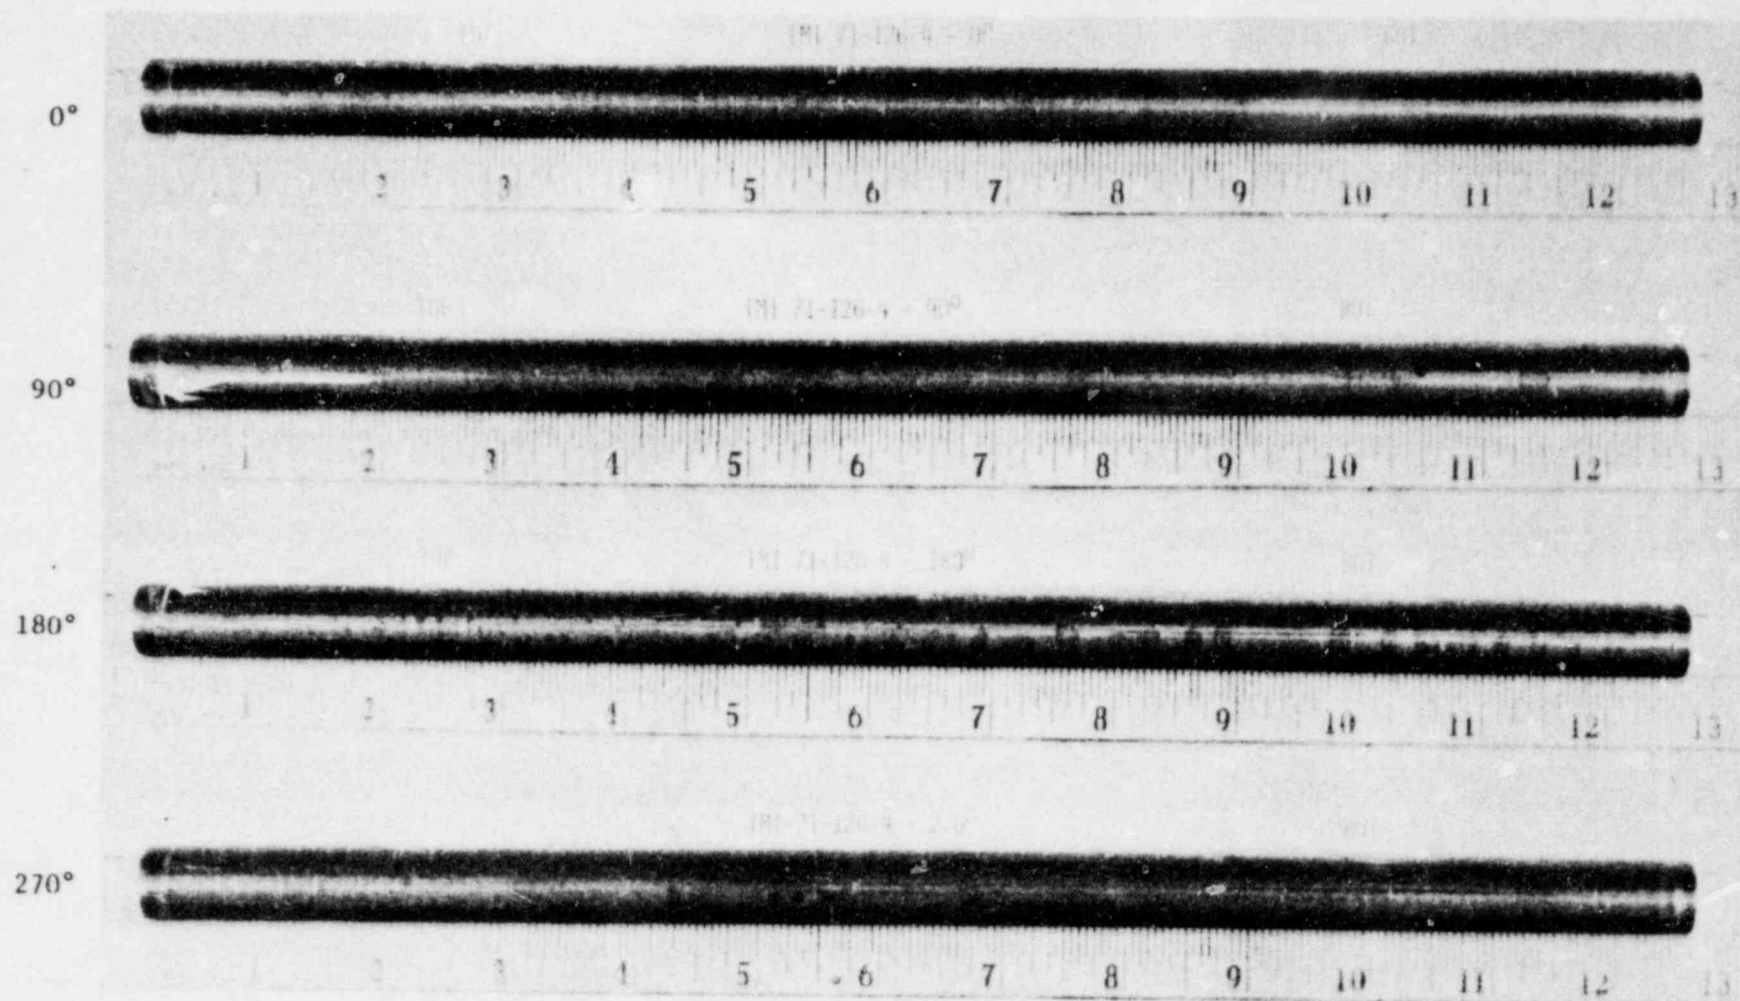
FIGURE 8. APPEARANCE OF AS-RECEIVED TUBE A-71-126 SEGMENT 3 AT 0, 90, 180 AND 270 DEGREE POSITIONS

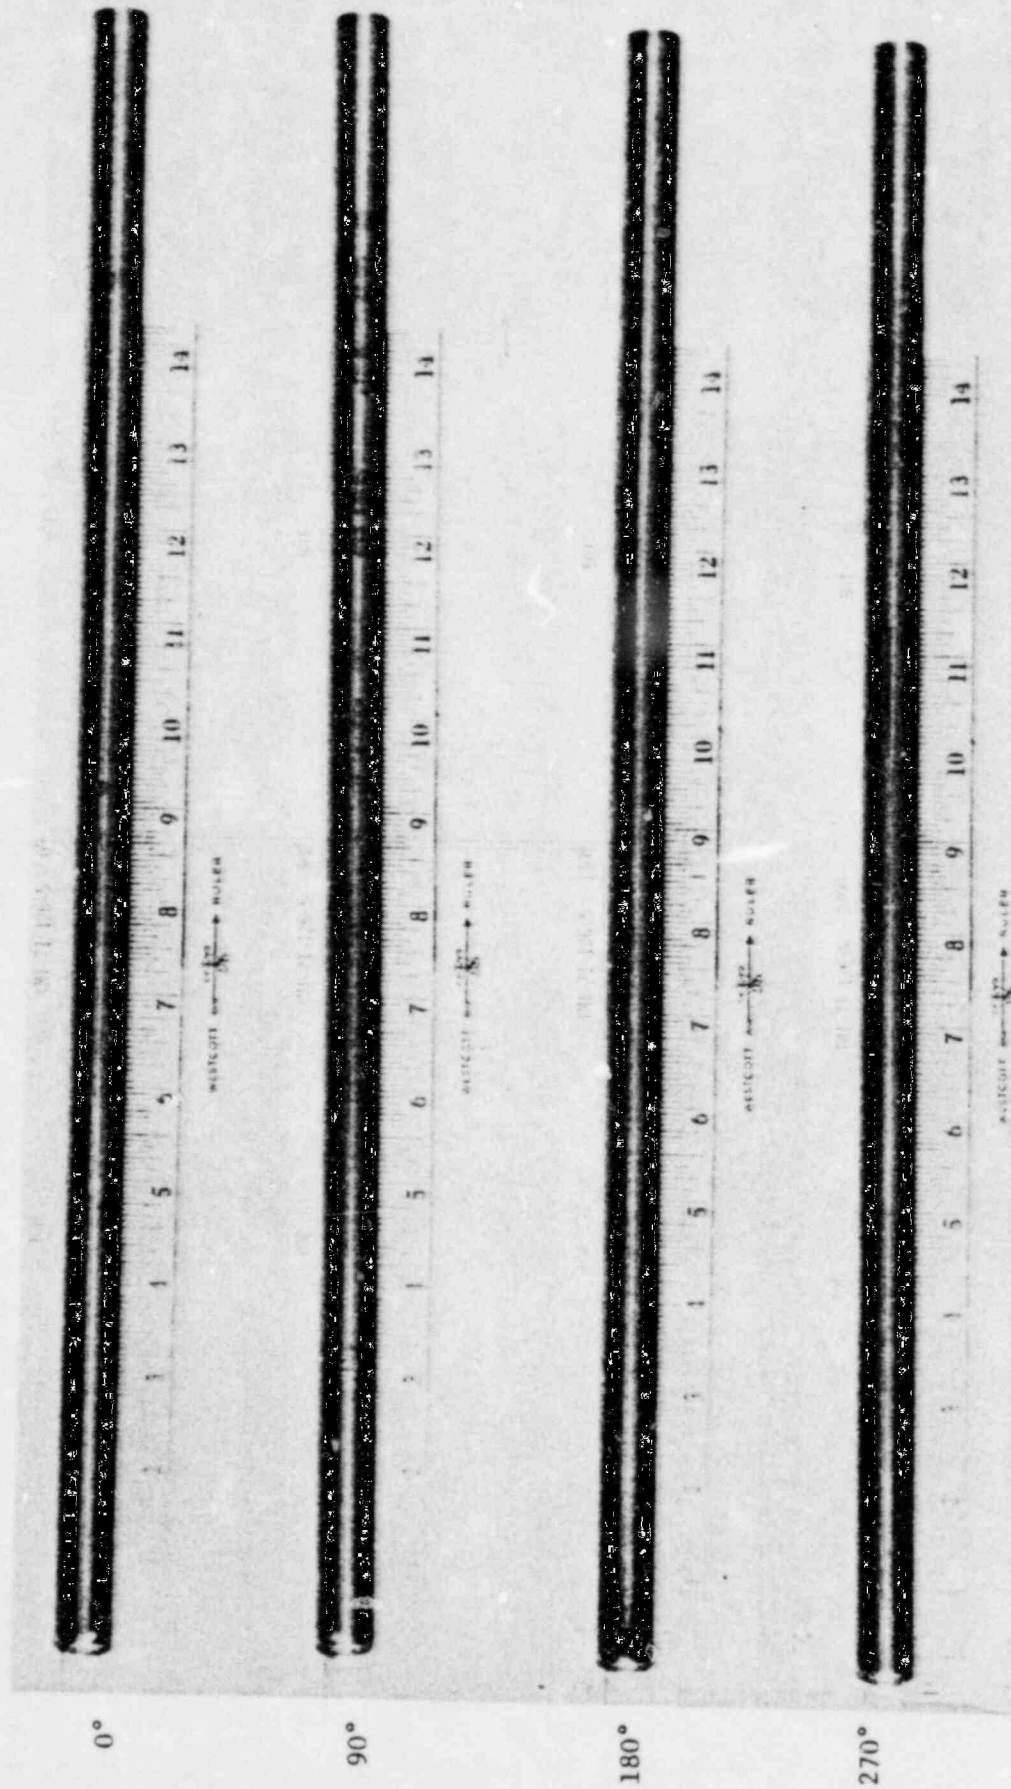
FIGURE 9. APPEARANCE OF AS-RECEIVED TUBE A-71-126 SEGMENT 4 AT 0, 90, 180 AND 270 DEGREE POSITIONS

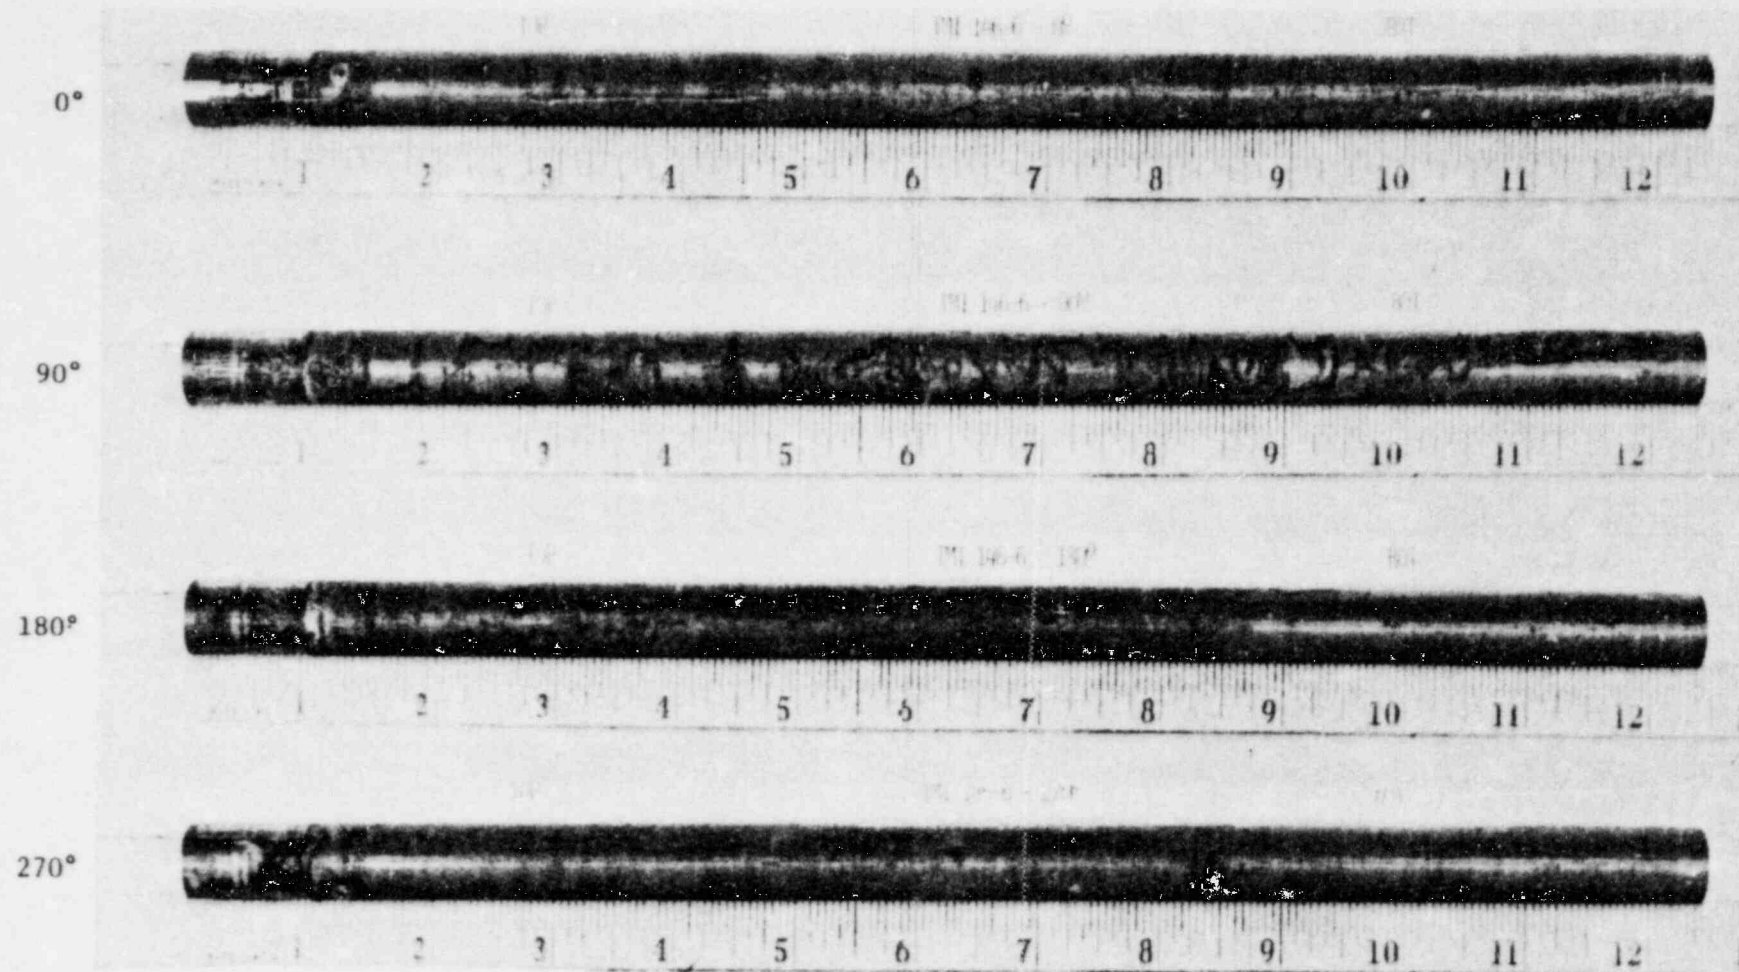
In Figure 13 a lip-crack can be seen extending from the slot in tube A-112-5. A similar lip-crack is visible in tube A-146-8 in Figure 15.

FIGURE 13. APPEARANCE OF AS-RECEIVED TUBE A-112-5 AT 0, 90, 180 AND 270 DEGREE POSITIONS

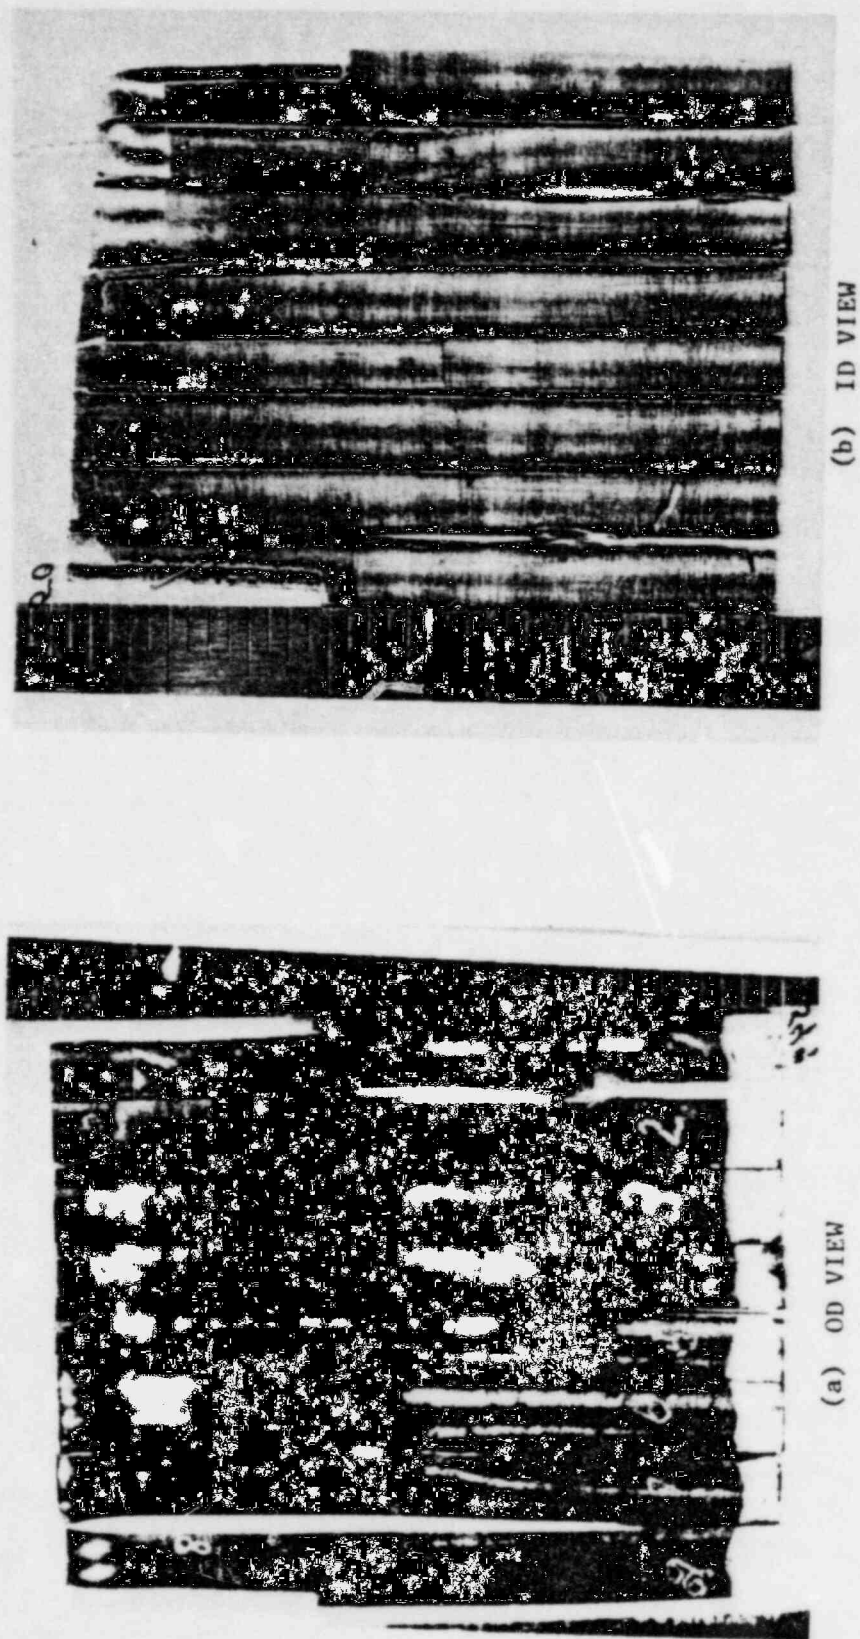
Top end (specimen A) of tube B-8-25 containing the roll-transition area was slit into eight longitudinal slices. This section had an EC indication at 1.25 inch location. Photographs of these slices (specimens A1-A8) are shown in Figure 16. Specimen A4 broke into two pieces during slitting, and specimen A3 also showed a through-wall crack in handling. Specimens A2, A5 and A6 were bent into U-shape with ID in tension, all three specimens showed cracks with ~90 percent wall penetration. The cracks in specimens A2 through A6 were located at 1.25 inch and spanned from 45° to 270°.

FIGURE 16. PHOTOGRAPH OF AS-CUT SLICES A1 THROUGH A8 FROM TUBE B-8-25

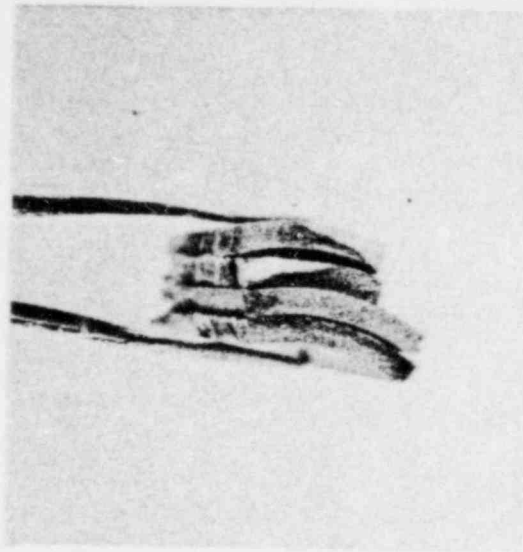
The total fracture surface area on A3 specimen was not large enough for very detailed ESCA analysis. Therefore, a second specimen, namely B, was used which consisted of multiple fracture surfaces stacked together, as shown in Figure 21. The results of ESCA analysis are summarized in Tables 7 and 8.

FIGURE 21. PHOTOGRAPH OF SPECIMEN B FROM TUBE B-8-25 SHOWING MULTIPLE FRACTURE SURFACES STACKED TOGETHER FOR ESCA ANALYSIS

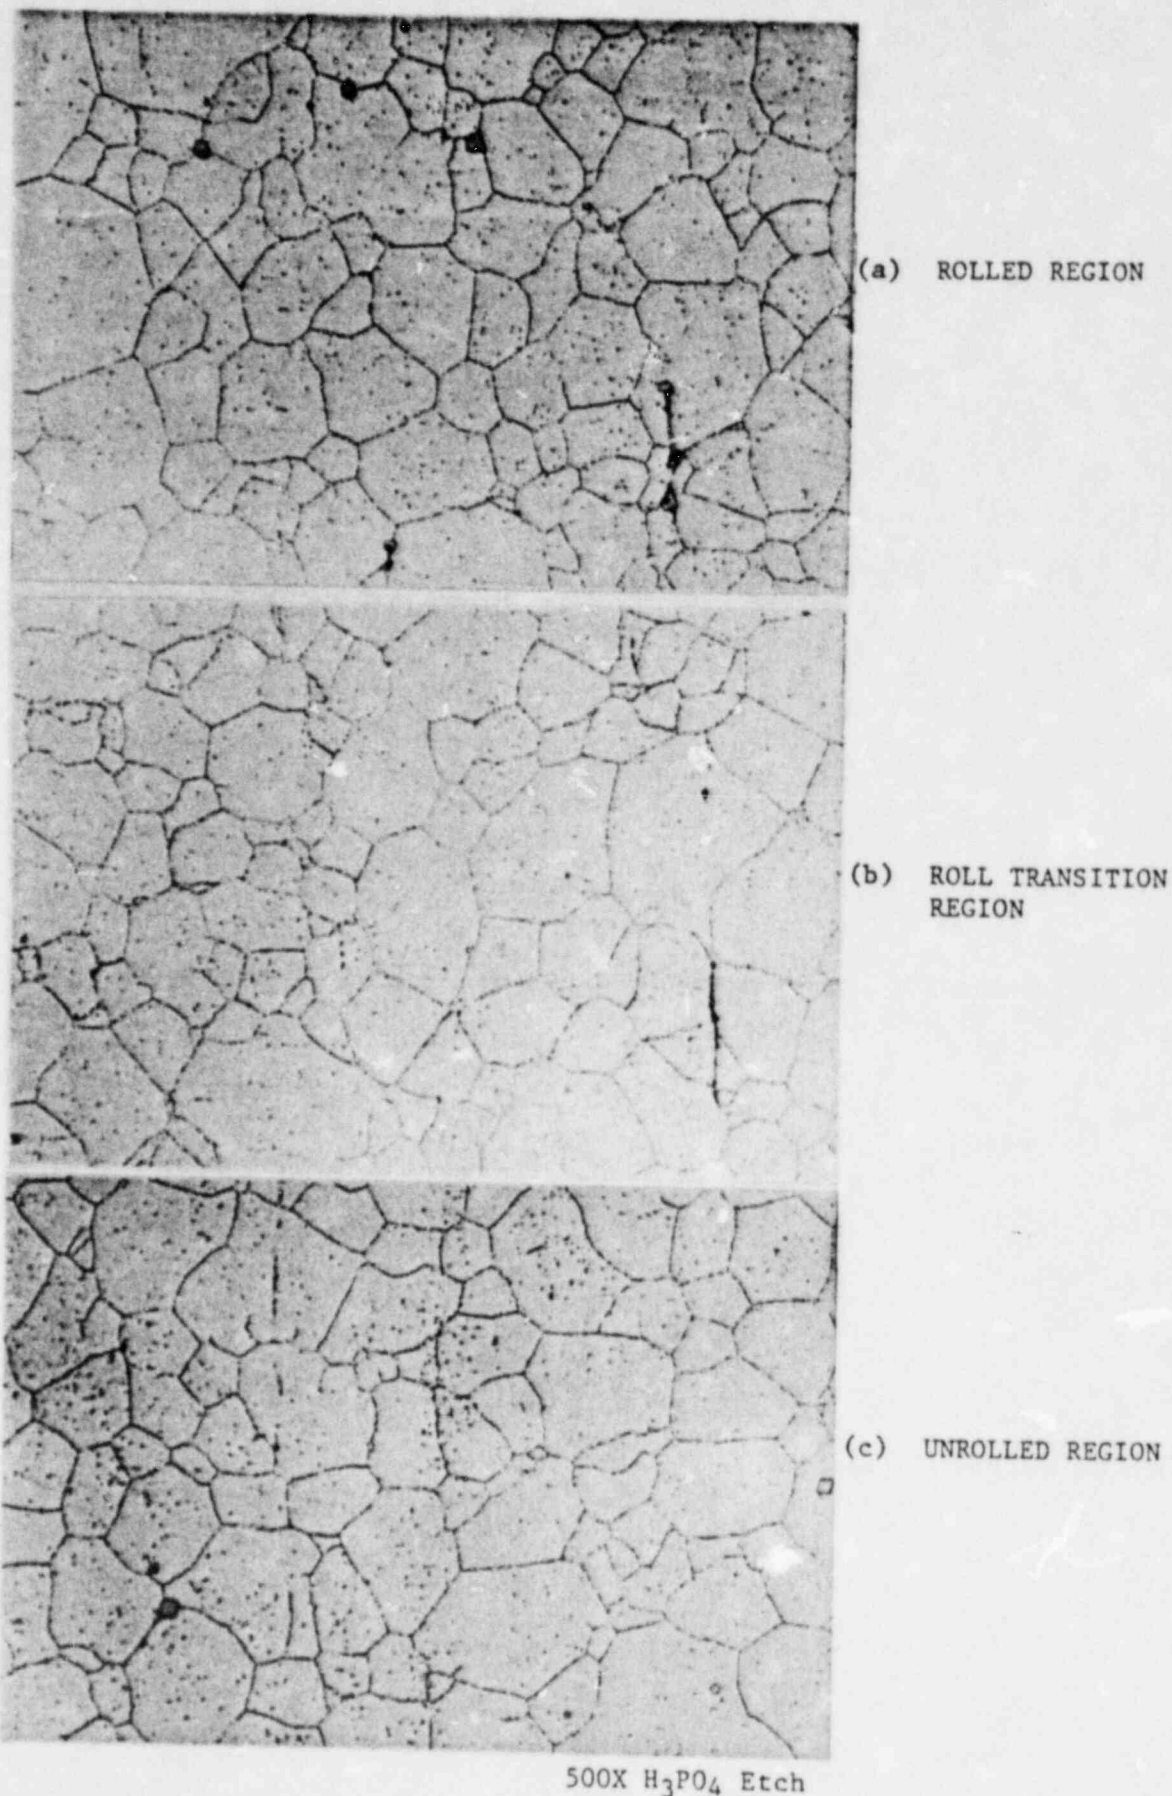
the alloy is shown in Figure 33 from three different sub-locations, i.e., rolled region, roll transition region, and the unrolled region. There is no noticeable difference between the three microstructures. In all three, the grain size is the same, and the carbide precipitates are discrete over grain boundaries and inside grains. No continuous network of carbide is visible in Figure 33.

FIGURE 33. PHOTOMICROGRAPHS OF THE MICROSTRUCTURE OF THREE DIFFERENT REGIONS OF SPECIMEN B FROM TUBE A-146-6

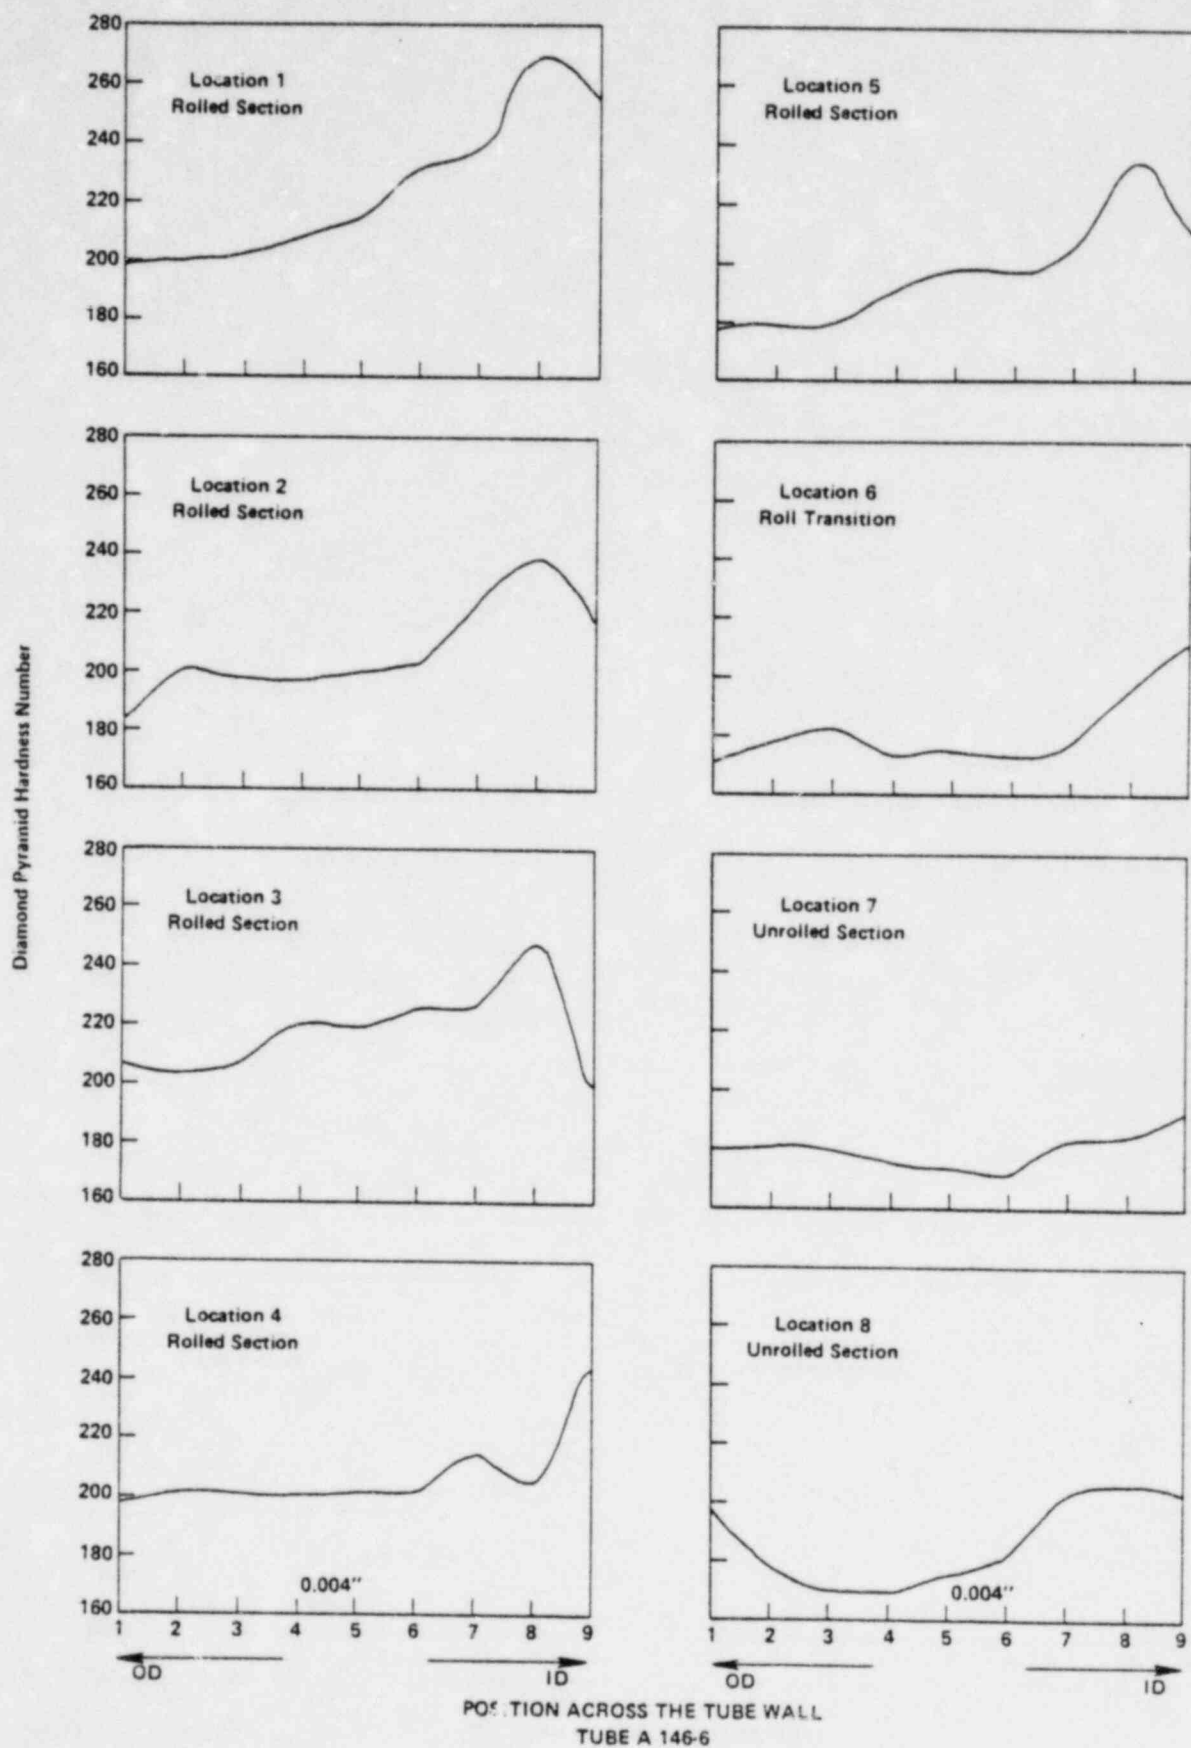
Microhardness values at 180° face of specimen B, taken at approximately 1/8 inch intervals are shown in Figure 34. Knoop diamond pyramid hardness readings at any sublocation was taken every 4 mils starting at ~2 mils from the ID edge of the tube. The highest values were in the rolled section of the tube (location numbers 1, 0.5 inch, to 5, 1.0 inch, in Figure 34) near the ID, the maximum was 270. In the roll transition region (location number 6, 1.1 inch) the maximum value at ID was only 210. The maximum value below the roll transition region was <200. These values are considered normal for fabricated Inconel-600[®] tubes, and the rolled region of the tube is not excessively cold worked.

FIGURE 34. MICROHARDNESS VALUES AT 8 DIFFERENT SUB-LOCATIONS ON SPECIMEN B FROM TUBE A-146-6

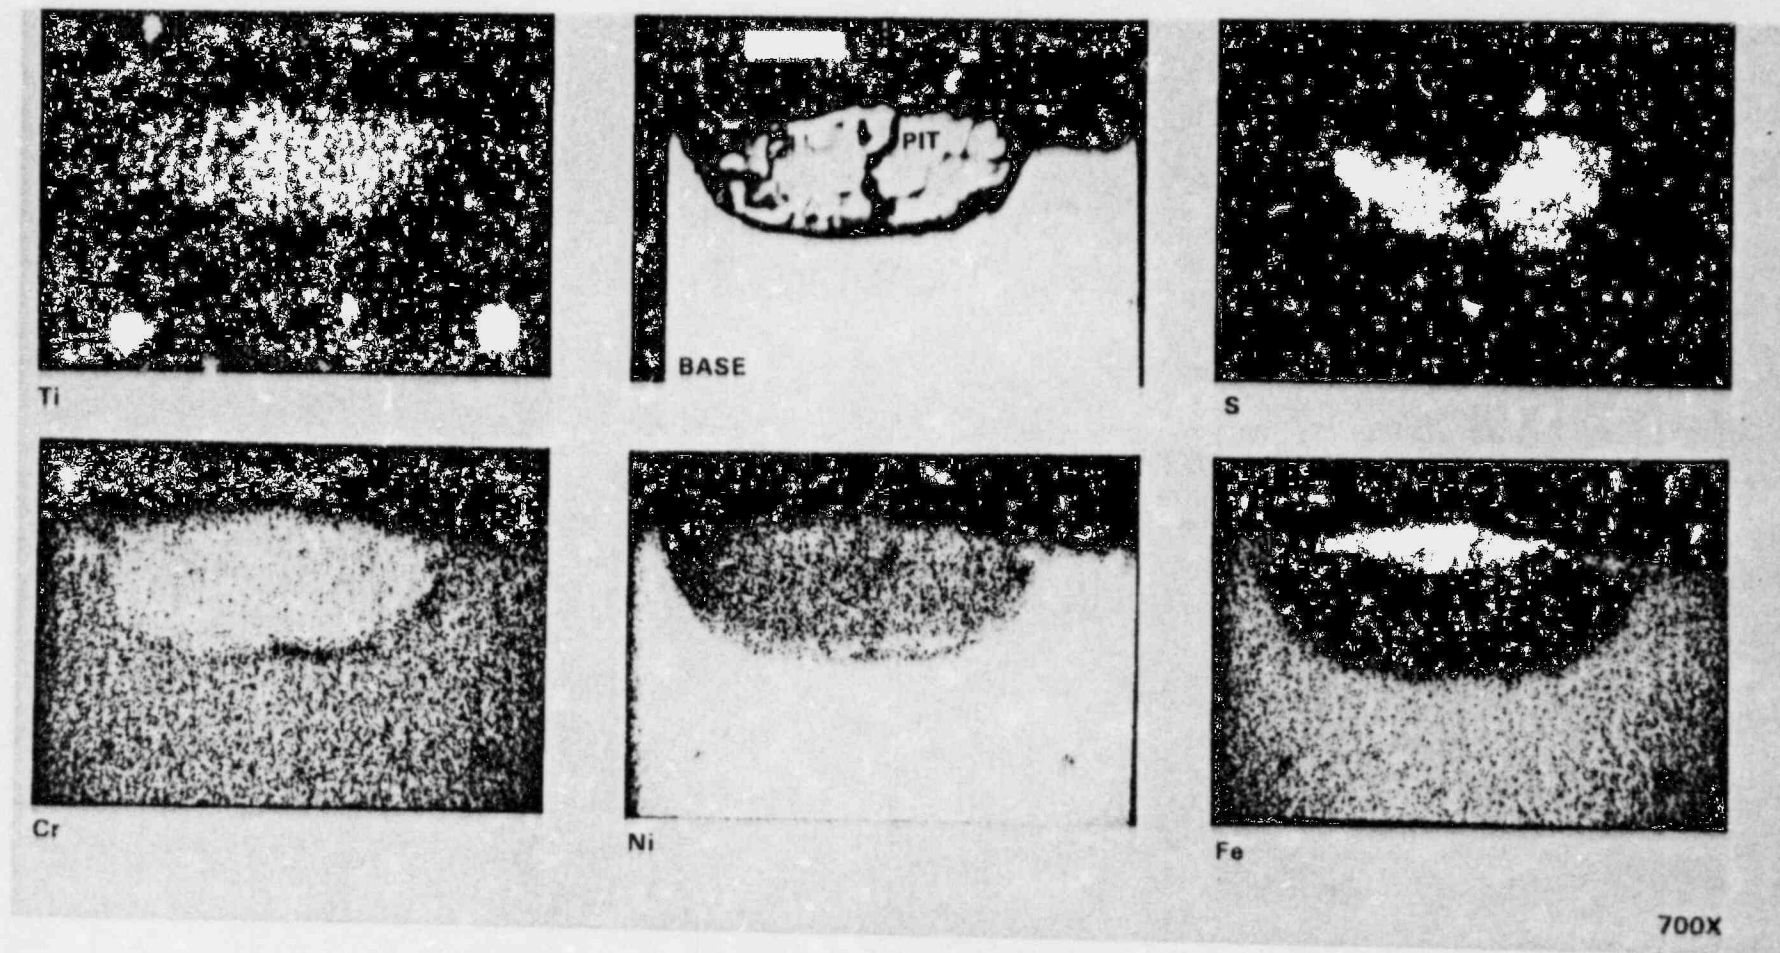
X-ray images of the specimen for elements Ti, S, Cr, Ni and Fe also are shown in Figure 38. The deposit inside the pit appears to be rich in Cr and Ti, but depleted in Ni and Fe with respect to the base metal. Sulfur is clearly present in all of the deposit. X-ray image of Cl was attempted, but no Cl was detected on the specimen.

FIGURE 39. BACK SCATTER ELECTRON IMAGE AND X-RAY IMAGES OF ELEMENTS Ti, S, Cr, Ni AND Fe OF A PIT IN SPECIMEN G FROM TUBE A-146-6

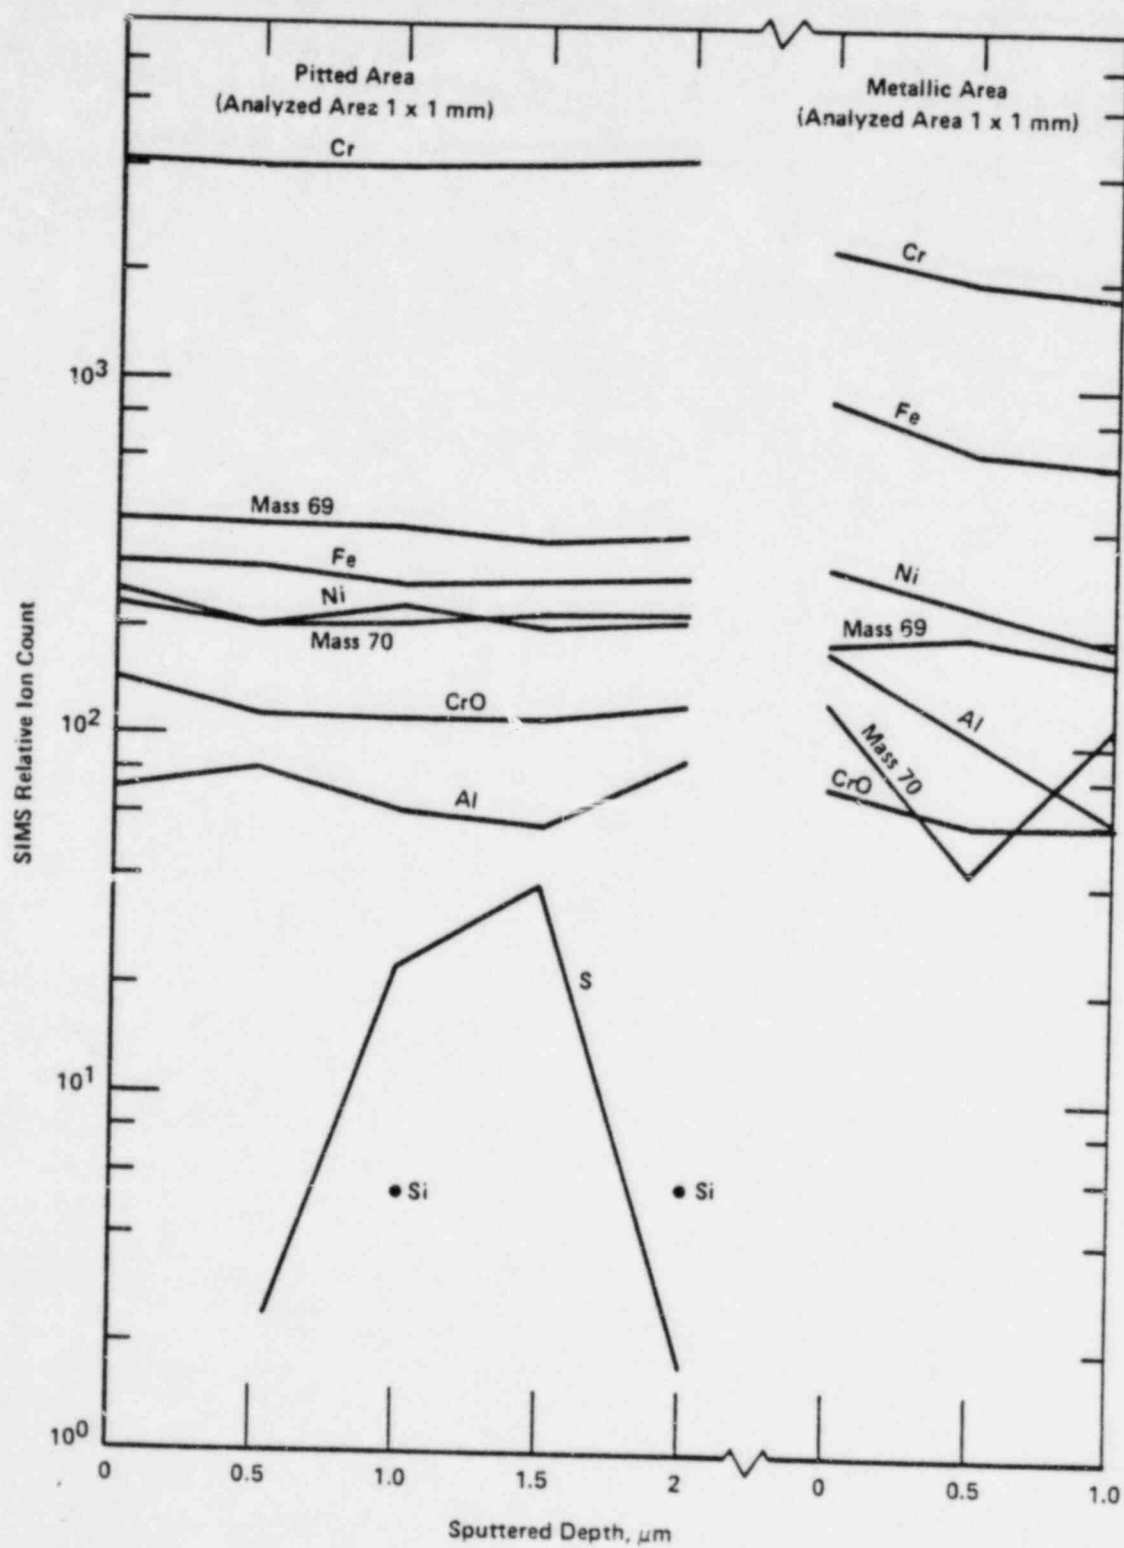
FIGURE 40. RELATIVE ION COUNT IN SIMS VERSUS APPROXIMATE SPUTTERED DEPTH ON THE ID SURFACE OF SPECIMEN F2 FROM TUBE A-146-6

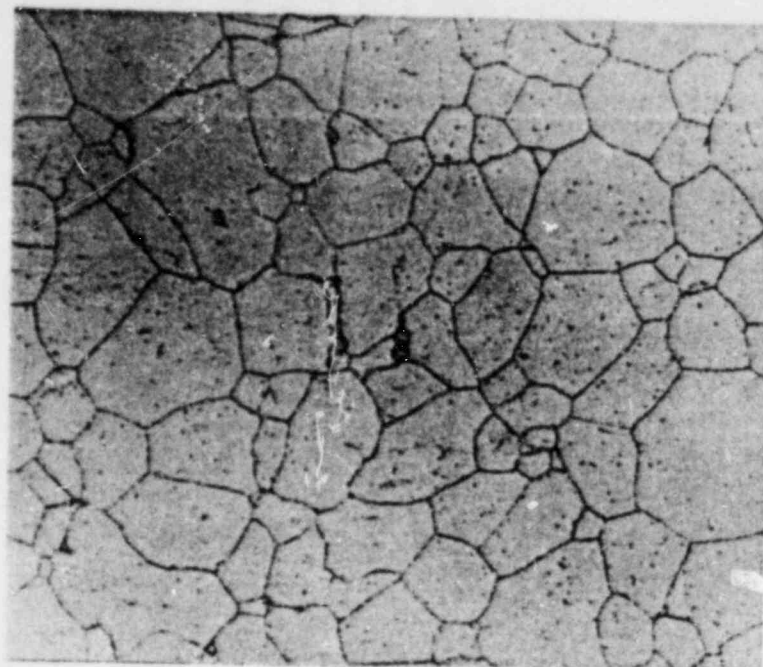
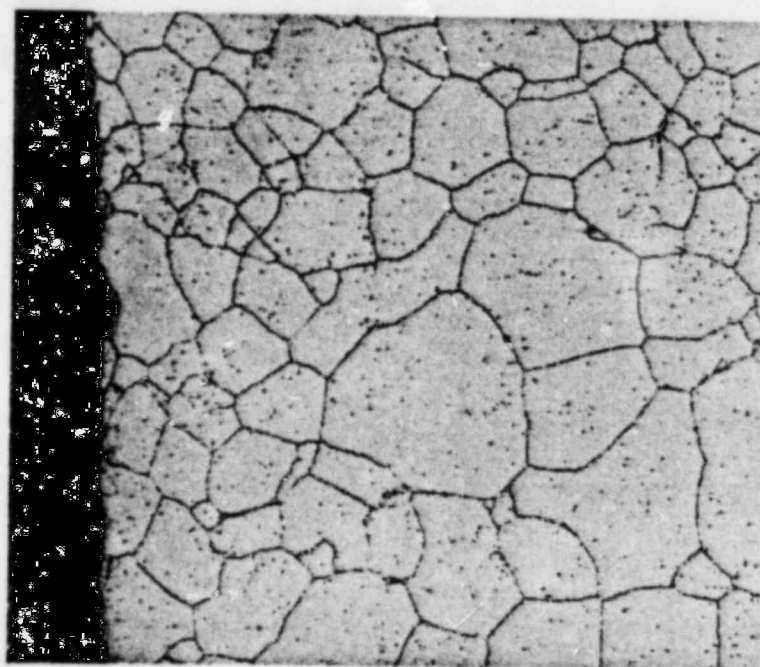
Photomicrographs of the etched specimen from three different regions of the tube, namely, rolled region, roll transition region, and the unrolled region are shown in Figure 42. The grain size in all three regions is the same; similarly, the carbide decoration of grains and grain boundaries. No continuous networks of carbides were observed. The microstructure of this tube is identical to that of tubes A-71-126 (Figure 31) and A-146-6 (Figure 33).

FIGURE 42. PHOTOMICROGRAPHS OF THE MICROSTRUCTURE OF TWO DIFFERENT REGIONS OF SPECIMEN B FROM TUBE A-146-8

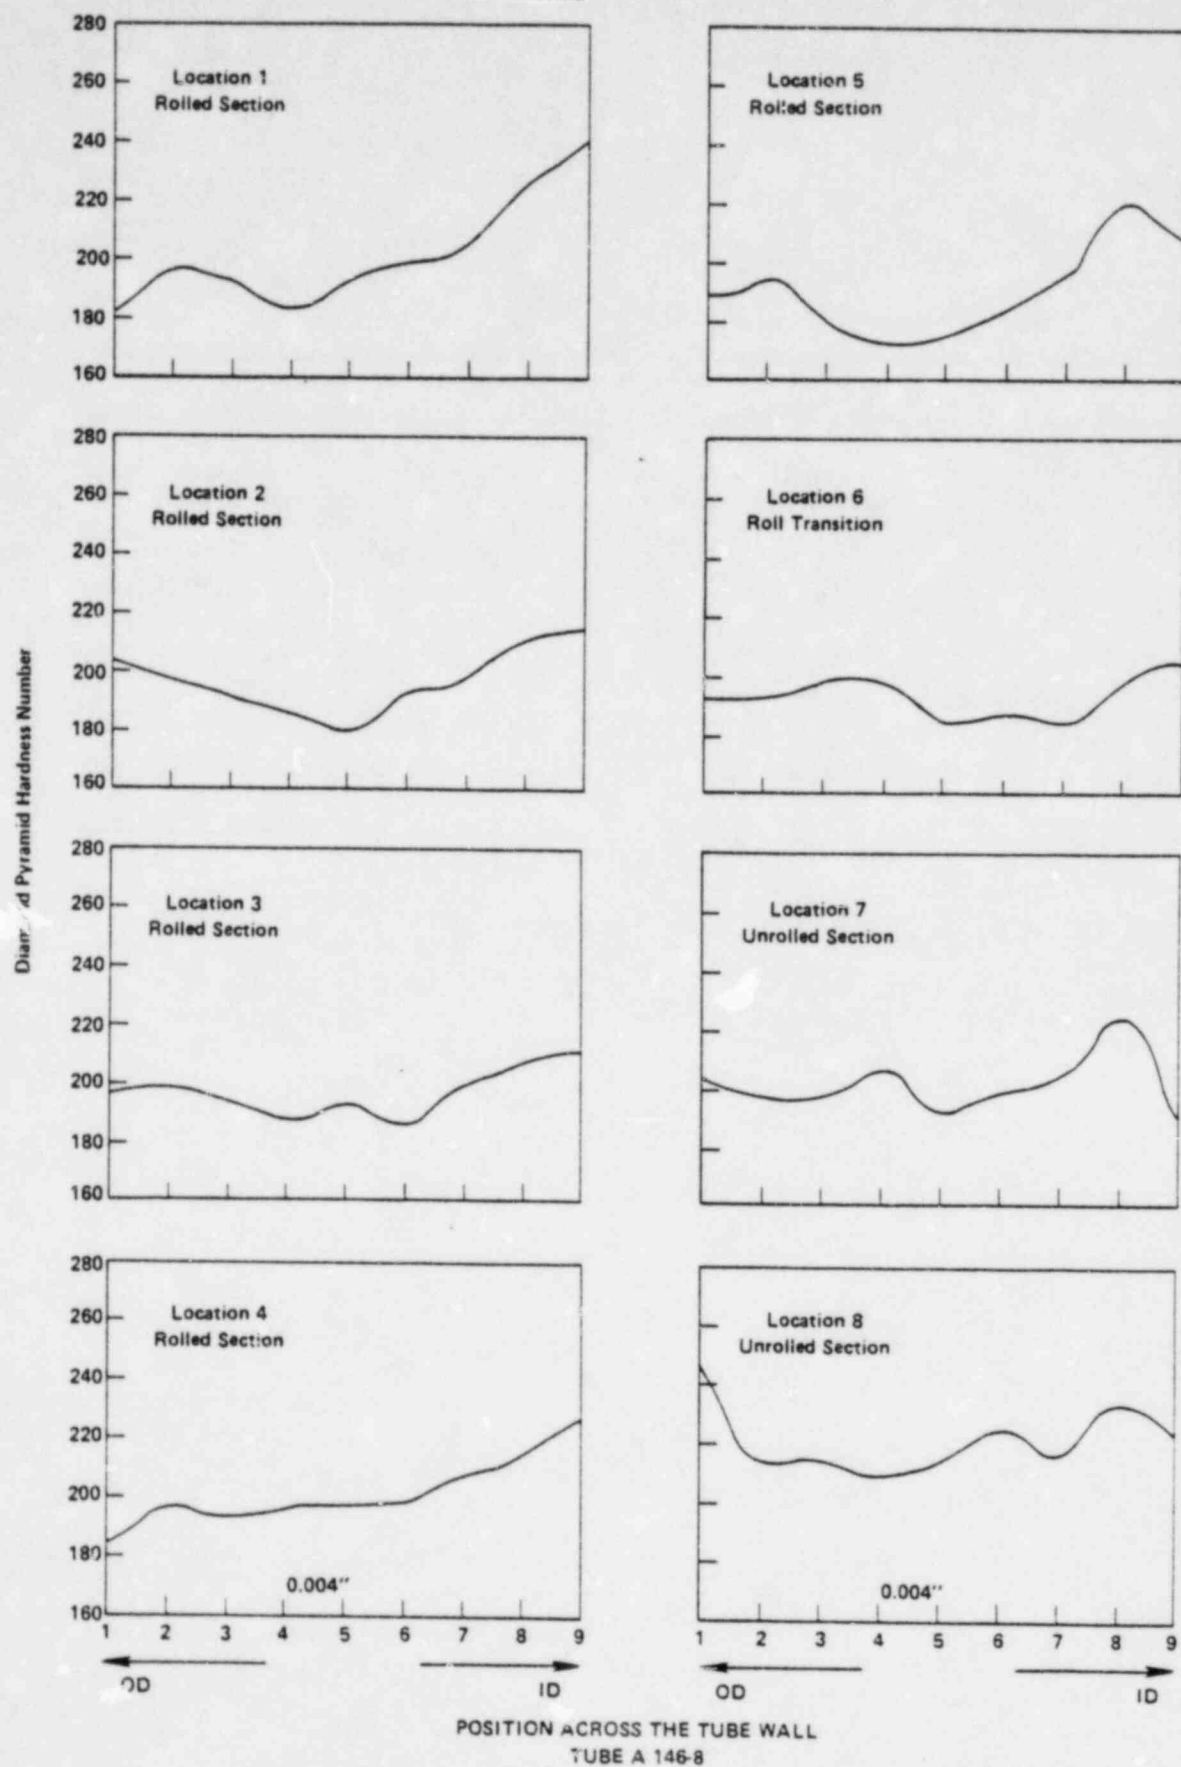
The microhardness measurements on specimen B were done in the same way as on tube A-146-6. Results for tube A-146-8 are shown in Figure 43. The maximum value, DPH 241, was obtained on the ID surface in the rolled region, and the minimum value, DPH 170, in the mid wall section of the roll transition region. These values again suggest that the tube was not excessively cold worked in any region.

FIGURE 43. MICROHARDNESS VALUES AT 8 DIFFERENT SUB-LOCATIONS ON SPECIMEN B FROM TUBE A-146-8 (SEE TEXT)

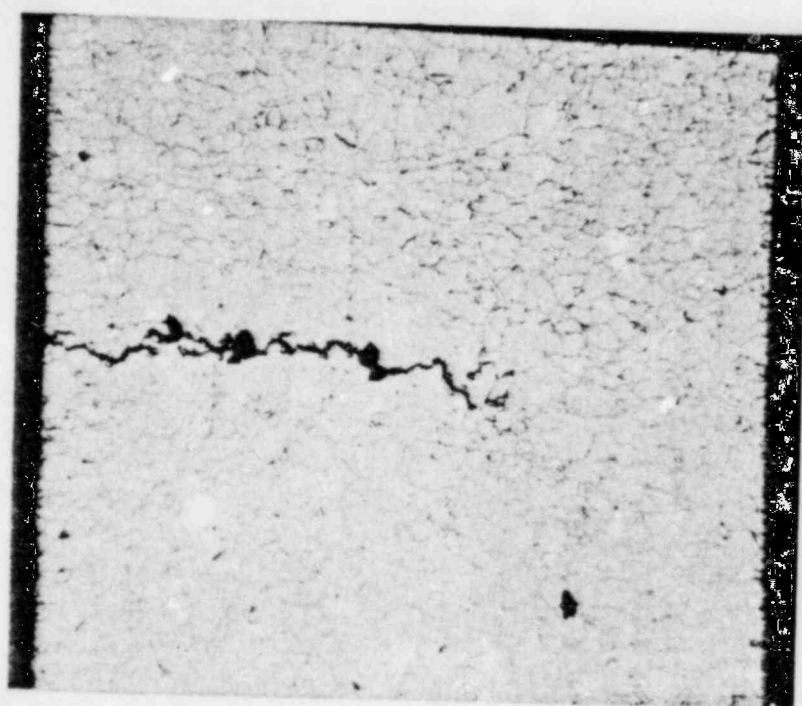
The apparent crack in specimen E2 was mechanically pulled apart, and the fracture surface was examined in the SEM. A SEM photograph of the fractured surface in Figure 46 shows the intergranular nature of the crack. A photomicrograph of the same crack present in metallographic specimen E1 is shown in Figure 47. The crack is intergranular and penetration is ~70 percent through wall. No IGA was noticed on the ID or OD surface of the tube in the vicinity of the crack.

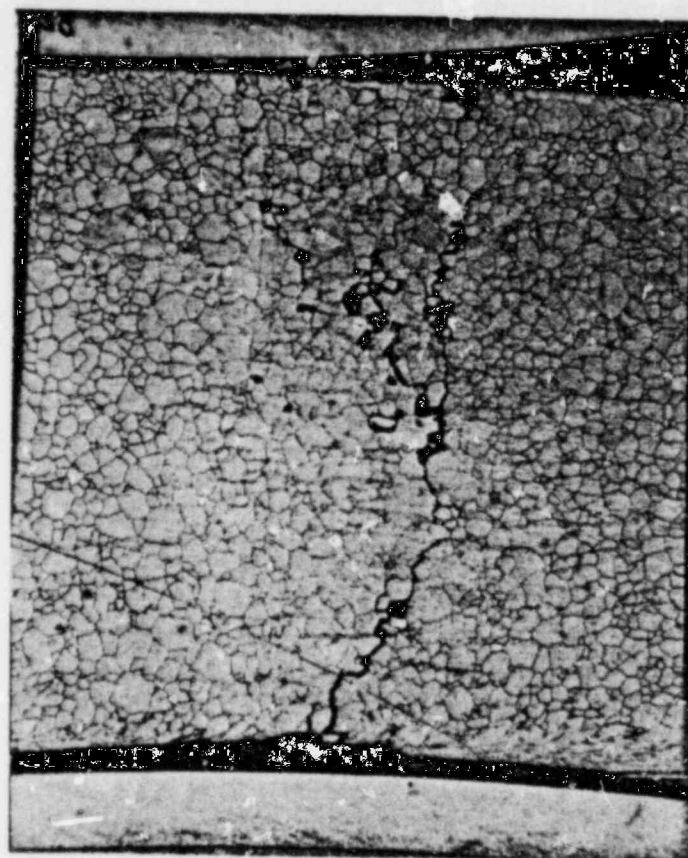
Micrographs of specimens A and C are shown in Figures 51 and 52, respectively. In specimen A, the tube wall separated at the main crack while preparing the metallographic mount, the separated wall is visible in Figure 51. A second crack which appears to be a major branch of the main crack also is nearly through wall. The transverse section in specimen C showed three different unconnected cracks. One such crack only is shown in Figure 52; the other cracks were similar in nature.
