Subject: Broken Swing Check Valve Arm

No. 9102-77-002

Swing Check Valves

... Inspection of internal components recommended ...

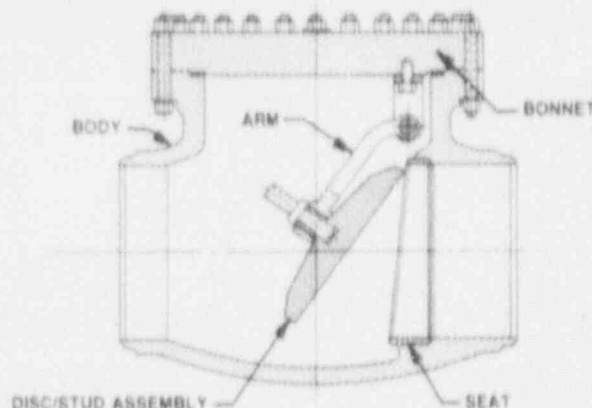
The fracture planes of the failed arm were in the collar region where arm attaches to the disc (see Figure). Corrosion products were found on the fracture faces. Failure analyses, performed by third parties under utility funding, included metallurgical examinations of five similar arms removed from valves in service that had not failed.

Examination showed a poor material condition in the failed arm consisting of casting defects, inadequate heat treatment and minor chemistry deviations. The significant casting defects were the presence of microcracks and shrinkage cavities formed during solidification of the casting and its subsequent cooling. These microcracks were not detectable using normal LP, MP and RT techniques. No microcracks were present in the other arms inspected.

It is hypothesized that the failure initiated at the surface connected casting defects which provided preferential sites for crevice corrosion. The simultaneous presence of corrosion sites and a microstructure susceptible to hydrogen assisted cracking enabled stress corrosion cracking to occur when the material was exposed to the relatively high chloride content service water. The cracks propagated along the dendrite grain boundaries which were not broken up by a sufficient heat treatment until failure occurred.

Based on the metallurgical tests and analyses, the dominant cause is considered to be the casting quality. Poor material properties were also contributory in the corrosive service water environment. Casting quality and material chemistry of the other swing arms examined were good. The failure of the swing arm is thus considered to be an isolated event.

A single occurrence of a swing arm failure has been experienced in a 4-inch 150 lb valve installed in a service water system. The failure occurred during hot functional testing and consisted of radial fractures, in two places, of the collar holding the disc/stud assembly to the valve arm.

Examination of the failed arm and five other swing arms removed from service indicate this failure to be an isolated event resulting from a synergistic combination of surface defects and corrosive service environment. Over one thousand similar valves have been supplied to the nuclear power industry. A review of INPO NPRDS data identified over 500 of these valves in service with no failures of the swing arm reported.

Although this failure is considered to be an isolated occurrence, BW/IP International, Inc., considers it prudent to inspect all swing arm check valves at the next opportunity. Valves installed in systems with a high chloride content should receive special attention.

- Perform visual inspection of valve internal components.
- Perform PT/MT examinations if indicated by visual inspection.
- Replace any defective components.
