ANNUAL REPORT

VIRGINIA POLYTECHNIC INSTITUTE
and STATE UNIVERSITY
RESEARCH REACTOR

January 1, 1982 to December 31, 1982

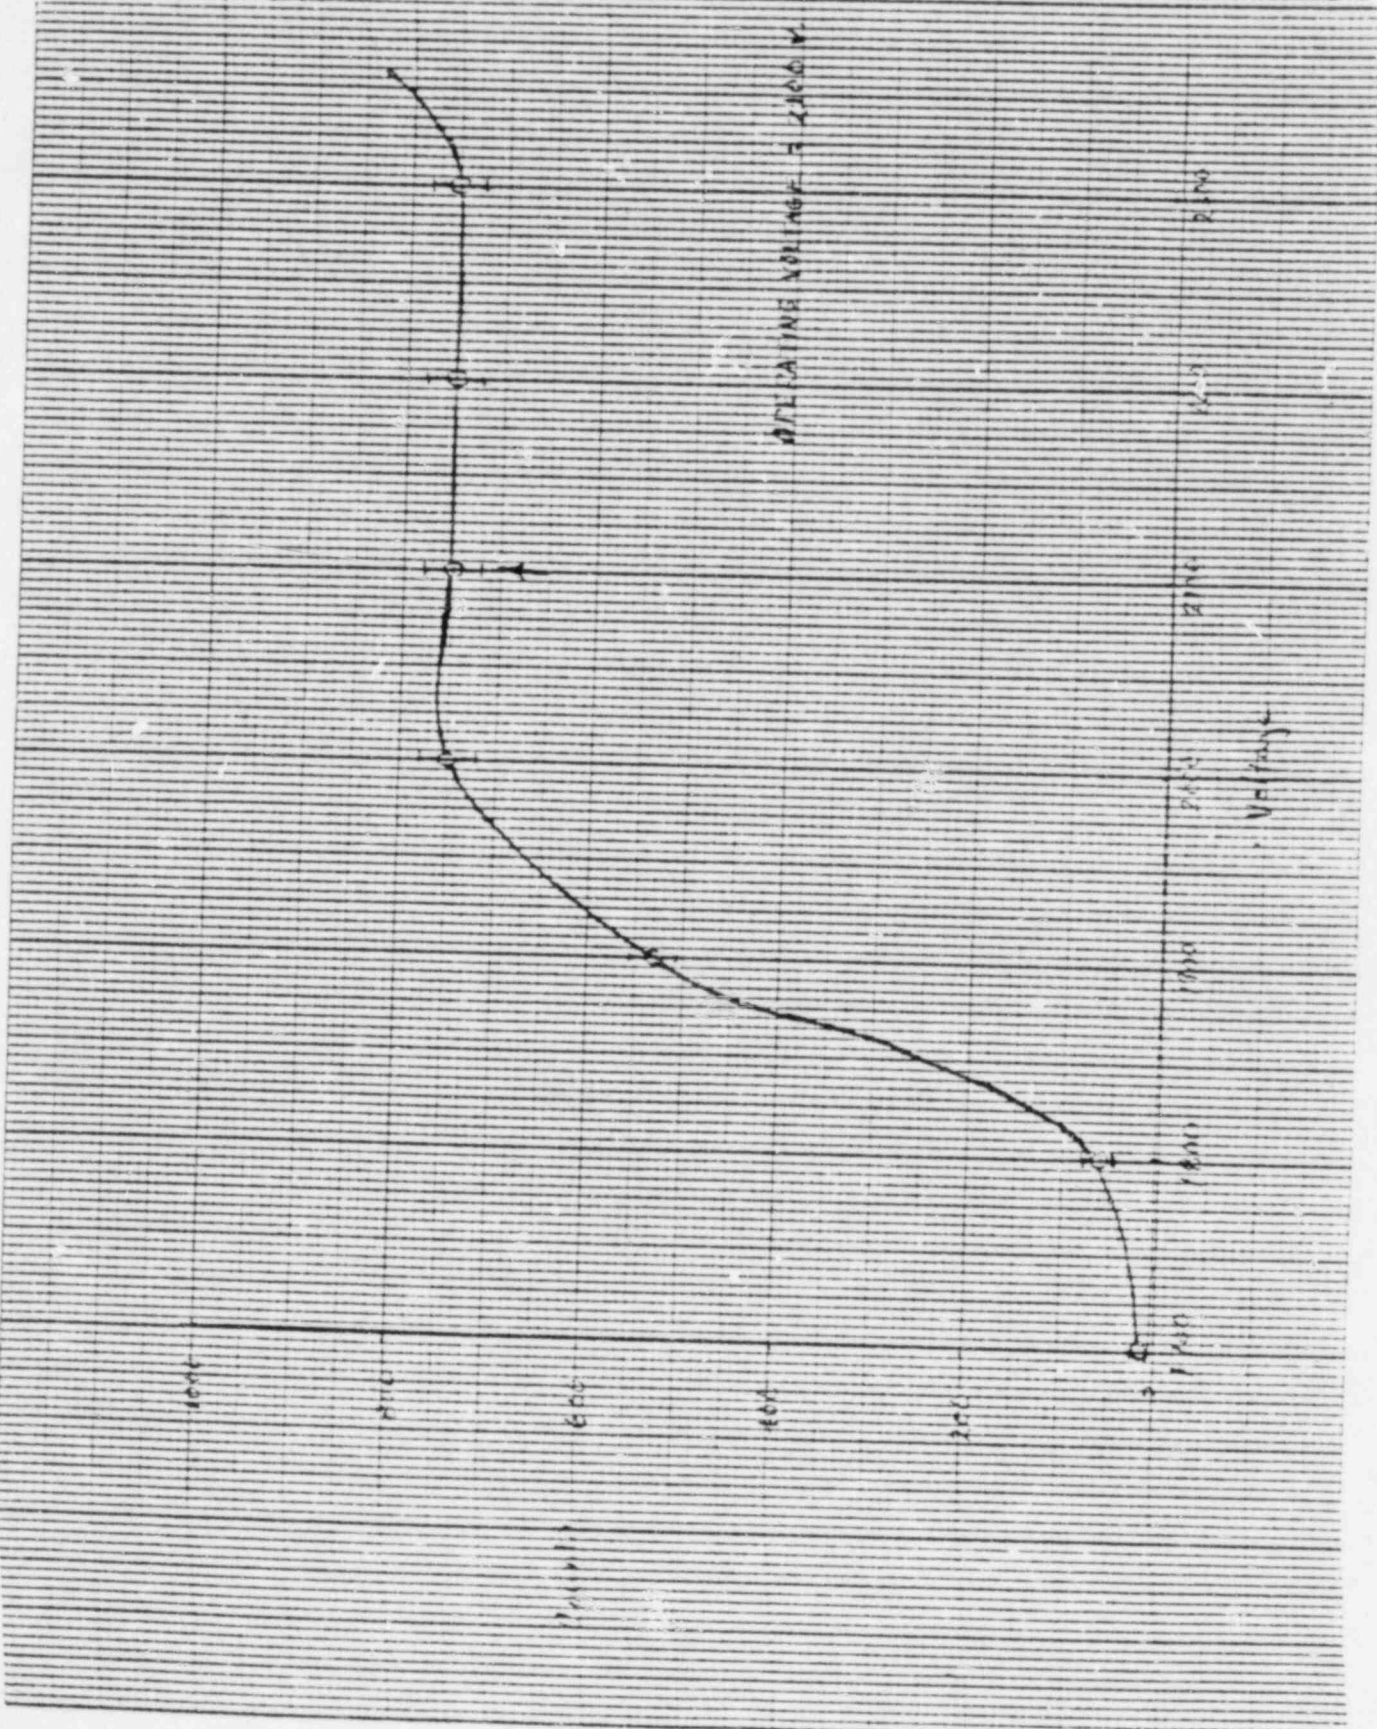
The following is a description of the equipment used for gathering the transmission data. See figure 1 for a layout diagram and figure 2 for the BF_3 calibration curve.
