**Department of Energy**

Subject: *2019 Annual Site Inspection and Monitoring Report for Uranium Mill Tailings  
Radiation Control Act Title I Disposal Sites*

Enclosed are seven copies of the *2019 Annual Inspection and Monitoring Report for Uranium Mill Tailings Radiation Control Act Title I Disposal Sites*. The report covers the annual inspections of the 19 Title I disposal sites managed by the U.S. Department of Energy Office of Legacy Management.

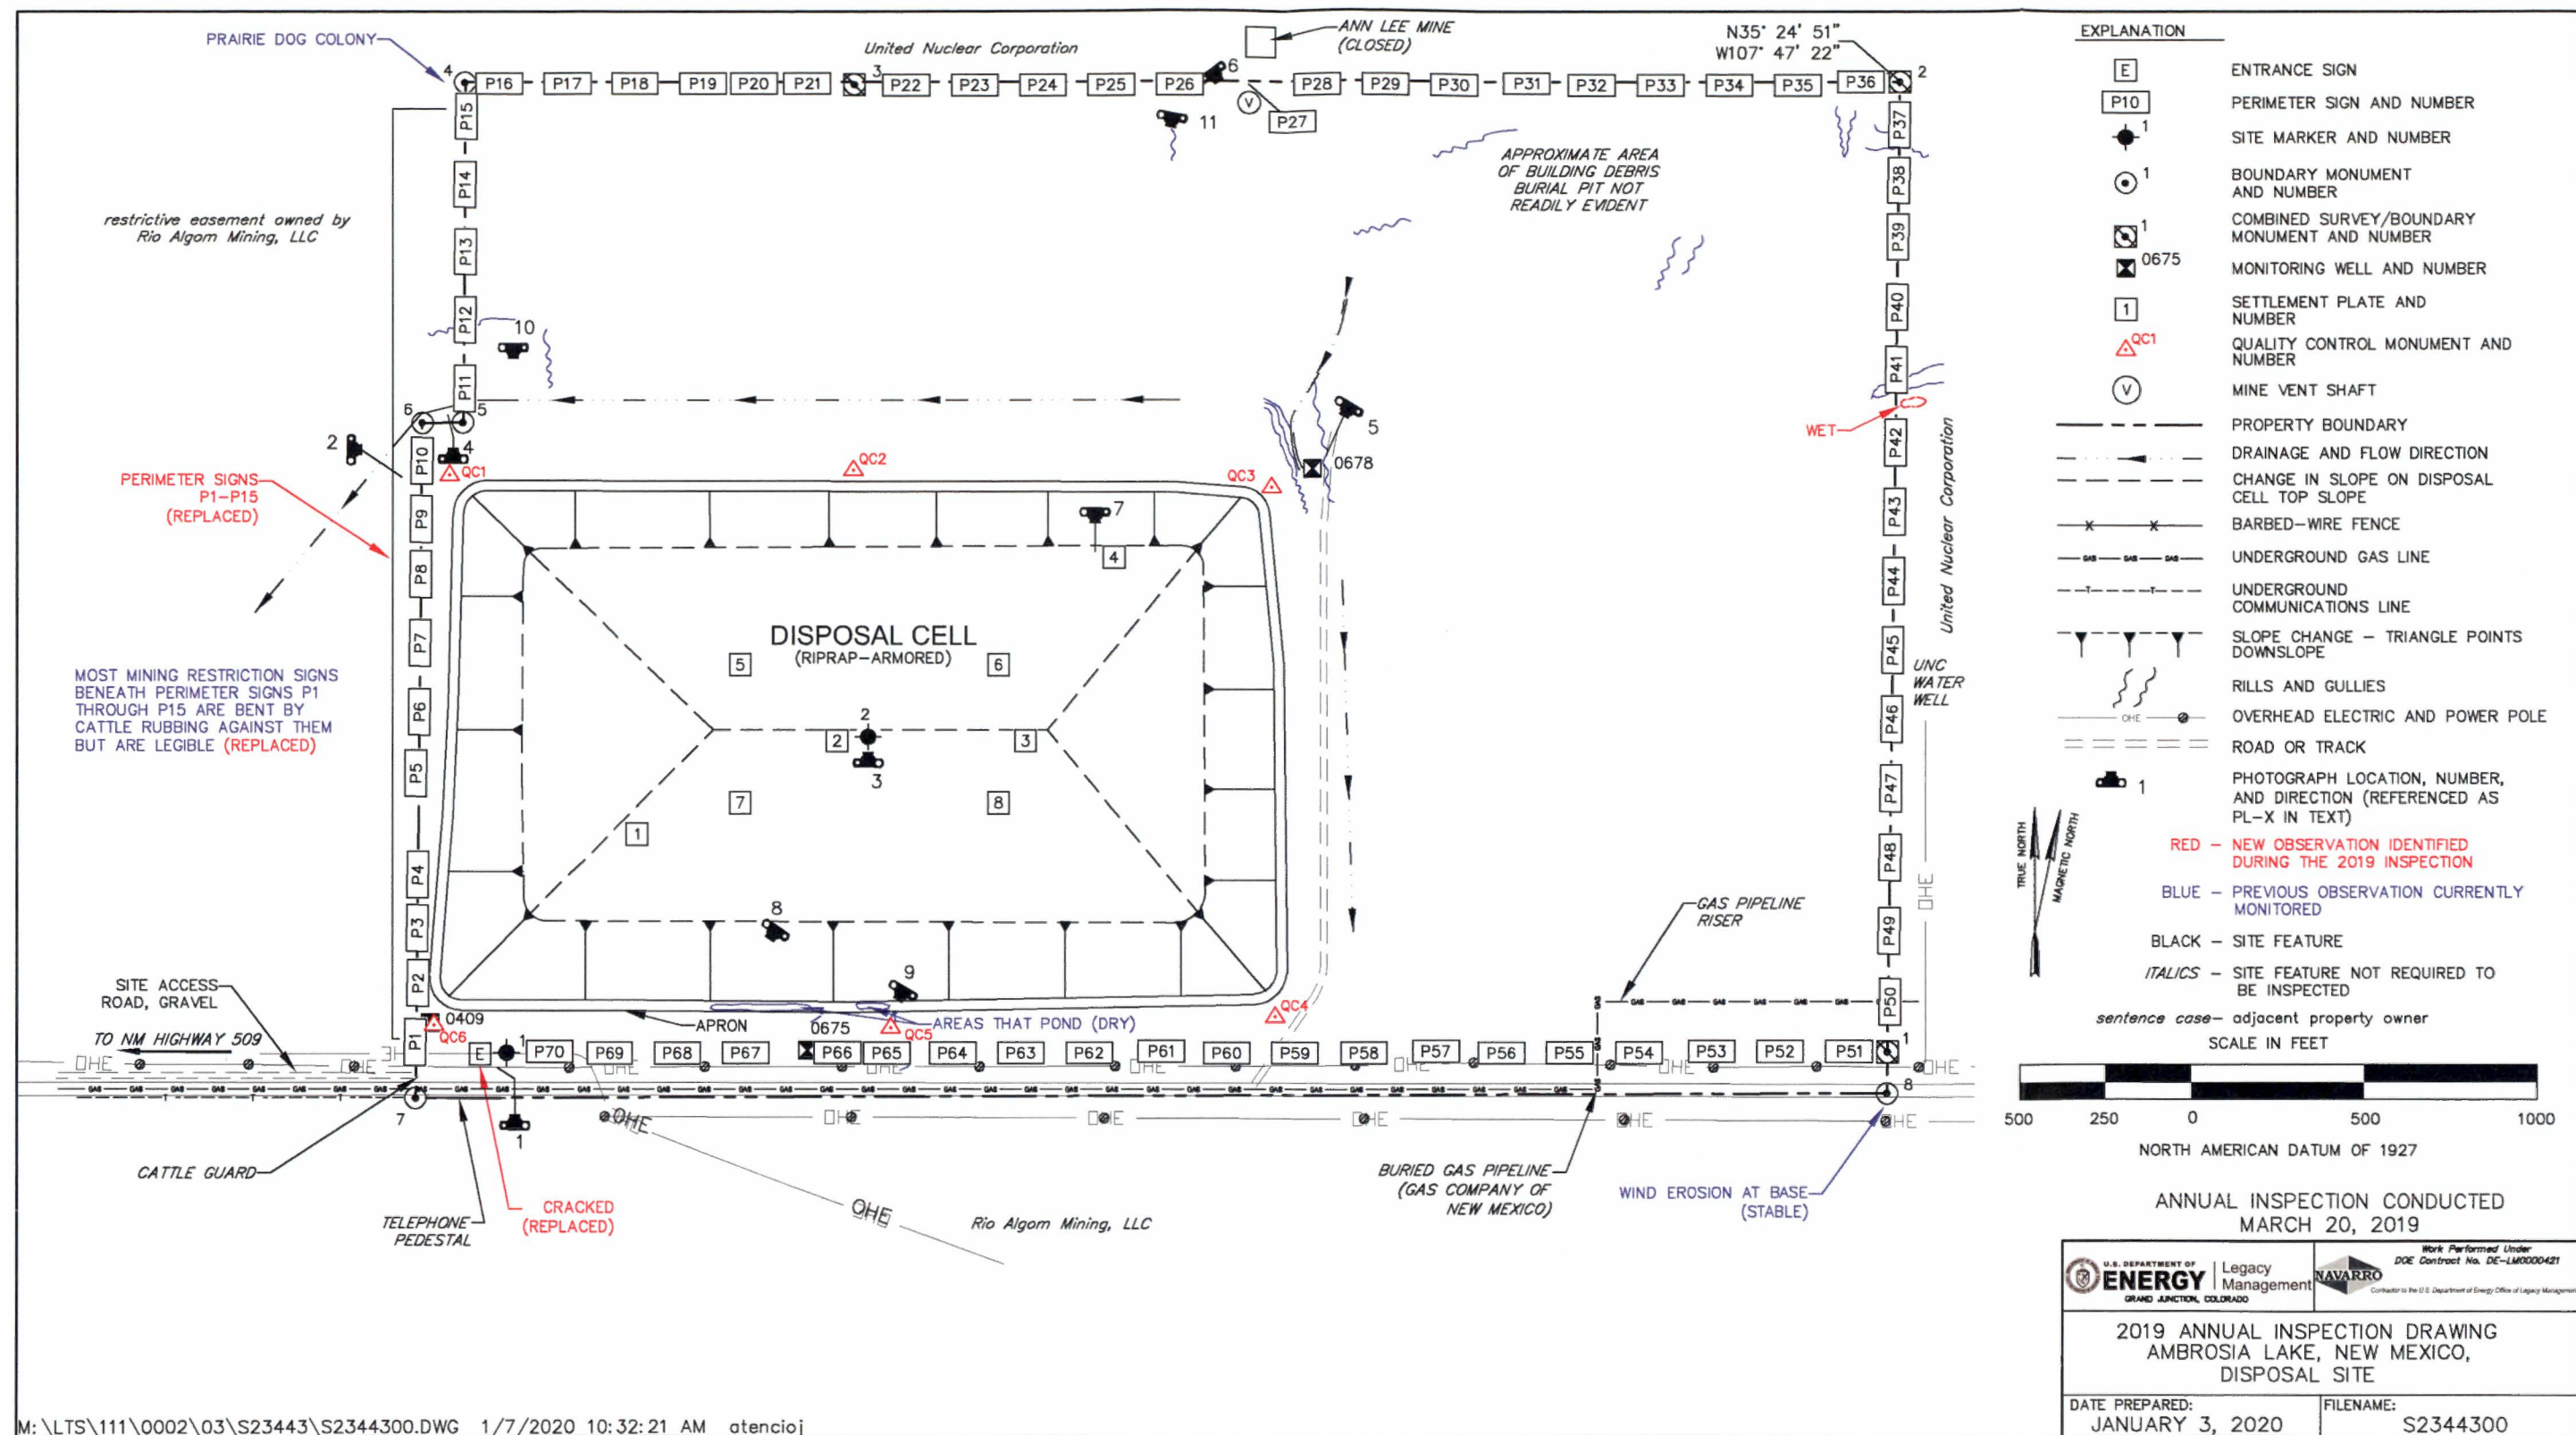
Figure 1-1. 2019 Annual Inspection Drawing for the Ambrosia Lake, New Mexico, Disposal Site

Figure 1-1 shows the locations of site features, including site surveillance features and inspection areas, in black. Site features that are present but not required to be inspected are shown in italic font. Observations from previous inspections that are currently monitored are shown in blue text, and new observations identified during the 2019 annual inspection are shown in red. Inspection results and recommended maintenance activities associated with site surveillance features are included in the following subsections. Photographs to support specific observations are identified in the text and in Figure 1-1 by photograph location (PL) numbers. The photographs and photograph log are presented in Section 1.10.

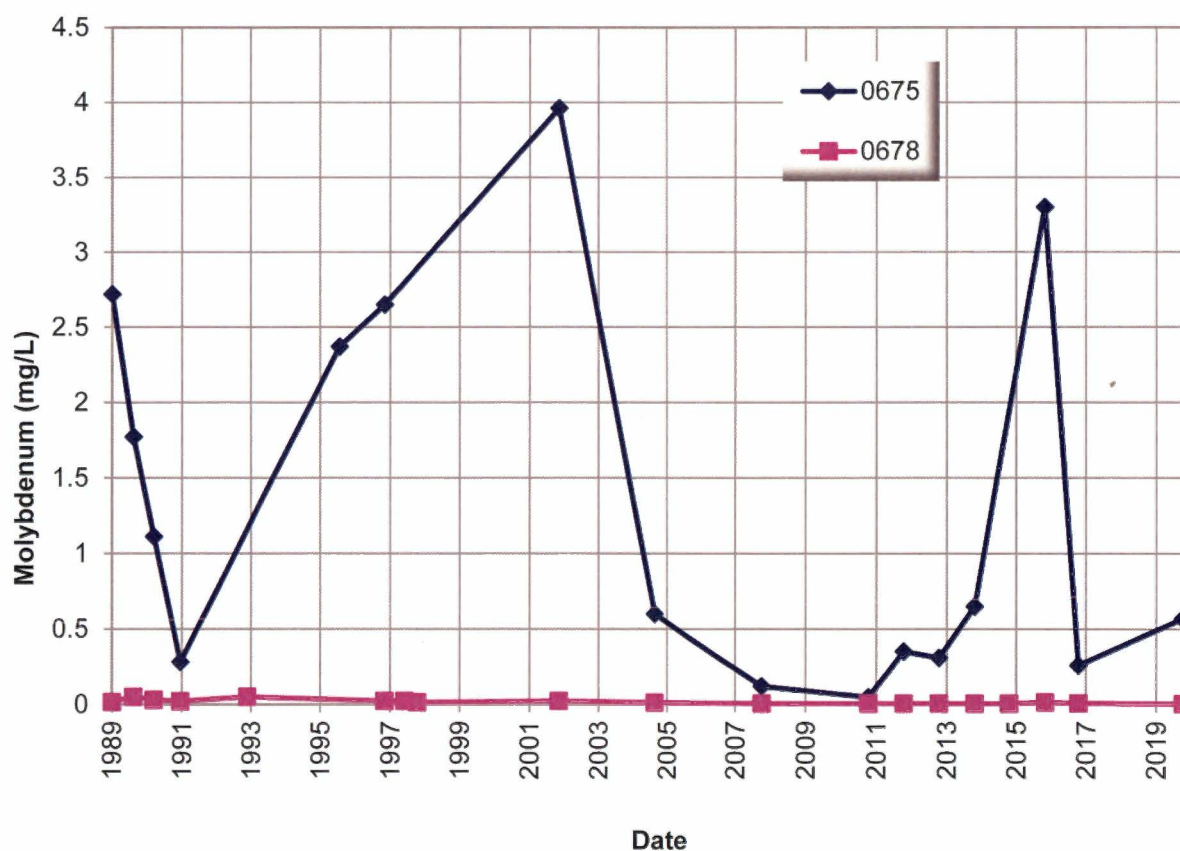
Figure 1-3. Molybdenum in Groundwater at the Ambrosia Lake, New Mexico, Disposal Site

Figure 1-3 through Figure 1-7 depict time concentration plots for molybdenum, nitrate, selenium, sulfate, and uranium in wells 0675 and 0678. Molybdenum levels in well 0675 had relative highs of 3.96 milligrams per liter (mg/L) in 2001 and 3.3 mg/L in 2015. Molybdenum has since decreased from 3.3 mg/L to 0.6 mg/L in 2019. By comparison, molybdenum levels have been consistently low in well 0678 since 1989.

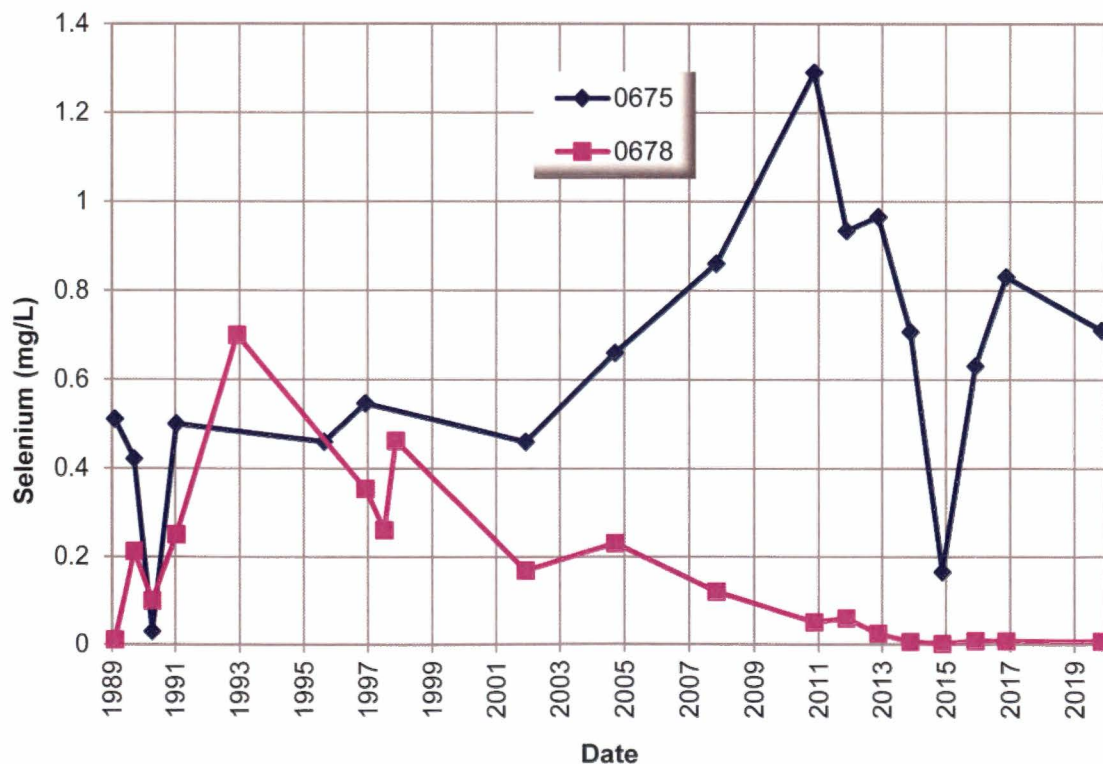
Figure 1-5. Selenium in Groundwater at the Ambrosia Lake, New Mexico, Disposal Site

Selenium in well 0678 decreased from 0.7 mg/L in 1992 to background levels in 2019. Selenium concentration in well 0675 was 0.7 mg/L in 2019 and has fluctuated between 1.3 mg/L and 0.17 mg/L since 1991. No apparent historical trend in selenium concentration is present in well 0675.

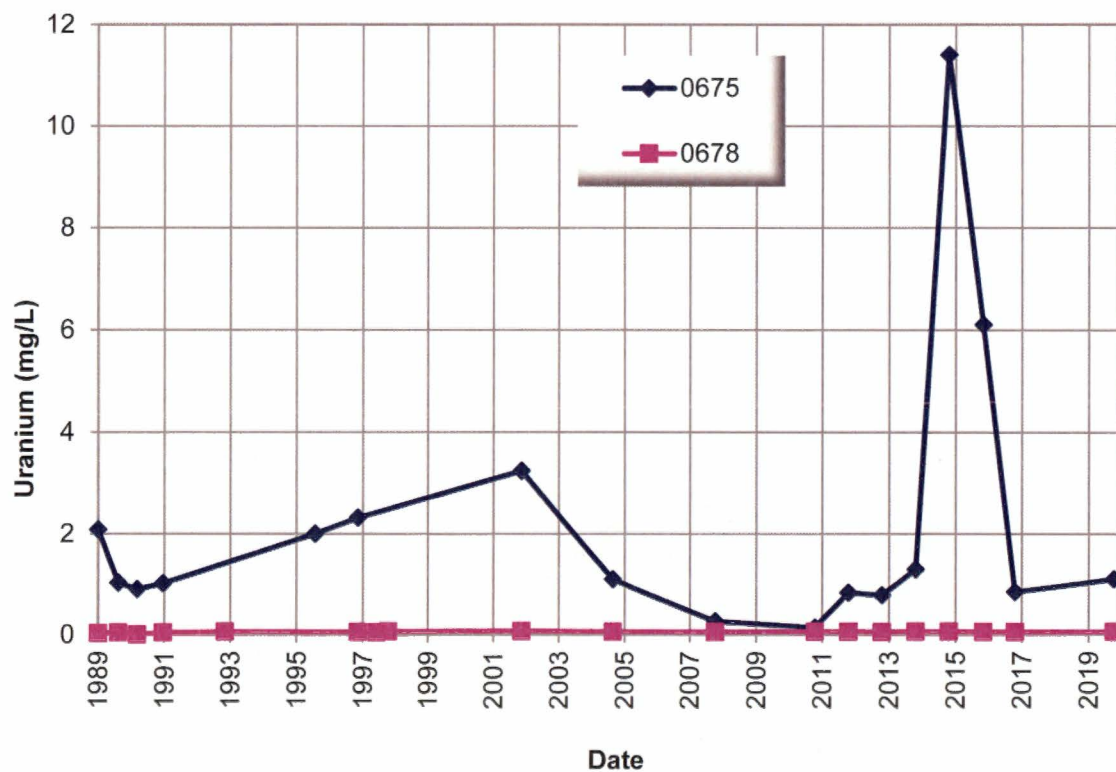
Figure 1-7. Uranium in Groundwater at the Ambrosia Lake, New Mexico, Disposal Site

In 2019, uranium in well 0678 was 0.052 mg/L, which was consistent with historical levels. Well 0675 had an anomalously high uranium concentration of 11.4 mg/L in 2014; uranium levels have since decreased to 1.1 mg/L in 2019.

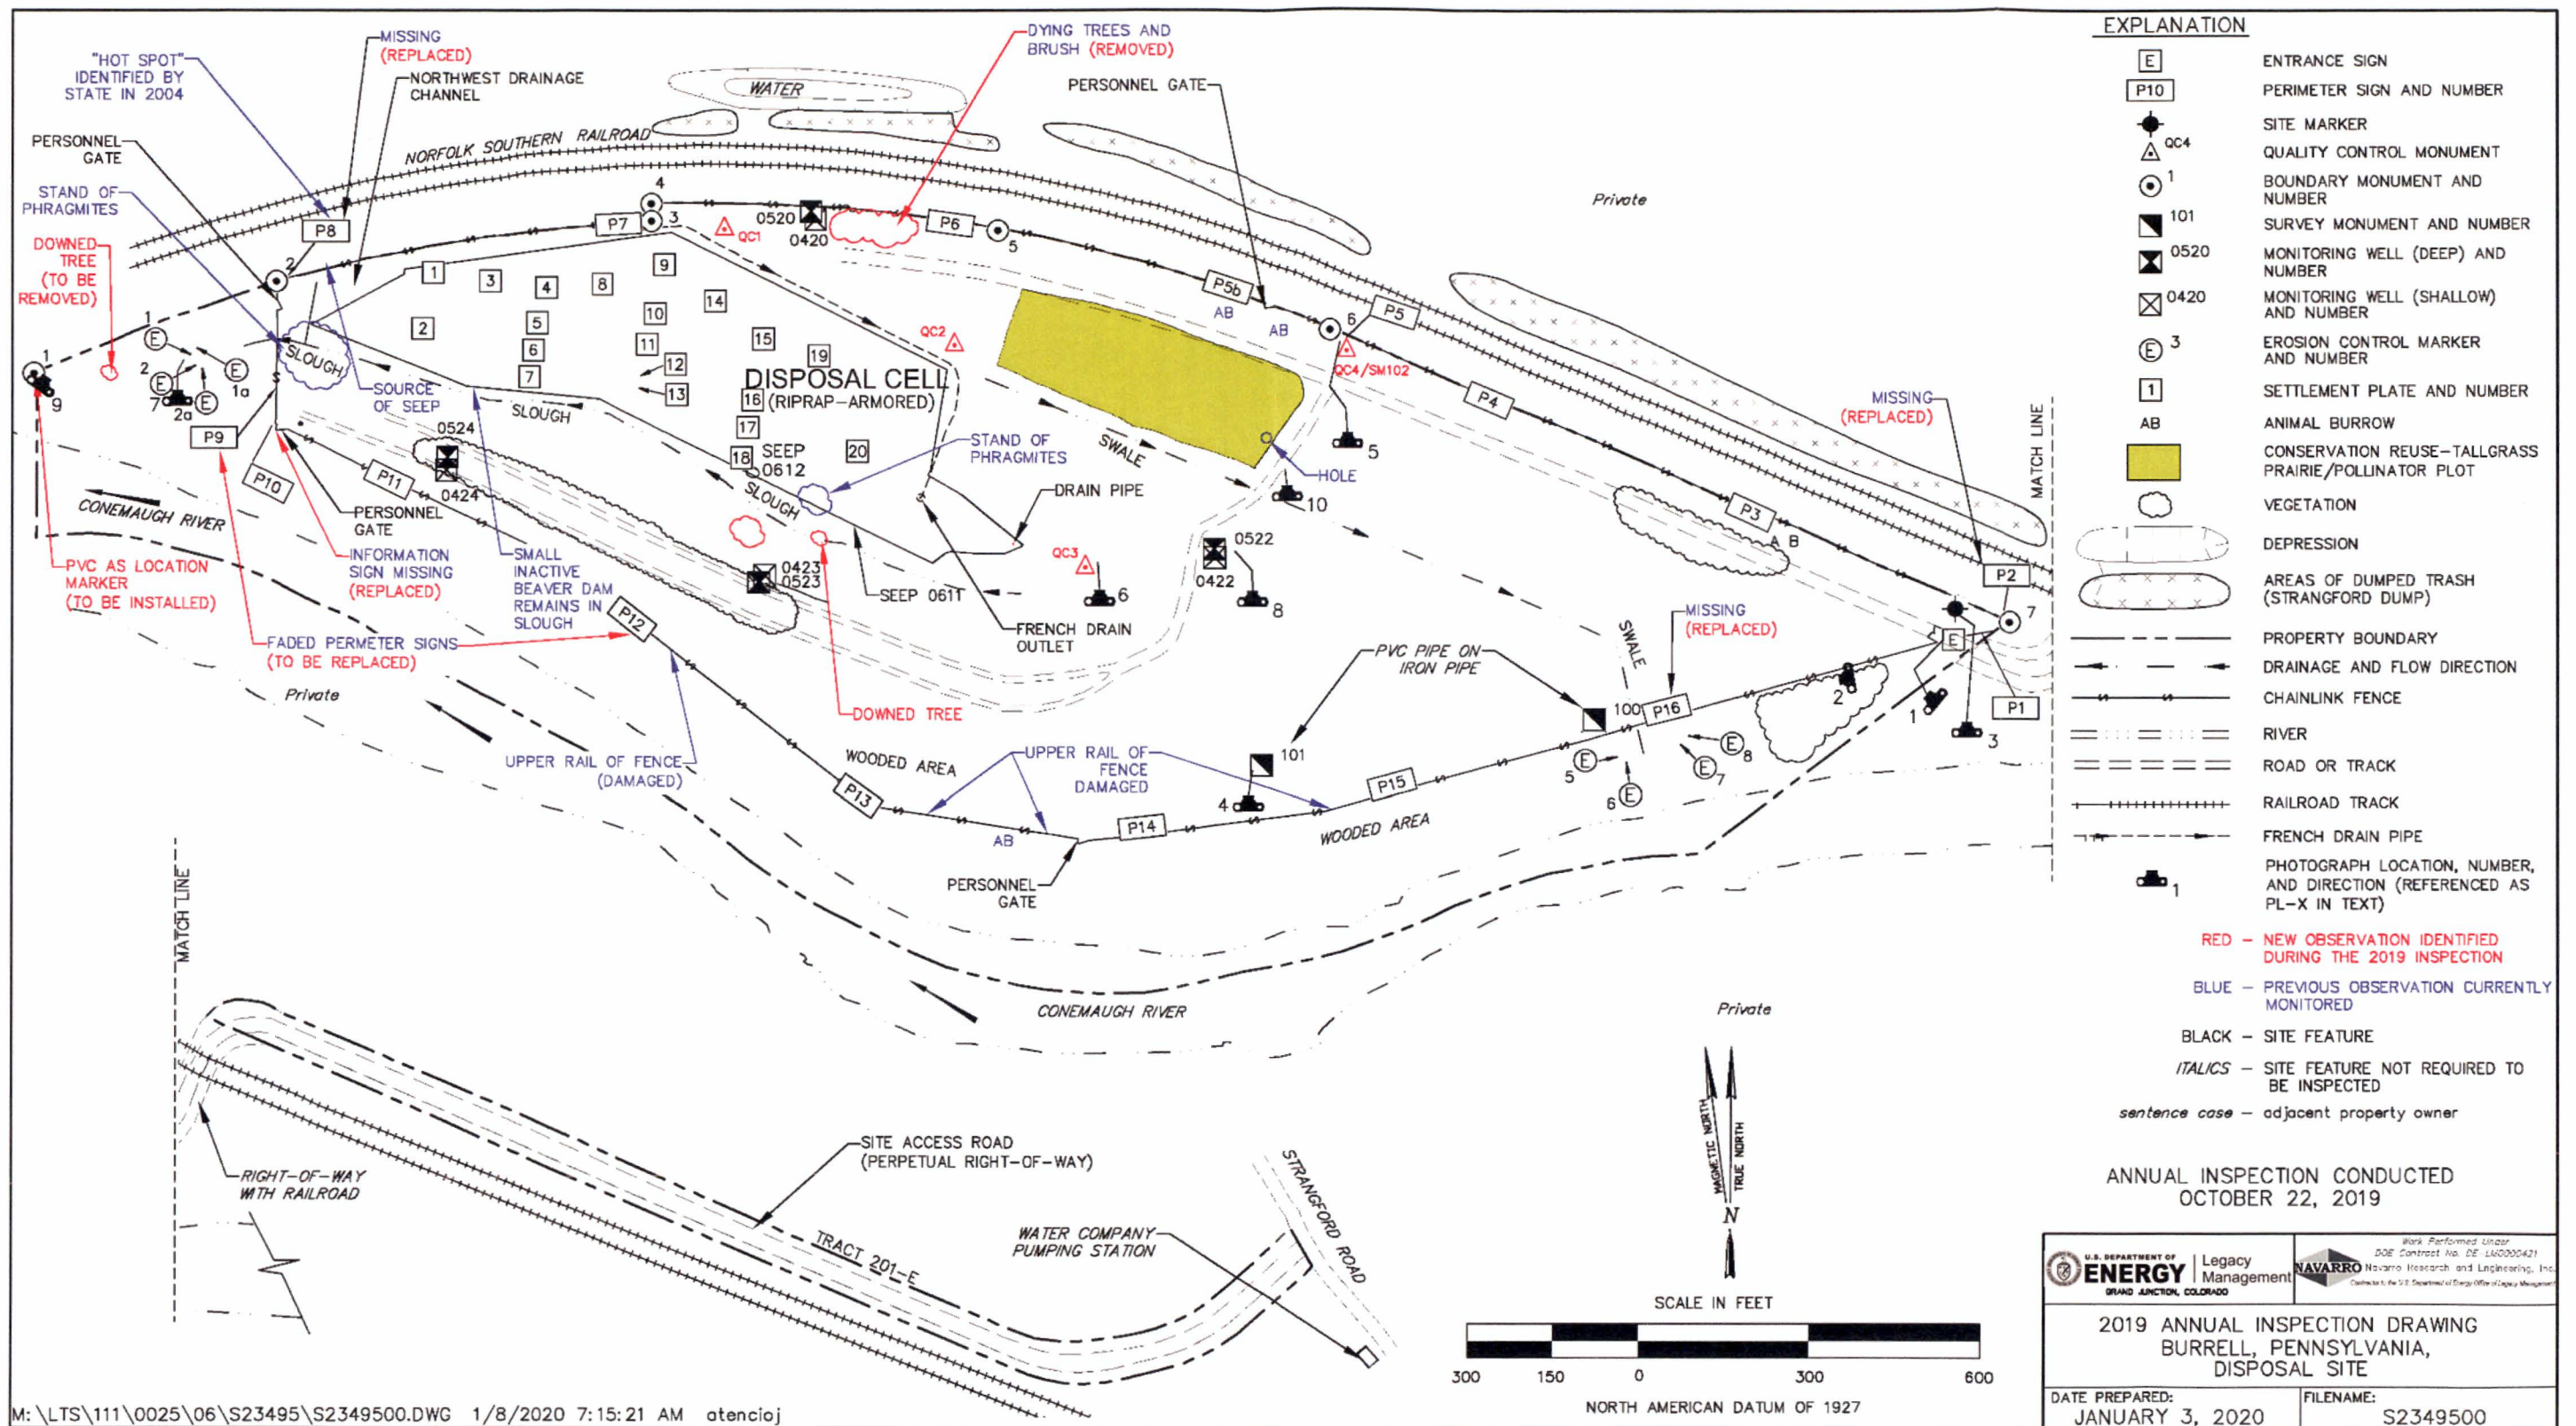
Figure 2-1. 2019 Annual Inspection Drawing for the Burrell, Pennsylvania, Disposal Site

Figure 2-1 shows the locations of site features in black, including site surveillance features and inspection areas. Site features that are present but not required to be inspected are shown in italic font. Observations from previous inspections that are currently monitored are shown in blue text, and new observations identified during the 2019 annual inspection are shown in red. Inspection results and recommended maintenance activities associated with site surveillance features are included in the following subsections. Photographs to support specific observations are identified in the text and in Figure 2-1 by photograph location (PL) numbers. The photographs and photograph log are presented in Section 2.10.

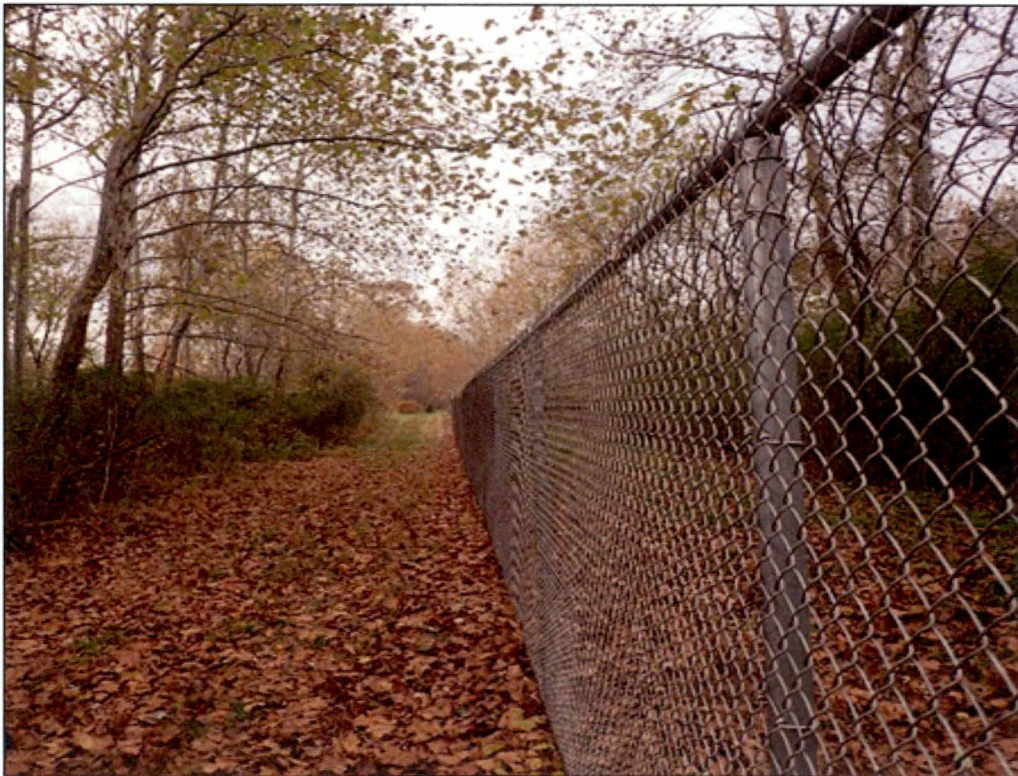
A chainlink security fence encloses the disposal cell and drainage features. The site herbicide subcontractor keeps the fence line clear of vegetation, which should prolong the life of the security fence (PL-2). Tree limbs growing toward, or hanging over, the security fence tagged during the 2018 inspection were removed in 2019 before the inspection. An information sign that was posted on the personnel gate at the west end of the site was identified as missing during the 2018 inspection and was replaced in 2019 before the inspection.

*PL-2. Southeast Fence Line*

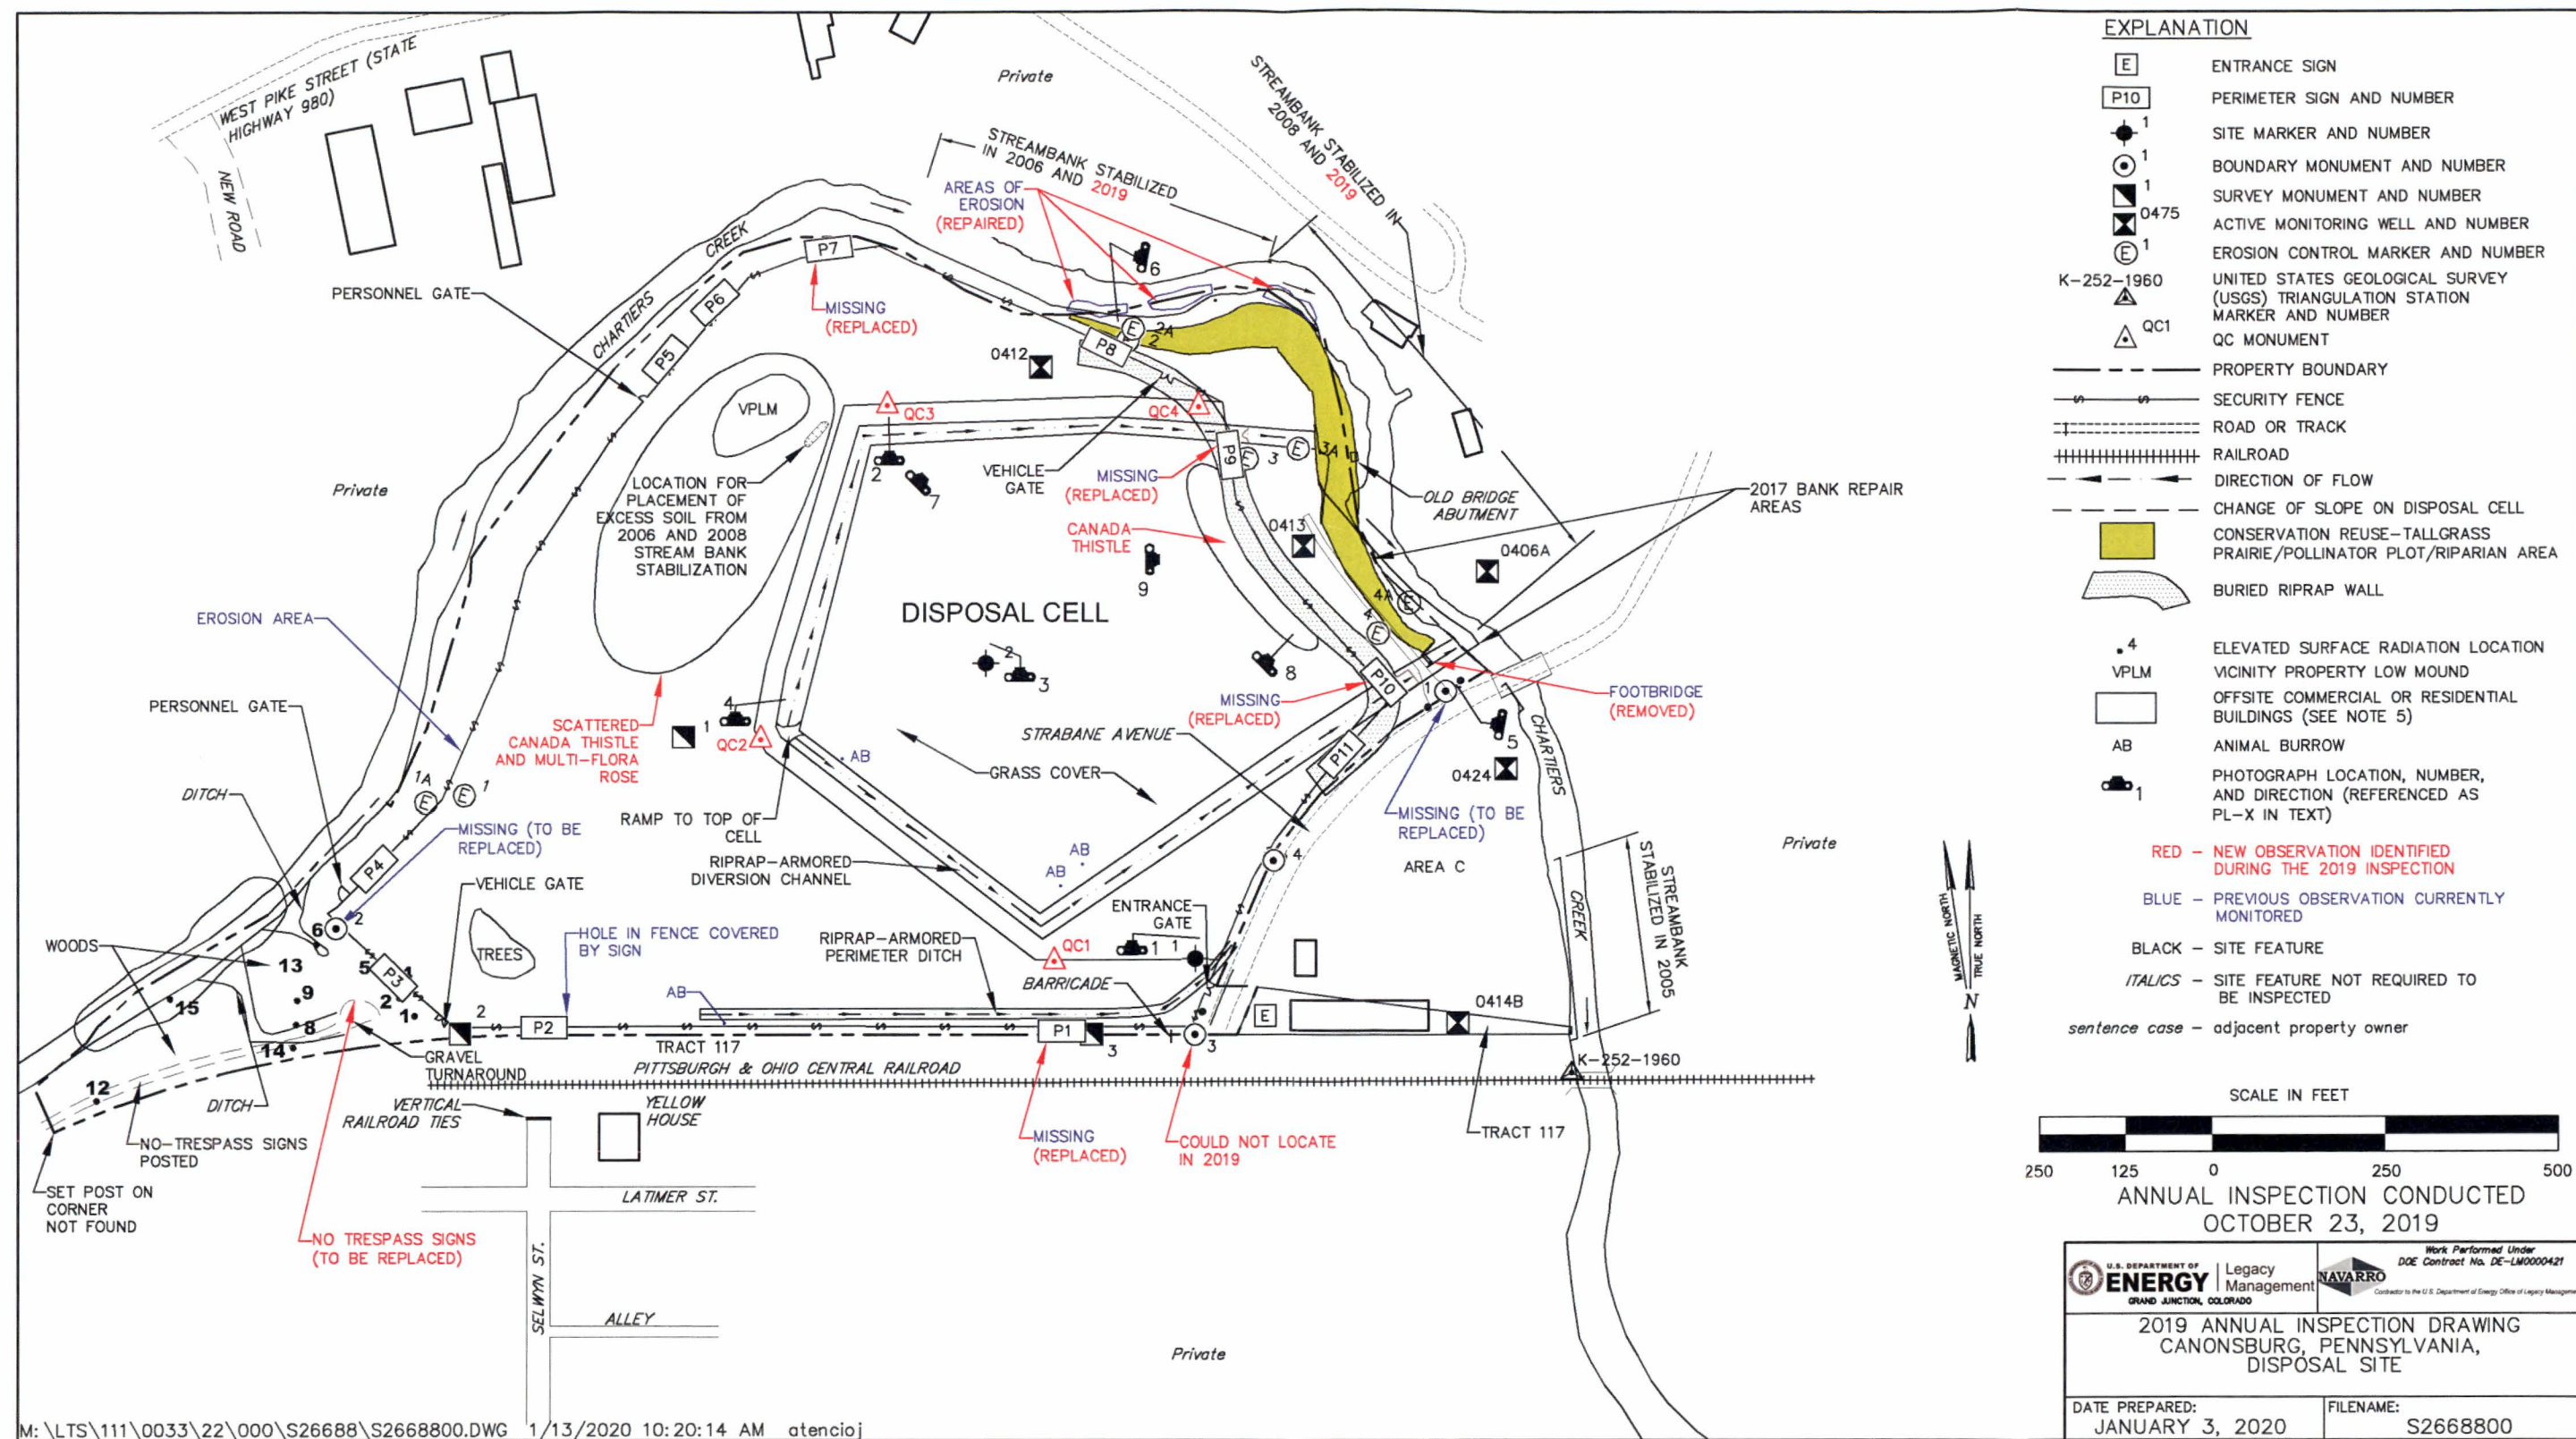
Figure 3-1. 2019 Annual Inspection Drawing for the Canonsburg, Pennsylvania, Disposal Site

Figure 3-1 shows the locations of site features in black, including site surveillance features and inspection areas. Site features that are present but not required to be inspected are shown in italic font. Observations from previous inspections that are currently monitored are shown in blue text, and new observations identified during the 2019 annual inspection are shown in red. Inspection results and recommended maintenance activities associated with site surveillance features are included in the following subsections. Photographs to support specific observations are identified in the text and in Figure 3-1 by photograph location (PL) numbers. The photographs and photograph log are presented in Section 3.10.

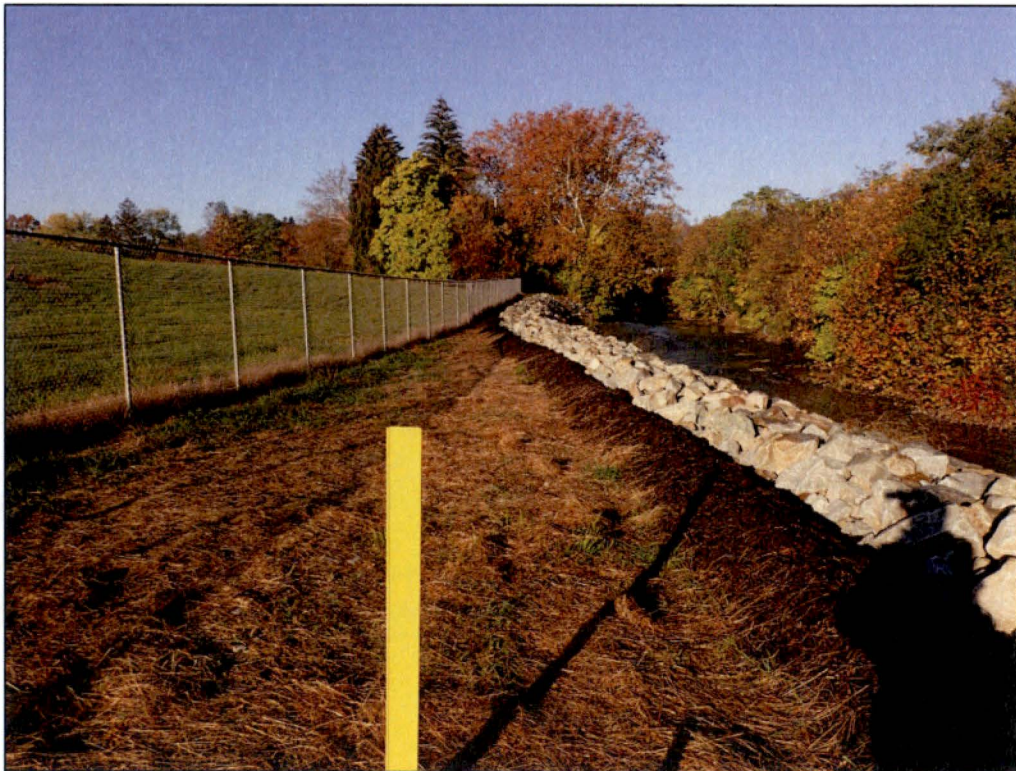
*PL-6. West End of Riprap Embankment*

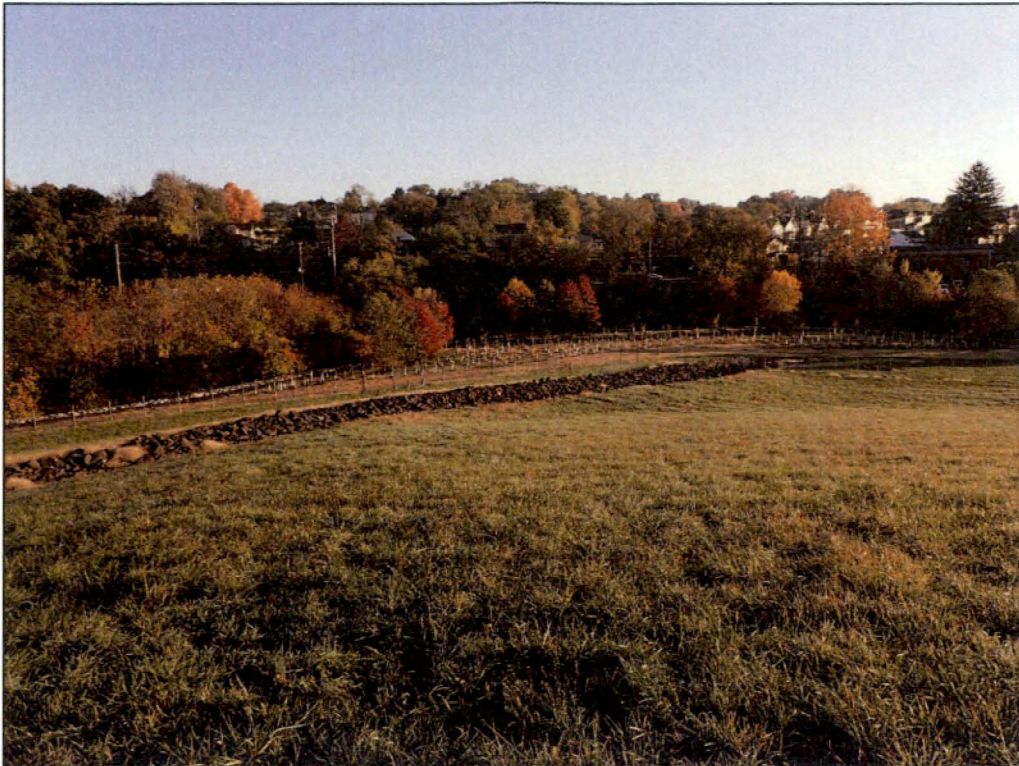
*PL-7. Newly Planted Riparian Area*

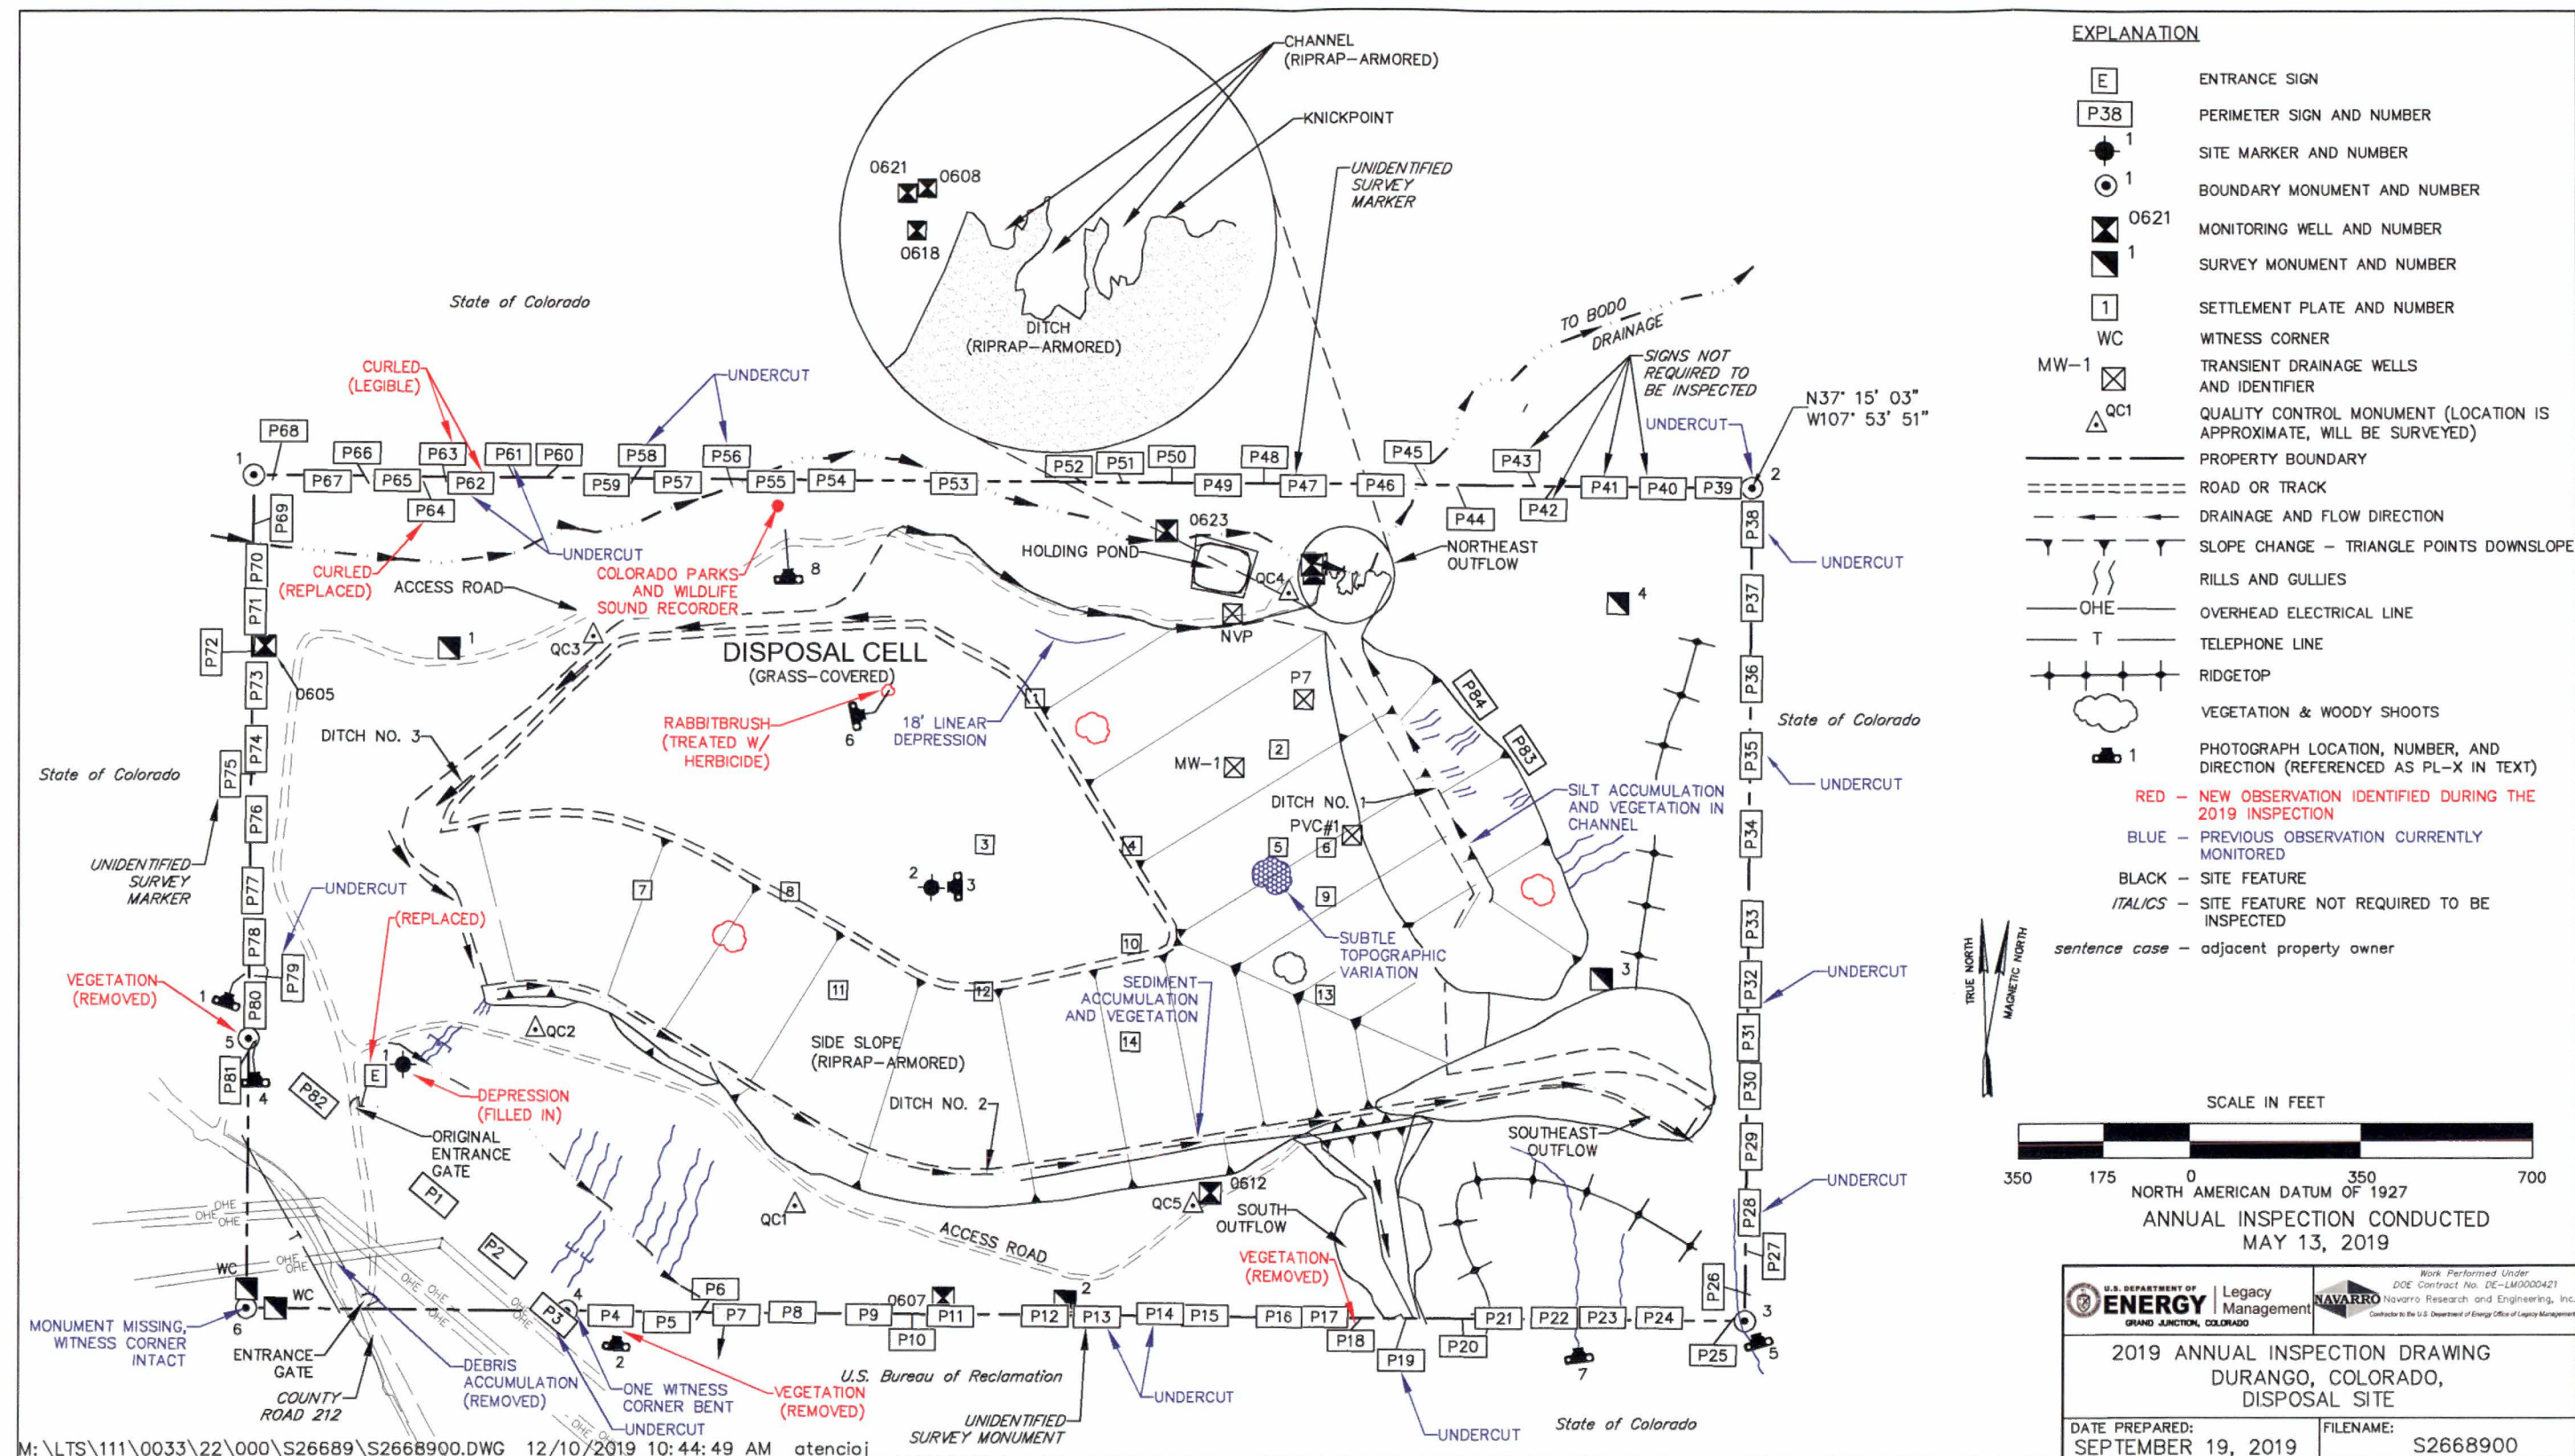
Figure 4-1. 2019 Annual Inspection Drawing for the Durango, Colorado, Disposal Site

Figure 4-1 shows the locations of site features in black, including site surveillance features and inspection areas. Site features that are present but not required by the LTSP to be inspected are shown in italic font. Observations from previous inspections that are currently monitored are shown in blue text, and new observations identified during the 2019 annual inspection are shown in red. Inspection results and recommended maintenance activities associated with site surveillance features are described in the following subsections. Photographs to support specific observations are identified in the text and in Figure 4-1 by photograph location (PL) numbers. The photographs and photograph log are presented in Section 4.11.

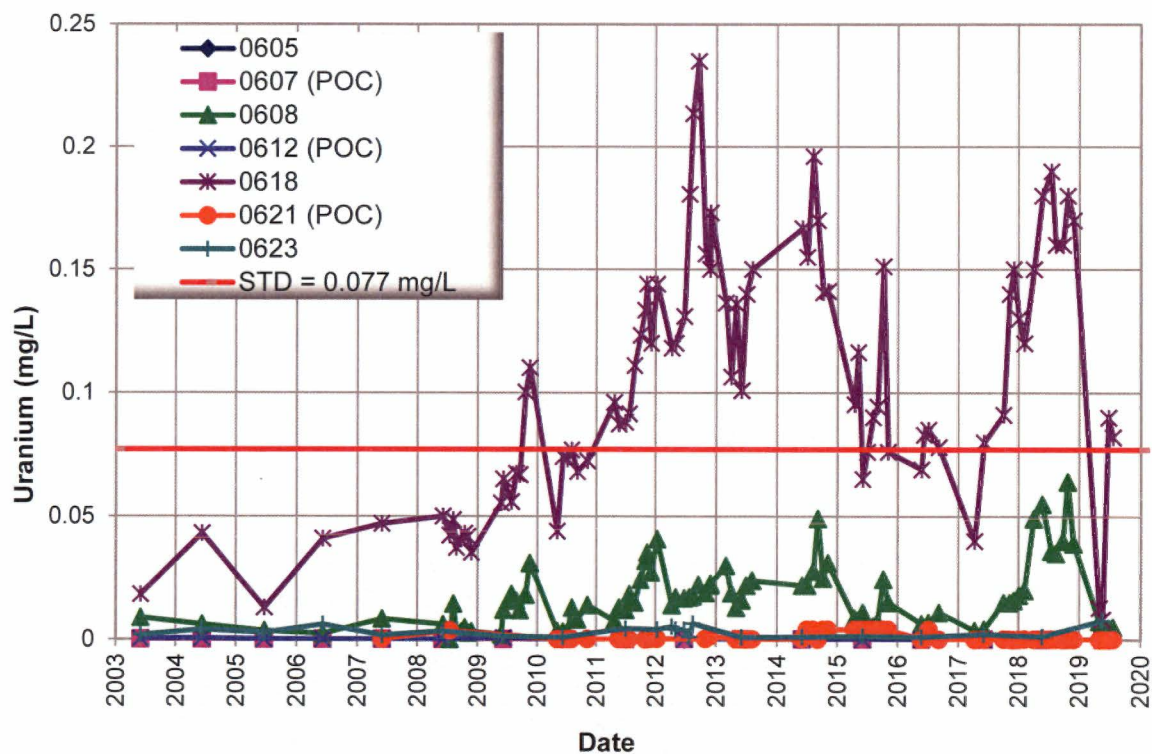
Figure 4-5. Uranium in Groundwater at the Durango, Colorado, Disposal Site

Wells completed in the alluvium are sampled as a BMP. Uranium concentrations in well 0618 have consistently been higher than concentrations in the other wells onsite. To monitor and

compare the elevated and variable uranium concentrations observed in this well, wells 0608, 0618, and 0621 are sampled monthly as weather permits. Figure 4-5 shows variable uranium concentrations between 0.04 milligrams per liter (mg/L) and 0.24 mg/L in well 0618 beginning in 2009 and continuing to the present. In 2019, uranium concentrations in well 0618 decreased from 0.18 mg/L to 0.02 mg/L—a value slightly below the minimum measured concentration—and then increased to 0.09 mg/L, which is within the range of measured historical concentrations. Investigating the cause of this variability at well 0618 continues.

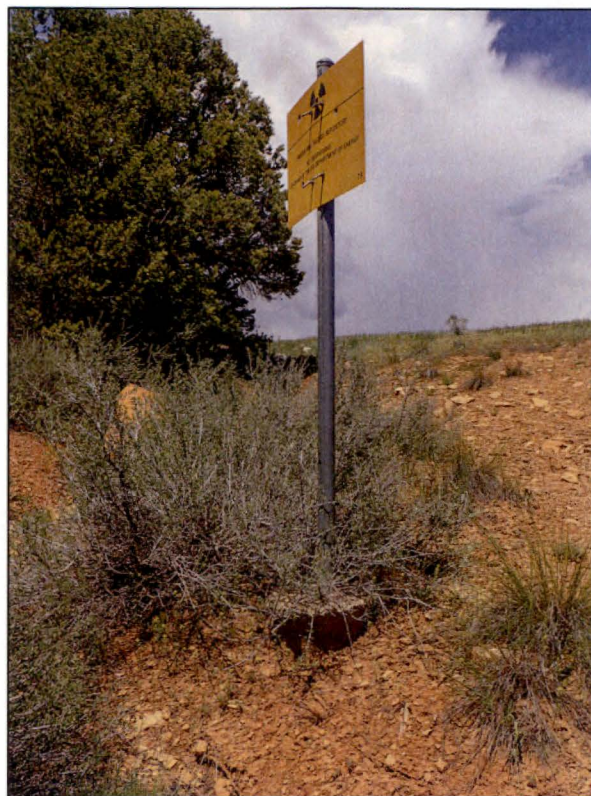
*PL-1. Concrete Base of Perimeter Sign P79 (Undercut by Erosion)*
